TECHNICAL REPORT

PACIFIC AREA EVALUATION OF A COMMERCIAL OMEGA

NAVIGATION SYSTEM INSTALLED IN

A VC-118 AIRCRAFT.
Supplement I.

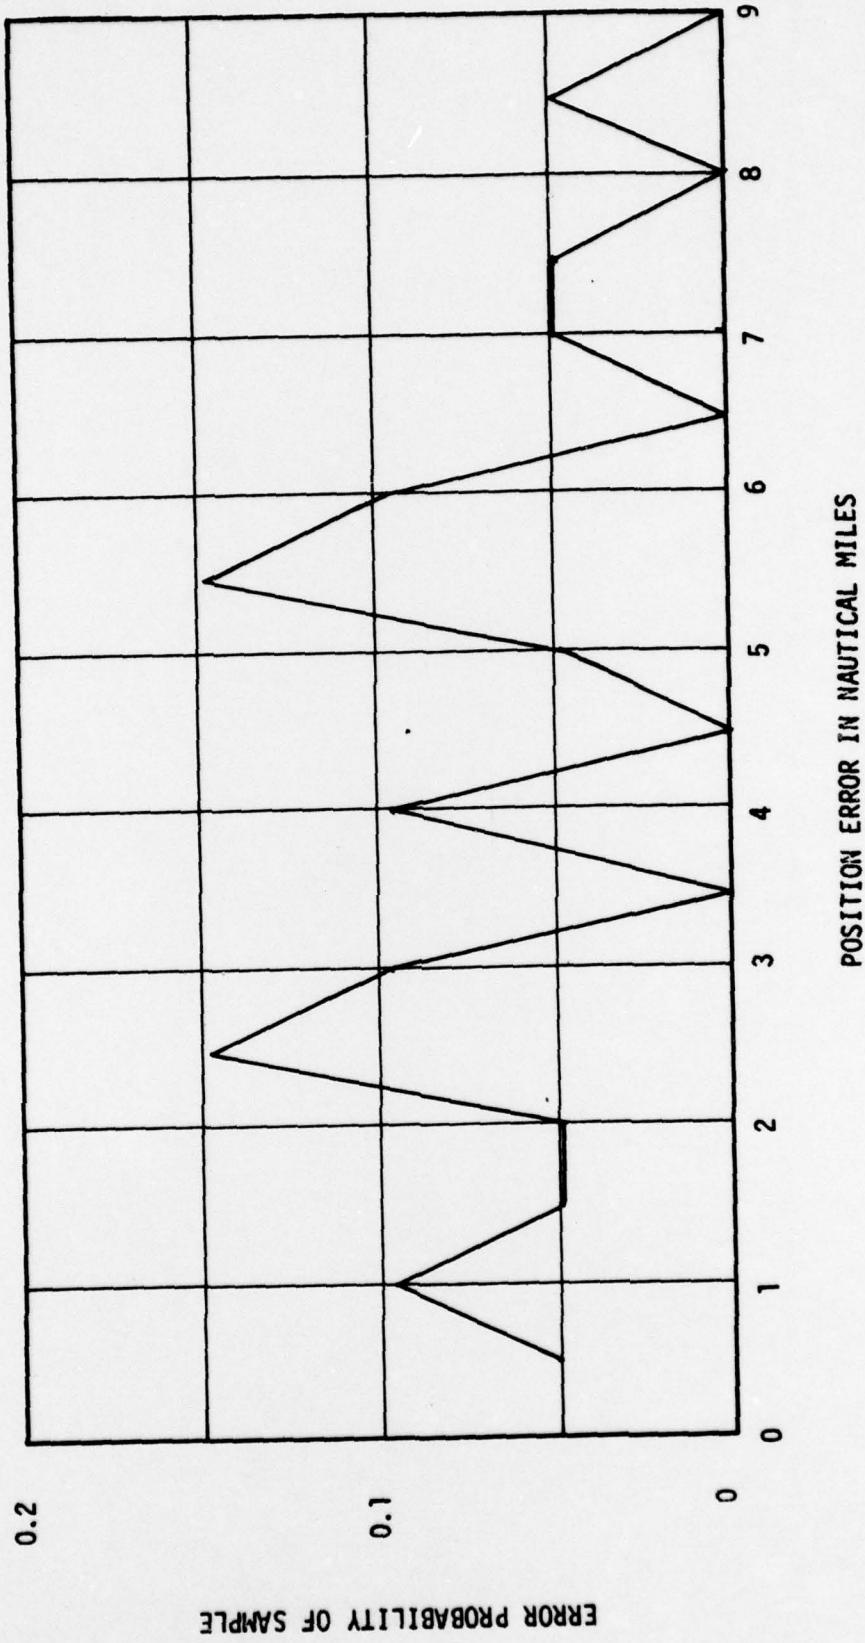
FIGURE 1. NAVIGATION ACCURACY: PROBABILITY DISTRIBUTION FOR MARK-ON-TOP DATA SAMPLE

5. The mark-on-top data points showed an average error of 3.80 nautical miles with a standard deviation of 2.280. The ONS was accurate to within 7.0 nautical miles in better than 90% of the samples, even though the TAS had not been continuously updated. The electronic/celestial data points showed an average error of 6.24 nautical miles. Additional data is found in enclosure (3).

The sample probability distribution for mark-on-top fixes is shown in figure 1 and for electronic/celestial fixes is shown in figure 2.

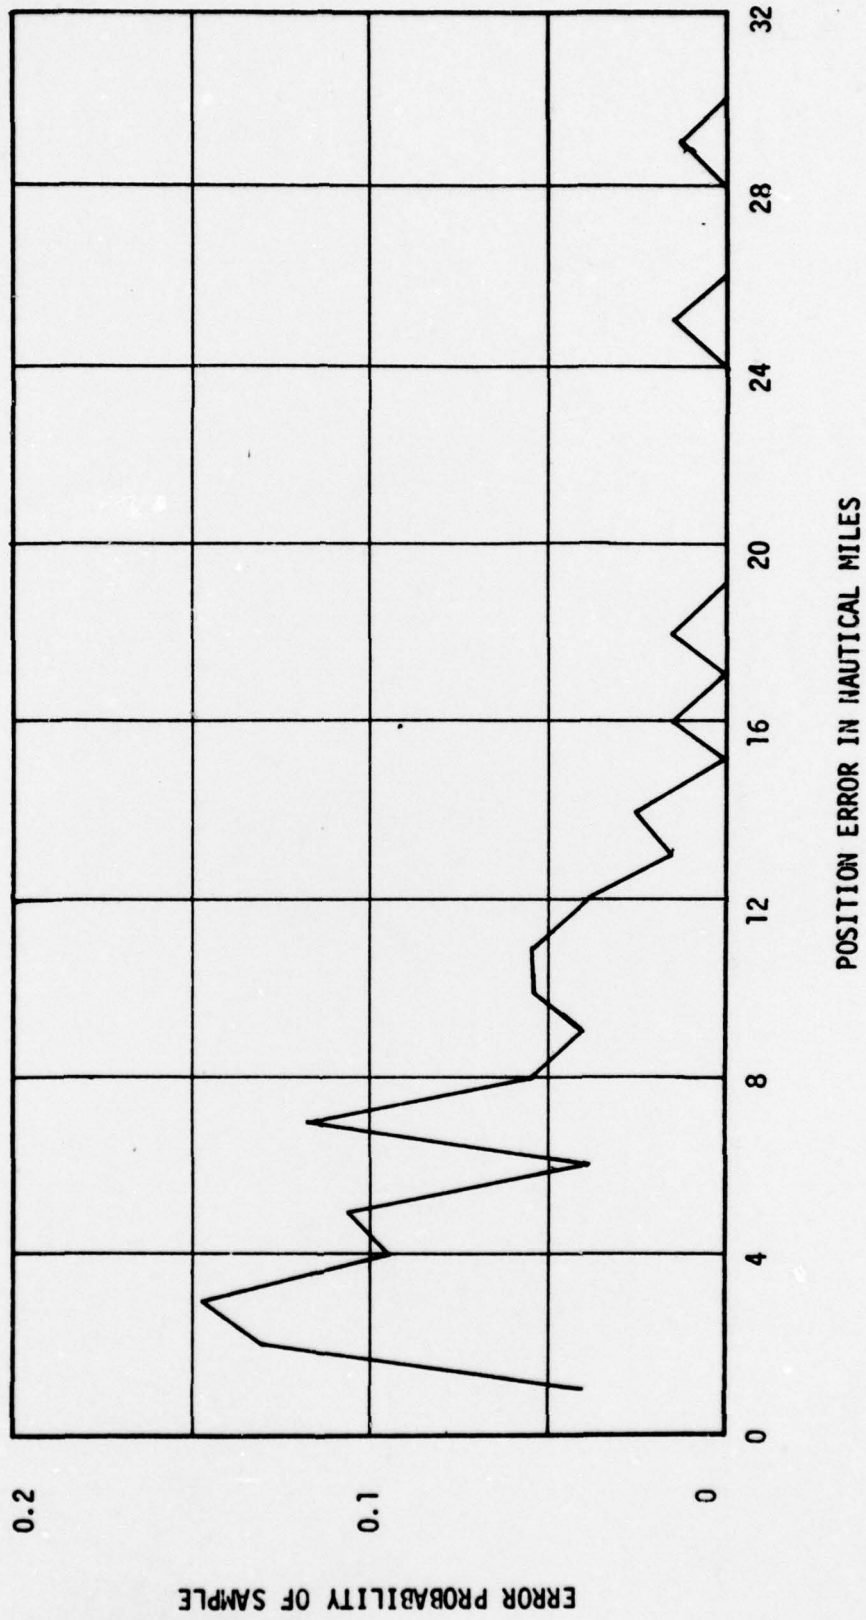
FIGURE 2. NAVIGATIONAL ACCURACY: PROBABILITY DISTRIBUTION FOR ELECTRONIC/CELESTRIAL DATA SAMPLE
