TECHNICAL REPORT HL-79-5

SHOALING IN HARBOR ENTRANCES

Hydraulic Model Investigation

Hydraulics Laboratory

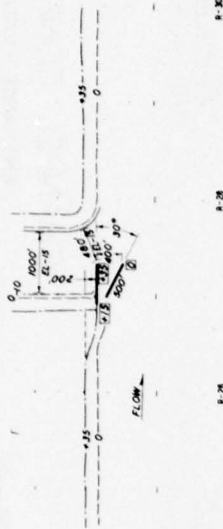
CHANNEL CONFIGURATION
 REVISED CHANNEL ALIGNMENT
 STRAIGHT REACH ENTRANCE
 BASE, AND PLAN D-6 EXTENDED TESTING
