REPORT NO. FAA-RD-79-3

THE ANALYSIS OF NATIONAL TRANSPORTATION SAFETY BOARD SMALL SINGLE-ENGINE FIXED-WING AIRCRAFT ACCIDENT/INCIDENT REPORTS FOR THE POTENTIAL PRESENCE OF LOW-LEVEL WIND SHEAR.

MAY 1979

FINAL REPORT

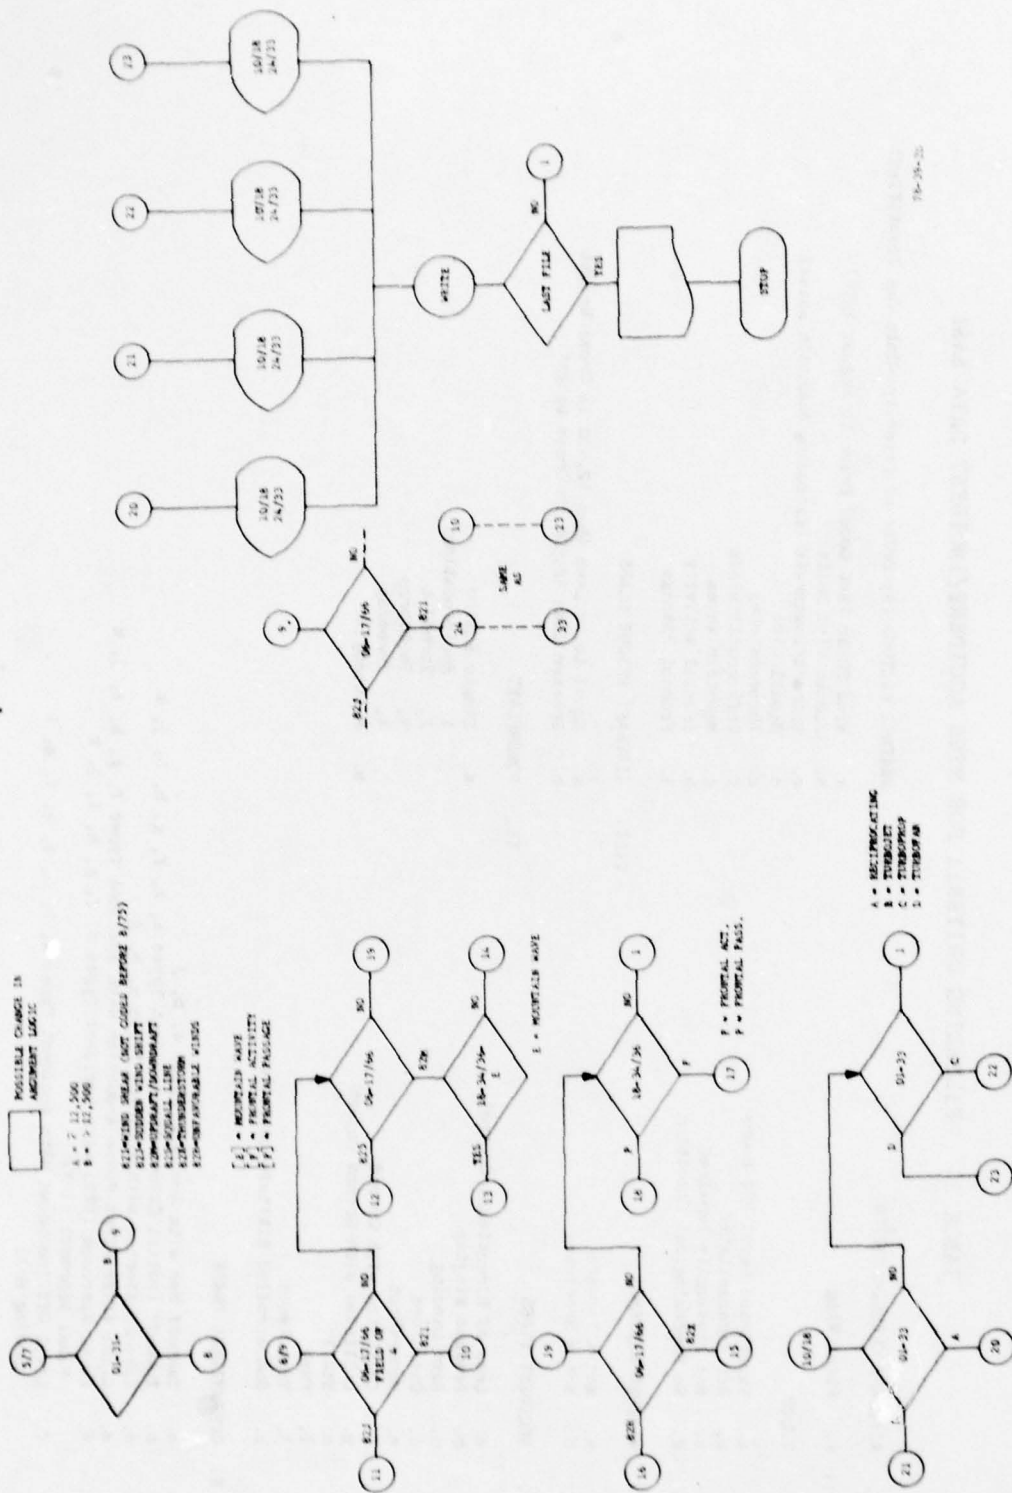
18-34-33

FIGURE 2. COMPUTER FLOW DIAGRAM FOR SCREENING NTSB DATA BASE (SHEET 2 of 2)

The flow diagram for the software to screen the NTSB data base is shown in figure 2, using the NTSB coding defined in reference 7. An expansion of the software-controlled filtering is shown in table 1. Incorporated into the program was a subroutine to generate an output summary for each
