6 CHARACTERIZATION OF ELECTRICALLY ACTIVE DEFECTS IN Si USING CCD IMAGE SENSORS.

Texas Instruments Incorporated

9 Final Technical Report,  
30 Jul 1976 - 31 Jan 1978

CHARACTERIZATION OF ELECTRICALLY ACTIVE  
DEFECTS IN SI USING CCD IMAGE SENSORS

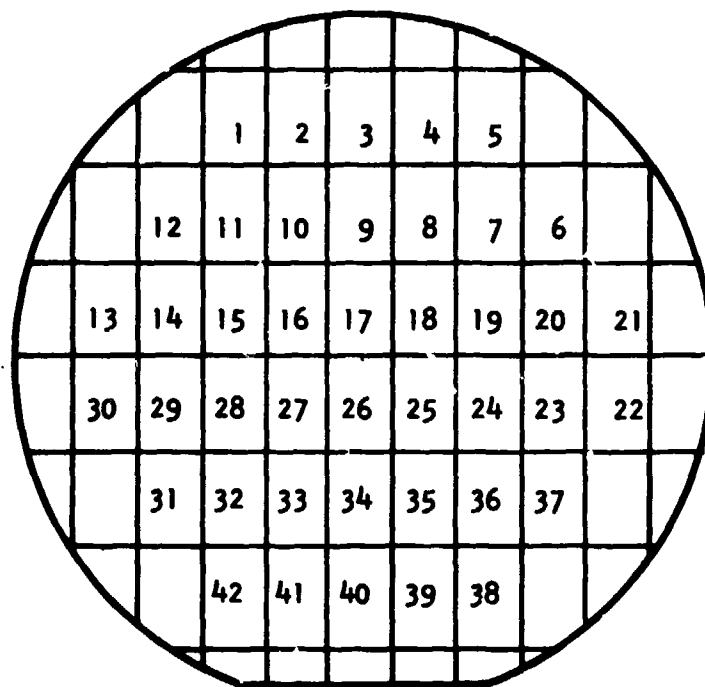
Figure 1 Device Number Positions on 7.6 cm Slices

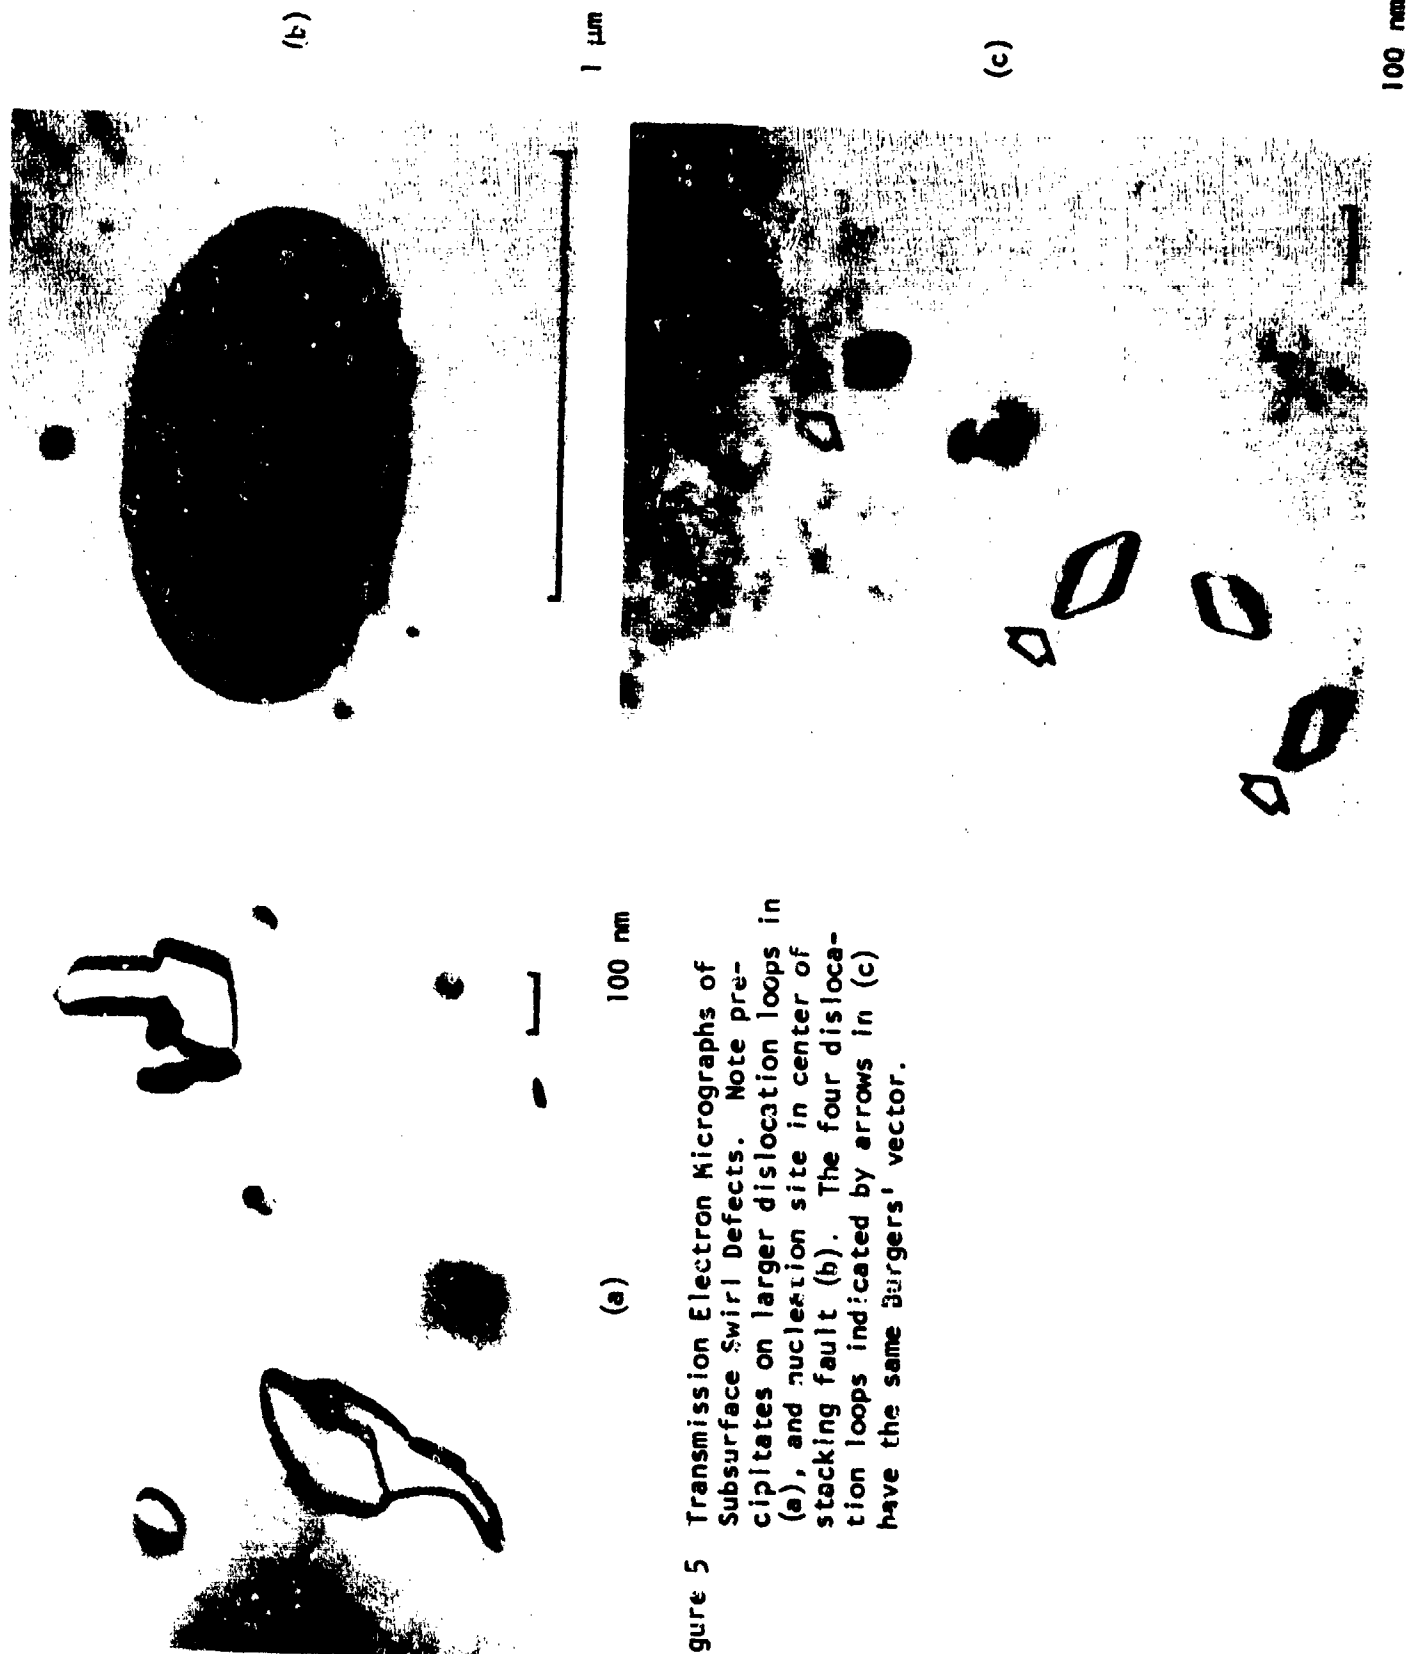
Figure 5 Transmission Electron Micrographs of Subsurface Swirl Defects. Note precipitates on larger dislocation loops in (a), and nucleation site in center of stacking fault (b). The four dislocation loops indicated by arrows in (c) have the same Burgers' vector.

At about  $5 \mu\text{m}$ , dislocations and stacking faults were seen. Typical examples of these are shown in Figure 5. The density of dislocation loops was  $\sim 100$  per pixel ( $\sim 10^7 \text{ cm}^{-2}$ ), while the density of stacking faults was  $\sim 1$  per 30 pixels ( $\sim 5 \times 10^3 \text{ cm}^{-2}$ ) in an  $\sim 1 \mu\text{m}$  thick sample taken from the high defect density regions of the material. No diffraction patterns could be obtained from any of the observed precipitate particles. The size and density of defects were found to be the same in regions under both the channels and the channel stops. The stacking faults, when imaged under conditions such that the stacking fault fringe should be out of contrast for a perfect stacking fault, revealed a residual fringe contrast (Figure 6). This is indicative of an adsorbed impurity on the stacking fault (see Section V).

Dislocation loops in similar material have been reported by Tice and Tan<sup>2,3</sup> and by Schwuttke.<sup>4</sup> They concluded that the dislocation loops originated by prismatic punching. Certainly Figure 5(c) is consistent with this assignment.

The stacking fault in Figure 5(a) is remarkable in that it has a precipitate particle at its center. Similar types of stacking faults have recently been reported and discussed by Maher, et al.,<sup>5</sup> and by Patel, et al.<sup>6</sup>

understand the occurrence of this precipitation in our devices, some additional experiments were performed. First, a series of slices was processed, with two being pulled after each high temperature step. Subsequently, all slices were studied using transmission x-ray topography. It was found that the precipitation was not visible after boron channel stop deposition, but prior to the boron drive/thick oxide growth step; however, it was visible in the topographs after the boron drive/thick oxide growth. Additional experiments were performed at 1000°C. By study of transmission x-ray topographs, it was observed that the precipitation was visible after a one-hour/withdrawal/two-hour cycle, but not when the material was left in the furnace the entire three hours. It is not clear exactly what is happening during the cooldown, but it seems reasonable to assume that prismatic punching occurs, followed by accelerated precipitation on the dislocations during the subsequent heat treatment. This would explain the precipitates on dislocations in Figure 5(a).

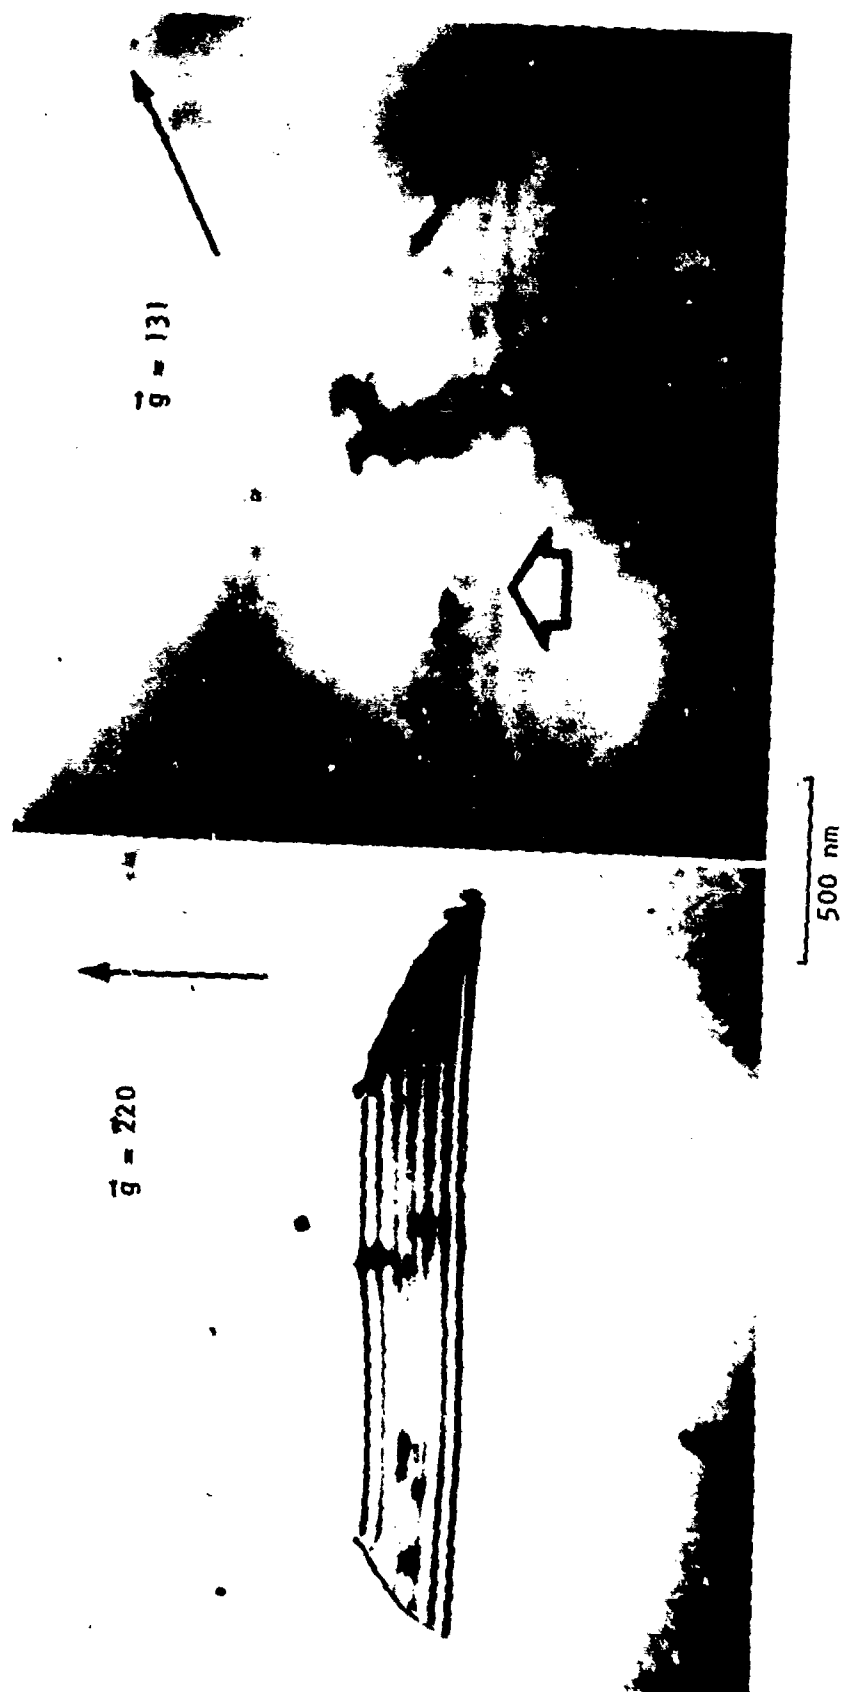
Figure 6 Stacking Fault Underneath a Channel. Residual contrast (open arrow) when  $\vec{g} = 131$  shows stacking fault has an adsorbed impurity.

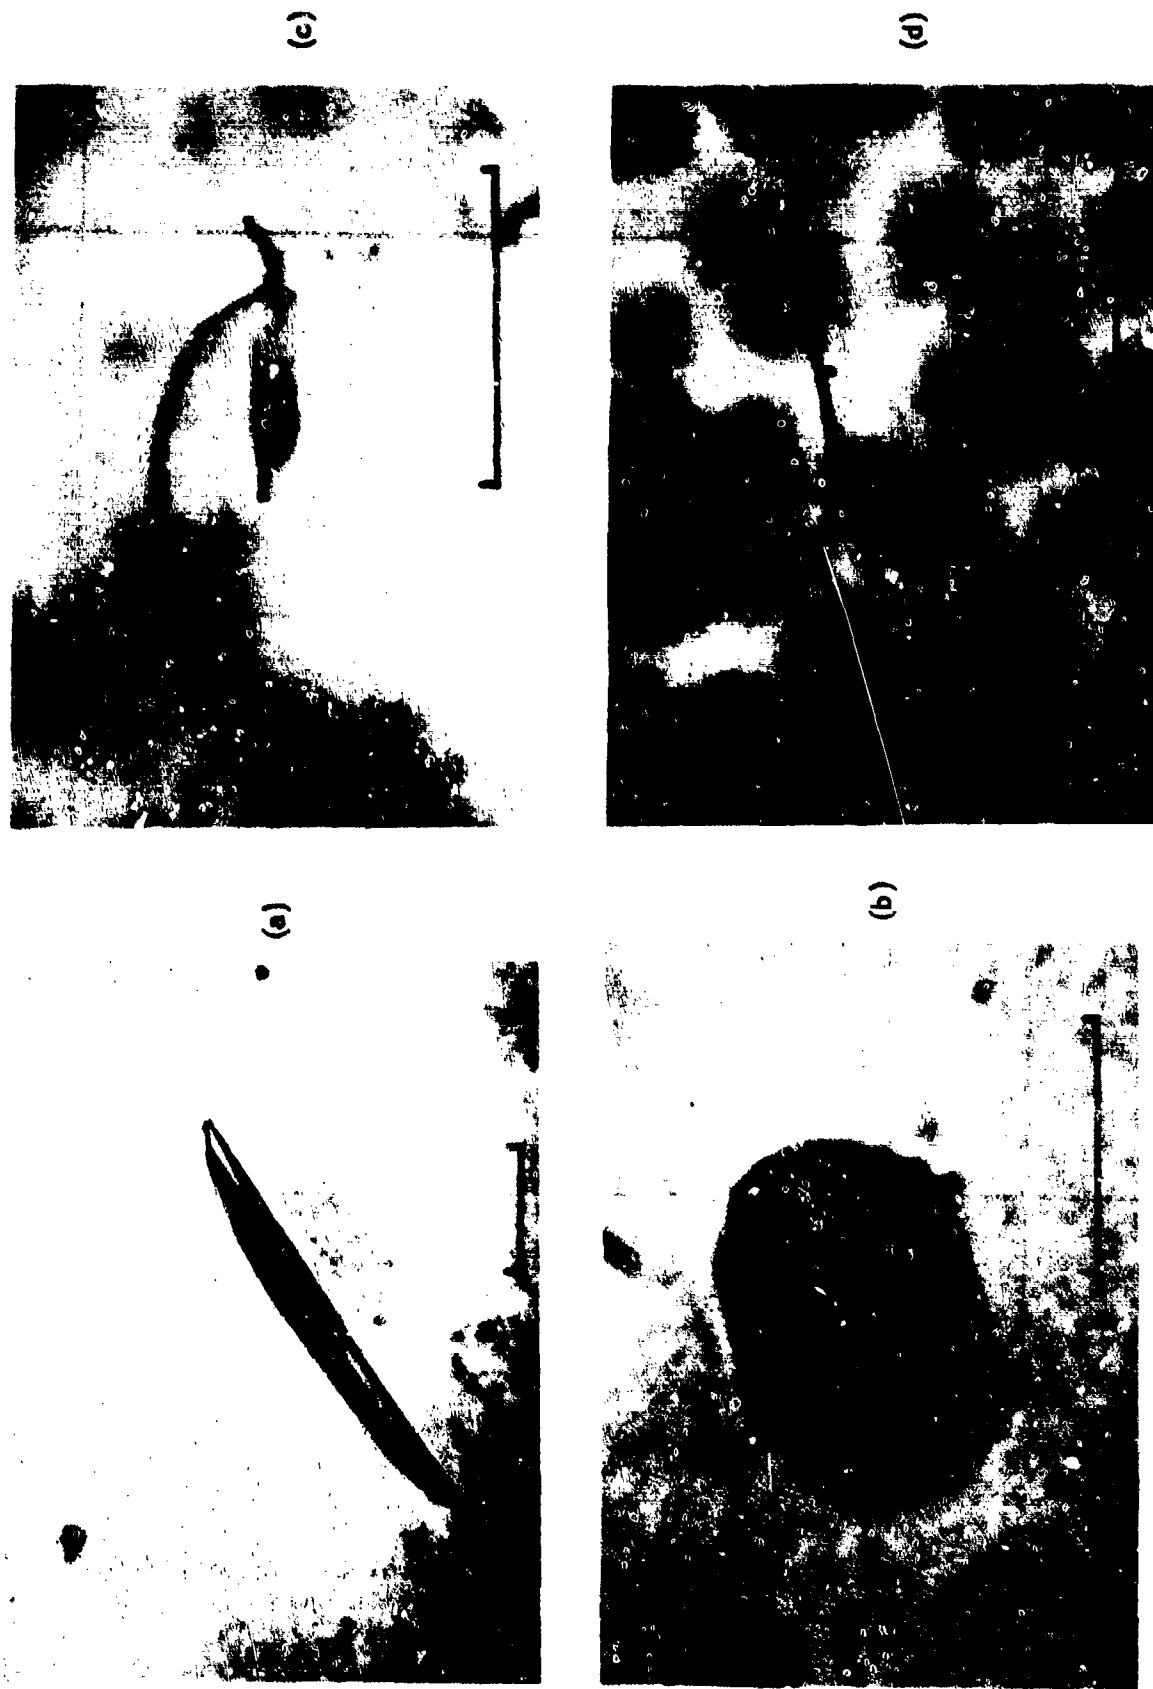
Figure 9 TEM Micrographs of Defects in Czochralski - Control Group Devices. (a) and (b), stacking faults in channel stops; (c) and (d), dislocations in channels. All markers = 0.5  $\mu\text{m}$ .

Samples for transmission electron microscopy were taken from regions of imagers that showed the highest density of defects. Typical defects seen in this material are illustrated in Figure 9. Stacking faults [Figures 9(a) and 9(b)] were seen only in the channel stops. Approximately 90% of these stacking faults were found to be located underneath the polysilicon gate (Figure 10). The length of the stacking faults varied from approximately  $0.5 \mu\text{m}$  to  $10 \mu\text{m}$ . Most were under  $1 \mu\text{m}$  in length. No precipitates were observed on any of these faults. Dislocation loops were

Dislocations such as those seen in Figure 9 cannot originate by a simple glide mechanism; that is, they cannot originate at some point in the crystal and move by slip to their present position because the plane containing both the dislocation line and the Burgers vector of the dislocation is a (100) plane and not a slip plane, which must be of the type (111). There are three mechanisms by which these pure edge dislocations may form: (1) through the unfauling of a stacking fault, (2) through the formation of the dislocation at the surface and the subsequent climb of the dislocation by the emission or absorption of silicon interstitials or vacancies, and (3) through a dislocation reaction such as  $\frac{1}{2}\langle 10\bar{1} \rangle \rightarrow \frac{1}{2}\langle 1\bar{1}0 \rangle + \frac{1}{2}\langle 01\bar{1} \rangle$ . Of these mechanisms, the first seems the most probable. In Section V, where the unfauling of stacking faults is studied, it is concluded that immediately after the unfauling process, if the Shockley partial is nucleated at the surface intersection of the Frank partial, the defect that should be observed is a dislocation in a predominantly  $\langle 110 \rangle$  direction with Burgers vector  $\frac{1}{2}\langle 1\bar{1}0 \rangle$  surrounding an interstitial plane of atoms. Both of these criteria are met by all of the dislocation loops we have studied. We conclude that the defects seen in this material originate from the same source, namely, the growth of a stacking fault.

The origin of the stacking fault is less clear. Certainly, the almost circular stacking fault with no precipitate in the center shown in Figure 9(b) is indicative of a subsurface bulk origin (see Section V). That most of the defects are of comparable size further supports that they are also nucleated from a subsurface bulk mechanism. The small size, however, suggests

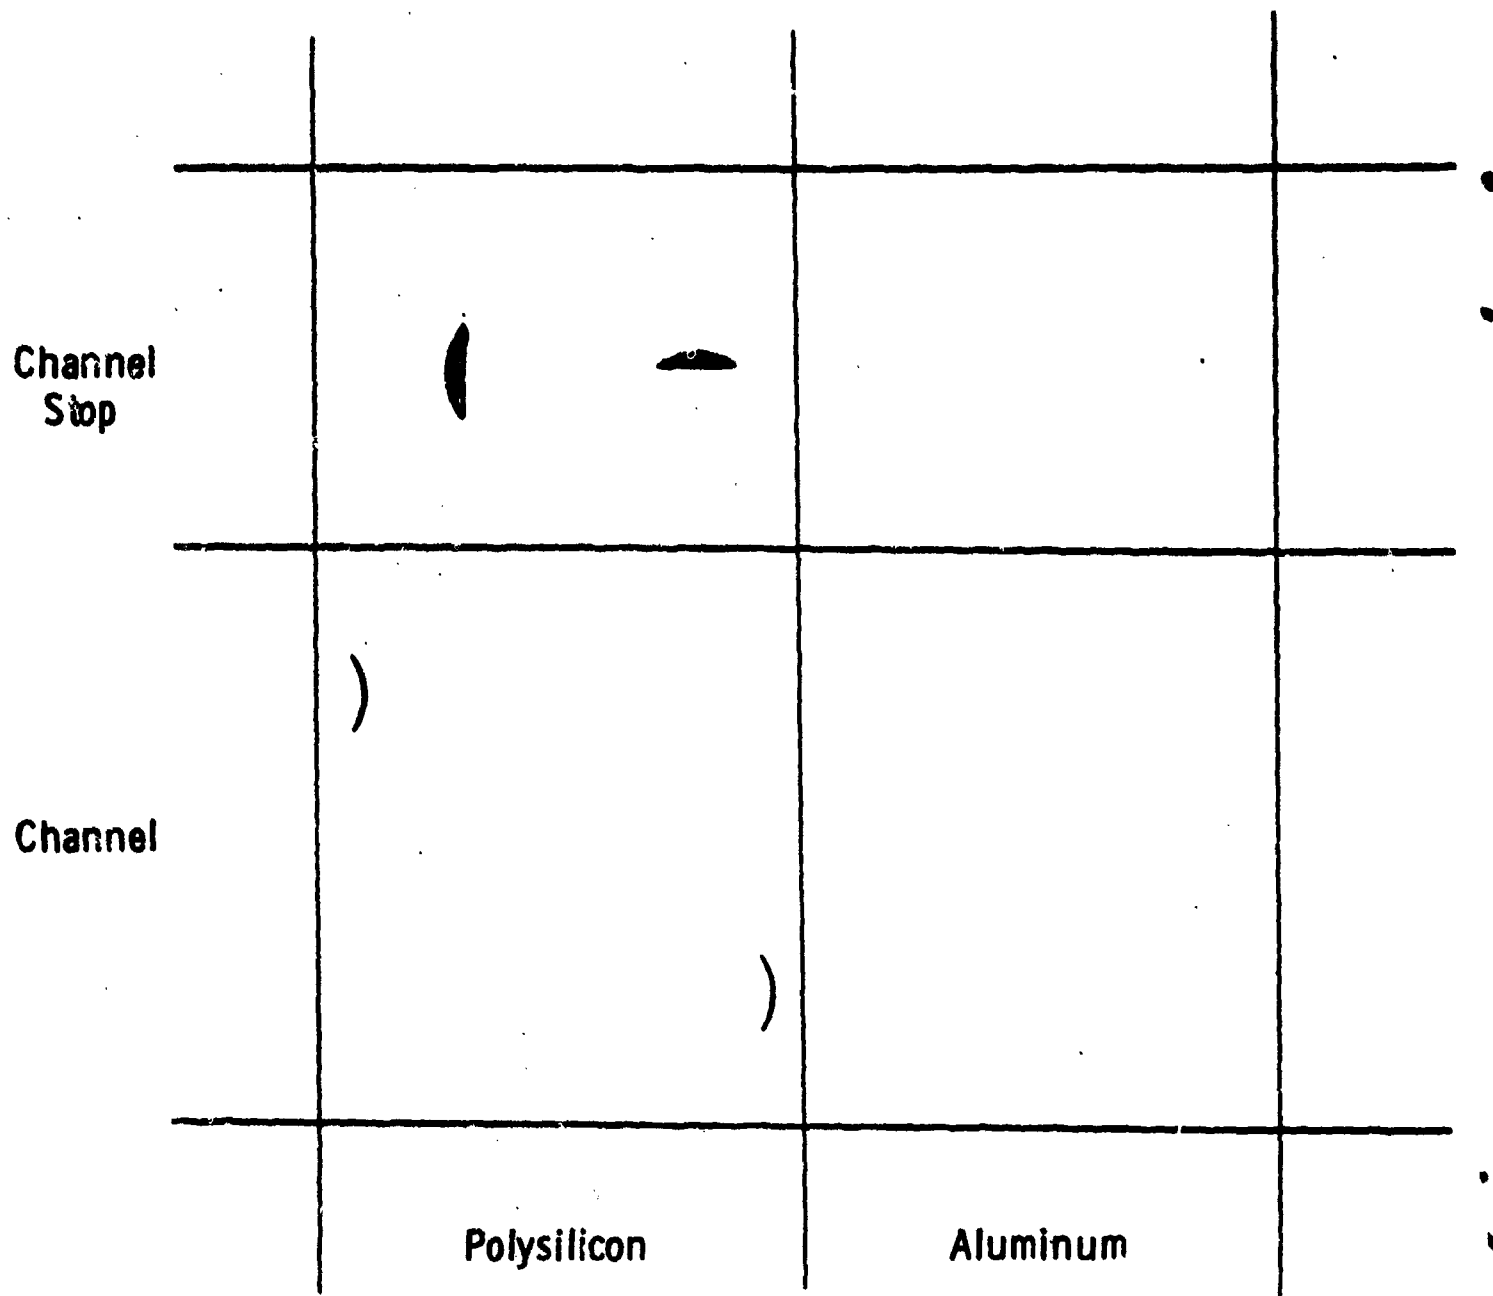
Figure 10 Distribution of Defects in Czoehralski - Control Group. Stacking faults in channel stops, and dislocation loops in channels, both predominantly under the polysilicon electrode.

As depicted in Figure 10 the distribution of defects, which is device dependent, could arise from a device-dependent nucleation mechanism, or a random nucleation mechanism, and a device-dependent annihilation mechanism. With the data at hand, it is impossible to distinguish which of these two mechanisms is at work, and plausible arguments for either may be made. If copper is, in fact, the nucleating agent of the stacking faults, then it is possible that the distribution of copper near the surface is device-dependent. Section V presents evidence that the source of copper for one mode of precipitation is the surface. If the amount of copper at the surface were a function of the thickness of the oxide and the presence of the overlying polysilicon, then the distribution of defects could be explained. An additional role played by the edges of the polysilicon would be to stress-assist the unfauling of the stacking fault, eliminating all stacking faults in this region.

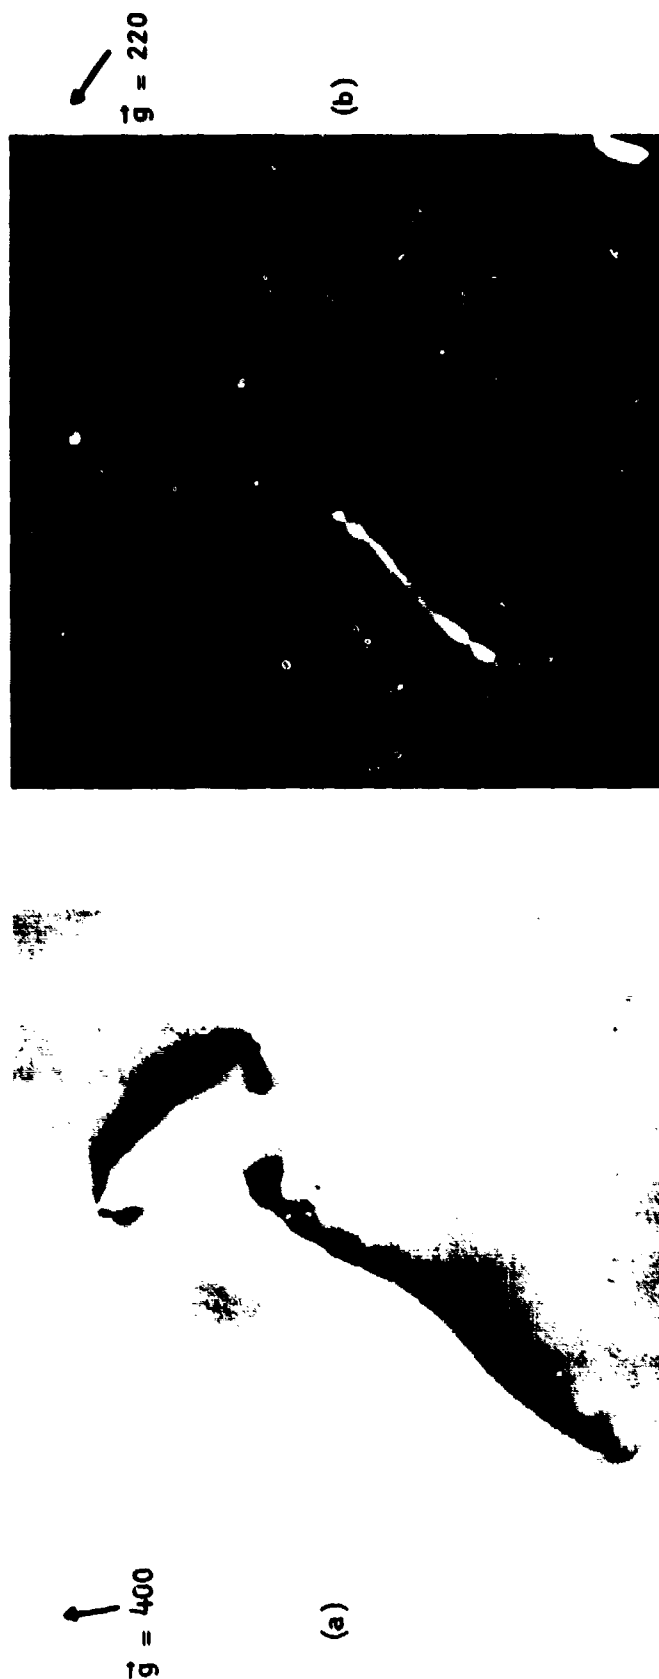
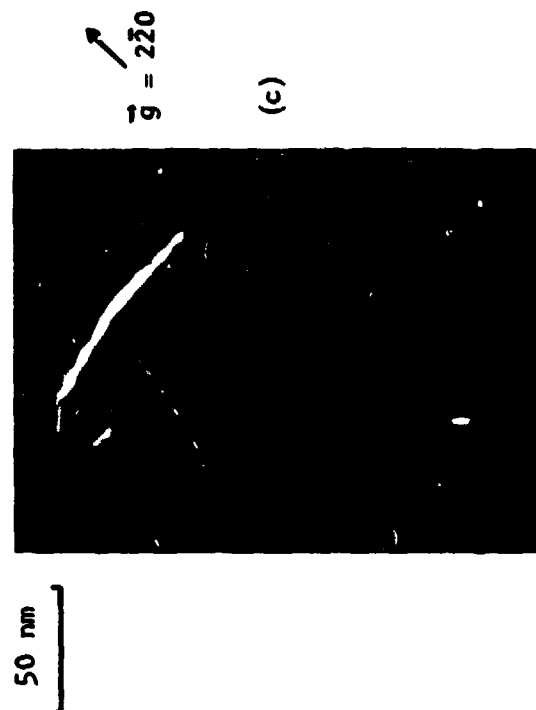
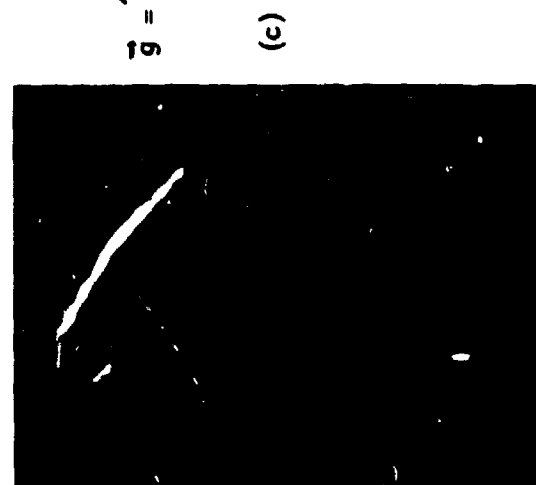
Figure 11 Dislocations in Channel Stops.  
(a) Bright field, (b) and (c) weak beam. Portions of the long dislocation line are dissociated.

Weak beam experiments were conducted on some of the dislocations in the TEM. Typical results are shown in Figure 11. These defects were found in the channel stops. The ends of the dislocations were frequently found to be dissociated on a (111) plane containing both the Burgers vector and dislocation line. The traces of these planes on the surface of the sample are perpendicular to the projection of the dislocation line.

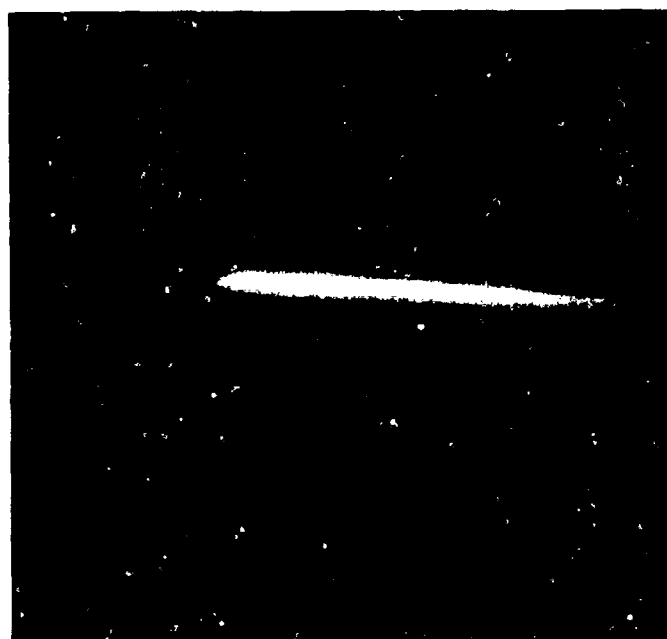
Figure 12 Weak Micrograph of Edge Dislocation in Channel. Only the end is dissociated.

A weak beam micrograph of a typical dislocation in the channel is shown in Figure 12. Only the end of the dislocation was generally found to be dissociated.

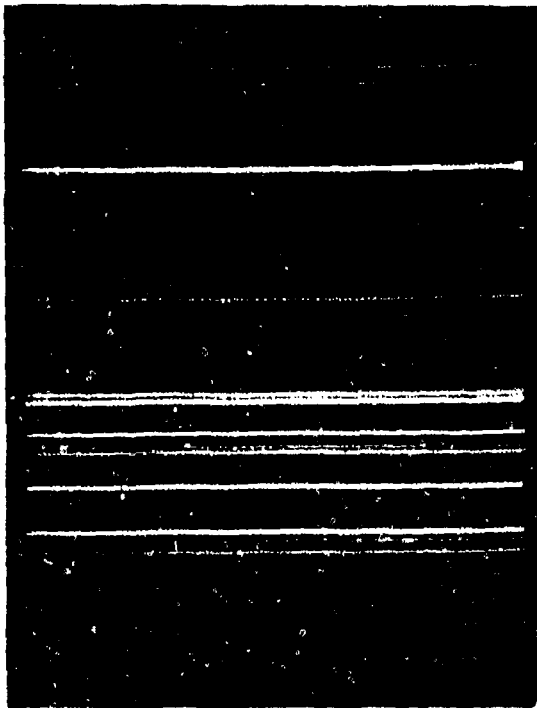
Figure 13 Dark Current Patterns - Float-Zoned Group

Dark current patterns from imagers on float-zoned material fell into two distinct categories. Devices in the central region of one slice and about the periphery of all slices showed dense patches of dark current lines running in  $\langle 110 \rangle$  directions on the slice [Figure 13(a)]. Devices outside of these regions showed a moderately low density of randomly distributed isolated dark current spikes [Figure 13(b)].

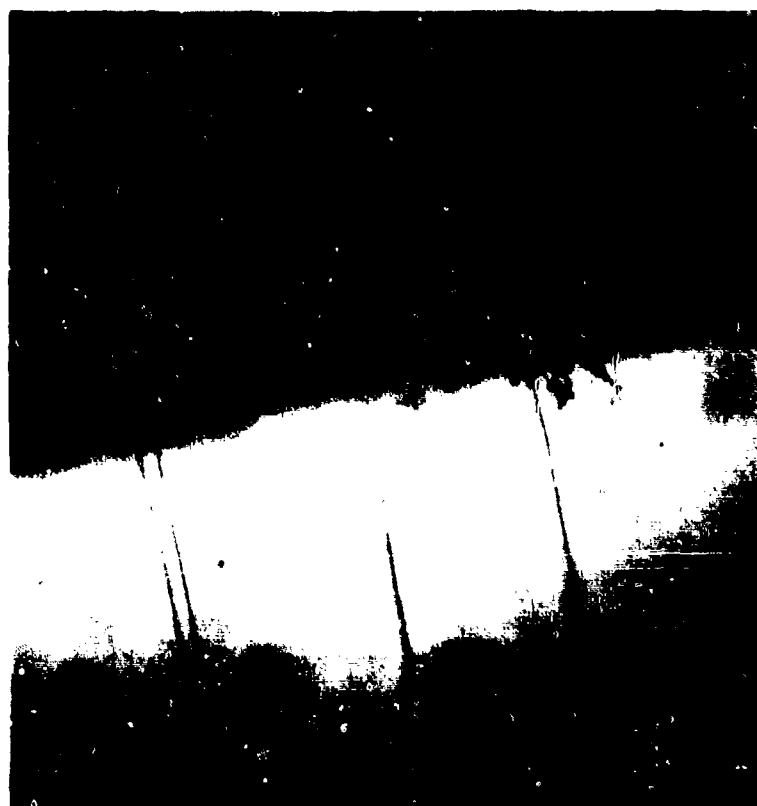
Polysilicon

Aluminum

Channel

Channel Stop

Figure 17 Transmission Electron Micrograph of 60° Dislocations Near Front Surface of Float-Zoned Wafer

In samples taken from devices near the center of the slice, long lengths of dislocation line, very close to the surface, were found to be oriented either parallel or perpendicular to the channels and channel stops. Contrast experiments show that all these dislocations are of the 60 type, i.e., their Burgers vectors are in  $\langle 110 \rangle$  directions that do not lie in the plane of the surface (Figure 17).

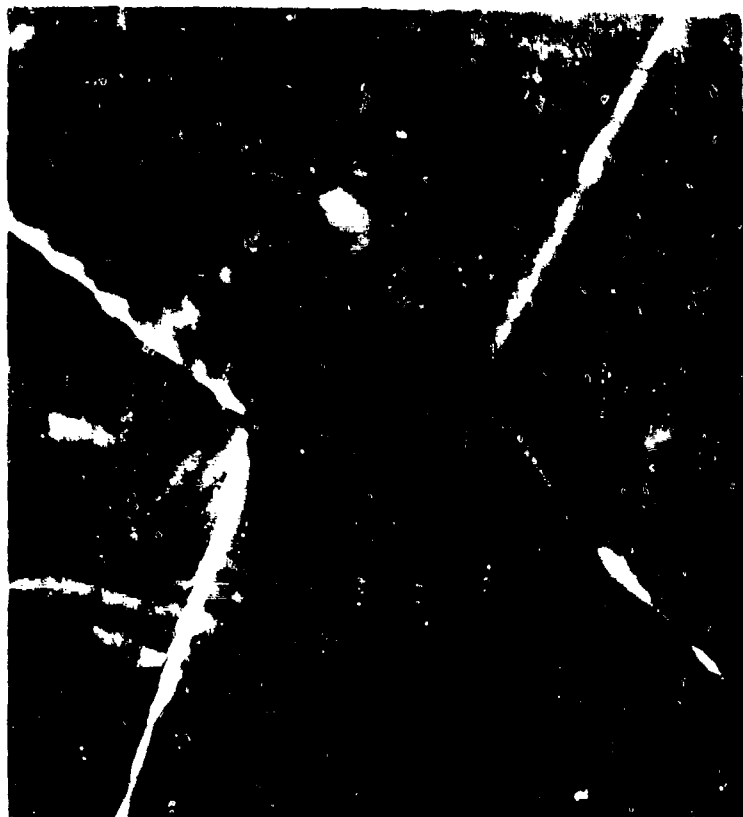
**Figure 18** Dark Field Transmission Electron Micrograph of Float-Zoned Wafer Showing Dislocation Reaction. Two perpendicular  $60^\circ$  dislocations moving on two different slip planes, but with the same Burgers vectors, have reacted to form nearly right angle configuration.

Occasionally, we find that a dislocation reaction has occurred. Figure 18 illustrates an example where two dislocations having the same Burgers vector, but lying on two different  $(111)$  planes (the traces of which are perpendicular in this figure), intersect.

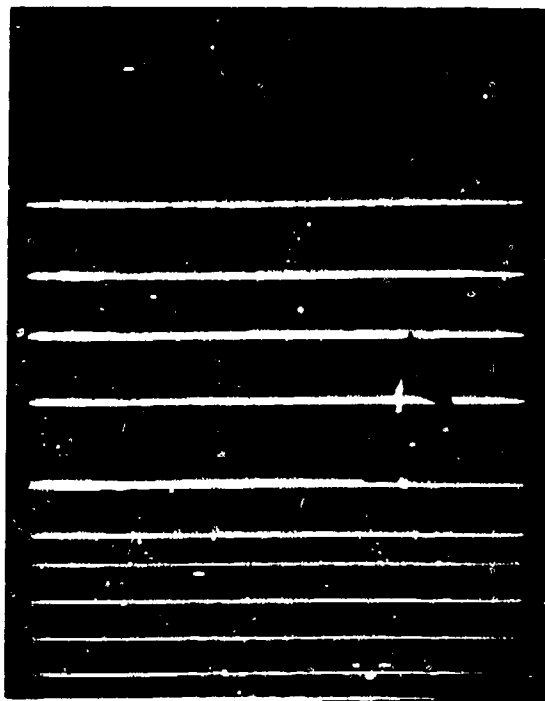
Figure 22 Dark Current Patterns - Czochralski Group I. Defect at arrow in (b) is shown in topograph, Figure 23(a).

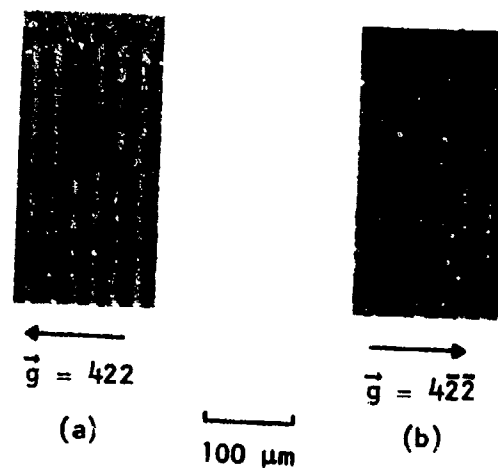
Figure 30 Reflection Topographs of Channel Stop Dislocations That are Dark Current Sources

A series of dislocations was found in one device. Two of the dislocations were dark current sources (the only dark current sources), while the remainder were not. Reflection topographs of the two dark current sources are shown in Figures 30 and 31, while two typical non-dark-current sources are illustrated in Figures 32 and 33. It will be seen that the dislocations that are dark current sources lie in the channel stop (Figure 31), while the dislocations that are not dark current sources lie in the channels. The contrast behavior of all dislocations in reflection topography shows them to be  $60^\circ$  dislocations. Transmission topography shows that all of the defects have been nucleated by surface sources. They are found only in the array region, and hence are associated with the stress field of the device superstructure.

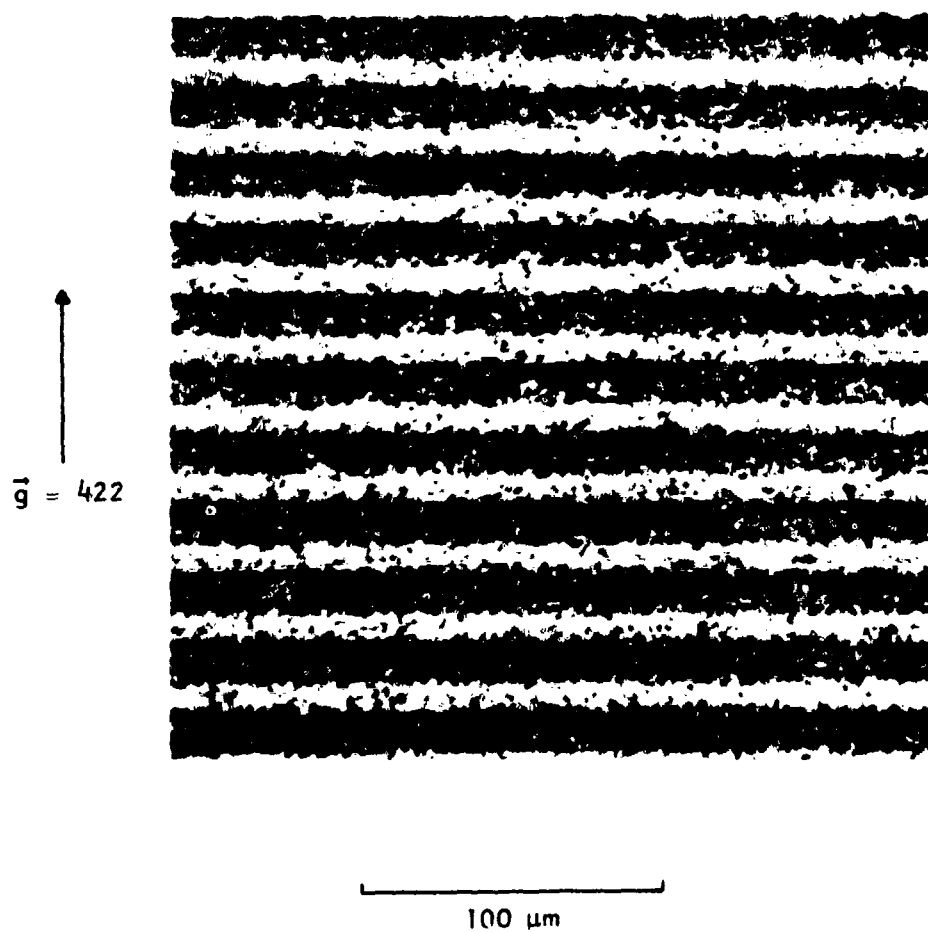
Figure 31 Topograph of Weak Dark Current Source

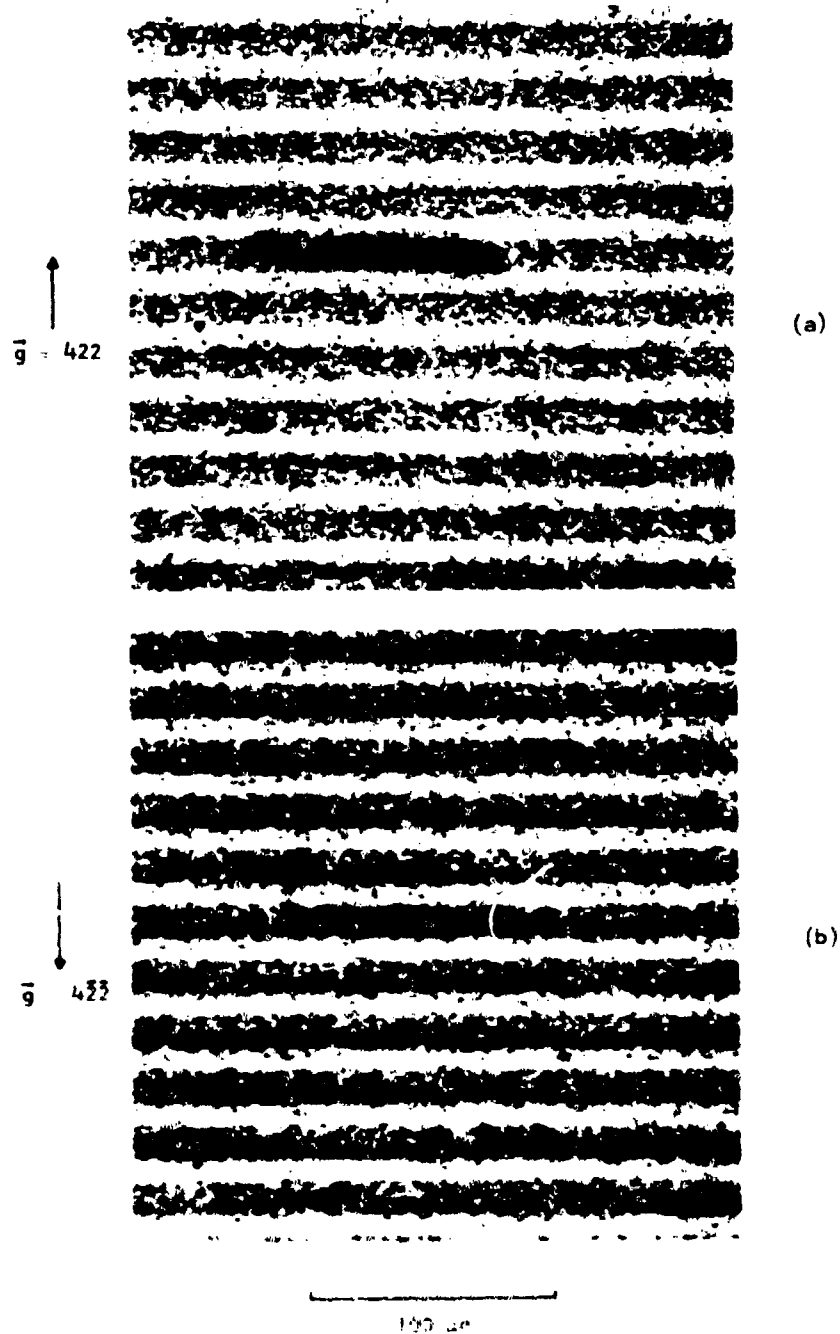
Figure 32 Electrically Inactive Dislocation in CCD Imager

The dislocations in Figures 32 and 33 are clearly in the depletion region of the device. Therefore, they must be electrically inactive. The origin of these dislocations is examined further in Section IV of this report.

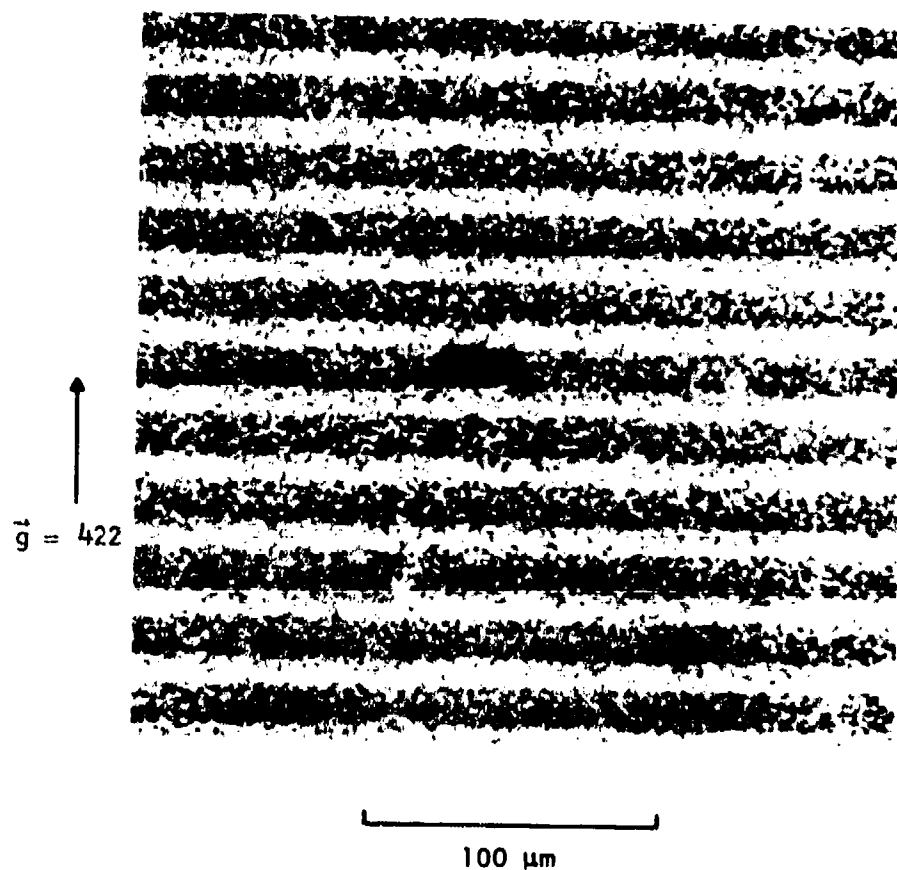
Figure 33 Electrically Inactive Dislocation in CCD Imager

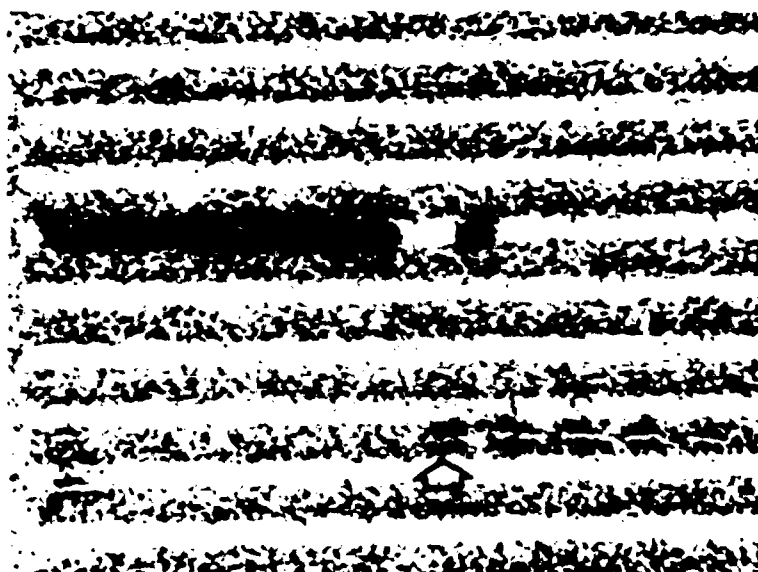
Figure 34 Enlargement of Figure 30(a). Scratch (arrow) is on regions of a channel that were overlaid with polysilicon. Part of the dislocation has been pulled out of the channel stop by the overlying polysilicon.

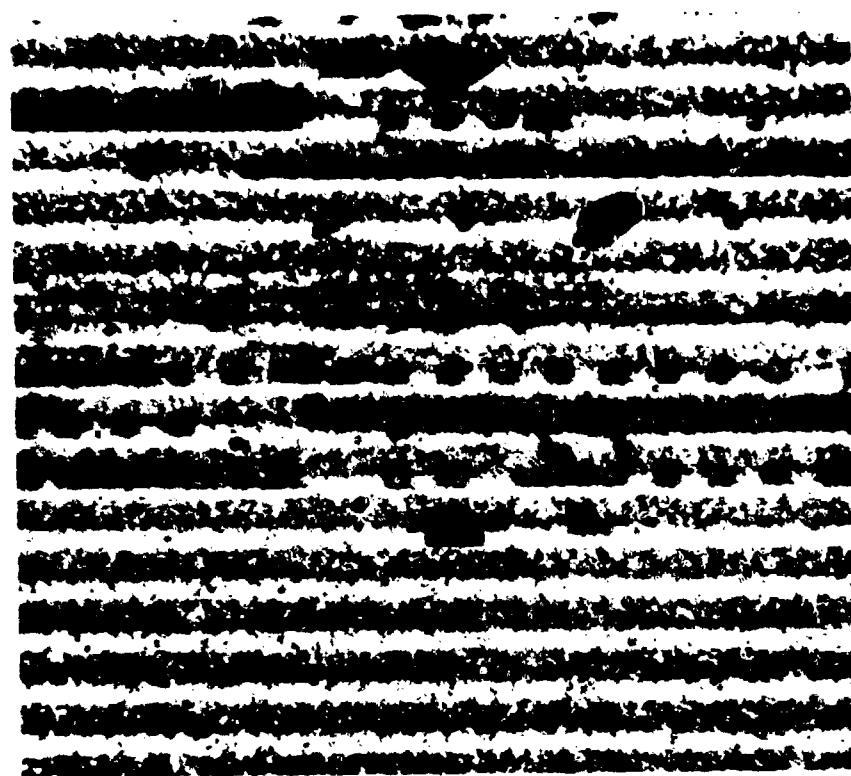
Figure 35 Dislocation Segments in CCD Imager. The segments are approximately 12  $\mu\text{m}$  long with a periodicity of 25  $\mu\text{m}$ . Segments on different channels/channel stops fall on a line perpendicular to the channels/channel stops (arrows). Thus the segments are formed by action of the polysilicon strain field on a continuous dislocation line.

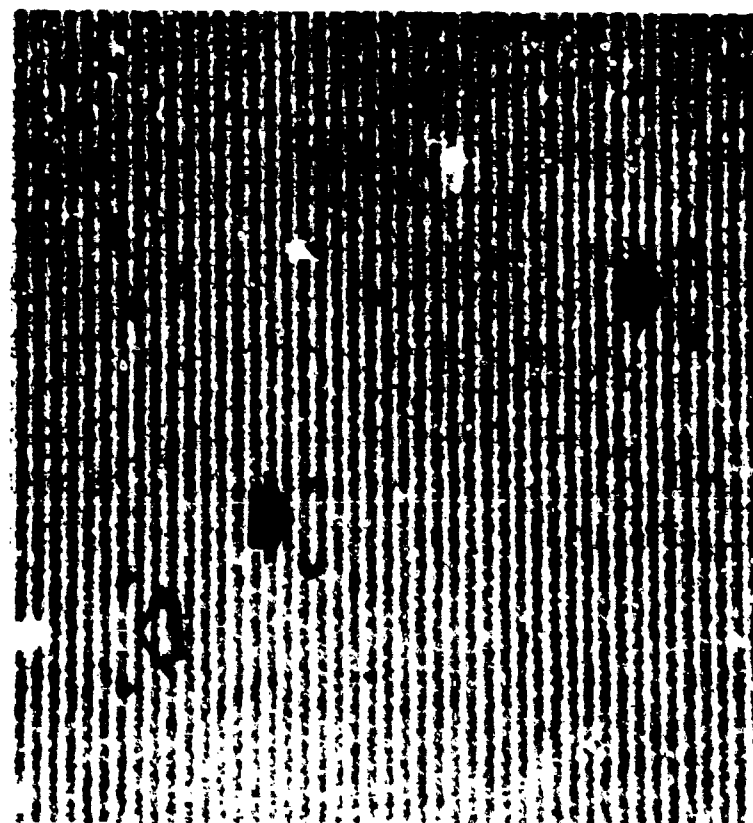
Figure 36 422 Reflection Topograph of Dislocation Loop in Channel Stops of an Imager. Solid arrows indicate electrically active loops, open arrow indicates a loop that is not a dark current source.

An additional type of dislocation capable of producing dark current is shown in Figure 36. In this topograph only the tips of the dislocations are imaged, with the bulk of the loop penetrating to some depth ( $> 20 \mu\text{m}$ ) into the silicon. Similar loops were found outside the array region of the device, in an area where the thick field oxide was grown. Their origin is obviously the thick oxide growth, but the formation mechanism is not clear. Contrast experiments showed they have a Burgers vector that is not in the plane of the surface, and their origin is probably through a slip process. The stress field of the thick oxide edge, however, is evidently not important in their formation.

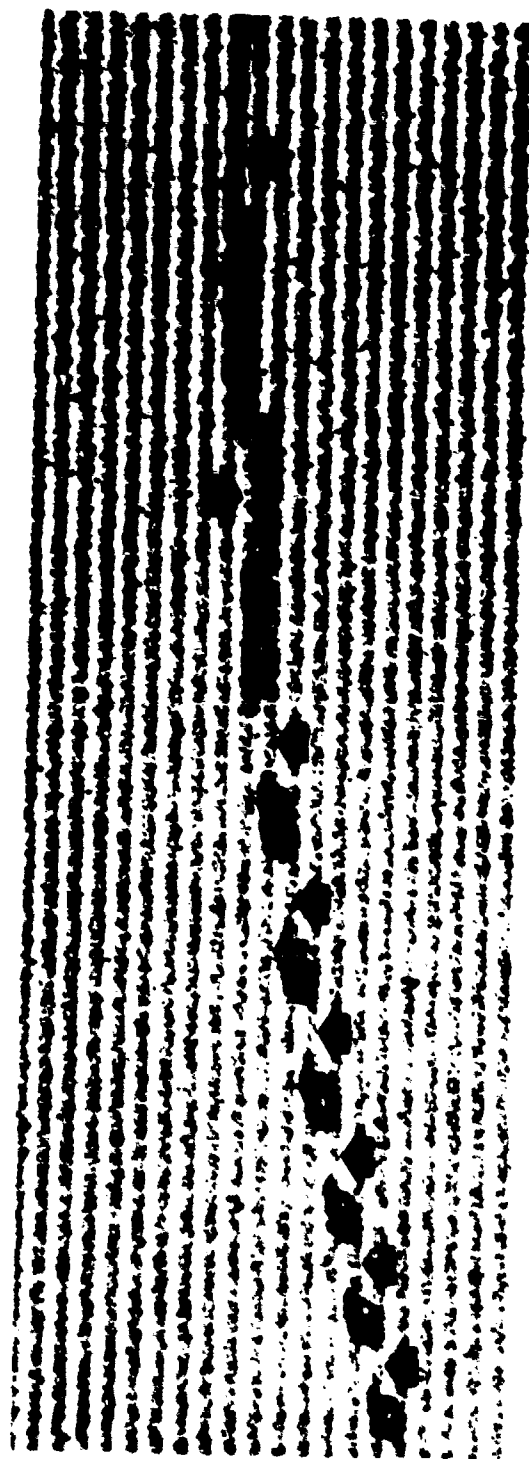
Figure 39 422 Reflection Topograph of Scratch on CCD Imager. Arrows indicate sources of dark current which occurred where scratch passed over a channel.

Figure 39 is a reflection topograph of a portion of a device on which a scratch was placed before processing. The sources of dark current are indicated by the arrows in this figure. It will be seen that the dark

current originates where the scratches cross the channels (the channels appear dark in this figure). Since the defects produced by a scratch during oxidation are stacking faults and dislocations if unfaulting occurs, this figure clearly shows that stacking faults on the channel stop are not dark current sources, while stacking faults on the channel are dark current sources.

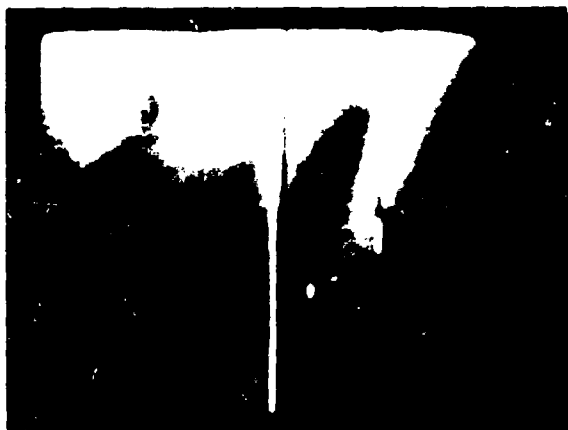
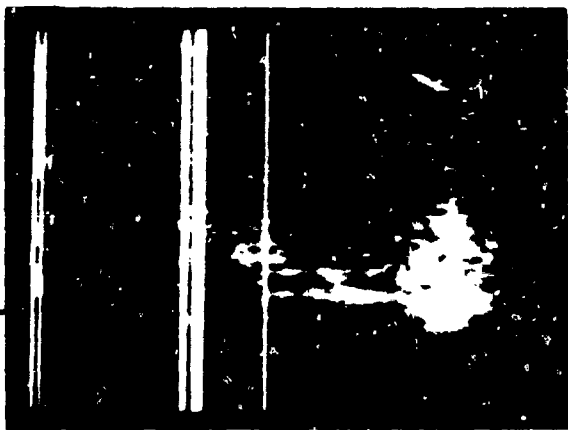
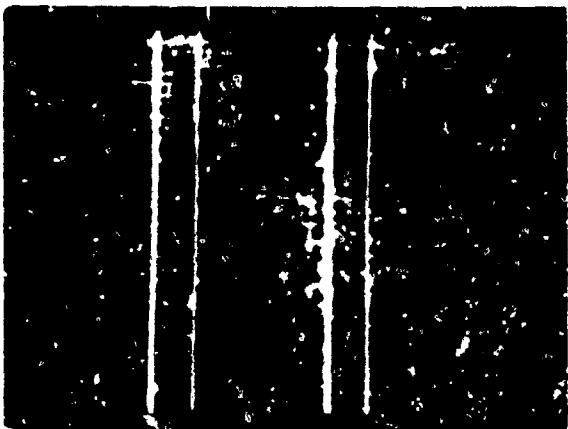
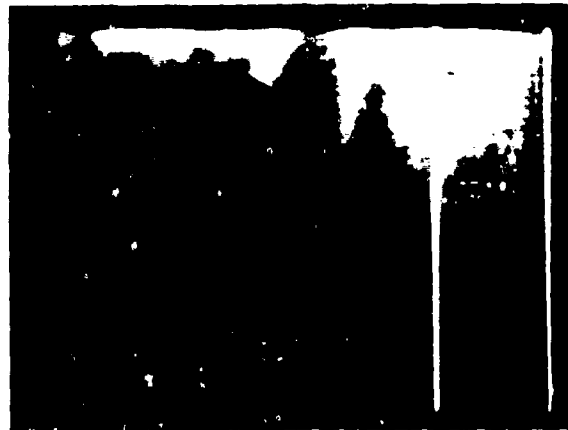
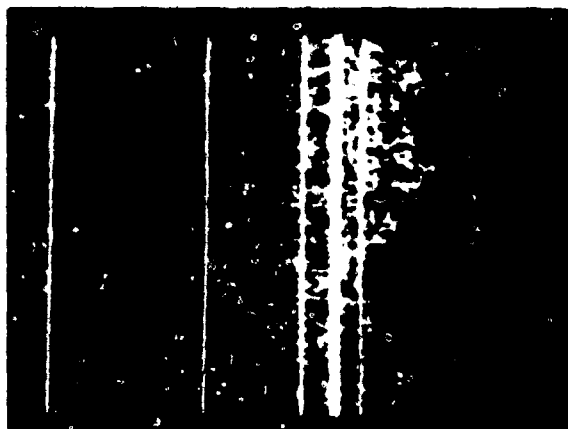
Figure 42 Dark Current Display, with Dark Current Readings, for Six Continuous Devices. The lower left corner of the device with 21.5 nA/cm<sup>2</sup> is black because of readout failure in the device.

While these results indicate that backside damage has a slightly beneficial effect, one control wafer in the lot showed degradation as a result of backside damage. This is illustrated in Figure 42. Here the dark current banding visible in devices without backside damage is replaced by dark current spikes on devices with backside damage. X-ray transmission topography, however, showed that this wafer received backside damage during processing similar to that which the float-zone slice received. As a result, dislocations were generated. The combination of the glass bead backside damage and process damage was sufficiently severe to cause dislocations to propagate to the front

surface where both were present. Thus, the dark current spikes are caused by dislocations. The mottled appearance of the dark current banding in the two center imagers of Figure 42 suggests that dislocations getter the dark current banding at close range. This is in agreement with previous observations.
