6 CHARACTERIZATION OF ELECTRICALLY ACTIVE DEFECTS IN Si USING CCD IMAGE SENSORS.

Texas Instruments Incorporated

9 Final Technical Report,  
30 Jul 1976 - 31 Jan 1978

CHARACTERIZATION OF ELECTRICALLY ACTIVE  
DEFECTS IN SI USING CCD IMAGE SENSORS

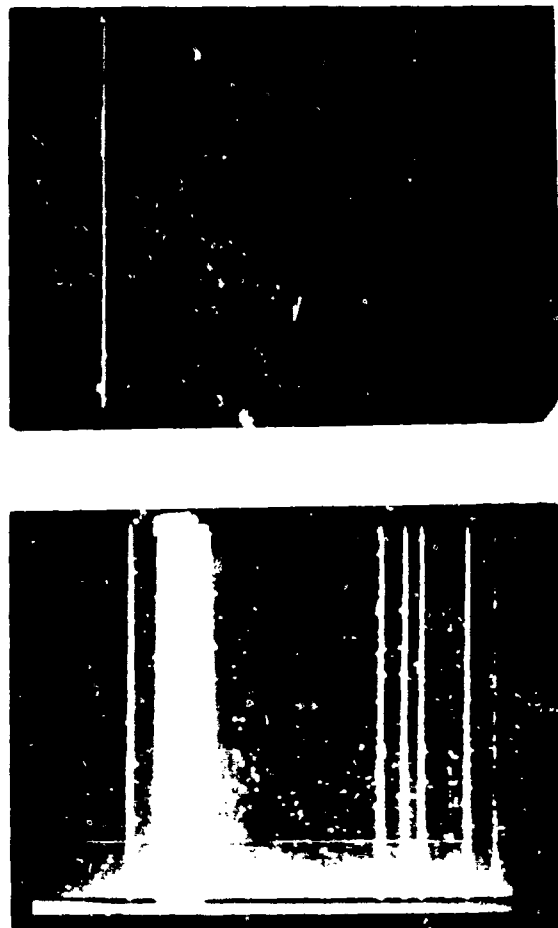
Figure 44 Dark Current Readout of Typical Devices on Control Slices Not Treated with ISS

Typical results for the untreated control slices are shown in Figure 44. Here, two adjacent devices from two slices illustrate the range of dark current spikes found on the center six devices. Typical devices from the ISS-treated slices are shown in Figure 45. From these results, we conclude that the ISS treatment does not lead to significant improvement in the density of dark current spikes on this material.

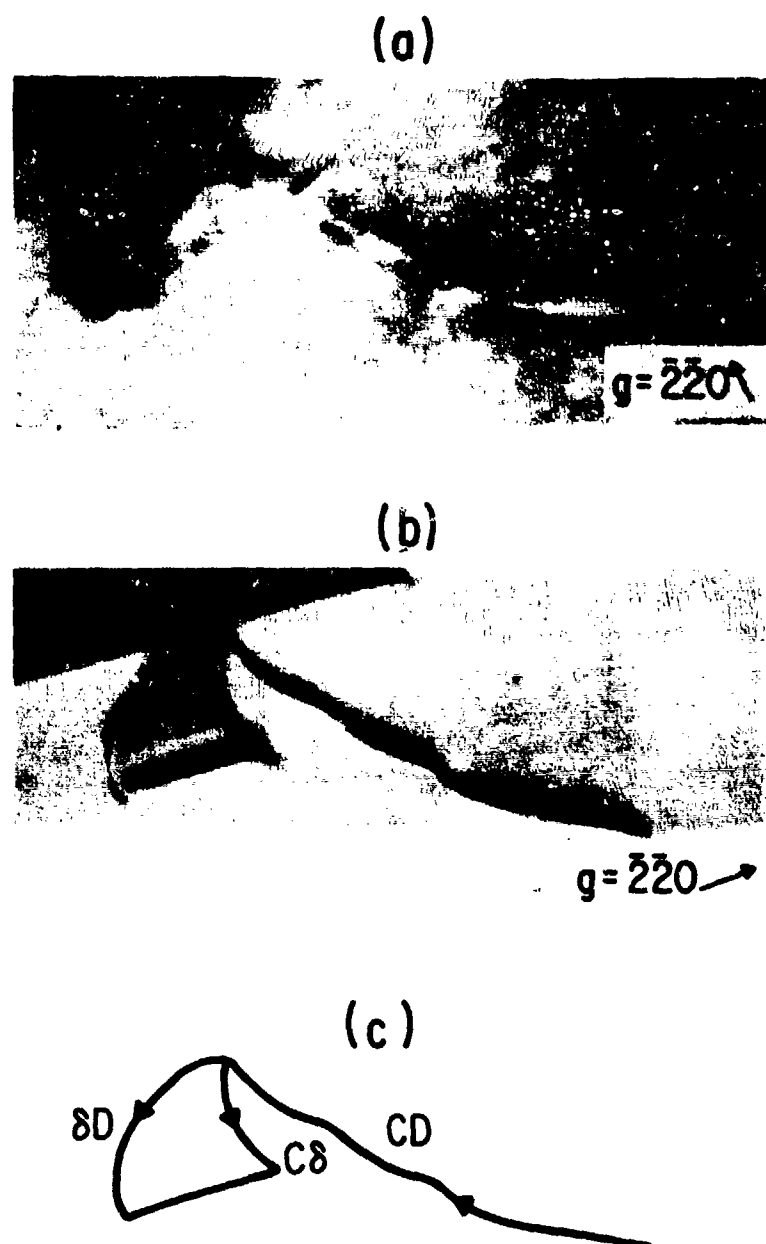
Figure 56 Partially Annihilated Stacking Fault. (a) Out of contrast. (b) In contrast. (c) Dislocation assignments according to Thompson notation.

In samples that had been subjected to a rapid pull, a small fraction ( $\leq 1\%$ ) of the stacking faults were found to be in the process of unfaulthing. An example of a nearly completely annihilated stacking fault is shown in Figure 56. The assignment in Figure 56(c) is made on the following basis: There are three possible reactions by which a perfect dislocation will produce two partial dislocations separated by a stacking fault:

Imaged in the TEM under two-beam conditions with  $\vec{g} = 220$ , the partial dislocations in reaction (1) would be visible along with the stacking fault; for reactions (2) and (3), the partial dislocations would be visible, but the stacking fault would be out of contrast. When  $\vec{g} = 2\bar{2}0$ , the Shockley partial and stacking fault of reaction (1) would be invisible, while the Frank partial would show weak contrast where it did not lie in a  $\langle 1\bar{1}0 \rangle$  direction. The partial dislocations of reactions (2) and (3) would be out of contrast for this reflection, but the stacking fault would be in contrast. Clearly, reaction (1) is the only case consistent with Figures 56(a) and 56(b).

Examination of Figure 56 shows that the perfect dislocation created by the unfaulthing reaction has moved off the (111) plane on which it was created (we shall show below that the stacking fault is, in fact, being annihilated rather than created), illustrating that some time has elapsed since the unfaulthing has occurred. Note also that the Shockley partial is curved into the stacking fault.

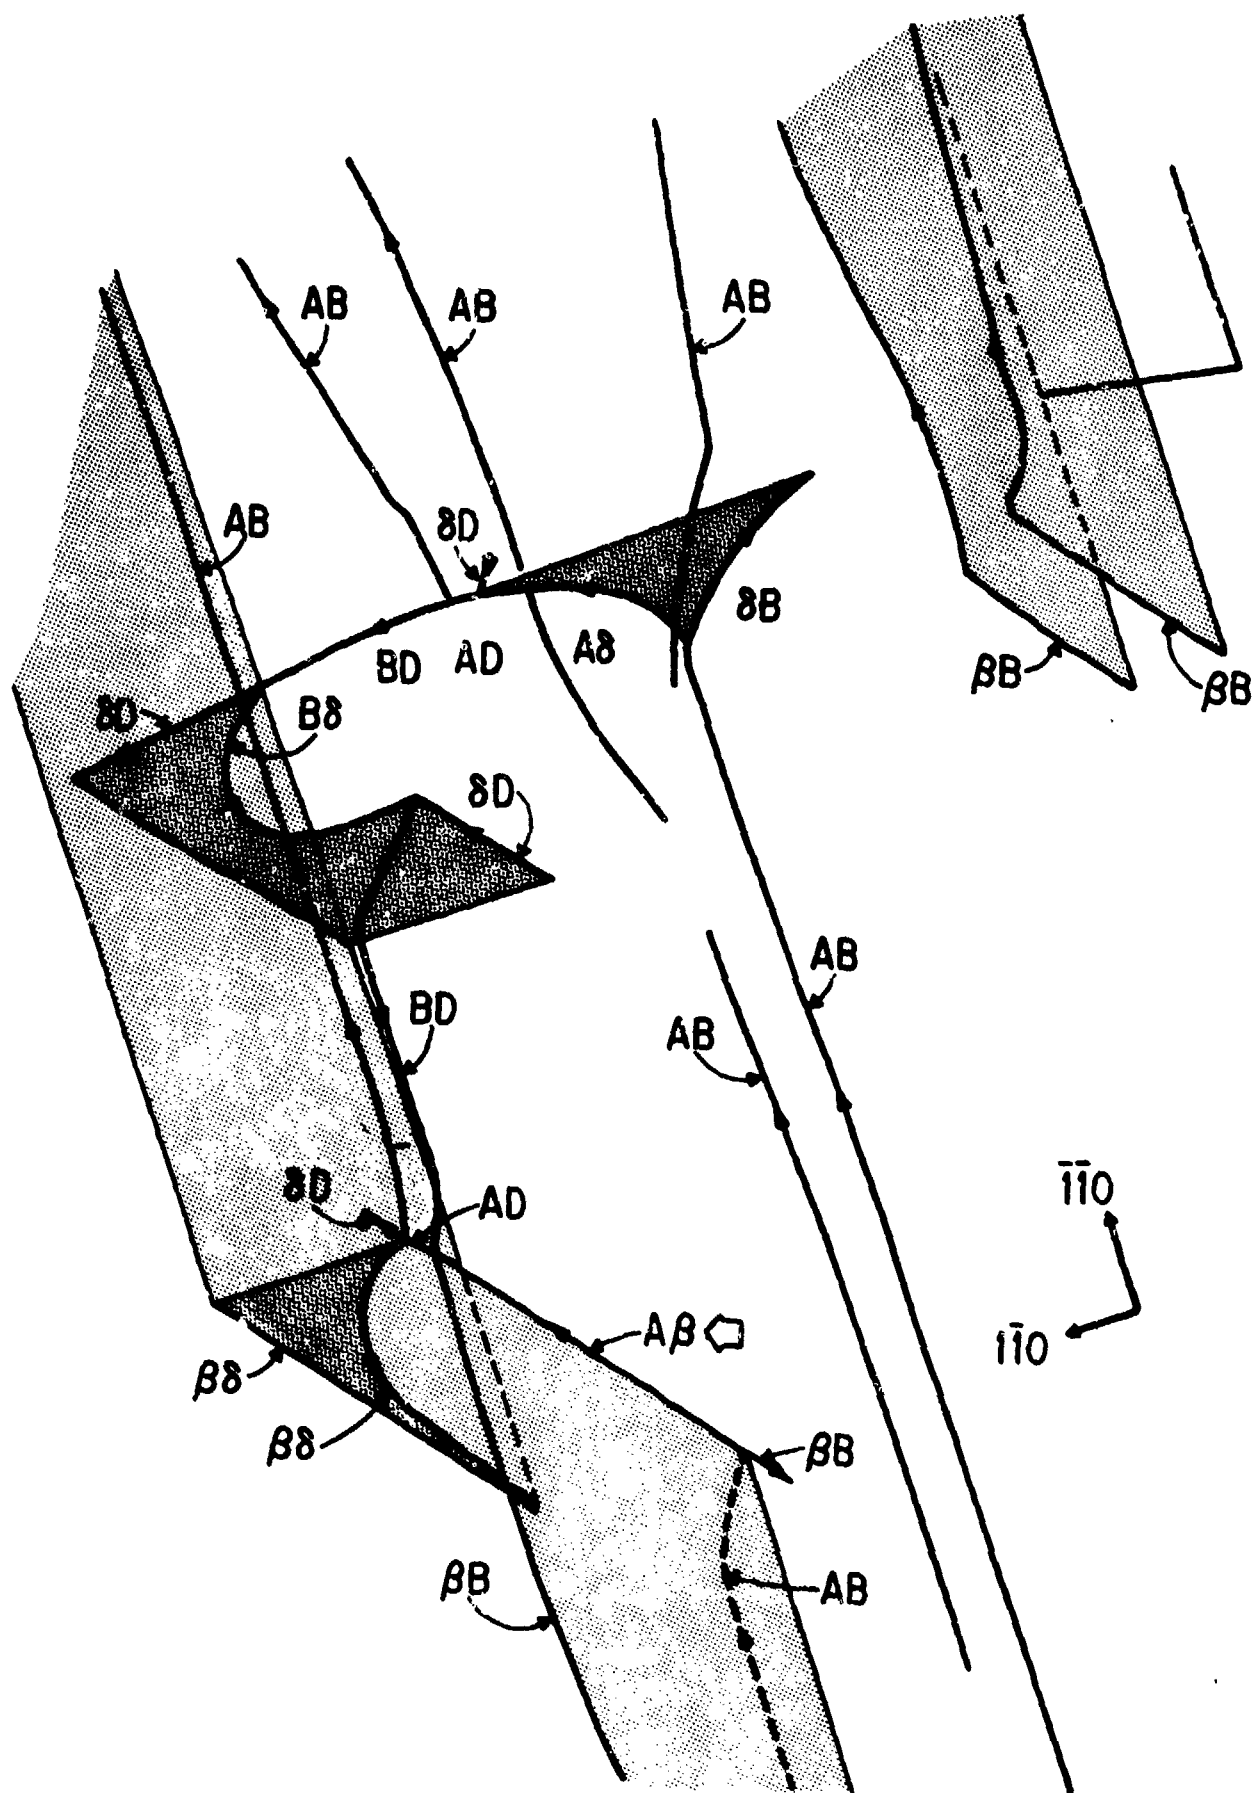
Figure 62 Dislocation Assignment of Figure 61 According to Thompson Notation

In some cases we have found entire arrays of stacking faults in the process of unfauling. An example of this is shown in Figure 61. From the four micrographs in this figure, the dislocation assignments of Figure 62 may be made. An interesting feature of these figures is a Shockley partial, indicated by the arrow in Figure 62, which is not curved into the stacking fault. This is the only case we have observed where the Shockley partial was not so curved.

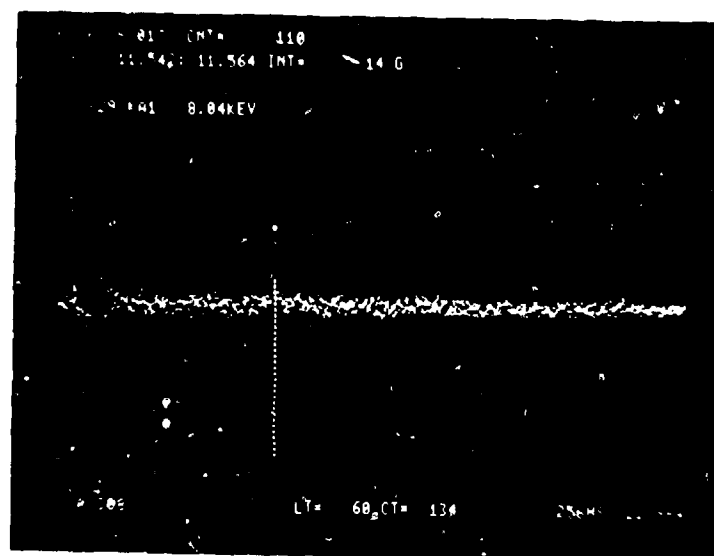
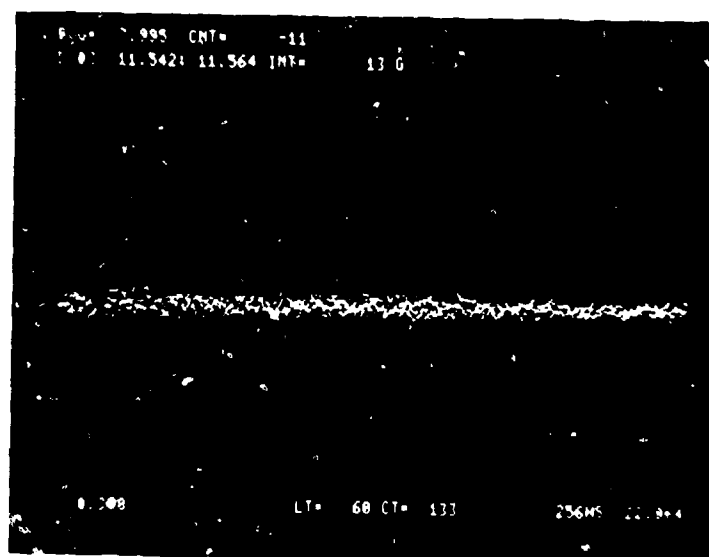
Figure 66 X-Ray Spectra. (a) From precipitate particle, (b) from region next to particle. Both spectra are the difference between the measured spectra and a spectra taken nearby. Copper is detectable only in (a).

X-ray analysis of the precipitates in the STEM mode showed they contained copper (Figure 66). Weak beam studies revealed that the precipitates are apparently formed during the unfauling of the stacking fault (Figure 67). Here, a series of very small precipitate particles can be seen on the perfect, undissociated dislocation formed by the unfauling. It will also be noted that a very small ( $\sim 10$  Å) precipitate is being formed at the node where the

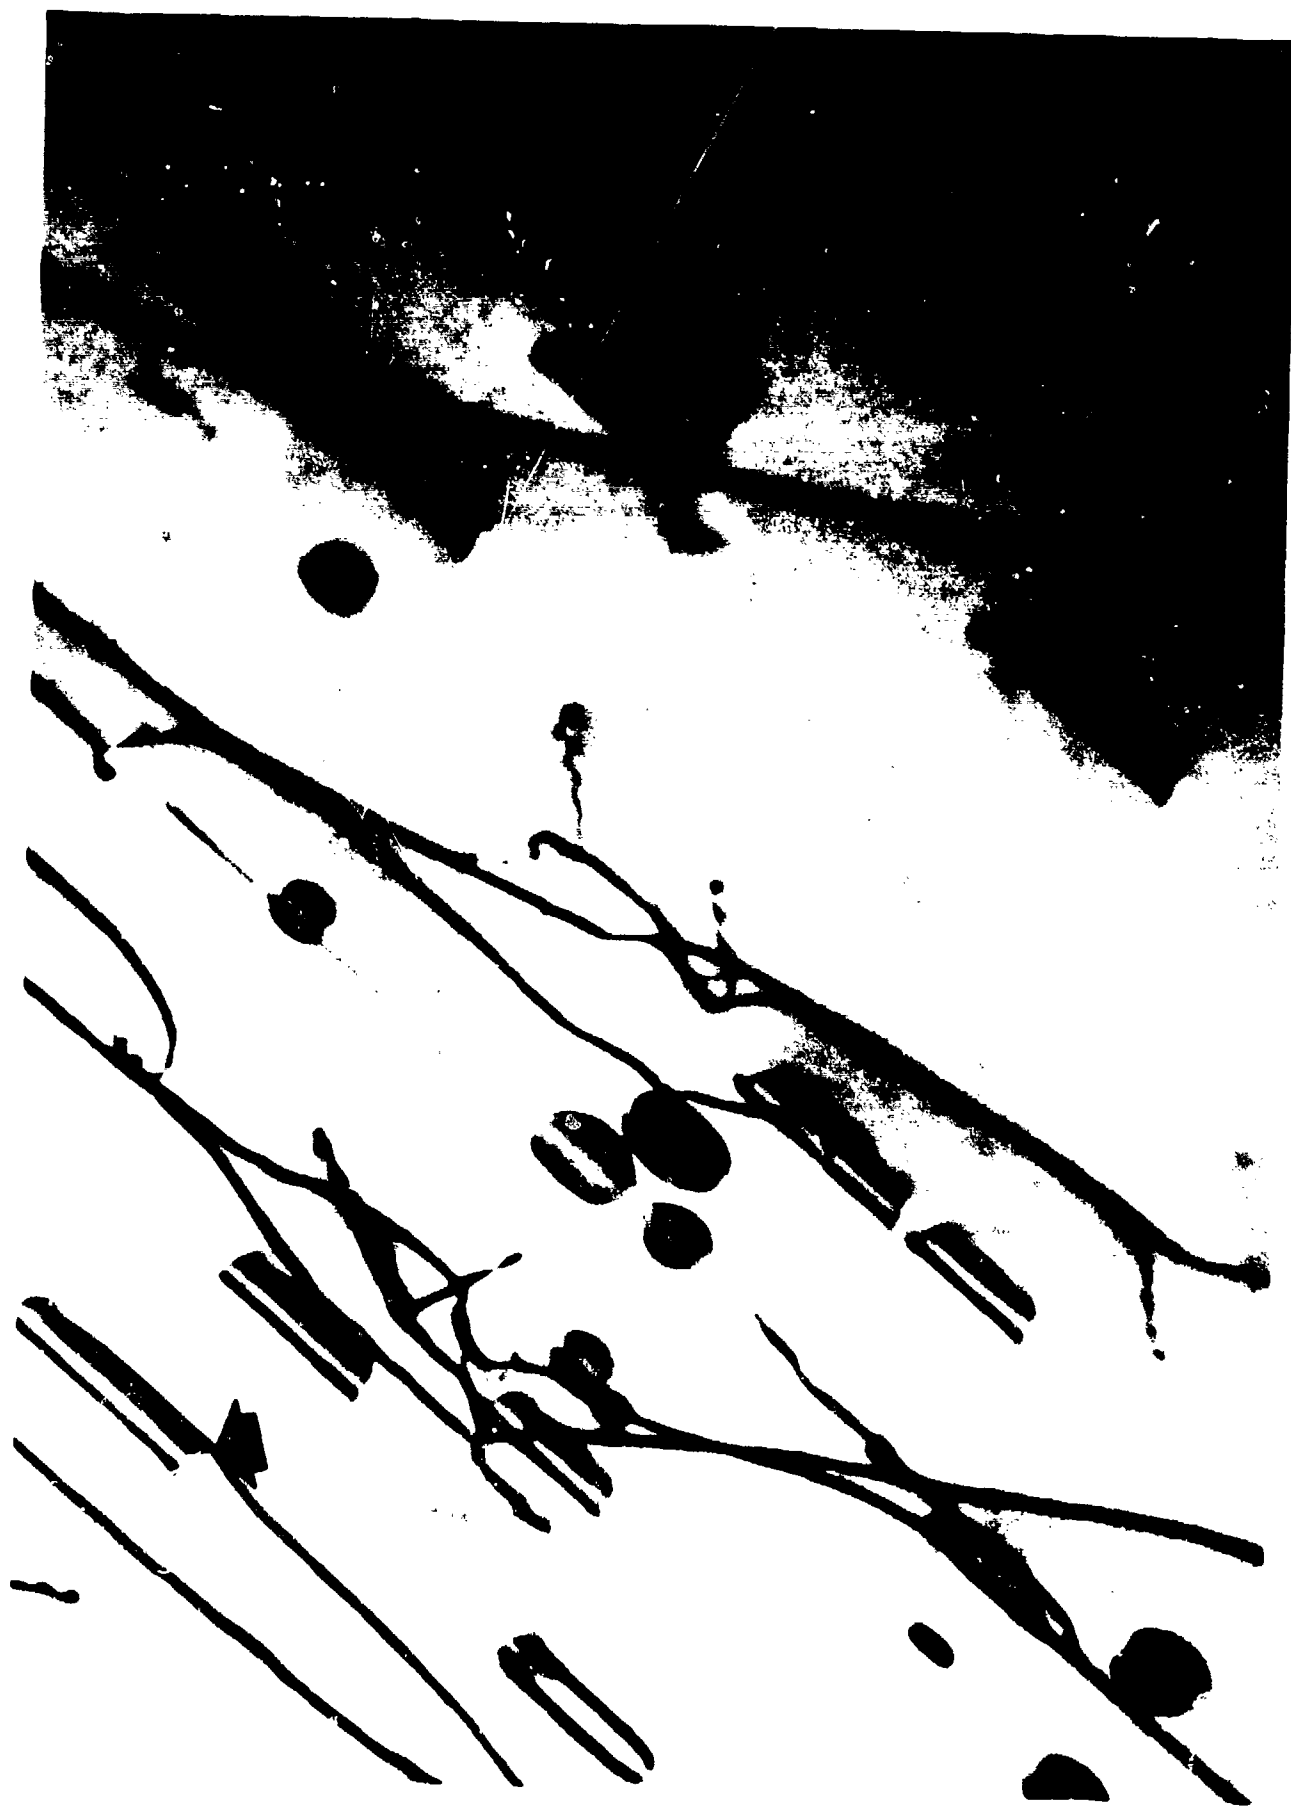
Figure 69 Subsurface Nucleation of Stacking Faults. Arrow indicates stacking fault in process of unfaulting.

In some regions of the samples, we find areas in which recent bulk nucleation of stacking faults has occurred (Figure 69). Occasionally, we also see peanut-shaped stacking faults such as in Figure 70. These stacking faults must be formed by the nearly simultaneous nucleation of two stacking faults on the same plane and grow together to form the observed shape. The simplest mechanism by which this simultaneous nucleation can occur is that the unfauling of a previous-generation stacking fault leaves behind nuclei on which next-generation stacking faults can occur.

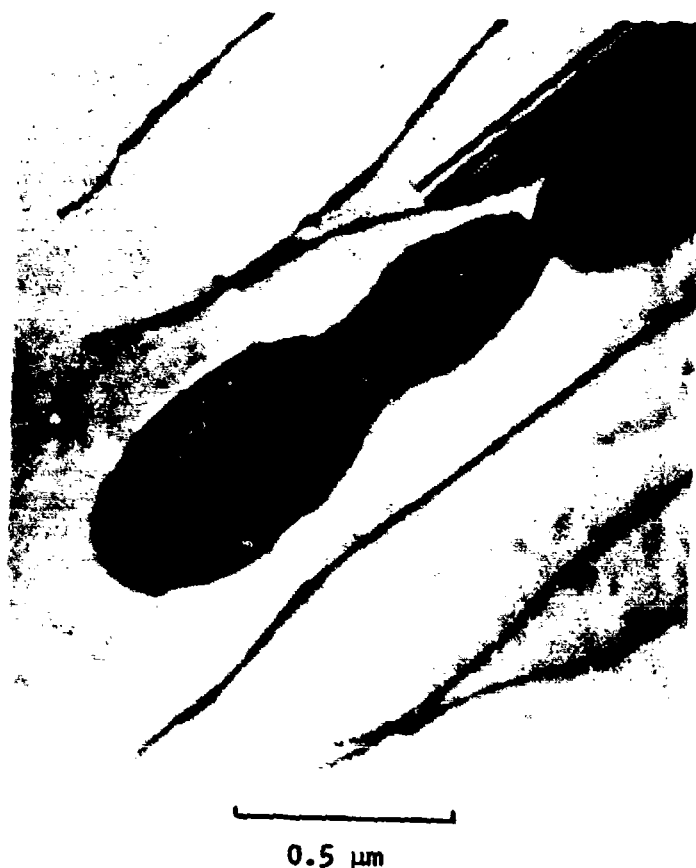
Figure 70 Peanut-Shaped Stacking Fault

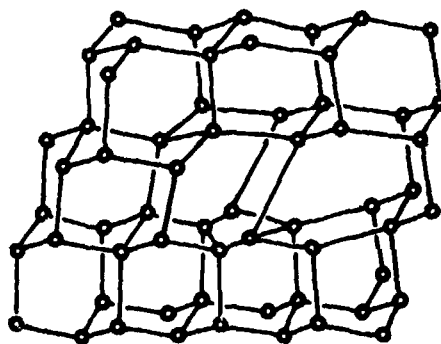
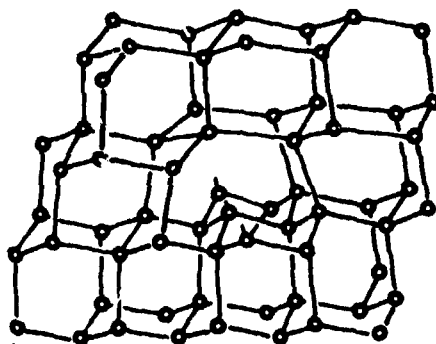
**Figure 72** Models of  $60^\circ$  Dislocations. (a) Glide set, (b) shuffle set. The dangling bonds in (a) may be healed pairwise (heavy line) by the formation of five and seven rings. In (b) they may be healed only by the formation of three rings.

Hirth and Lothe<sup>31</sup> show that two types of dislocations are possible in silicon. They name these the "shuffle" and "glide" sets of dislocations. Examination of ball and stick models of these dislocations (Figure 72) shows that the dangling bonds formed on the glide set of dislocations may be healed by the formation of five and seven rings (rather than the normal six rings found in the perfect crystal), while the dangling bonds on the shuffle set may be joined only by the formation of three rings. The formation of three rings would appear energetically unfavorable because of the large strain associated with their formation. Thus, if the dissociated dislocations we observe belong to the glide set, their core structure could have no dangling bonds, thus accounting for their electrical inactivity. If the undissociated dislocations belonged to the shuffle set, then the dangling bonds, or the adsorption of impurities to the dangling bonds, could account for their electrical activity. Conversion of the electrically inactive glide dislocation to an electrically active dislocation could then occur either through constriction of the two partials into an undissociated dislocation, or possibly, as has been recently discussed, through the conversion of one of the partials from the glide set to one of the shuffle set, by the application of suitably high stresses at low temperatures.<sup>32</sup>

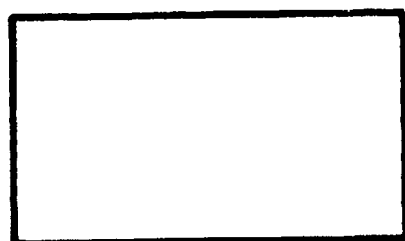
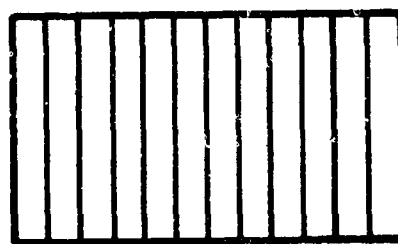
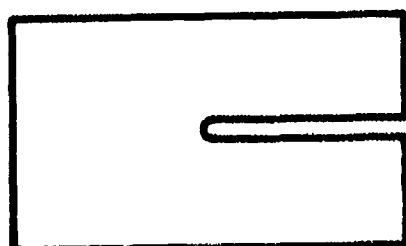
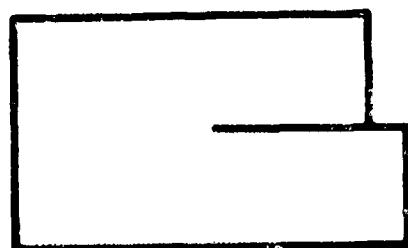
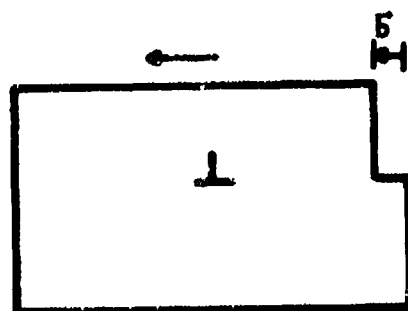
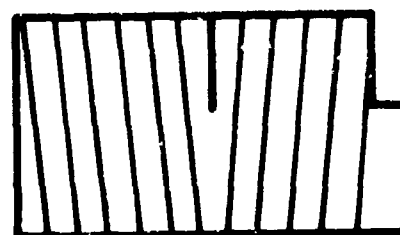
The formation of a dislocation in a solid is illustrated in Figure A-1. Beginning with a solid continuum block (a), a cut is made partially through the block along a plane (b). Then the portion of the block above the cut is shifted to the left and the portion below to the right (c). The two portions of the block above and below the cut are then rejoined to give rise to the dislocation in the continuum, which is located where the cut plane stopped (d). The shift of the portion of the block above the cut with respect to the portion of the block below the cut is called the Burgers vector of the dislocation and is labeled  $\vec{b}$  in Figure A-1(d). In this figure the shift has been made perpendicular to the line of the dislocation (which runs perpendicular to the plane of the figure), and the resulting dislocation is called an edge dislocation. Note that the Burgers vector may make any angle to the dislocation line simply by shifting the top portion of the block in an appropriate direction with respect to the bottom before the cut plane is rejoined. In particular, if the Burgers vector is parallel to the dislocation line, it is called a screw dislocation.

The situation in a crystal is schematically illustrated in Figures A-1(e) and A-1(f). Because of the periodicity of the crystal lattice, when the top and bottom halves of the crystal are rejoined, continuity of the

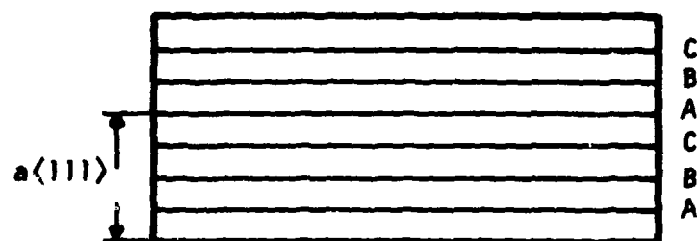
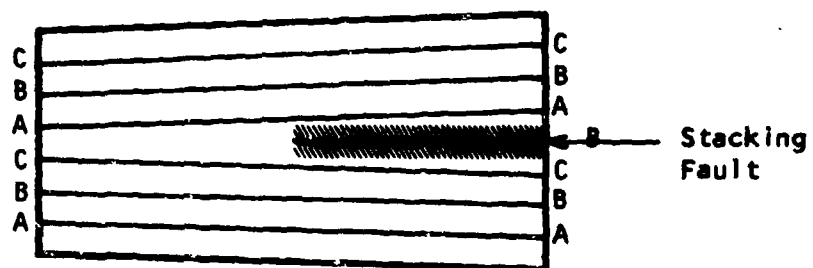
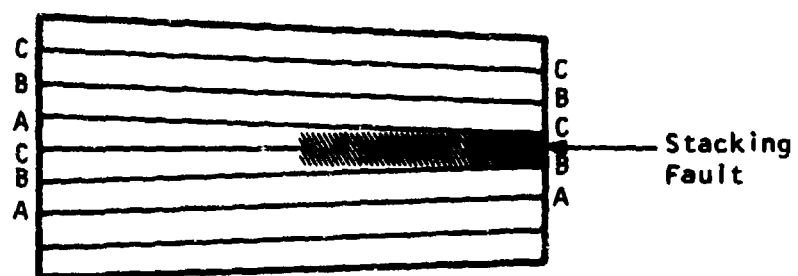
In a face centered cubic material, (111) planes of atoms are stacked in a three-layer sequence such as illustrated in Figure A-2(a). The distance between neighboring planes such as A and B is  $a/3\langle 111 \rangle$ . Any of the planes A, B, and C can be transformed to any other plane A, B, or C by a single translation, i.e., they are isomorphous. Thus, if an A plane is translated

If the normal stacking sequence ABCABC . . . is altered to, for example, ABAB . . . (the stacking sequence for hexagonal symmetry), the resulting defect is called a stacking fault. For example, suppose an extra B plane were inserted between an A and a C plane [Figure A-2(b)]. In this figure the stacking fault is on the right side of the crystal. Note the hexagonal sequences BAB and BCB. Where the stacking fault ends in the crystal there is a partial dislocation. In Figures A-2(b) and (c), these are called Frank partial dislocations and have Burgers vectors of  $a/3\langle 111 \rangle$ . With an extra added plane, the stacking fault is called an extrinsic stacking fault. If, however, a plane of atoms were removed, such as an A plane in Figure A-2(c), an intrinsic stacking fault would be created [again on the right side of Figure A-2(c)]. Again, note the hexagonal stacking sequence BCB in this figure.

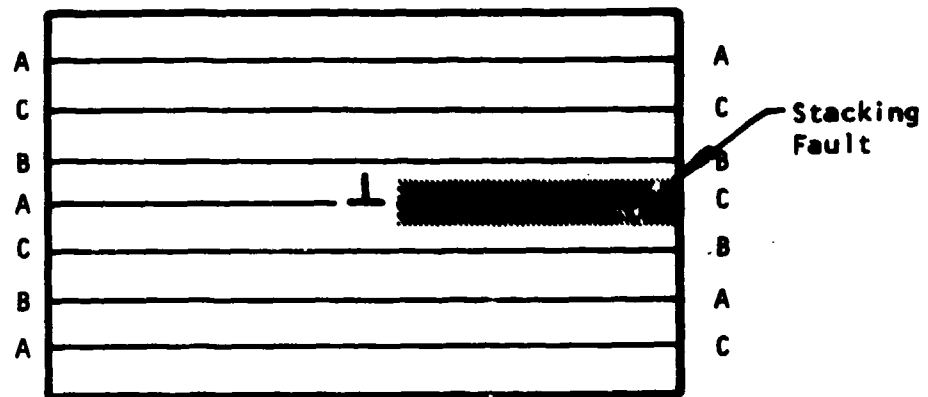
Figure A-3 Shockley Partial Dislocation

Because a  $(111)$  plane of one type can be converted to a  $(111)$  plane of another type by a translation of  $a/6\langle 11\bar{2} \rangle$ , an additional type of partial dislocation is possible. This may be accomplished by cutting in a crystal on a  $(111)$  plane between an A and a B plane, for example, and translating the bottom of the crystal by  $a/6\langle \bar{2}11 \rangle$  before rejoining the crystal across the cut. The result is a Shockley partial dislocation, which has a Burgers vector of  $a/6\langle \bar{2}11 \rangle$  (Figure A-3). In this figure note the stacking sequence BCB, indicating that the resulting stacking fault is intrinsic in nature [compare with Figure A-2(c)].

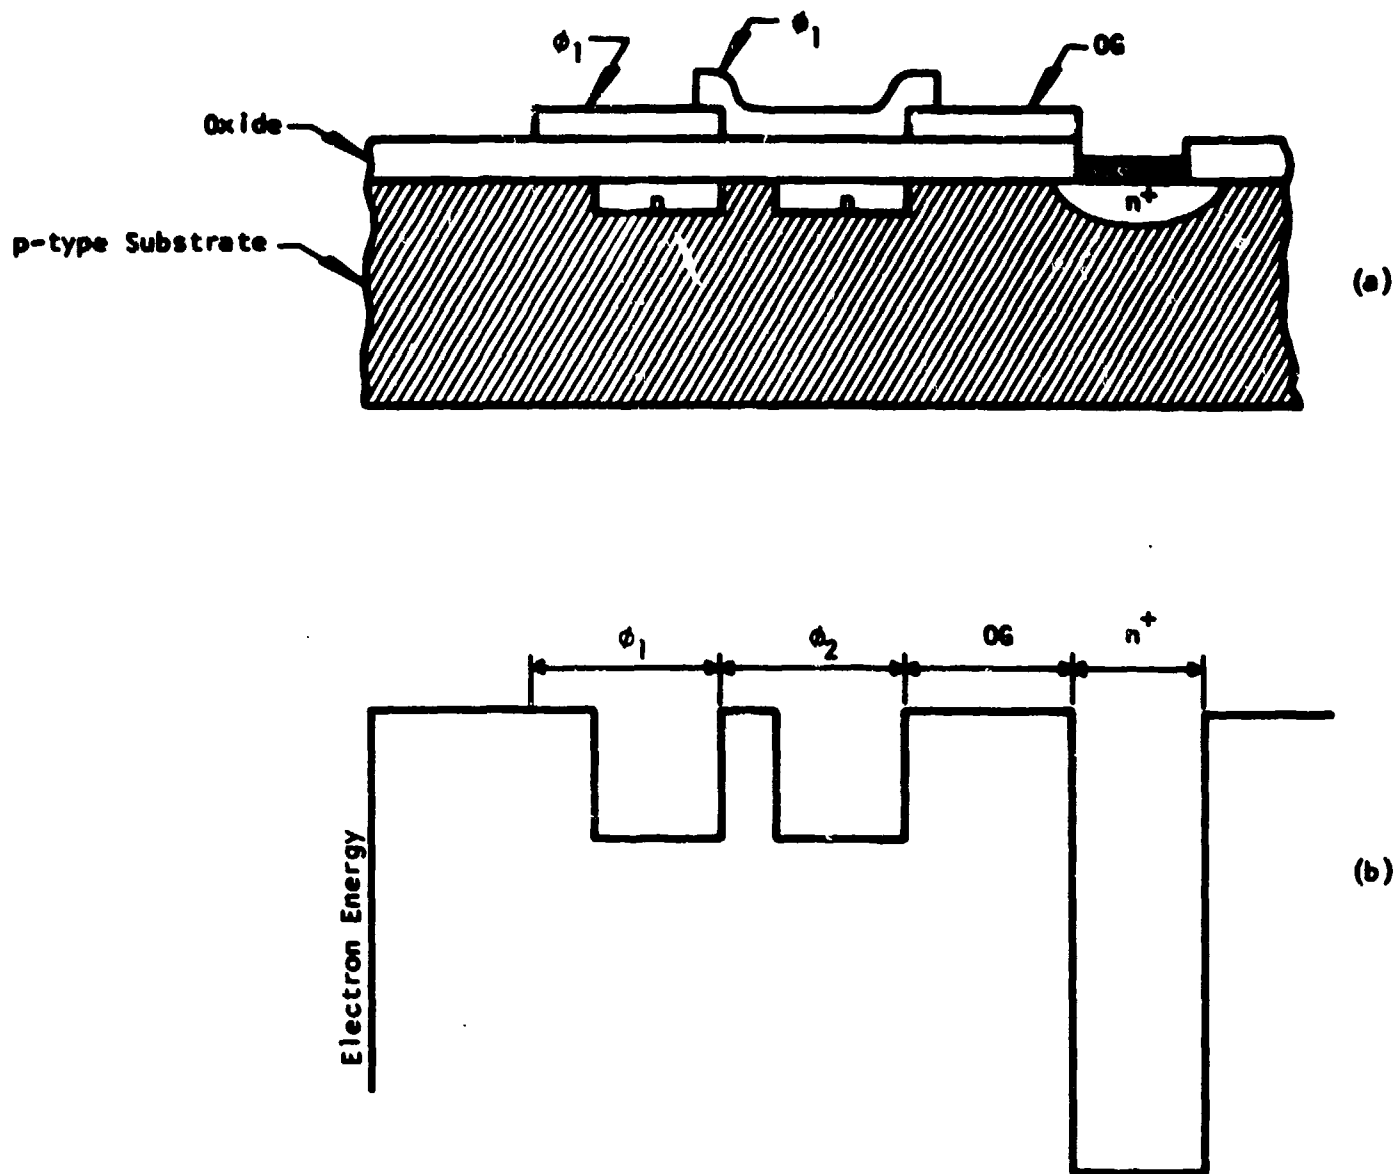
It is appropriate to review the operation of the CCD to clarify the meaning of the data reported in this work. The basic unit of the CCD imager is the MOS capacitor. Imagine a pair of these arranged so that the conducting gate electrodes ( $\phi_1, \phi_2$ ) overlap, as in Figure B-1(a). The p-type substrate is doped with n-type pockets at the edge of each electrode, with the last element a contacted  $n^+$  layer. The output gate OG serves to isolate the n and  $n^+$  regions. The gates  $\phi_1$ ,  $\phi_2$ , OG, and the contact to  $n^+$  are electrically insulated from each other.

When none of the electrodes are connected to external voltages, the electrons are in thermal equilibrium throughout the substrate. In normal operation, the substrate is connected to ground;  $\phi_1$ ,  $\phi_2$ , and OG are connected to independently controlled power supplies; and the  $n^+$  contact is held at a high positive voltage. Next, the output gate is pulsed positively, lowering the energy of any electrons in the substrate near the oxide interface. By a proper choice of the pulse height, the electrons in the n-pocket under  $\phi_2$  are "connected" to the  $n^+$  doping region, where they see lower energy states and thus flow to the  $n^+$  where they are collected and swept out by the  $n^+$  power supply. When the pulse under the output gate is removed, the n-pocket under  $\phi_2$  is depleted. A local charge from the ions remains, and thermal equilibrium is destroyed. Now  $\phi_2$  is pulsed, lowering the electron energy under all of  $\phi_2$ . This allows the electrons in the n-pocket under  $\phi_1$  to see the lower (electrostatic) energy levels under  $\phi_2$  and, as a result, transfer to the n-pocket under  $\phi_2$ . A second pulse on the OG transfers these electrons to the  $n^+$  region and out through the power supply. In practice, it takes several clocking cycles to reach a steady state condition for the time averaged current through the  $n^+$  supply. Once this condition is reached, the electron energy for zero volts on  $\phi_1$ ,  $\phi_2$ , and OG is as shown in Figure B-1(b). Also

Figure B-1 Minimum Device Structure of the Two-Phase CCD. (a) Circuit architecture, (b) electron energy profile at depletion.

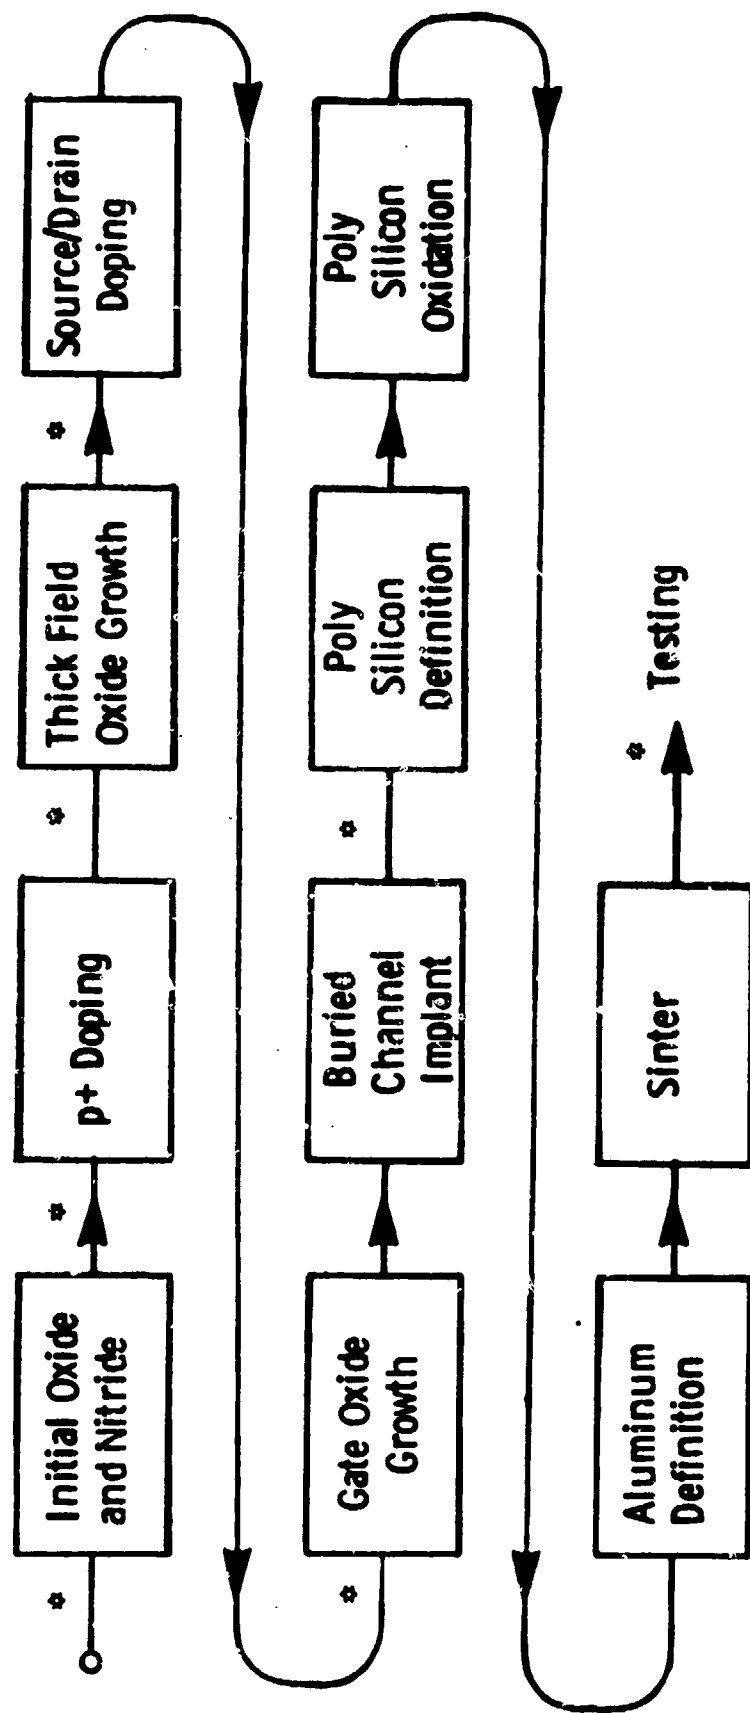
- (1) After an initial cleanup of the slices, an initial oxide is grown. A CVD nitride etch and diffusion mask is deposited on the initial oxide.
- (2) The moat region is patterned, using optical photolithographic techniques, and the nitride is etched. Using the nitride as an etch mask, the initial oxide is etched. A subsequent boron diffusion dopes the p regions of the device.
- (3) A long oxidation cycle grows a thick field oxide in the moat and channel stop regions of the imager.
- (4) Regions to receive  $n^+$  doping, such as source/drain regions, are then opened by nitride and oxide removal. A phosphorus diffusion forms the  $n^+$  regions.
- (5) At this point, the initial thin oxide is stripped back to the silicon, and an oxidation is performed to achieve a clean, high integrity, gate oxide.

Figure C-1 CCD Imager Process Flow Diagram

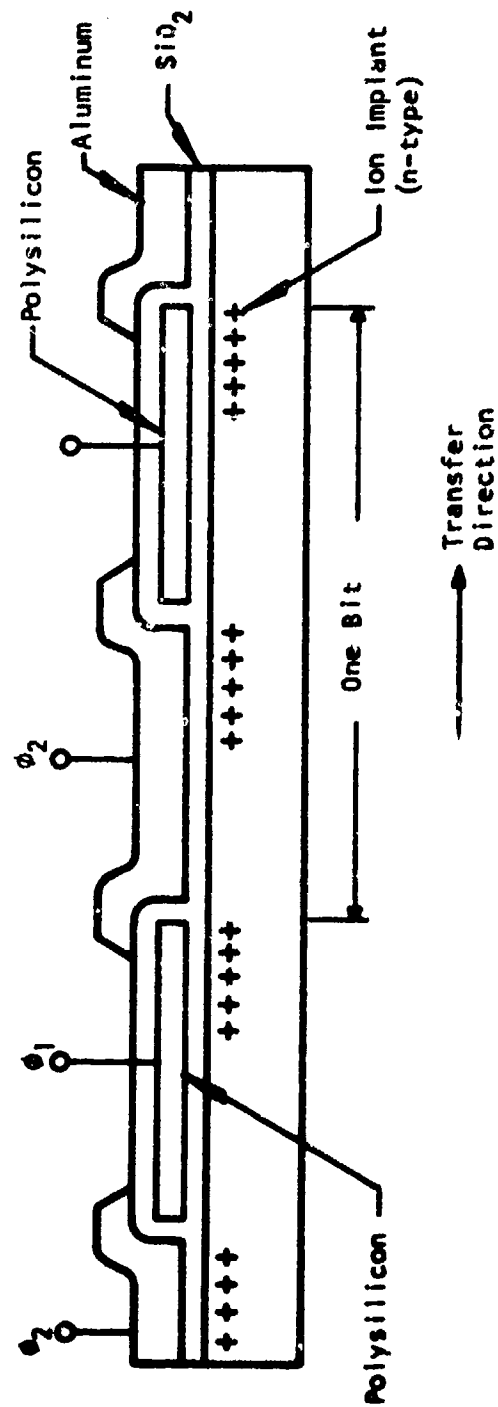
The device is doped so that the depletion region from the buried channel extends ~5  $\mu$ m into the Si from the gate oxide - silicon interface. All electrically active defects that reside in this depletion region will generate dark current signal. Defects outside the depletion region can contribute only after the carriers diffuse to the CCD wells.

Figure C-2 Device Cross Section Showing Profile Along Transfer Direction

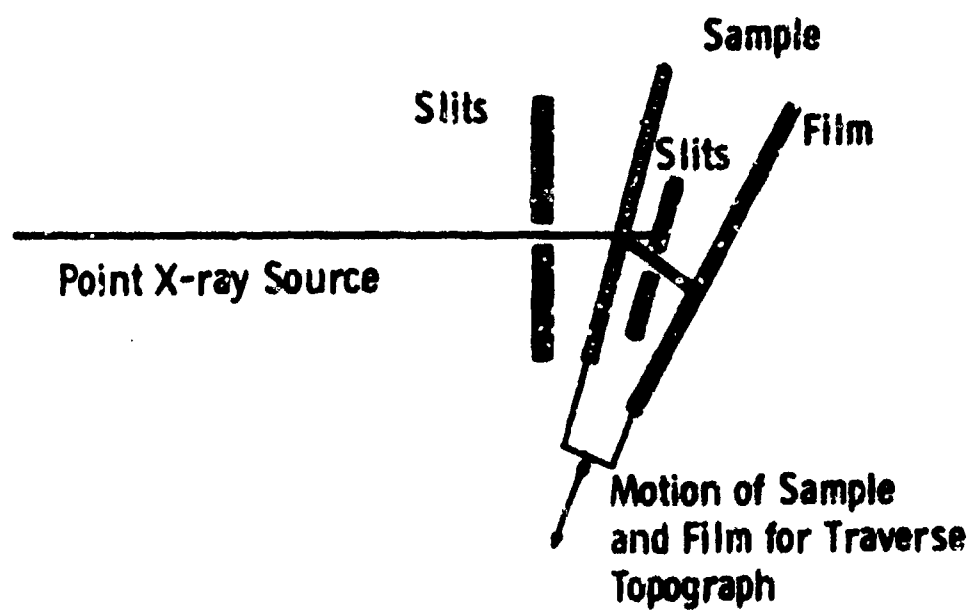
Figure B-1 Transmission X-Ray Topography

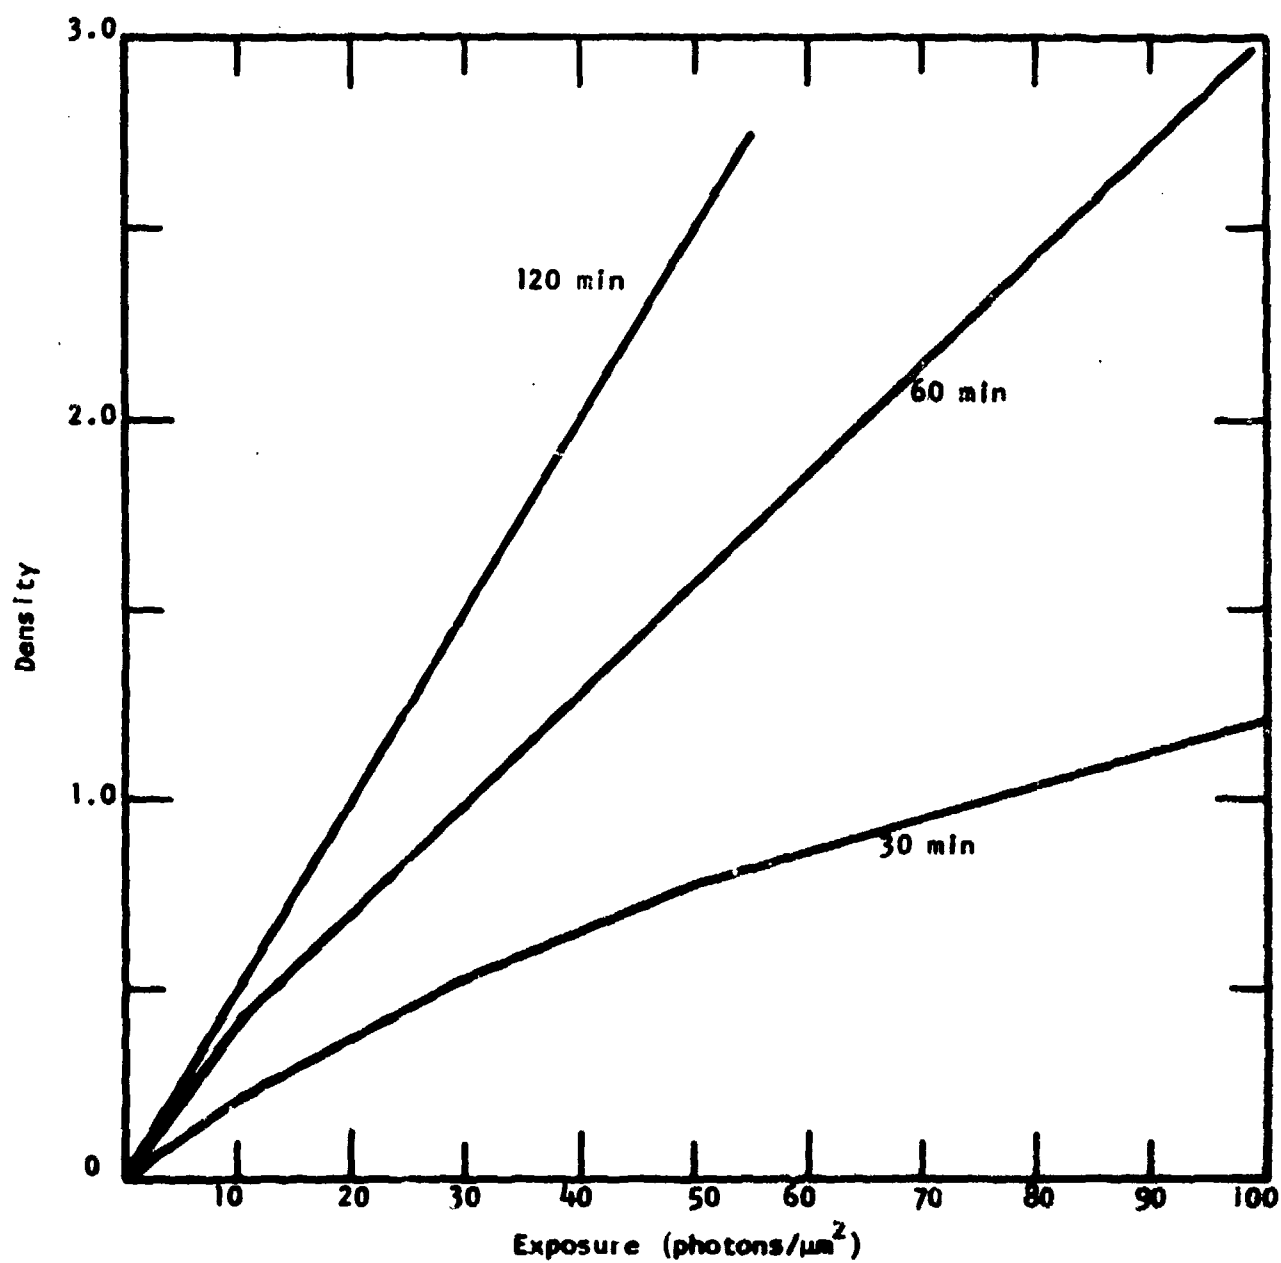
Figure D-2 Density vs Exposure Curves for Elon-Ascorbic Acid Developer at Various Development Times. Ilford L-4 25  $\mu\text{m}$  emulsion,  $\text{CuK}\alpha_1$  radiation.

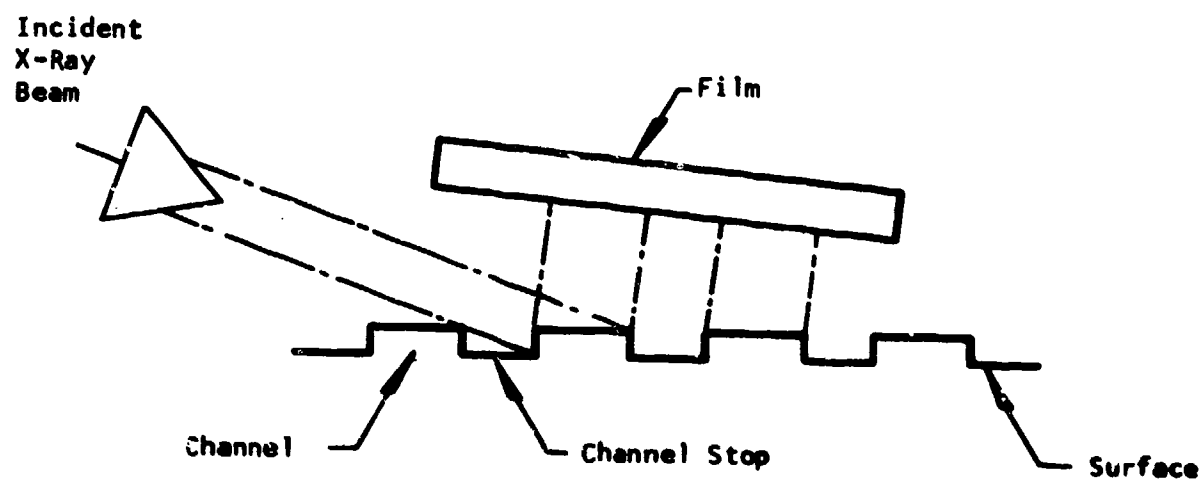
Figure 0-4 Experimental Arrangement for 422 Topograph Illustrating Surface Relief Contrast Mechanism

Figures D-3(a) and D-3(b) show that for the  $422$  reflection, the channels appear dark in the topograph, while the channel stops appear light. This type of contrast arises from the surface relief of the imager. This may be qualitatively understood by reference to Figure D-4. The channel stop is recessed as a result of the thick oxide growth over the channel stop. The protruding channels therefore intersect a proportionately larger amount of the x-ray beam than do the channel stops, and, subsequently, cast a shadow on the channel stops. Thus, the channels receive a higher incident x-ray intensity than the channel stops, and have, therefore, a higher diffracted intensity for this reflection. The exact diffraction process is somewhat more complicated and requires considerations of energy flow from the dynamical theory to be fully explained. We find, for example, that the diffracted intensity from this reflection is higher than that of the  $42\bar{2}$  reflection [Figure D-3(c)], for which the surface relief of the channels and channel stops plays no part. This shows that there is an additional enhancement in overall diffracted intensity that is not accounted for in the simple argument given above.

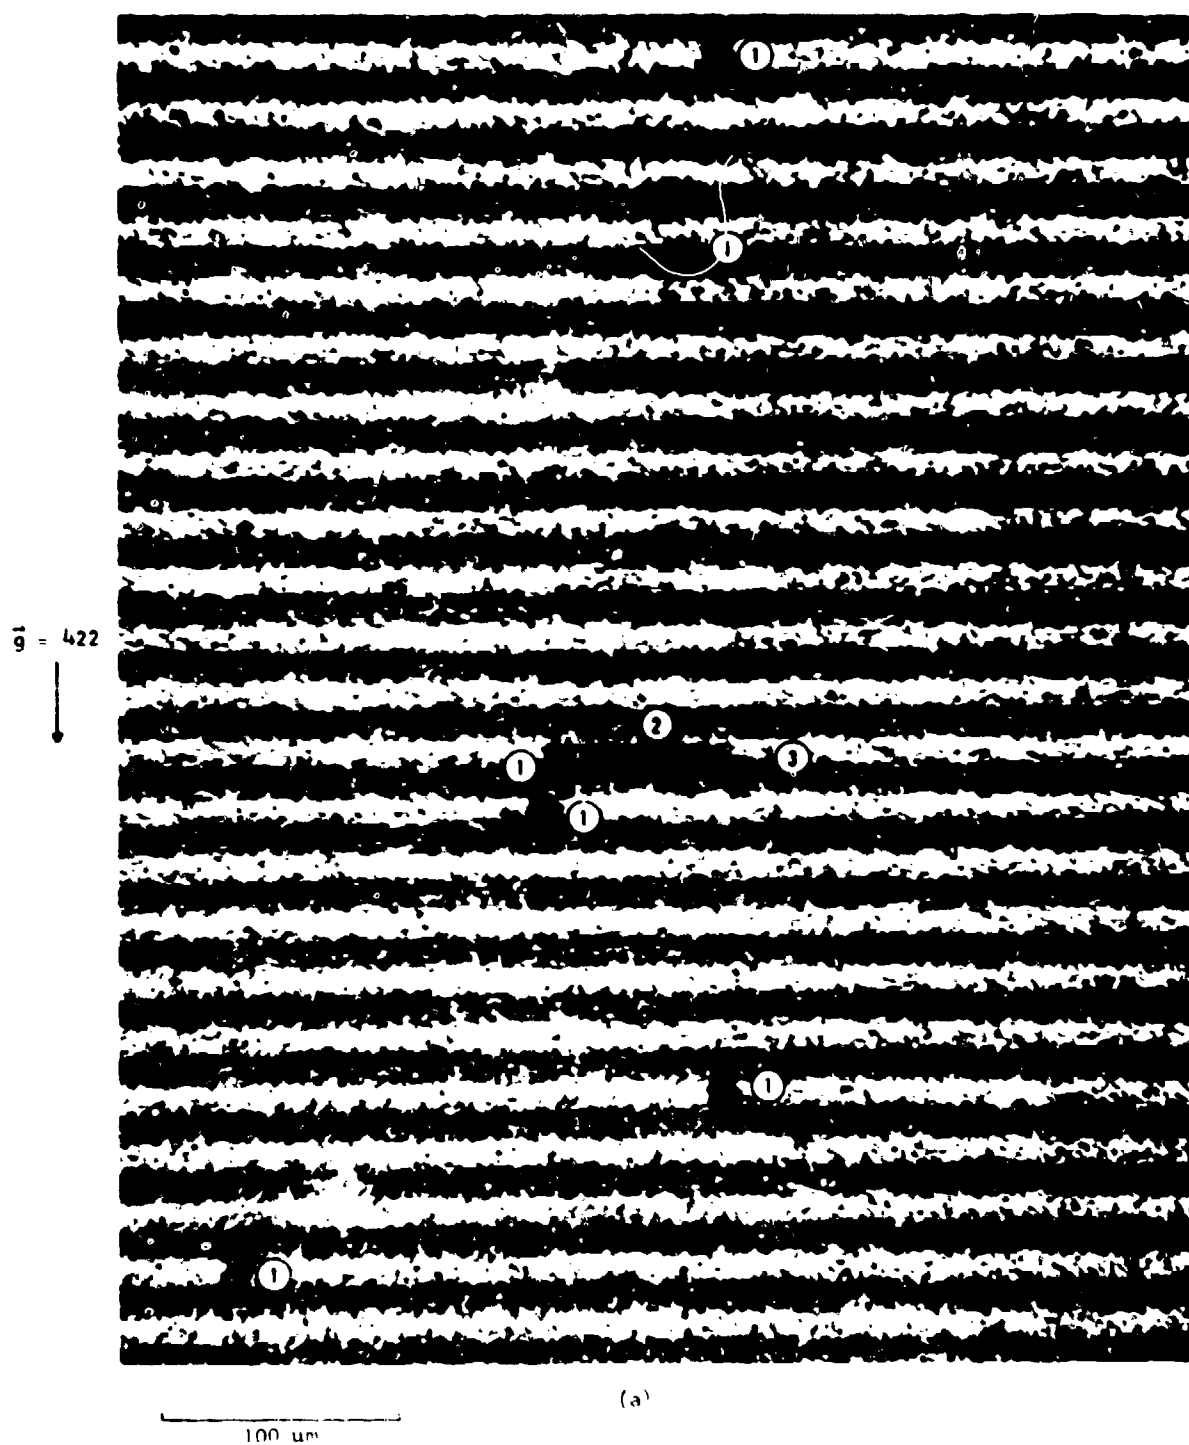
Figure D-5 Topograph of Dislocations in Device on Float-Zoned Material

↑  
g = 422

100  $\mu$ m

Figure D-5 (Continued)

Figure D-5 is a topograph of such a defect which was found in a nonoperational portion of a device on float-zoned material. Defects labeled "1" are dislocations emergent from the bulk of the material, as confirmed by transmission topography. Defect "2" is a dislocation that has grown off an emergent dislocation from the bulk, labeled "3."

A reflection topograph of this same region under a different diffraction condition is shown in Figure D-5(b). Several important points are illustrated in these topographs. First, close examination of Figures D-5(a) and D-5(b) shows all defect images are split. This double contrast arises from the strain field of a single dislocation with an edge component. According to the kinematical theory of image formation<sup>38,39</sup> lattice planes that are tilted more than  $\sim 2$  times the angle over which the perfect crystal diffracts will diffract kinematically, giving an added intensity. For a dislocation with an edge component, there are two such regions, one on either side of the core (Figure D-6), and hence the bimodal contrast pattern. Such a splitting has previously been observed in transmission topographs, where the diffraction conditions used caused the splitting to be  $\sim 5$  times that in our topographs.<sup>39</sup> The observed total image size is in the range of what is theoretically expected for a single dislocation. According to Lang and Polcarova,<sup>40</sup> the image width of a dislocation is given by

Now if  $\vec{g} \cdot \vec{b} = 3$  [which is the case for  $\vec{b} = \frac{1}{2}(101)$ ], and if  $C \approx 2$ , then the calculated and observed image size would agree. The effect of the radiation incident on the channel/channel stop edge should be to increase the extinction distance, allowing for a smaller value of  $C$  for agreement.

Comparison of Figures D-5(a) and D-5(b) also shows that the image of the channels and channel stops is shifted from the image of the defects in these topographs. A study of several pairs of topographs indicates that this shift is approximately  $5 \mu\text{m}$  between the two topographs for the (224) type of reflections. This means that in each of the two topographs, which are symmetrically related by a  $180^\circ$  rotation of the device, the image of the channels and channel stops is shifted  $2.5 \mu\text{m}$  toward the incident x-ray beam (in the direction of the  $\vec{g}$  vector), and hence the correct location of the defect is in a position  $2.5 \mu\text{m}$  in the direction of the  $\vec{g}$  vector.
