6 CHARACTERIZATION OF ELECTRICALLY ACTIVE DEFECTS IN Si USING CCD IMAGE SENSORS.

Texas Instruments Incorporated

9 Final Technical Report,  
30 Jul 1976 - 31 Jan 1978

CHARACTERIZATION OF ELECTRICALLY ACTIVE  
DEFECTS IN SI USING CCD IMAGE SENSORS

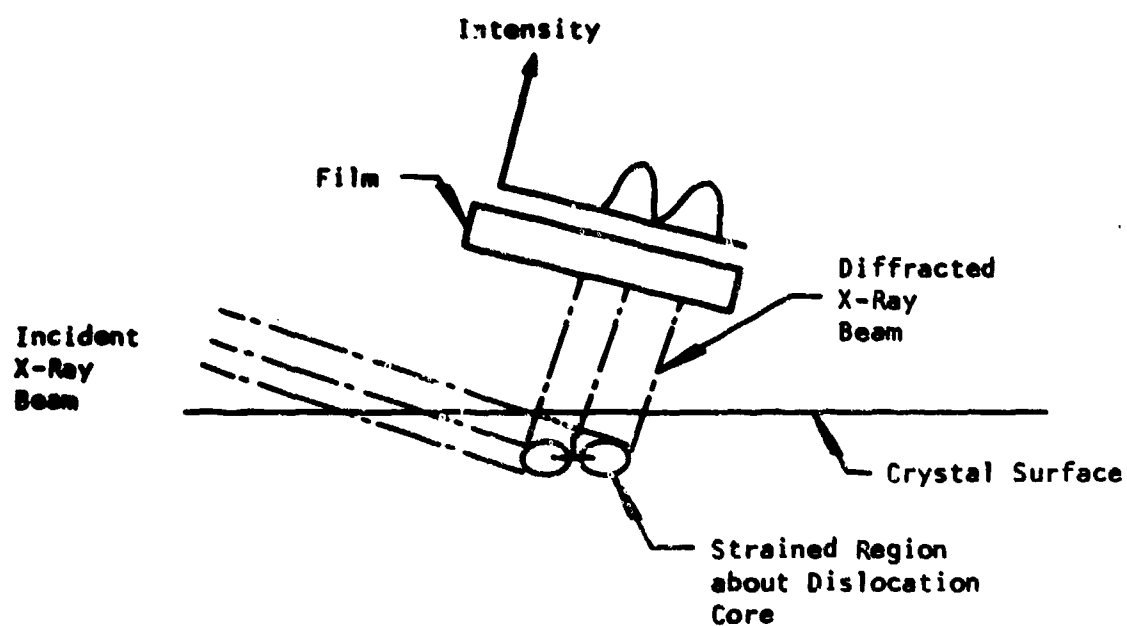
Figure D-6 Origin of Bimodal Contrast from an Edge Dislocation
