MARINE GAS TURBINE HOT CORROSION
DEPENDENCE ON INGESTED SALT LEVELS

Report No. FR-11544

R.H. Barkalow and F.S. Pettit
United Technologies Corporation
Pratt & Whitney Aircraft Group
Government Products Division
West Palm Beach, FL 33402

Final Report: 29 July 1977 to 31 Oct 1978

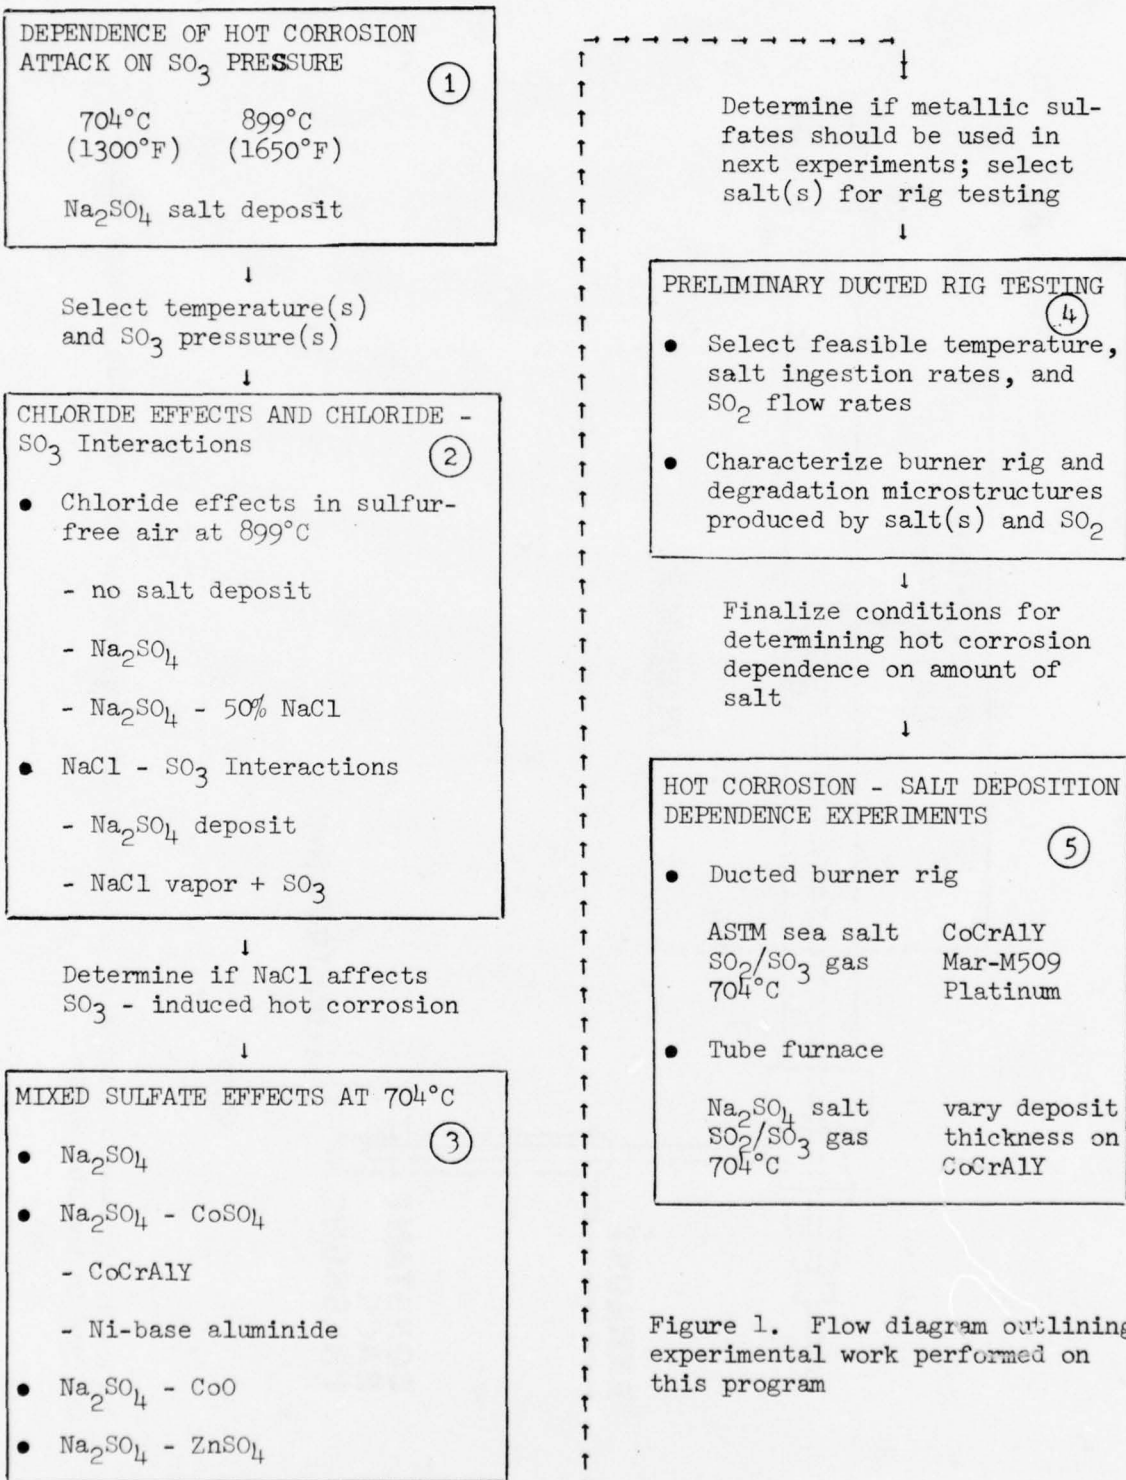
Figure 1. Flow diagram outlining experimental work performed on this program

Conclusions and inferences from the service evaluation and laboratory test results summarized in the preceding paragraphs were the basis of formulating the test plan for this program as outlined in Figure 1. The plan includes tube furnace experiments to provide basic data on the effects of important hot corrosion variables and burner rig testing to determine severity of hot corrosion versus ingested salt level. Implicit in both types of experiments is the assumption that the partial pressure of SO_3 in the gaseous environment is a critical parameter. Hence, except for baseline furnace experiments to compare sulfur-containing versus sulfur-free air, all testing is done at controlled values of SO_3 pressure.

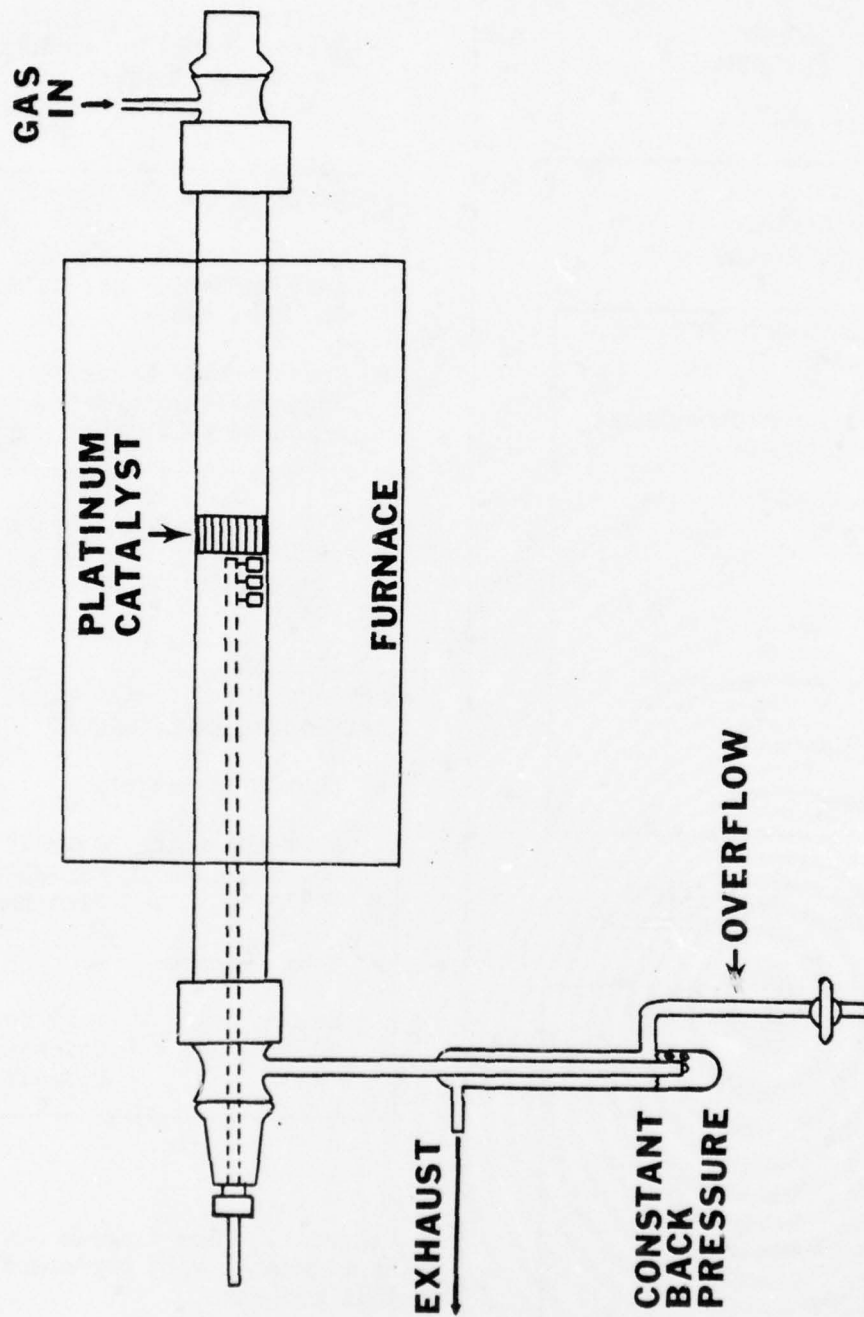
Figure 2. Schematic diagram of horizontal tube furnace for hot corrosion testing with SO_3 gas in the atmosphere.

All tests were performed in the horizontal tube furnace illustrated in Figure 2. The input gas was mixed from bottled SO₂ and O₂ with flowmeters capable of providing ratios as low as 0.0001 volume fraction SO₂; total flowrate was 11.5 liters/hour. A catalyst of sputtered platinum on DuPont Torvex® honeycomb alumina was maintained at the same temperature as the specimens, which were suspended on platinum wires from a ceramic tube. The specimens were coated with 1 mg/cm² of Na₂SO₄, exposed for 20 hours, water washed, and recoated with fresh salt for continued testing. Total exposure time was 100 hours unless sooner terminated because of severe attack.

The air experiments were performed in a vertical tube furnace; those involving NaCl vapor were run in the horizontal furnace of Figure 2 by inserting a salt-filled boat upstream of the specimens. Material behavior

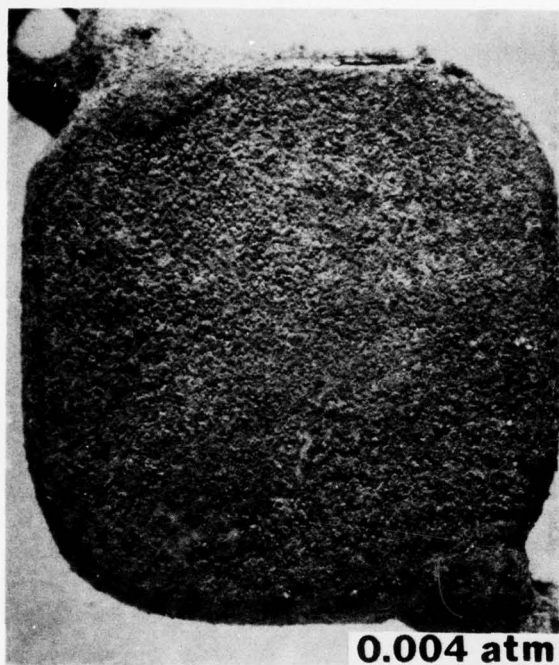
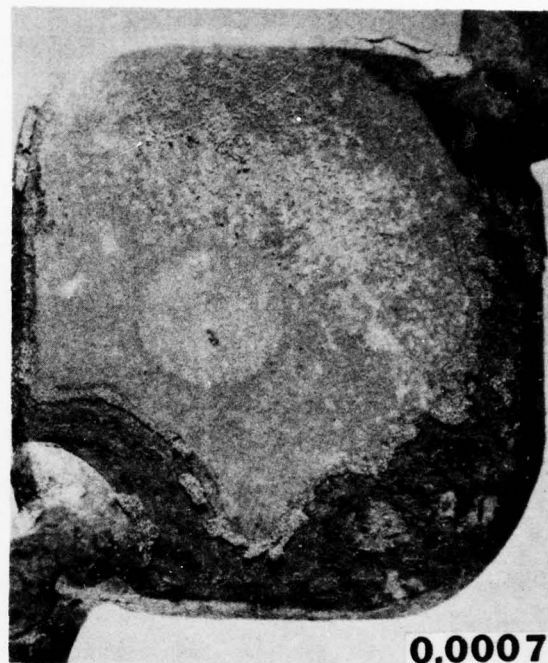
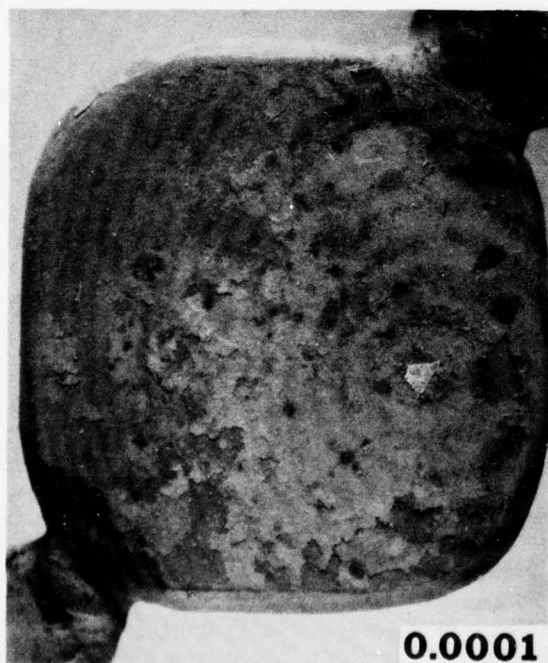
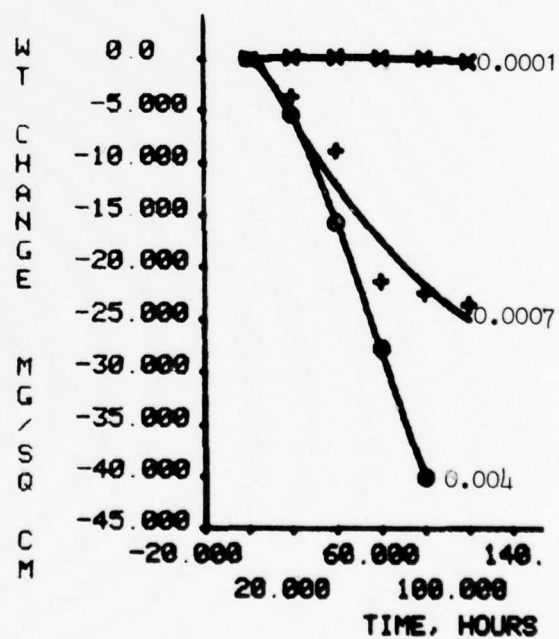
Figure 3. Effect of SO₃ pressure on 704C sulfate-induced hot corrosion of CoCrAlY-coated (PWA 68; Co - 15 to 24 Cr - 11.5 to 13.5 Al - 0.2 to 0.7 Y) IN 792, as shown by surface condition after 20 hours and weight change data for 100-hour cyclic exposure.

Surface photographs and weight change data showing severity of attack versus SO_3 pressure are presented in Figures 3 - 8. Except for an unusually large weight loss of one of the specimens (uncoated IN 792) at the intermediate value of p_{SO_3} , all observations and $\Delta M/A$ data indicate strong and consistent dependence of severity of attack on SO_3 pressure.

The surface photographs in Figures 3 - 7 are those taken of each specimen at the initial examination after 20 hours exposure, where the difference in surface condition as a function of SO_3 pressure was most evident. The effect of SO_3 pressure on severity of attack - especially at 0.004 versus 0.0007 atm - was not well illustrated by black and white surface photographs after longer exposure times, although the difference in degradation of the coated specimens at 0.0007 versus 0.0001 atm was apparent (Figure 8).

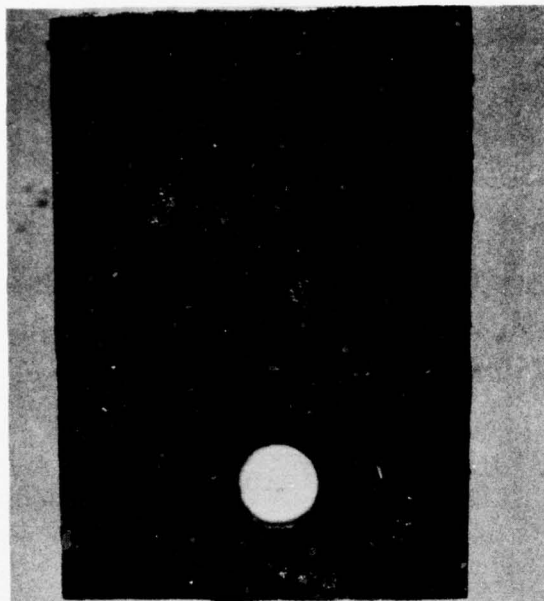
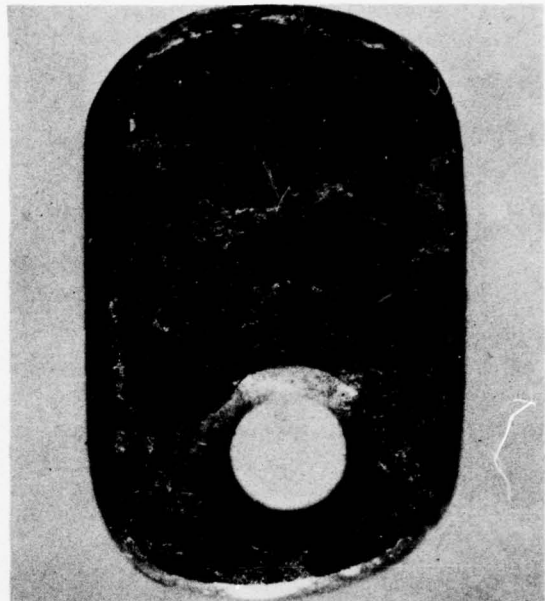
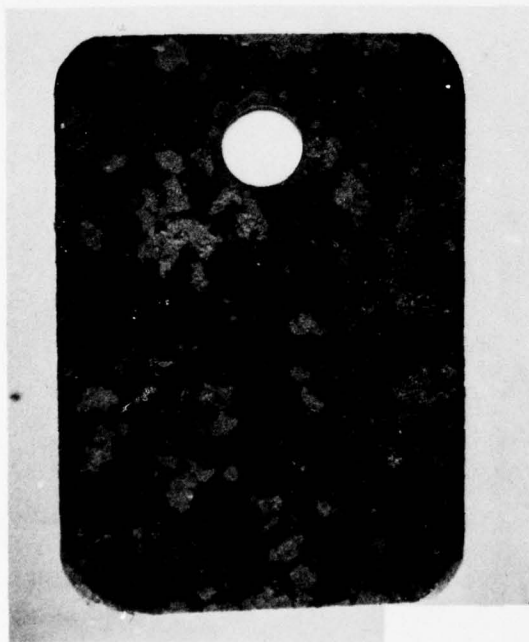
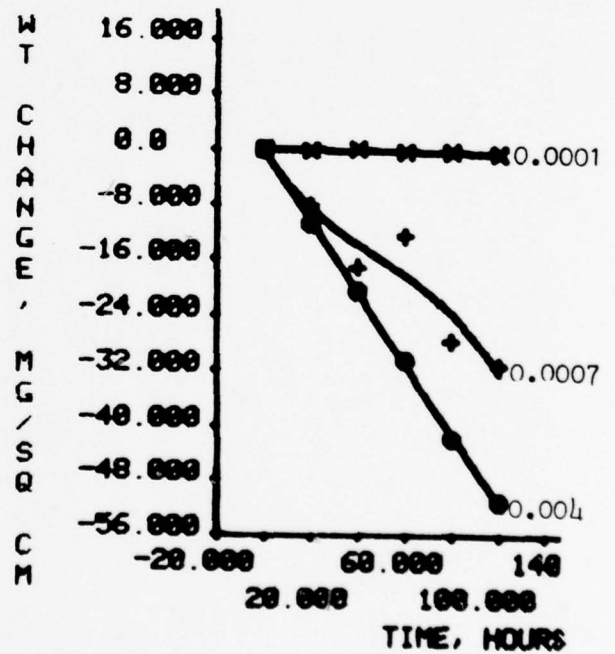
Figure 4. Effect of SO_2 pressure on 704C sulfate-induced hot corrosion of uncoated Mar-M509 (Co-23.4Cr-10.0Ni-0.2Ti-7.0W-3.5Ta-0.5Zr-0.6C), as shown by surface condition after 20 hours and weight change data for 100-hour cyclic exposure.

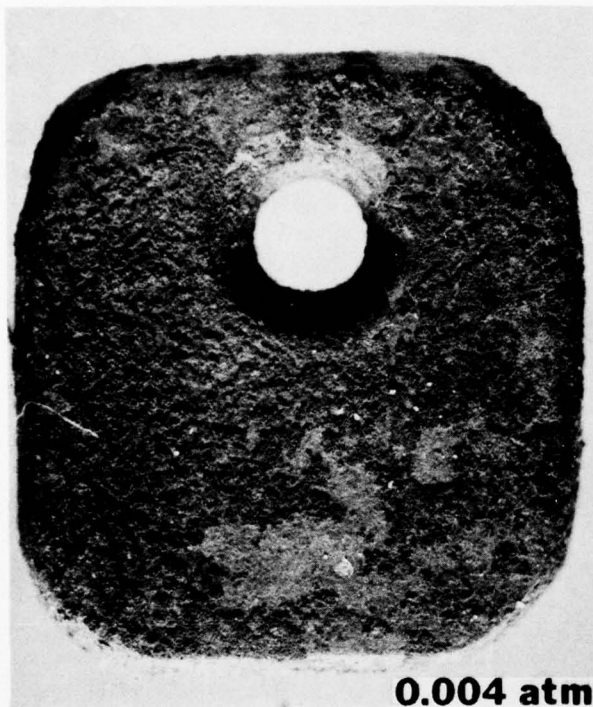
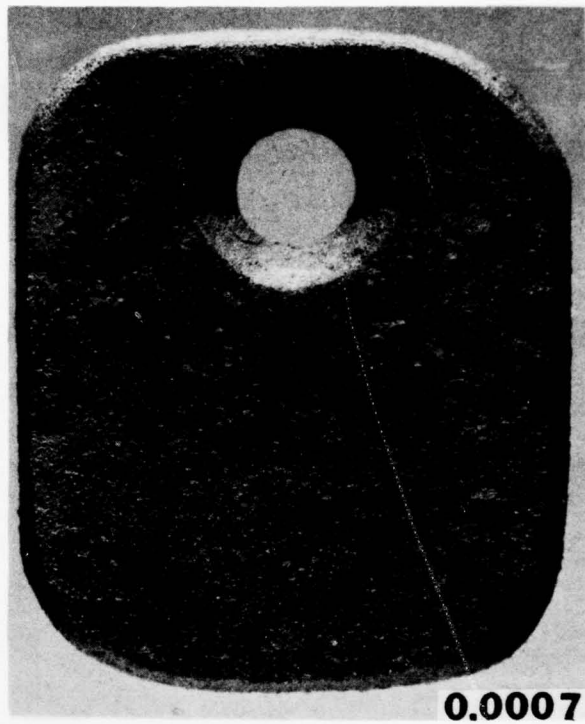
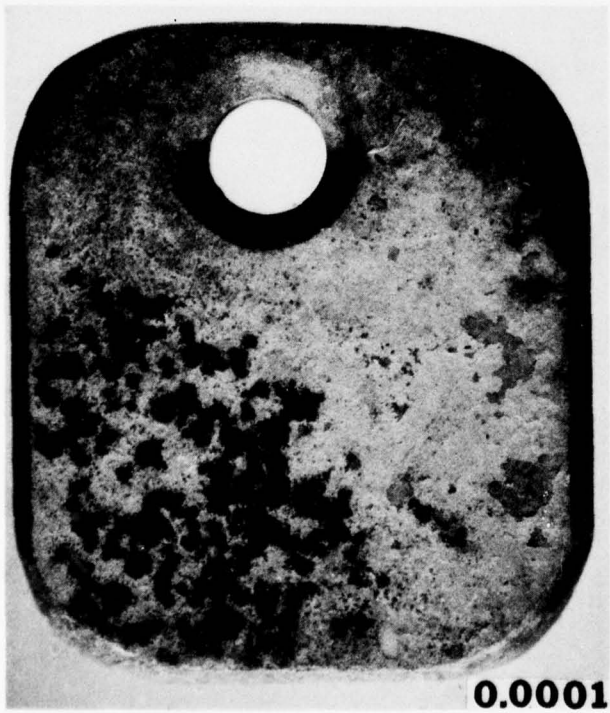
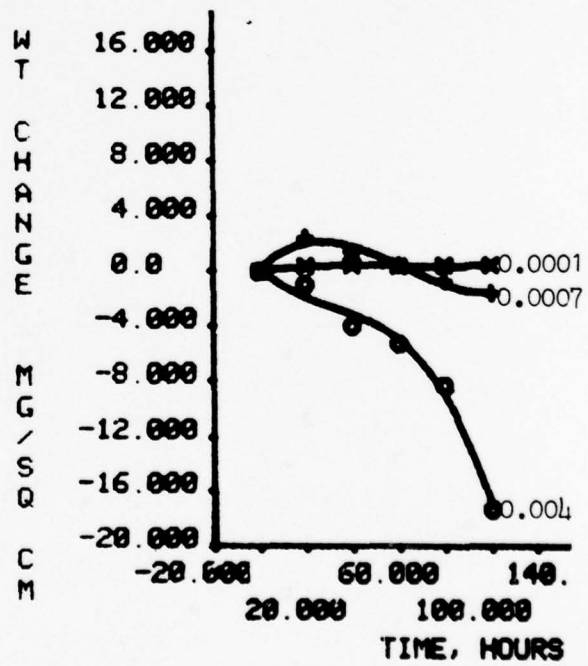
Figure 5. Effect of SO_2 pressure on 704C sulfate-induced hot corrosion of aluminized (PWA 28) Mar-M509, as shown by surface condition after 20 hours and weight change data for 100-hour cyclic exposure.

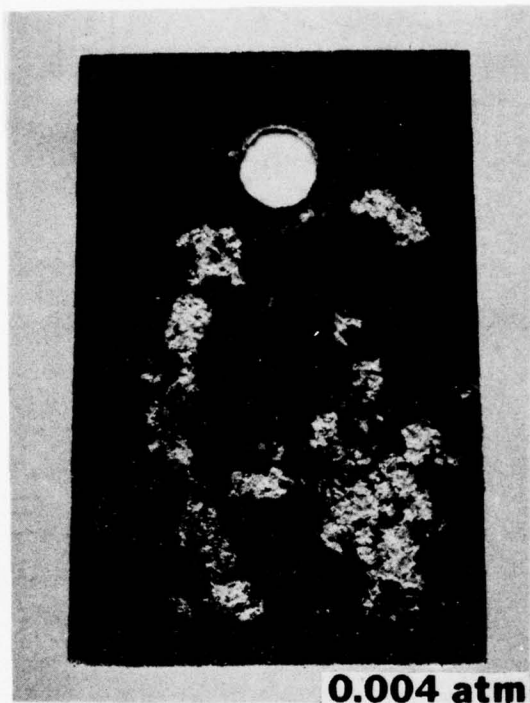
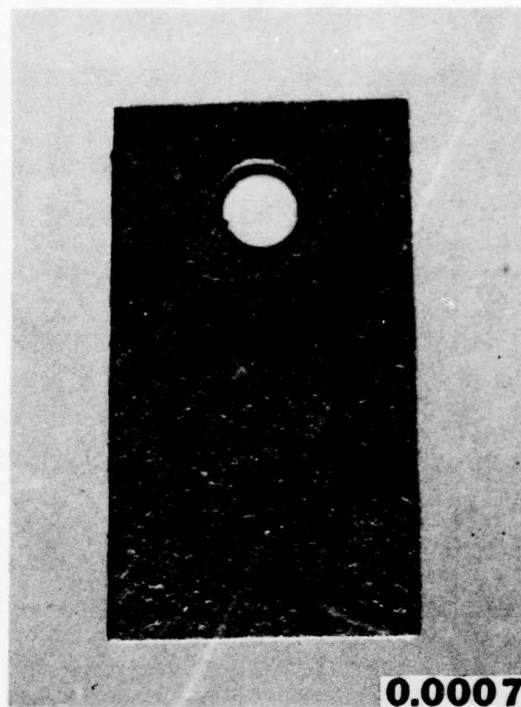
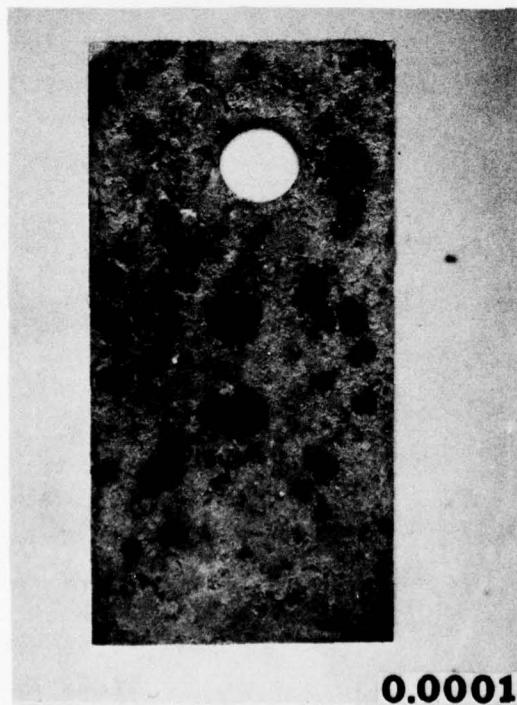
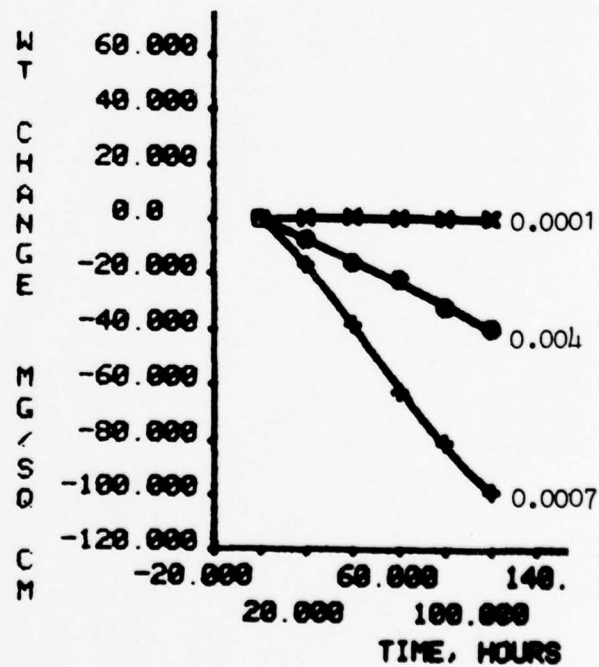
Figure 6. Effect of SO_2 pressure on 704C sulfate-induced hot corrosion of uncoated IN 792 (Ni-12.0Cr-9.0Co-4.5Ti-3.1Al-1.9Mo-3.8W-3.9Ta-0.12C-0.1Zr-0.02B), as shown by surface condition after 20 hours and weight change data for 100-hour cyclic exposure.

At $p_{\text{SO}_3} = 0.0007$ atm, uncoated IN 792 suffered large weight changes at both 704 and 899°C (Figure 30a). Although the weight loss at 704°C may have been anomalously large (Figure 6), it is clear from corresponding

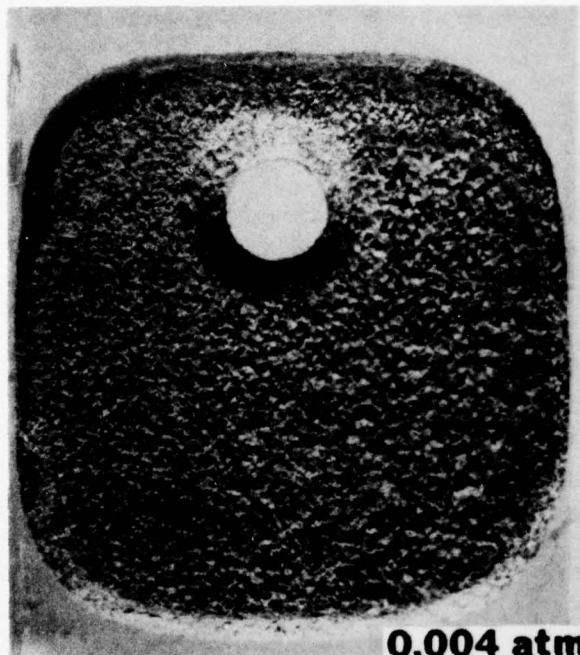
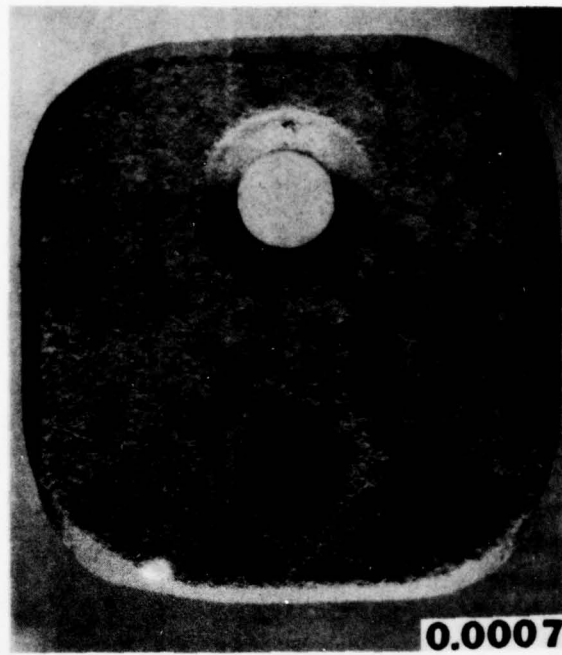
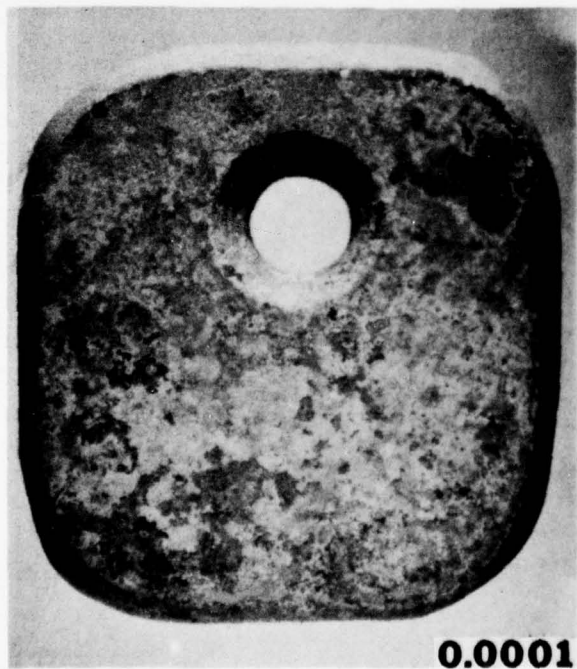
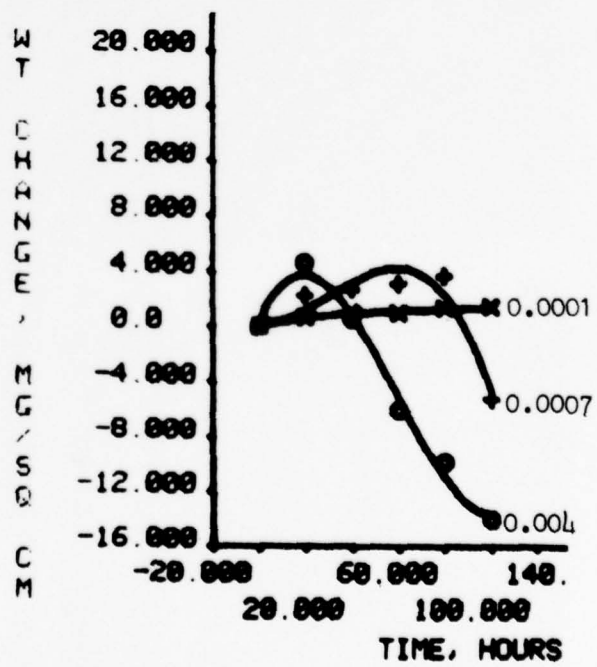
Figure 7. Effect of SO₂ pressure on 704C sulfate-induced hot corrosion of aluminized (PWA 273) IN 792, as shown by surface condition after 20 hours and weight change data for 100-hour cyclic exposure.

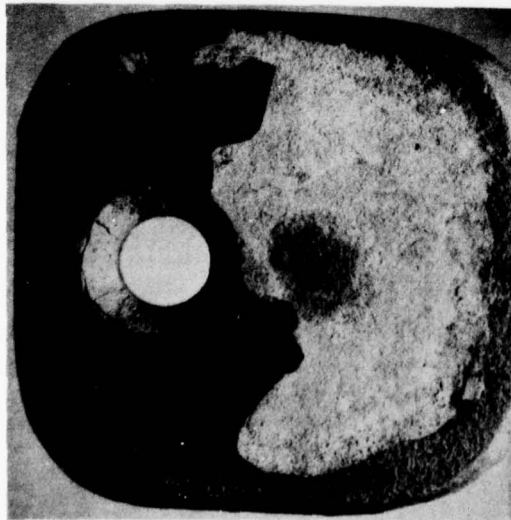
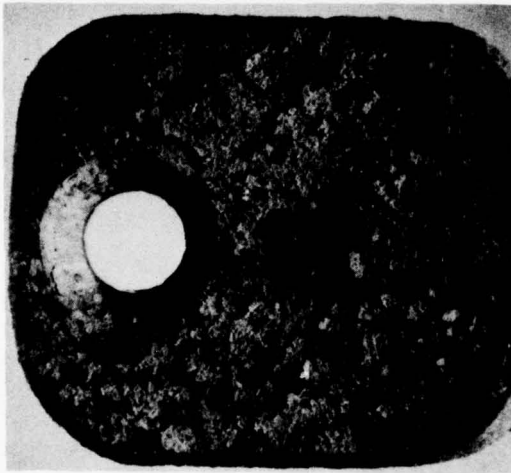
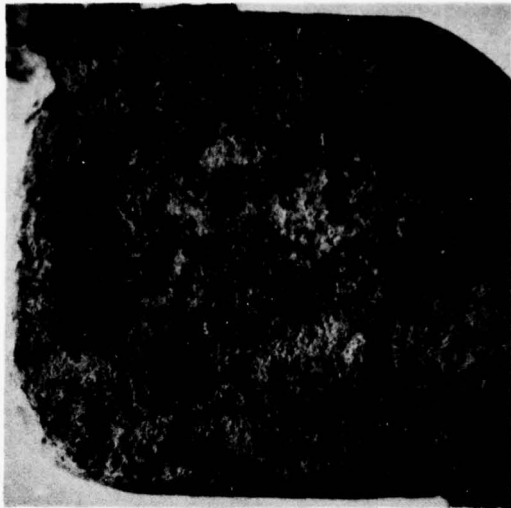
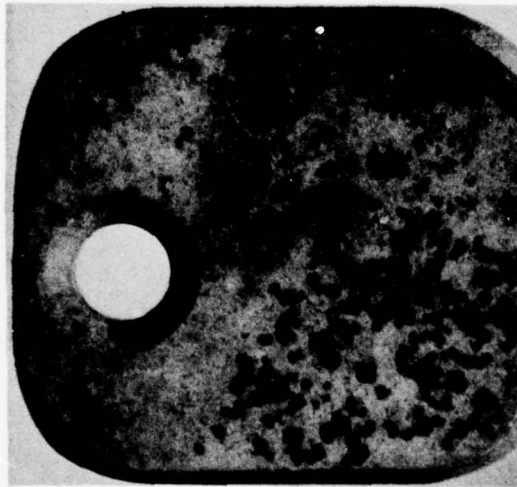
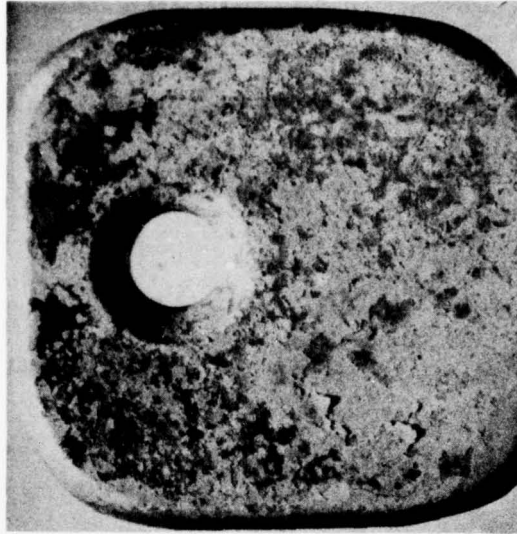
Figure 8. Effect of SO₂ pressure on 704C sulfate-induced hot corrosion of CoCrAlY and aluminide coatings (PWA 68 on IN 792, PWA 28 on Mar-M509, and PWA 273 on IN 792), as shown by surface condition after 100-hour cyclic exposure.

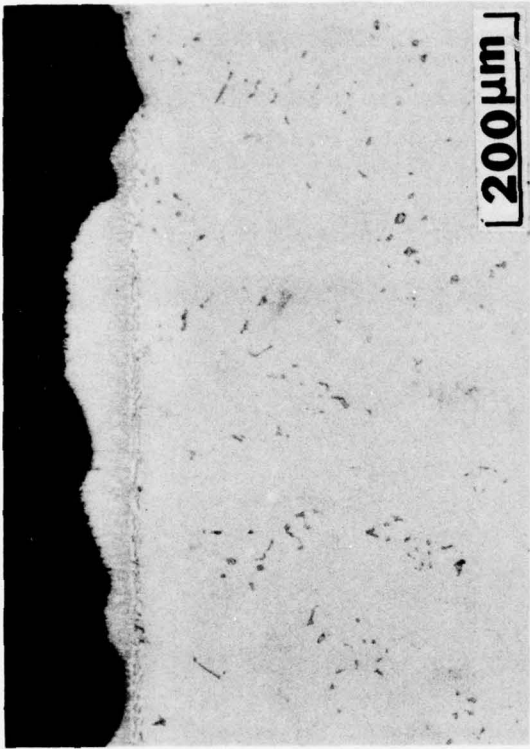
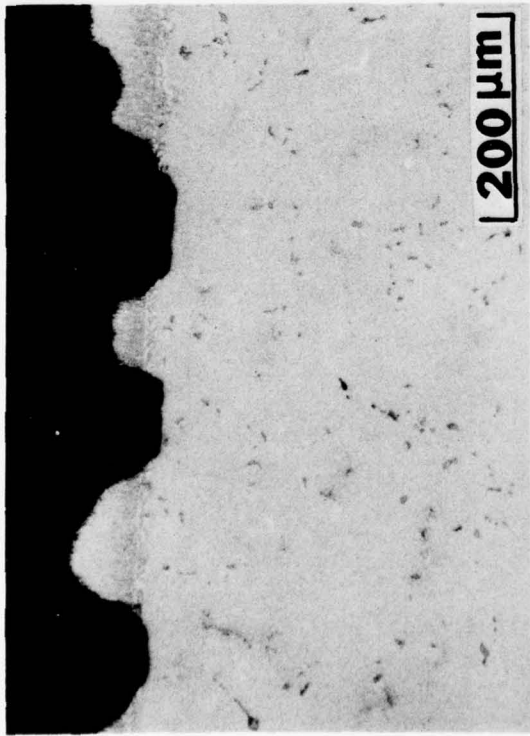
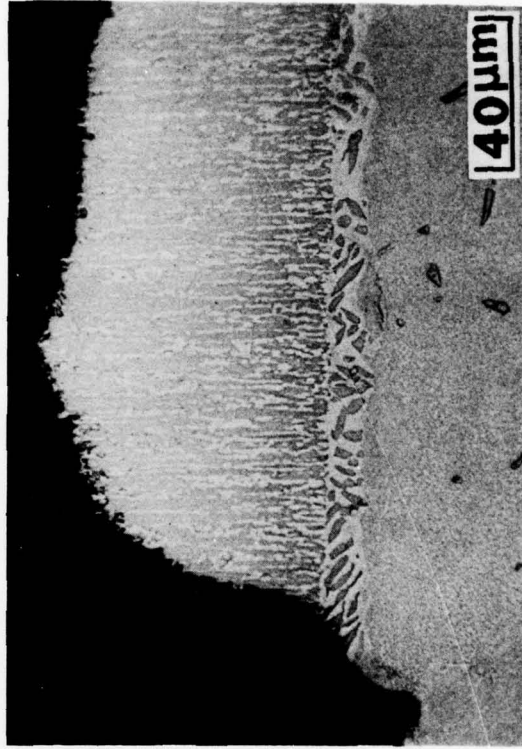
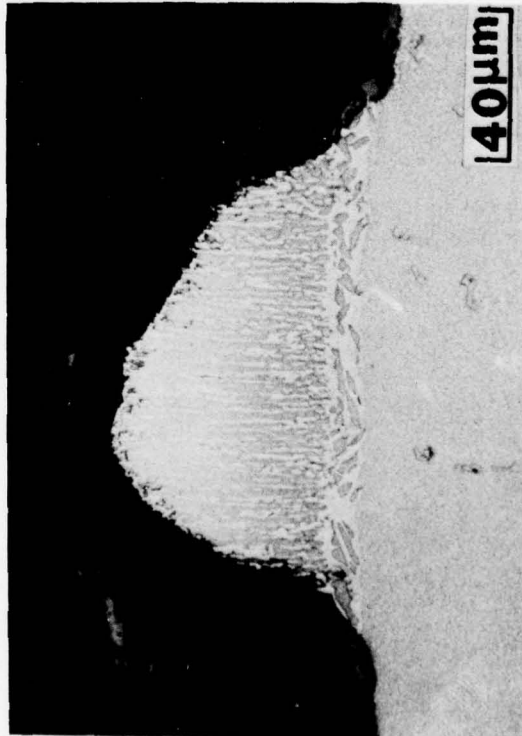
Figure 9. Typical depth of attack and nodular morphology of corrosion front produced by cyclic exposure of PWA 68 CoCrAlY for 100 hours at 704C and PS03 = 0.004 atm. Specimen was lightly etched to emphasize coating thickness and microstructure.

Post-test metallography showed that the PWA 68 CoCrAlY coating tested at 0.004 atm SO_3 was penetrated or almost penetrated in numerous locations, with most areas showing general surface degradation as well as localized nodular attack (Figure 9). The uncoated alloys in the same test (Figures 10a, 10b) showed highly irregular surfaces reflecting the substantial material consumption and scale spallation inferred from visual inspection and the large weight losses; however, there was no indication of alloy depletion, sulfide precipitation, or internal oxidation in advance of the scale/metal interface. The PWA 28 aluminide coating on Mar-M509 was almost completely consumed; the heavy scale shown in Figure 10c was spalled off in most areas and substrate attack was observed. In contrast, the PWA 273 on the Ni-base IN 792 was heavily attacked but still protective (Figure 10d).

Less severe attack, especially of the Co-base coatings, at $p_{\text{SO}_3} = 0.0007$ atm is evident from comparison of Figures 11 and 12 versus Figures 9 and 10. The CoCrAlY and the Co-base aluminide both failed in the 100-hour test at 0.004 atm; at the lower SO_3 pressure, both were substantially corroded but still intact, at least over most of the area of the specimen.

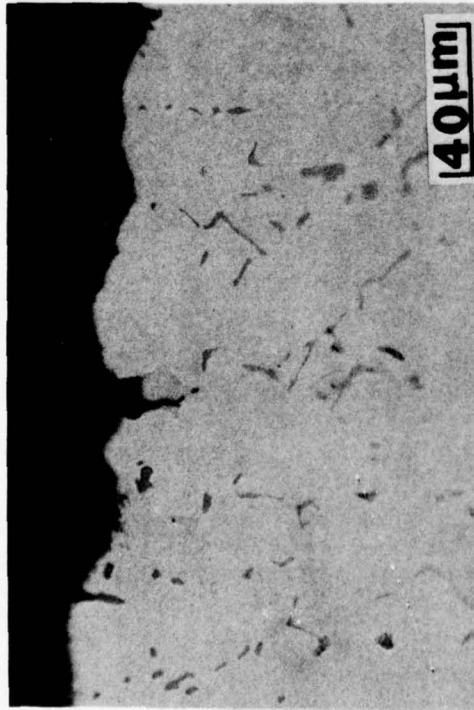
10a. Uncoated Mar-M509

Figure 10. Uncoated and aluminized alloys tested concurrently with the CoCrAlY coating of Fig. 9 (i.e. 100 hours at 704C, $PSO_2 = 0.004$ atm). Arrow in 10c shows innermost diffusion zone of the PWA 28 microstructure; the rest of the coating was completely oxidized and spalled off in most areas.

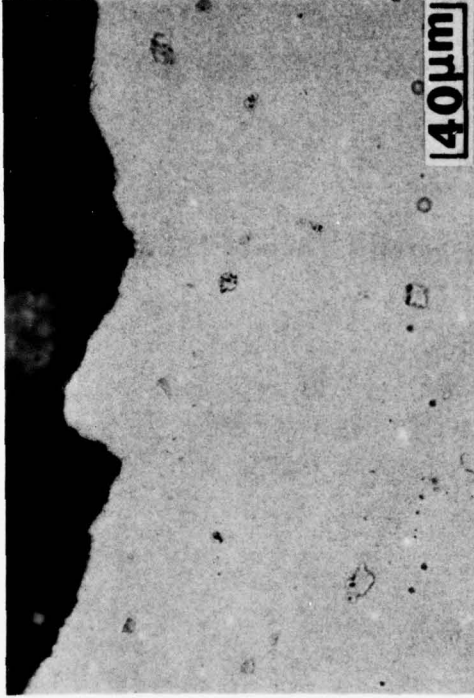
10b. Uncoated IN 792

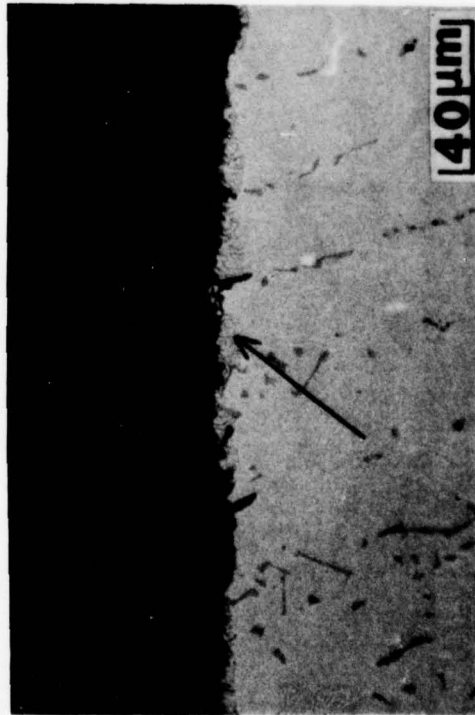
10c. Mar-M509/PWA 28 aluminate

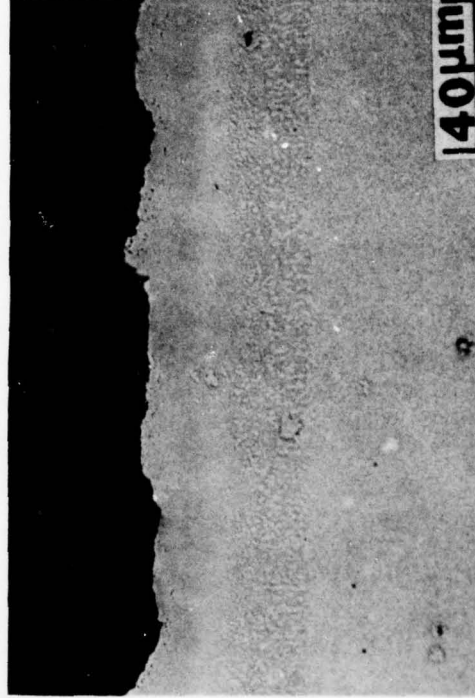
10d. IN 792/PWA 273 aluminate

The aluminide coating on IN 792 was resistant to SO_3 effects at 704°C; although significant weight losses and surface degradation were observed, the coating was not penetrated even by 100 hours at 0.004 and 0.0007 atm (Figure 10, 12). Conversely, exposure to SO_3 at 899°C caused rapid sulfidation and penetration of the coating after only 20 hours (Figure 24).

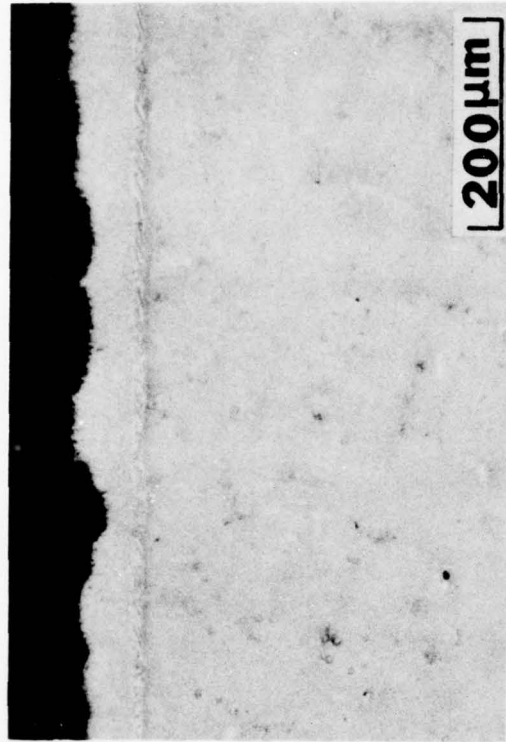
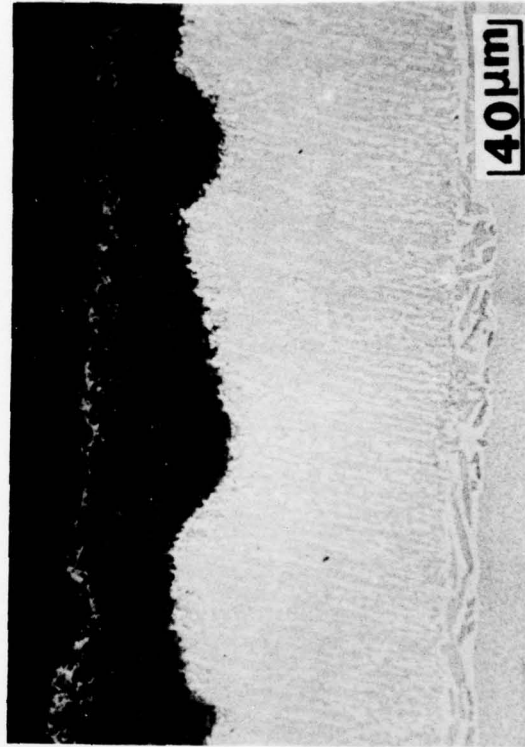
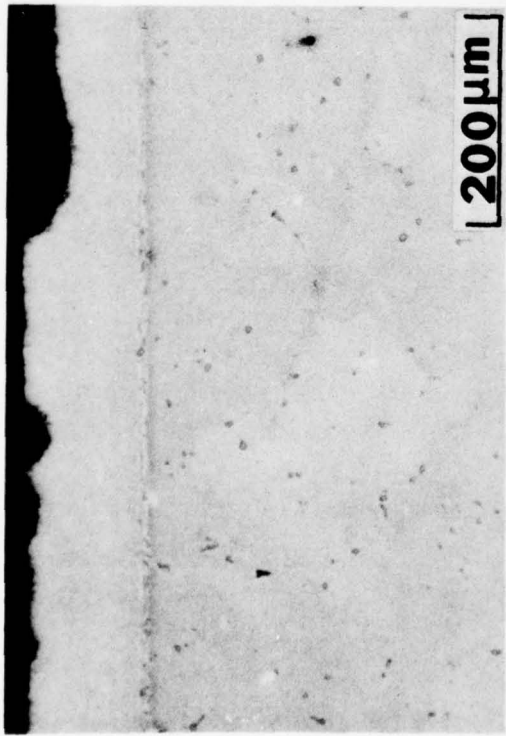
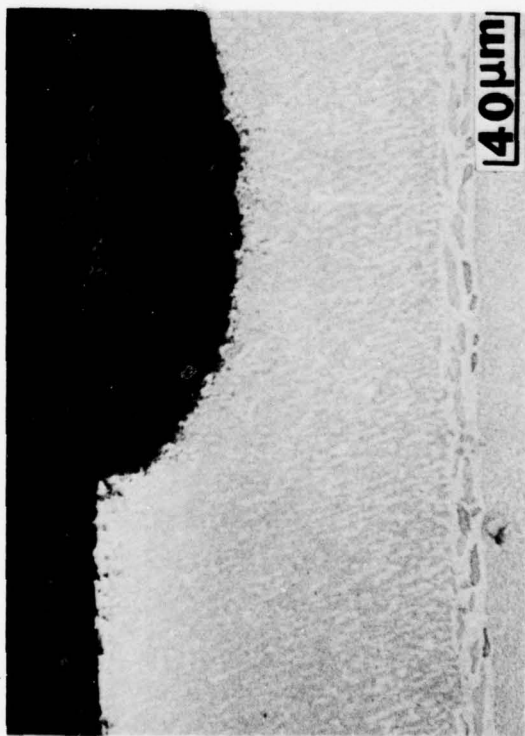
Figure 11. Typical depth of attack and nodular morphology of corrosion front produced by cyclic exposure of FWA 68 CoCrAlY for 100 hours at 704C and $PSO_2 = 0.0007$ atm. Consumption of approximately half of the coating was observed in many areas, but the coating was apparently not penetrated.

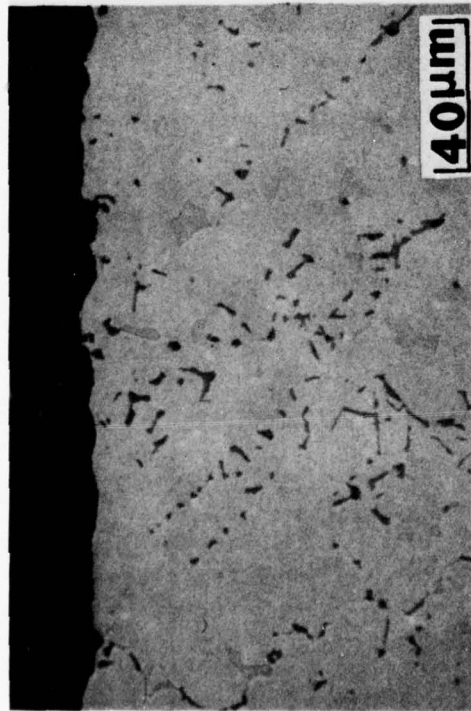
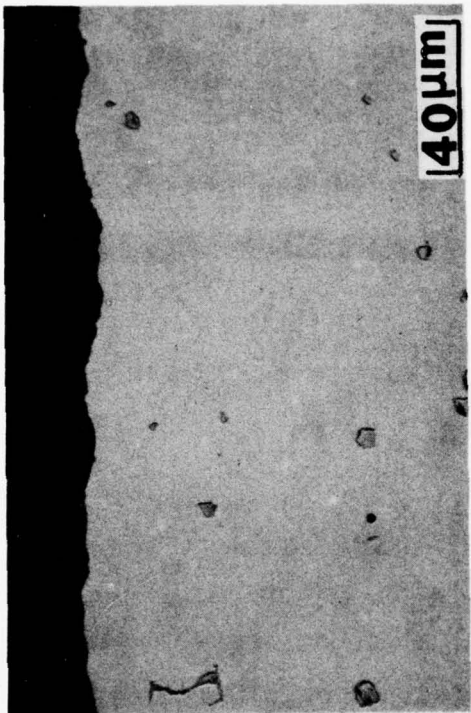
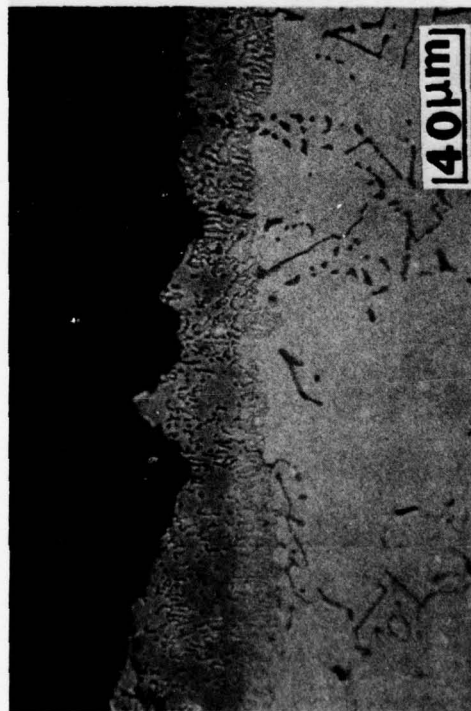
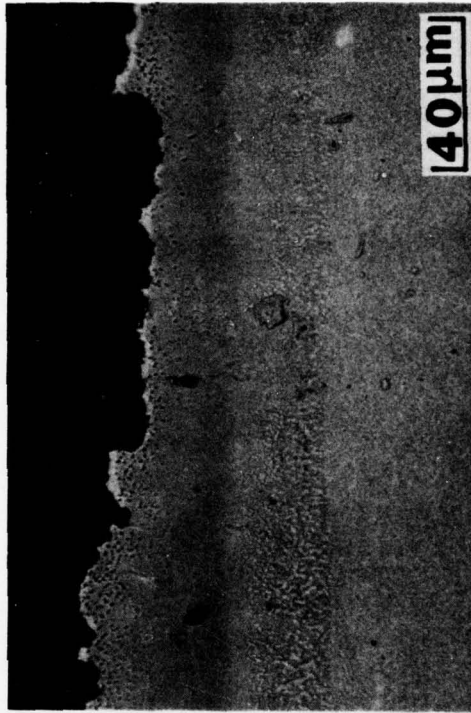
12a. Uncoated Mar-M509

12b. Uncoated IN 792

12c. Mar-M509/PWA 28 aluminide

12d. IN 792/PWA 273 aluminide

Figure 12. Uncoated and aluminized alloys tested concurrently with the CoCrAlY coating of Fig. 11 (i.e. 100 hours at 704C, $PSO_3 = 0.0007$ atm).

metallography that high temperature promoted gross sulfidation (Figure 25c) in contrast to negligible internal attack at 704°C (Figure 12b). At 0.0001 atm, a small but clearly measurable weight gain at 899°C (Figure 30b) again suggests more substantial ingress of sulfur into the alloy due to the higher test temperature.

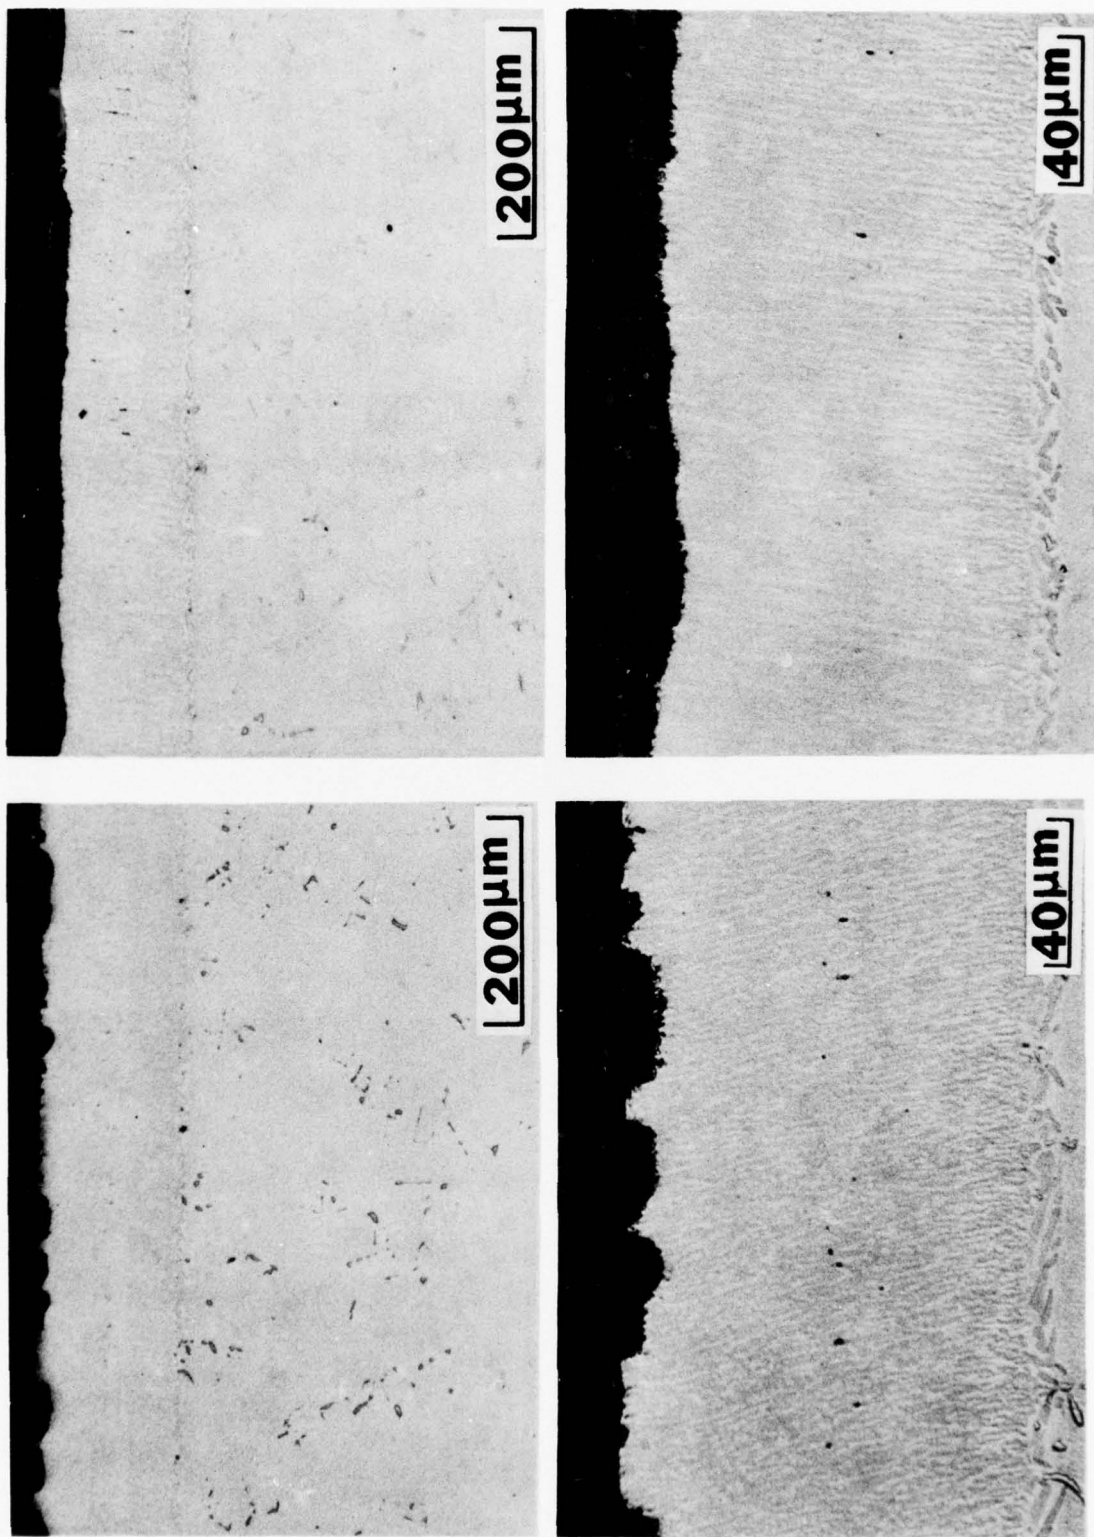
Figure 13. Typical microstructural degradation of PWA 68 CoCrAlY coating produced by cyclic hot corrosion testing for 100 hours at 704C and $PSO_3 = 0.0001$ atm. Comparison with Figs. 9 and 11 shows effect of SO_3 pressure on depth of attack.

It is clear that SO₃-induced hot corrosion of CoCrAlY is less severe at 899 than at 704°C. Although 100-hour exposure at 899°C and $p_{\text{SO}_3} = 0.0007$ atm produced substantial microstructural degradation in some areas (e.g. Figure 22), examination of the test coupons after 20 hours showed extensive corrosion at 704°C versus negligible attack at 899°C, and weight changes were much less at the higher temperature (Figure 28). At 0.0001 atm, the negligible 899°C attack indicated by surface condition (Figure 20c) and post-test metallography contrasts with the significant extent of corrosion shown in Figures 13 and 18.

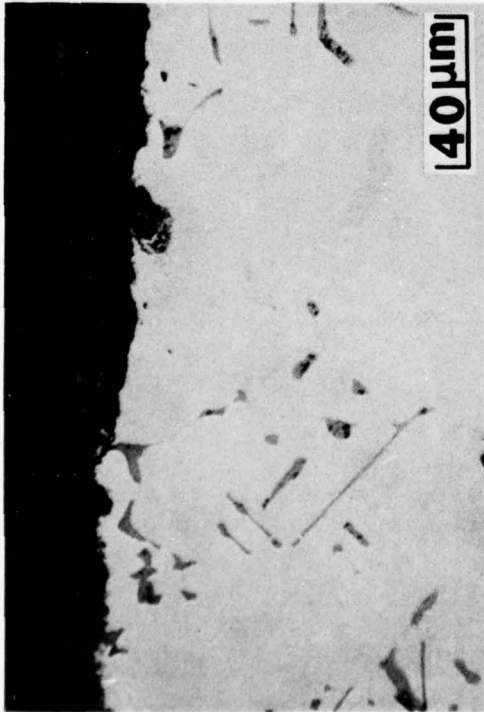
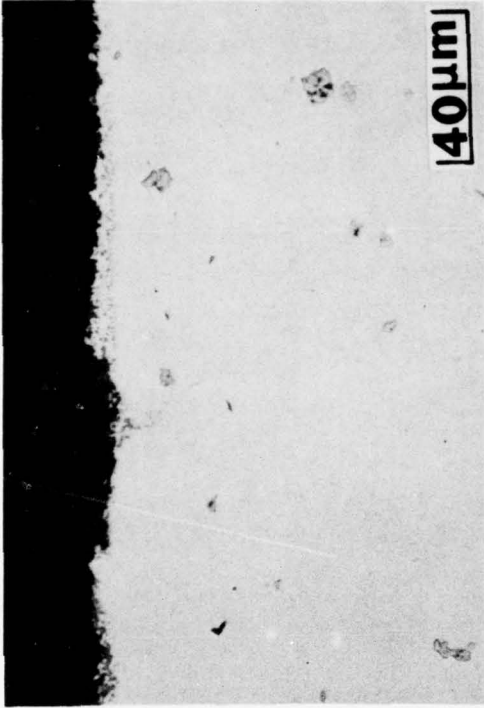
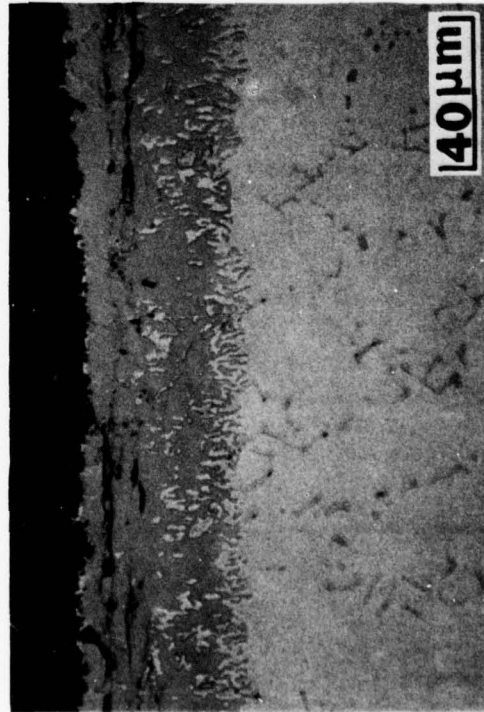
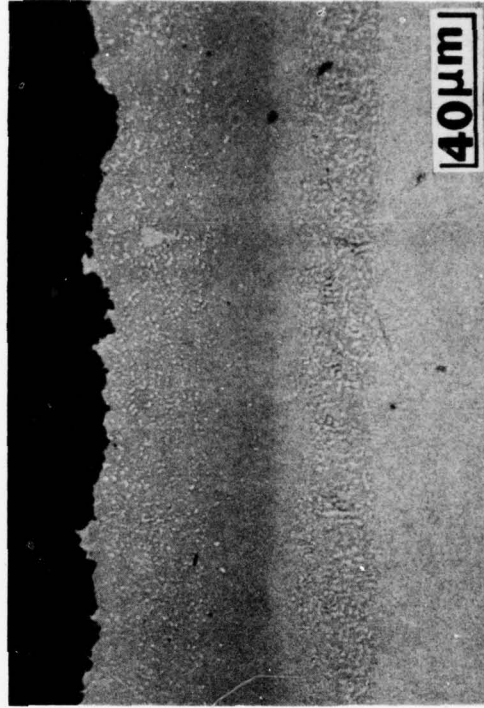
14a. Uncoated Mar-M509

14b. Uncoated IN 792

14c. Mar/M509/FWA 28 aluminide

14d. IN 792/FWA 273 aluminide

Figure 14. Uncoated and aluminized alloys tested concurrently with the CoCrAlY coating of Fig. 13 (i.e. 100 hours at 704C, $PSO_3 = 0.0001$ atm). Comparison with Figs. 10 and 12 shows effect of SO_3 pressure on microstructural degradation.

14. Uncoated and aluminized alloys tested concurrently with the CoCrAlY coating of Fig. 13.	54

Somewhat surprisingly in view of the performance of CoCrAlY and the uncoated Co-base Mar-M509, the aluminide coating on Mar-M509 was more severely attacked at 899 than at 704°C. Figure 29b shows a relatively large 899°C weight loss at 0.0007 atm; at the lower SO₃ pressure, Figure 26b versus Figure 14b again indicates greater microstructural degradation at 899°C, perhaps resulting from coating-substrate interdiffusion.
