MARINE GAS TURBINE HOT CORROSION
DEPENDENCE ON INGESTED SALT LEVELS

Report No. FR-11544

R.H. Barkalow and F.S. Pettit
United Technologies Corporation
Pratt & Whitney Aircraft Group
Government Products Division
West Palm Beach, FL 33402

Final Report: 29 July 1977 to 31 Oct 1978

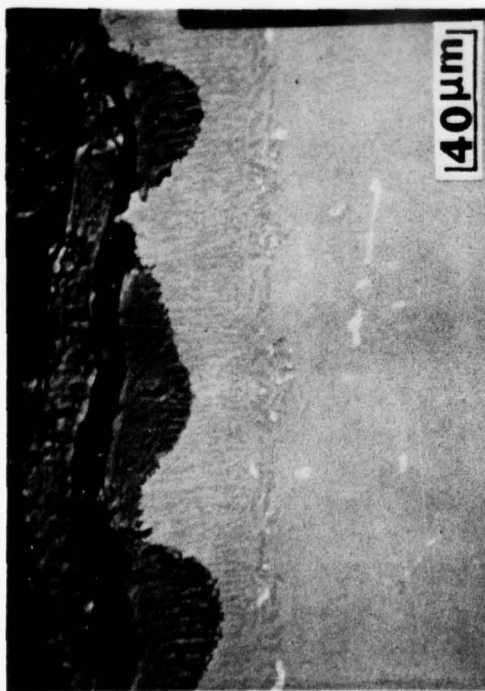
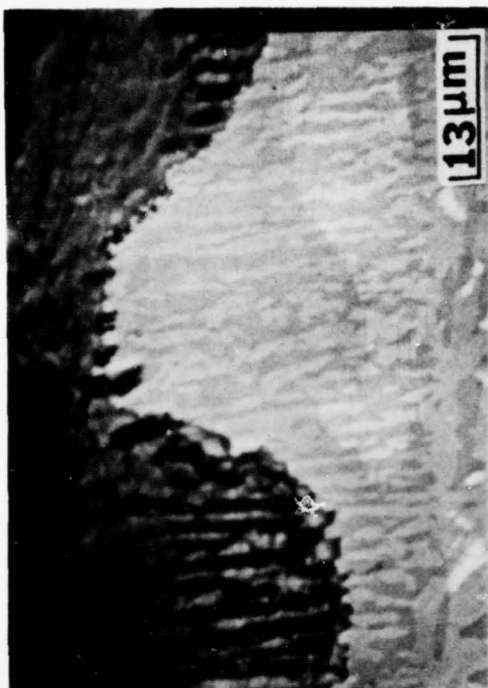
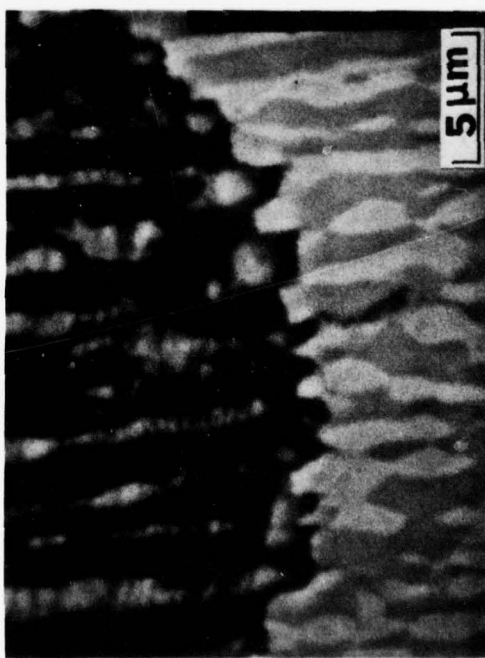
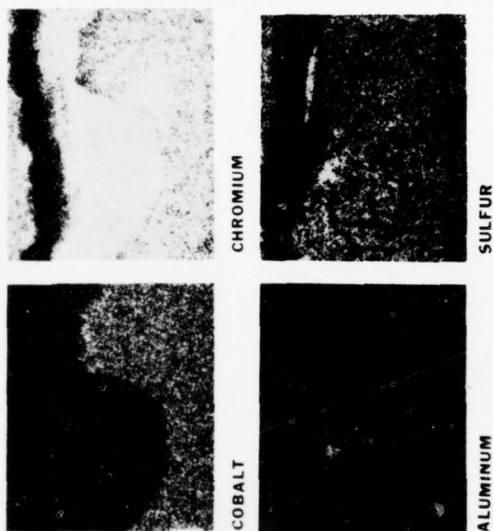
15a. Nodular attack and surface scale

15b. Ghost microstructure of oxidized coating

15c. Attack front at bottom of nodule

Figure 15. SEM photomicrographs (back scattered electrons) and X-ray maps (approximately the area of 15b) showing the structure and composition of the scale and scale/metal interface after 70hC hot corrosion of PWA 68 CoCrAlY at $PSO_3 = 0.004$ atm. Figs. b and c show areas in 15a at higher magnification.

**Wet polished specimens have sometimes shown a generally broad distribution of sulfur (but not sodium) rather than the concentration of sulfur at the attack front as illustrated in Figure 15. Conversely it has been observed that dry polished specimens sometimes show a well defined sulfur-rich band at the attack front rather than the uniform distribution of sulfur shown in Figures 16 and 17. Easily detectable sulfur is invariably present, however, and the sulfur-containing scale is a characteristic feature with important implications regarding the mechanism of SO_3 -induced attack, even though the sulfur distribution (i.e. uniformly in the volume of the protrusion or concentrated at the attack front) may be variable and not well understood.

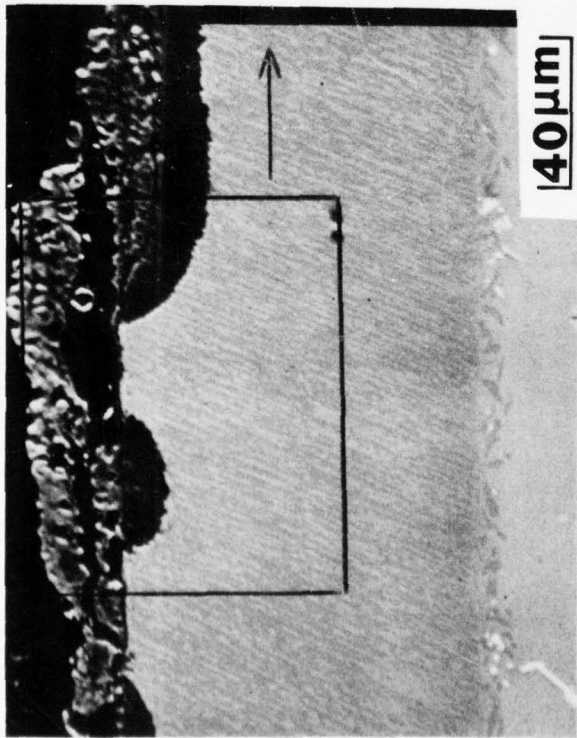
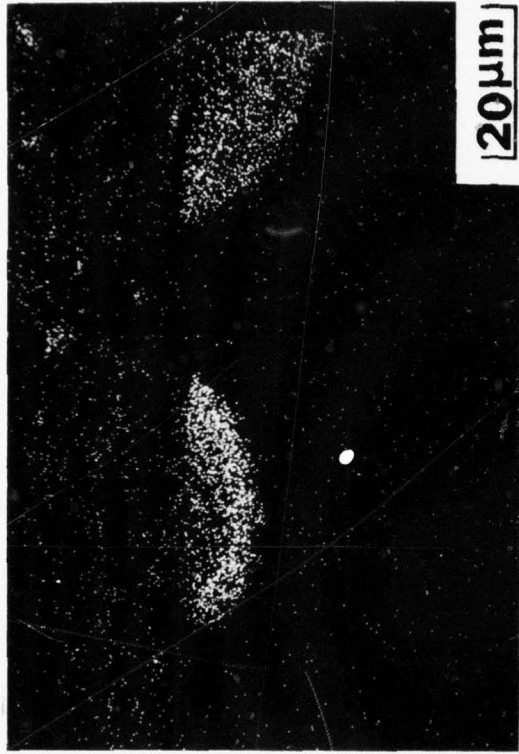
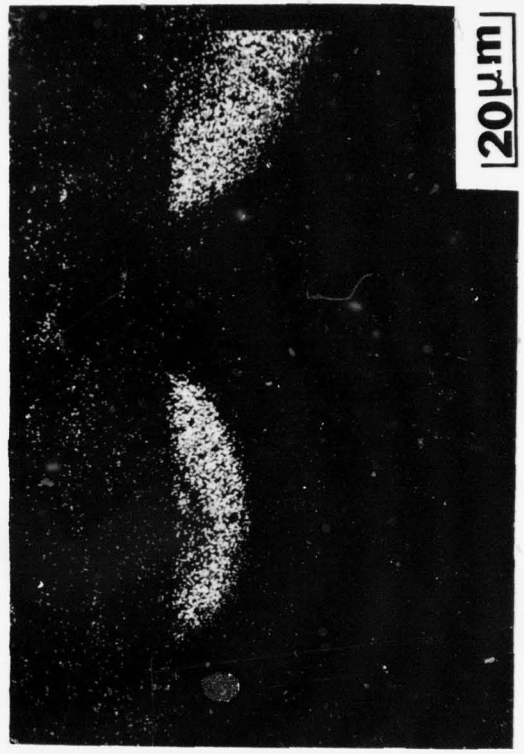
Typical scale thickness and depth of attack

Sodium X-rays

Sulfur X-rays

Figure 16. Accumulation of Na_2SO_4 salt in developing protrusion, as shown by sodium and sulfur X-ray images of a dry polished specimen. Depth of attack illustrated was produced by exposure for 40 hours at 704C with $p_{\text{SO}_3} = 0.0007$ atm. Area at right of box is shown at higher magnification in Fig. 17

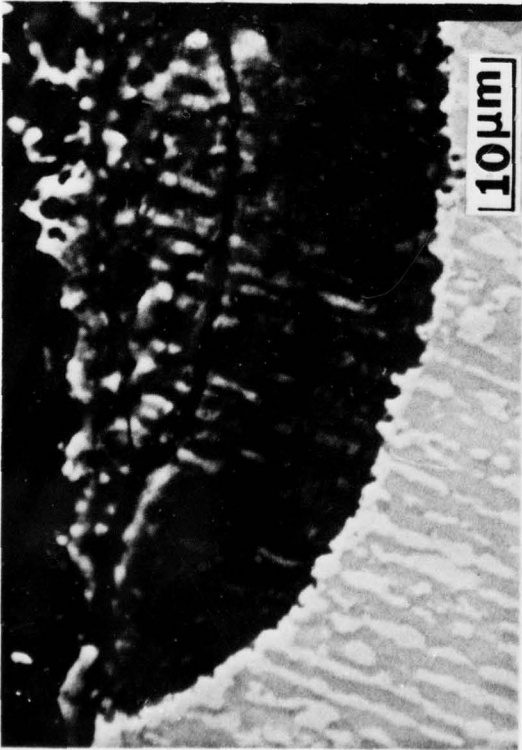
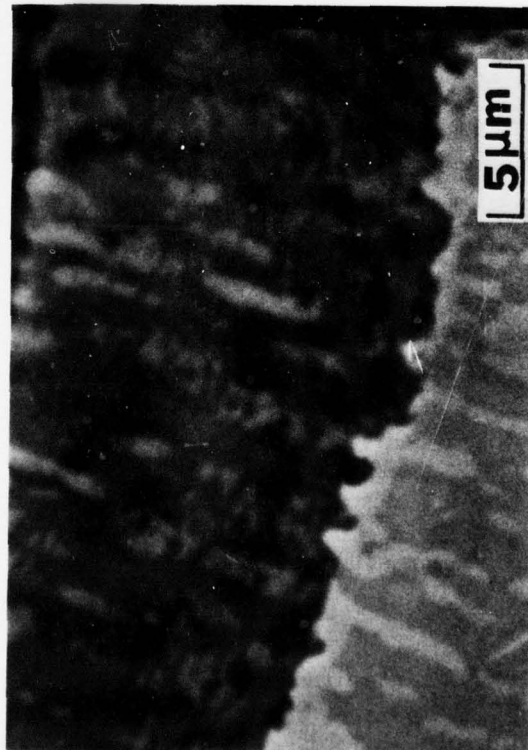
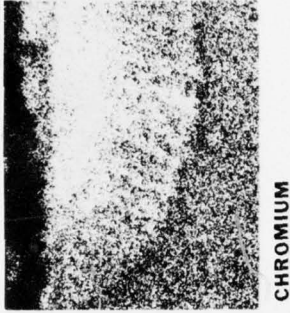
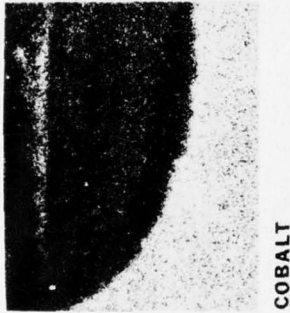
Back scattered electron photomicrographs

CHROMIUM

SULFUR

COBALT

ALUMINUM

Figure 17. High magnification SEM photomicrographs of a portion of the developing protrusion illustrated in Fig. 16. Note the ghost image in the oxidized coating, including resolution of the columnar microstructure in the Cr X-ray map. Also evident are the fine striations parallel to the scale/metal interface and a very thin β -denuded zone at the corrosion front.

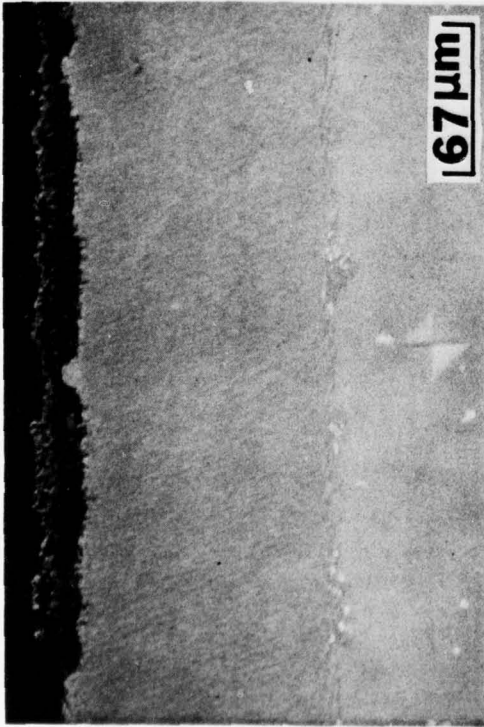
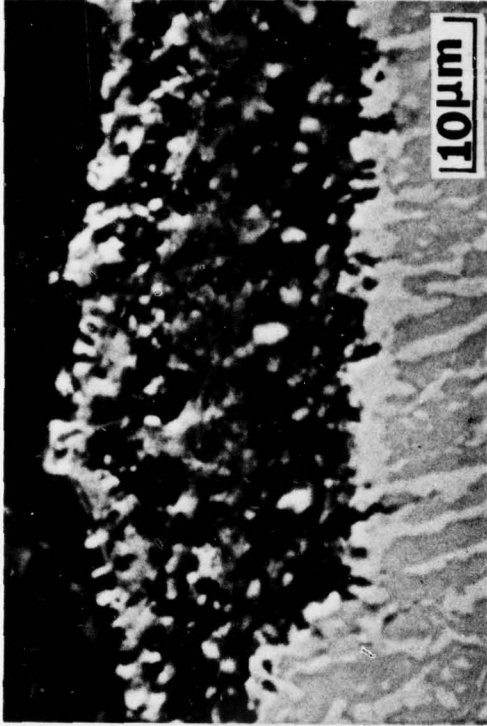
Typical depth of attack and scale thickness

Microstructure of attack front

X-ray maps of above area

Figure 18. SEM photomicrographs (back scattered electrons) and X-ray maps showing the structure and composition of the scale and scale/metal interface after 100 hours at 704C and $p_{SO_2} = 0.0001$ atm. Note the characteristic Co depletion and Co-rich cap, the presence of Al and Cr in both the pit and the external scale, and the presence of sulfur in the scale at the corrosion front.

It is clear that SO₃-induced hot corrosion of CoCrAlY is less severe at 899 than at 704°C. Although 100-hour exposure at 899°C and $p_{\text{SO}_3} = 0.0007$ atm produced substantial microstructural degradation in some areas (e.g. Figure 22), examination of the test coupons after 20 hours showed extensive corrosion at 704°C versus negligible attack at 899°C, and weight changes were much less at the higher temperature (Figure 28). At 0.0001 atm, the negligible 899°C attack indicated by surface condition (Figure 20c) and post-test metallography contrasts with the significant extent of corrosion shown in Figures 13 and 18.

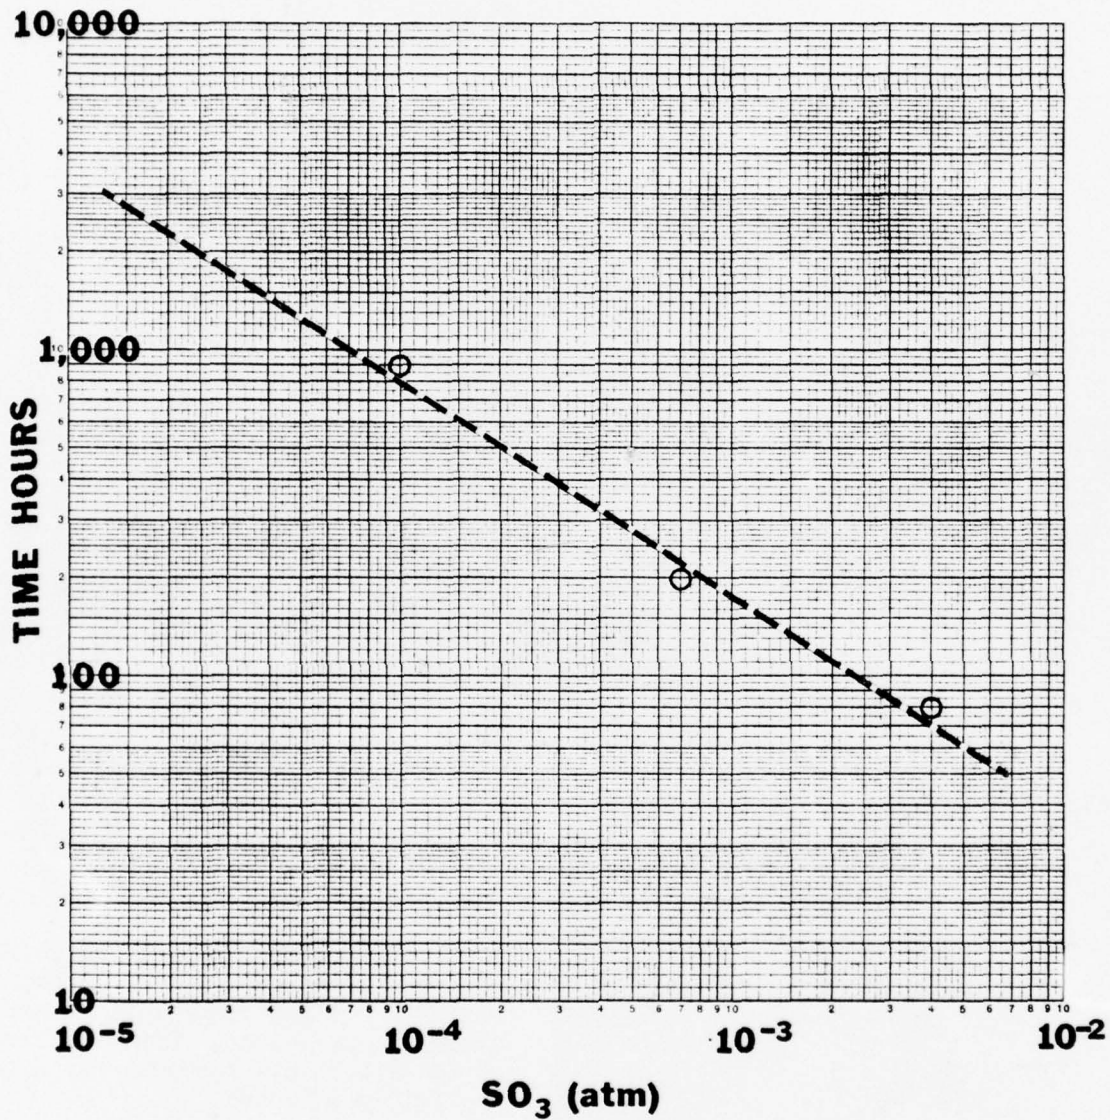
Figure 19. Time to penetration versus SO₃ pressure for PWA 68 CoCrAlY coating as described in text. Note that the graph is an approximation serving only to demonstrate a dependence of rate of attack on SO₃ pressure under otherwise constant test conditions. It is not a prediction of service lifetime versus SO₃ pressure in a gas turbine engine.

Although the graph of Figure 19 must be interpreted with caution because of the limited testing and crude approximation of failure times, it is clear that severity of attack, under otherwise constant environmental conditions, is a strong function of SO_3 pressure.

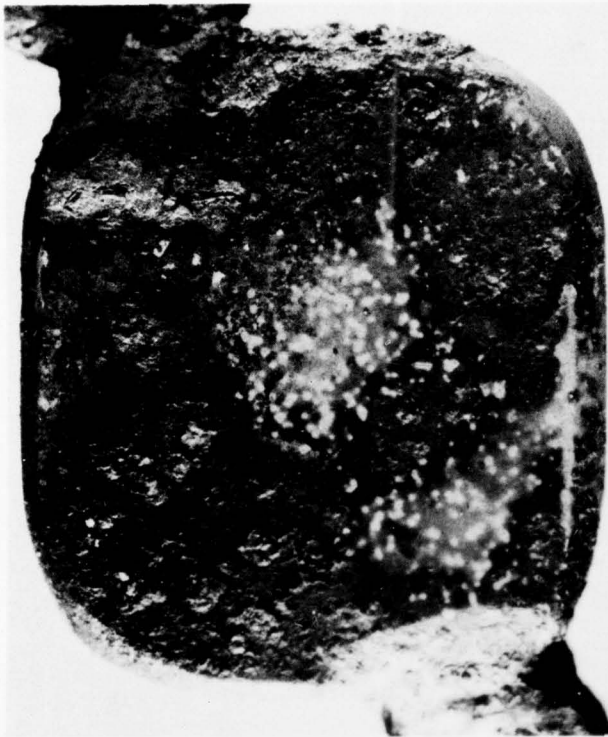
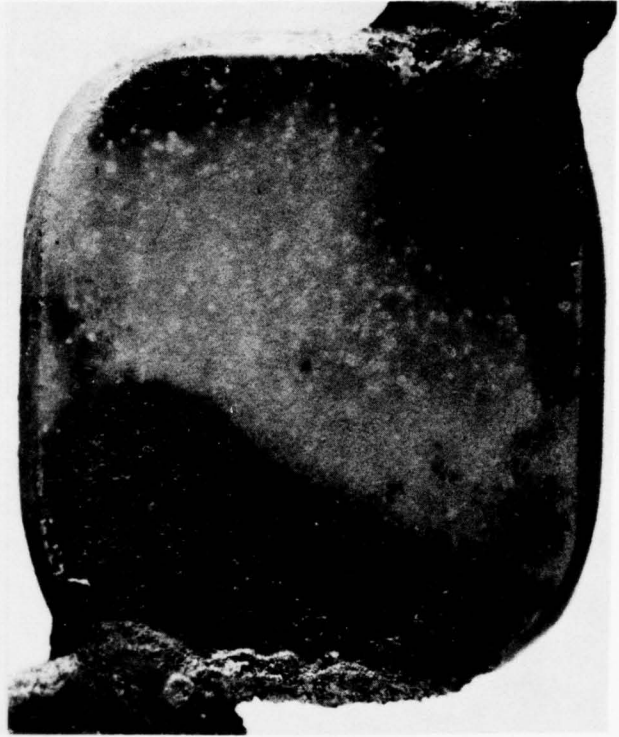
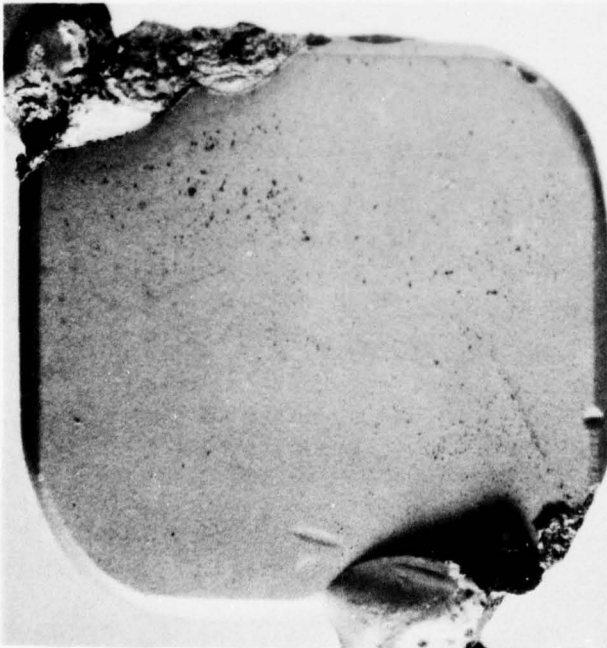
20a. $p_{SO_3} = 0.0007 \text{ atm}$

20b. 0.0007 atm , opposite side

20c. $p_{SO_3} = 0.0001 \text{ atm}$

Figure 20. Surface condition of PWA 68 CoCrAlY coatings after 100 hours in 899°C hot corrosion test at indicated SO_3 pressures. Opposite side of the 0.0001 atm specimen was also negligibly affected.

In the initial high temperature test at $p_{\text{SO}_3} = 0.0007$ atm, the FWA 68 CoCrAlY was significantly attacked (Figure 20a), although half of one surface was still adherent alumina (Figure 20b) and a very small weight change (about 1 mg/cm² in 100 hours) suggested much less attack than that produced by the same SO_3 pressure at 704°C. At 0.0001 atm, attack of the CoCrAlY was limited to the very small spots of blue spinel shown in Figure 20c; post-test metallography showed no discernable microstructural degradation.

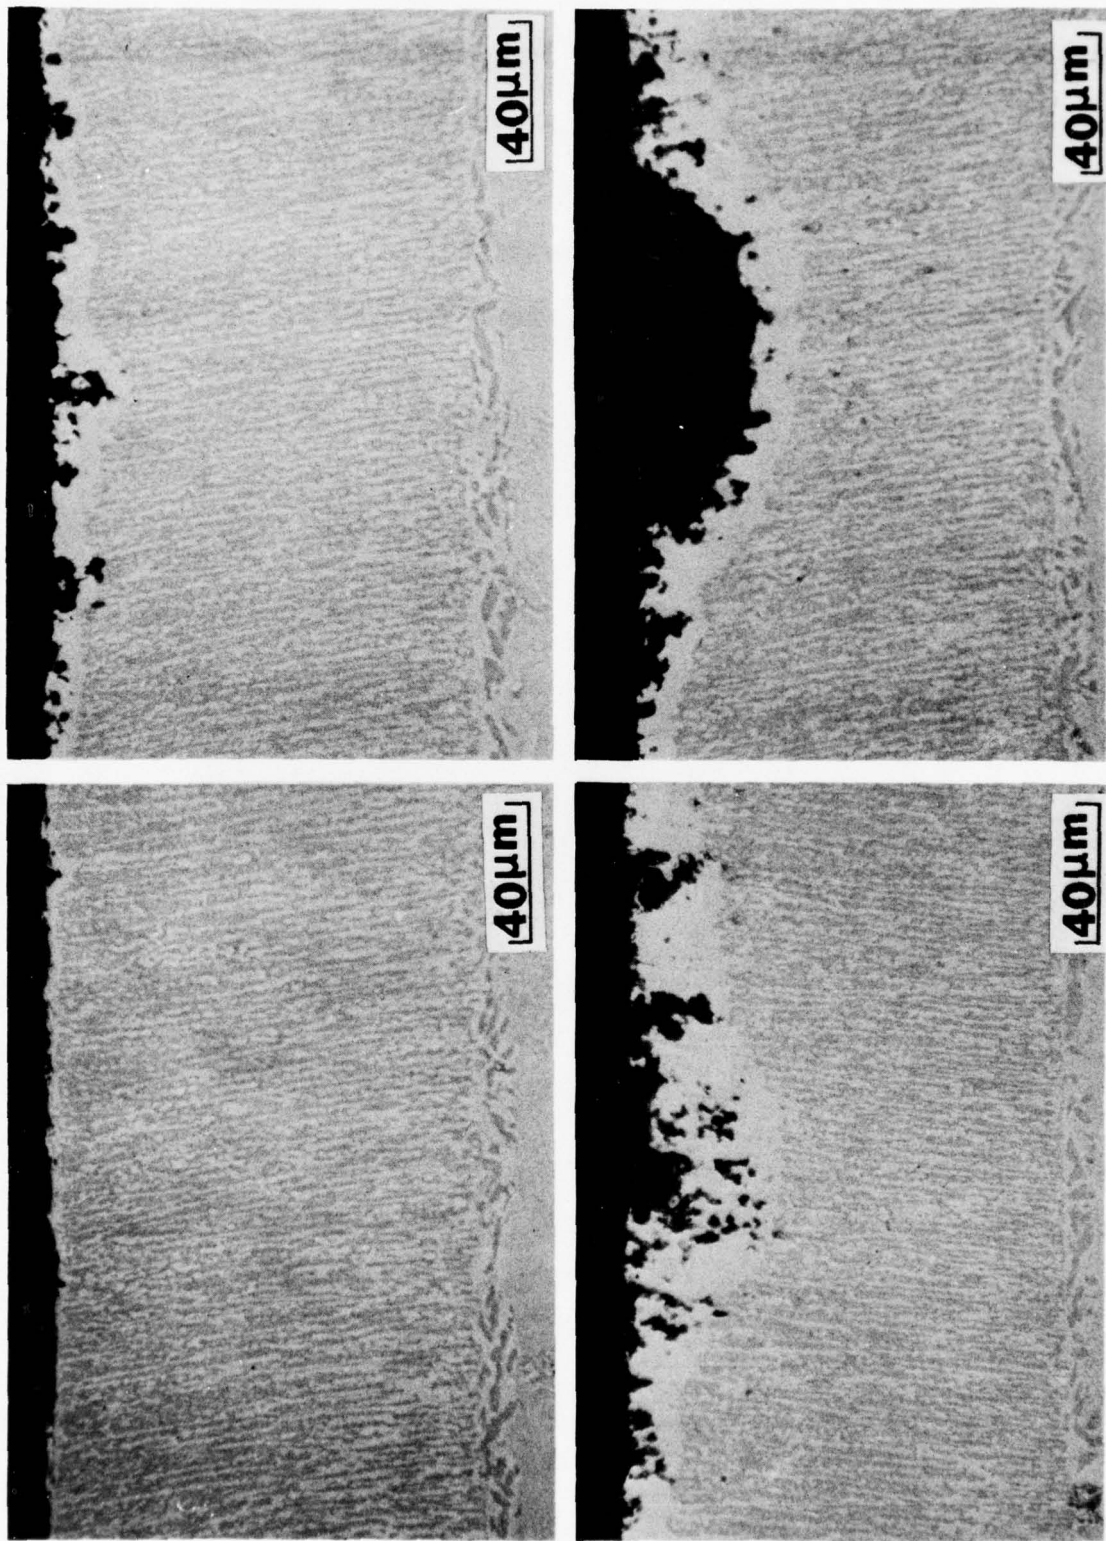
Figure 21. Microstructures of PWA 68 CoCrAlY exposed 100 hours at 899°C and $p_{SO_3} = 0.0007$ atm.

Microstructural features of the 0.0007 atm CoCrAlY specimen are shown in Figures 21 and 22. Optical photomicrographs of randomly selected areas (Figure 21) illustrate the varying severity of attack inferred from the surface condition. SEM examination of a more severely degraded area (Figure 22 and corresponding X-ray maps in Figure 23) shows a highly irregular scale/metal interface and a very prominent β -denuded zone. There is strong concentration of sulfur in the scale as well as sulfur-containing particles in the two-phase $\alpha + \beta$ structure in advance of the β -denuded zone. Line profiles along the path marked in Figure 22 show a slight gradient in Al and Cr content.

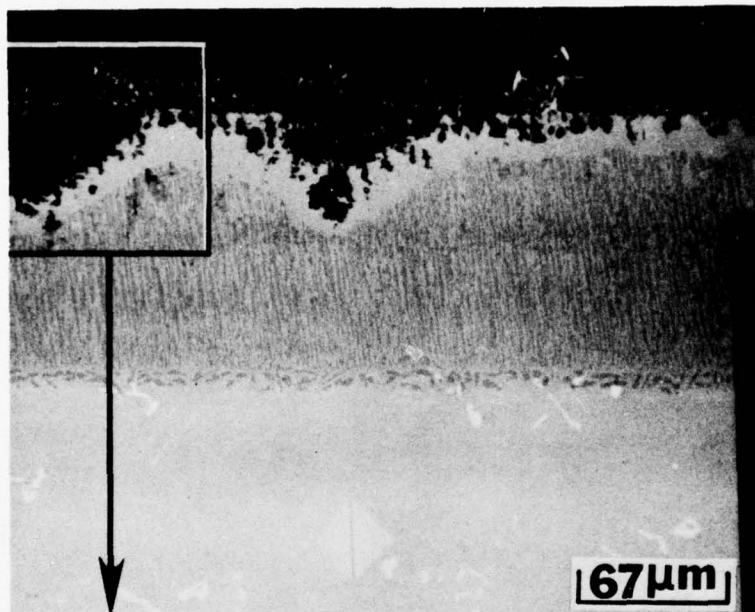
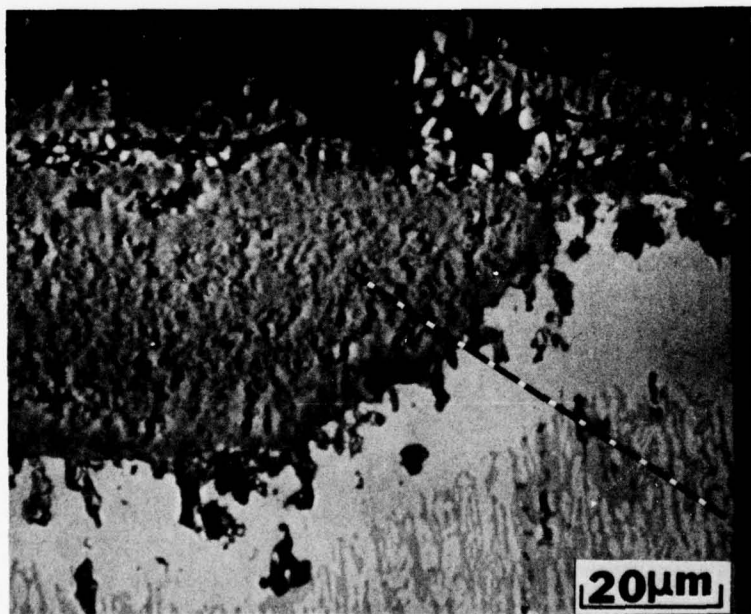
Figure 22. Back scattered electron photomicrographs of heavily corroded area in the CoCrAlY specimen of Fig. 21. X-ray maps in Fig. 23 are the area of the lower photo, but slightly distorted (compressed vertically) due to electronic problems. Dotted line is path of concentration profiles for Al, Cr, S, and O.

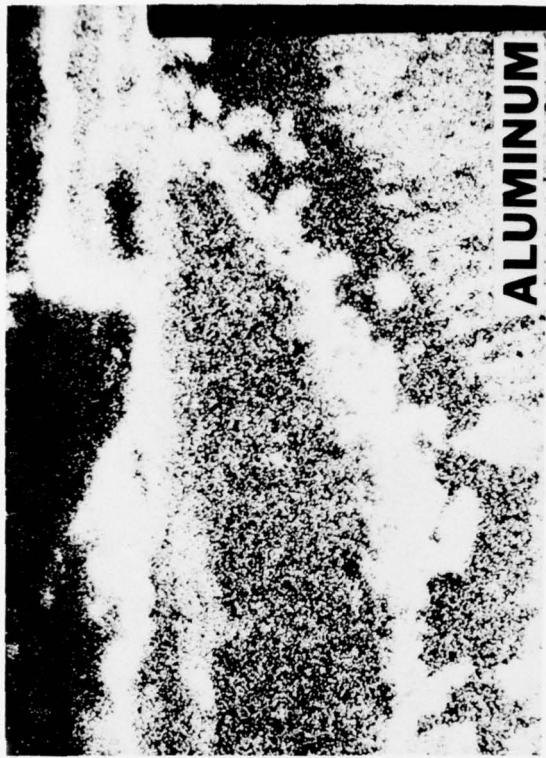
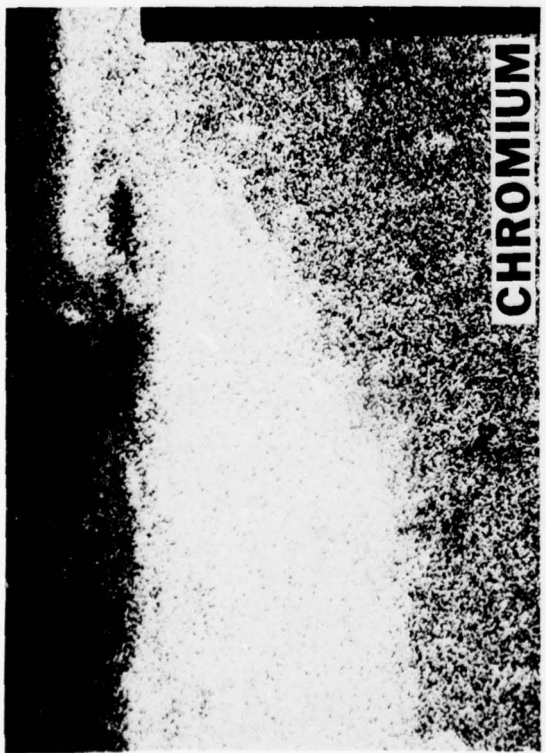
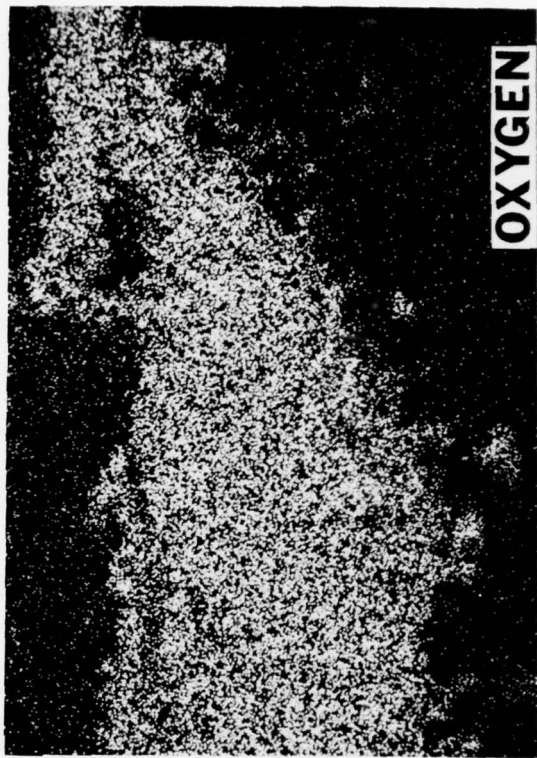
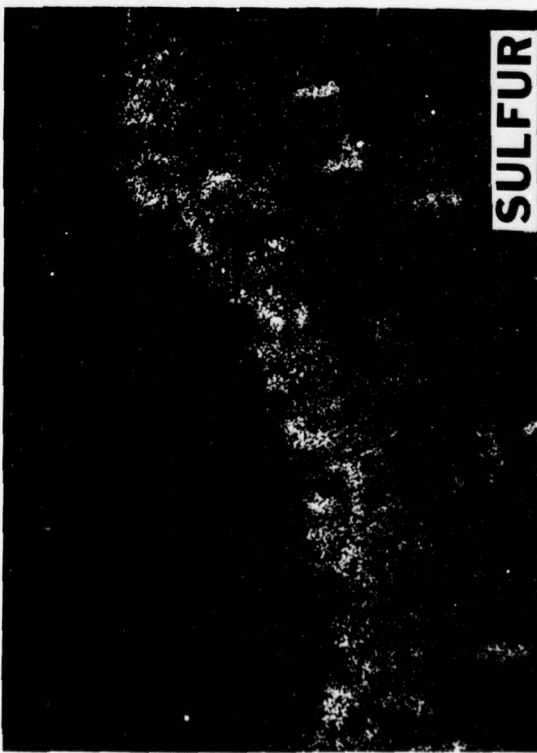
Figure 23. X-ray maps showing element distribution characteristic of SO₃-induced hot corrosion of CoCrAlY coating at 899C.

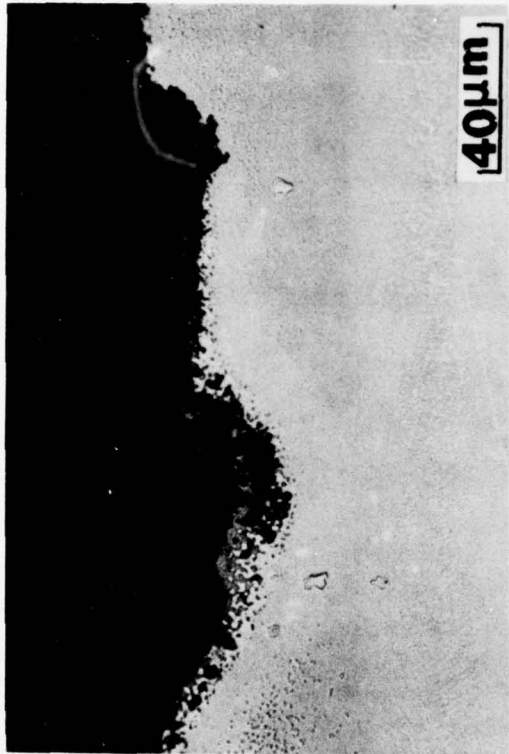
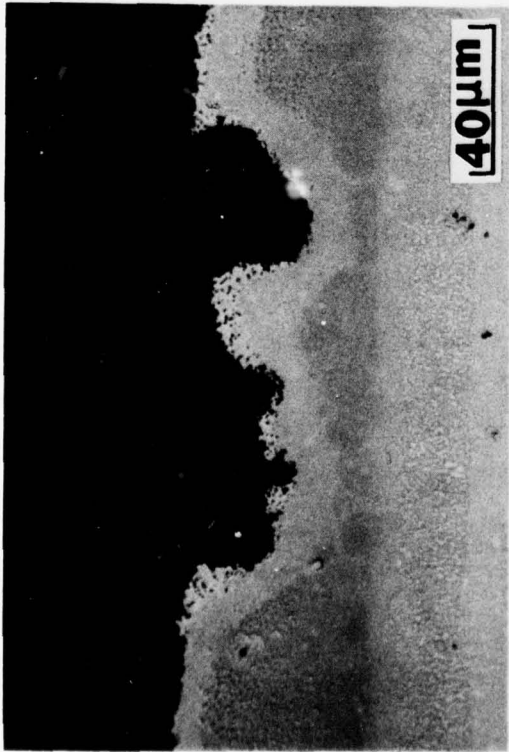
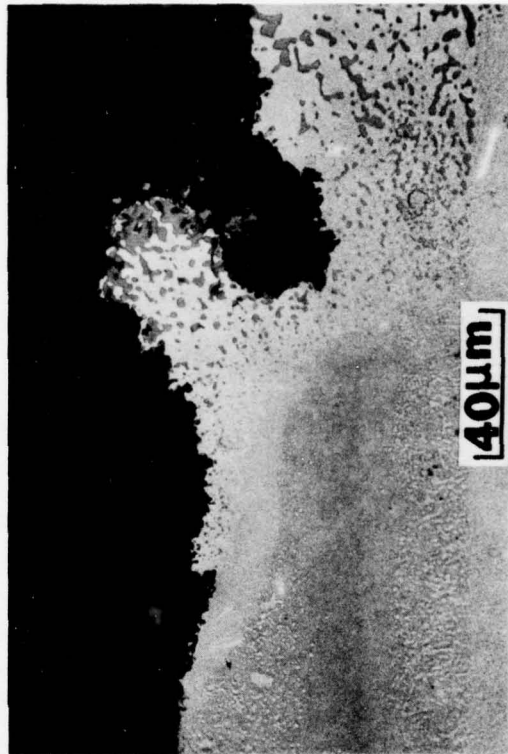
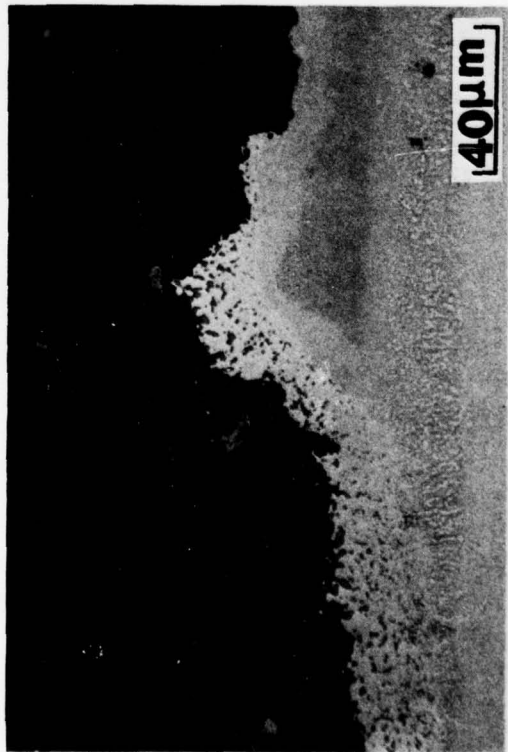
a. 20 hours at $P_{SO_3} = 0.0007$ atm
b. 20 hours at $P_{SO_3} = 0.0001$ atm
Figure 24. Degradation and failure of PWA 273 aluminide coating by SO_3 -induced hot corrosion at 899C.

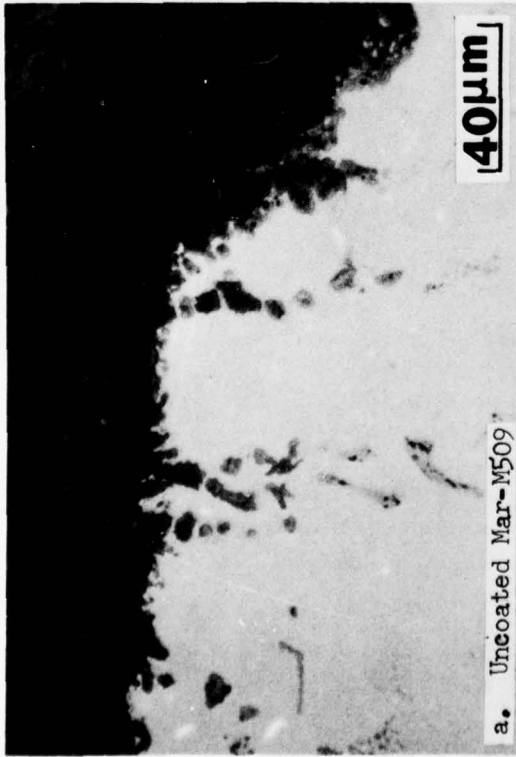
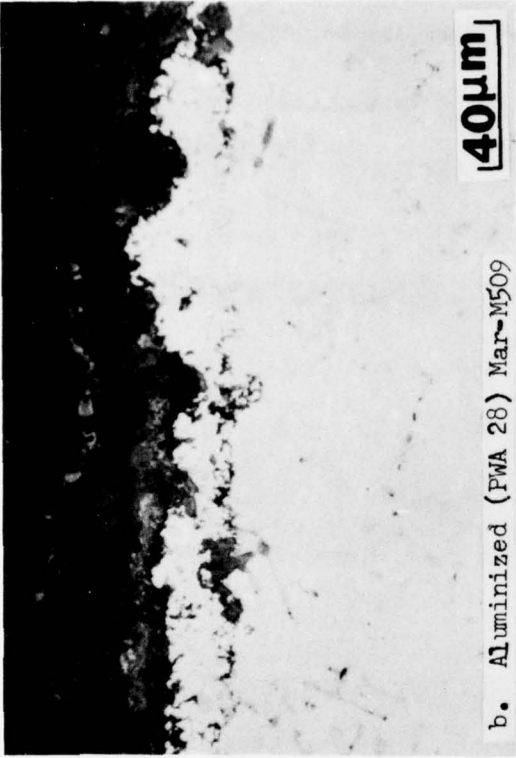
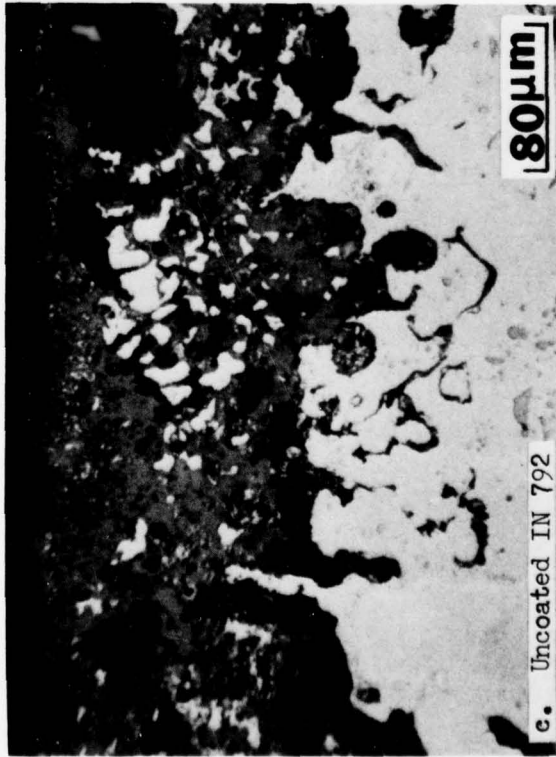
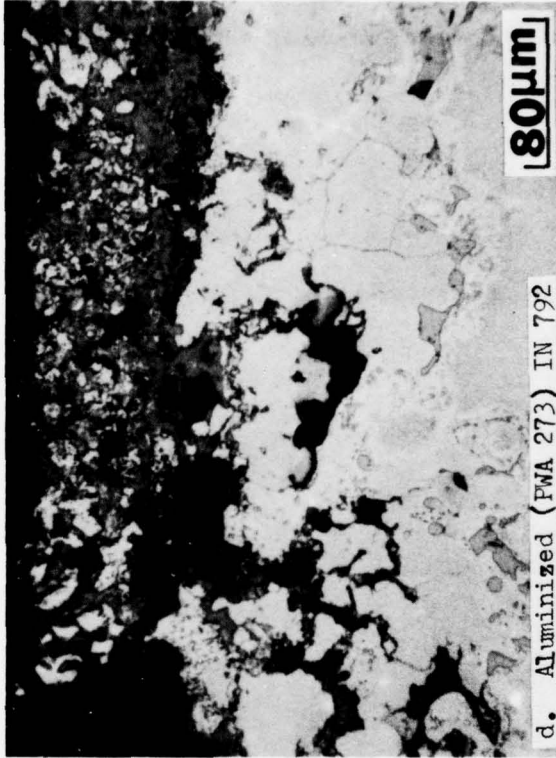
Figure 25. Uncoated and aluminized alloys exposed 100 hours (except 80 hours for aluminized IN 792) at 899C and $PSO_3 = 0.0007$ atm. Note different magnification of Co-base and Ni-base alloys.

metallography that high temperature promoted gross sulfidation (Figure 25c) in contrast to negligible internal attack at 704°C (Figure 12b). At 0.0001 atm, a small but clearly measurable weight gain at 899°C (Figure 30b) again suggests more substantial ingress of sulfur into the alloy due to the higher test temperature.

Microstructures of the uncoated and aluminized alloys exposed to NaCl and SO₃ at 899°C are presented in Figure 40; comparison with the structures developed at the same temperature with SO₃ alone (Figure 25) shows substantially less attack in the experiment with NaCl vapor. The Co-base system (uncoated and aluminized Mar-M509) shows no features attributable to NaCl, while the concurrently tested Ni-base system apparently exhibits the type of internal oxidation characteristic of chlorides.

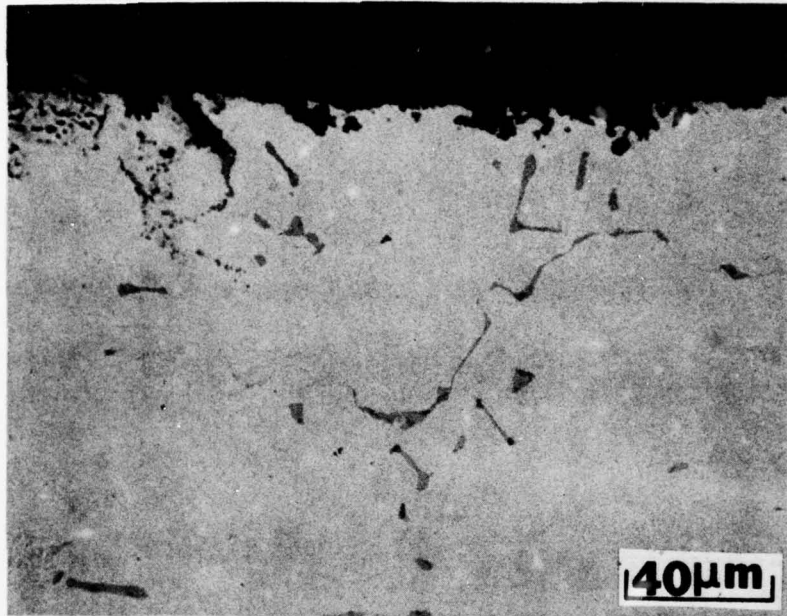
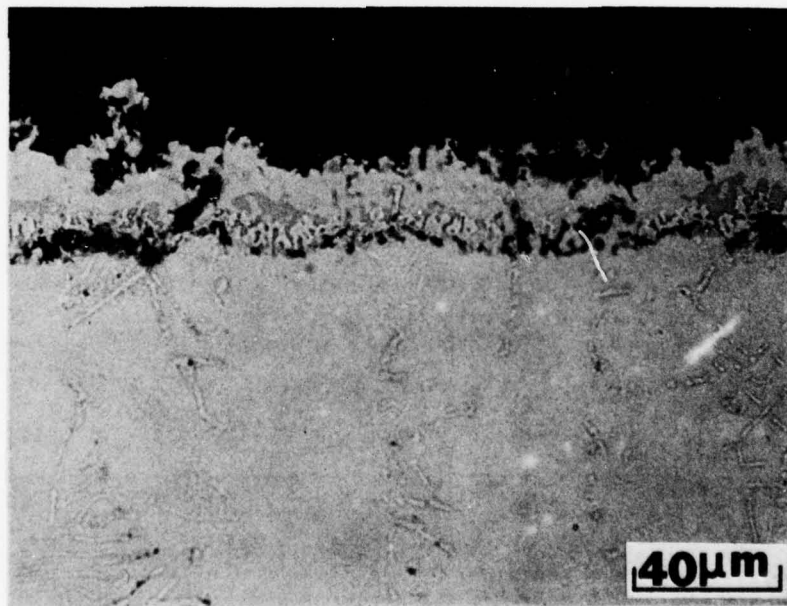
a. Uncoated

b. Aluminized

Figure 26. Typical microstructures and depth of attack of uncoated and aluminized Mar-M509 exposed 100 hours at 899C and $p_{SO_3} = 0.0001$ atm.

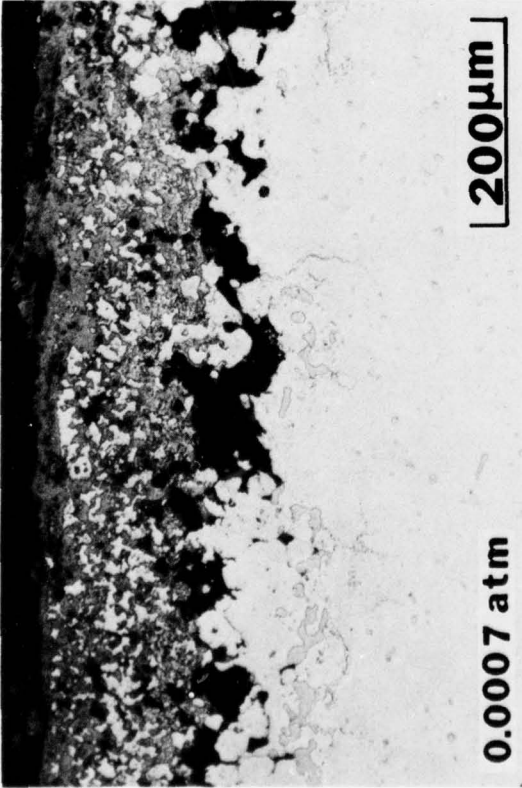
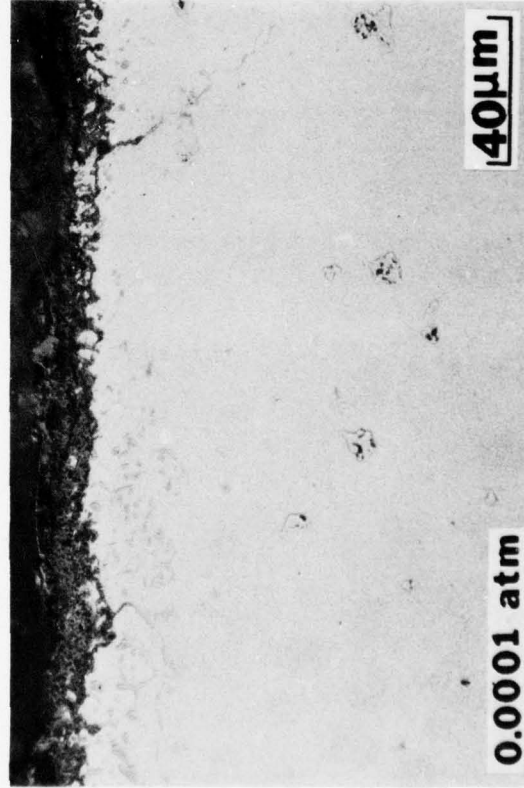
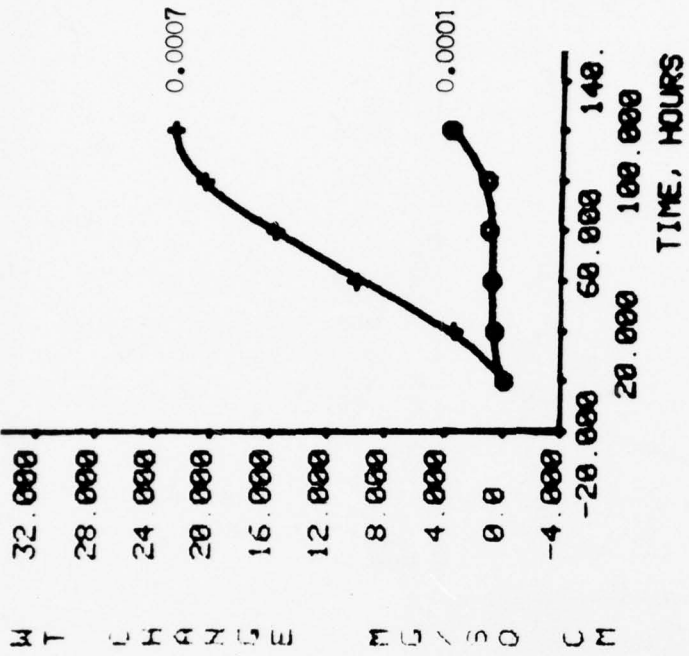
Figure 27. Effect of SO_2 pressure on 899C hot corrosion of uncoated IN 792, as shown by depth of attack and weight change data for 100-hour exposure at 0.0007 and 0.0001 atm. Note different magnification of the two photomicrographs.

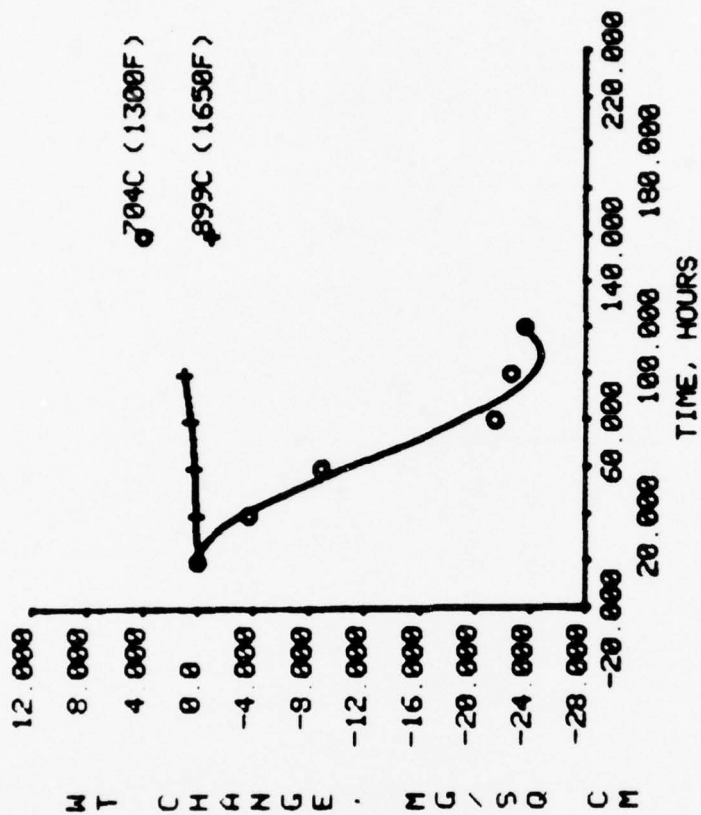
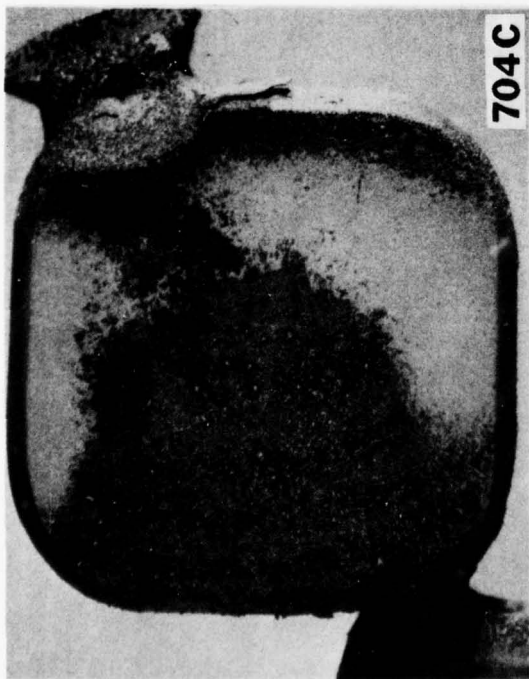
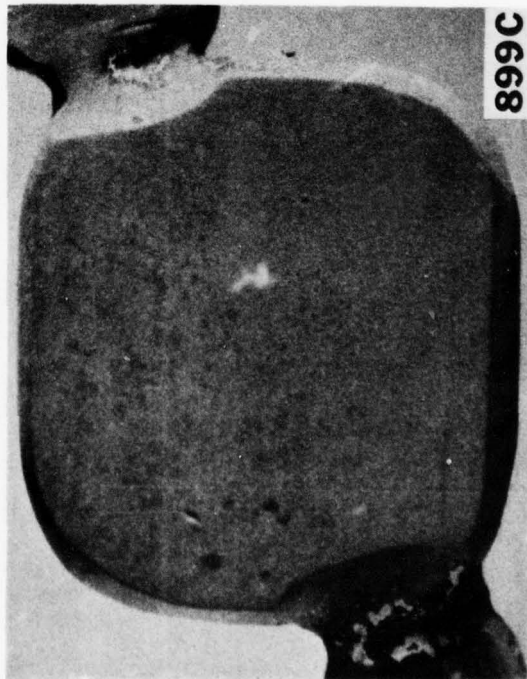
HOT CORROSION OF COCRALY, 704 VS. 899 C

Figure 28. Effect of temperature on severity of attack of FWA 68 CoCrAlY coating at fixed SO₃ pressure of 0.0007 atm, as shown by surface condition after 20 hours and weight change data for 100-hour cyclic exposure.

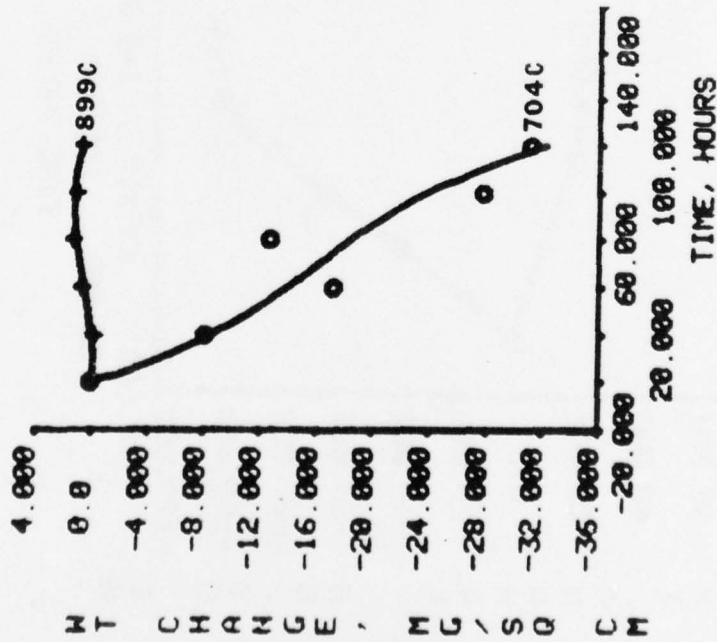
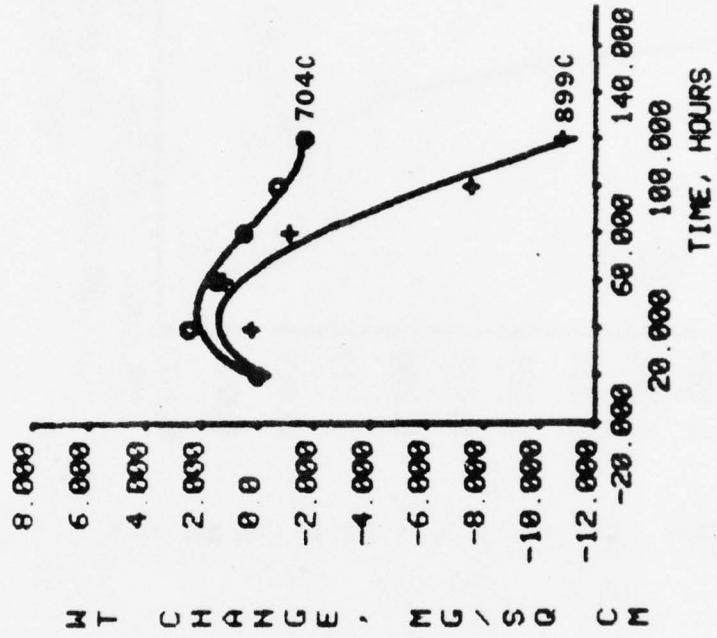
a. uncoated

b. aluminized

Figure 29. Weight change data showing effect of temperature on severity of attack of uncoated and aluminized Mar-M509 at fixed SO_3 pressure of 0.0007 atm.

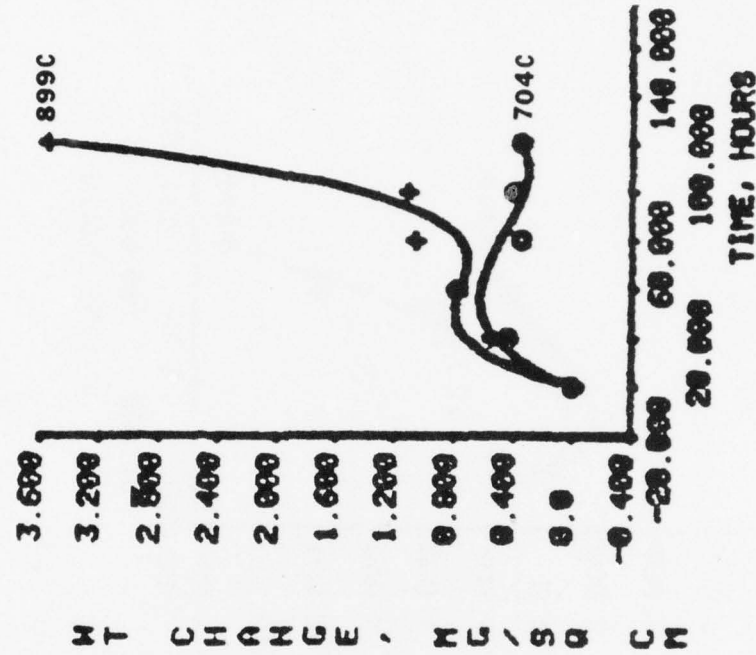
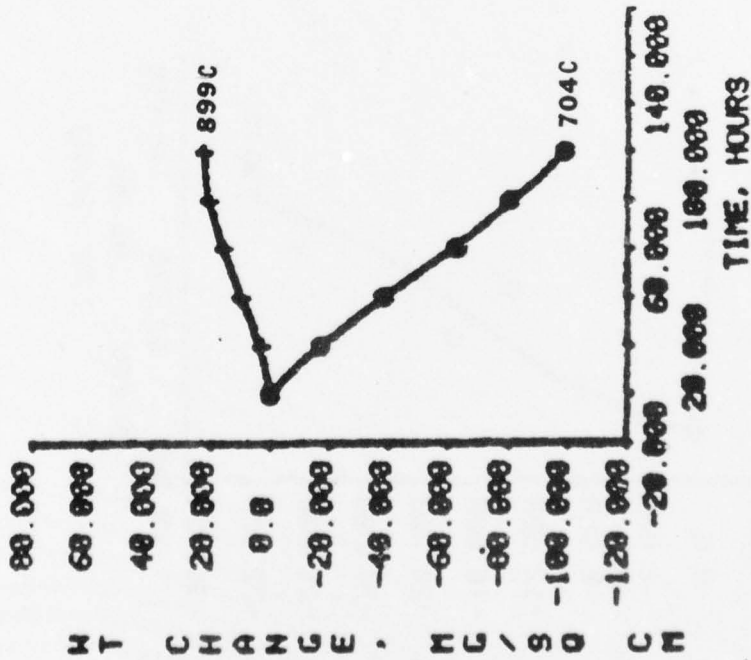
Figure 30. Effects of temperature and SO₃ pressure on severity of attack of uncoated IN 792, as shown by weight change data at fixed SO₃ pressure (30a and 30b respectively) and relative magnitude of $\Delta M/A$ values at 0.0007 versus 0.0001 atm.
