MARINE GAS TURBINE HOT CORROSION
DEPENDENCE ON INGESTED SALT LEVELS

Report No. FR-11544

R.H. Barkalow and F.S. Pettit
United Technologies Corporation
Pratt & Whitney Aircraft Group
Government Products Division
West Palm Beach, FL 33402

Final Report: 29 July 1977 to 31 Oct 1978

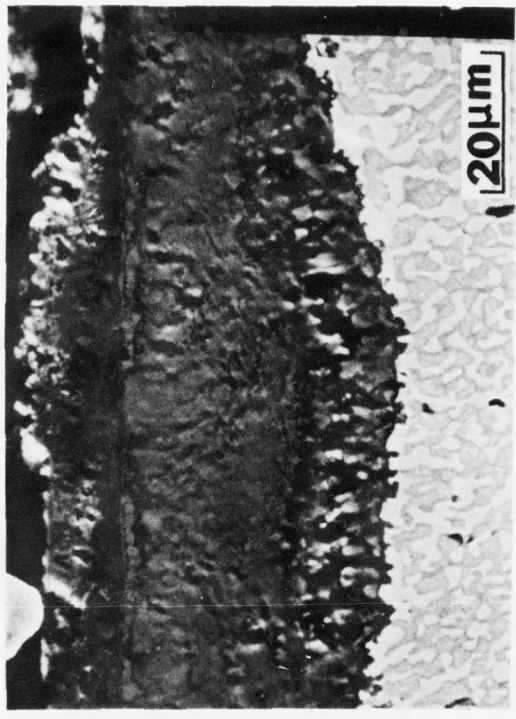
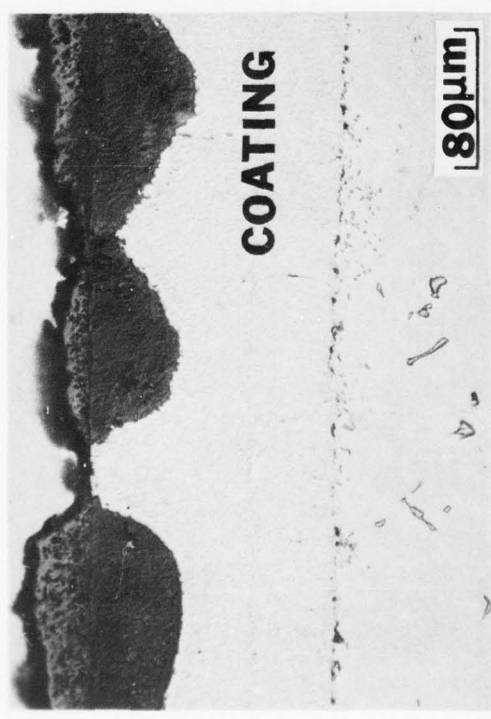
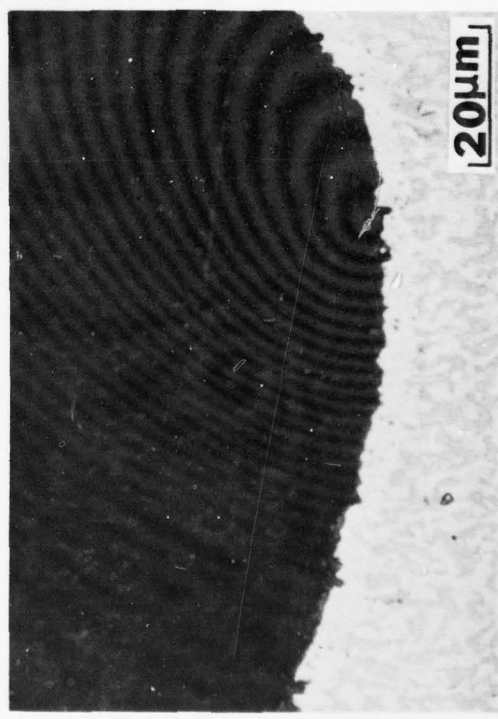
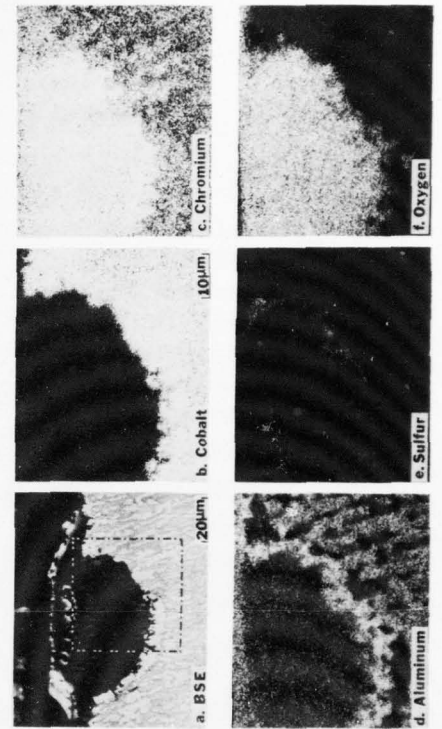
Figure 31. Typical degradation microstructures observed in CoCrAlY-coated turbine hardware from GTV Asiafreighter after approximately 4200 hours service.

Based on this reasoning and the information summarized in the bullet items just listed, it is strongly believed that hot corrosion of the type illustrated in Figure 31 is due to low temperature (i.e. about 750°C or below) exposure to condensed Na_2SO_4 salt and SO_3 in the combustion gases.

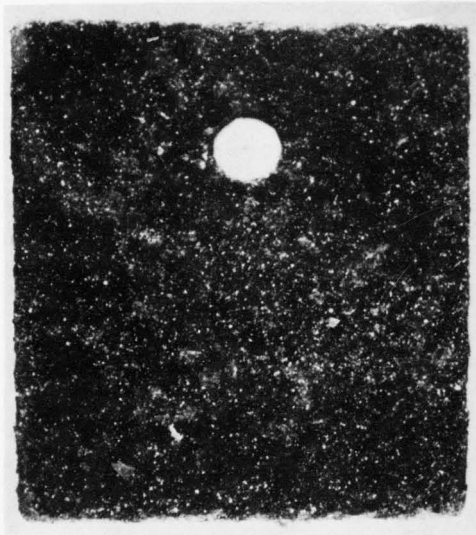
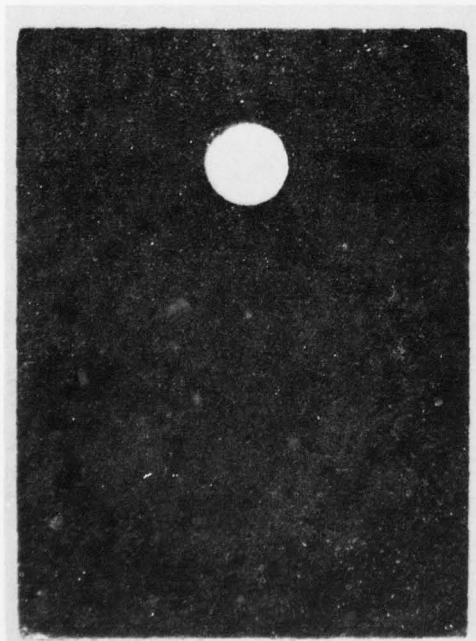
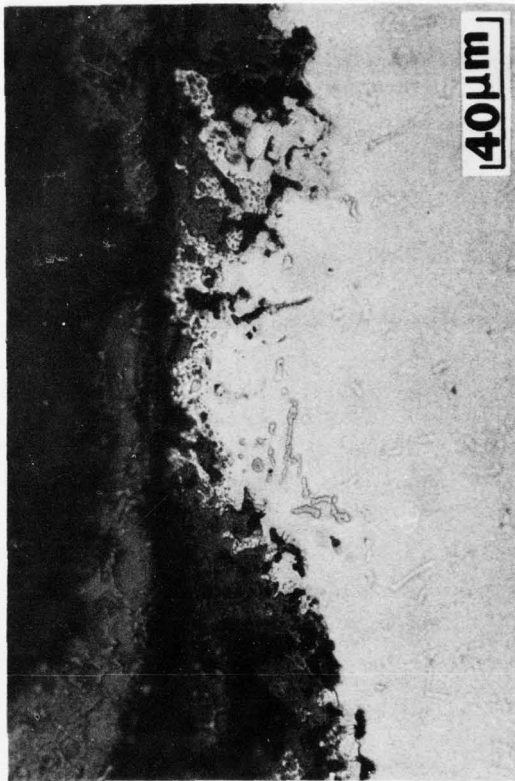
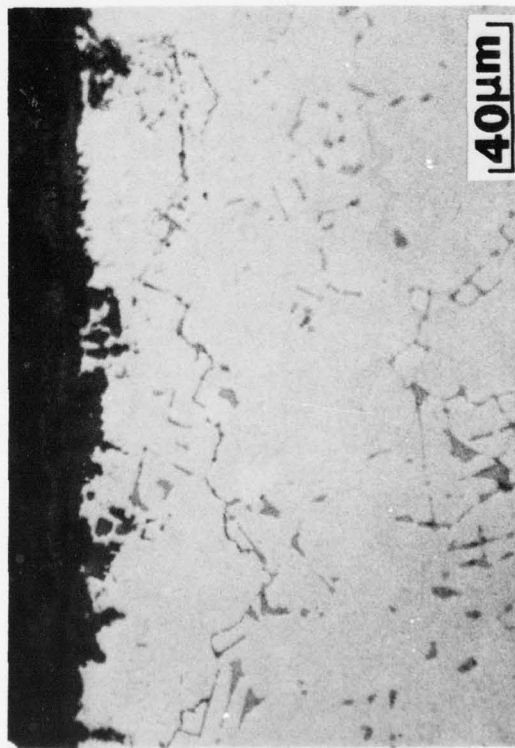
a. Chloride-free air

b. Air with 300 ppm NaCl vapor

Figure 32. Effect of chloride vapor on sulfate-induced hot corrosion of uncoated Mar-M509. Specimens were exposed under identical conditions (200 hours at 899C, 1 mg/cm² Na₂SO₄ salt deposit) except for chloride-free air versus 300 ppm NaCl vapor in the furnace atmosphere.

Uncoated Mar-M509 was substantially more degraded in the experiment with NaCl vapor (Figure 32). The effect is believed to be real, although the relatively slight degradation of the specimen tested in air is of questionable reproducibility and the chloride effect might not be as pronounced as the results of these two experiments suggest. For the Co-base coatings, observation of a number of randomly selected areas on the entire cross section would support the conclusion that degradation was slightly greater due to the NaCl vapor, especially for the aluminized Mar-M509. The CoCrAlY coatings were only lightly attacked in both tests and the difference might have been within experimental scatter.

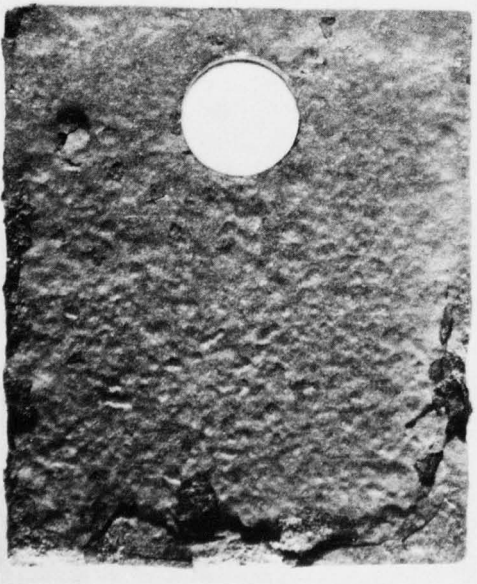
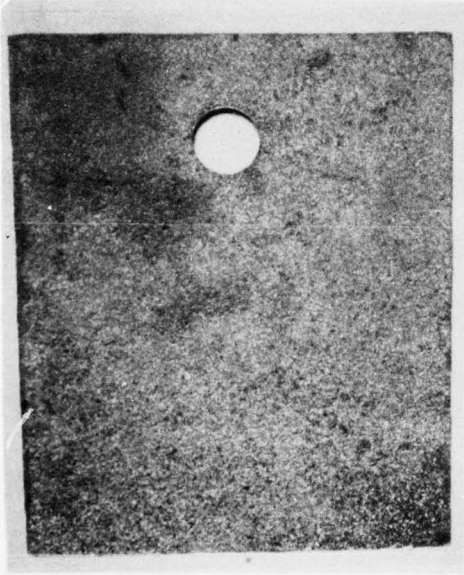
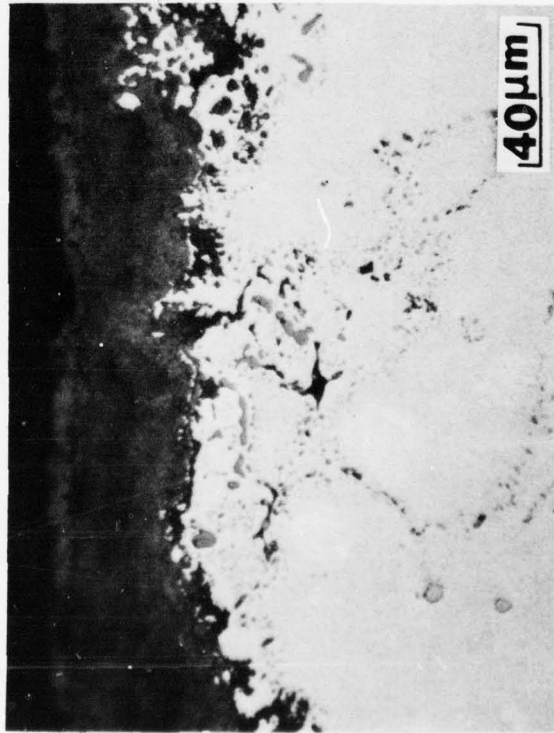
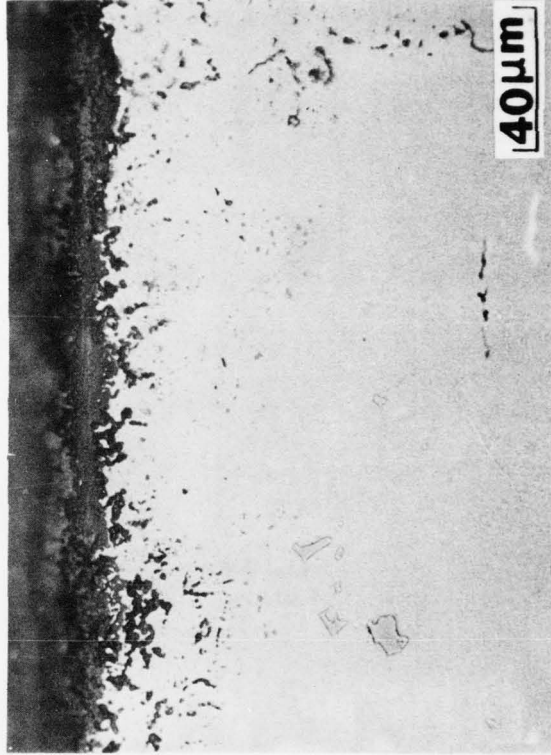
a. Chloride-free air

b. Air with 300 ppm NaCl vapor

Figure 33. Effect of chloride vapor on sulfate-induced hot corrosion of uncoated IN 792. Specimens were concurrently tested with those of Fig. 32.

The concurrently exposed Ni-base alloys were less corroded in the chloride-containing atmosphere, as shown in Figure 33 by surface condition and metallography of uncoated IN 792. Visual inspection of the aluminized sample indicated minimal attack except for a massive edge failure which is not attributed to the chloride vapor; post-test metallography confirmed minimal microstructural degradation except for cut-edge attack.

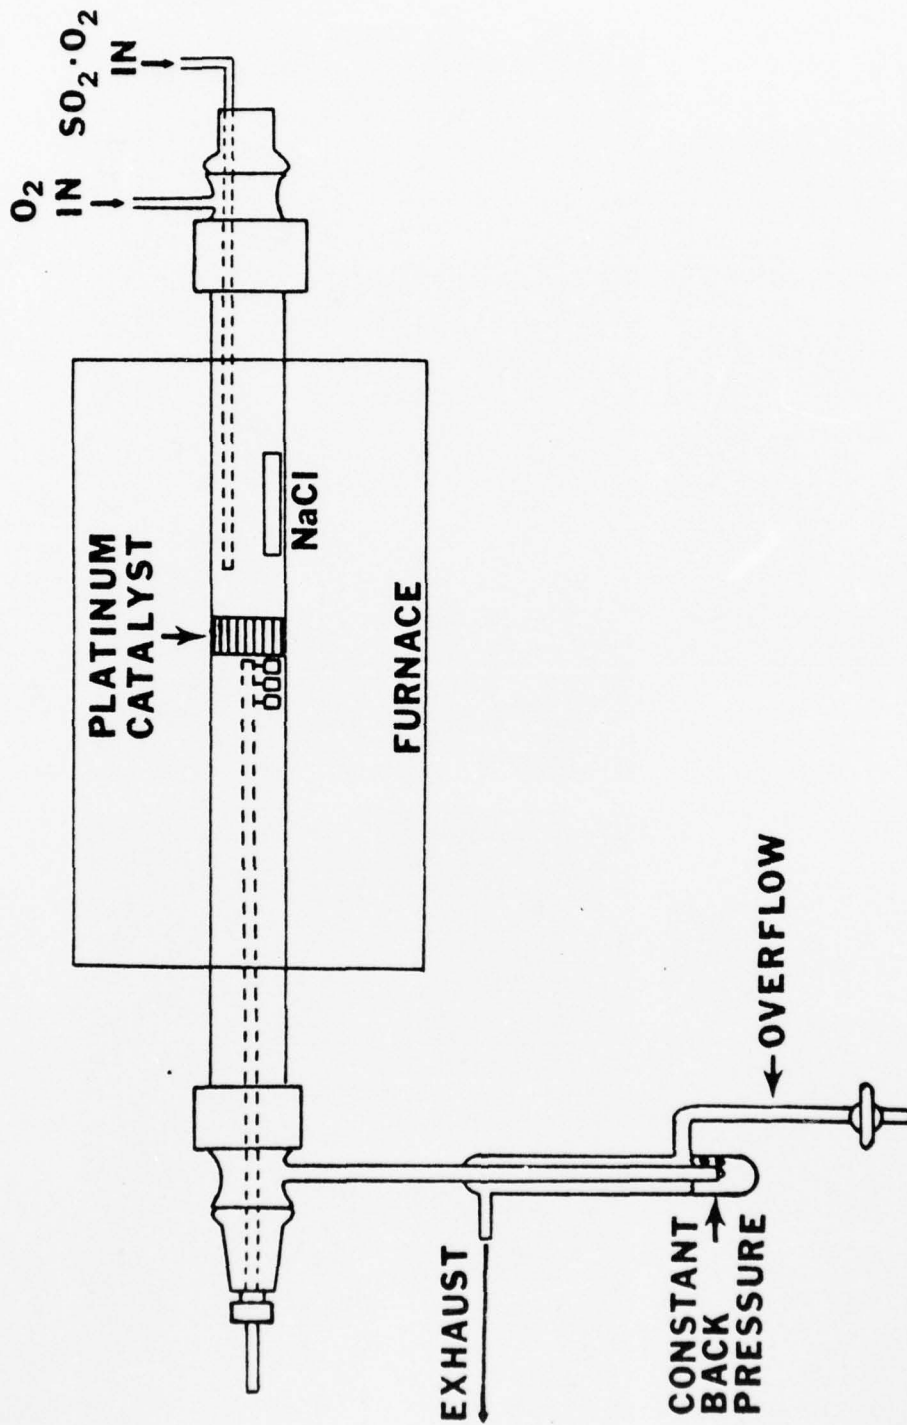
Figure 34. Schematic diagram of horizontal tube furnace for hot corrosion testing with both SO₂ gas and NaCl vapor in the atmosphere. Apparatus is the same as that in Figure 2 except for the separate input of oxygen and SO₂:O₂, which is necessary to avoid reaction of the SO₂ with solid NaCl prior to reaching the catalyst and the specimens.

The horizontal tube furnace described in Section 1 was modified as shown in the sketch of Figure 34 to permit exposure of the test specimens to both SO₃ and NaCl vapor. Gas flow rates and SO₂:O₂ input ratios were the same as those of the preceding experiments with SO₃ gas, but it was necessary to introduce the SO₂ down stream of the NaCl boat to prevent consumption of the SO₂ via reaction with the solid NaCl. Tests were run at an SO₃ pressure of 0.0007 atm, since degradation produced by this concentration was known to be substantial but not sufficiently catastrophic to overwhelm a possible effect of the chloride. A chloride vapor concentration of 30 ppm - maintained by heating the NaCl to 677°C (1250°F) - was arbitrarily selected.

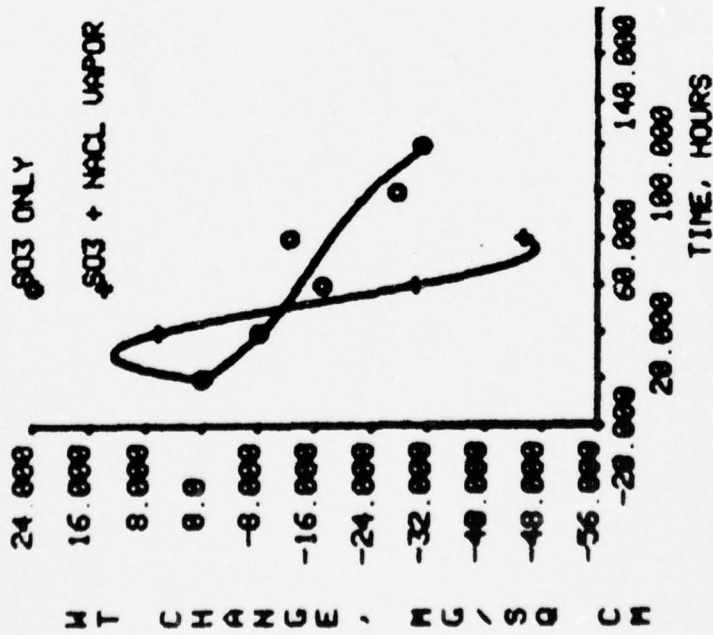
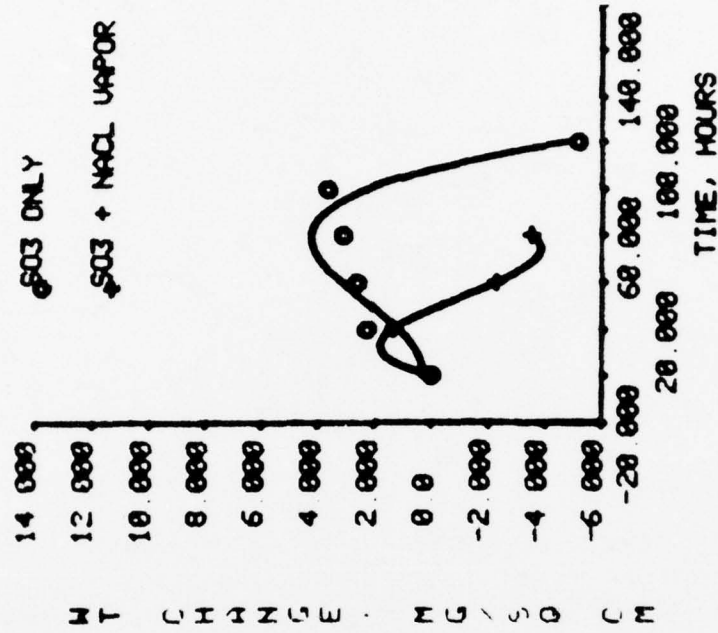
a. Mar-M509

b. Aluminized IN 792

Figure 35. Weight change data for uncoated Mar-M509 and aluminized IN 792 in SO₃ and SO₃ + NaCl atmospheres (704C, P_{SO₃} = 0.0007 atm, NaCl vapor concentration = 30 ppm).

Visual inspection after the initial 20-hour exposure cycle suggested increased attack of all of the specimens except the uncoated Mar-M509, although the effect was not dramatic. After 60 hours, consistently larger weight losses of Mar-M509 and aluminized IN 792 (Figure 35) apparently reflect increased scale spallation due to the chloride. Weight changes of the other test materials were not significantly different in chloride-containing versus chloride-free atmospheres.

Such an effect, if present, would almost surely have caused a substantially increased degradation rate of the samples in Figures 35 to 40, where a relatively high SO_3 pressure and a relatively high concentration of NaCl vapor left microstructural features characteristic of both processes. Indeed, as mentioned in presenting the results, the degradation of several of the specimens did appear greater than in the corresponding test at the same SO_3 pressure but without chloride vapor. However the difference was probably within experimental scatter, or at most could be considered an additive effect of increased scale spallation and SO_3 -induced attack. The depth of attack in no case was significantly greater than that attributable to the SO_3 pressure alone.

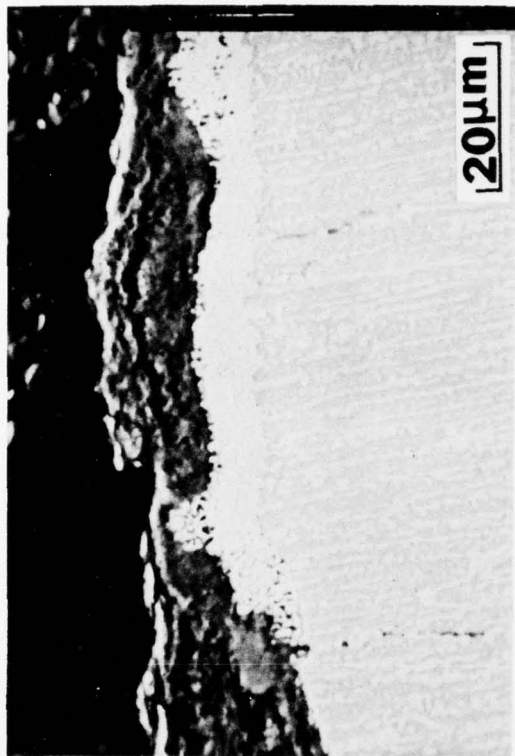
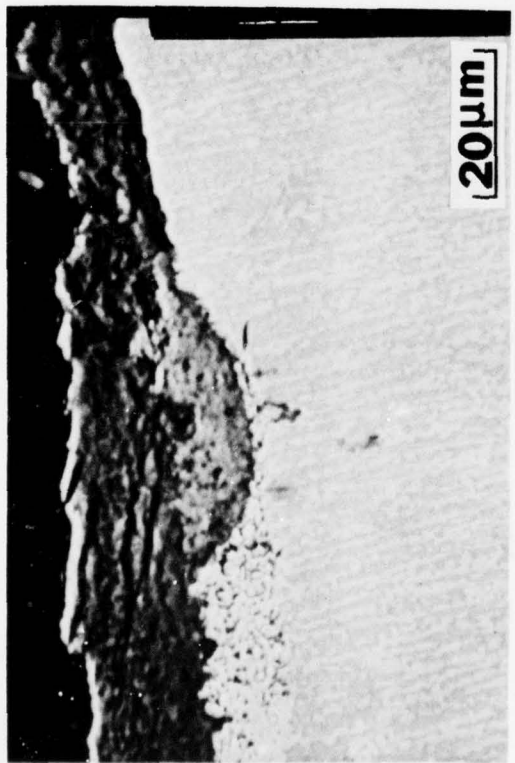
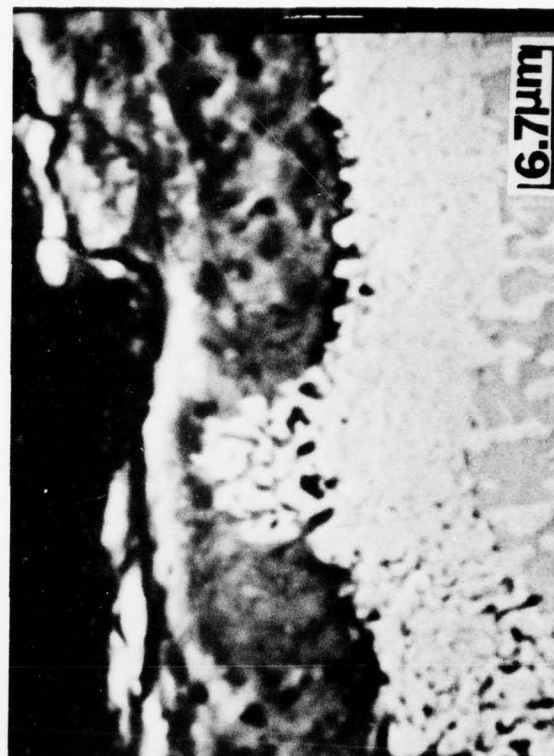
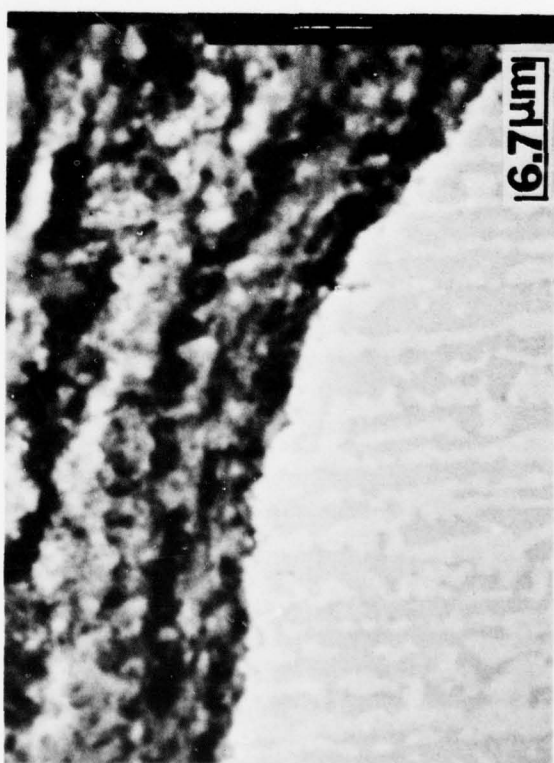
Figure 36. Microstructures of PWA 68 CoCrAlY coating tested at 704C with simultaneous presence of gaseous SO_3 (0.0007 atm) and NaCl vapor (30 ppm). Note characteristic morphology of both SO_3 - and NaCl-induced hot corrosion in randomly selected areas of the attack front.

Post-test metallography showed an unusual superposition of microstructural features characteristic of low temperature SO_3 -induced attack and chloride-induced dealloying. The mixed microstructure was especially prevalent in the CoCrAlY coating, where adjacent areas showed a sharp transition between the complete absence of internal oxidation typical of SO_3 effects and the substantial dealloying and pore formation typical of chloride corrosion (Figure 36). Areas with the SO_3 -type morphology were also characterized by sulfur in the scale (Figure 37a, 37b); other areas showed variations in the composition and ghost microstructure of the scale which suggested that attack may have oscillated between SO_3 - and chloride-type (Figure 37c).

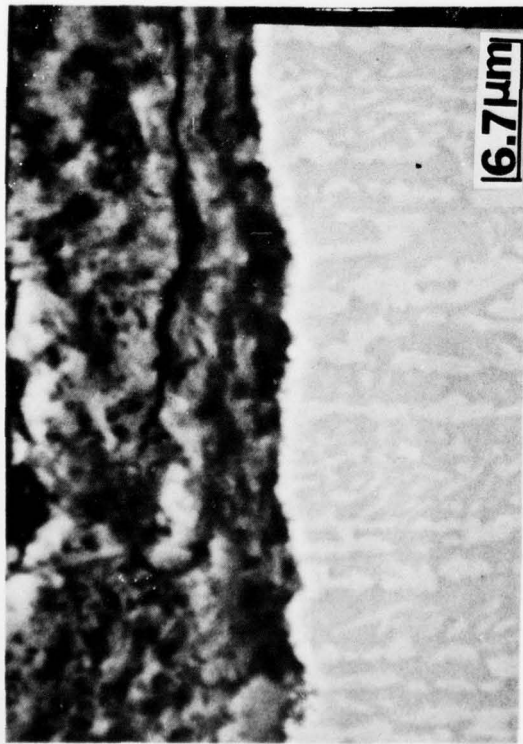
a. SO_3 -type morphology of attack front (i.e. no diffusion zone or internal oxidation).

Figure 37. Sulfur-containing scale in area showing SO_3 -type morphology of attack front (a and b); variation in composition and morphology of scale, possibly indicating attack mechanism oscillating between SO_3^- and chloride-type corrosion.

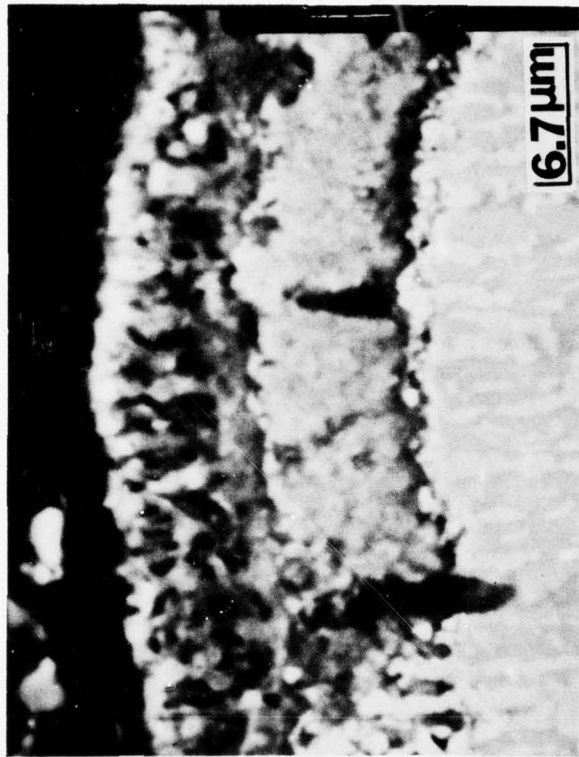
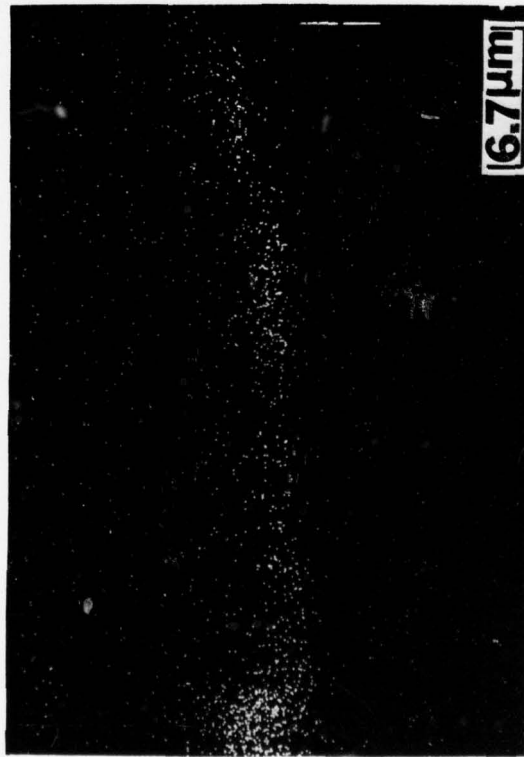
c. Variable composition (indicated by different contrast in back scattered electron image) and morphology of scale

b. Sulfur X-ray image of above area

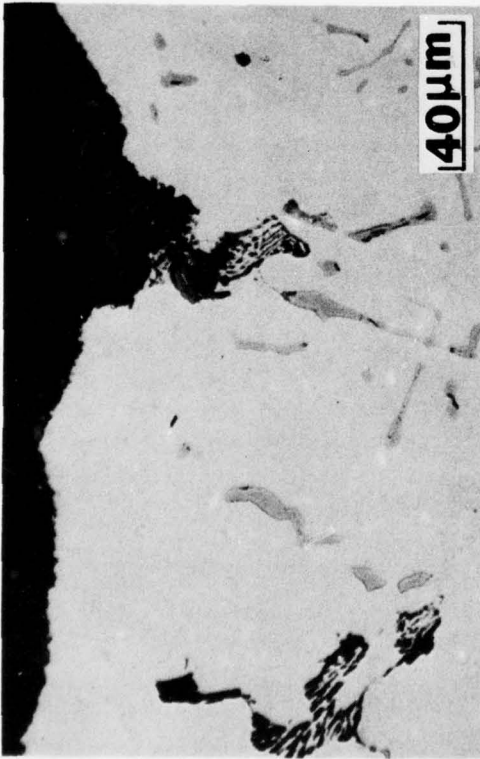
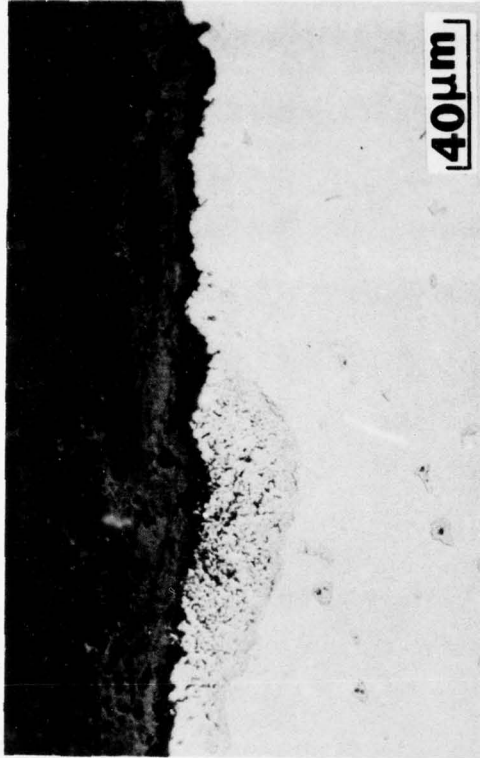
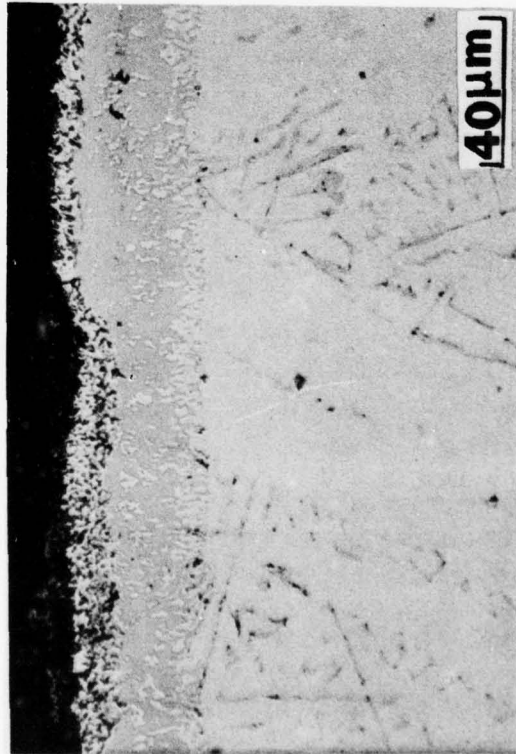
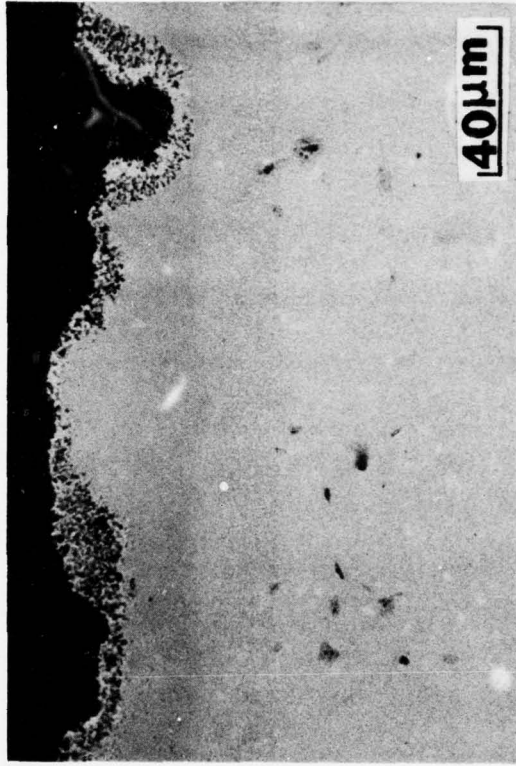
38a. Uncoated Mar-M509

38b. Uncoated IN 792

38c. Mar-M509/FWA 28 aluminide

38d. IN 792/FWA 273 aluminide

Figure 38. Uncoated and aluminized alloys tested concurrently with the CoCrAlY coating of Figs. 36 and 37 (i.e. 60 hours at 704C, $PSO_3 = 0.0007$ atm, 30 ppm NaCl vapor)

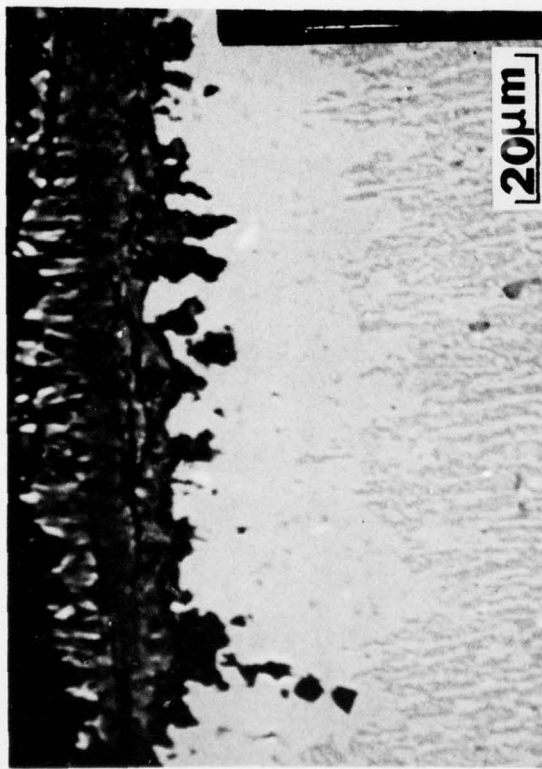
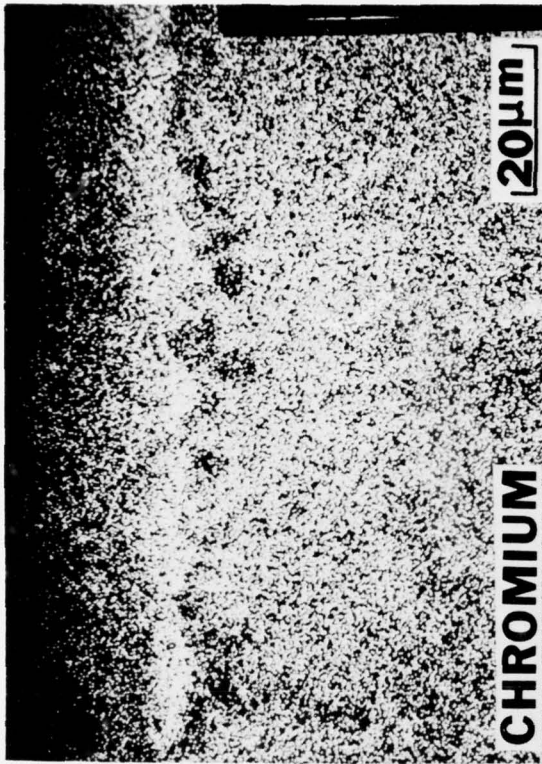
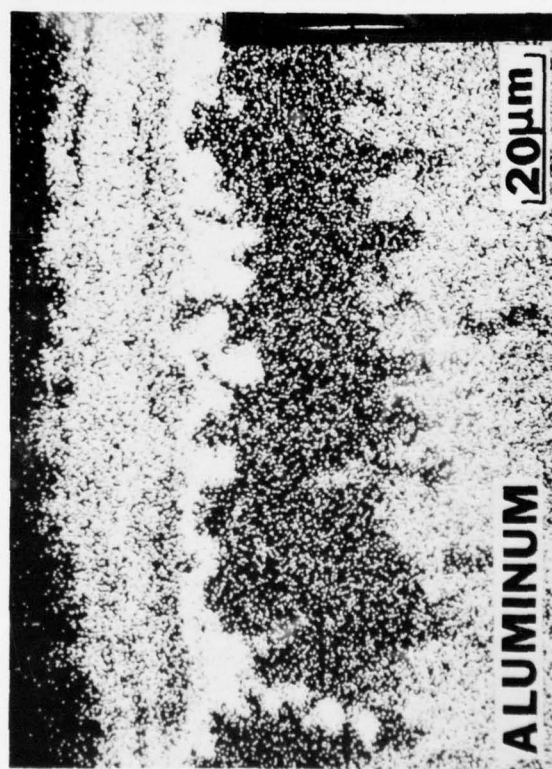
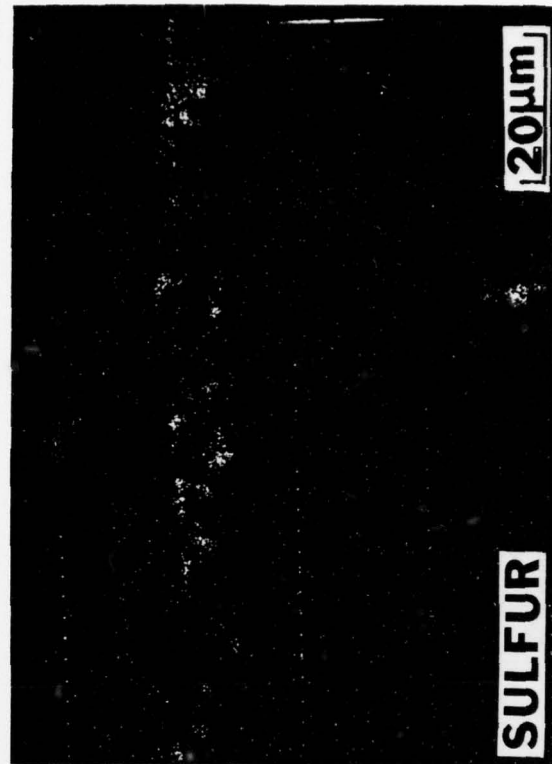
Figure 39. Typical microstructure, depth of attack, and element distribution (Cr, Al, and S) of CoCrAlY coating exposed for 100 hours at 899C with $p_{SO_3} = 0.0007$ atm and 30 ppm NaCl vapor.

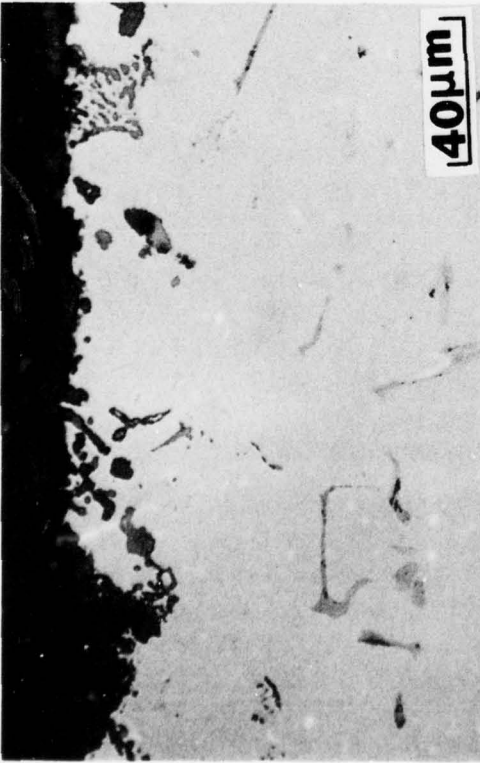
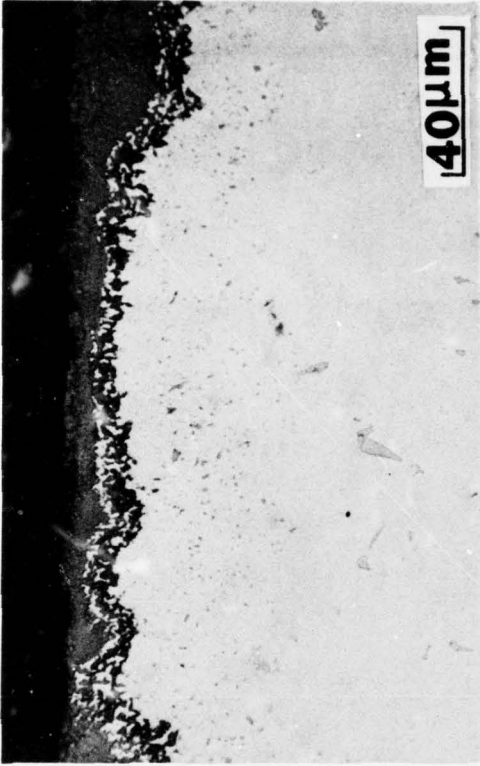
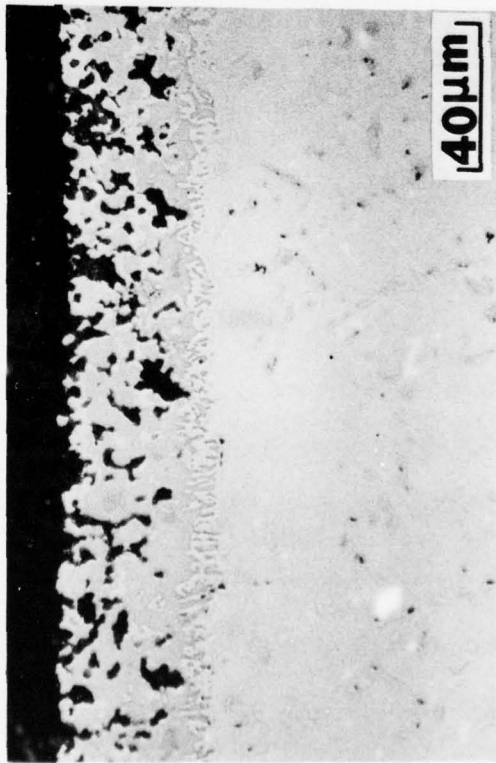
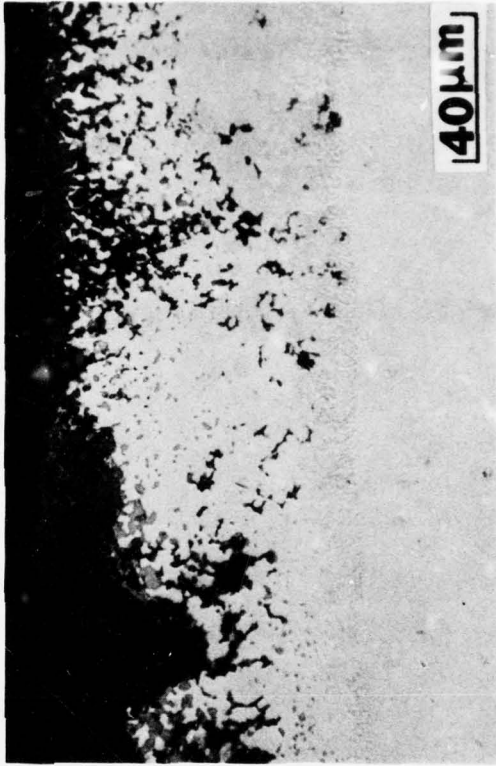
40a. Uncoated Mar-M509

40b. Uncoated IN 792

40c. Mar-M509/PWA 28 aluminide

40d. IN 792/PWA 273 aluminide

Figure 40. Uncoated and aluminized alloys tested concurrently with the CoCrAlY coating of Fig. 39 (i.e. 100 hours at 899C, $PSO_3 = 0.0007 \text{ atm}$, 30 ppm NaCl vapor).

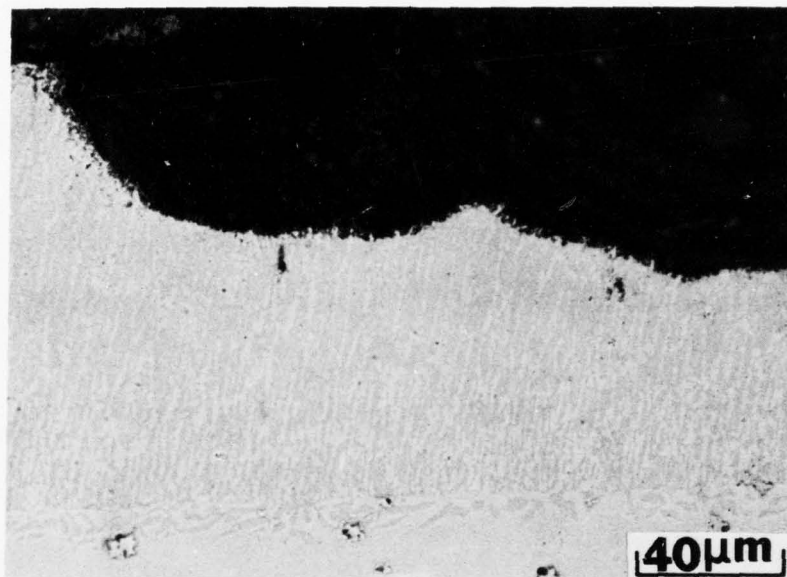
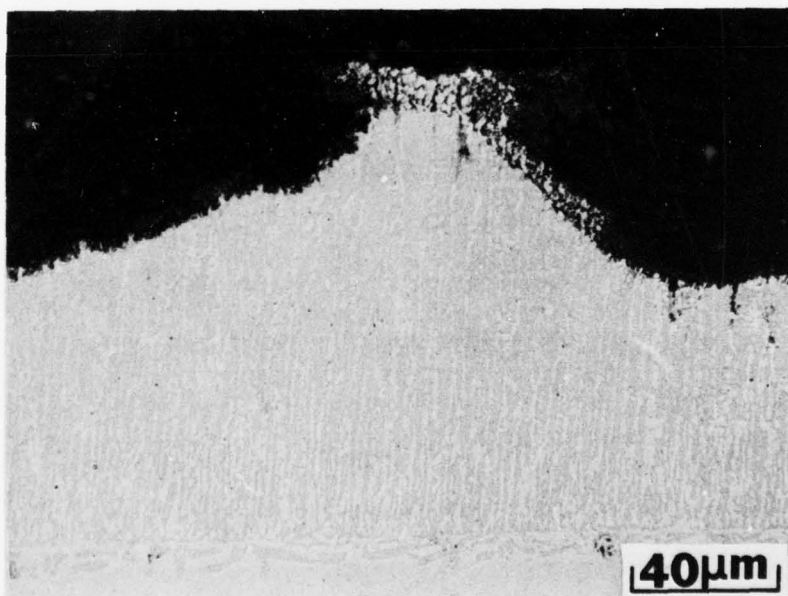
a. Na_2SO_4 - 50m% CoSO_4 salt deposit

b. Na_2SO_4 - 50m% ZnSO_4 salt deposit

Figure 41. Typical depth and microstructure of hot corrosion attack produced by 100-hour cyclic exposure of CoCrAlY at 704C with $p_{\text{SO}_3} = 0.0007$ atm and 30 ppm NaCl vapor.

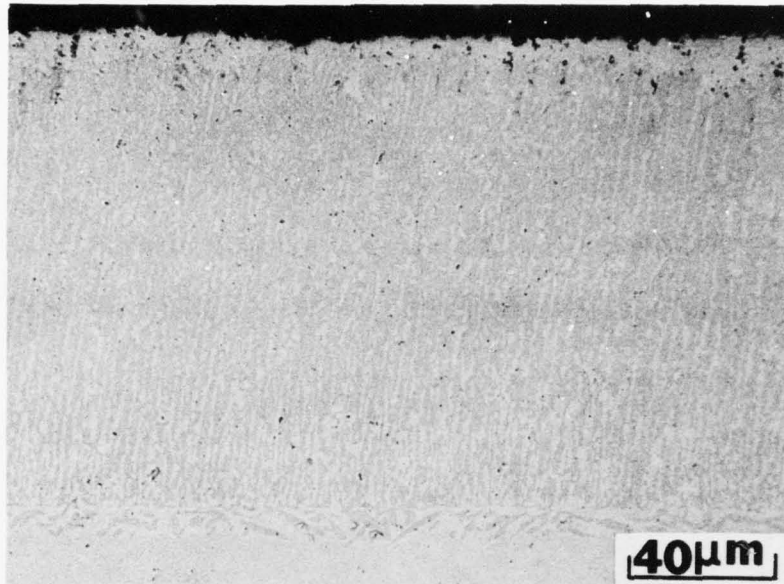
Figure 42. Negligible microstructural degradation of CoCrAlY coating covered with a 2 mg/cm^2 mixture of Na_2SO_4 and CoO and exposed for 100 hours concurrently with the specimens of Fig. 41 (704C , $p_{\text{SO}_3} = 0.0007 \text{ atm}$, 30 ppm NaCl vapor).

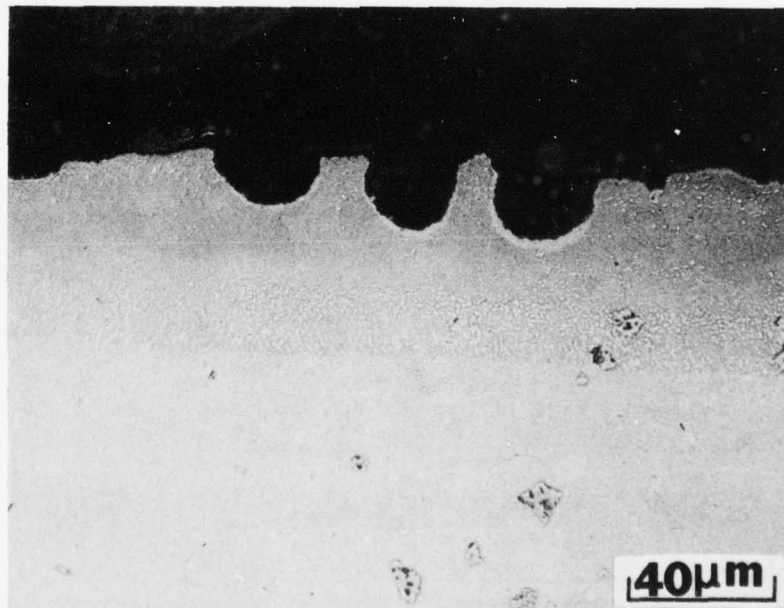
Figure 43. Nodular attack of PWA 273 Ni-base aluminide coating produced by a salt deposit of $\text{Na}_2\text{SO}_4 - 50\text{m}\% \text{CoSO}_4$ and cyclic exposure for 100 hours at 704C , $p_{\text{SO}_3} = 0.0007 \text{ atm}$, and 30 ppm NaCl vapor.

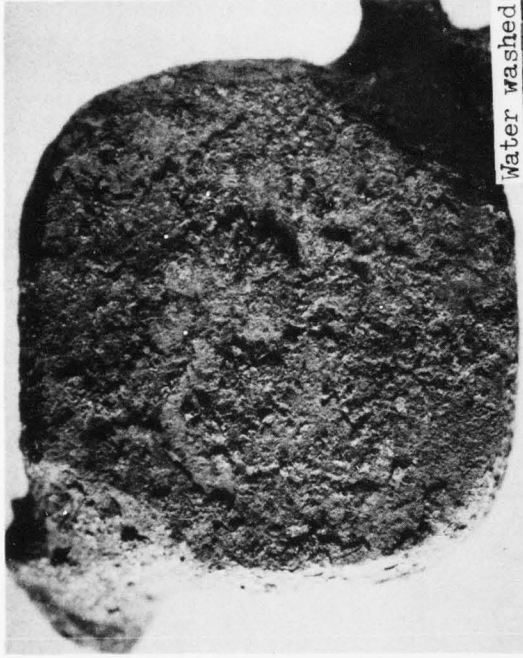
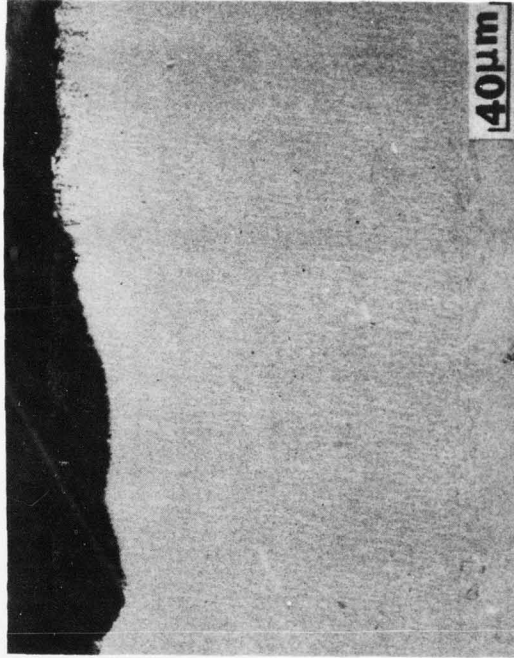
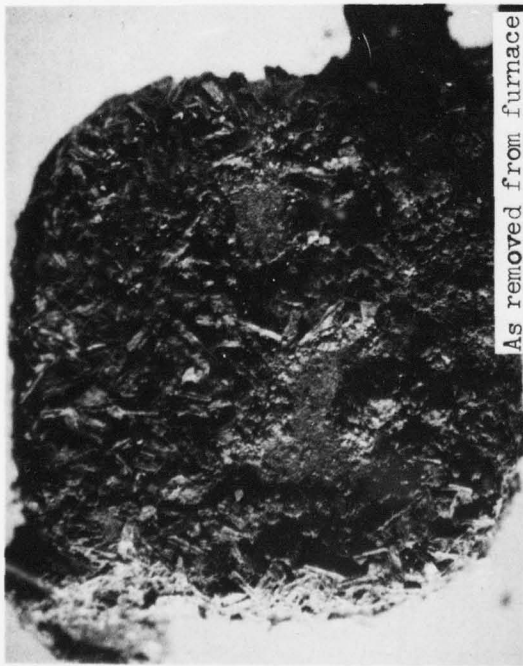
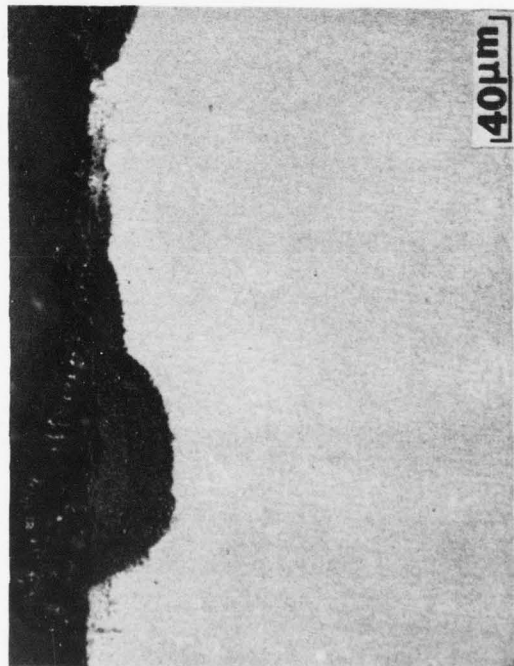
Water washed

As removed from furnace

Figure 44. Surface condition and typical depth of attack of CoCrAlY coating produced by 5 mg/cm² salt deposit exposed for 20 hours at 704C with pSO₃ = 0.0007 and 30 ppm NaCl vapor.

Testing of a CoCrAlY specimen coated with a 5 mg/cm^2 salt deposit was terminated after 20 hours because visual inspection indicated substantial corrosion; surface condition before and after water washing and depth of attack revealed by sectioning the specimen are shown in Figure 44. Note the chloride-type attack, in spite of the very thick salt deposit.

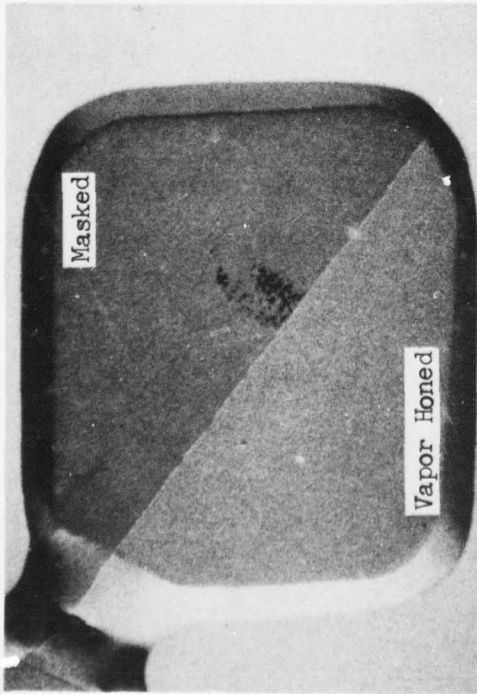
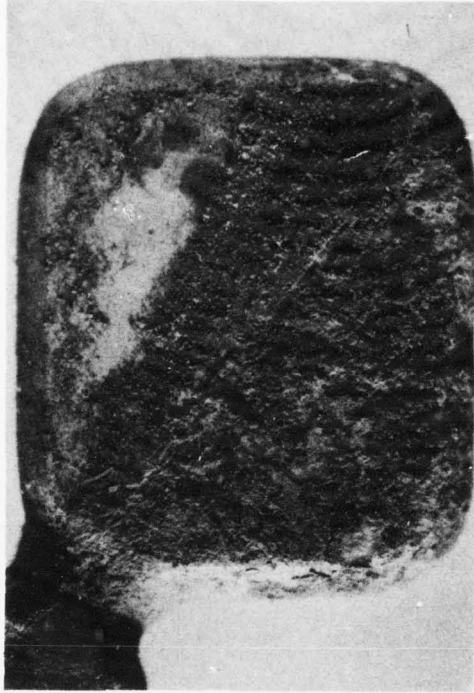
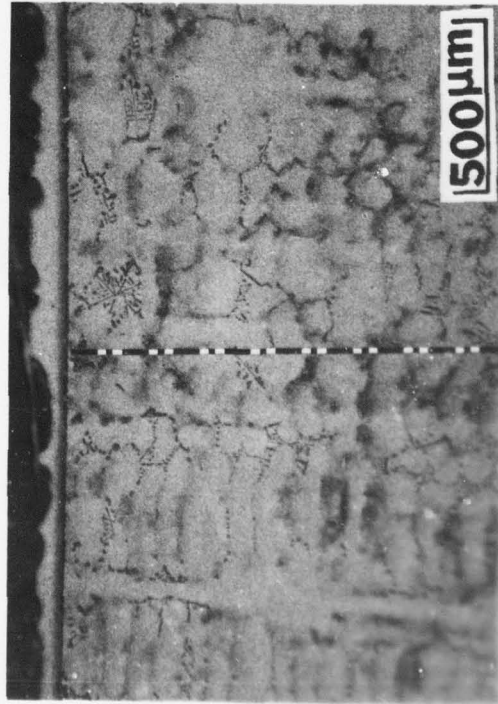
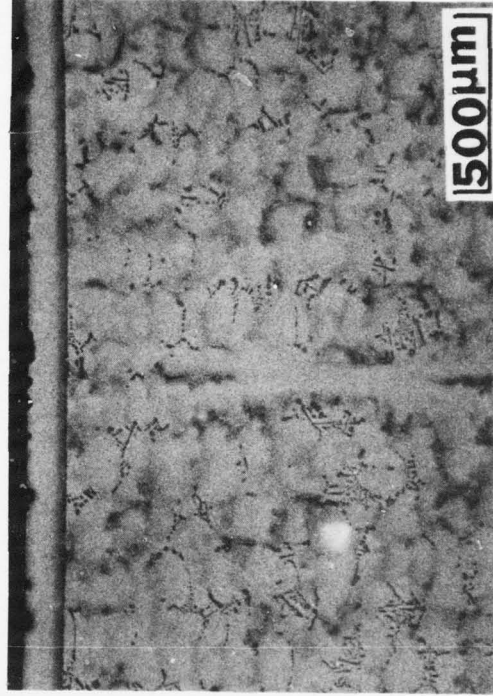
Pre-test condition

Exposed 20 hours; 704C, P_{SO₃} = 0.0007 atm

Transition between masked and vapor honed areas

Typical degradation of masked area

Figure 16. CoCrAlY specimen prepared by masking and vapor honing as described in text.

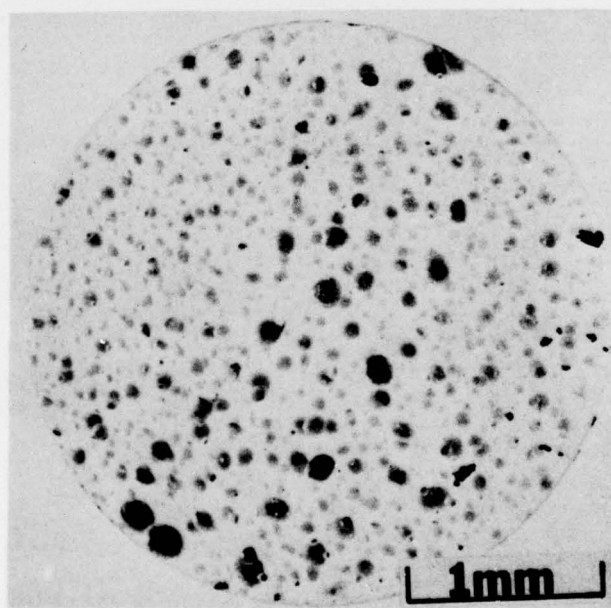
a. 100% Na_2SO_4

b. Na_2SO_4 - 50% CoSO_4

Figure 46. Deposits of 100% Na_2SO_4 and Na_2SO_4 - 50% CoSO_4 exposed 20 hours at 70°C with $p_{\text{SO}_3} = 0.0007$ atm.

Deposits of 1 mg/cm^2 of Na_2SO_4 and $\text{Na}_2\text{SO}_4 - 50\% \text{ CoSO}_4$ were applied to single crystal tablets of high purity alumina. On visual inspection after a 20-hour exposure, the Na_2SO_4 deposit was of uniform thickness except for small areas where flakes of salt had spalled off; there was no clear evidence that the deposit had melted (Figure 46a). In striking contrast, the mixed sulfate deposit was small globules of solidified liquid (Figure 46b).

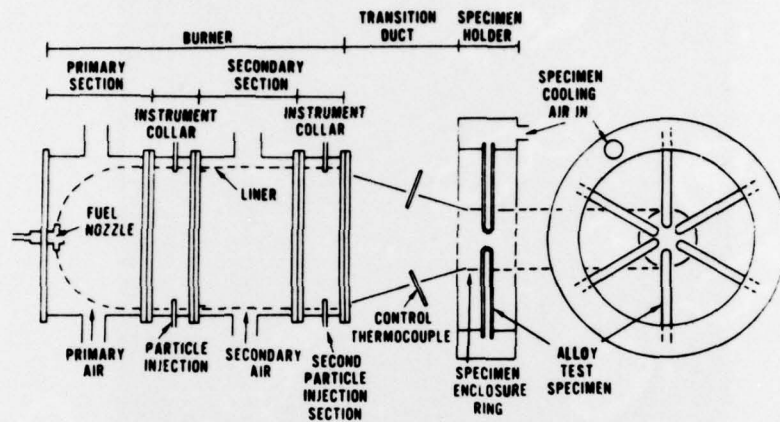
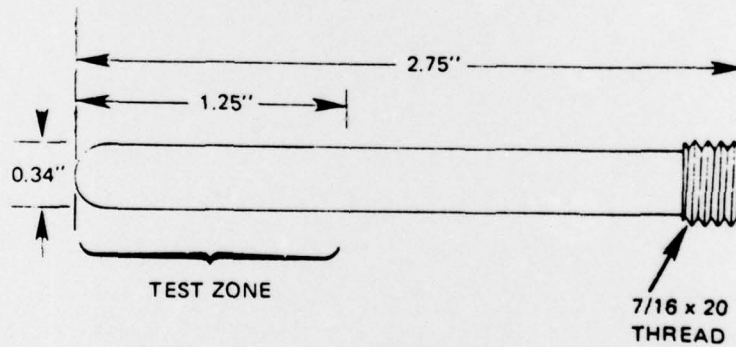
Figure 47. Schematic diagram of ducted burner rig and cylindrical test specimen used for hot corrosion - salt deposition rate dependence tests. (Aqueous salt solution was injected into the primary combustor through hypodermic tubing near the fuel nozzle; provision for particle injection and specimen cooling were not utilized on this program.)

A high velocity ducted burner rig (Figure 47) previously used for oxidation and hot corrosion testing at relatively high temperatures (870 to 1000°C) was equipped with provision for mixing SO₂ with the primary air supply. To achieve the lower test temperature desired for this program, the burner rig operating parameters (primary air pressure, secondary air pressure, and fuel pressure) were adjusted empirically until a suitable temperature distribution on dummy specimens was measured with a calibrated infrared pyrometer. Testing was initiated using a salt ingestion rate of approximately 0.9 grams/hour, based on experience from a previous program. An SO₂ flow rate of 30 liters/hour was arbitrarily chosen to compromise between a desire for high SO₃ pressure to accelerate testing and environmental considerations which dictated minimizing the SO₃/SO₂ effluent to the atmosphere.

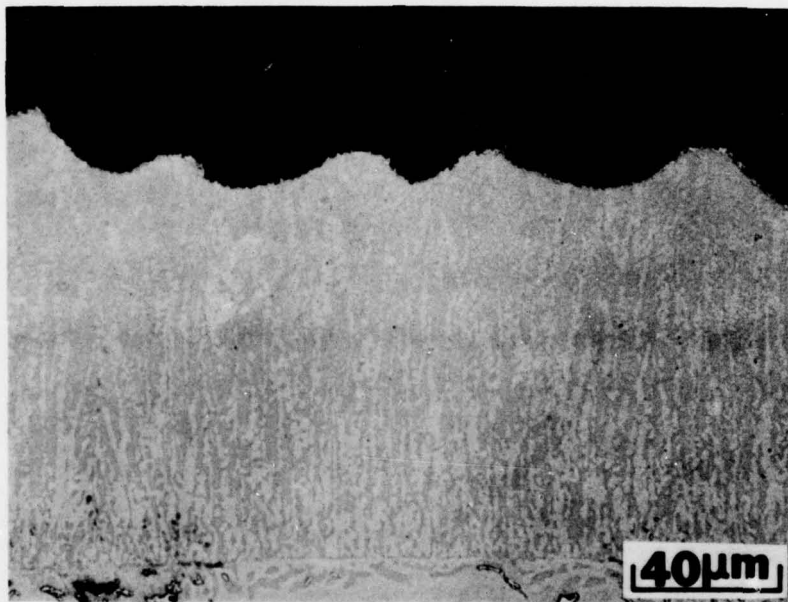
Figure 48. Nodular attack developed in preliminary burner rig test with ASTM sea salt and SO_2 gas mixed with the primary air. Exposure time = 26 hours at 704°C , calculated SO_3 pressure = 5.3×10^{-7} atm.

The initial experiment was terminated after 26 hours because a large mass of carbon was building up inside the burner rig and small amounts appeared to be depositing on the specimens as well. However a cross section of the CoCrAlY coating showed nodular attack of morphology resembling that of the 704°C tube furnace tests (Figure 48), in spite of the low SO₃ pressure (calculated as 5.3×10^{-7} atm, assuming 0.1 wt% sulfur in the fuel and equilibrium at the specimen temperature) and operating conditions in which carbon was being deposited on the burner liner and probably on the test specimens.
