MARINE GAS TURBINE HOT CORROSION
DEPENDENCE ON INGESTED SALT LEVELS

Report No. FR-11544

R.H. Barkalow and F.S. Pettit
United Technologies Corporation
Pratt & Whitney Aircraft Group
Government Products Division
West Palm Beach, FL 33402

Final Report: 29 July 1977 to 31 Oct 1978

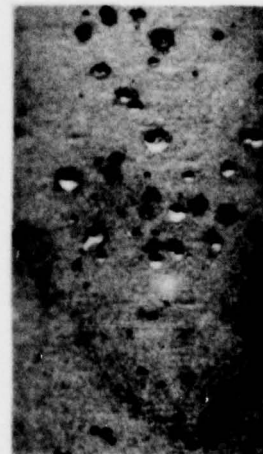
Figure 49. Salt deposit and oxide mounds (inset: pits after removal of mounds) on CoCrAlY specimen exposed 10.5 hours to Na_2SO_4 - 50% MgSO_4 salt. Calculated SO_3 pressure = 5×10^{-5} atm.

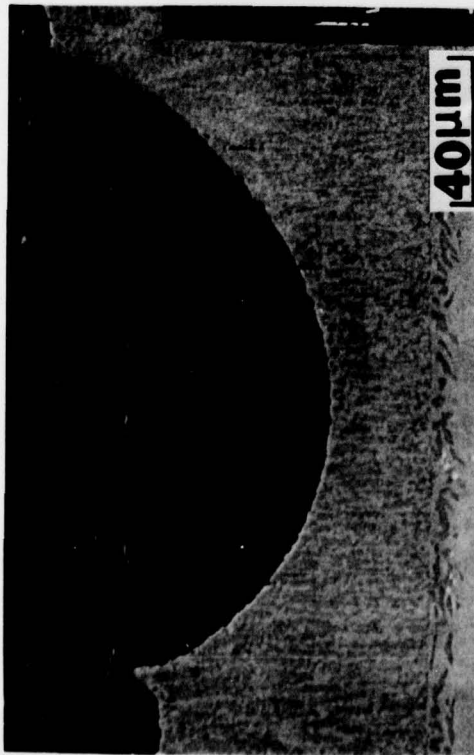
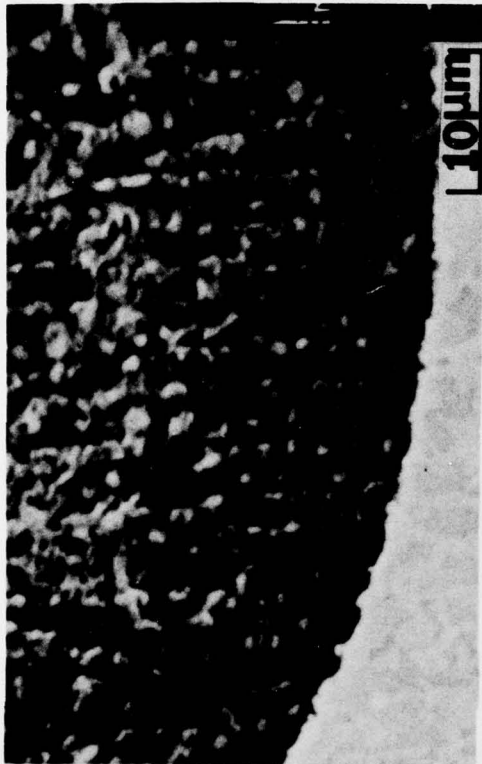
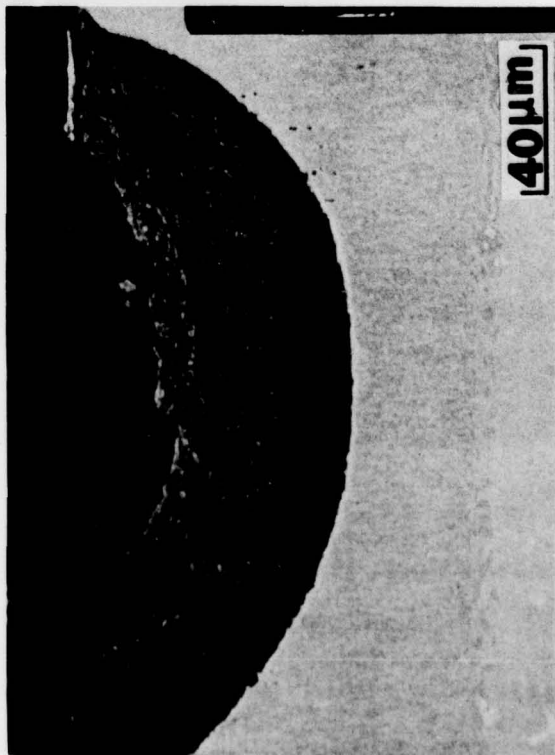
Exposure to show coating microstructure

Ghost image in scale

Exposure to show scale

Sulfur X-rays of above area

Figure 50. Depth and microstructure of pitting attack, as shown by sectioning through the sample of Fig. 49.

Metallographic examination of the CoCrAlY specimen tested with the $\text{Mg-Na}_2\text{SO}_4$ salt mixture confirmed deep pitting after only 10 hours exposure time (Figure 50). Since the SO_3 pressure at the 60 liter flow rate was apparently high enough (calculated as 5×10^{-5} atm) to promote substantial attack, it was decided to resume testing with the ASTM sea salt for the compatibility with other programs which was originally the reason for choosing it.

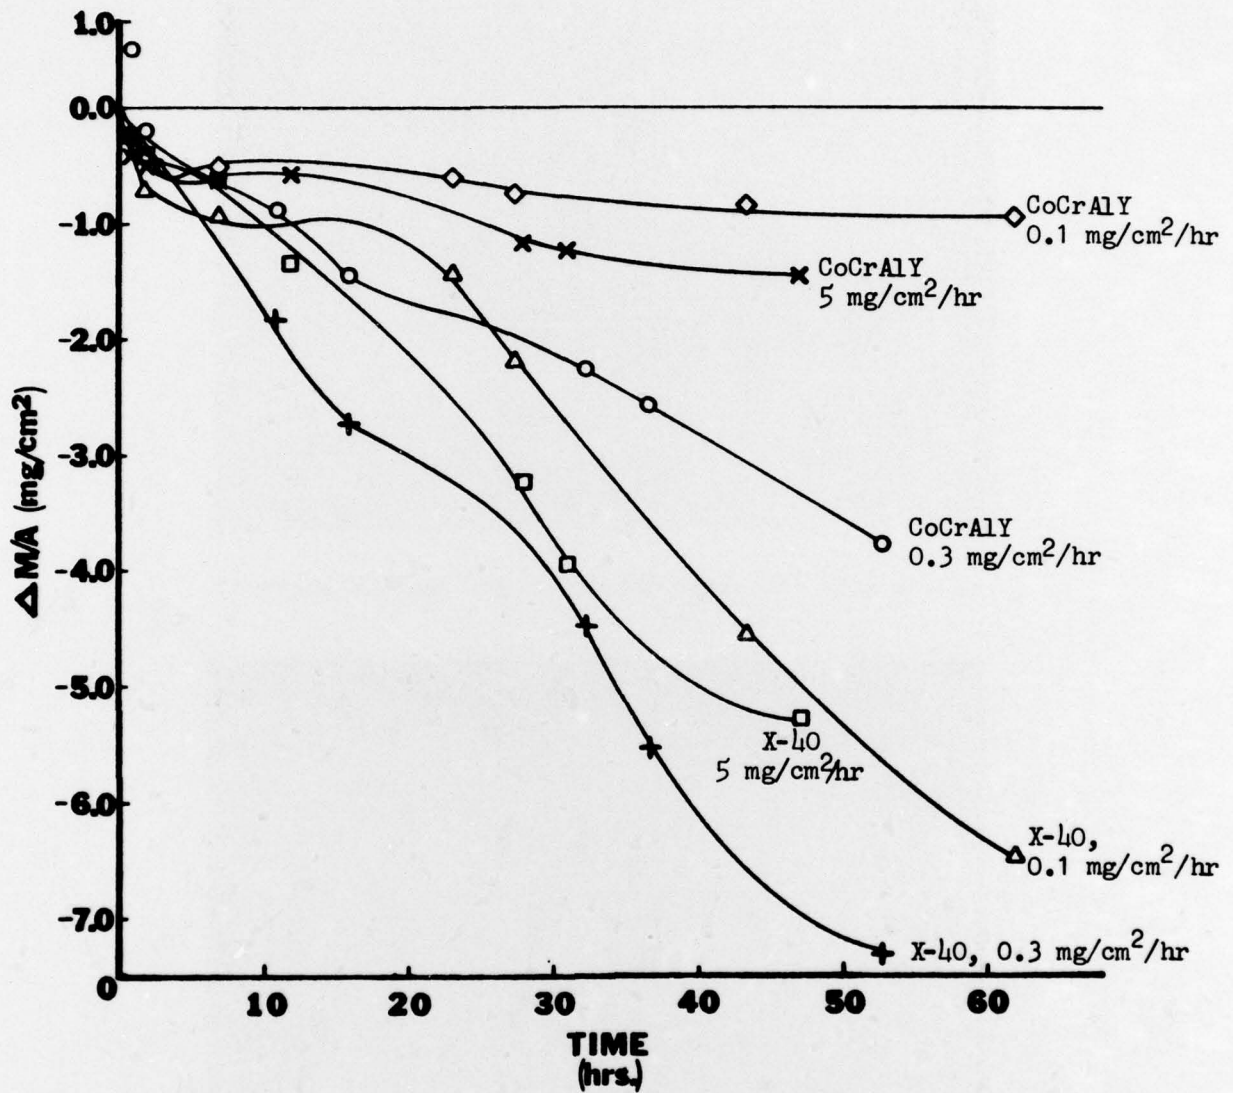
Figure 51. Weight change data showing effect of deposition rate on severity of attack of CoCrAlY coating and uncoated X-40 (concurrently exposed at each deposition rate) in 704C ducted burner rig hot corrosion test with ASTM sea salt and equilibrium SO_3 pressure of 5×10^{-5} atm.

Weight change data for the three tests in which $\Delta M/A$ was measurable are plotted on the same scale in Figure 51 to show parallel behavior of the CoCrAlY and X-40 which indicates that the data are internally consistent. Maximum attack was encountered at the intermediate deposition rate. At the lower rate, general surface degradation was much less extensive, but small pits were observable after the first hour of testing.

In the second test, at a higher deposition rate, the general surface degradation and localized pitting attack shown in Figure 53a were observed after 28 hours, and a deposit of the thickness shown in Figure 53b built up during the final overnight run prior to termination of the test. Detailed examination of the surface condition after 47 hours showed that many of the small pits observed at 28 hours apparently had not grown on further exposure; also the final weight loss was not as large as expected from the projection of the curve established by previous weighings. Such behavior - i.e. the failure to sustain a rate of hot corrosion propagation apparently established in previous exposure periods - is not uncommon in burner rig testing but is rarely observed under the more precisely controllable conditions of tube furnace experiments. An obvious possibility is a decrease in the severity of the reactive environment due to random fluctuations in burner rig operating conditions, with a ducted rig being perhaps especially susceptible to random variations in SO_3 pressures. Also, especially in the case of this test, the large ingestion rate may have built up a deposit of such thickness that the innermost salt/metal interface was protected from the effects of the reactive gaseous environment. Neither of these rationalizations, however, is supported by the large weight loss of the concurrently tested X-40 (see Figure 51).

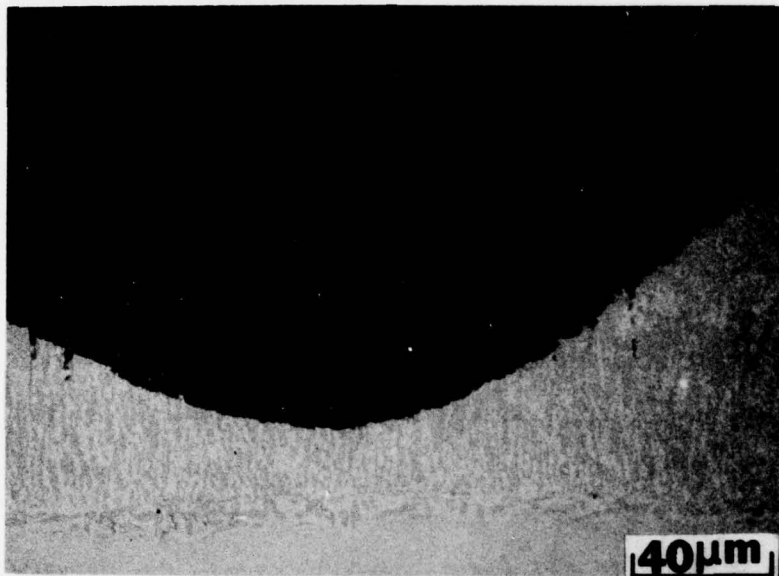
a. Maximum attack at about 70° gas/salt impingement

Figure 52. Depth and typical morphology of hot corrosion attack of CoCrAlY coating tested in ducted burner rig with ASTM sea salt and SO_2/SO_3 gas. Total exposure time = 52.7 hours at 704C; calculated SO_3 pressure = 5×10^{-5} atm; measures salt deposition rate = 0.3 $\text{mg}/\text{cm}^2/\text{hr}$.

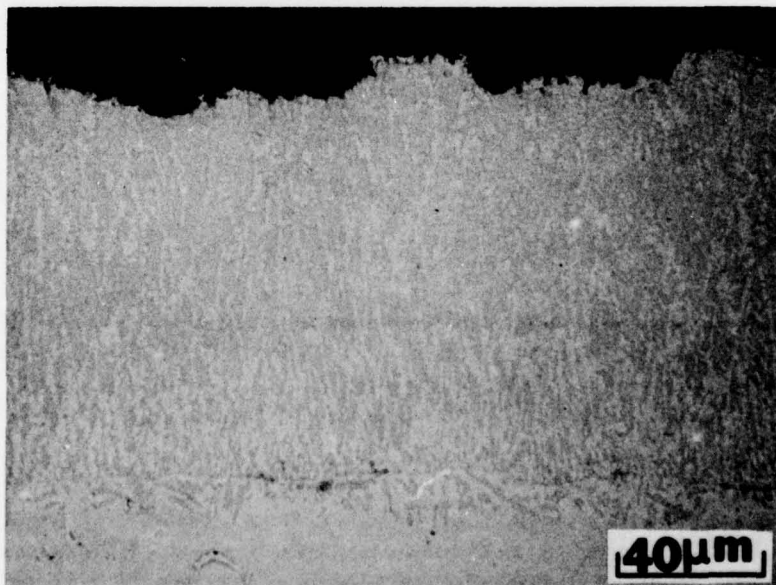
b. Typical structure at approximately 10° impingement

Photomicrographs showing the nature and severity of attack of the CoCrAlY specimen at the 0.3 mg/cm²/hr deposition rate are presented in Figure 52. As expected, the cross section through the cylinder showed a marked angular dependence of severity of attack, with the portions of the leading edge exposed to high angle impingement of the salt-containing gas stream being more deeply corroded than the sections which experienced low angle gas impingement. The trailing edge showed no discernable micro-

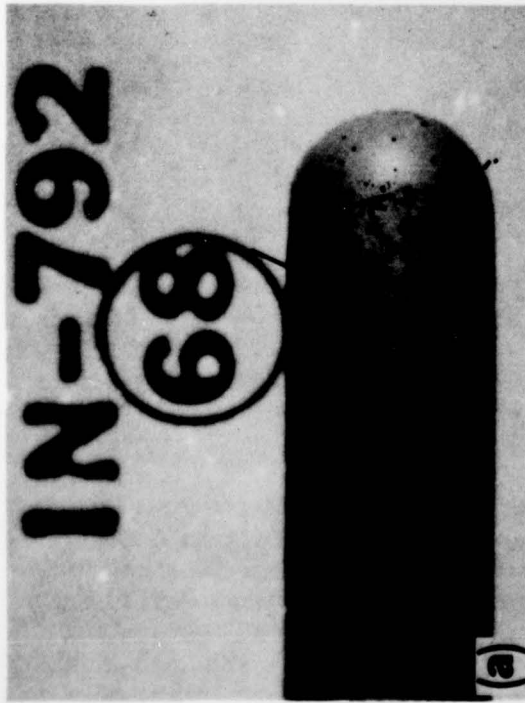
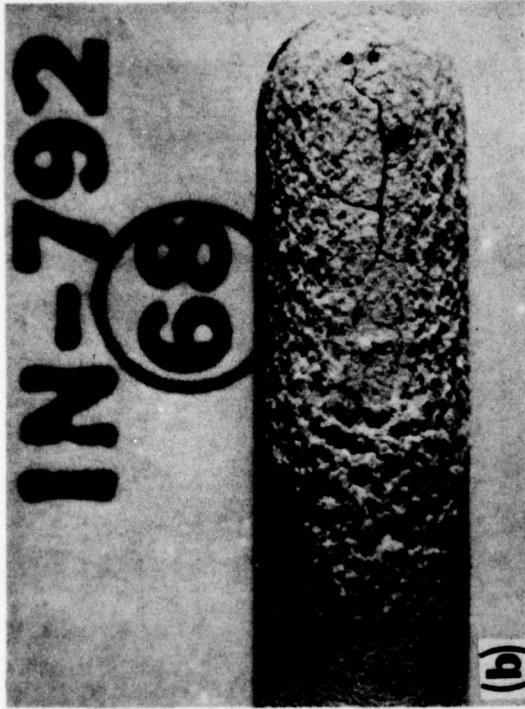
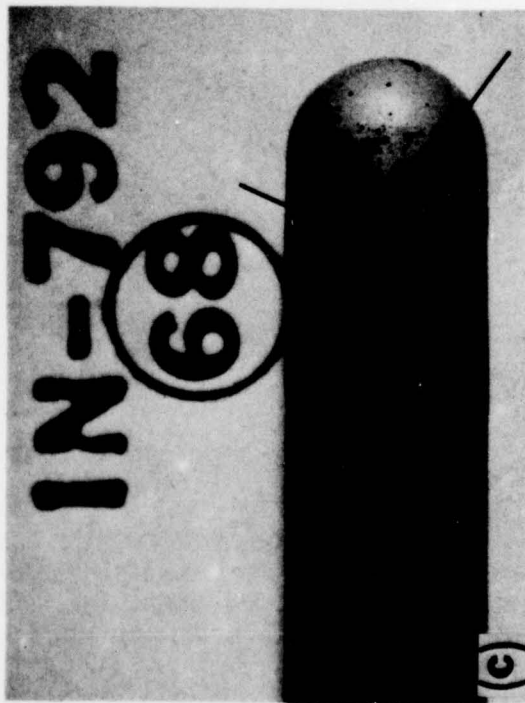
- (a) Surface condition after 28 hours. Arrows mark features visible in (c).
- (b) Salt deposit built up during 19-hour overnight run after taking photo (a).
- (c) Surface condition after 47 hours; i.e. after washing off the salt shown in (b). Arrows point to same features as in (a).

Figure 53. Surface condition of washed CoCrAlY specimen and salt deposit formed in 19-hour exposure at $5 \text{ mg/cm}^2/\text{hr}$ deposition rate.

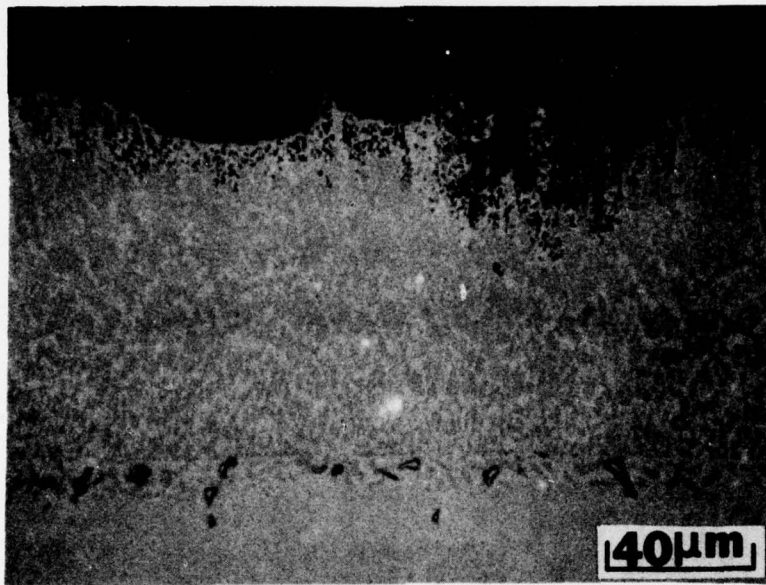
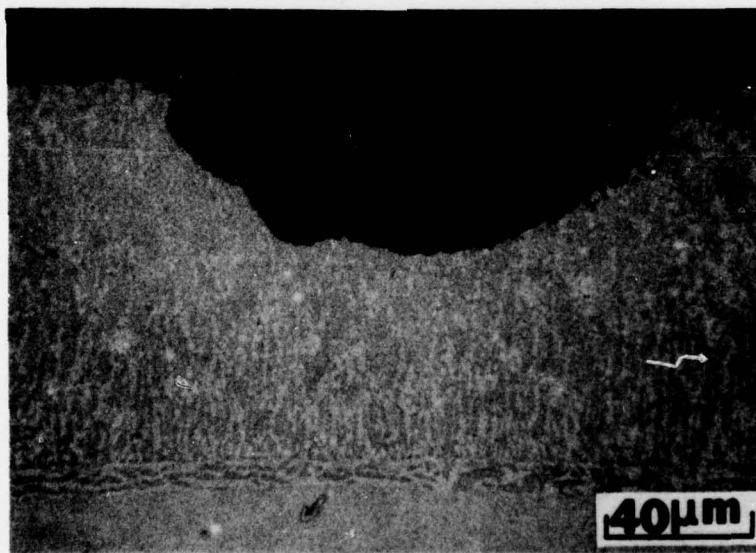
a. Chloride-type morphology near tip of specimen

b. Nodular attack near center of hot zone

Figure 54. Hot corrosion of CoCrAlY coating exposed 47.1 hours in ducted burner rig; environmental conditions were as described in Fig. 52 except for salt deposition rate of $5 \text{ mg/cm}^2/\text{hr}$. Extensive chloride-induced dealloying and internal oxidation as in top photo was not common; typical degradation microstructure was SO_3 -type nodular attack.

Post-test metallography on three sections through the CoCrAlY specimen showed maximum attack of about 50 μm and evidence of substantial chloride-induced dealloying in some areas (Figure 54). Of course it was initially suspected that the large amount of salt was not completely sulfated, but simple calculation showed that the moles of SO_2 added to the burner rig air supply was almost two orders of magnitude greater than the moles of chloride in the ingested sea salt and chemical analysis of the deposit washed from the sample indicated no detectable chloride.

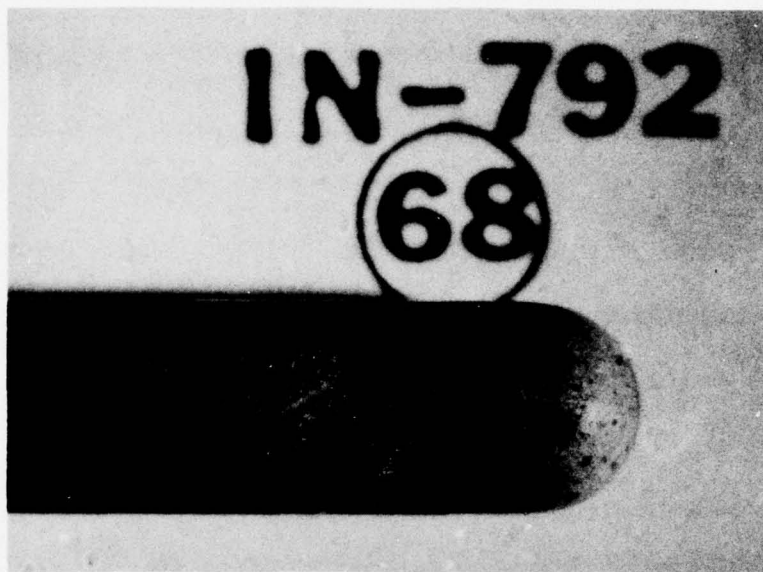
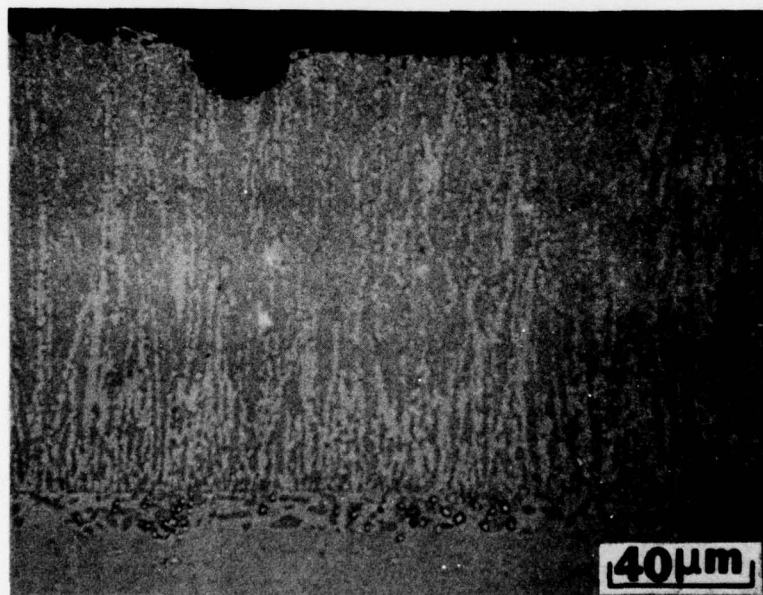
a. Surface condition

b. Depth of attack

Figure 55. Hot corrosion of CoCrAlY coating exposed 61.1 hours in ducted burner rig; environmental conditions were the same as for the specimens of Figs 52 - 54 except for salt deposition rate of less than $0.1 \text{ mg/cm}^2/\text{hour}$.

At the 0.168 g/hr ingestion rate, surface degradation of both CoCrAlY and X-40 were detectable after 1 hour of testing, and small but clearly measurable weight losses of the X-40 indicated continuing corrosion during a 61-hour exposure. Post-test metallography of the CoCrAlY showed less attack than anticipated from the surface condition; microstructural degradation in most areas was negligible and the deepest pit observed on several planes of polish was about 20 μm (Figure 55).

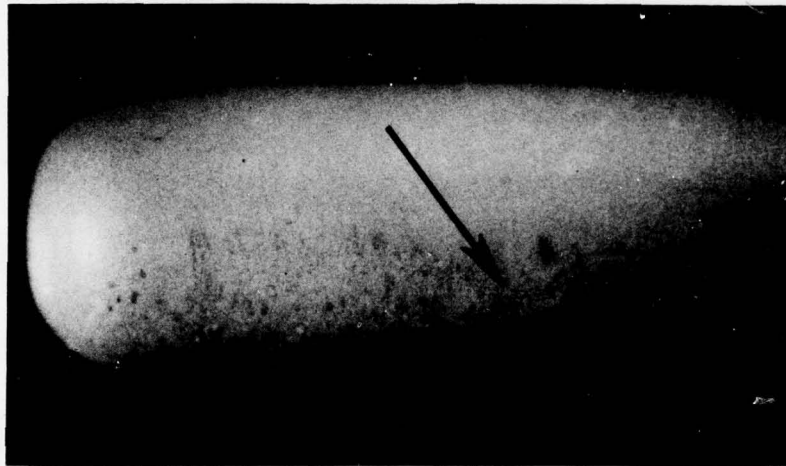
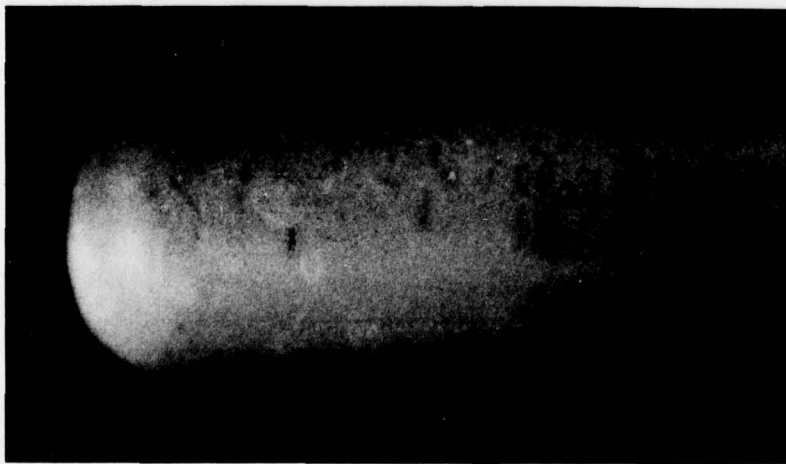
↑ ↑ ↑ ↑ ↑
salt
impingement
↓ ↓ ↓ ↓ ↓

Figure 56. Surface condition of CoCrAlY-coated specimen exposed 6 hours to salt flux of $4 \text{ mg/cm}^2/\text{hour}$. Photos are opposite sides of same specimen, oriented to show difference between leading and trailing edges.

Visual observation of the CoCrAlY specimen after 2 hours of testing and careful water washing to remove rig spatter showed small green areas where the oxidation product was not the uniformly protective alumina characteristic of the trailing edge. Testing was continued, and the surface condition documented after a total exposure time of 6 hours (Figure 56). Continued exposure for a total of 21 hours resulted in slightly increased darkening of the leading edge surface, and careful examination with binocular and metallurgical microscope showed small pits of depth and frequency greater than attributable to oxidation in the absence of a condensed salt deposit.

No apparent differences in the general surface condition of the leading and trailing edges were evident on post-test scanning microscopy. Also the dull green areas observed on visual inspection were not discernable on the SEM, even though the transition between a greenish-colored area and the surrounding gray alumina had been marked with a microhardness indenter. However the line of fine dots marked in Figure 56 was found to be a series of small pits, typically of the size, depth, and morphology shown in Figure 57. Examination of randomly selected areas suggested that the entire leading edge was characterized by numerous pits of this type (of the order of 100 per cm^2), and no features of this nature were observed on the trailing edge.

The surface features in Figures 56 - 57 and the sulfur enrichment in the shallow pit of Figure 58 are considered unequivocal indication of hot corrosion attack induced by salt condensed from the burner rig flame. Such attack occurred even though the salt deposition rate was barely discernable by visual inspection. Moreover the fact that degradation of this extent was observable after a relatively short testing time is believed to represent an unacceptable rate of hot corrosion.

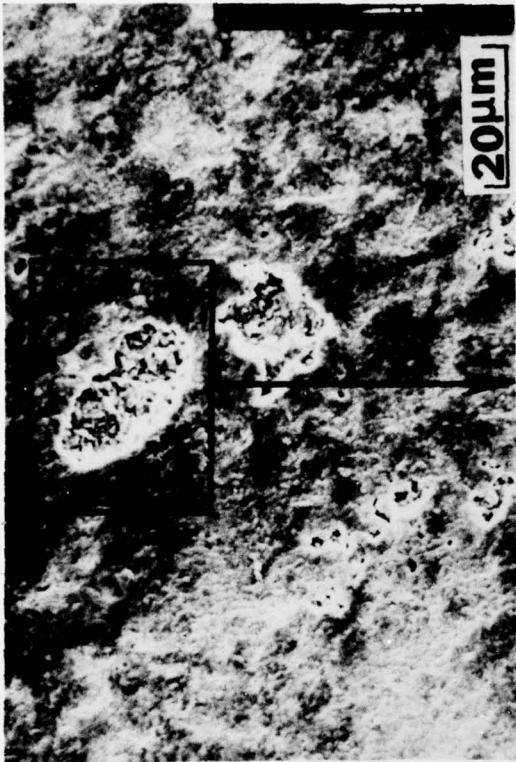
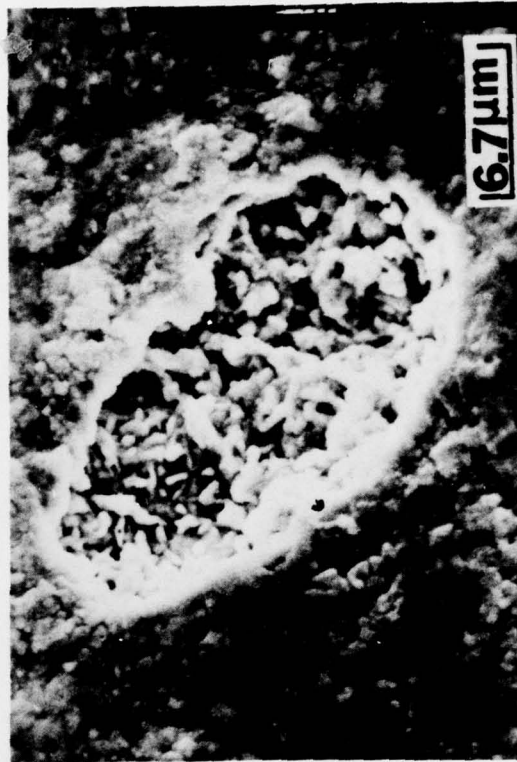
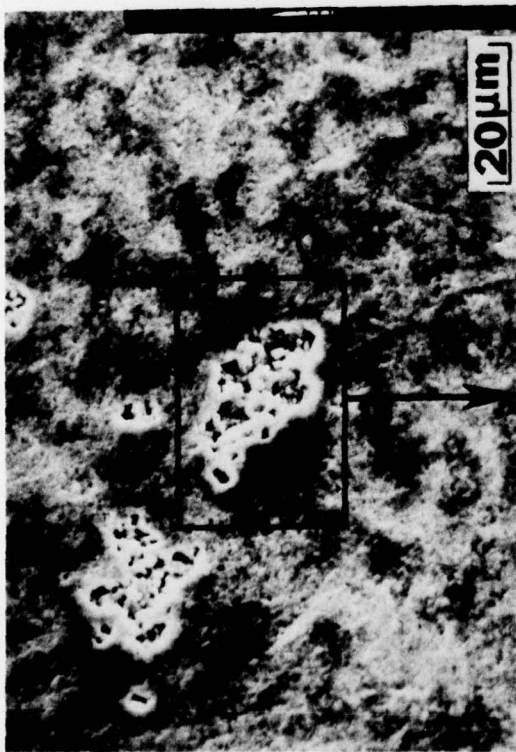
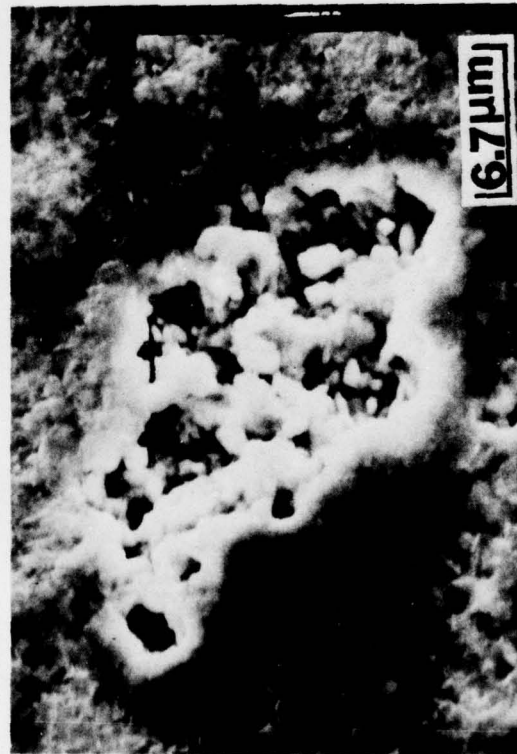
Figure 57. Surface features observed on the leading edge of the specimen described in Fig. 56.

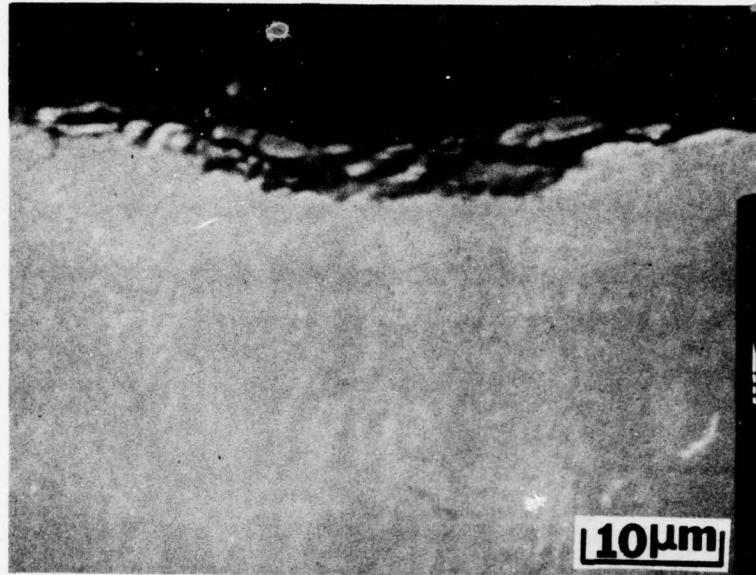
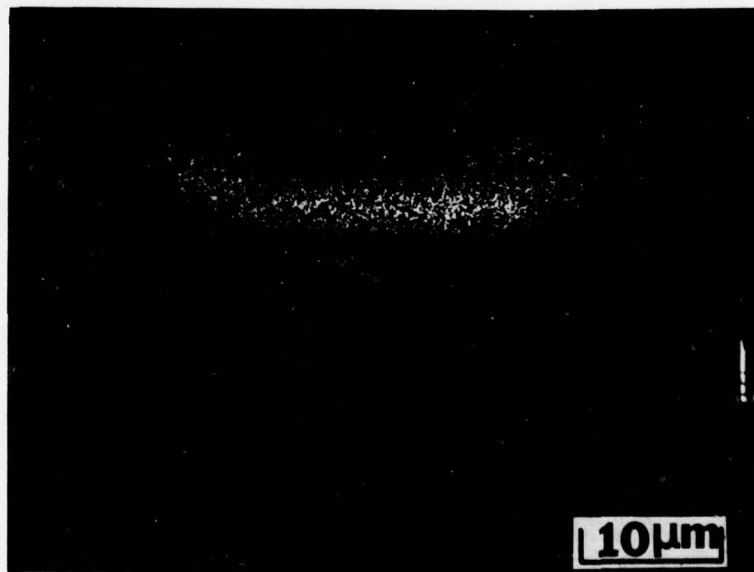
a. Back scattered electron image

b. Sulfur X-rays from above area

Figure 58. Metallographic cross section presumably through a small pit of the type shown in Fig. 57.

The specimen was cut for metallography approximately in the center of the test zone. Metal consumption up to 5 μm was observed in several areas (e.g. Figure 58a), and the corrosion products were rich in sulfur (Figure 58b).

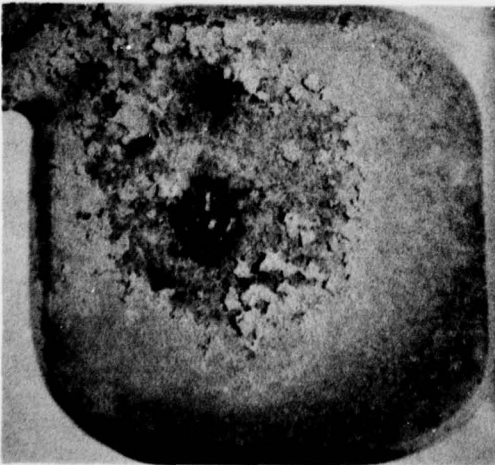
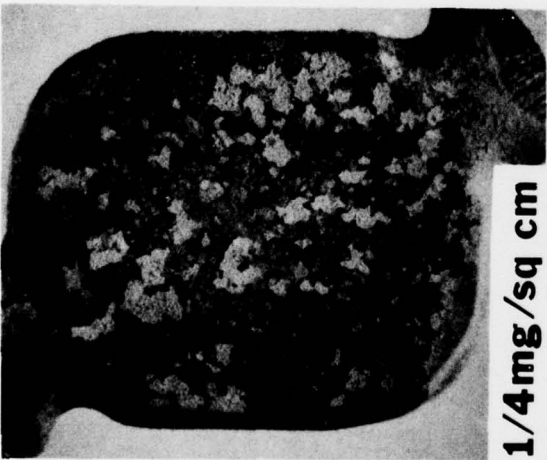
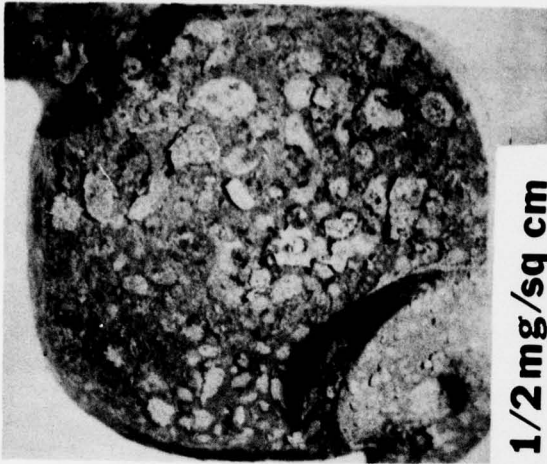
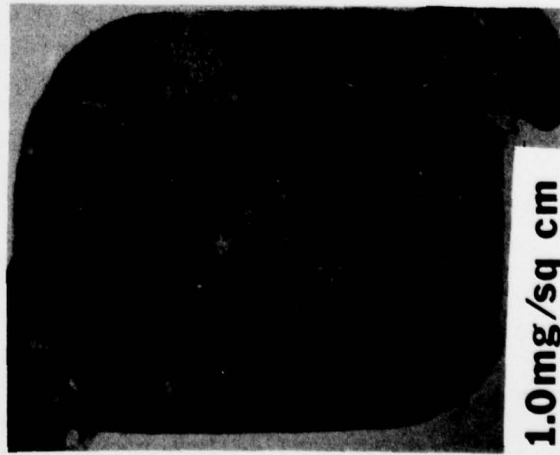
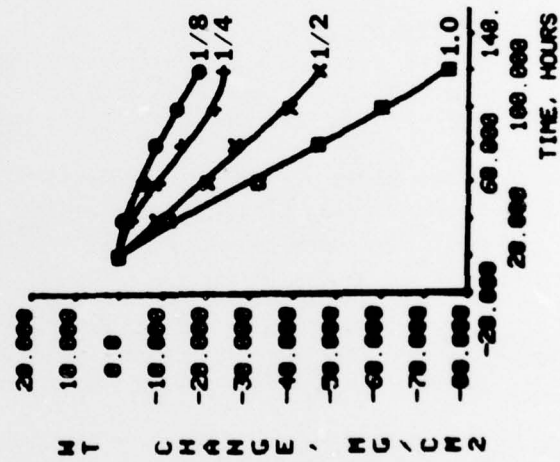
1/8mg/sq cm

1/4mg/sq cm

1/2mg/sq cm

1.0mg/sq cm

Figure 59. Surface photographs of CoCrAlY-coated coupons with various deposit thicknesses after 20 hours exposure in tube furnace at 704C and $PSO_3 = 0.0007$ atm; weight change data versus deposit thickness for 100-hour cyclic test.

Visual inspection after 20 hours showed an obvious dependence of severity of attack on amounts of applied salt (Figure 59). The difference in surface condition became less apparent as all of the specimens continued to degrade on further exposure, although weight change data remained remarkably consistent up to 100 hours (Figure 59). Post-test metallography showed that even the specimen with the thinnest deposit had suffered consumption of up to half of the coating thickness.
