ORI-TR-1474

STUDY OF TASK PERFORMANCE PROBLEMS IN
REPORTS OF COLLISIONS, RAMMINGS, AND GROUNDINGS
IN HARBORS AND ENTRANCES

MARCH 1979

FINAL REPORT

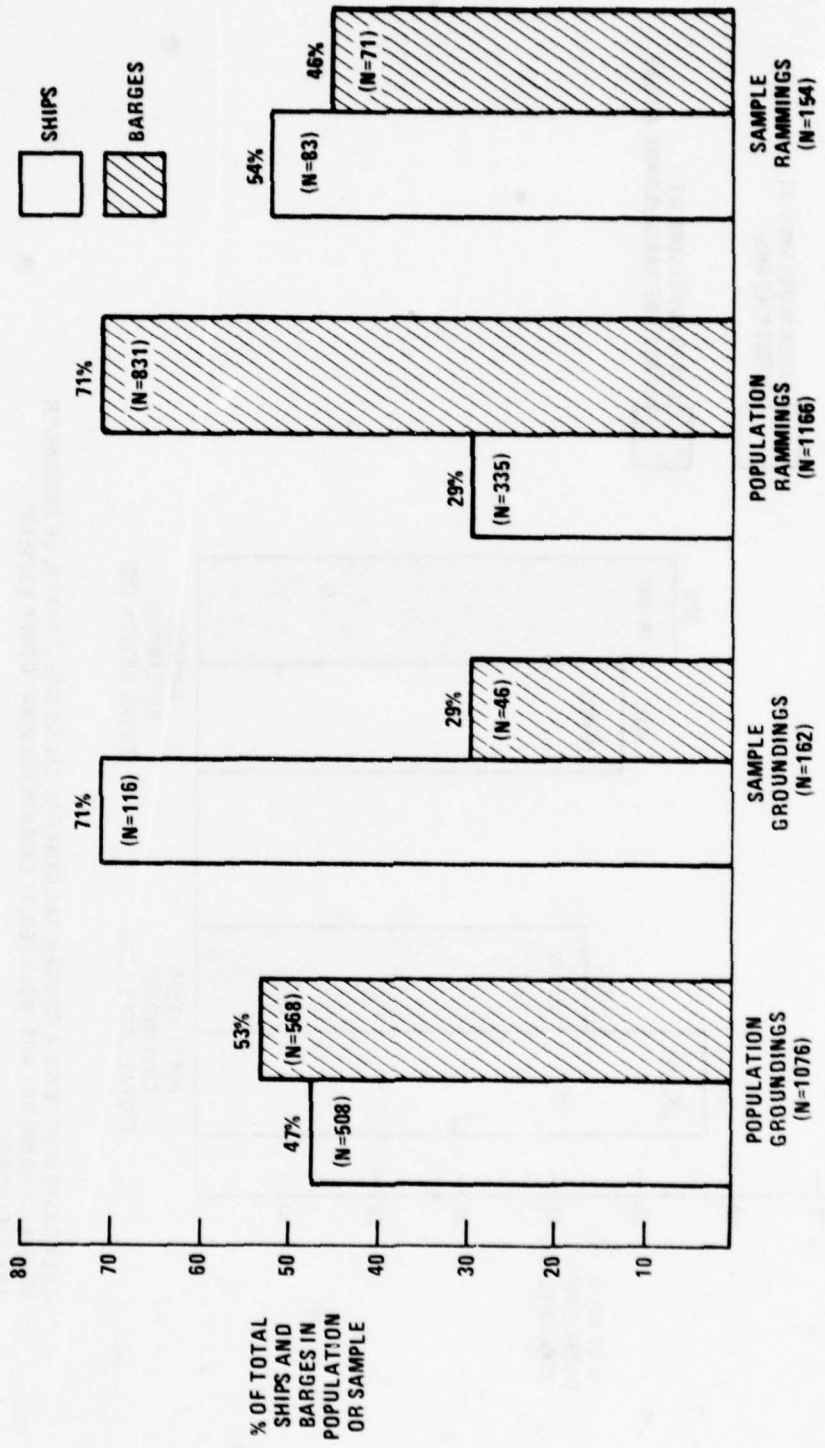
FIGURE 2.2. SHIP AND BARGE INVOLVEMENT IN GROUNDINGS AND RAMBLINGS: COMPARISON OF SAMPLE TO POPULATION

Figures 2.2 and 2.3 compare the types of vessels involved in the sample and population accidents. In Figure 2.2, ships are shown to be very substantially overrepresented in the sample groundings and rammings. That is another indication that the sample tends to include the more severe accidents. In Figure 2.3, however, an opposite tendency is suggested, although it is not marked; the sample is weighted slightly with accidents involving barges. This is believed to have happened because of the "Towing Addendum," which is an additional form used in reporting tug/towboat-barge accidents. This form includes very useful data elements. (Its use was discontinued in FY 1976, which is believed to be a significant loss for the casualty/accident data base.)

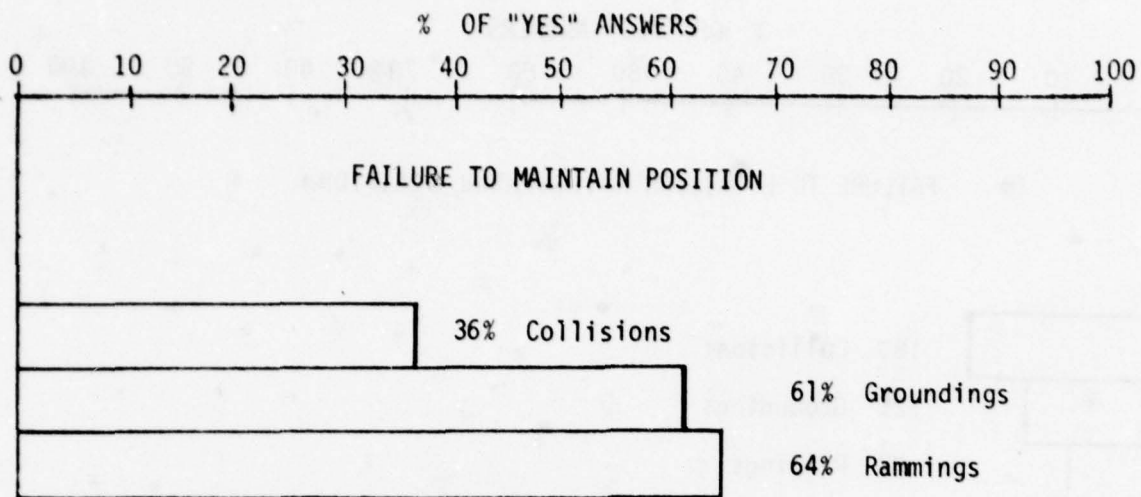
CASUALTY PRECIPITATING FACTORS - CHART 3.38

These percentages reflect answers to questions VI. 15 in the R/G-CAG and questions XII. 73 and XII. 74 in the C-CAG.

Collisions 16 PV only + 12 OV only + 4 both = 32/88
 Groundings 99/162
 Rammings 98/154

Failure to Maintain Position. This is the most common of all problems cited in the causal factors section. Maintaining position was found to be a problem in over 60 percent of both rammings and groundings cases and in 36 percent of the collision cases. The criteria for coding failure to maintain position is related to a vessel's inability to realize an intended path. These "intended paths" were not irrational hopes such as wanting a 10,000 GRT vessel doing 5 knots to stop in 100 yards, but were considered to be more reasonable expectations of what the vessel could do. Some examples are: a PIC on a barge intending to position his vessel close to a bridge support in order to get in line for an upcoming turn finds suction (or wind or current) forces the barge to scrape the bridge support; a barge is pushed aground by high seas; a ship in a turn reacts surprisingly slowly, crosses the channel and strikes an oncoming vessel.

Current, wind, and suction effects near structures and channel banks predominate as contributing or underlying factors in cases of failure to maintain position leading to the groundings and rammings. In the collision cases, failure to maintain position is less often attributed to the effects of environmental forces.
