**REVIEW OF  
LIGHTNING PROTECTION TECHNOLOGY  
FOR  
TALL STRUCTURES**

**Office of Naval Research  
National Aeronautics and Space Administration  
Federal Aviation Administration  
U.S. Air Force**

**Held at the  
Lyndon B. Johnson Space Flight Center  
Houston, Texas**

**November 6, 1975**

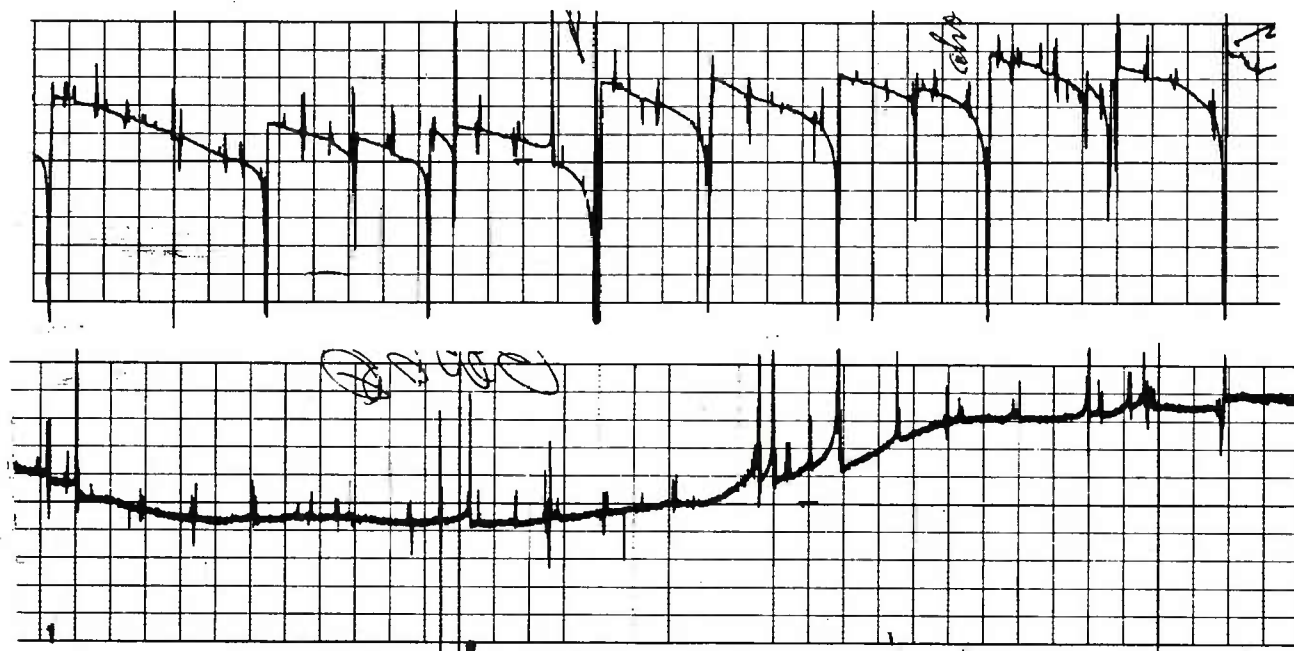
FIGURE 4, C-9, EGLIN AFB FLORIDA, DISSIPATION CURRENT HISTORY

In May 1973, LEA completed installation of an Umbrella Array System as illustrated by Figure 3. For the subsequent 15 months period, the system was instrumented and monitored continuously by Air Force personnel. No strikes were noted during this period; conversely, high dissipation currents were recorded regularly. Figure 4 presents a segment of one such chart; the dissipation current flow averaged 2200 microamperes during this period.

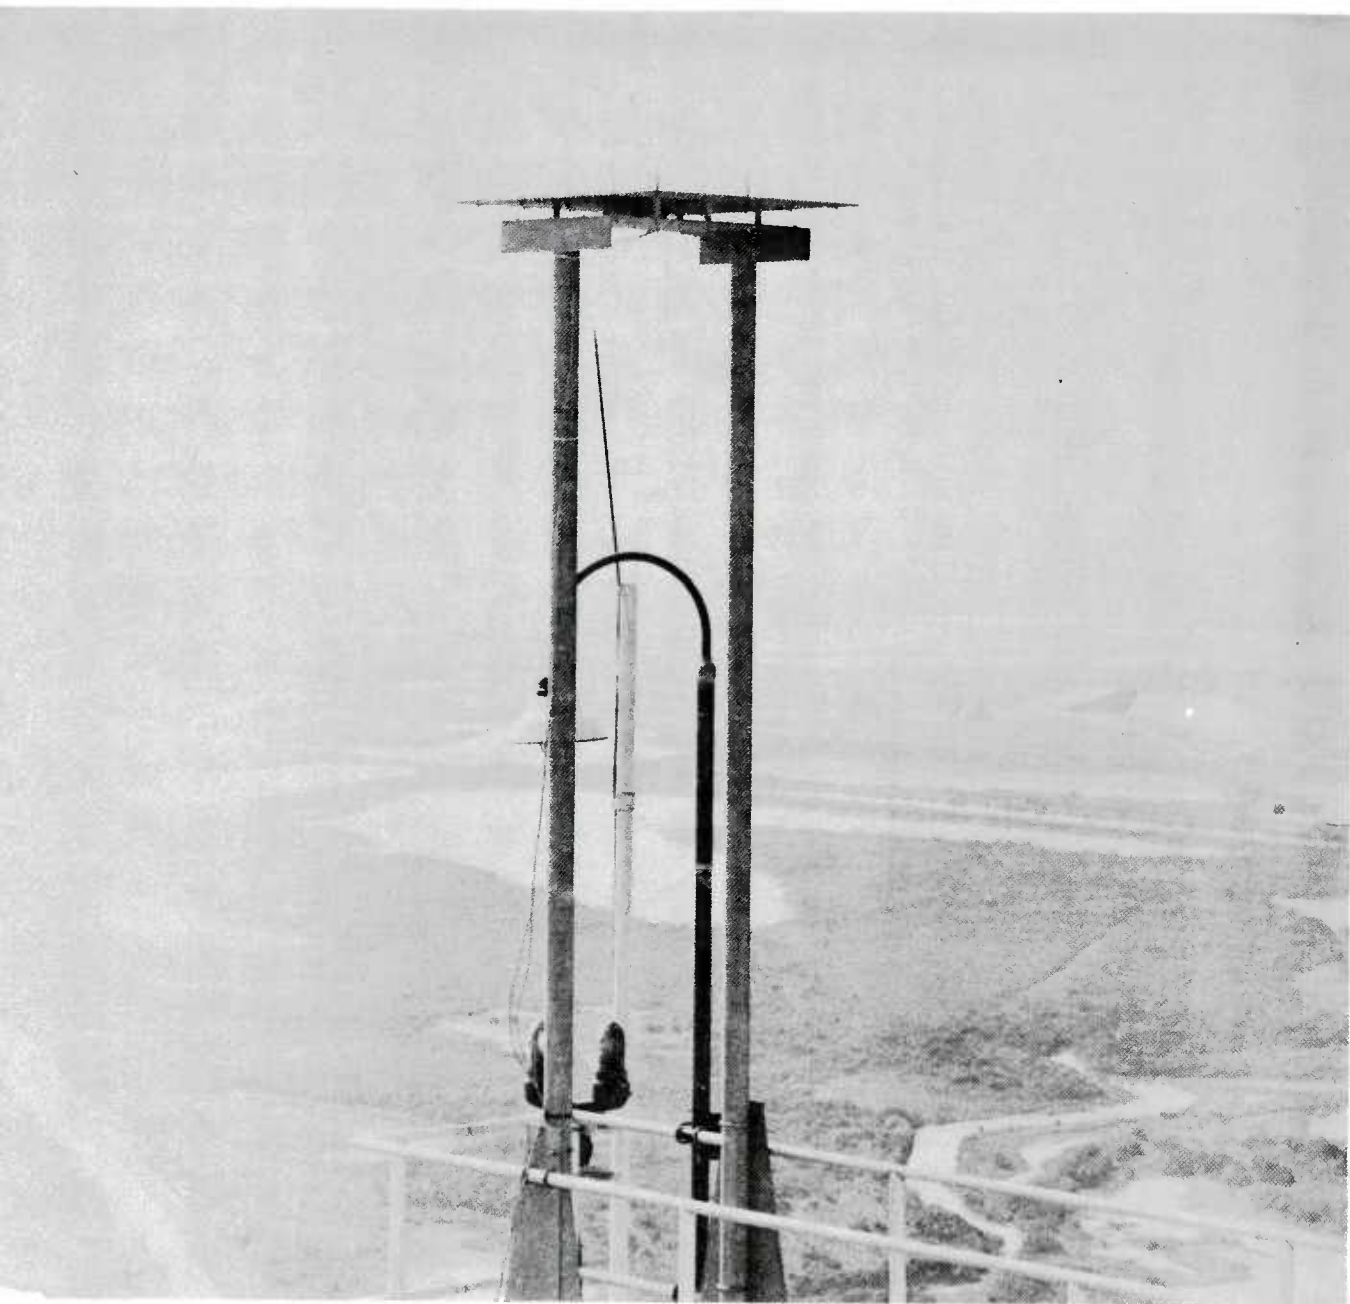
MOBILE SERVICE STRUCTURE, ARRAY #1

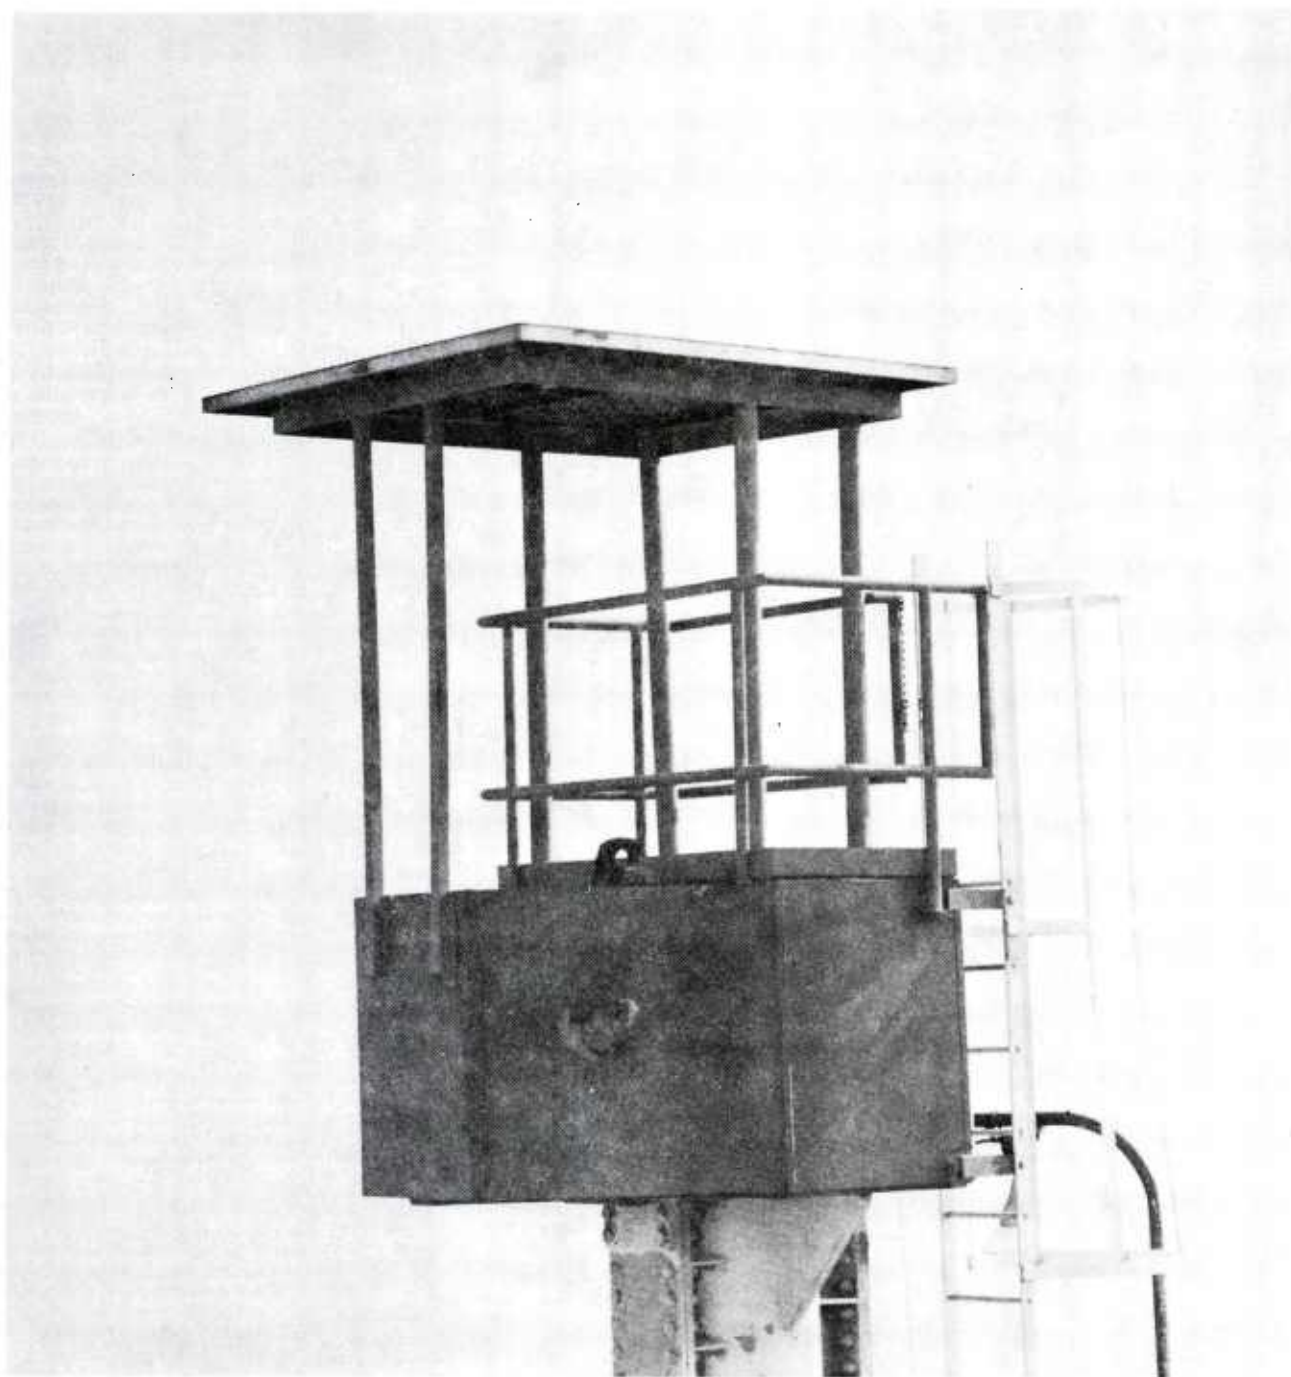
MOBILE SERVICE STRUCTURE, ARRAY #3

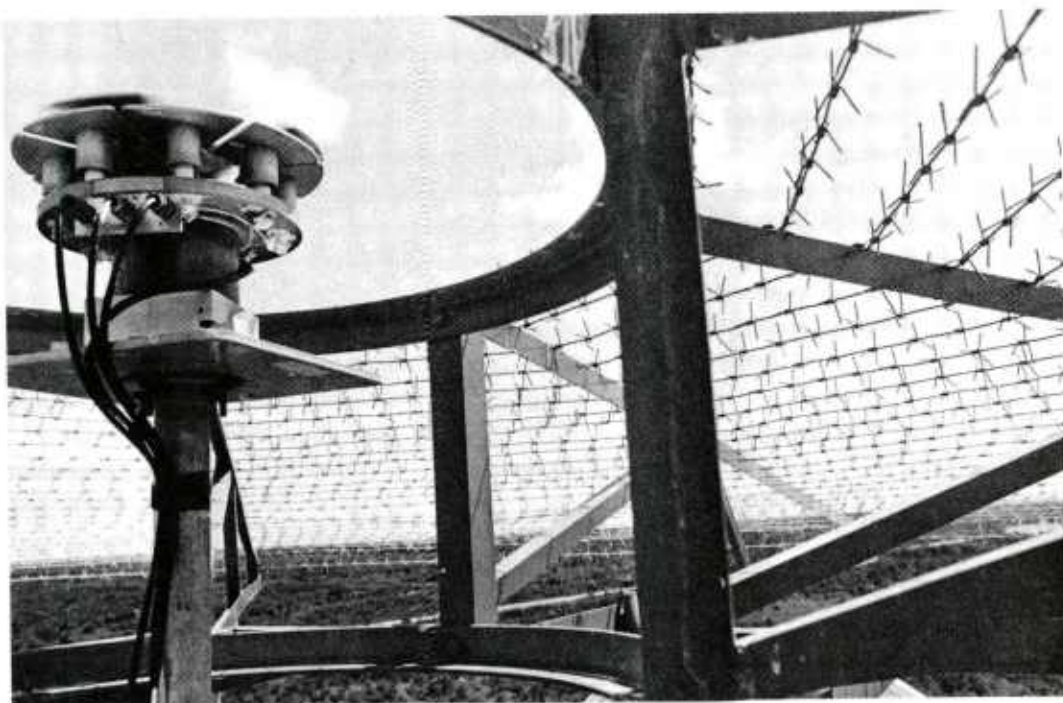
Figure 4. Close up of umbrella array at MILA

The dissipating wire is the material used to form the umbrella array, the truncated cone and the barrier types of arrays, whereas the rigid conducting material forms a disc or panel array. Figure 3 shows an umbrella array installed on a 100 foot collimation tower at NASA/GSFC's satellite tracking station on Merritt Island, Florida. The array is approximately 20 feet in diameter and is comprised of the dissipating wire wrapped spirally around the "umbrella" framework. A close-up of the array is shown in Figure 4. Approximately 1000 feet of the dissipating wire is used in such an array.

A closer view of the collimation tower complete with umbrella array is shown in Figure 13<sub>a</sub>, a close up of the array in Figure 4. The building at the base of the tower housed an 8 channel Brush Recorder (Fig. 13<sub>b</sub>). Also visible in Figures 13<sub>a</sub> and <sub>c</sub> are 3 tripods which were used for corona current and field mill investigations. These tripods were each 20 feet tall and were separated by a distance large enough that they would not normally electrostatically interfere with one another. Field mills were located atop the 5 ft and 20 ft tripods, and the other two tripods were used for corona current investigations.

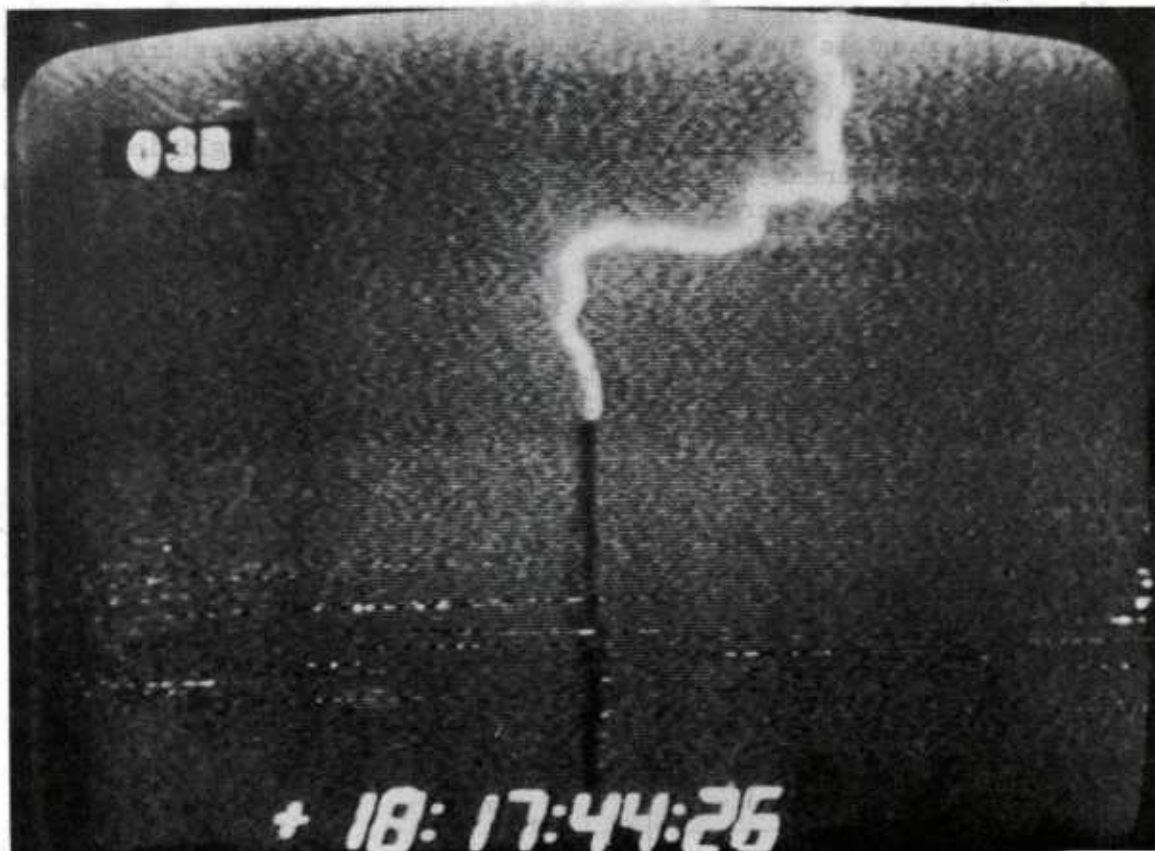
Figure 11.

Lightning striking a 500 foot meteorological tower at NASA's Kennedy Space Center, Florida, and hitting the dissipation array

An excellent photograph of the striking distance phenomena just described is shown in Figure 11 where lightning is striking a 500 foot tower at NASA/KSC. This photograph was supplied by NASA/JSC, Houston. At the time of the strike a dissipation array was on top of this tower, but according to the manufacturer the galvanizing process had not been performed properly and the array was not working; it was replaced shortly afterwards. Once more, however, we would like to reiterate that we believe the metallic finish of a grounded conductor should not influence the formation of ions above it in the avalanche process.

NASA/KSC personnel also measured the corona current from a panel type dissipation array on top of a 500 foot tower at KSC and found that the value throughout the summer thunderstorm season remained below 200  $\mu$ A. This array was also struck by lightning (Figure 11).

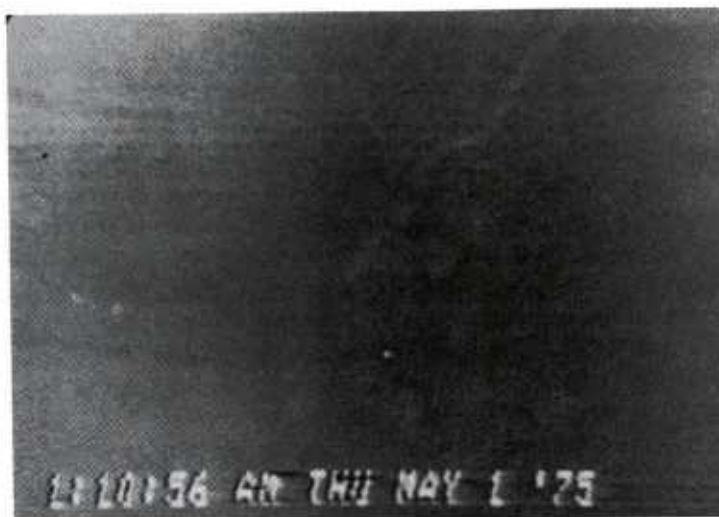
Lightning striking an array on top of the 1200 ft tower  
as viewed from the forestry tower

The photographs shown in Figures 27a and b show two strikes to the tower as observed from the forestry tower on 1 May and 8 June 1975. The bright dot in the center of the picture is a fault on the silicon diode tube. Heavy rain was falling at these times, but later in the record the strike point was identified as the tower top. Further photographs of lightning to the 1200 foot tower array taken from the trailer are shown in Figures 28a-c. These occurred in May 1975 within a few seconds of one another and there is no doubt that the strike was to the array at the top of the tower. Two minutes later the tape recorder was damaged by a large surge in the remote control line, which ran from the base of the tower, probably indicating another strike. Figure 28c shows much blooming but indicates an upward going leader as a horizontal branch to the west is shown, whereas two frames later when the camera blooming stops it is evident that the main strike is vertical.
