REPORT NAEC-92-131

### AEROSTRUCTURE NONDESTRUCTIVE EVALUATION BY THERMAL FIELD TECHNIQUES

Final Report for Period 17 March 1978 - 17 January 1979  
AIRTASK A3400000/051B/8F41461406

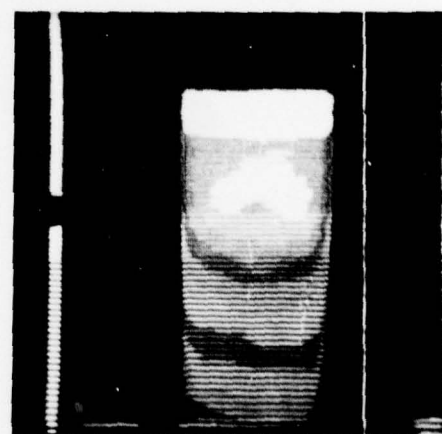
Note: White rectangle at top is the heated top half of main plate; grey area is cover plate on front. Note that only the top two rivets get hot, indicating a loose third rivet and air space between the main plate and cover plate.

FIGURE 10 - DRAWING AND INFRARED PHOTOGRAPHS OF IMPERFECTLY RIVETED ALUMINUM JOINT

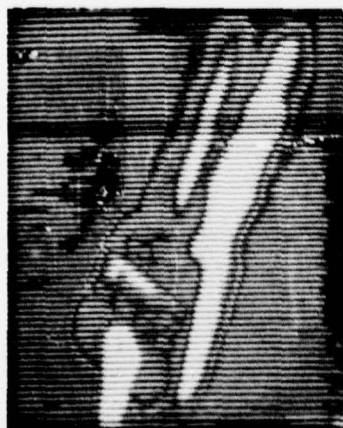
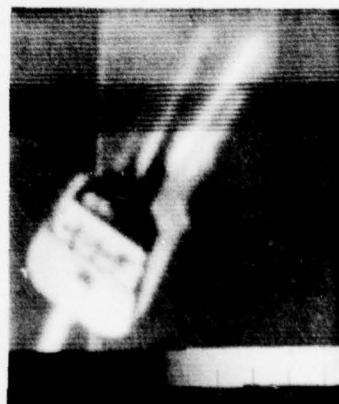
FINGER REFLECTION  
WITH ISOTHERMS

FINGER REFLECTION  
WITH GRAY SCALE

CAR KEY REFLECTION  
WITH ISOTHERMS

CAR KEY REFLECTION  
WITH GRAY SCALE

FIGURE 12 - HEAT REFLECTED FROM UNPAINTED SURFACE  
OF 6061-T6 ALUMINUM SPECIMENS

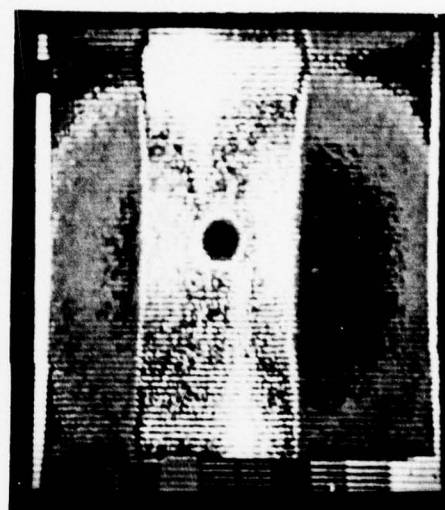
FIGURE 15 - BLACK AND WHITE VERSUS COLOR PHOTOGRAPHS OF COLOR VIDEOSCREEN  
RECORDED DURING SGTf TEST OF [O] GRAPHITE/EPOXY SHOWING "HOT  
SPOTS" ALONG CRACKED SURFACES EXTENDING FROM THE HOLE  
(THE PATTERN IS VISIBLE IN BOTH CASES)

A. VIDEO DISPLAY. Considerably better definition of thermal field perturbations was obtained from the color isotherm screen than from the black and white continuous shade screen. Color was not essential, since flaws appeared as distinctly on the black and white photographs as they did on the color screen. Figure 15 presents a direct comparison of black and white versus color photographs of an SGTf test at  $1^{\circ}\text{C}$  sensitivity. Note that the frictional heat dissipated along cracked surfaces extending from the hole are especially visible in both photographs. It is suggested that alternating black/grey/white strips might be used in place of color to reduce equipment cost.

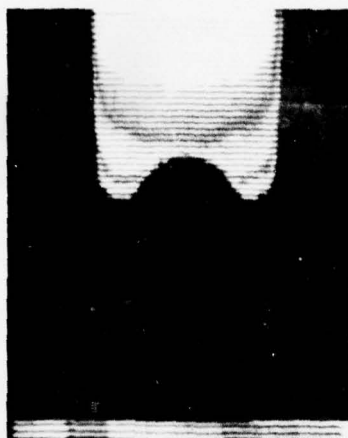
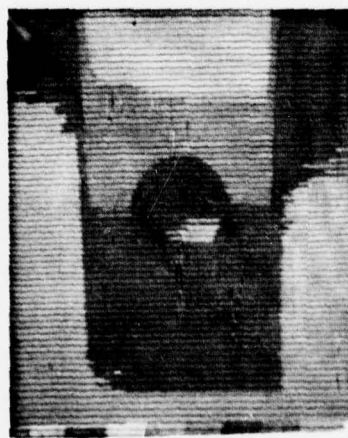
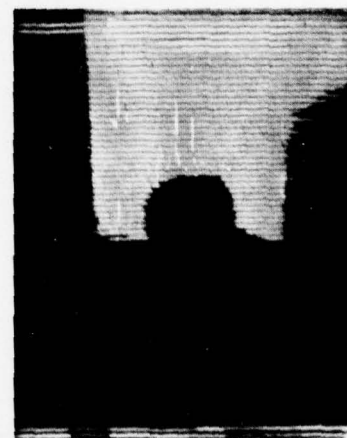
FIGURE 16 - COMPARISON OF VARYING IR CAMERA SENSITIVITY RANGES USED DURING EATF CONDUCTIVITY TESTS OF BLACK PAINTED ALUMINUM WITH 1/2-INCH-DIAMETER THROUGH-HOLE

B. TEMPERATURE SENSITIVITY RANGE. For the types of heat generation techniques used in this study, temperature sensitivity ranges with full-scale readings of 1, 2, and  $5^{\circ}\text{C}$  gave the best identifiable isotherm readouts. A comparison of perturbed isotherms around a 1/2-inch diameter hole in black-painted aluminum for sensitivity ranges of 1 to  $50^{\circ}\text{C}$  is shown in Figure 16. Note that curved isotherms can clearly be seen in the 1, 2, and  $5^{\circ}\text{C}$  ranges; little curvature in the  $10^{\circ}\text{C}$  range, and none in the 20 or  $50^{\circ}\text{C}$  ranges. Although some sensitivity adjustment will be desirable, perhaps the ranges of  $10^{\circ}\text{C}$  and above can be excluded for NDE purposes.
