TECHNICAL REPORT HL-79-17

NAVIGATION CONDITIONS AT THE UPSTREAM APPROACH TO LOCK AND DAM NO. 3 MISSISSIPPI RIVER

Hydraulic Model Investigation

November 1979

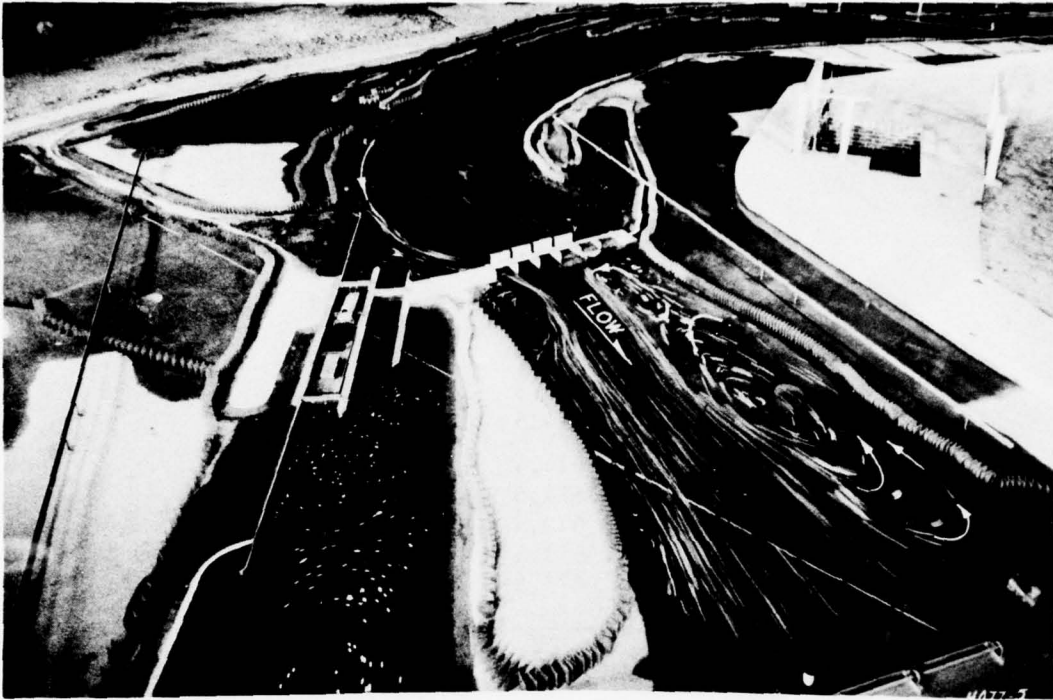
Photo 1. Base test; discharge 36,000 cfs, upper pool el 674.0

a. Surface currents in lock approach and in approach to gated dam

b. Path of 600-ft downbound tow approaching lock guide wall with existing conditions. Note tendency for tow to be moved away from guide wall

24. Because of the set of the currents moving from along the right bank toward the spillway, navigation conditions for downbound tows were extremely difficult and hazardous even with the low flows tested. Downbound tows attempting to approach the guide wall would tend to be moved riverward by currents moving toward the spillway (Photo 1b). Downbound tows reaching the guide wall would tend to have their stern moved riverward unless mooring lines are attached to the wall. Upbound tows leaving the lock would also tend to be moved riverward, but no

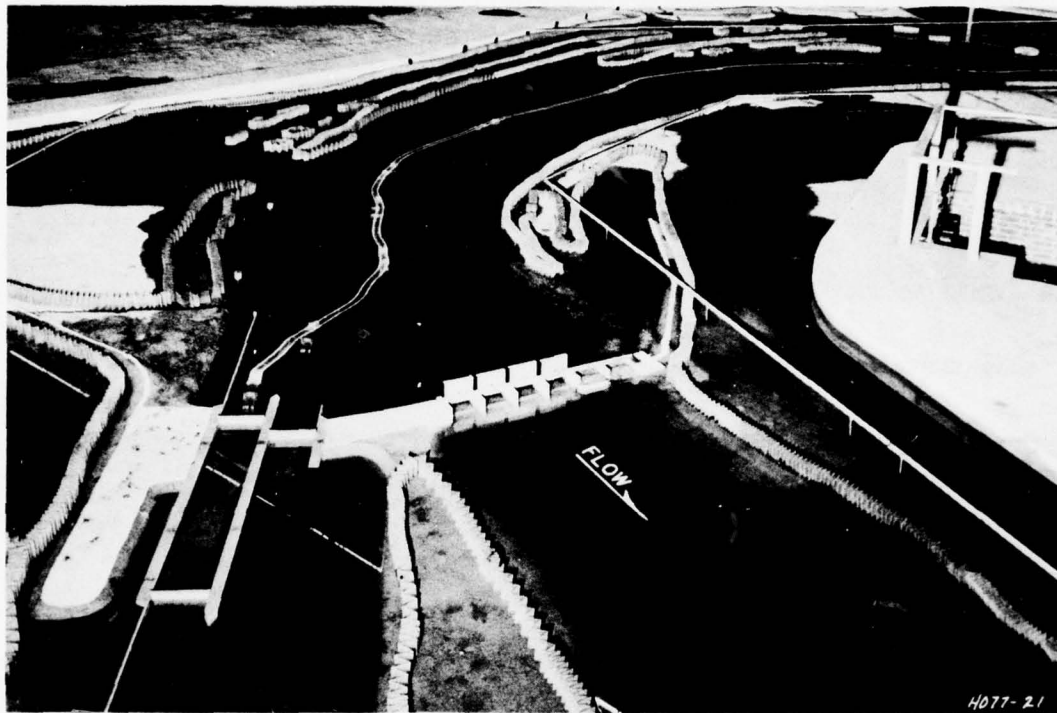
Photo 1 (Sheet 2 of 2)

c. Path of 600-ft upbound tow leaving lock showing effects of crosscurrents on head of tow

serious difficulties were indicated for tows having sufficient power and steerage to overcome the effects of the currents (Photo 1c).

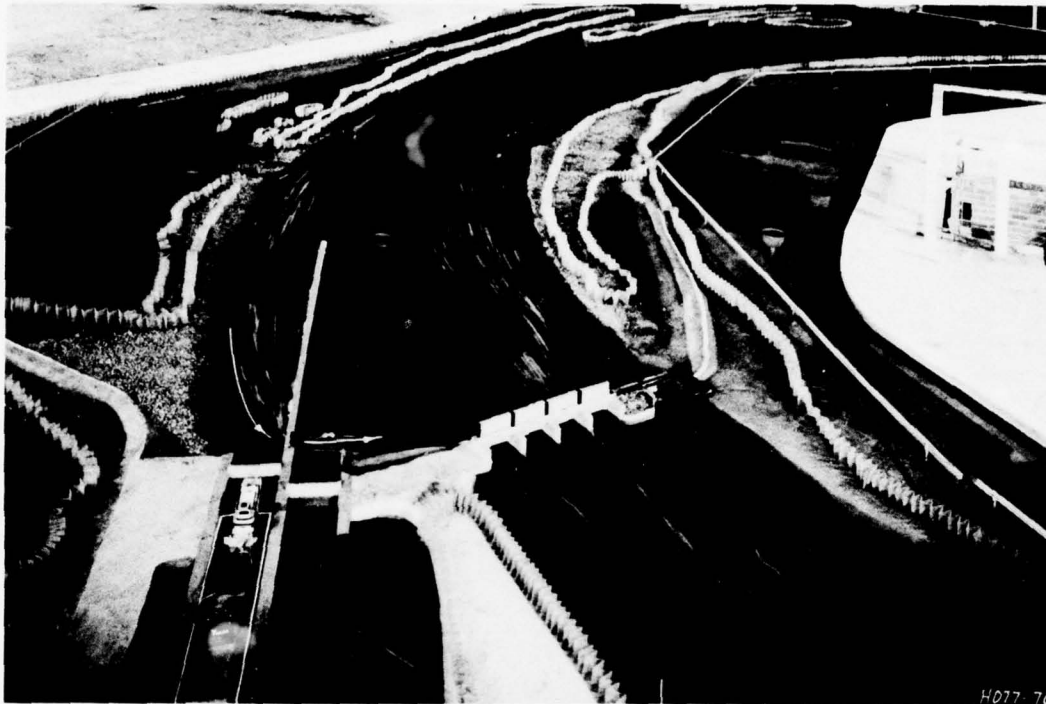
Photo 3. Plan A-modified; discharge 36,000 cfs, upper pool el 674.0.
Surface currents in approaches to lock and dam. Note flow through
the ice gap in upper guard wall

32. With the guard walls of plan A and plan A-modified, there would be a tendency for most of the floating debris and ice moving along the right bank to drift into the lock approach. The ice and debris gap in the guard wall would be effective in passing a considerable amount of flow and most of the loose ice and debris entering the lock approach, particularly with the longer wall (Photo 3).

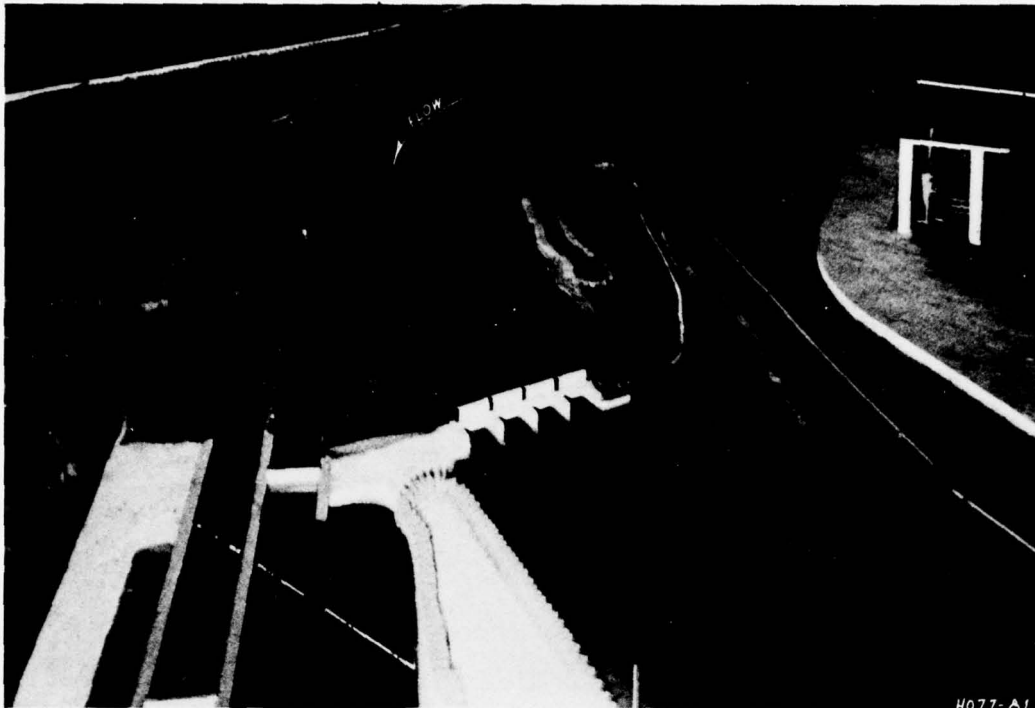
Photo 5. Plan A-modified; discharge 36,000 cfs, upper pool el 674.0

a. Path of downbound 1,200-ft tow approaching lock

b. Path of upbound 1,200-ft tow leaving lock
