# POSTCRASH FUEL FIRE HAZARD MEASUREMENTS IN A WIDE-BODY AIRCRAFT CABIN

Richard G. Hill  
George R. Johnson  
Constantine P. Sarkos

DECEMBER 1979

FINAL REPORT

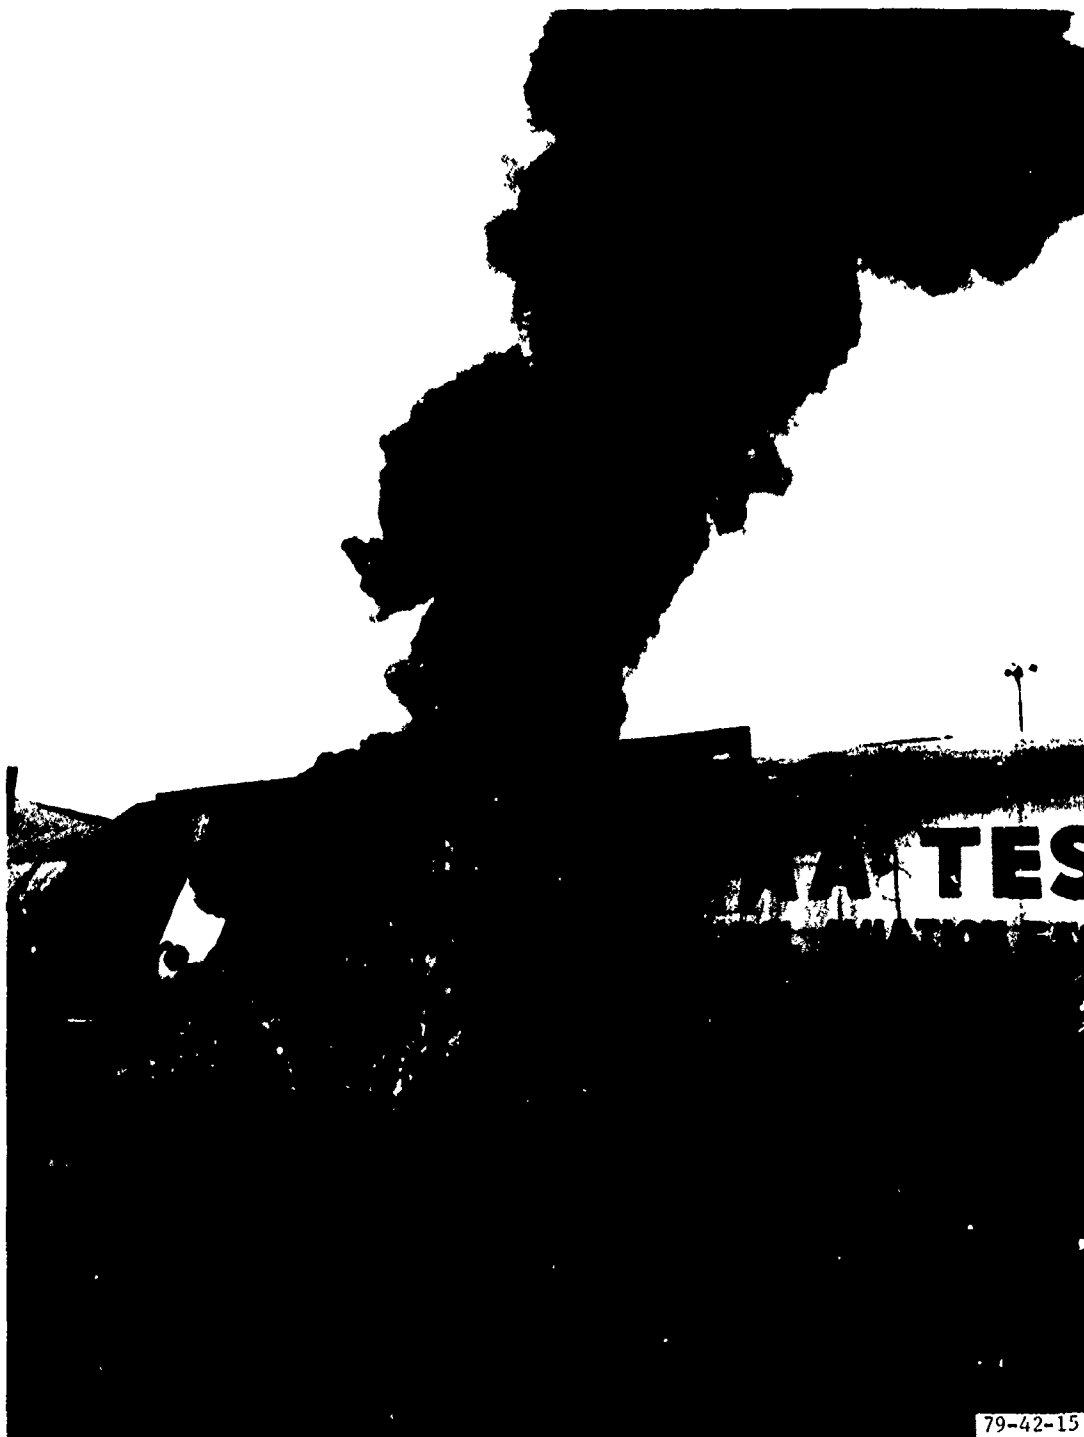
FIGURE 15. TYPICAL TEST FIRE

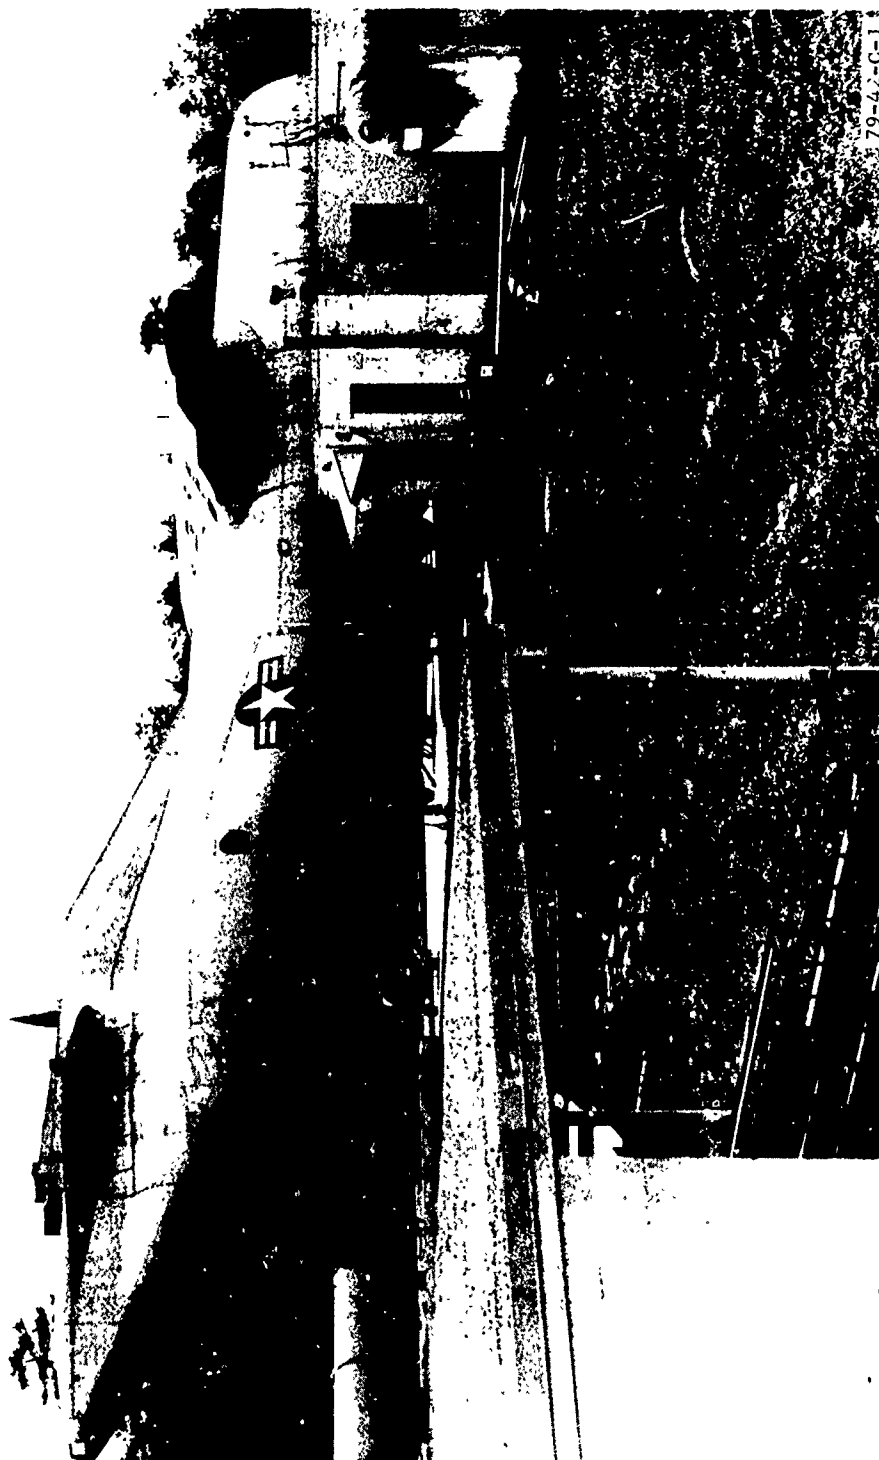
79-42-C-1

FIGURE C-1. C133 TEST ARTICLE

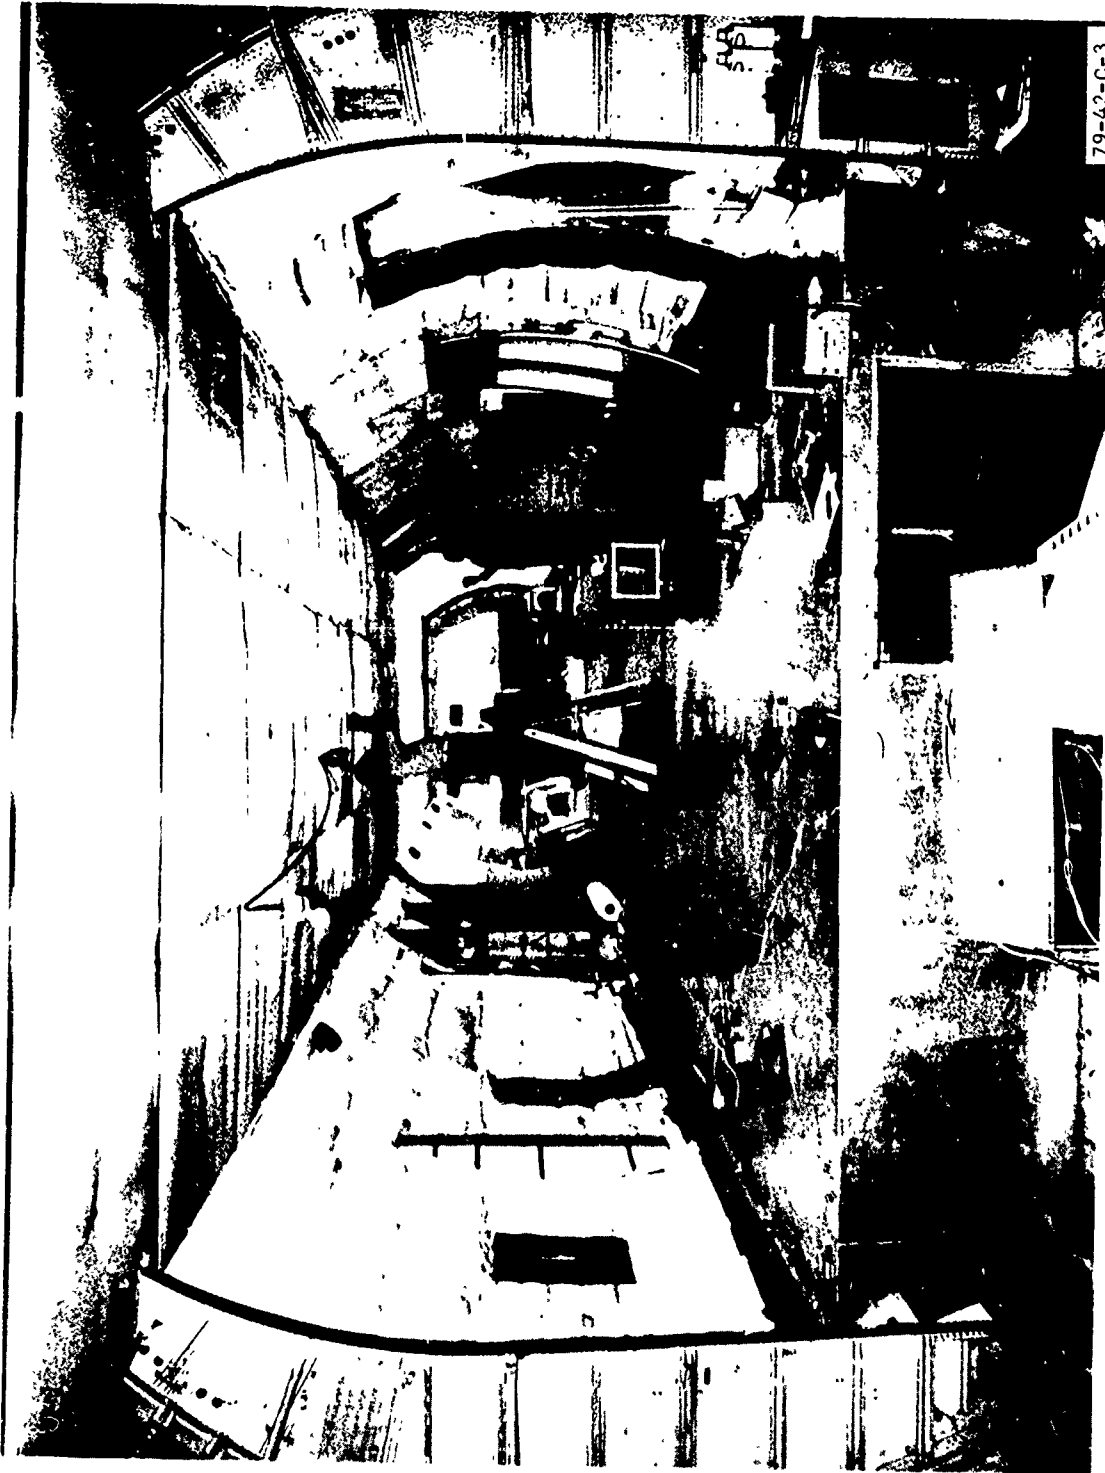
FIGURE C-3. FUSELAGE INTERIOR, AFTER INSTALLATION OF FLOOR AND PROTECTIVE COVERINGS
