LOW SPEED, HARD OBJECT IMPACT ON
THICK GRAPHITE/EPOXY PLATES

Lee W. Gause
Aircraft and Crew Systems Technology Directorate
NAVAL AIR DEVELOPMENT CENTER
Warminster, Pennsylvania 18974

11 MAY 1978

FINAL REPORT
AIRTASK NO. WR02303001
Work Unit No. DG 602

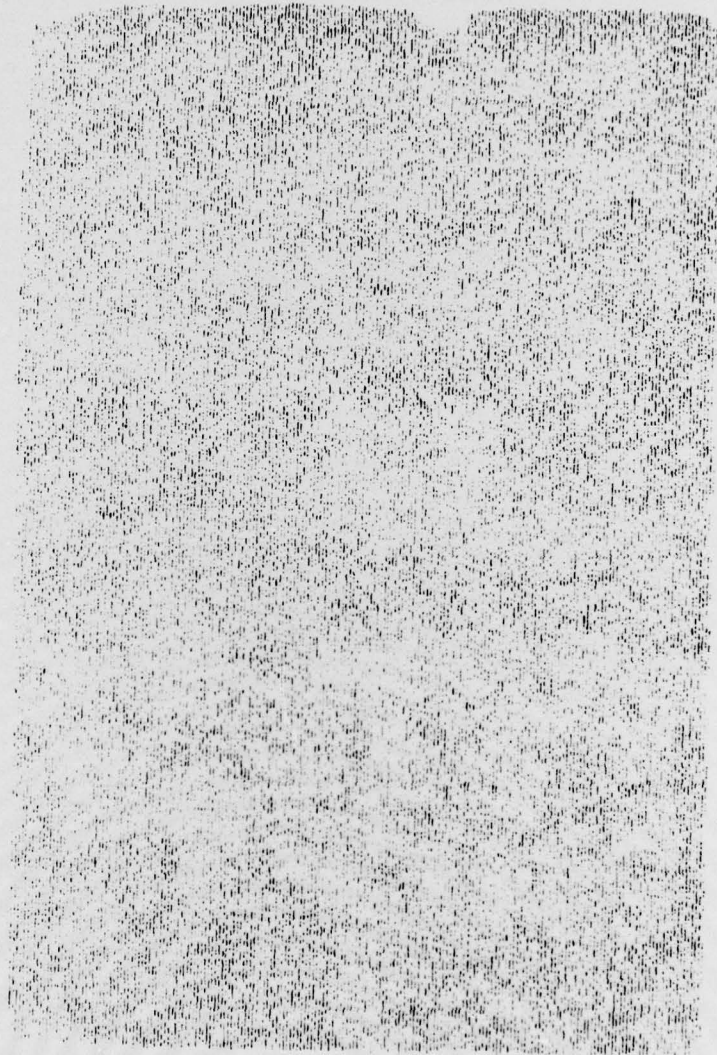
FIGURE 1 - C-Scan of Undamaged Plate.

The ultrasonic inspection technique used throughout this program is to monitor the acoustic amplitude corresponding to a reflection thickness resonance of the back surface echo and use this amplitude to modulate the intensity of a C-scan, reference (c). Using this technique, it was possible to detect delaminations in the laminates as small as 1/8 in. (3 mm) in diameter occurring at any depth throughout the thickness. Figure 1 presents a C-scan for an undamaged plate and figure 2 shows typical delamination damage. Although the C-scan does not record the depth of the damage, the equipment operator can read damage depth from an oscilloscope display of the ultrasonic pulse-time response when this information is needed.

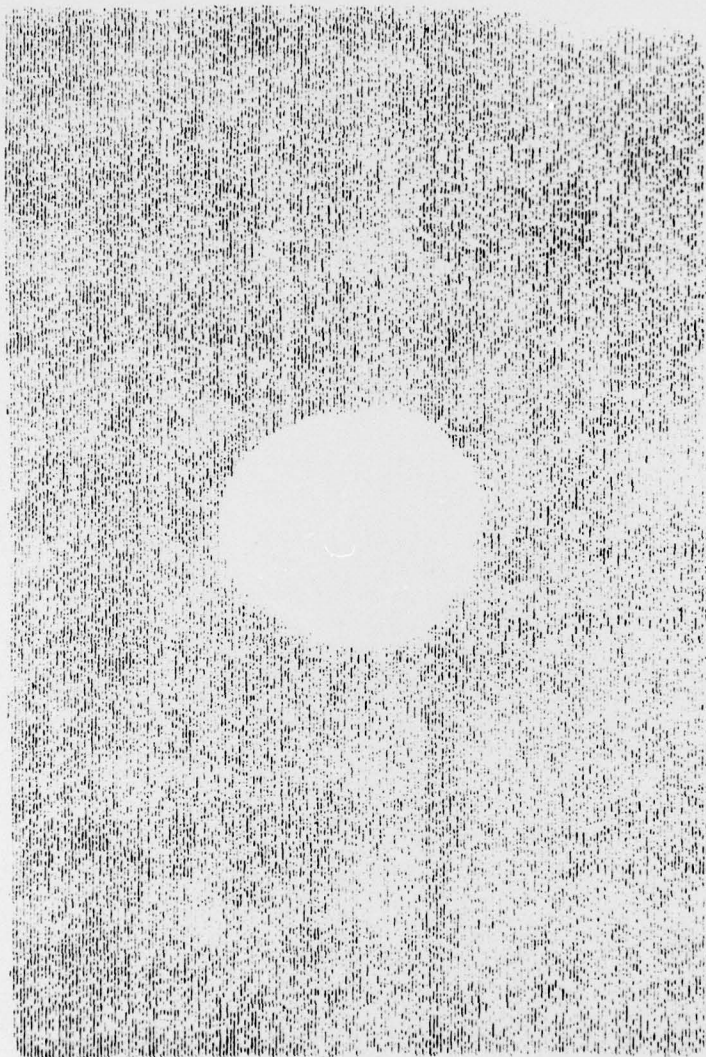
FIGURE 2 - C-Scan of Typical Delamination Damage.

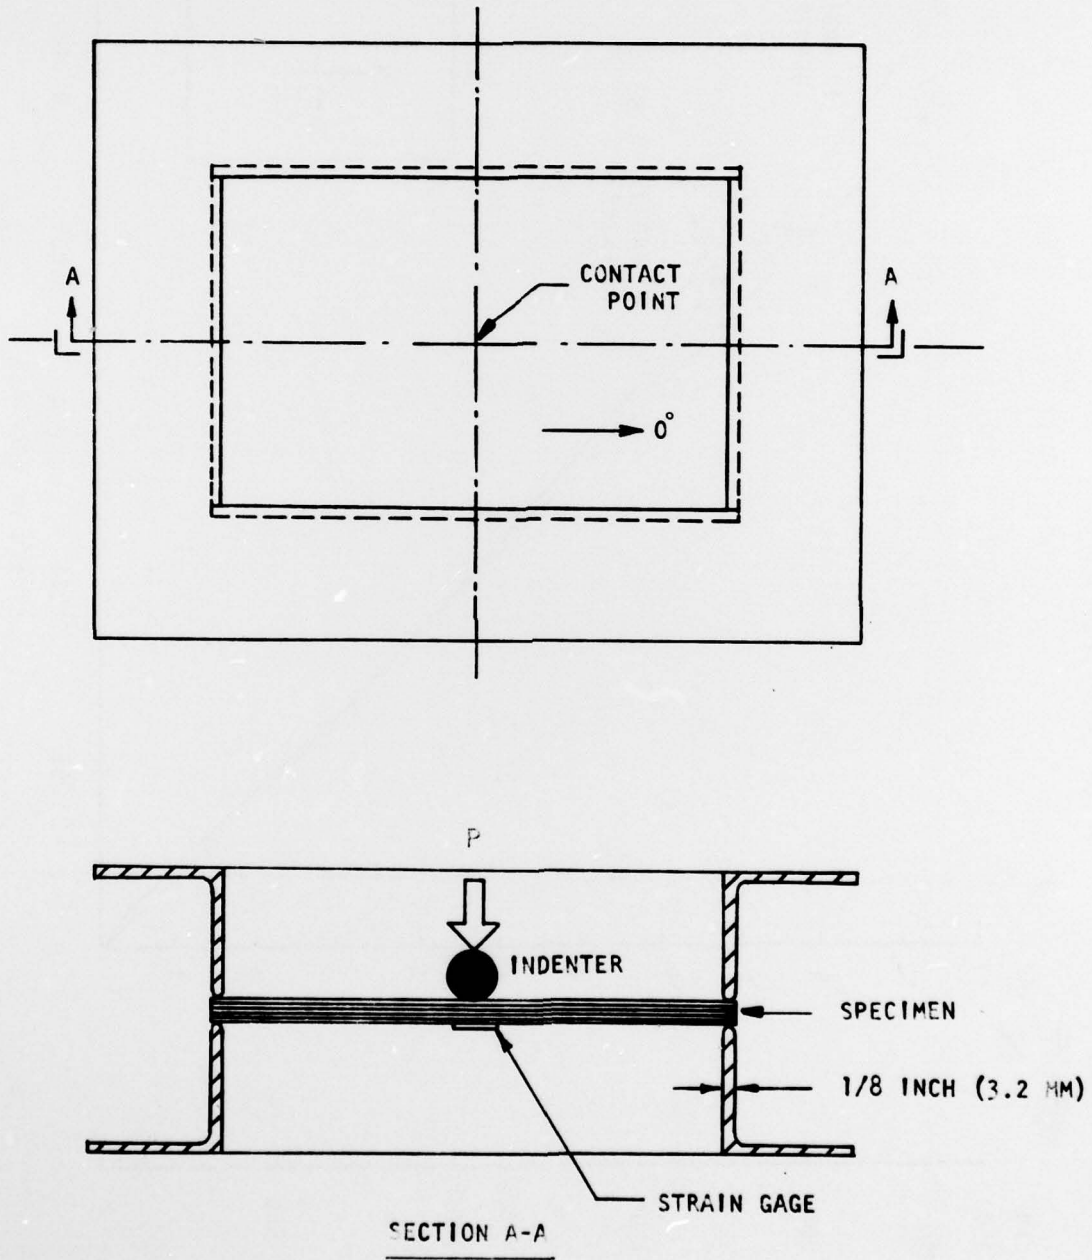
FIGURE 3 - Static Test Set-Up.

Two specimens of laminate B were tested. Each specimen was supported along all edges as a simply supported plate in a rigid frame and a steel indenter was pressed into the center of the plate, figure 3, until damage resulted. Here damage was determined by a loud sound in company with a sudden drop in the load. One test used a 1/4 in. (6.4 mm) radius indenter and the other a 1 in. (25.4 mm) radius indenter. A strain rosette was located on the back face of the specimen opposite the contact point. Figure 4 is a record of the load versus strain during this test. Note that although the flexural response of the two indenters is identical, i.e., both ϵ_x and ϵ_y follow the same strain versus normal load curve, the failure loads are different by 37 percent. Results of visual and ultrasonic inspection are given in table II.

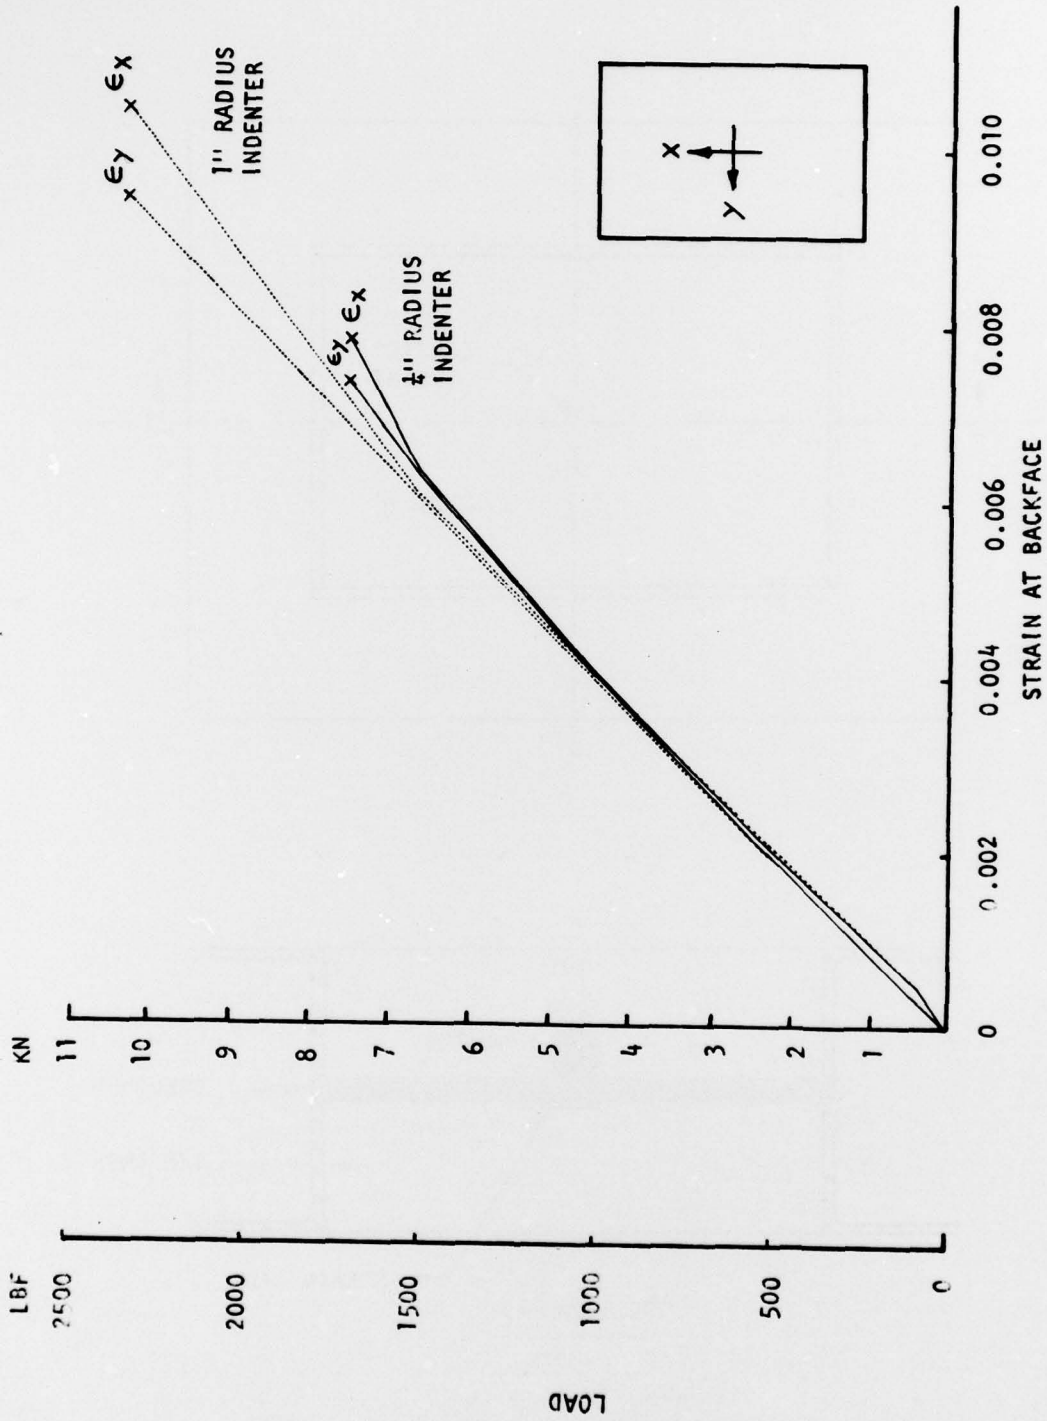
LOAD VERSUS STRAIN FOR STATIC TEST
OF LAYUP SEQUENCE B

FIGURE 4 - Static Test Load vs Backface Strain.

The damage mode resulting from a transverse normal static load on this geometry specimen is clearly a transverse shear failure. The smaller the radius of the indenter, the smaller the normal load required to cause damage. This is due to the larger local transverse shear stress caused by the smaller indenter

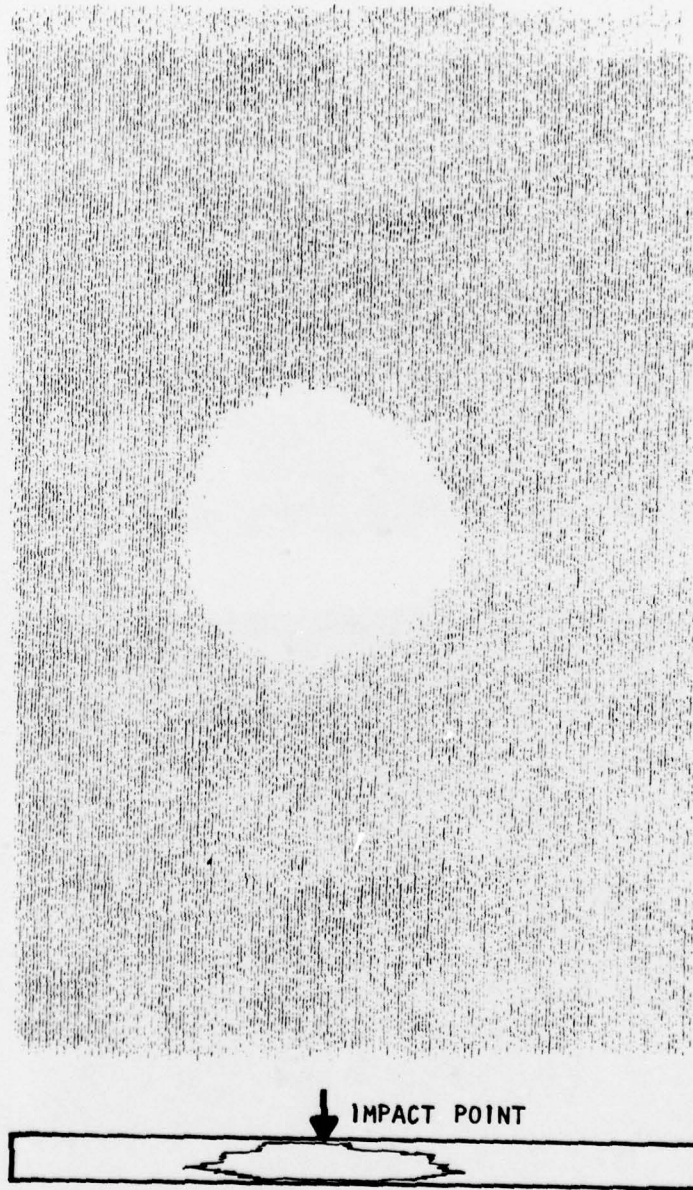
FIGURE 5 - Typical C-Scan of Impact Damage. (48 ply 4 inch x 6 inch simply supported plate impacted by 1/2 inch diameter contactor of 2 LBM dropped from 6.0 feet.)

An impact damage threshold was determined for each layup sequence by incrementally increasing the drop height of a 1 lbm (454 g) indenter until damage could be detected either visually or by ultrasonic inspection. Damage threshold was also determined for laminate B using a 2 lbm (908 g) indenter. Additional impacts were conducted above threshold level to examine impact threat versus damage magnitude relations. Results are presented in table III and figures 5 and 6.

Specimen No.	Impact Mass (LBM)	Drop Height (Ft)	Visual	C-Scan (Length x Width) In.	Impact V = √
A1	1.01	1.00	None	None	
A2	"	2.00	"	"	
A2	"	3.50	"	"	
A1	"	4.00	"	"	
A2	"	6.00	"	Delamination below impact point between 4th and 5th ply 1/4 inch diameter	
A1	2.01	"	Slight back face cracking	(1.63 x 1.56) see figure 5	
A2	"	"	"	(1.81 x 1.50)	
A3	"	"	"	(1.65 x 1.40)	
A4	"	"	Slight front face cracking	(1.75 x 1.30)	
A5	"	"	Slight back face cracking	(1.70 x 1.55)	
A6	"	"	"	(1.85 x 1.55)	
B1	1.00	3.73	None	None	
B1	"	4.11	"	Delamination at 10% depth 1/16 inch diameter	
B2	"	4.85	"	(0.20 x 0.14)	
B1	"	5.61	"	(0.50 x 0.48)	
B3	2.00	1.50	"	None	
B3	"	1.63	"	"	
B3	"	1.75	"	"	
B3	"	2.00	"	Delamination at 10% depth 1/16 inch diameter	
B1	"	4.11	"	(2.06 x 2.15)	
B4	"	"	"	(0.10 x 0.12)	
B5	"	"	"	(1.30 x 1.38)	
B6	"	"	"	(1.30 x 1.45)	
B7	"	"	"	(1.70 x 1.90)	
B8	"	"	"	(1.50 x 1.75)	
B9	"	6.00	Slight back face cracking	(1.64 x 1.95)

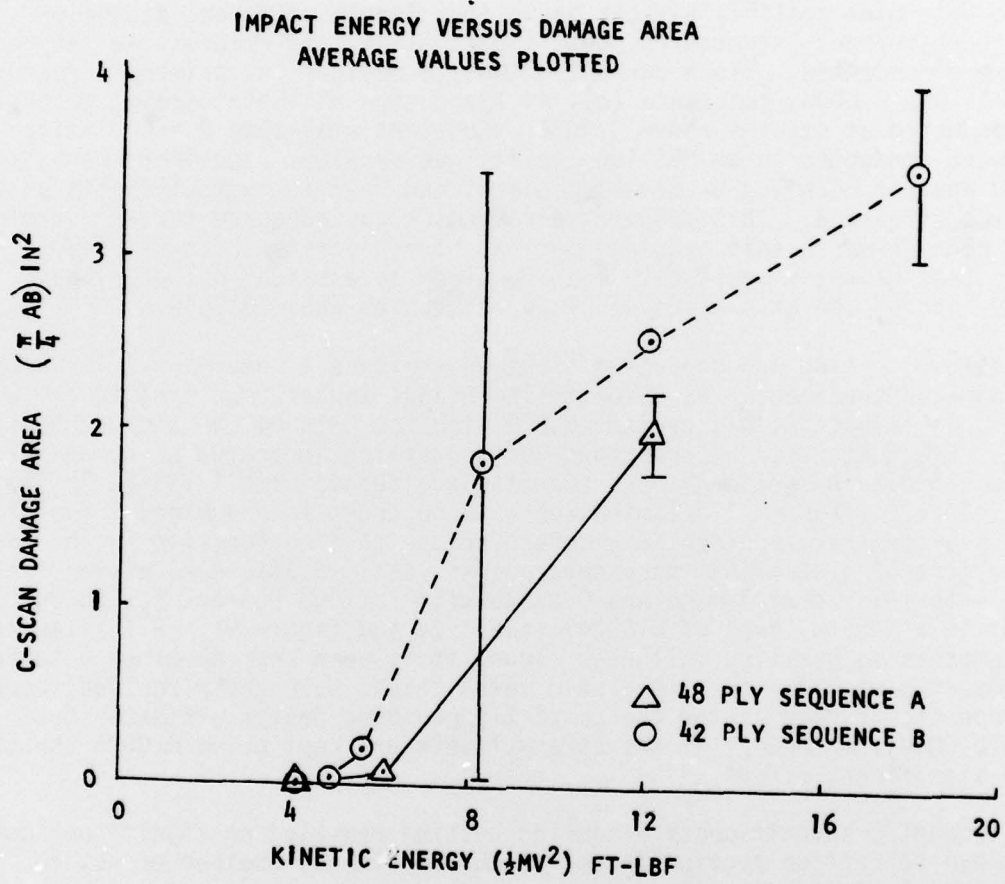
FIGURE 7 - Impact Engery vs Damage Area. (1/2 inch tip diameter dropped weight test.)

Figure 7 is a plot of damage area versus impact energy. The laminates experience no effects from impacts up to approximately 5 ft-lbf (6.8J) when the slight incipient damage occurs. Increased energy impacts result in greater damage. Experimental scatter in damage areas, particularly the 8.22 ft-lbf (11.1J) impacts on B laminates, was extreme. An examination of the location in the original panel from which the specimens were extracted showed that the specimen possessing the greatest impact resistance was taken from the central portion of that panel and was thus the most uniform in thickness and properties, and the specimen suffering the greatest damage was extracted from a corner of the original panel. These results accent the need for careful layup and cure of advanced composite materials to ensure uniformity of properties and high quality for the finished part.

Examination of the impact energy versus damage area for both laminate A and B indicates laminate A to sustain less damage than laminate B. In both laminates impacts less than 12.0 ft-lb induced no visible front face damage with back face damage apparent at 12.0 ft-lb impacts. In laminate B the 18.0 ft-lb impact resulted in an obvious (but small) dent at the impact point with extensive back face cracking.

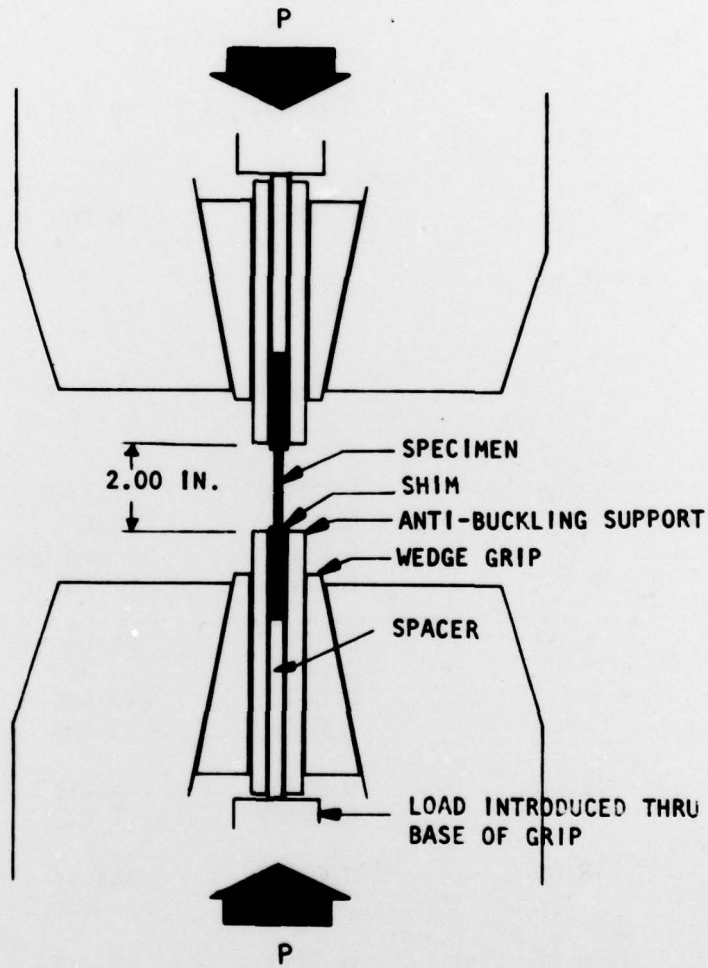
FIGURE 8 - Compression Fatigue Test Grip Arrangement.

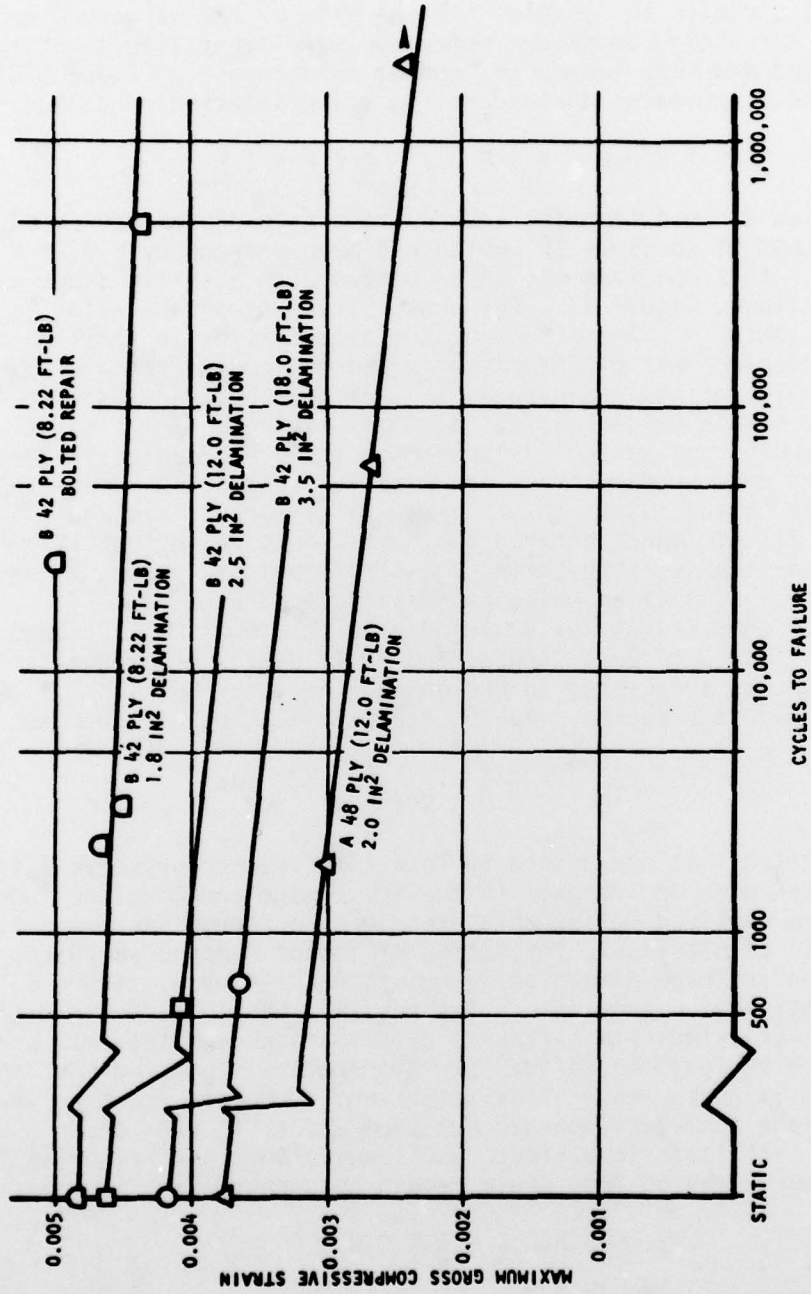
FIGURE 9 - Life to Failure.

Laminate B specimens were fatigue tested with damage caused by 8.22, 12.0, and 18.0 ft-lb energy level impacts. Results are presented in table IV and figure 9. Although the B laminates sustained larger C-scan damage areas than the A laminate for equivalent impacts, laminate B is more tolerant of the damage. The laminate B static compressive strains for all damage levels tested were above the 0.0040 maximum ultimate design strain level. Although these tests were conducted to constant amplitude fatigue, some conclusions can be made about the ability of the laminate to function with impact damage in an actual aircraft structure. If we assume that the low load cycles can be truncated in the flight by flight NAVAIR fatigue spectrum used in the structural validation testing of the AV-8B composite wing design, (a very severe spectrum) and that the only number of maximum load cycles are important to the fatigue life of the laminate,

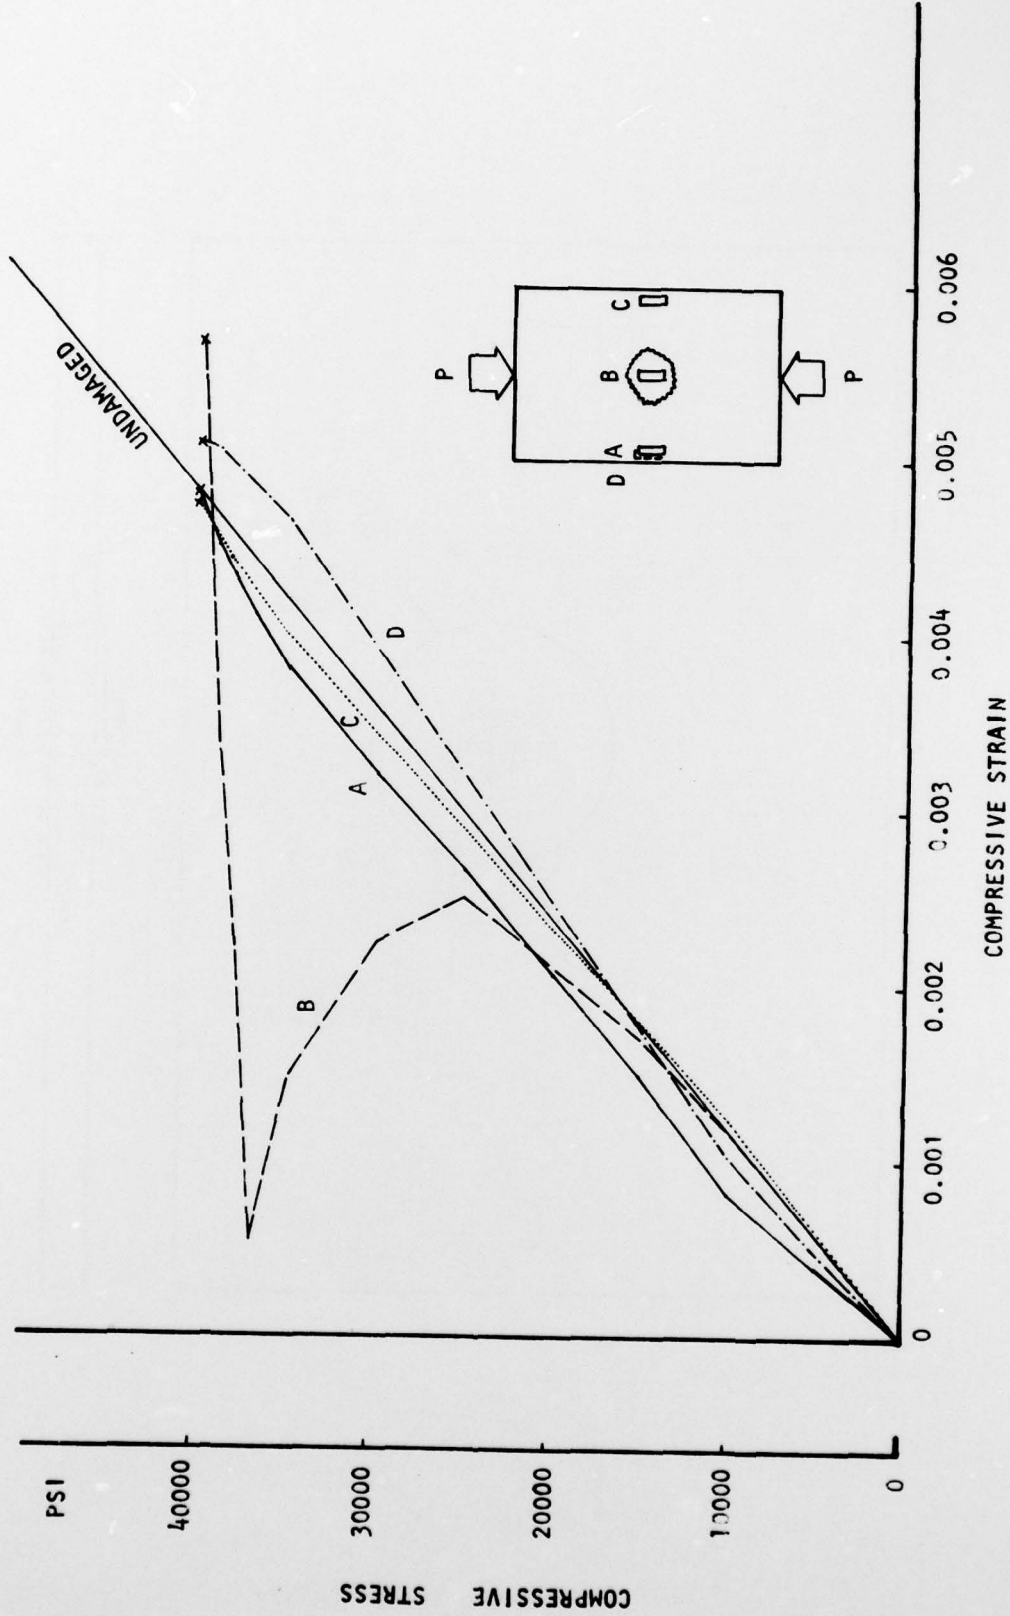
STATIC COMPRESSIVE STRAIN TO FAILURE FOR 42 PLY LAMINATE DAMAGED BY 3.22 FT-LB IMPACT.

FIGURE 10 - Static Test of Damaged Specimen.

The mechanism of load transfer around the damage region was examined during the static test of specimen B5, which had been damaged by a 8.22 ft-lb (11.14J) impact. This specimen was instrumented with a strain gauge array and loaded to failure, figure 10. The gross stress-strain behavior is the same as an undamaged laminate. The effect of the delamination is to allow transverse (out-of-plane) displacement of the plies in the damaged region and therefore allow local buckling of the laminate as is indicated by appearance of the failed specimen and the strain gauge readings directly over the impact point. It appears that the sub-visual damage (delaminations) did not damage the graphite fibers. Failures under compressive load results from matrix damage and the resultant inability of the matrix to stabilize the fibers. This would suggest that a possible fix of impact damaged laminates would be to stabilize the laminate against local transverse buckling. A simple bolted repair, figure 11, was tried on a laminate B specimen which had been damaged by an 8.22 ft-lb impact. This specimen was then successfully cycled at a strain of 0.0050 (20 percent greater than the static failure strain) for 26417 cycles before failure, indicating the repair was successful in preventing the local buckling of the graphite fibers in the damage region. Again, frequent NDI inspection revealed no damage growth.

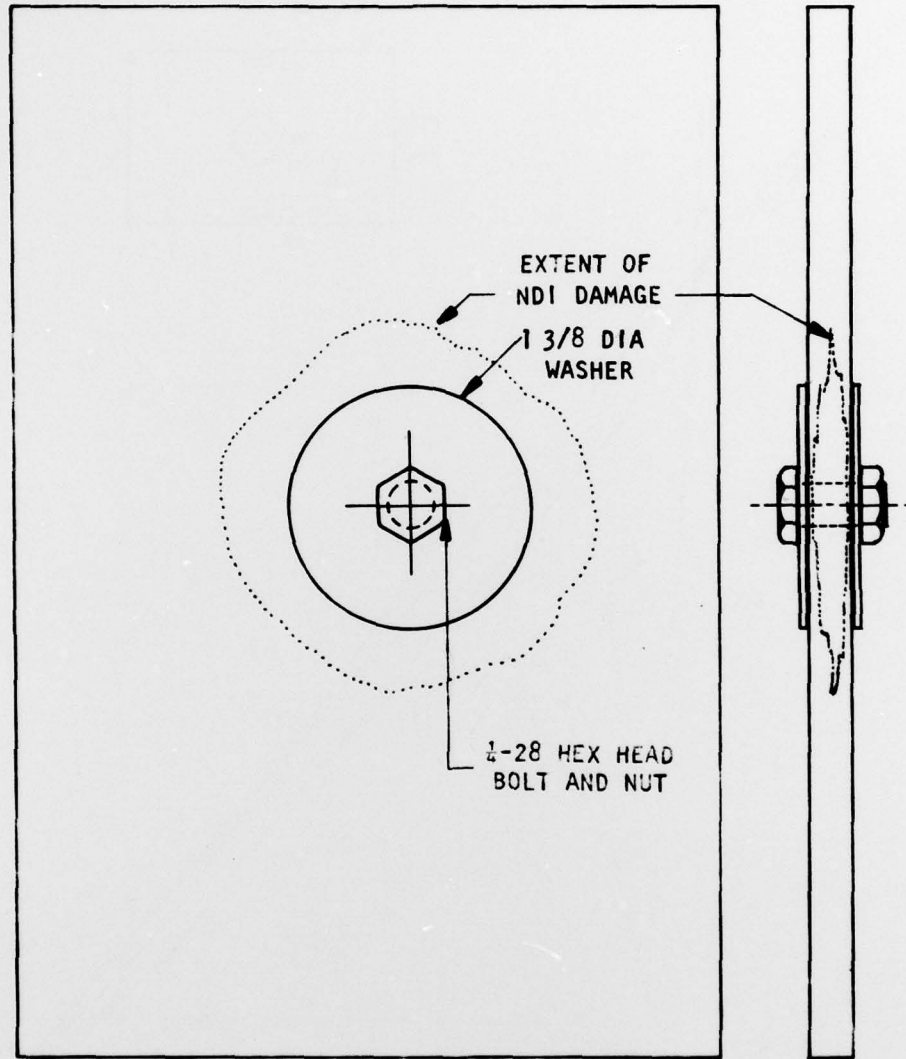
FIGURE 11 - Simple Bolted Repair.

Specimen	Impact Energy 1/2 mv ² (ft-lb)	Maximum Gross Compressive Strain	Cycles to Failure (at 1.5 Hz)	Comments
A5	None	0.00559	Static + [*] _{**}	No Effect - Validate Test Fixture
A2	6.06	0.00400	10 900 +	No Effect - Retested at Highest Strain
		0.0050	10 000 +	No Effect
A1 A2	12.06	<.0040		Specimens Acci- dentally Destroyed due to Fatigue Machine Mal- function
A3	12.06	0.00378	Static	
A4	"	0.00300	1836	Slight Damage
A5	"	0.00243	2 000 000 +	Growth (<1/16 in.)
A6	"	0.00270	61 255	
B5	8.22	0.00482	Static	See figure 10
B6	"	0.00452	3 069	
B7	"	0.00438	496 509	
B8	"	0.00465	2 184	
B9	12.00	0.00463	Static	
B10	"	0.00407	533	
B4	18.00	0.00417	Static	
B2	"	0.00367	655	
B1 Repaired	8.22	0.00500	26 417	See figure 11

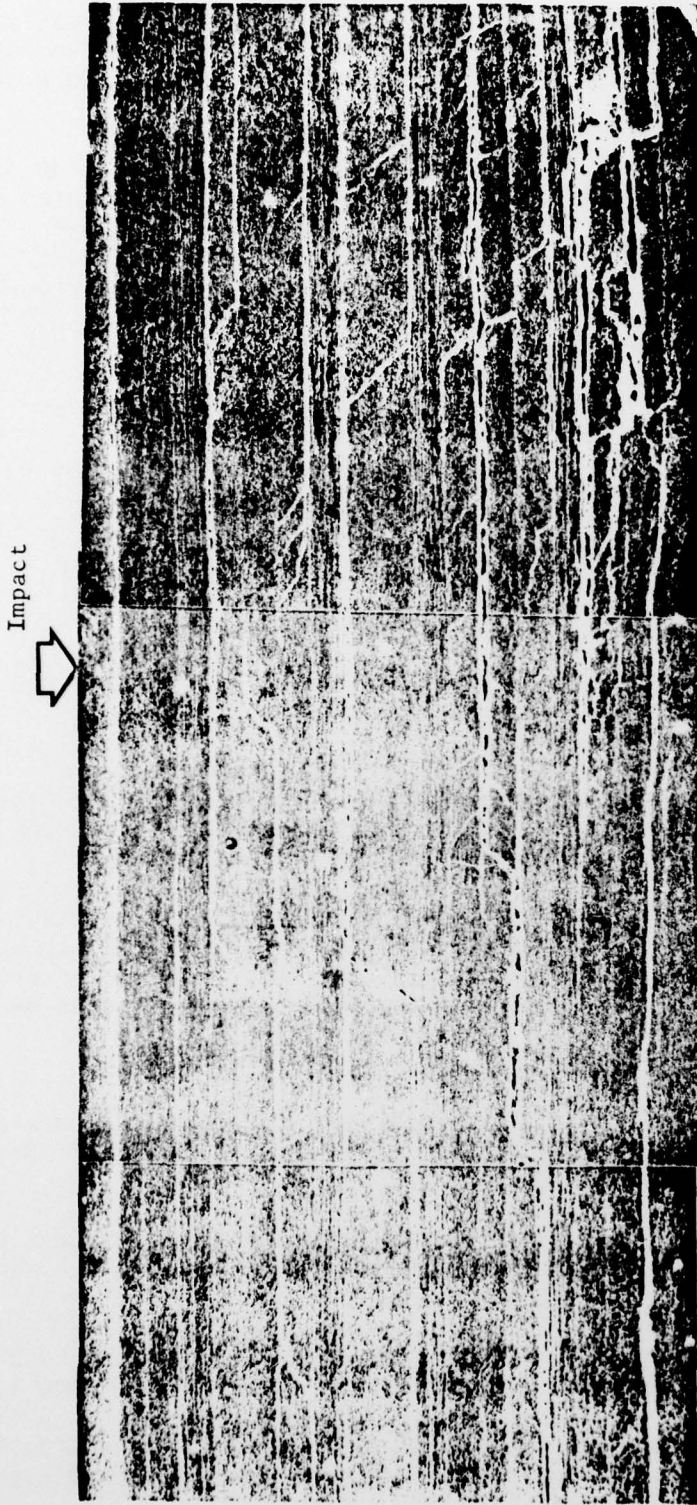
Panel 901-5, Location D
16 Plies Gr/Ep [($\pm 45/0/90$)₂]_s
Blunt Impactor at Center of 5 inch Square Area
Total Absorbed Energy = 2.41 ft. lbs.
(Incipient Damage Indicated at 1.93 ft. lbs)
Damage Not Visible on Impacted Surface
Slight Matrix Crack on Back Face

FIGURE 12 - Photomicrograph of Impact Area of 16 Ply Panel 901-5 (D)/
(From reference (f)).
