DDA-EDR-9990

**HIGH-TEMPERATURE RADIAL TURBINE DEMONSTRATION**

Donald S. Monson, B. A. Ewing  
DETROIT DIESEL ALLISON DIVISION  
General Motors Corporation  
Box 894  
Indianapolis, Ind. 46206

**Final Report for Period 15 June 1977 - 15 November 1979**

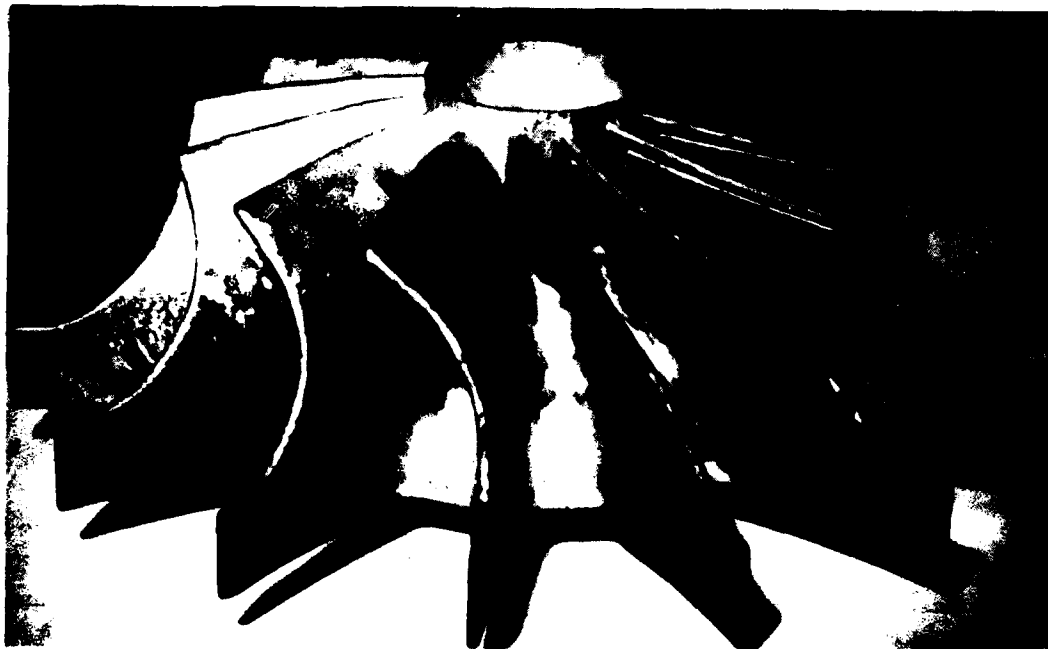
Figure 53. Side view of macroetched No. 1 airfoil casting.  
(Excellent fill was achieved in this casting.)

The pouring conditions for this assembly were modified slightly from those used for the first wheel assembly in an attempt to achieve a finer and more uniform grain by lowering the mold and pour temperatures from 2000°F to 1950°F and from 2900°F to 2850°F, respectively. As shown in Figures 51 through 54, a grain size refinement was achieved; however, reduced fluidity caused misruns in five airfoils.

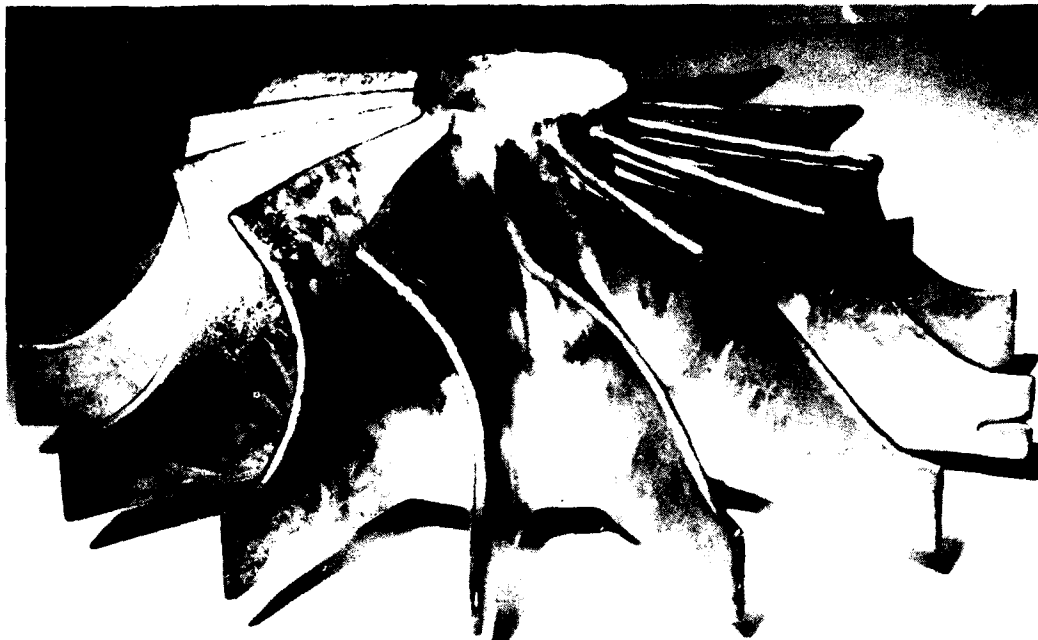
Figure 54. Side view of macroetched No. 2 airfoil casting showing misrun in inducer vane location.

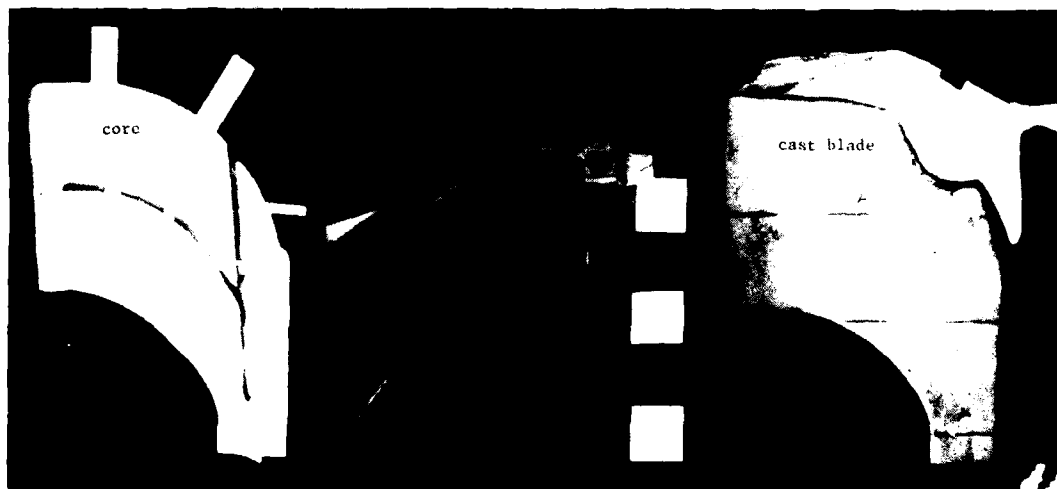
Figure 55. Typical airfoil cross sections from airfoil casting No. 2 (shows cooling channels).

Figure 55 is a typical cross section of one of the airfoils from this casting and shows the complexity and uniform wall thickness of the airfoil.

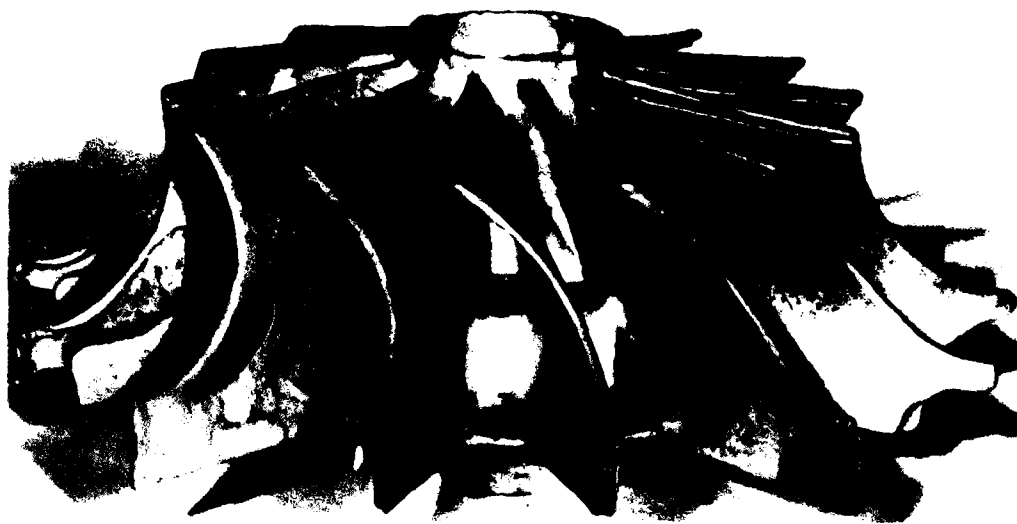
Figure 57. Side view of macroetched No. 3 airfoil casting.

As is indicated by Table 5 and Figures 56 and 57, gross misrun occurred in casting 3 because too low a mold temperature was used inadvertently. (A mold temperature of 2000°F was to have been used; however, thermocouple records indicated that the mold temperature was 1925°F.) As with the first two castings, wall thicknesses were ultrasonically determined for nine locations on each blade. As indicated in Table 6, the wall thickness varied significantly between locations G and H where the thicknesses would have been expected to be nearly the same.

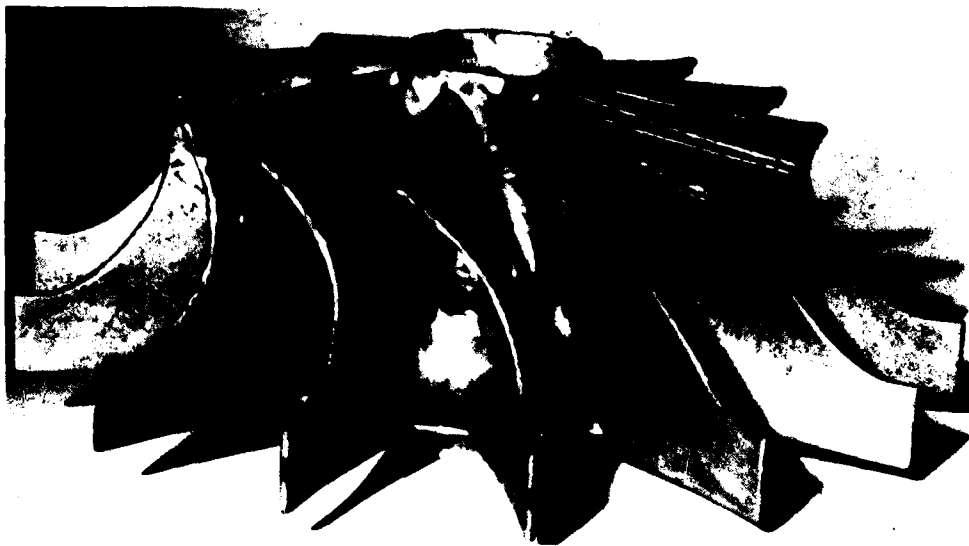
Figure 61. Side view of No. 5 airfoil casting.

The pour rate for casting 5 was slowed from that of casting 4. The intended effect of the slower pouring rate was to provide a "gentler" metal stream so as to lessen the possible disturbance to the airfoil cores. The other pouring parameters remained the same as for casting 4, which exhibited good fill characteristics. As shown in Figure 61, the result for casting 5 was a single defect in the convex surface of one airfoil similar to the apparent kissout observed in casting 4. Wall thickness data in the problem area (G) were generally improved over those for castings 3 and 4; however, the improvement apparently was not sufficient to keep the core from flexing during pouring.

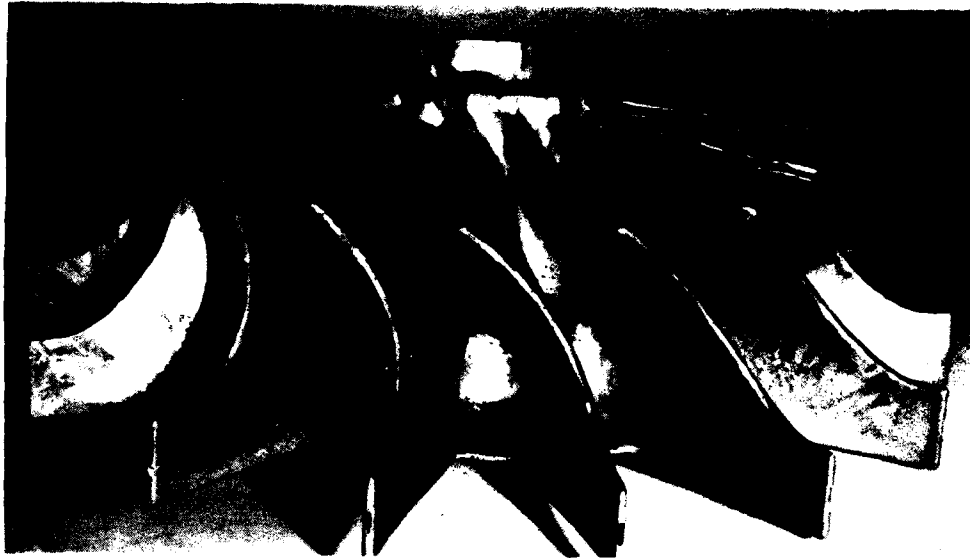
Figure 62. Side view of No. 6 airfoil casting.

The result for casting 6 was again a kissout in one of the blades. Figure 62 shows the casting with a core kissout on the convex side of one blade. As with casting 5, the wall thickness data were generally improved over those of castings 3 and 4; however, core instability appeared to have occurred during pouring.

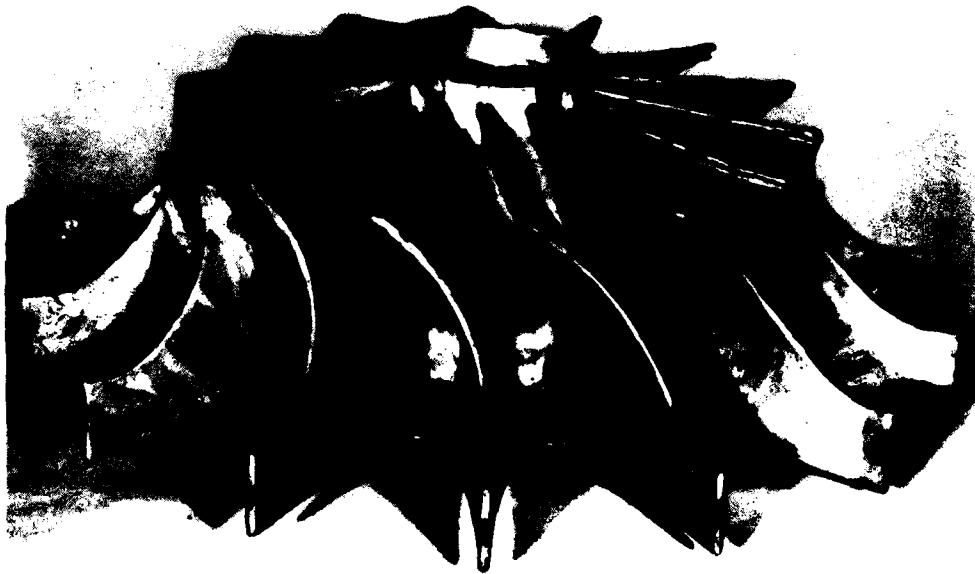
Figure 63. Side view of No. 7 airfoil casting showing good fill and core stability.

Pouring parameters for casting 7 were identical to those of casting 6. They resulted in an excellent casting, free of kissout and possessing good surface quality, as shown in Figure 63. Wall thickness checks (Table 6) were very satisfactory and showed good consistency. Especially notable is the consistency of wall thicknesses in location G where previous kissouts had surfaced. The reduced scatter of wall thicknesses in location G (0.006 in.) indicates a greatly improved core stability and is attributable to the added ID core printout. The ID printout in the conical surface is shown in Figure 64.

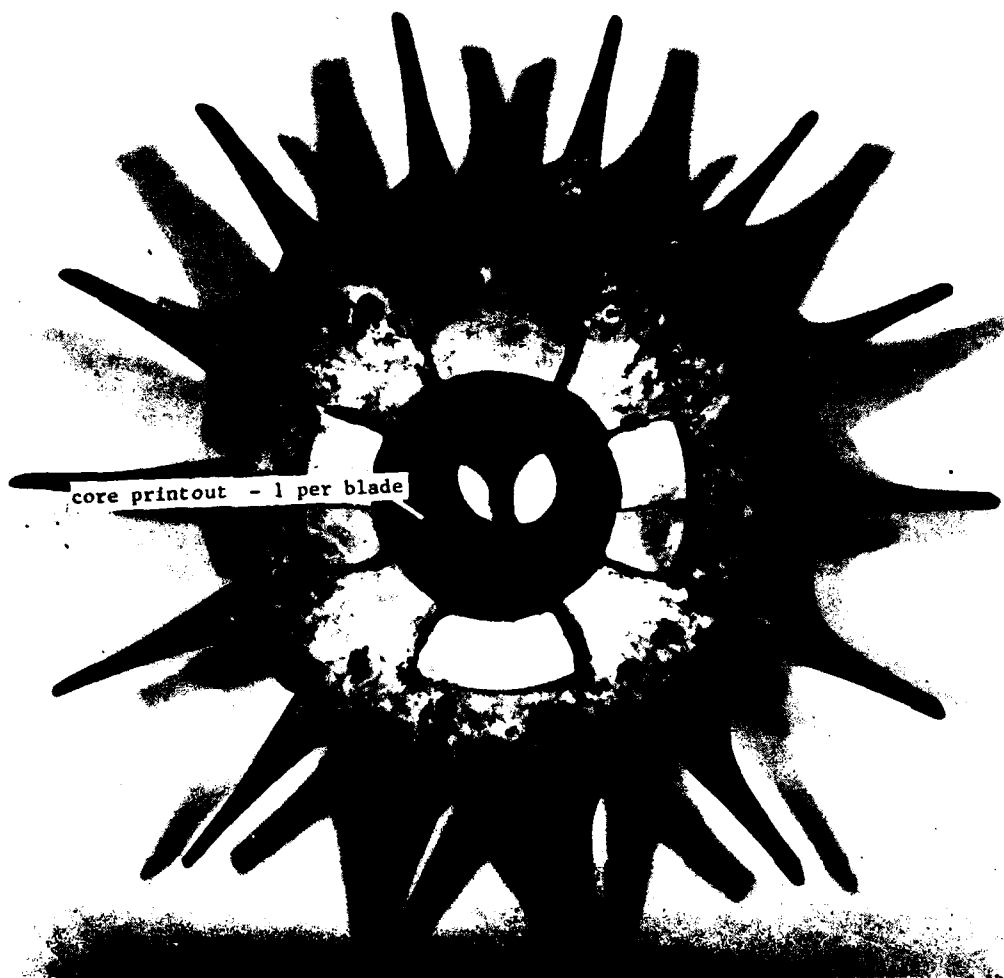
Figure 64. Airfoil casting No. 7 conical ID printout.

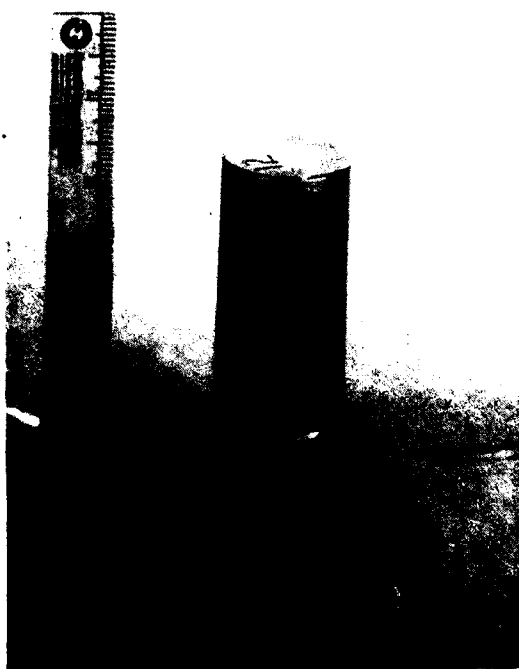
Figure 67. Powdered metal plug.

For this purpose 11 metal can HIP-consolidated PA101 preforms were obtained from the Udimet Powder Metals Division of Special Metals Corporation. The configuration obtained is shown schematically in Figure 66; the composition and sieve analysis of the material are listed in Appendix A. Photographs of the canned and fully machined appearance of the PA101 plug are shown in Figure 67. Upon receipt at DDA, the material was fluorescent penetrant and sonic inspected and judged to be acceptable. Following the NDT work, thermally induced porosity (TIP) tests and microstructural checks were run on samples cut from each of the PA101 plugs. A flat pancake, approximately five inches in diameter and one inch thick, representative of the same master heat and consolidation practices employed for the plug, was also TIP tested. It was also heat treated to a cycle consisting of 2 hours at 2050°F, gas fan cooled to room temperature, 24 hours at 1600°F, and air cooled to room temperature. Specimens from the pancake were then evaluated for tensile and stress rupture capability.

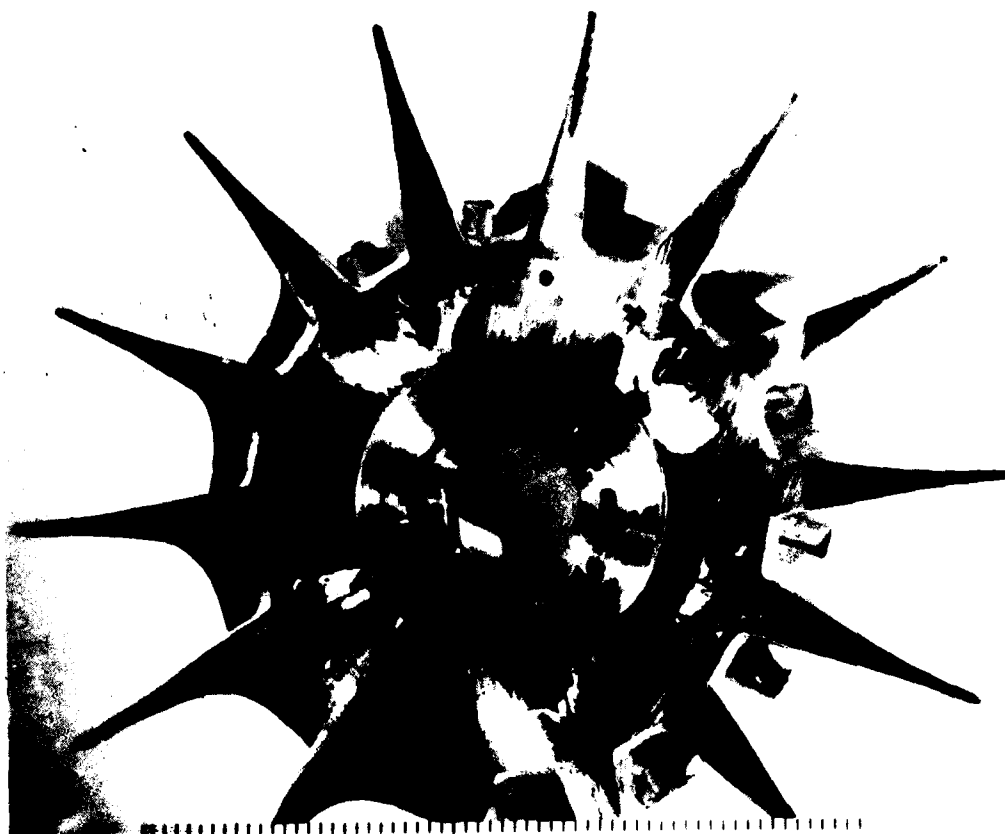
Figure 82. Rotor No. 4 rough machined showing three plugs prior to insertion into printouts.

The casting (No. 7) for rotor 4 was cast with full conical surface ID core printouts which had been ground to identical rectangular dimensions prior to wax injection to facilitate uniformity in the plugging operation. Prior to plug brazing, the ID surface was rough machined to 0.020 mil over finish dimension. This allowed for a small amount of finishing stock in the casting to accommodate removal of the excess braze and to finish the rotor ID to its final dimension. The plugs used for rotor 4 were cut from a bar of Mar-M247 alloy which was ground to leave approximately a 0.003-inch gap per side for braze fill. As with rotor 3, a series of laser pips were then tacked on each plug to maintain a uniform fit in the printout, and a wire retainer was tack welded on the end of each plug. Figure 81 shows several plugs with laser "pips" and wire retainers. Following an acetone bath to remove surface contamination, the plugs were inserted into the rotor (Figure 82), Mar-M247 braze alloy was applied over the inserted plugs, and the 2225°F (30 min) + 2000°F (10 min) + 2100°F (60 min) vacuum braze cycle was performed. The appearance of the brazed rotor is shown in Figure 83 and again in Figure 84 following the final grind to finish dimension. Following the finish grind, the shell was placed in the vacuum outgas cycle (2100°F, 1 hr) along with the plug to prepare the mating surfaces for assembly. However, the surfaces of the pieces in the furnace load became coated with a smut-like film resulting from contamination from the residual core. The mating surfaces were hand polished and re-outgassed to a satisfactory condition.

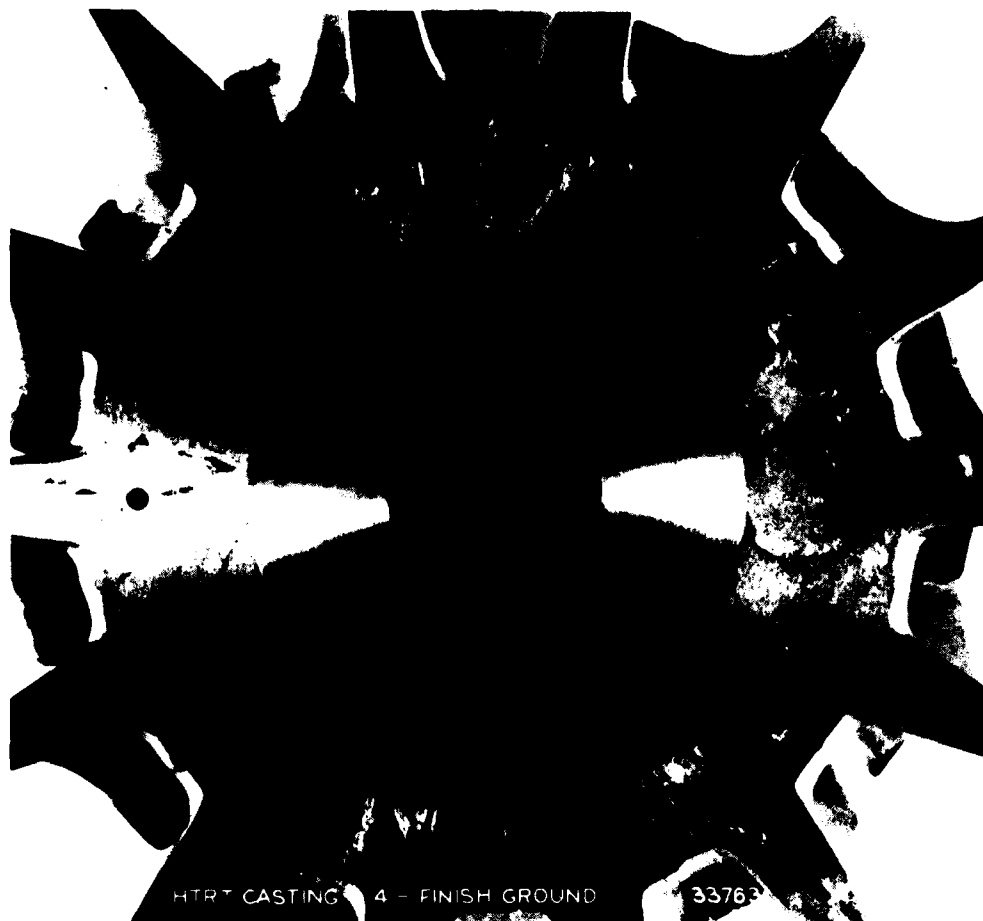
Figure 84. Rotor No. 4 following grinding operation in which excess braze was removed and the surface ground to final dimension.

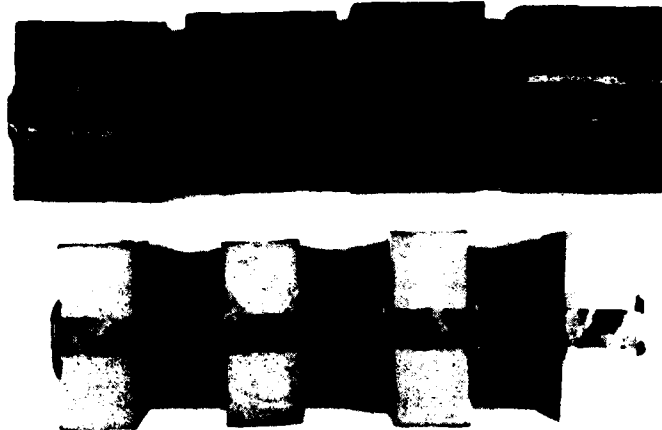
Figure 94. Weld coupons (left to right) OG-3, OG-1, AG-2, AG-1.

In anticipation of additional bond separations, the three remaining coupons were leak checked. Coupon AG-2 indicated leaks, but OG-1 and OG-3 appeared to be good. The three coupons were then halved, similar to AG-1, and evaluated at the bond joint. Figure 94 shows the four weld coupons polished and etched. Coupon AG-2 revealed intermittent bonding in the bond joint and total separation of approximately 0.050 inch immediately below three of four welds. The outgassed weld coupons, OG-1 and

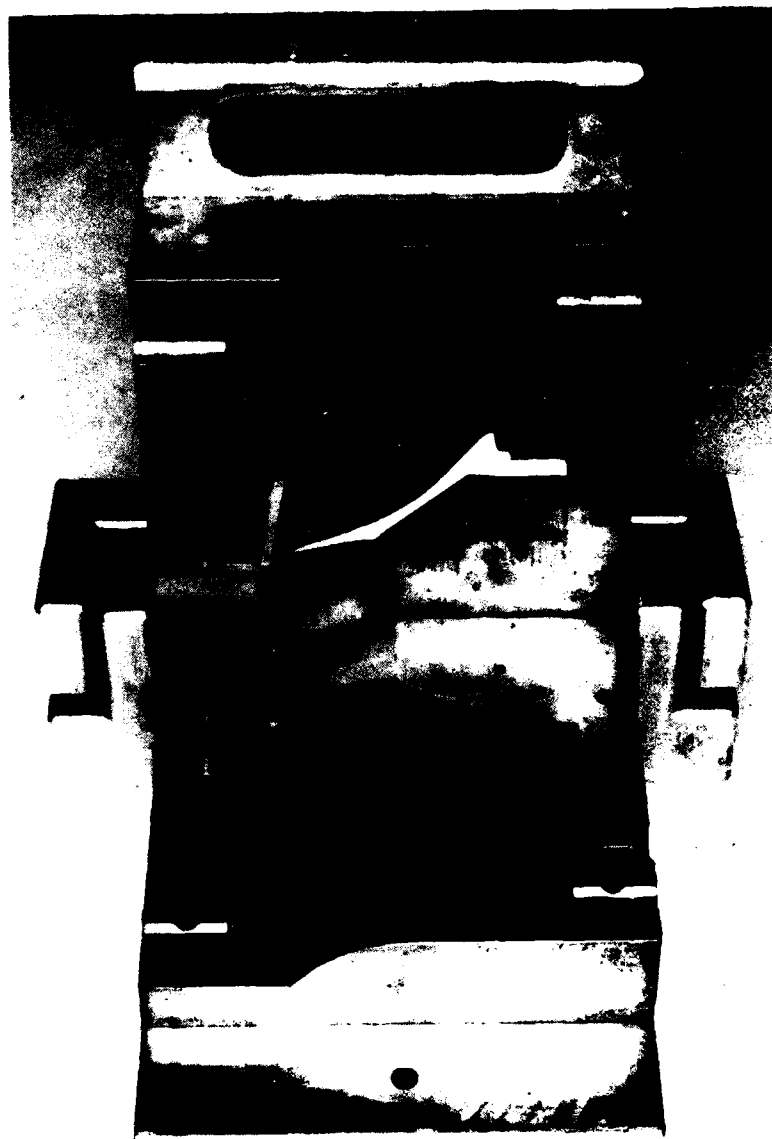
Figure 108. Core die and resultant core for an air-cooled HTRT airfoil shell.

These features were included in the full-scale tooling, which consisted of a ceramic core die, core setter dies for core curing, a wax airfoil die, and an assembly fixture. These tools are shown in Figures 107 through 109.

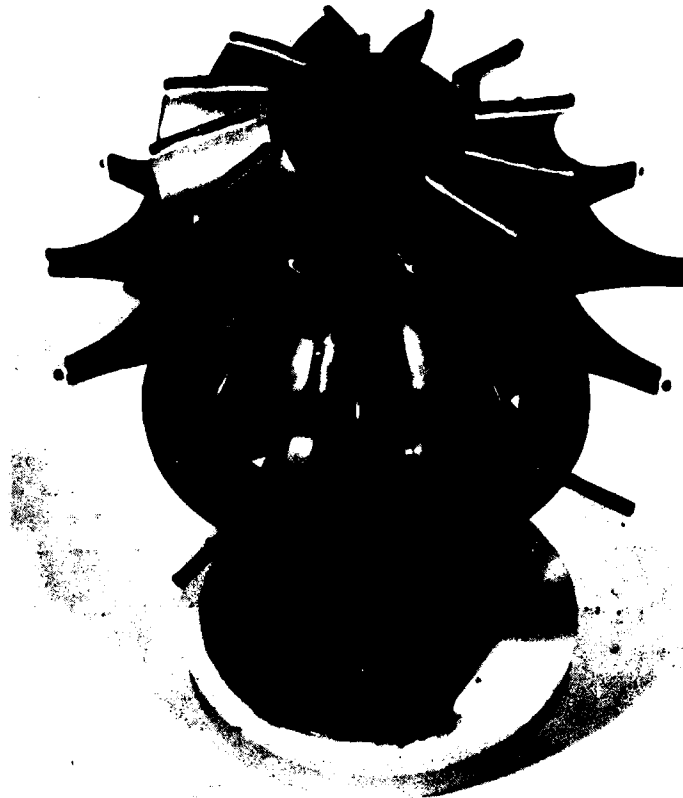
A modest bottom fill scheme also was employed to further reduce the shock of the molten metal impinging downward on the core. The addition of six 1/8-inch-diameter bottom "spoke-type" feeder gates coming off a center downpole was expected to allow some filling of the airfoil cavities from the bottom to provide some support on both sides of the core before the large mass of metal entered through the top gates. This approach was believed to reduce the tendency for airfoil misrun that was a problem on the first trial. The bottom feeding approach is shown in Figure 116.

Figure 116. Bottom fill, to decrease core shock, and "spoke-type" gating used to improve fill in exducer airfoil tips of HTRT casting No. 2.

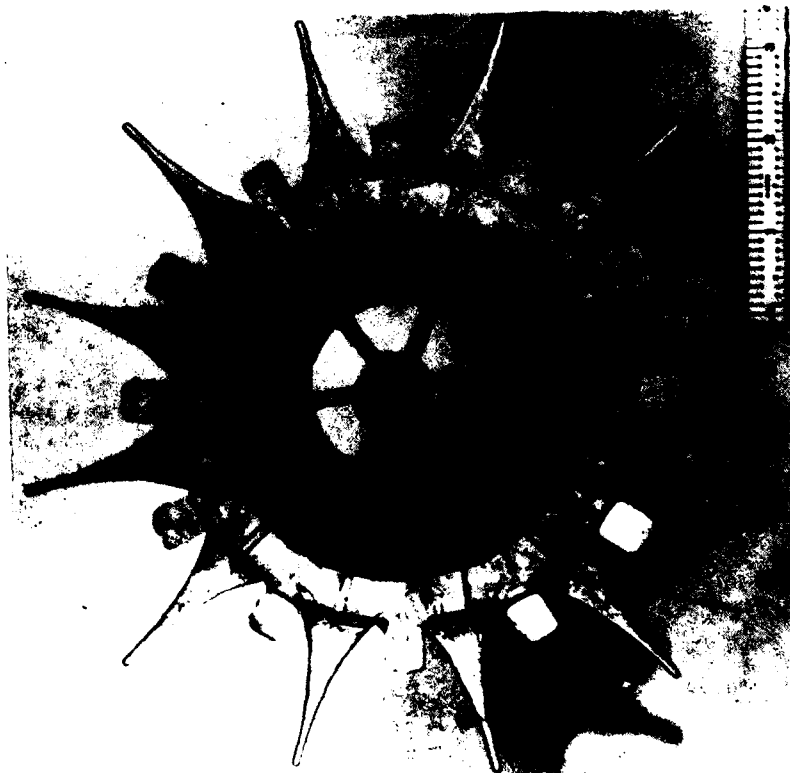
Figure 118. Full-scale HTRT casting No. 2  
(downstream view).

The overall casting quality was generally good--specifically, the surface finish was good (no dirt, fins, or roughness); however, there was evidence of "heat wrinkling" as a result of the airfoils in the rib area. The grain structure is shown in Figures 117 and 118. Grain size was generally 1/8 to 1/4 in. equiaxed with some columnar grain originating at the exducer core print and areas of powder fine grain at the extreme airfoil tips and at the cold folds.

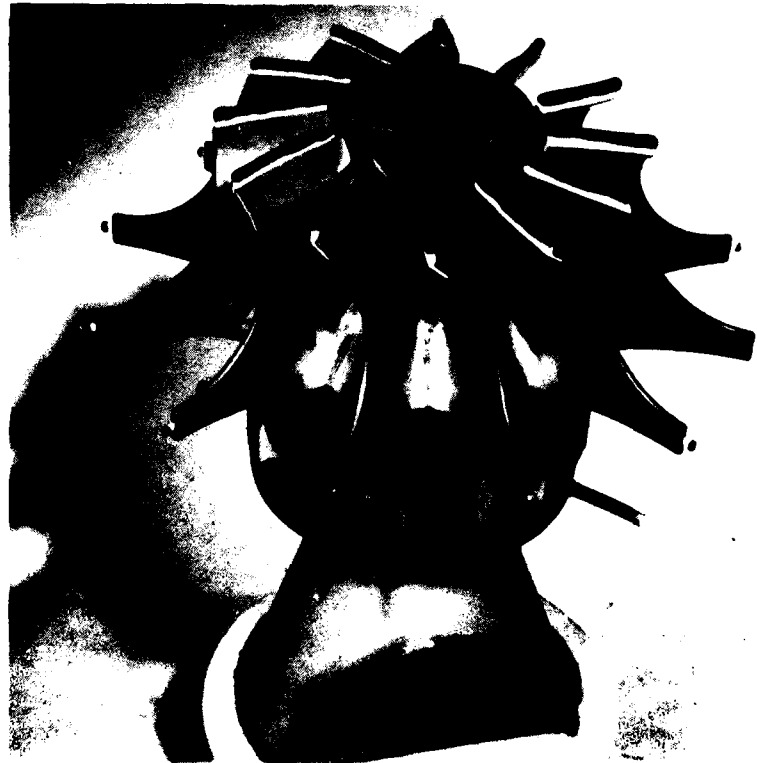
exducer section to feed twelve radial gates as shown in Figure 120. The philosophy behind this gating design was to fill more from the bottom and to reduce the flow pressure on the concave side of the core.

Figure 120. Oblique view of wax pattern and gating assembly for HTRT casting No. 3, showing exducer feed gates (inverted position).

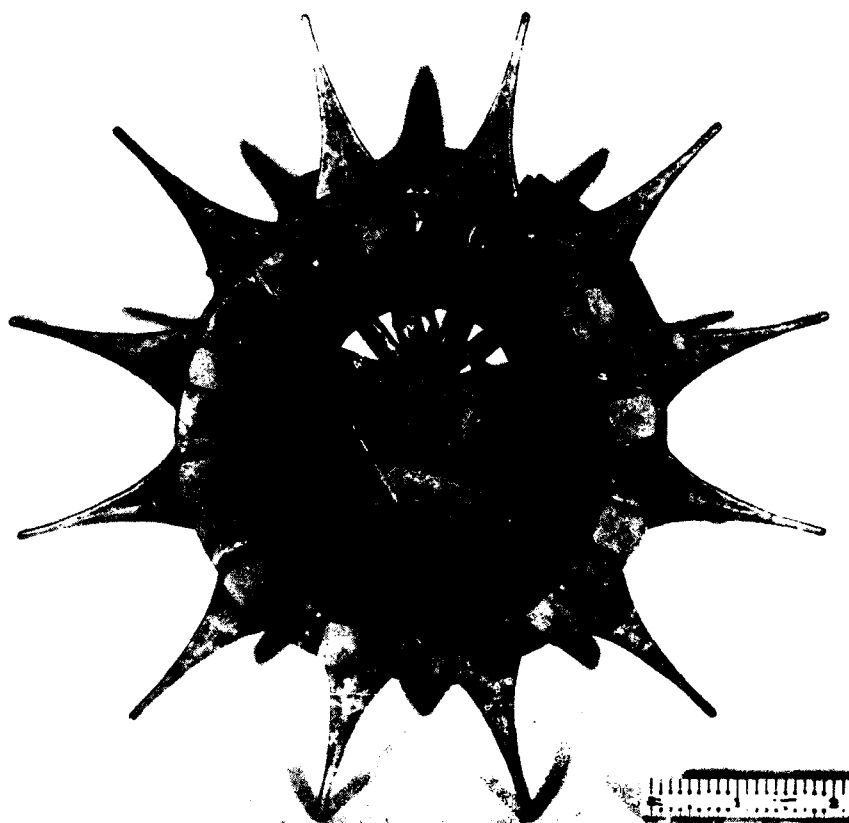
The back side of the rotor casting is presented in Figure 121 which shows the gating modifications, i.e., gates shifted over the convex side of the airfoil, tapered center downpole, and exducer gates to each airfoil. This photograph also shows the equiaxed and uniform grain structure on the ID of the casting. Figure 122 shows the airfoil grain structure which is exceptionally uniform and fine considering the extremely high mold preheat (2050°F) and pouring temperatures (2950°F).

Figure 121. Ingates, tapered downpole, exducer gates, and ID grain size in HTRT casting No. 3.

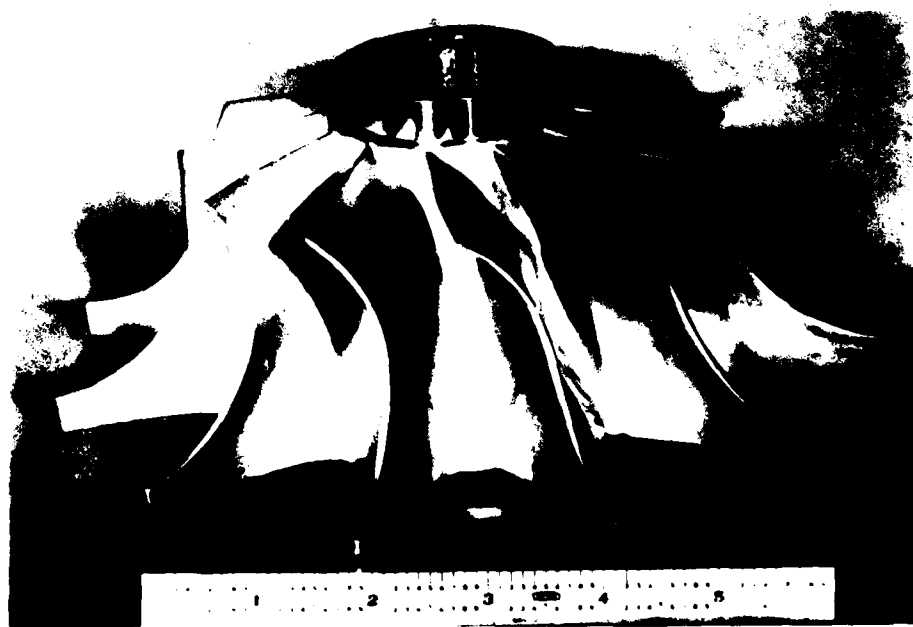
Figure 136. Side view of finish-machined HTRT rotor assembly.

Following braze sealing, the rotor was HIP bonded and, upon subsequent ultrasonic inspection, proclaimed to be sound. After heat treatment, rotor No. 3 was finish machined. Figures 134 through 136 show the rotor after machining.

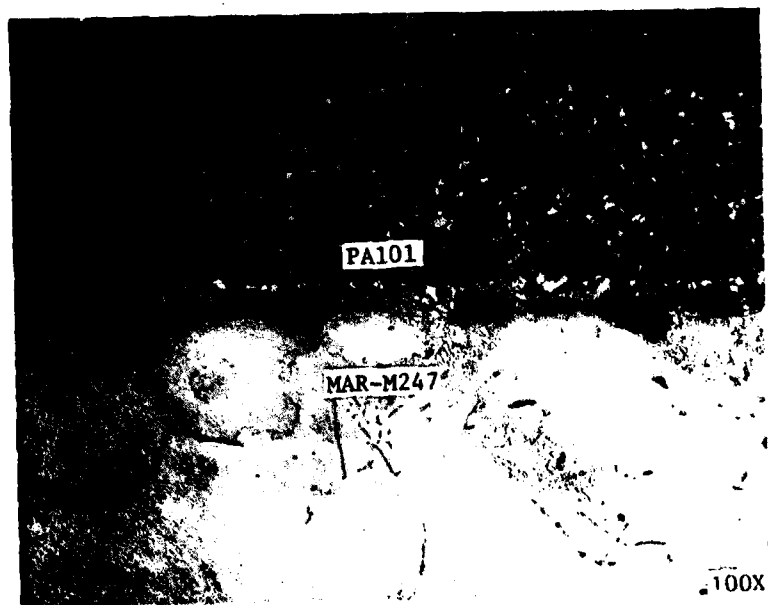
cylindrical section

conical section

Figure 156. Photomicrographs of bond line.

A cut-up evaluation was then accomplished. Figure 155 is a photograph of a macroetched polished section of the rotor assembly after test. Photomicrographs of the bond line, Figure 156, at both the conical and cylindrical sections of the rotor indicate that the high stress encountered during this test did not affect bond line integrity.
