## THESIS

The Effect Of Multiple Weld Repairs  
On The Fatigue Resistance Of  
Welded Aluminum Alloy 5083-0

John R. Panico

December 1979

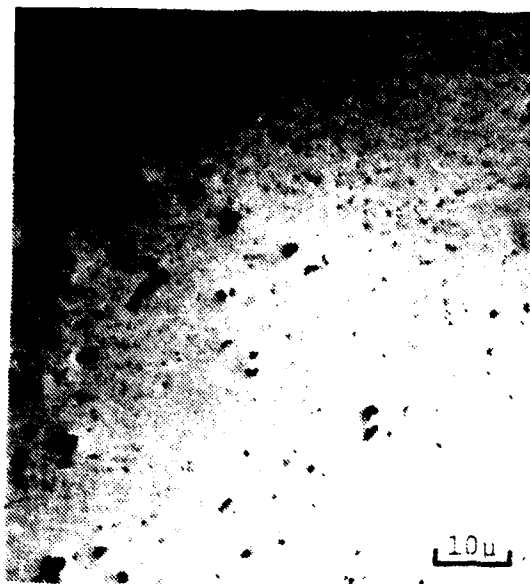
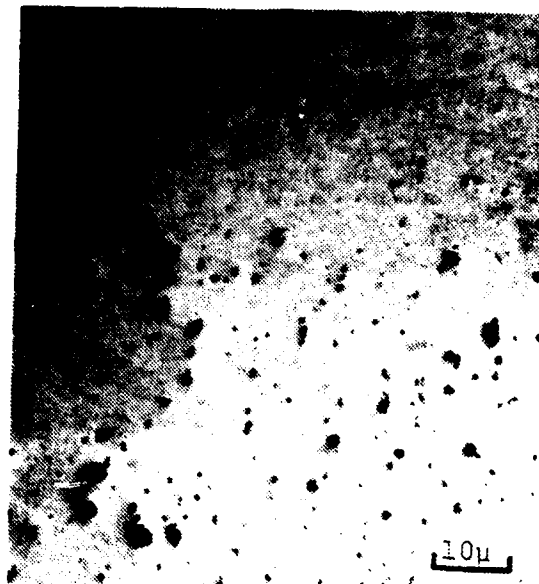
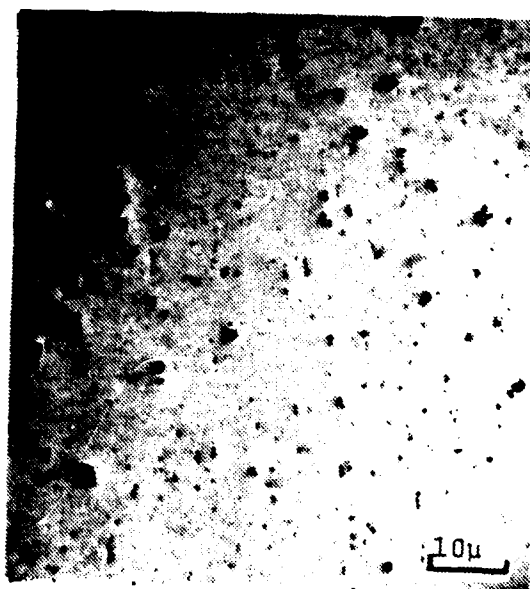
Figure 10. Photographs taken of the "as-polished" specimen subjected to 16 repair simulations. The locations represented are the interface (a), approximately 6 mm (b), 18 mm (c) and 27 mm (d) from the interface. (100X)

Lt. G.R. Speight's research in this area disclosed that the insoluble inclusions  $(\text{FeMn})_3\text{SiAl}_{12}$  and  $\text{Mg}_2\text{Si}$  grew and coarsened with increasing numbers of weld repairs [27]. Figures 9 and 10 illustrate this coarsening. Figure 9 shows micrographs of an as-polished specimen subjected to the original two-pass weld only. Figure 10 shows micrographs of an as-polished specimen subjected to sixteen repair simulations. This coarsening had little apparent effect on tensile strength, stress corrosion cracking susceptibility and hardness, although, as noted previously, there was a slight tendency toward degradation in these properties.

Summarized in Section II above. Figures 9 and 10 illustrate the microstructure.
