TECHNICAL REPORT M-279  
May 1980

ROOFING REPAIR MATERIALS FOR KOREAN  
RELOCATABLE BUILDINGS—TEST AND EVALUATION

by  
Robert E. Muncy

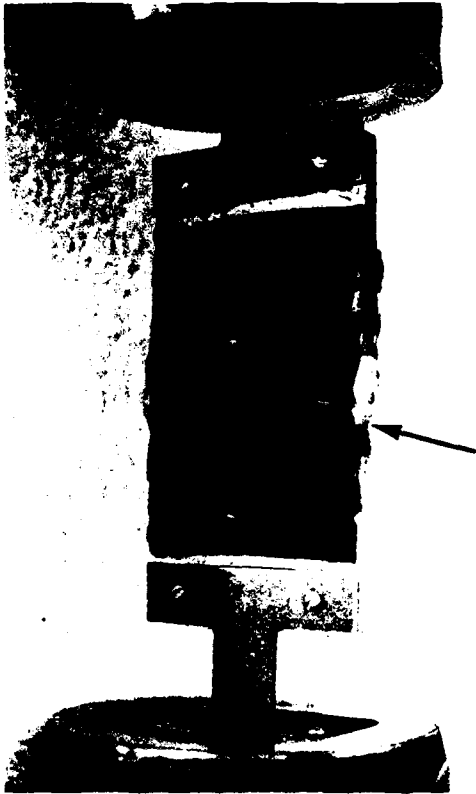
Figure 7. Enlarged tear in PS-5.

Specimen PS-5 was tested at -40°F (-40°C). A tear became visible at 800 cycles; at 1150 cycles, the tear extended halfway across the specimen. However, when the test was terminated at 1930 cycles, the tear still was not completely across the material (Figure 7).

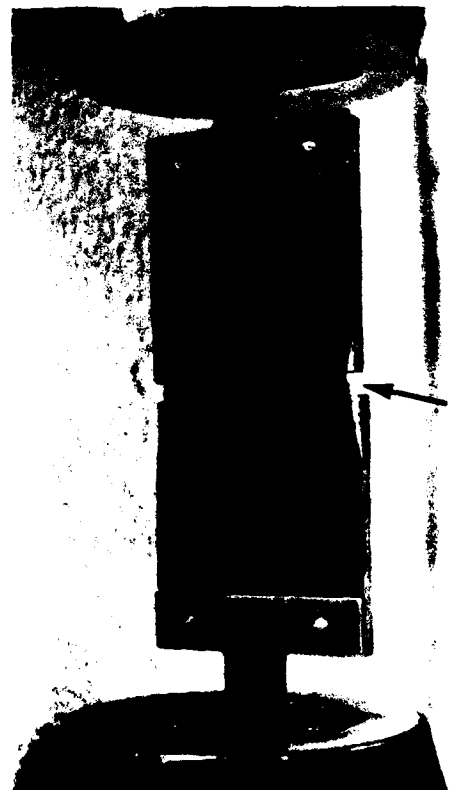
Figure 8. Maximum gap between test coupons.

Displacement in all three Contourflash tests was 3/8 in. (9.5 mm) (Figure 8).
