ARMY ENGINEER WATERWAYS EXPERIMENT STATION VICKSBURG--ETC F/G 13/2  
BALD EAGLE CREEK AND LITTLE JUNIATA RIVER CHANNEL IMPROVEMENT P--ETC(U)  
APR 80 J F GEORGE  
WES/TR/HL-80-5

| REPORT DOCUMENTATION PAGE | | READ INSTRUCTIONS<br>BEFORE COMPLETING FORM |
|---|---|---|
| 4. TITLE (and Subtitle)<br>BALD EAGLE CREEK AND LITTLE JUNIATA RIVER CHANNEL<br>IMPROVEMENT PROJECT; Hydraulic Model Investigation | 5. TYPE OF REPORT & PERIOD COVERED<br>Final report, Dec 78-Mar 79 | |
| 7. AUTHOR(s)<br>John F. George | 8. CONTRACT OR GRANT NUMBER(s) | |
| 9. PERFORMING ORGANIZATION NAME AND ADDRESS<br>U. S. Army Engineer Waterways Experiment Station<br>Hydraulics Laboratory<br>P. O. Box 631, Vicksburg, Miss. 39180 | 10. PROGRAM ELEMENT, PROJECT, TASK<br>AREA & WORK UNIT NUMBERS | |

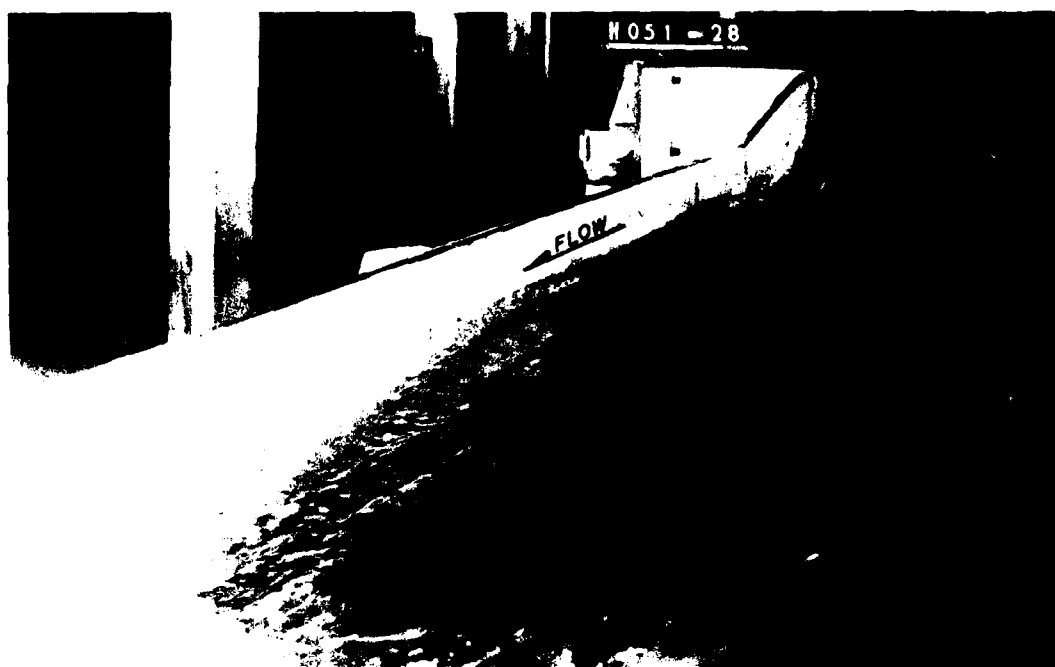
Photo 3. Looking upstream at the right side of Westvaco Dam showing the drawdown in the water surface at the right abutment; discharge 13,400 cfs

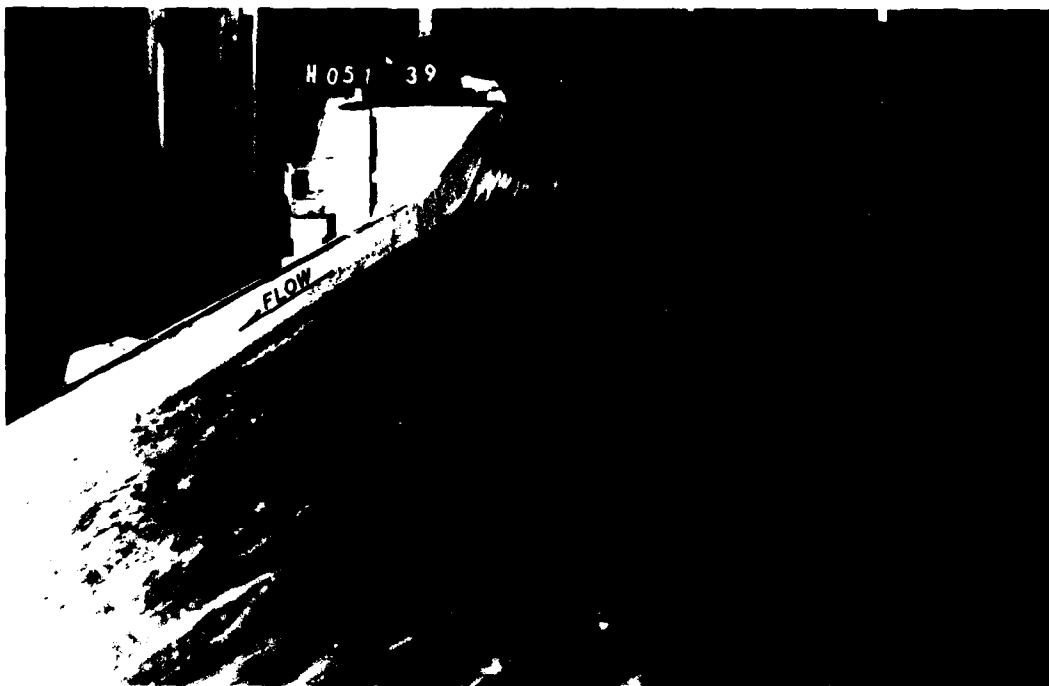
Photo 8. Looking upstream at flow conditions along right wall of Westvaco Dam with the type 3 curved wing wall on the right abutment; discharge 13,400 cfs

order to reduce the drawdown in water surface that occurred at the right abutment. The type 3 wing wall modification with a 25-ft radius (Photo 7) resulted in improved flow conditions in the transition section immediately downstream (Photo 8). Rectangular slots, 1 ft wide by 2 ft high, at the bottom of the wing wall (Photo 7) allowed circulation of flow behind the wall, thereby eliminating stagnant conditions that could develop in front of the existing intake structure. Flow conditions in the vicinity of Westvaco Dam with the type 3 modification are shown in Photo 9. Water-surface profiles and elevations are provided in Plate 8 and Table 3, respectively. Velocities measured upstream of Westvaco Dam are shown in Plate 9.
