# Draft Translation 753

## THERMOGRAPHY CONTROL OF HEAT INSULATION AND TIGHTNESS OF BUILDINGS

. Axen and B. Pettersson

| REPORT DOCUMENTATION PAGE | | 14 READ INSTRUCTIONS<br>BEFORE COMPLETING FORM |
|---|---|---|
| 20. ABSTRACT (Continue on reverse side if necessary and identify by block number)<br>The purpose of this publication is to present the usefulness of the heat camera (IR camera) and its reliability for locating and charting deficiencies in insulation and tightness of completed buildings, and to indicate an appropriate procedure for routine application of the thermography method. | | |

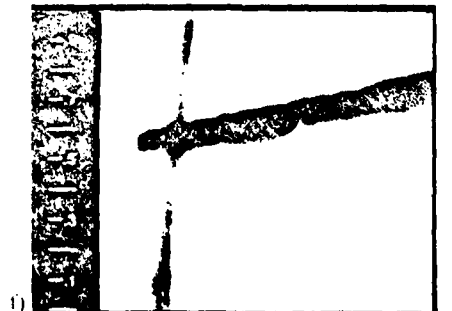
**a) Outside wall with steel construction**

**Top to bottom:**

Horizontal steel bolts  
Air leakage, in  
Corrugated sheet metal  
90 mm mineral wool  
(with sheathing paper)  
30 mm mineral wool  
(with vapor barrier)

- b) 0 minutes. The horizontal bolt cooled. Minor signs of air leakage appear.
- c) After 1 minute. Dark portions appear on the wall surface below the steel bolt.
- d) After 2 minutes. Darker portions larger than in picture c).
- e) After 3 minutes. The dark portions below the bolt are still visible.
- f) After 4 minutes. The thermogram resembles that in picture b).

The wind conditions can vary significantly over time and at locations relatively close to each other. Other variations can definitely affect the measuring results of thermography. Examples are shown in FIGURE 22. There may also be local variations due to the design of the (number and placement of) buildings in the area as well as surrounding terrain.

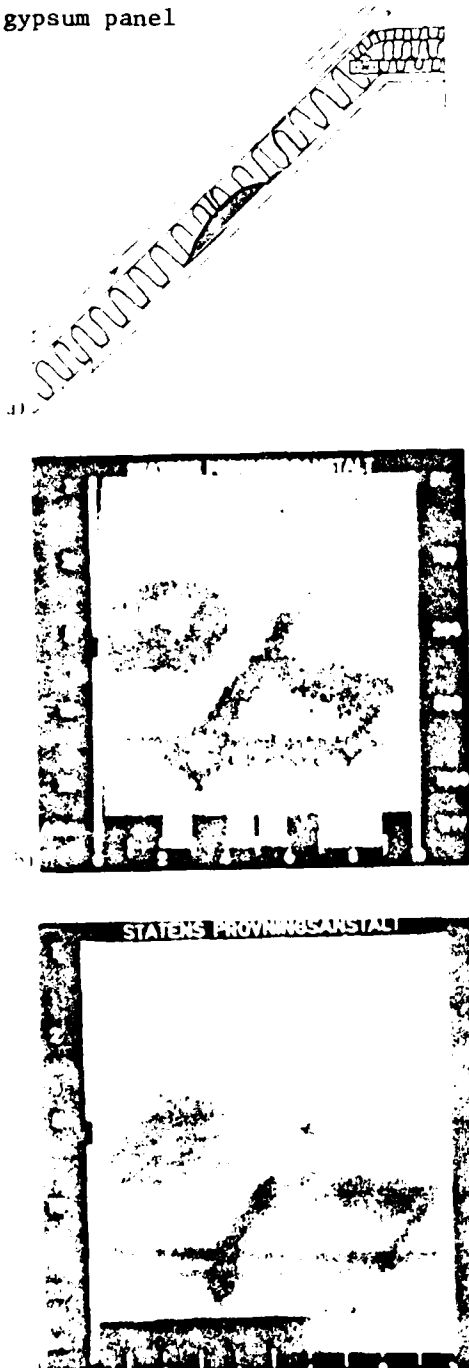
**FIGURE 33:** Color thermograms and black/white thermograms from the same surface portion.

Sloping roof, from the top:

Cloud cover: Clear (thermo-graphed building portion not affected by sun)  
Outdoor air temp.:  $-2^{\circ}\text{C}$   
Indoor air temp.:  $+21^{\circ}\text{C}$   
Wind conditions: Calm  
 $p_i - p_u$ :  $-5\text{ Pa}$

- a) Construction of insulated sloping roof portion with deficient insulation.
- b) Color thermogram of sloping roof portion.  
Upper temperature limit for color:  
white .....  $+21.0^{\circ}\text{C}$   
yellow .....  $+20.4^{\circ}\text{C}$   
red .....  $+19.7^{\circ}\text{C}$   
purple .....  $+19.0^{\circ}\text{C}$   
light green .....  $+18.4^{\circ}\text{C}$   
dark green .....  $+17.7^{\circ}\text{C}$   
light blue .....  $+17.0^{\circ}\text{C}$   
dark blue .....  $+16.3^{\circ}\text{C}$
- c) Thermogram (grey tone image) of the same surface portion as color thermogram in b). The cooled (dark) portions are related to deficient insulation.
- d) Isotherm image:  
 $t_{\text{ref}} = +20^{\circ}\text{C}$   
 $\Delta I = -1.2$  isotherm units  
 $\Delta t = 1.5^{\circ}\text{C}$   
 $v = 0\text{ m/s}$

In a color thermogram (see FIGURE 33), each color tone represents a specific temperature interval. The temperature distribution over the surface is reproduced with good clarity.

FIGURE 33 b) shows an example of color thermogram.

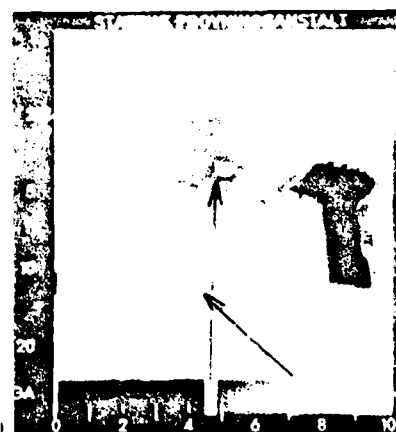
FIGURE 46: Deficiency - unsatisfactory fitting of insulation material around the ventilation channels - in the insulation and tightness execution at the truss where ventilation channel penetrates.

- Truss construction and rafters at the ventilation passage.
- Deficient insulation execution at the connection of the ventilation channel to the rafters.
- Thermogram of surface portion at the roof with the connection of ventilation duct from drying cabinets. The surface portion is cooled due to uneven function of the insulation material.

$\Delta t = 4.0^\circ\text{C}$

$v = 0$  m/s

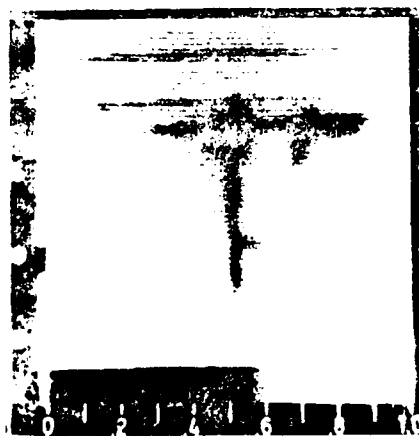
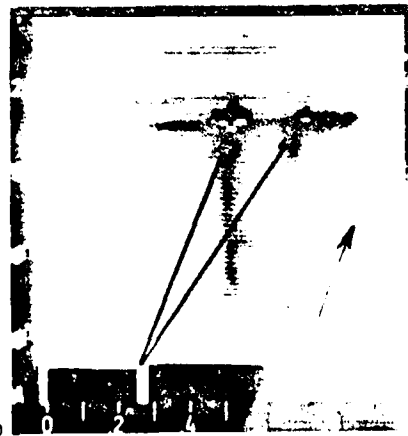
FIGURE 47: Deficiency in insulation and tightness at the eaves due to unsatisfactory fitting of insulation material and badly executed wind barrier.

- a) Construction at the eaves.
- b) Erroneous insulation execution in the wall and at the eaves.
- c) Thermogram of surface portion at the roof angle, showing a cooled area of irregular shape. A narrow, cooled area extends downward into the wall. The cooling caused partially by inward air leakage, partially by badly executed insulation in the wall and at the eaves.

$\Delta t = 6.5^{\circ}\text{C}$

$v = 0.5 - 1.8 \text{ m/s}$  (at the eaves)

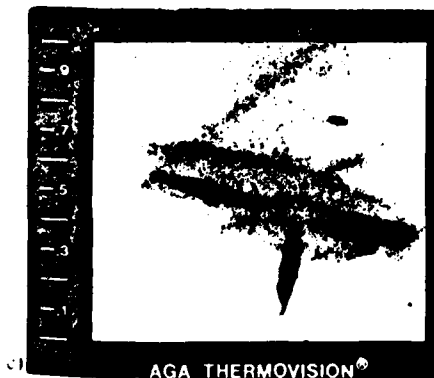
FIGURE 57: Deficiency in roof beam tier due to moisture leakage into the construction.

COMPARISON THERMOGRAM - ROOF TRUSS CONSTRUCTION OF LIGHT CONCRETE

b) Roof portion, where part of the wood panel has been removed. The surface of the wood panel was dry on the measuring occasion. However, both concrete and sheathing were moist due to inward water leakage in the untight construction.

c) Thermogram of roof portion showing a cooled area. The cooling is due to moisture damage.

$\Delta t = 0.5^\circ\text{C}$

$v = 0$  m/s

Pp. 101-103: examples of deficiencies in insulation and tightness standards in truss tiers, FIG. 55 - 57.

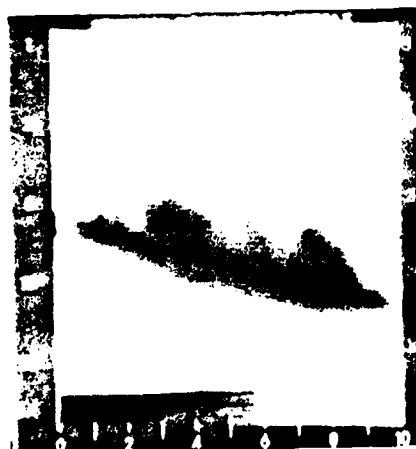
**FIGURE 60:** Deficiency - crack formation - in insulation and tightness due to insufficient filling of insulation material in the wall, in combination with inward air leakage in joint due to unsatisfactory connection between beam tier and outside walls.

COMPARISON THERMOGRAM - INTERMEDIATE BEAM TIER OF CONCRETE

a) Construction of intermediate beam tier with connection to outside wall (In figure: Inside / Inside)

b) Inward air leakage at connection of intermediate beam tier with gable wall.

c) Thermogram of surface portion at floor angle (upper floor). Cooled areas have relatively uneven outlines. Cooling caused by inward air leakage due to untight connection of the beam tier.

$\Delta t = 5.0^{\circ}\text{C}$

$v = 1 - 3 \text{ m/s}$

Pp. 104-110: examples of deficiencies in insulation and tightness standards in beam tiers, FIG. 58 - 64.

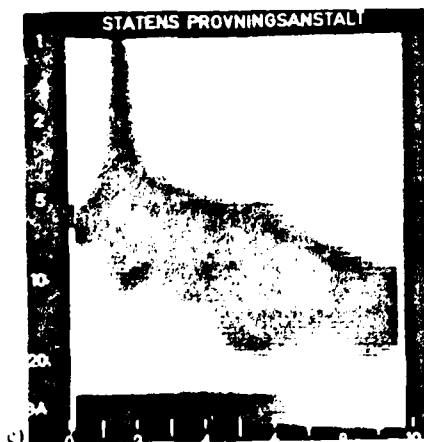
COMPARISON THERMOGRAM - VENTILATION DUCT PENETRATION IN BEAM TIER

FIGURE 63: Deficiency in insulation due to incomplete filling of insulation material and bad sealing around vertical ventilation ducts.

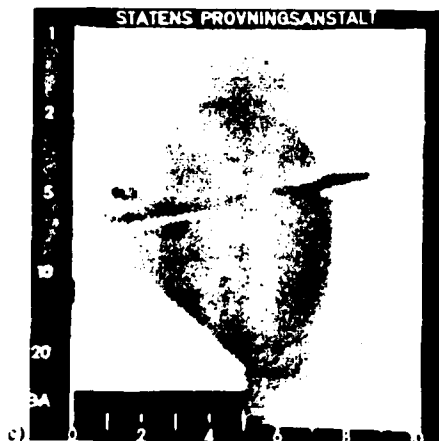
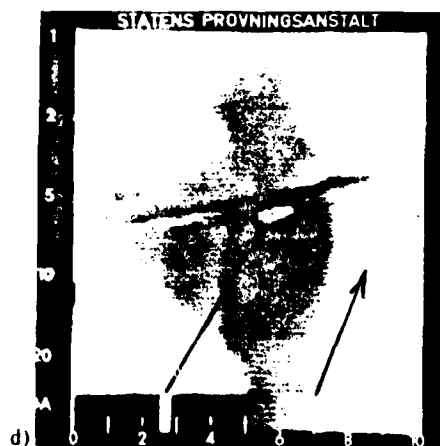
COMPARISON THERMOGRAM - FLOOR JOIST TIER OF CONCRETE AT CRAWL SPACE  
(connection to outside wall of wood).

FIGURE 65: Deficiency in insulation and tightness due to bad sealing of joists.

Pp. 111-115: examples of deficiencies in insulation and tightness standard at the connections of the floor joint tiers, FIG. 65 - 69.

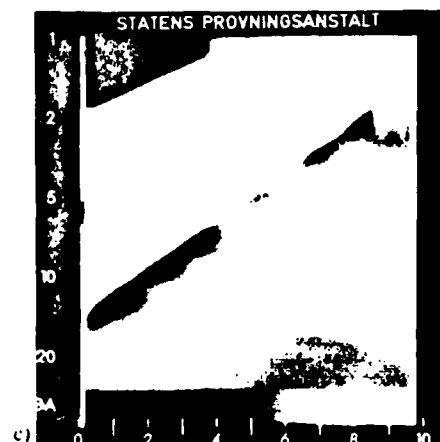
COMPARISON THERMOGRAM - FLOOR JOIST TIER OF CONCRETE, SLAB CONSTRUCTION  
(connection with outside wall)

FIGURE 66: Deficiencies in insulation and tightness due to bad edge insulation.

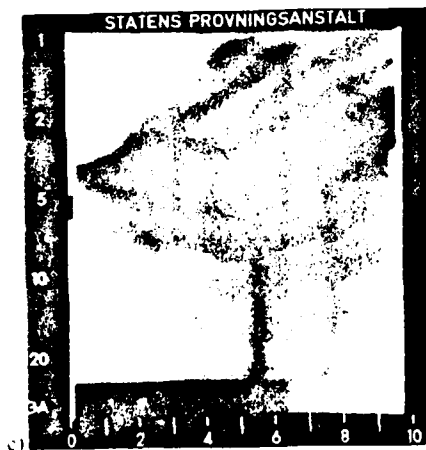
b) Deficiency in tightness in corner

c) Thermogram of surface portion at outside wall corner. Wall and ceiling surfaces are cooled. Cooling caused by inward air leakage in channels formed in the sheet screen construction.

COMPARISON THERMOGRAM - OUTSIDE WALL OF WOOD WITH EXTERIOR WOOD SIDING

**FIGURE 75:** Deficiency in insulation and tightness due to incomplete filling with insulation material in the spaces between studs for the height of an entire apartment level.

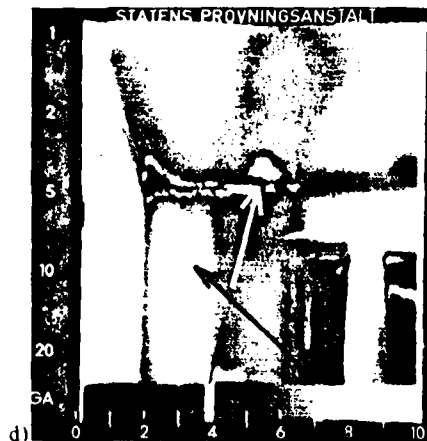
FIGURE 76: Deficiencies in insulation and tightness due to incomplete filling of insulation material at the roof connection.

b) Deficiency in insulation and tightness.

COMPARISON THERMOGRAM - UPRIGHT MEMBER WALL OF WOOD AT CONNECTION WITH INSULATED SLOPING ROOF PORTION

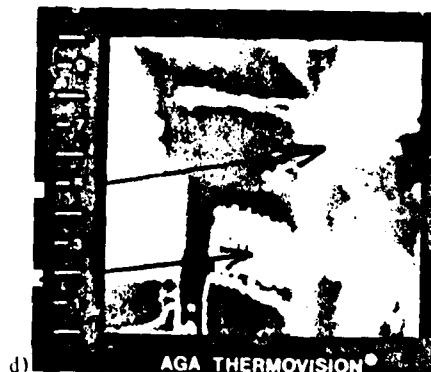
FIGURE 77: Deficiency in insulation and tightness due to incomplete filling with insulation material and unsatisfactory sealing layer.

a) Construction of wall at oriel (In figure: Attic (l) / Inside (r))

b) Deficiency in insulation and tightness. Air leaks into the construction at studs and in corner areas and is propagated through channels between the panel boards.

COMPARISON THERMOGRAM - OUTSIDE WALL PORTION OF WOOD AT WINDOW CONNECTION

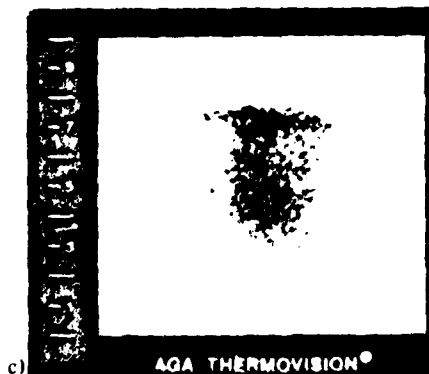
FIGURE 84: Deficient insulation function due to incomplete contact of insulation material (B quality) with the concrete.

b) Deficiency in the insulation execution. The filling of mineral wool against the concrete is incomplete. (In figure: Crumpling[?])

c) Thermogram of surface portion in center of wall. Cooled surface appears, corresponding the corner portion of a mineral wool panel. The cooling caused by bad filling and contact against the outer side of the concrete.

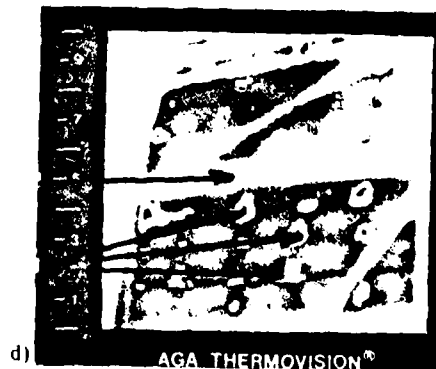
COMPARISON THERMOGRAM - INDUSTRIAL BUILDINGS - OUTSIDE WALLS  
OF METAL CASEMENTS WITH MINERAL WOOL INSULATION

FIGURE 92: Deficiencies in insulation and tightness due to incomplete mineral wool insulation.

c) Thermogram of wall portion at vertical steel profile with uneven temperature distribution. The cooling of certain portions is related to deficient filling with mineral wool. Hollows in spaces between studs are due to rats having removed insulation material.

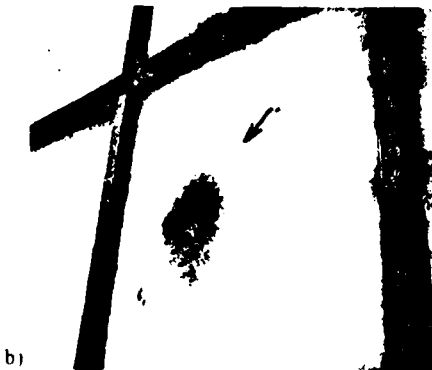
c) Thermogram of wall portion. A warm portion appears at the center of the insulated wall portion. The warming is related to outward leakage of warm air.

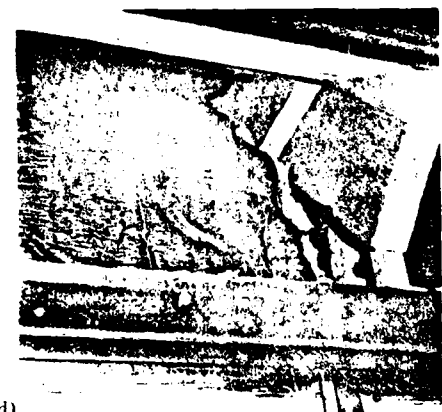
FIGURE 117: THERMOGRAMS TAKEN BEFORE AND AFTER ACTION AS PER FIG. 116

a) Thermogram of cooled area at roof angle (before action). Jagged form of cooled surface shows cooling caused by inward air leakage. Leakage into residential room could not be measured or observed. Cooling caused by outdoor air leaking into construction and propagating in the wall between mineral wool and gypsum panel.

b)  $t_{ref} = + 22^\circ\text{C}$   
 $\Delta I = - 1.7$  isotherm units  
 $\Delta t = 2.5^\circ\text{C}$   
 $v = 0$  m/s (no air leakage into room)

Thermography study after action showed satisfactory results with good tightness at soffit and even temperature distribution over the surface. Control approx. 2 years after first thermography and approx. 6 months after action, see fig. 117.
