ESL-TR-80-45

## FLUSH AM-2 MAT PATCH FOR RAPID RUNWAY REPAIR

JAMES L. GREENE

SEPTEMBER 1980

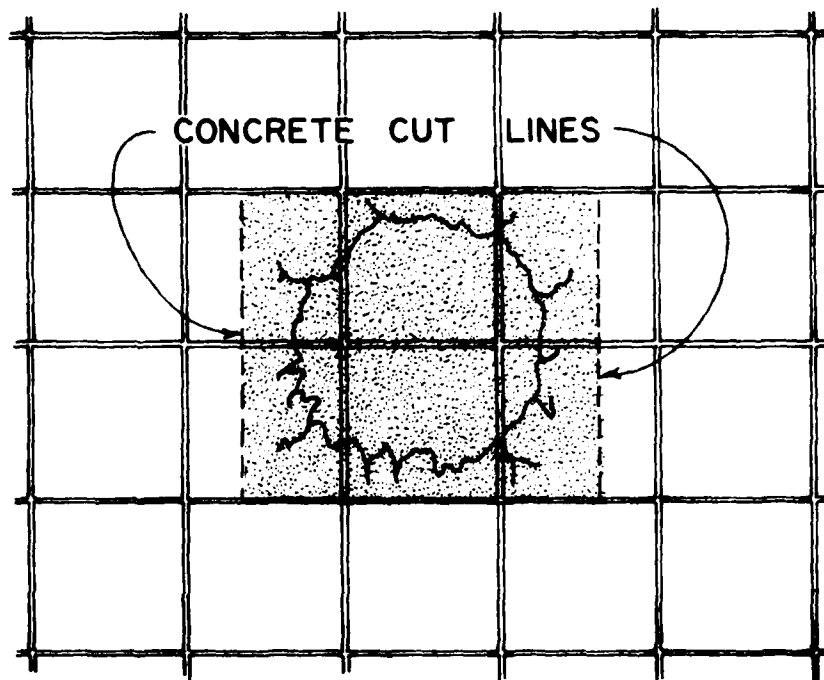
Figure 1. Illustration of Cutting Rectangular Patch

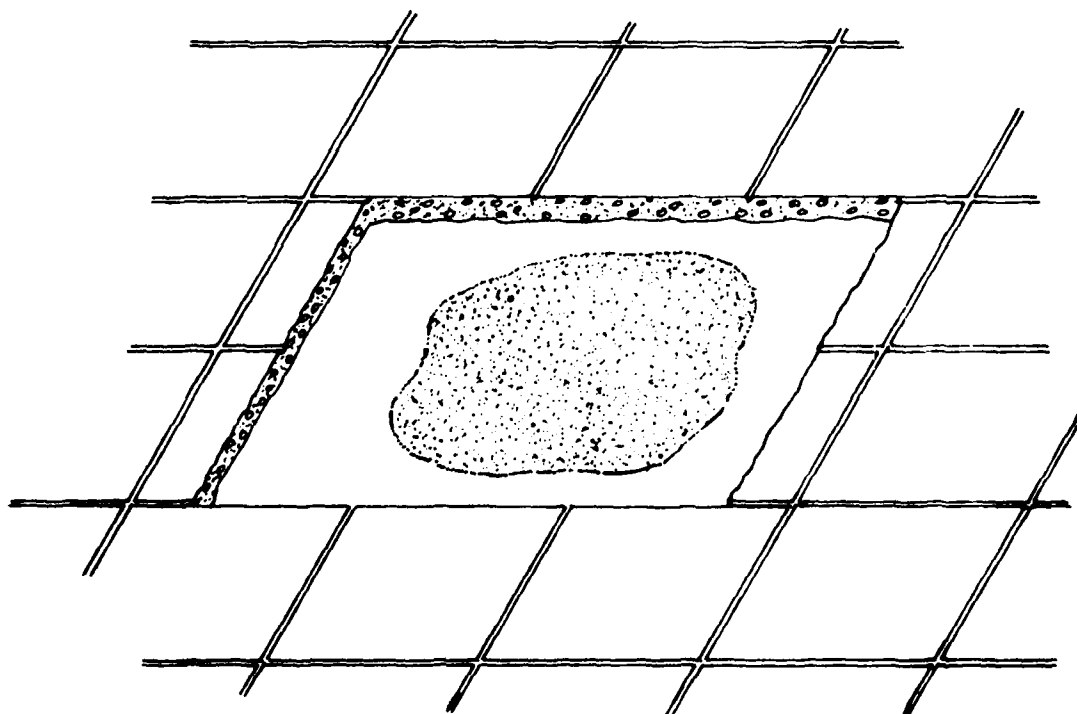
Figure 2. Illustration of Filled Crater

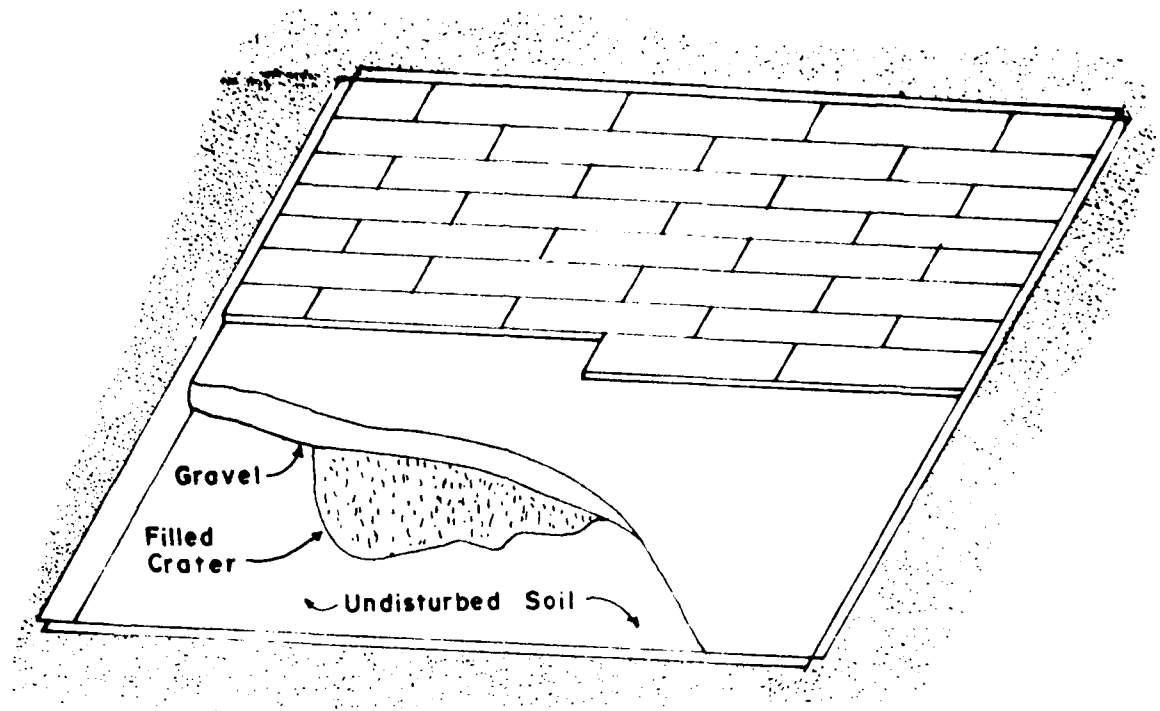
Figure 3. Patch Area Backfilled to Appropriate Elevation

The current bomb damage repair procedure for repairing portland cement concrete pavements is to backfill and then place an AM-2 landing mat section over the damaged area. The positioned AM-2 mat section extends approximately 1-1/2 inches above the pavement surface. Computer simulation predicted catastrophic aircraft failures in fighter aircraft crossing such AM-2 mat sections when placed in a multiple configuration covering several separated bomb craters. There is an urgent need to develop a capability for rapid runway repair without this roughness problem. One possible short term solution is to continue to use AM-2 mat, but to recess the mat sections so that they are essentially flush with the existing pavement. This concept is illustrated in Figures 1 through 4. As Figure 1 indicates, the first step is to cut the concrete pavement around the perimeter of the cratered area leaving a vertical face which can accommodate a modular sized, recessed AM-2 mat section. Following the cutting and removal of defective material, the crater is backfilled as illustrated in Figure 2. The appropriate mat surface elevation is achieved by building up the open area with gravel or other material (Figure 3). Figure 4 illustrates the completed patch.

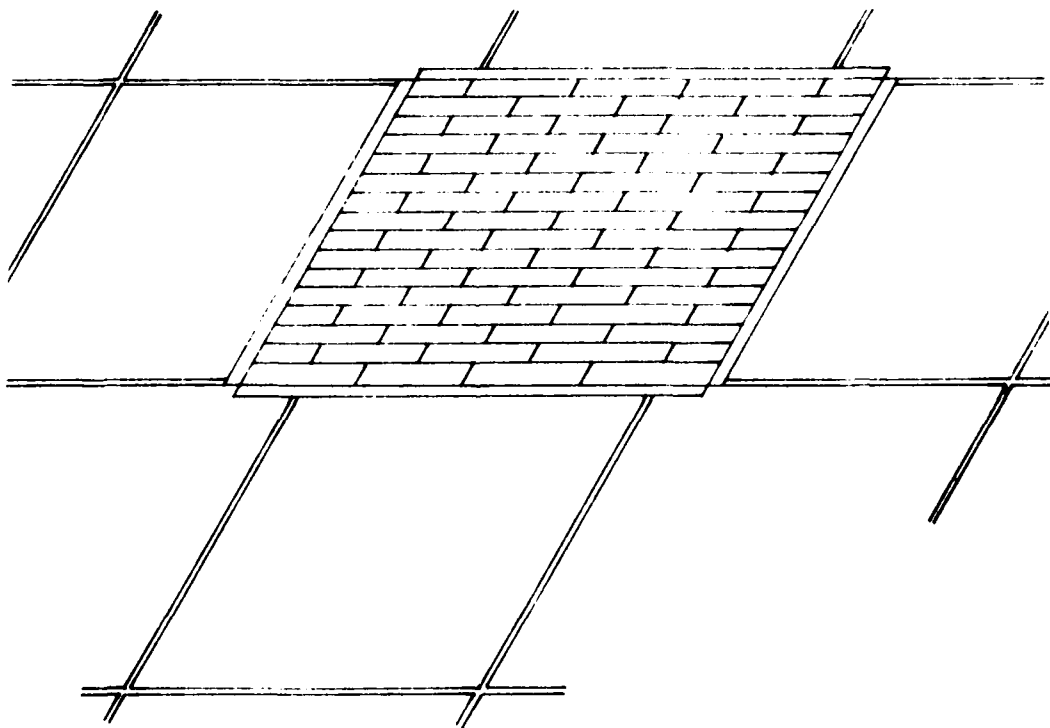
Figure 4. Completed Flush AM-2 Patch

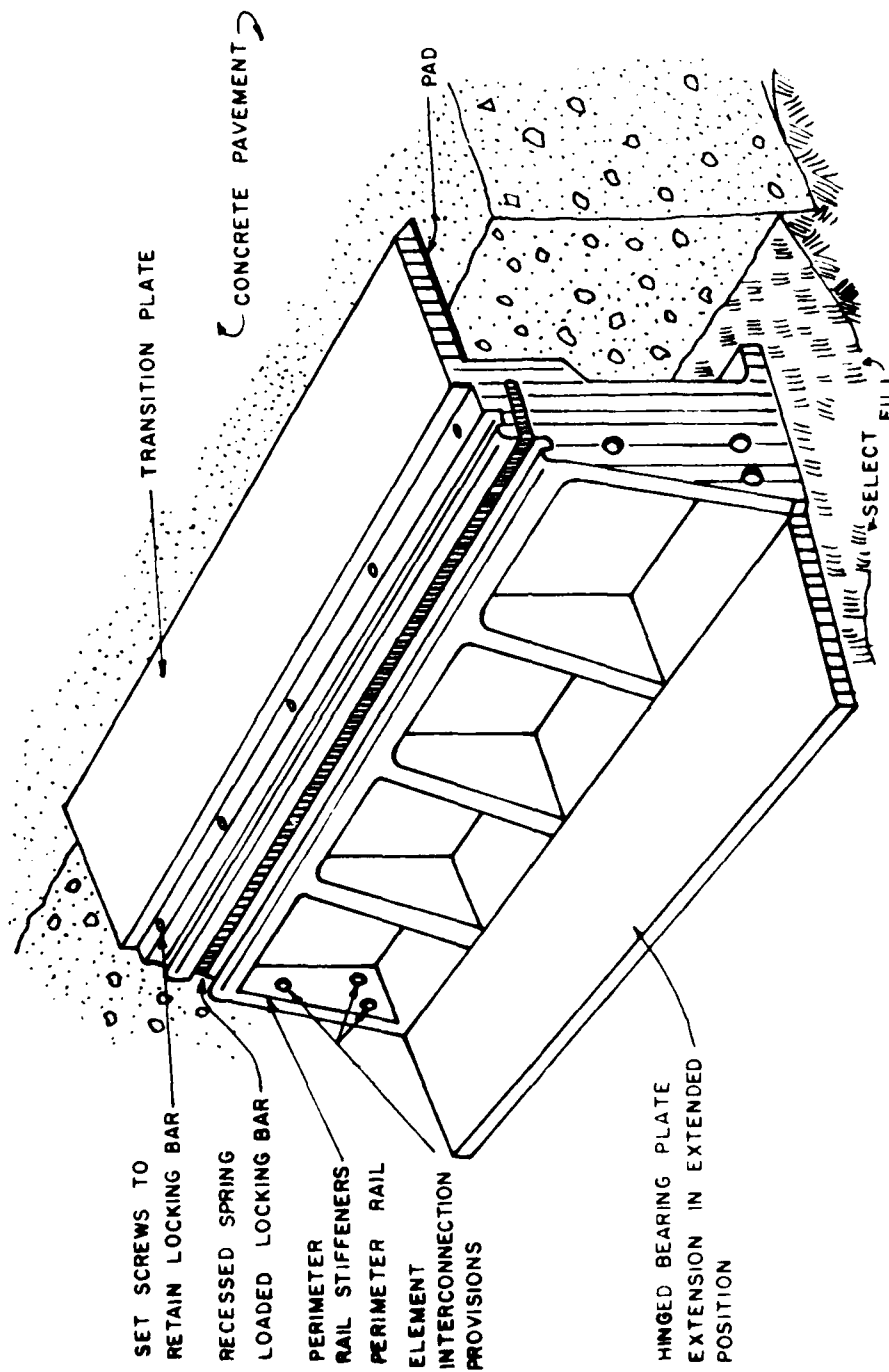
Figure 5. Perimeter Rail Concept

(2) The overall system design was to be modular with flexibility to adjust to varying crater sizes. Standard AM-2 panels were to be used except for perimeter panel requirements. These panels were to be modified to attach to a perimeter anchoring system to be designed by Utah State University. One concept for a perimeter anchoring system was provided, and Utah State University was given the option of designing other concepts. The mandatory concept consisted of a perimeter rail as conceptualized in Figure 5.

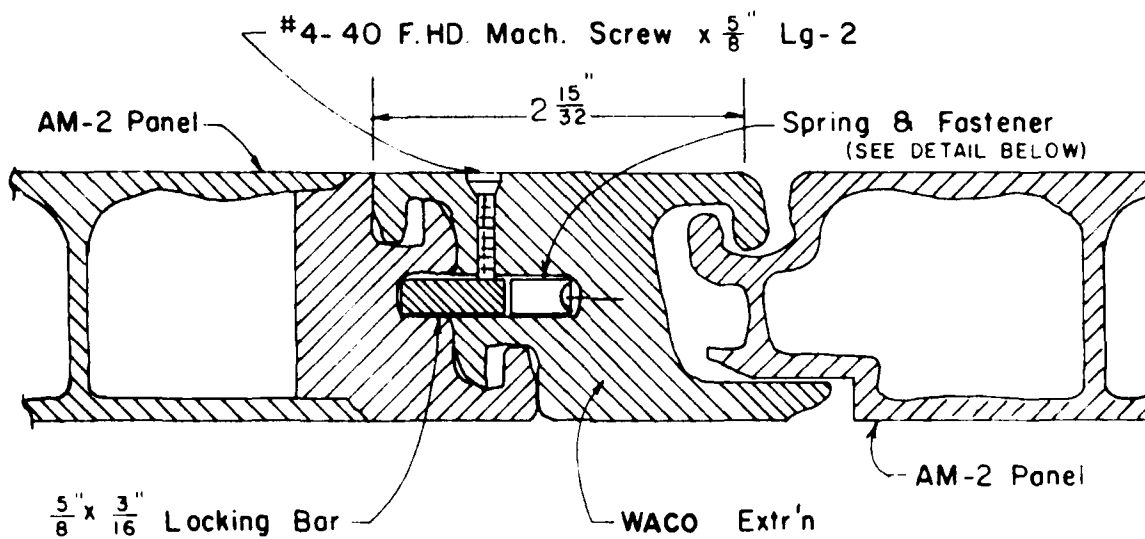
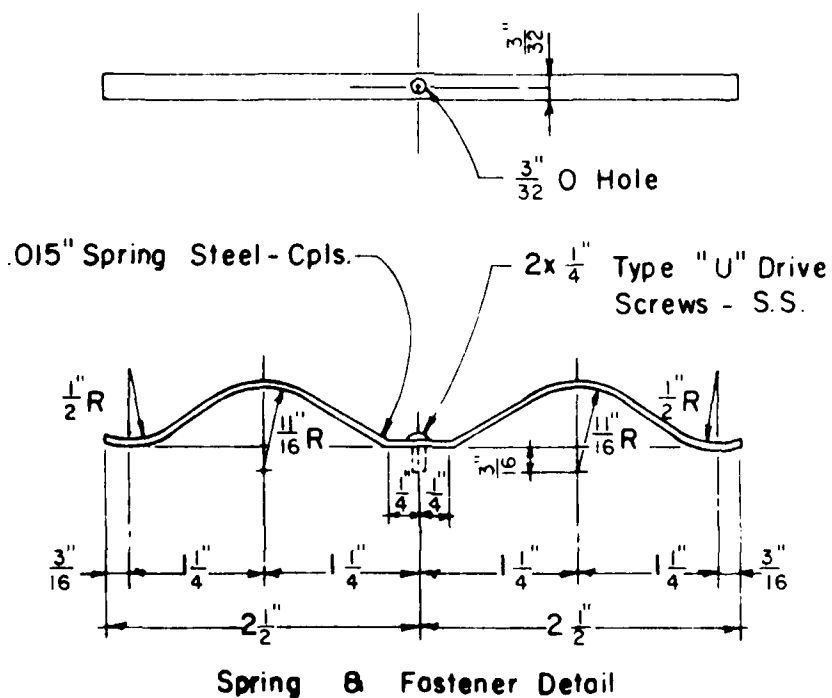
### WACO Extrusion #A-44352

Figure 7. Detail of WACO Extrusion

(4) Figure 6 shows a suggested arrangement for the 20-foot by 20-foot prototype patch. Those panels designated "A" panels are standard AM-2 panels. The others are standard panels with altered edge connectors and panel dimensions. Due to the desired short fabrication time, the perimeter rail elements were to be built from aluminum plate sections assembled by shop welding. The platform component necessarily conforming to a particular AM-2 panel and connector was to be built up using a transition piece extrusion, manufactured by the Washington Aluminum Company (WACO) of Baltimore, Maryland as extrusion piece A-44352. Figure 7 provides details of this piece.

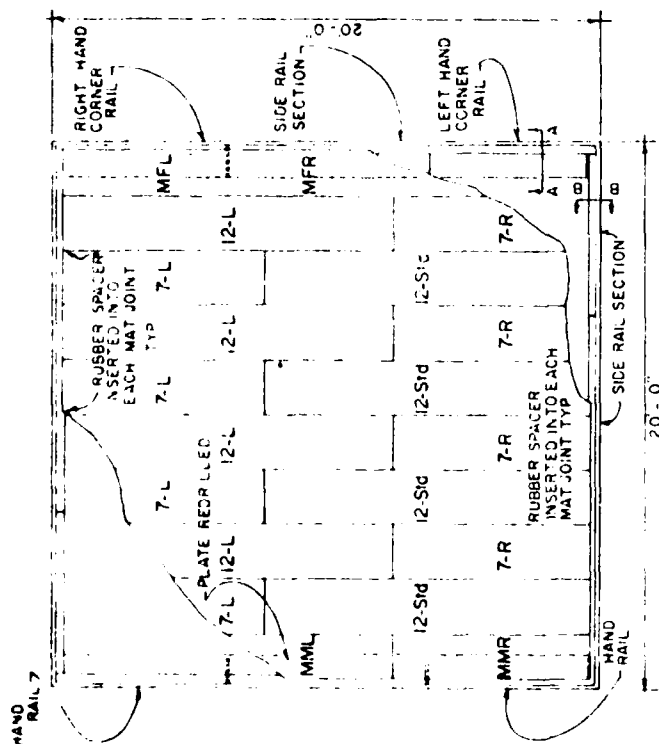
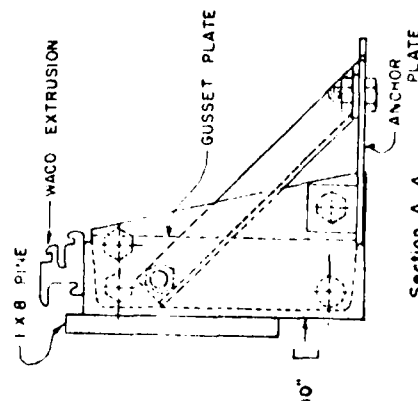
## Section B-B

## Section A-A

Figure 8. Perimeter Rail System

The perimeter rail system consisted of a built-up rail which was used to anchor a patch made of standard and modified AM-2 panels. The rail consisted of a 10-inch aluminum 6061-T6 channel with WACO extrusion No. 44352 welded on top to receive the AM-2 panels. An anchor plate was attached to the bottom of the channel to resist pullout of the rail assembly when braking action is applied. A rubber spacer was inserted between adjacent AM-2 panel connectors to prohibit the panels from closing up in the direction of traffic and possibly pull the patch away from the other end. A 1-inch x 8-inch pine board was attached to the channel to prevent debris from filling the cavity between the rail and the concrete. A plan view, parts list, and details are shown on Figure 8.

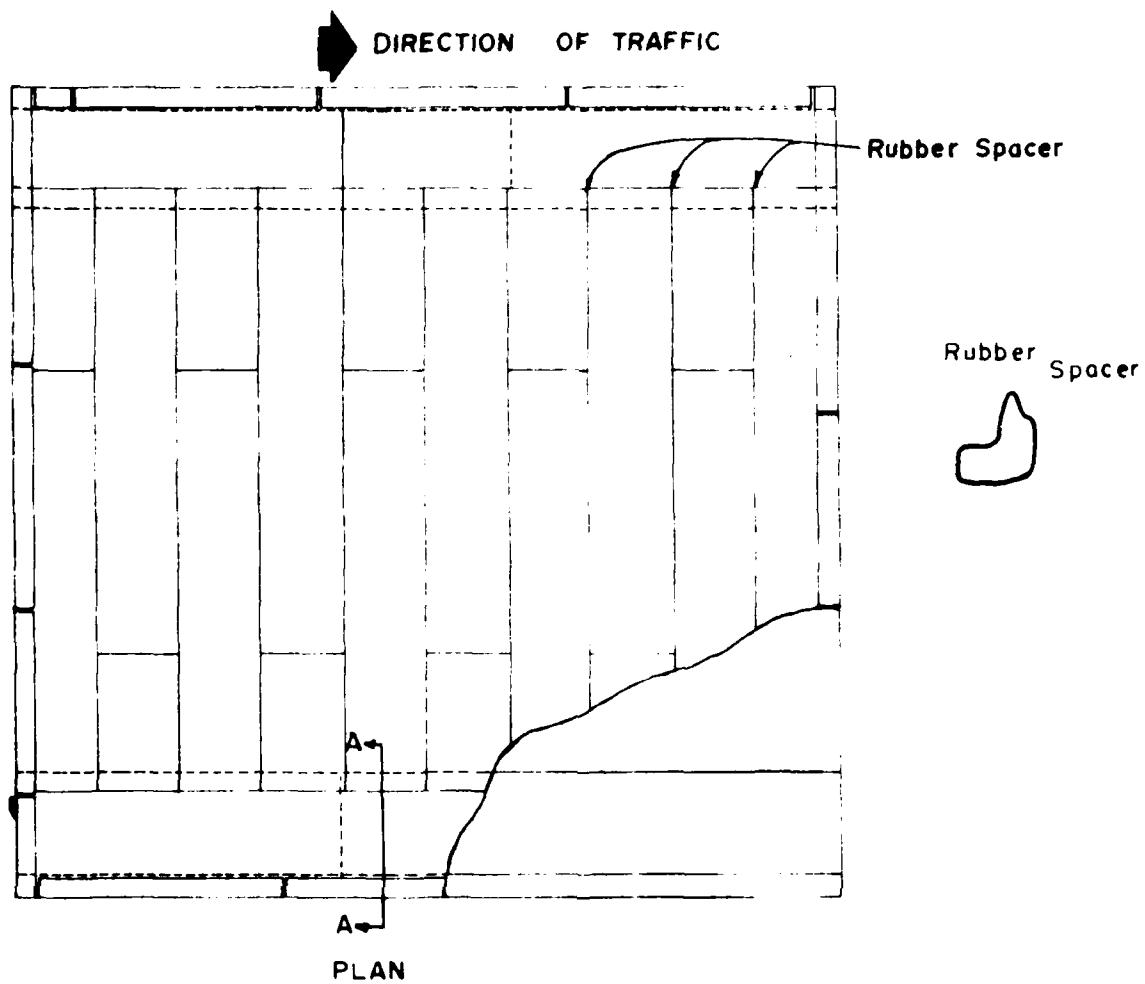
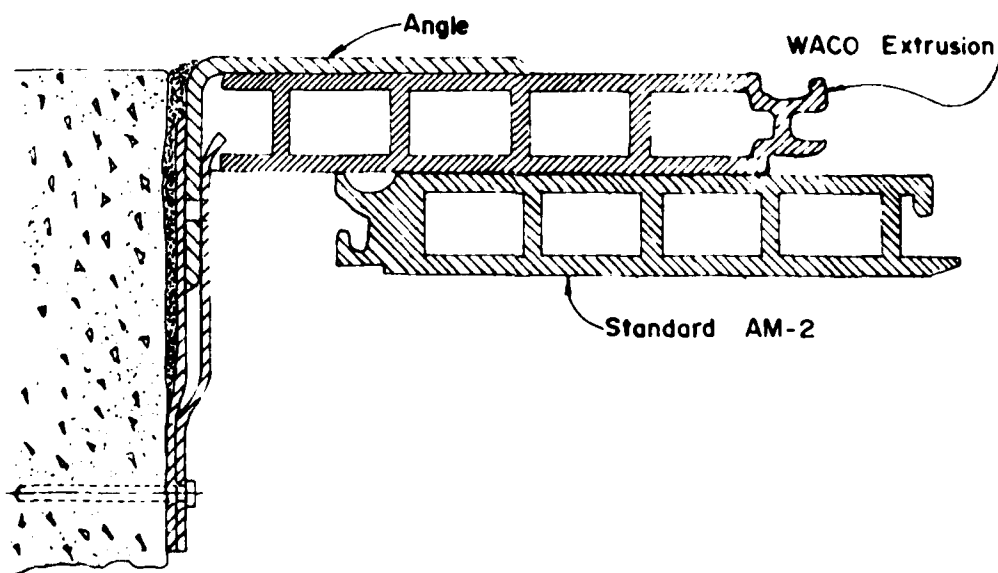
Section A - A

Figure 9. Side Panel System

In the side panel prototype, standard AM-2 panels were laid around the perimeter of the pit with the top surface flush with the top of the base course. Panels which had been modified by welding a WACO extrusion on the side were placed on top of those panels to which transverse panels were connected. In order to connect, the connectors on one end of the transverse panels had to be inverted. The anchoring system consisted of an angle which prevented uplift of the mat. The angle locked into a locking assembly which was fastened to the perimeter concrete. Details of the prototype are shown on Figure 9.

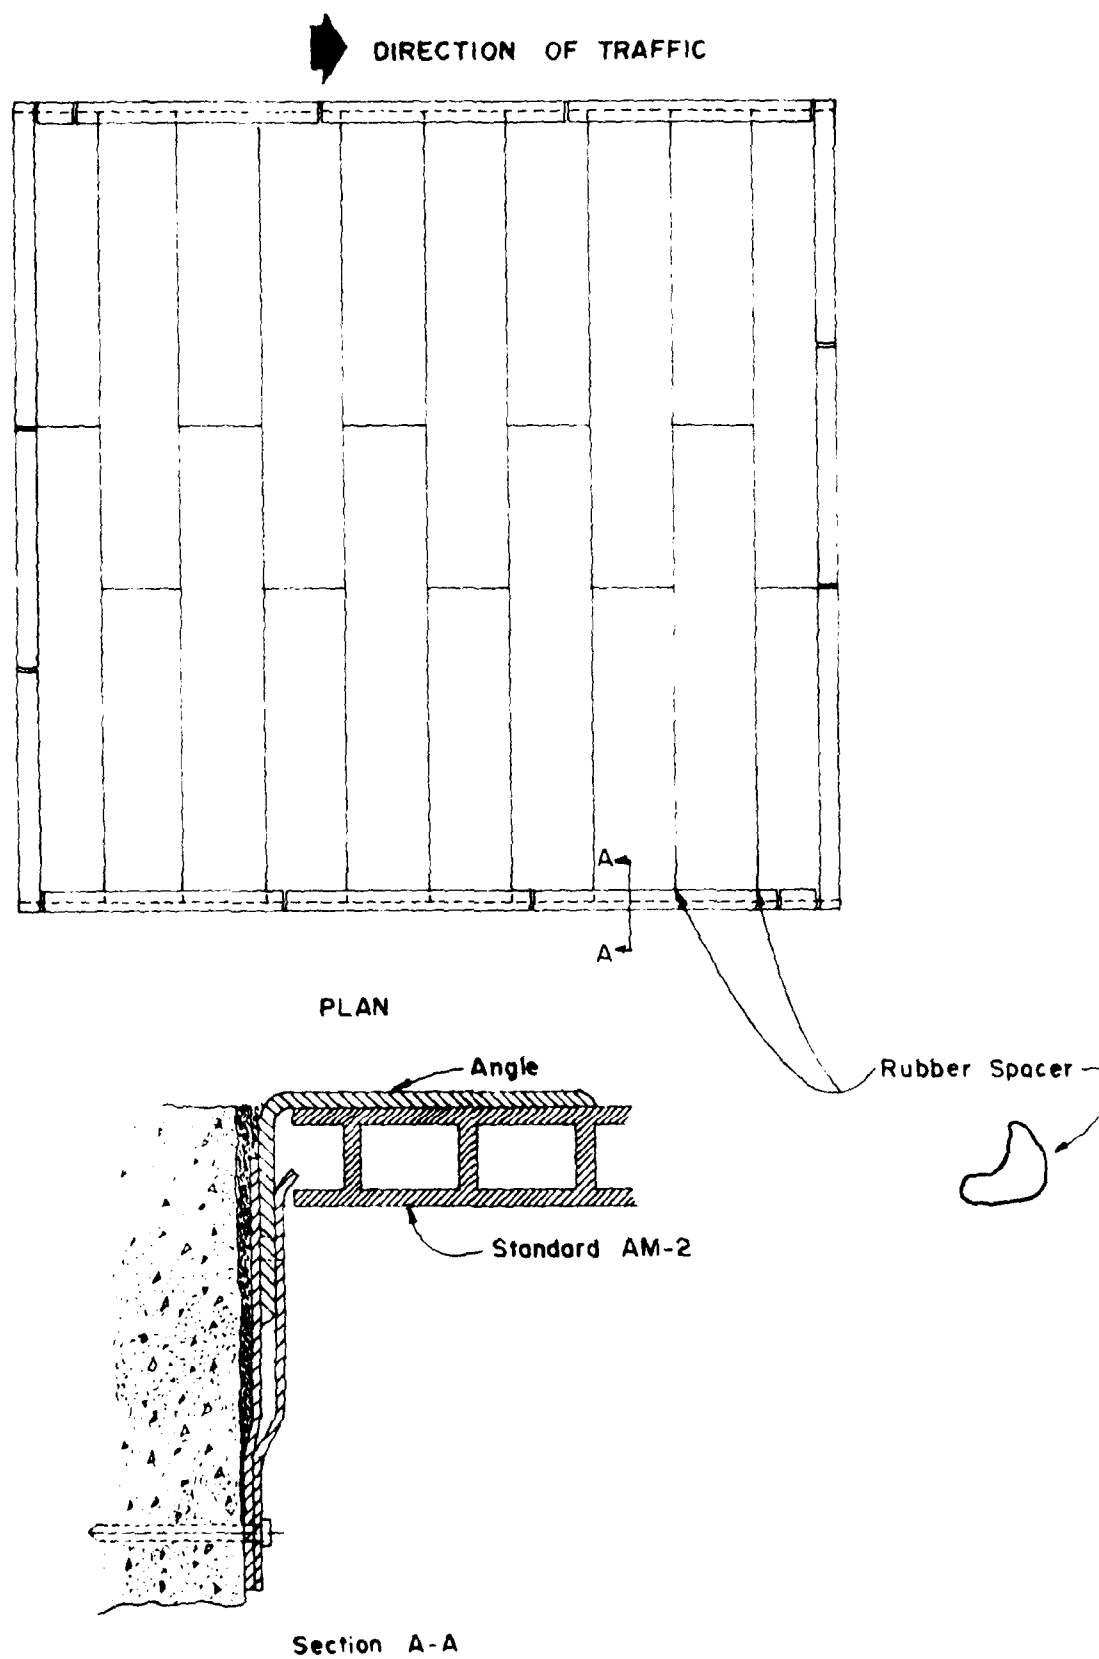
Figure 10. Standard AM-2 Mat System

Since installation time is a major factor, AFESC also decided to test two simpler systems. One system consisted of standard AM-2 panels cut to fit the 20-foot by 20-foot pit. The anchoring system designed for the side panel concept was used to anchor this prototype. Details are shown in Figure 10. The other system was tested using Silikal®, a polymer concrete, to anchor the AM-2 mat. This system consisted of standard 6-foot and 12-foot AM-2 panels used to form an 18-foot by 18-foot mat. Z-Shaped clips approximately 4 inches wide and 6 inches long on one end and 12 inches long on the other were fastened to the top of the panels and anchored in Silikal® (approximately 12 inches wide and 6 inches deep). Details of this concept are shown in Figure 11.

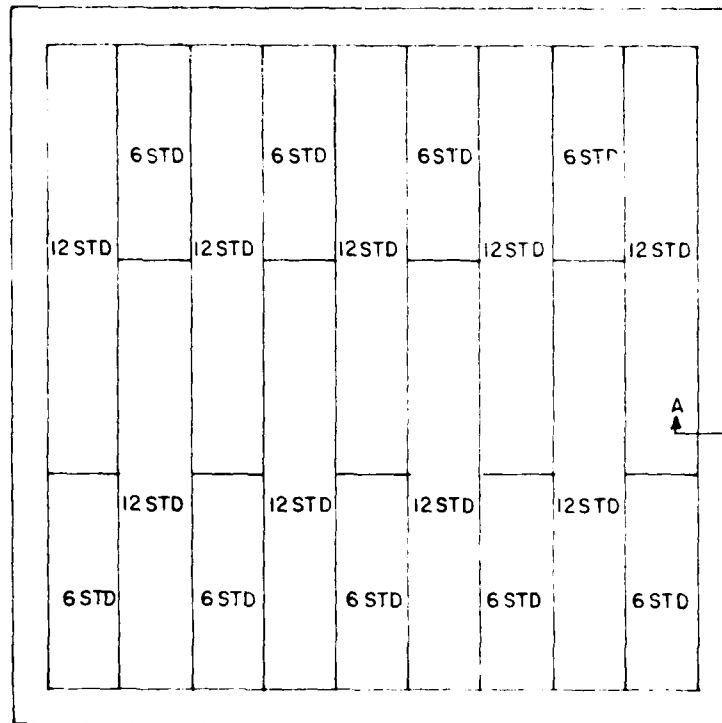
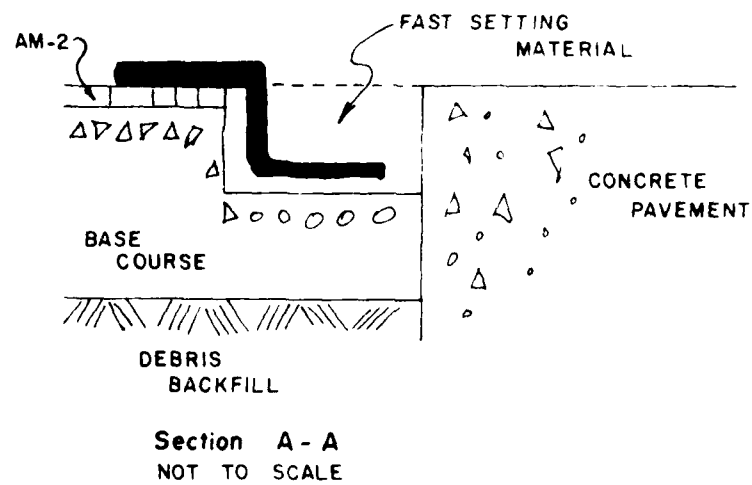
PLAN

Figure 11. Z-Clip System

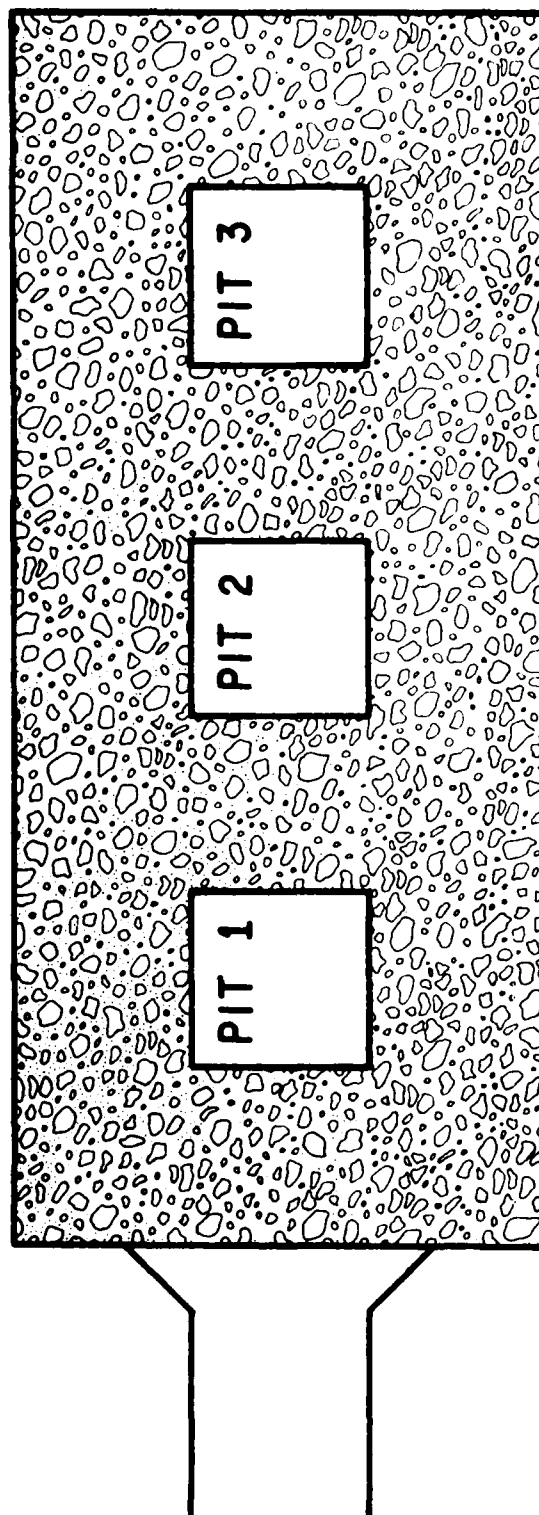
Figure 12. Layout of Test Pit

The pits for all tests were prepared in the same manner. All tests were conducted in pit 2 of the Small Crater Test Facility at Tyndall Air Force Base, Florida (Figure 12). Pit 2 is a 20-foot by 20-foot square opening in a section of portland cement concrete pavement 12 inches thick. The subgrade of pit 2 is a clay with a CBR of approximately 4. Twelve inches of crushed limestone base were placed on the pit 2 clay subgrade. The base was compacted with a RayGo 400 Vibratory Compactor in order to achieve a density of approximately 90 percent of maximum (modified AASHO). The prototype patches were placed on the compacted base and the patch trafficked with the F-4 and C-141 load carts at weights of 27,000 and 140,000 pounds, respectively. The traffic patterns used to traffic the patch are shown on Figures 13 and 14. After completion of the trafficking, a 70,000-pound force was applied to the patch to represent braking action of the C-141. The clay subgrade used in the tests was a local clay obtained near Wewahitchka, Florida. The clay had the following characteristics:

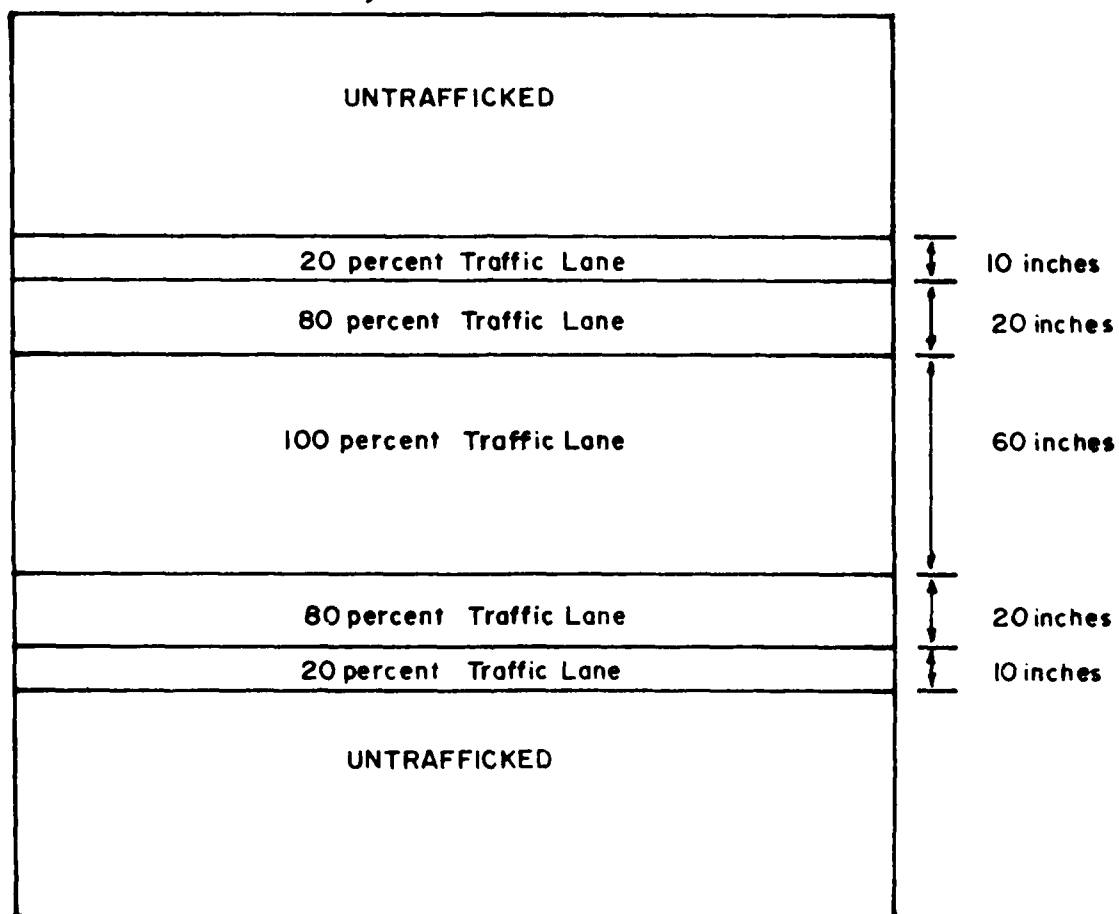
20-foot by 20-foot Test Item

Figure 13. Traffic Pattern for F-4 Load Cart

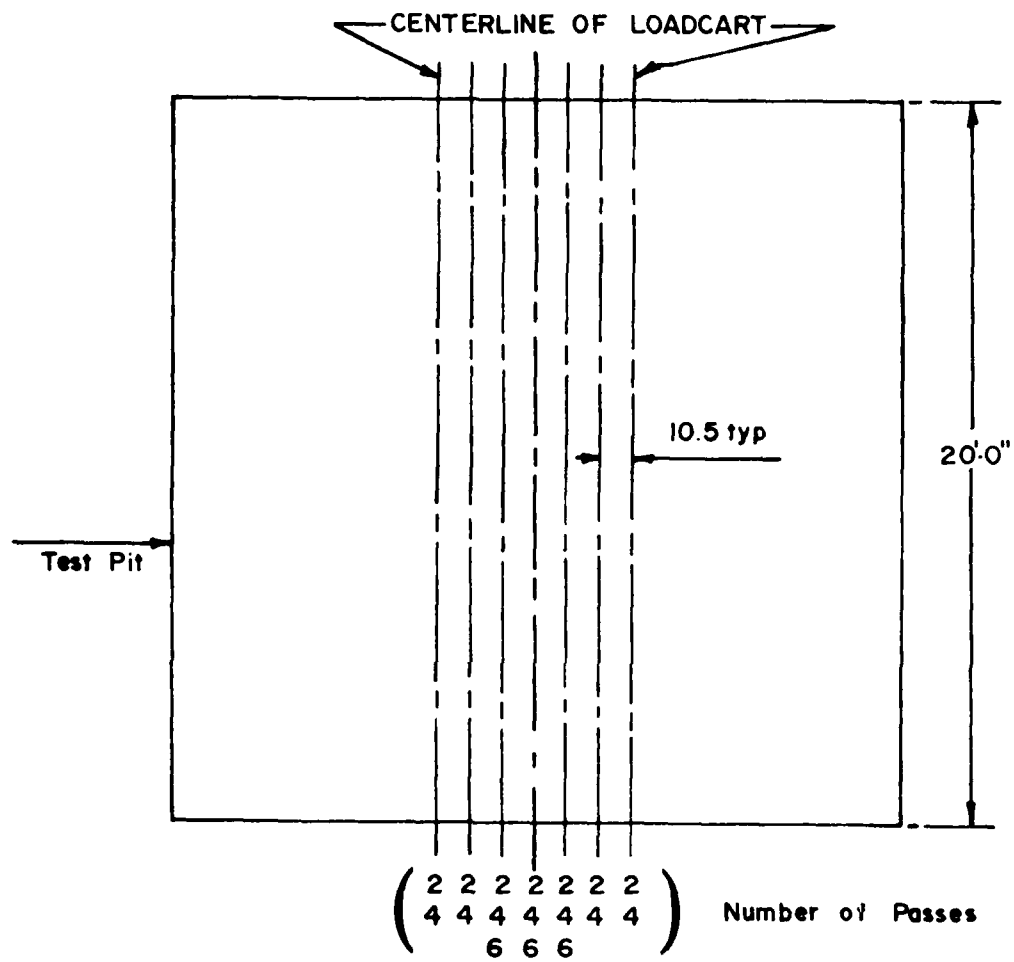
10 Coverages of C-141 Loadcart

Figure 14. Traffic Distribution Pattern for the C-141 Load Cart

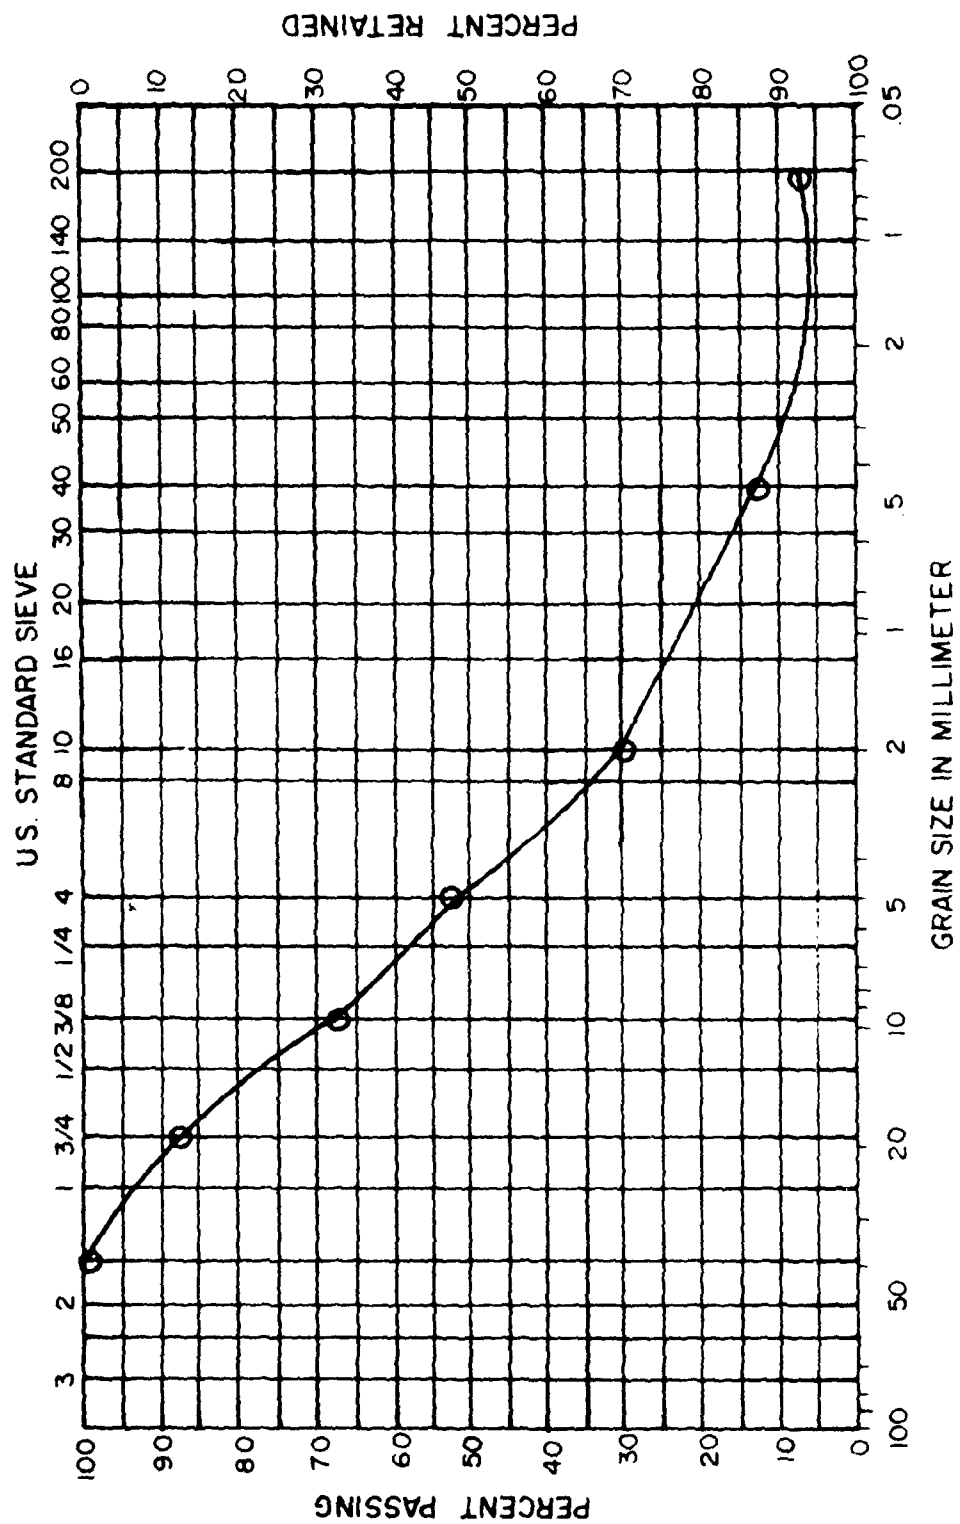
Figure 16. Base Course Aggregate Gradation

| Gradation | See Figure 16 |

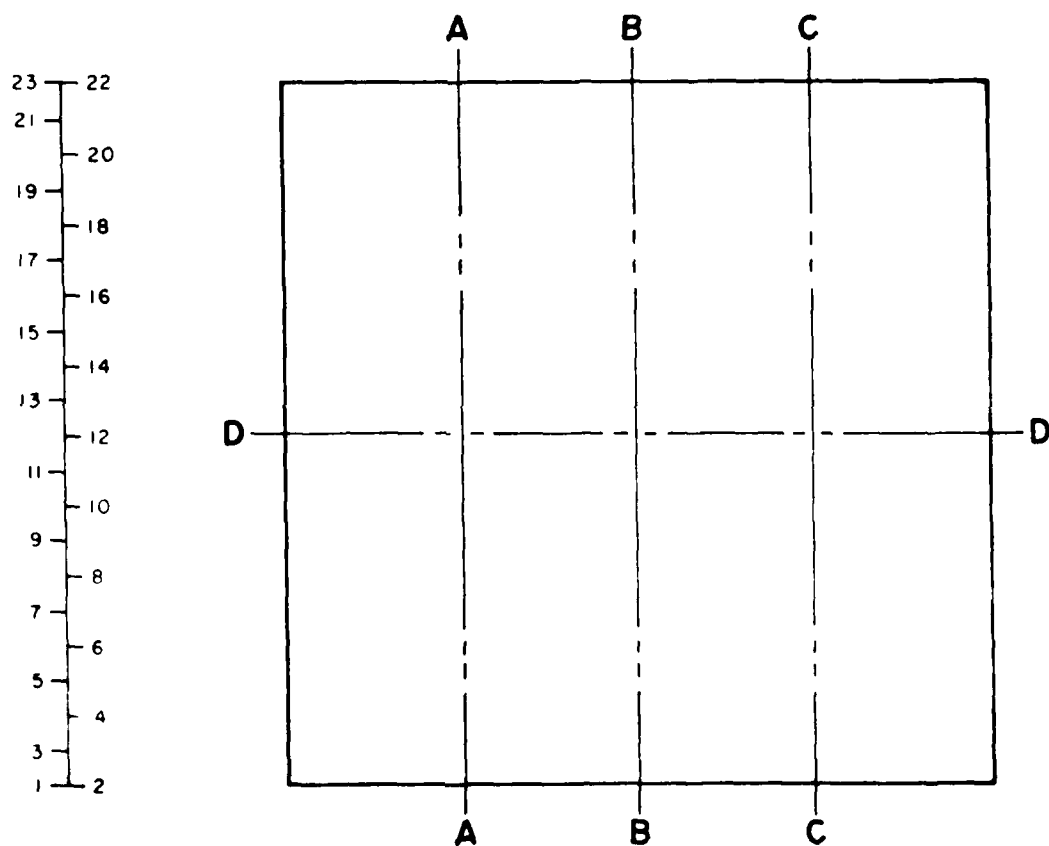
SHOTS 1 & 23 ON CONCRETE  
 SHOTS 2 & 22 ON ADJACENT CONCRETE

Figure 17. Base Lines

Original elevations of the subgrade, base, and mat were taken at one-foot intervals along three base lines in the direction of traffic and in the center of the mat in a transverse direction. Elevations were taken on the mat along the same base lines at specified intervals during the trafficking and on the base course after completion of the trafficking. The structural status of the patch was monitored throughout the testing. A layout of the base lines is shown on Figure 17. Figures 18 through 45 show elevations taken during each test.

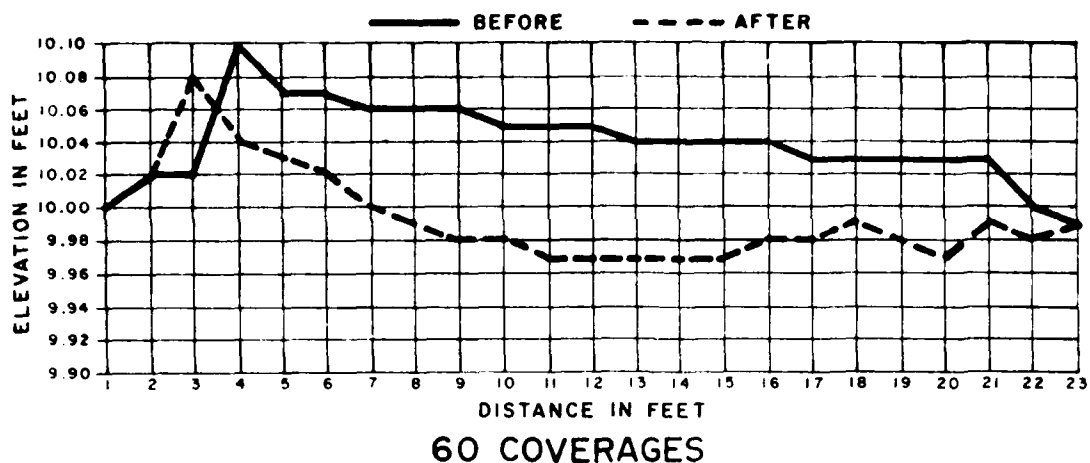
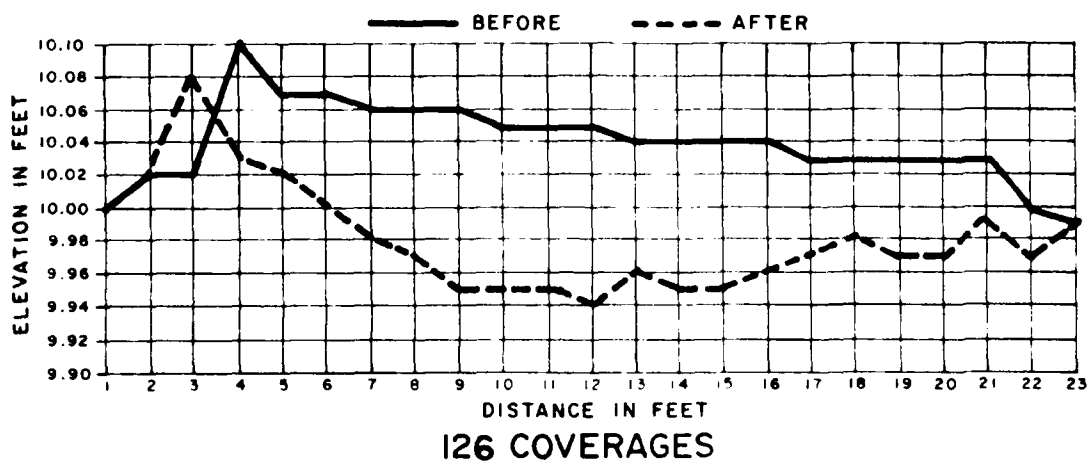
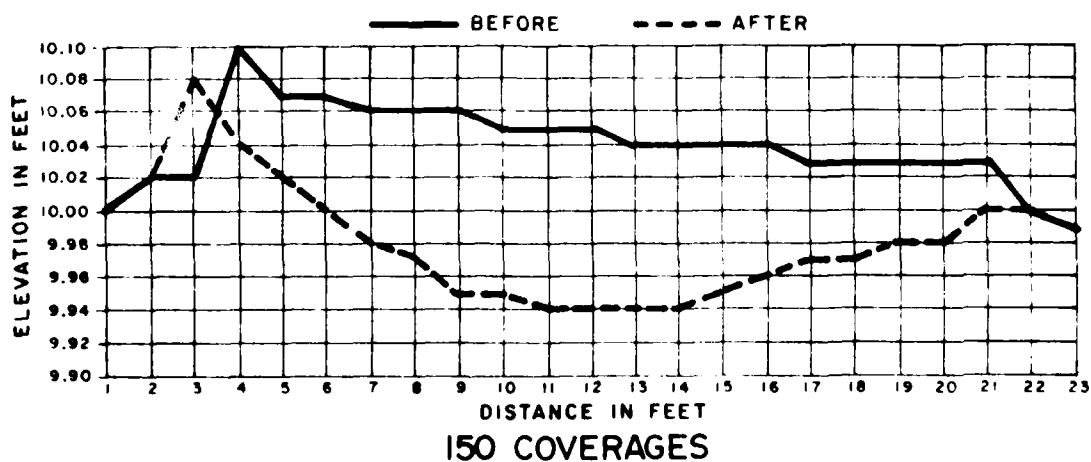
Figure 18. Coverages on Z-Clip System,  
F-4 Aircraft, Base Line A-A

Trafficking with the F-4 load cart began two hours after completion of the patch. Periodically, elevations along the base lines were measured and visual observations made to determine the structural integrity on the patch. Plots of the elevations are shown on Figures 18 through 27. Visual observations are noted below:

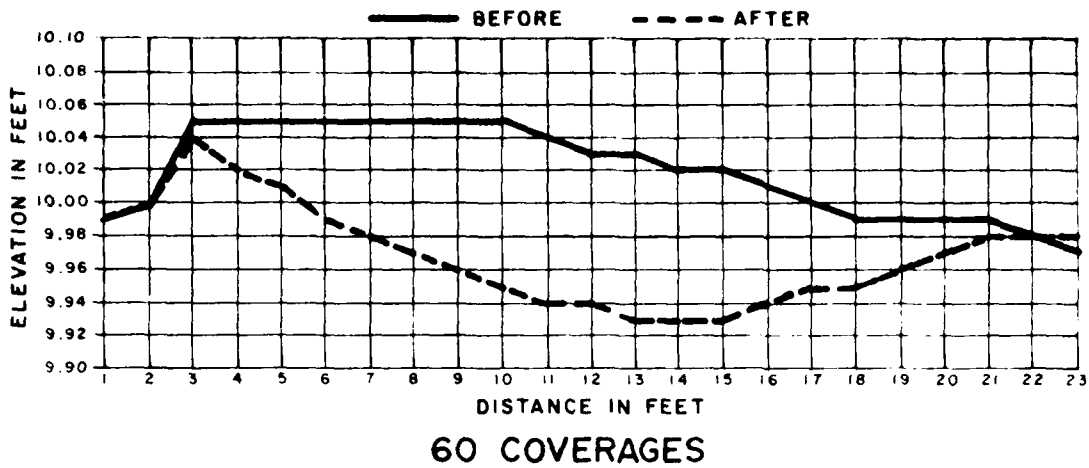
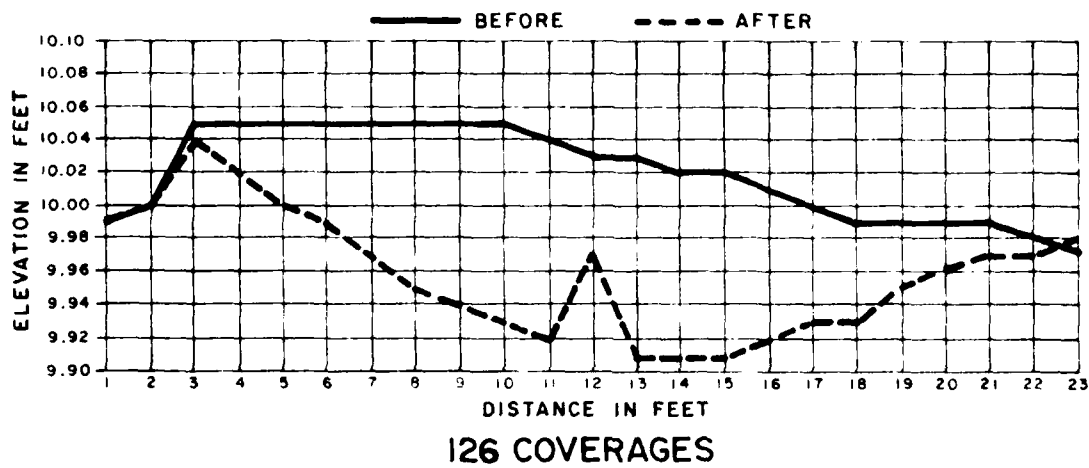
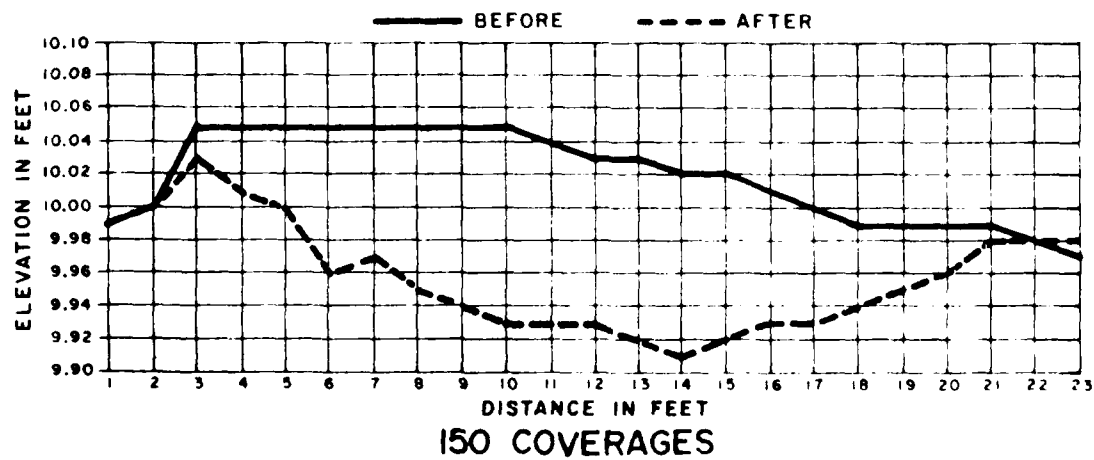
Figure 19. Coverages on Z-Clip System,  
F-4 Aircraft, Base Line B-B

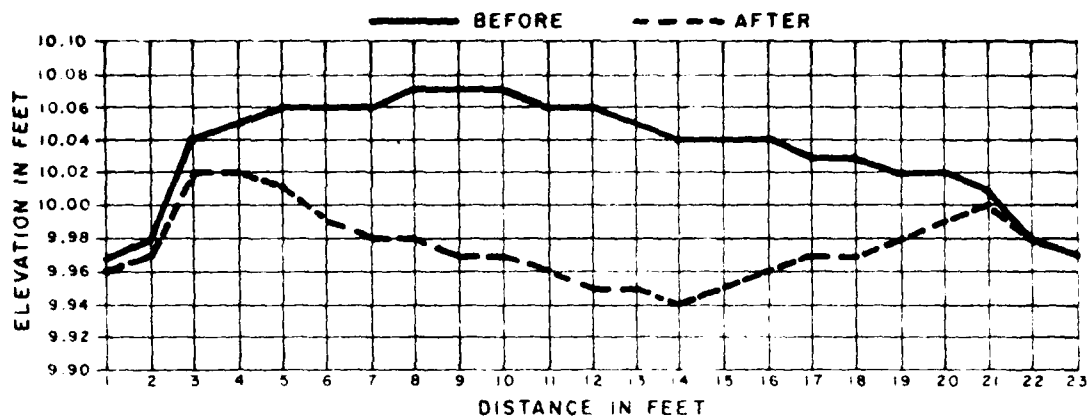
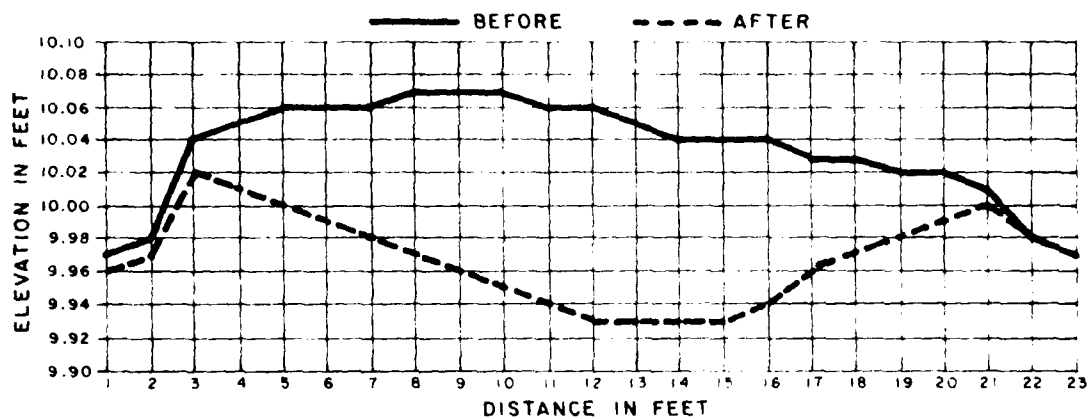
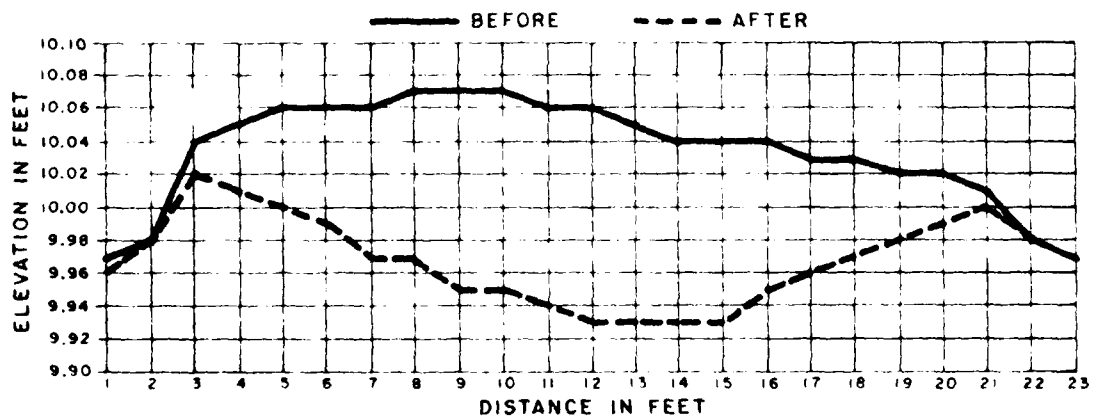
60 COVERAGES

126 COVERAGES

150 COVERAGES

Figure 20. Coverages on Z-Clip System,  
F-4 Aircraft, Base Line C-1
