ESL-TR-80-45

## FLUSH AM-2 MAT PATCH FOR RAPID RUNWAY REPAIR

JAMES L. GREENE

SEPTEMBER 1980

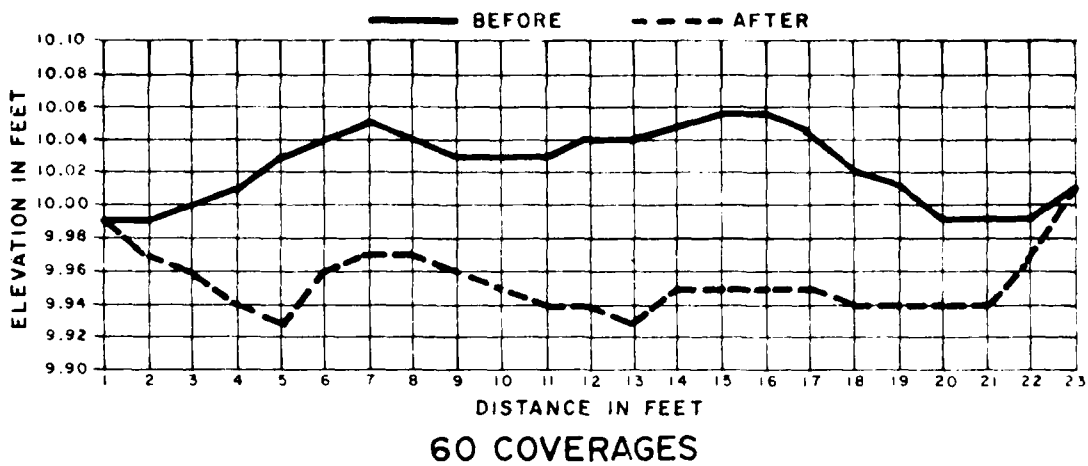
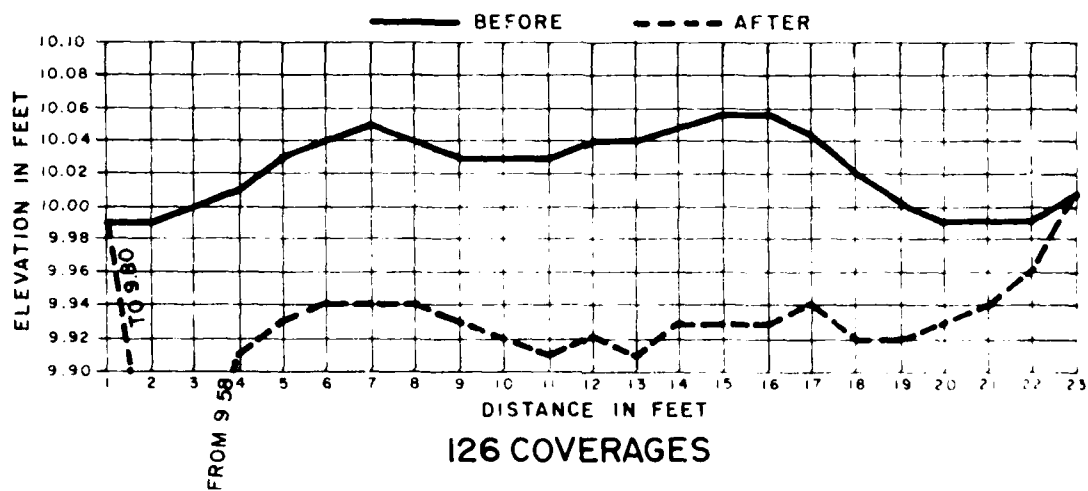
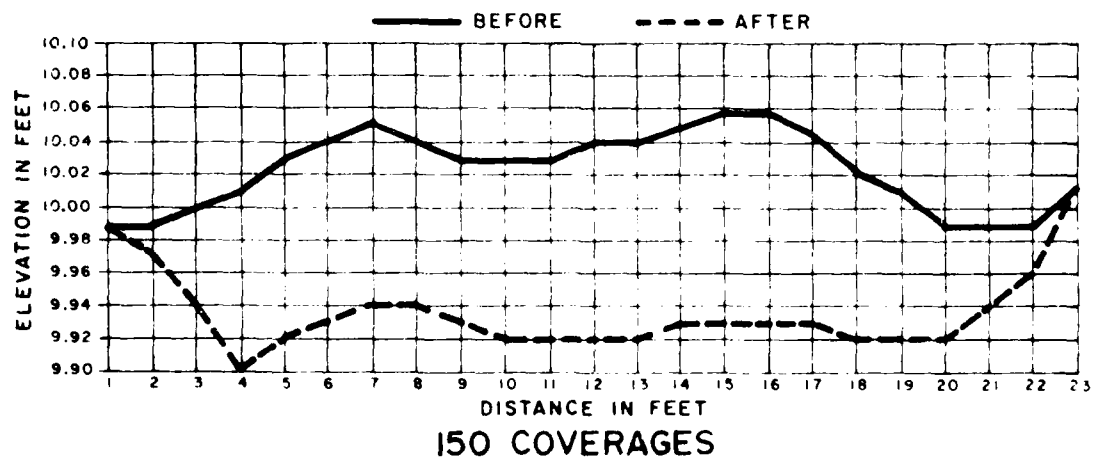
Figure 21. Coverages on Z-Clip System,  
F-4 Aircraft, Base Line D-D

Trafficking with the F-4 load cart began two hours after completion of the patch. Periodically, elevations along the base lines were measured and visual observations made to determine the structural integrity on the patch. Plots of the elevations are shown on Figures 18 through 27. Visual observations are noted below:

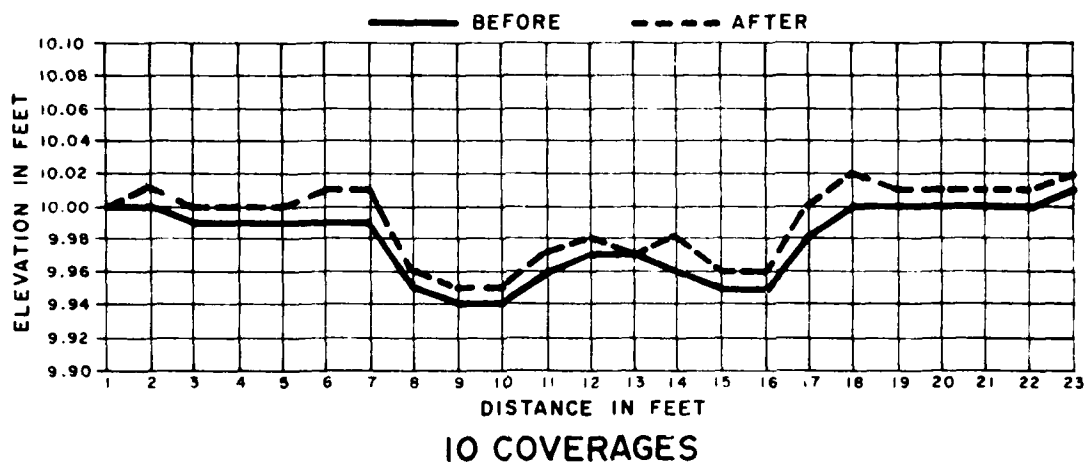
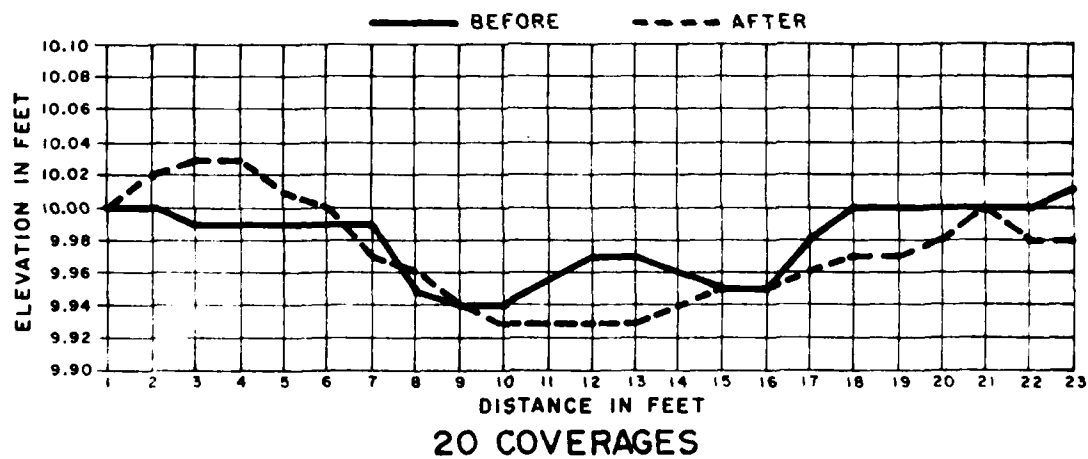
Figure 22. Coverages on Z-Clip System, C-141 Aircraft,  
Base Line A-A

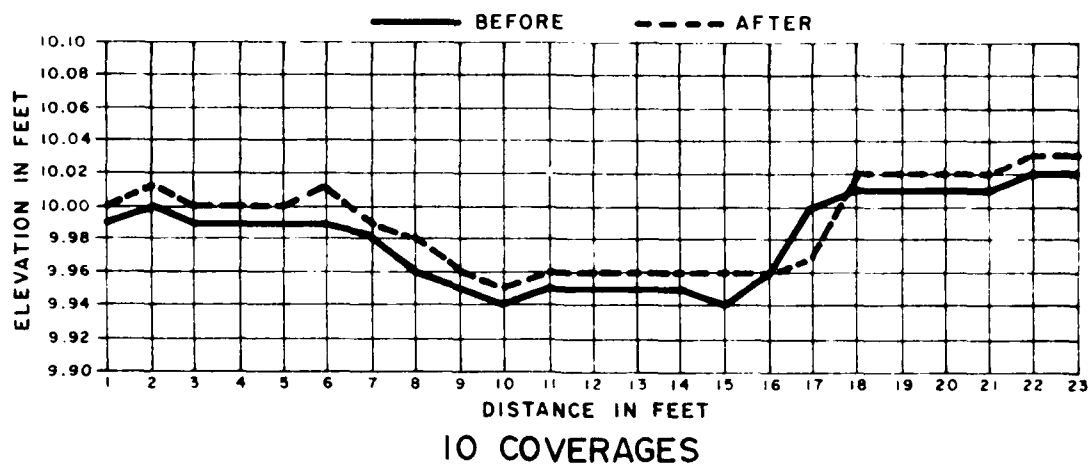
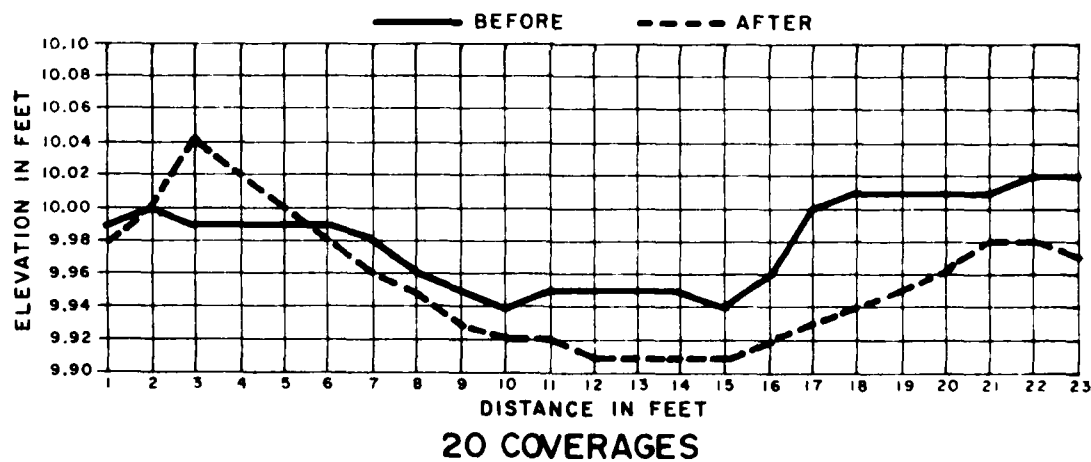
Figure 23. Coverages on Z-Clip System, C-141 Aircraft, Base Line B-B

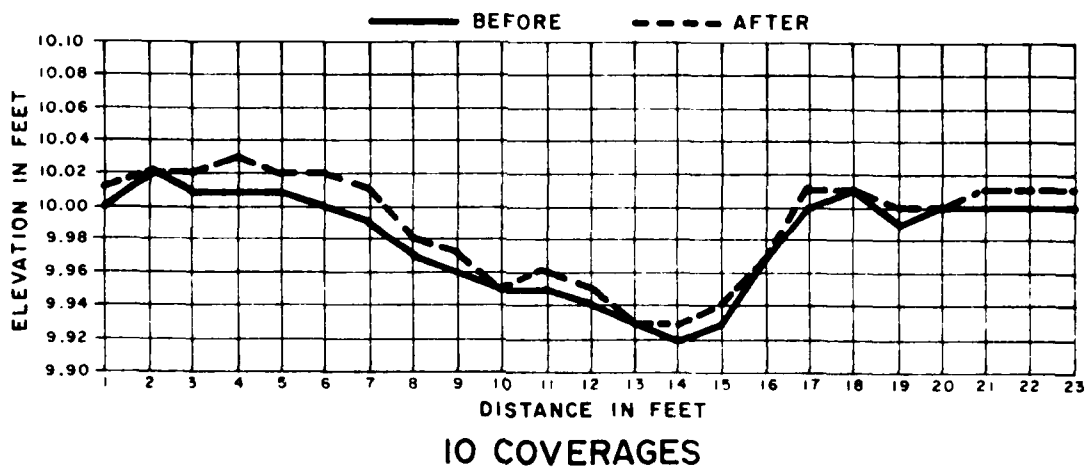
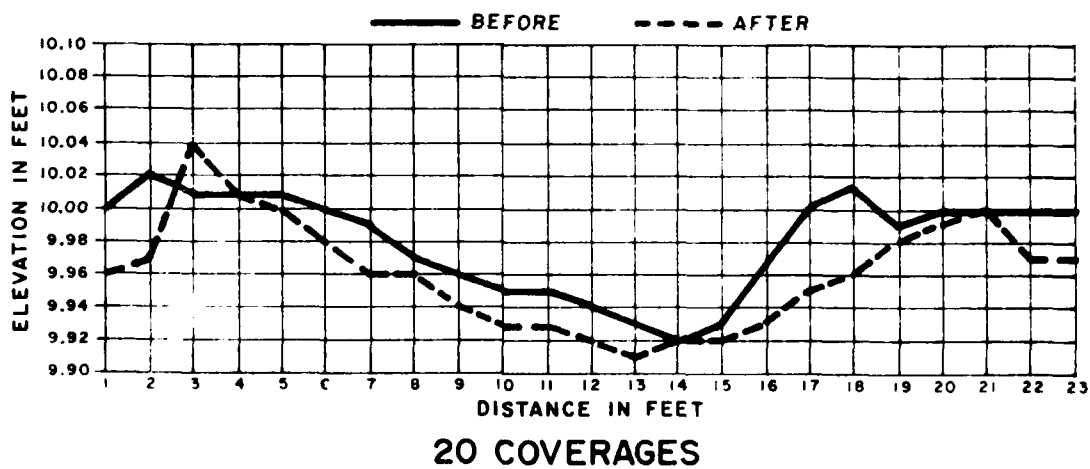
Figure 24. Coverages on Z-Clip System, C-141 Aircraft,  
Base Line C-C

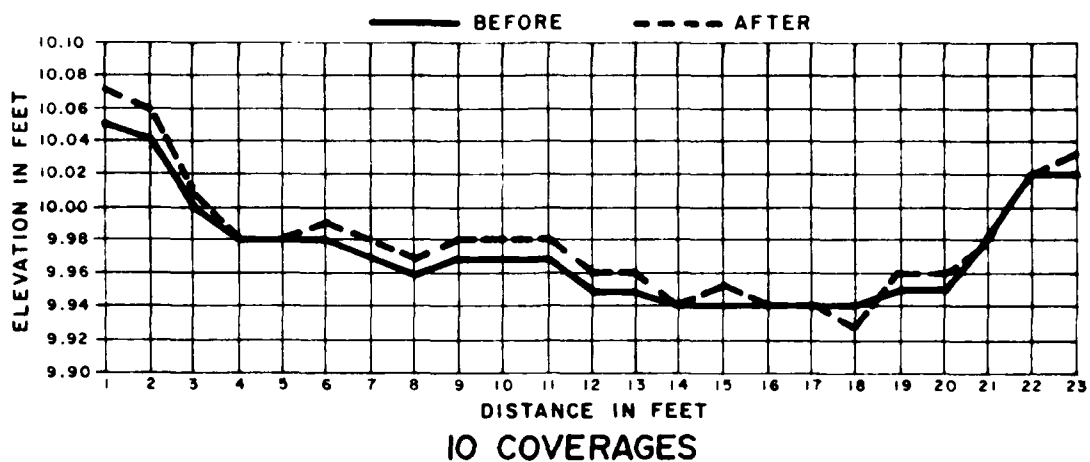
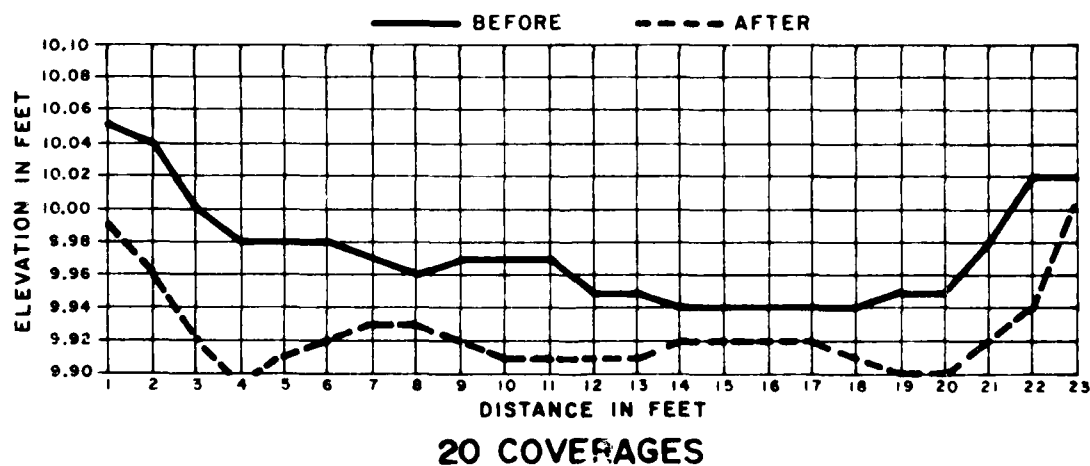
Figure 25. Coverages on Z-Clip System, C-141 Aircraft,  
Base Line D-D

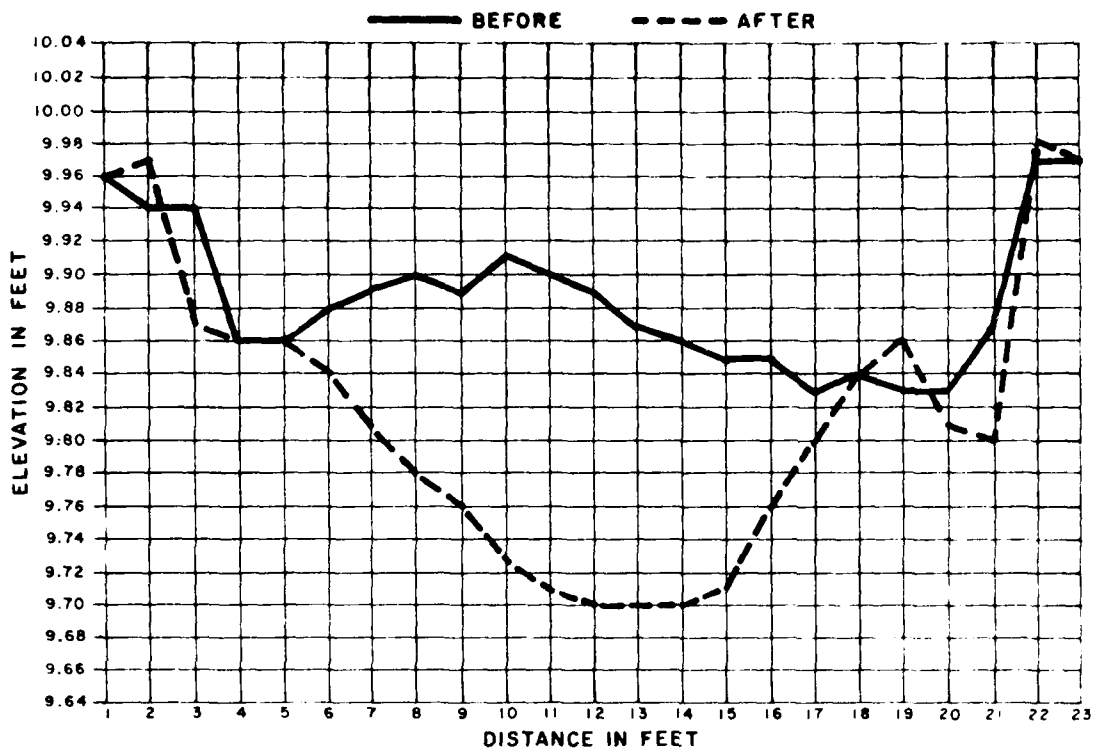
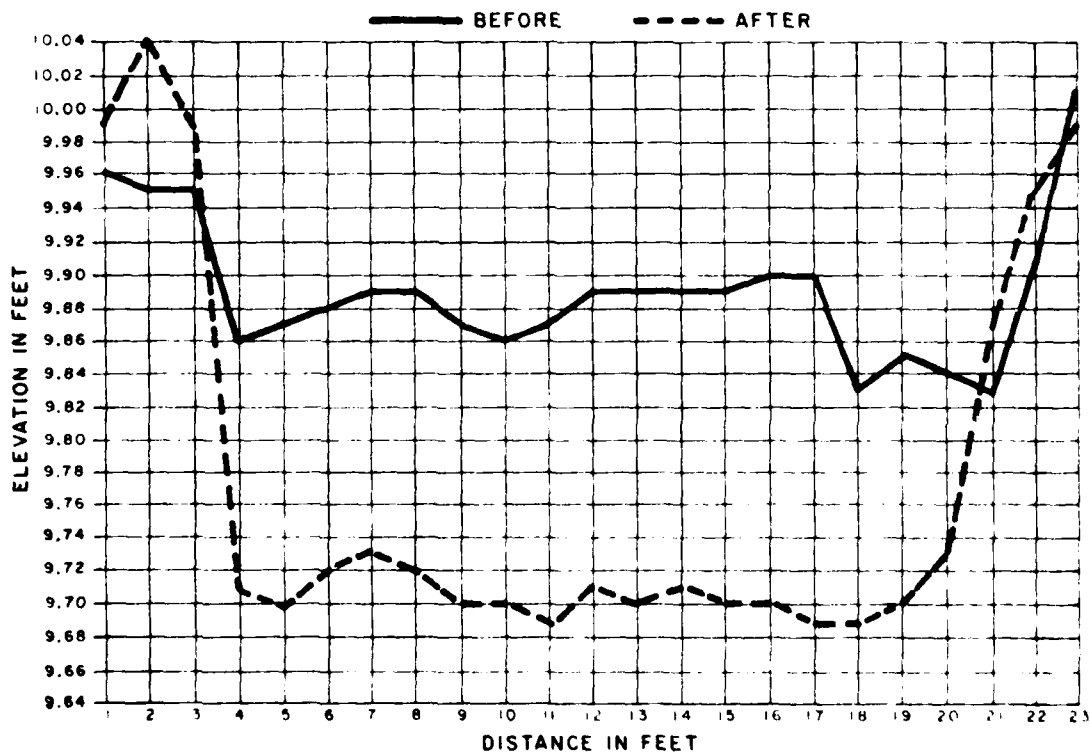
BASE LINE C-C

BASE LINE D-D

Figure 27. Coverages on Z-Clip System,  
150 Cov. F-4/20 Cov. C-141,  
Base Lines C-C and D-D

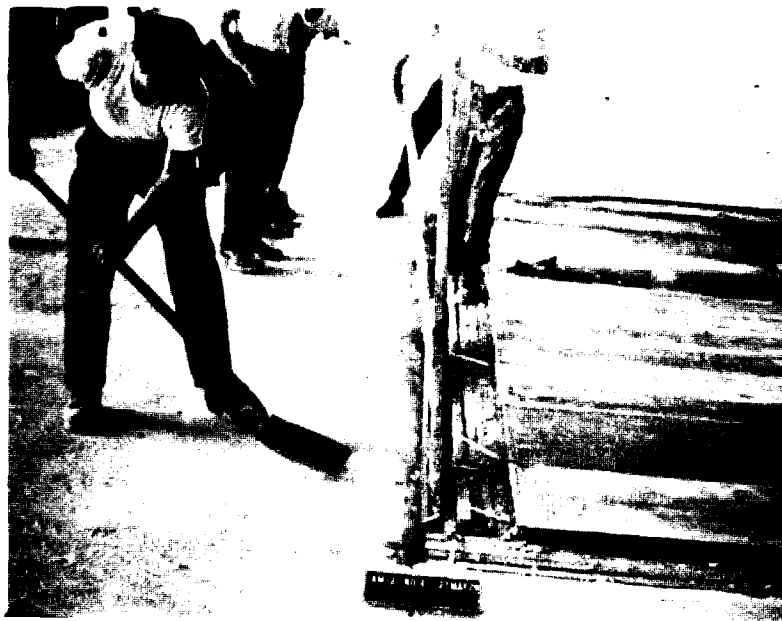
Figure 30. Test 1 (Z-Clit) - Removing Wooden Box (Form for Placing Silikal®)

Visual observations are shown in Figures 28 through 42.

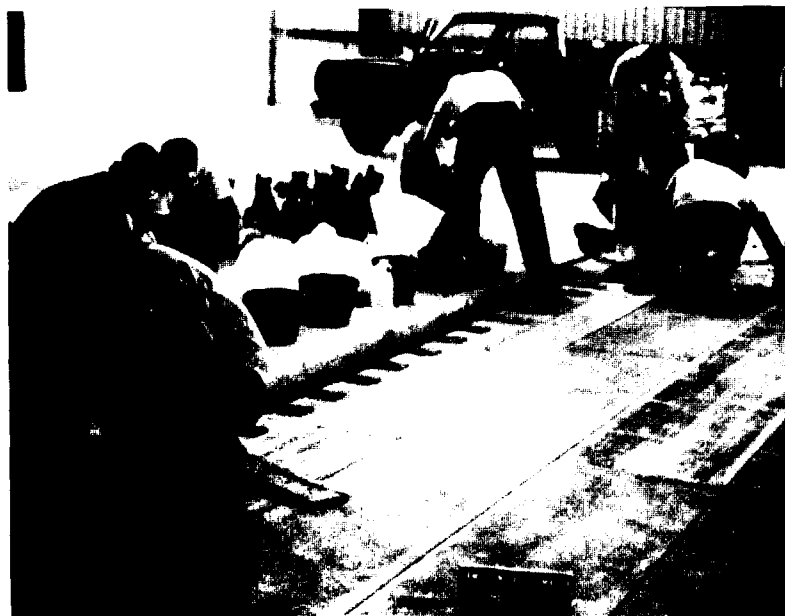
Figure 33. Test 1 (Z-Clip)-Placing  
Silik '0

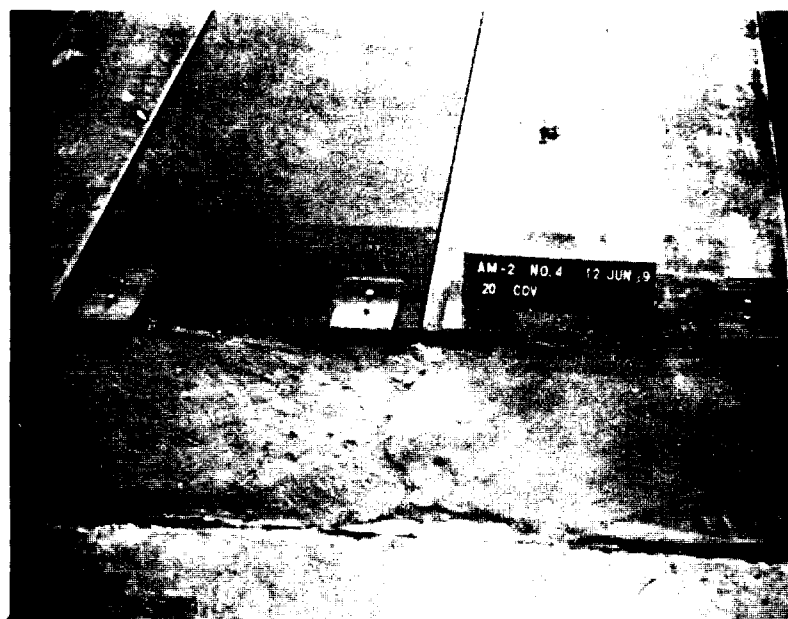
Figure 36. Test 1 (Z-Cl 15)-20 Coverages of F-4

- (1) 10 Coverages: Several of the clips had pulled loose from the panels. Maximum separation was 1/4 inch.
- (2) 20 Coverages: A few hairline cracks were noted around the inside edge of the Silikal®.

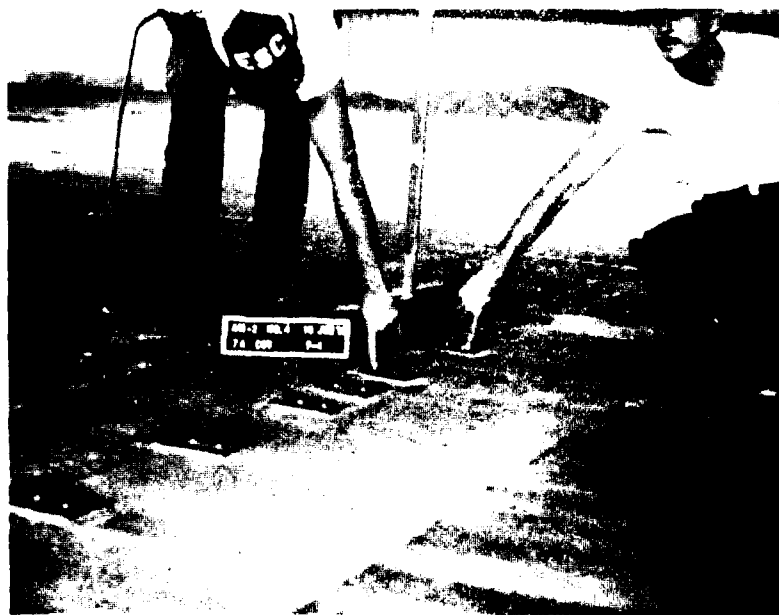
Figure 39. Test 1 (Z-C 11) - 24 Coverages of F-4  
(Loose Nails)

- (5) 74 Coverages: Some nails had to be hammered back in. The spalled concrete was swept from the traffic lane.
- (6) 80 Coverages: Spalling of the Silikal® had increased. Many clips in the traffic lane were loose. Nails were constantly being hammered in to prevent damage to the tire.

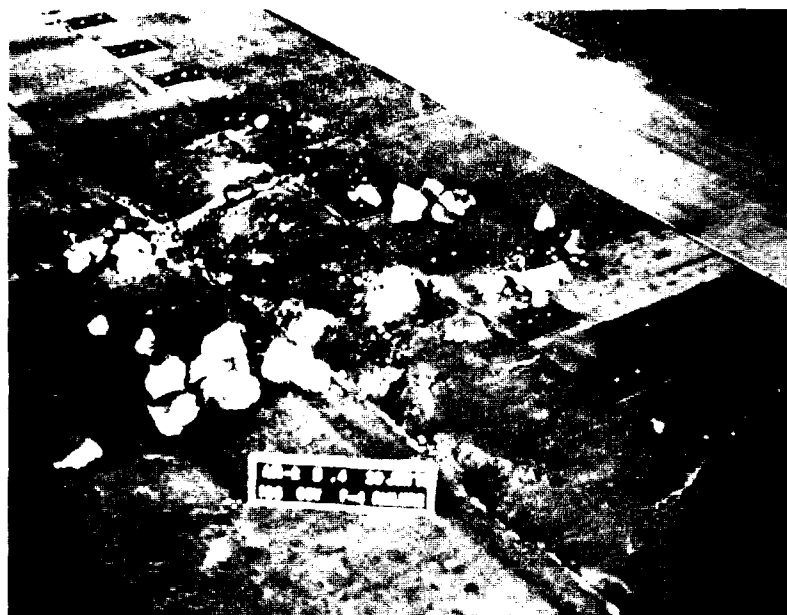
Figure 40. Test 1 (Z-Clip)-126 Coverages of F-4  
(Failure)

(7) 126 Coverages: Structural failure of the patch had occurred. The Silikal® was badly spalled with 3- or 4-inch pieces readily removed by hand. A sizeable deflection of the panels was noted as the load cart crossed.

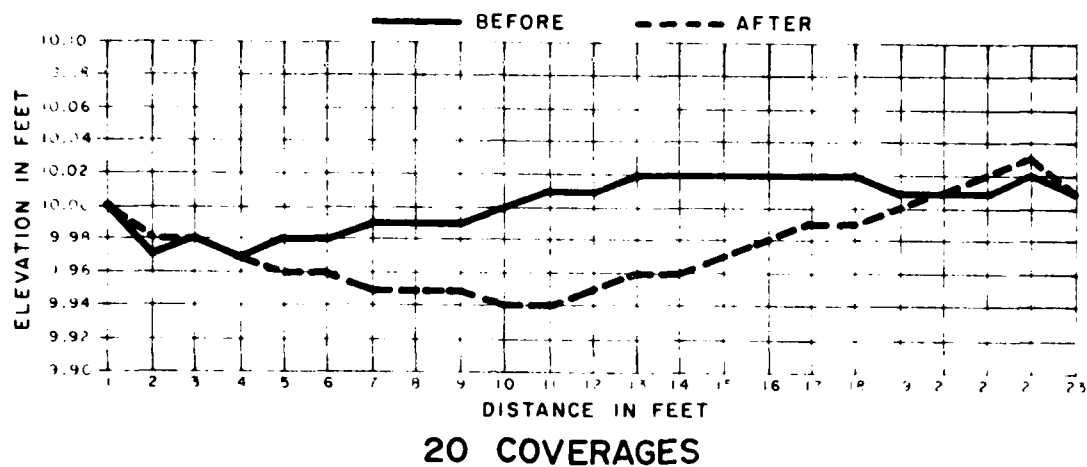
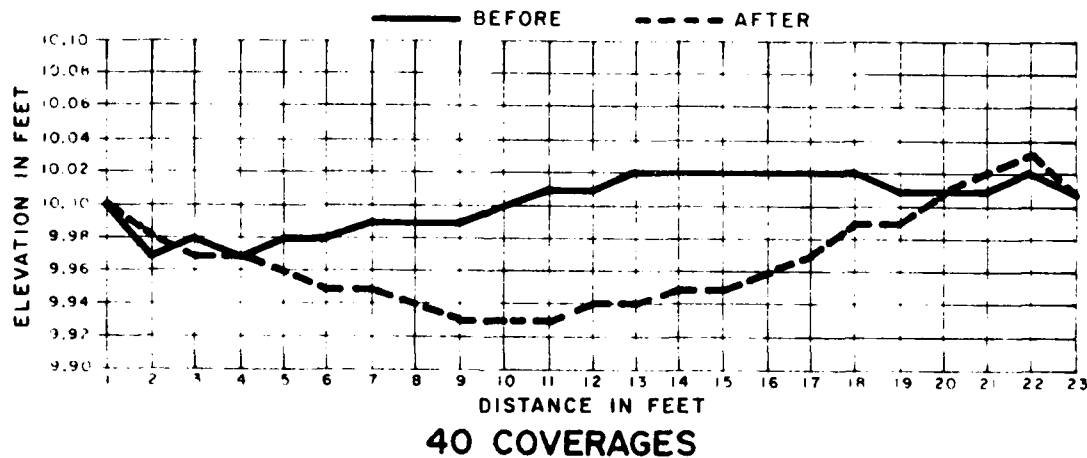
Figure 43. Coverages on Perimeter Rail System, F-4 Aircraft, Base Line A-A

It was apparent immediately after trafficking began with the F-4 load cart that this system was weak. The rail, resting directly on the subgrade, settled after a few coverages causing the load cart to bounce as it came on or off the patch. This also exposed the sharp edge of the concrete posing possible damage to the F-4 tire. It was noted that after 20 coverages there were several short tears where the extrusion was welded to the ends of the panels. There was about a one inch lip at the edge of the concrete. Failure was determined at 60 coverages due to the amount of deflection of the rail and the resulting possibility of tire damage. Since failure occurred in the early stages of testing with the F-4, the C-141 trafficking was not accomplished.

Test data for this concept is shown on Figures 43 through 48. Visual observations during testing are shown in Figures 49 through 56.

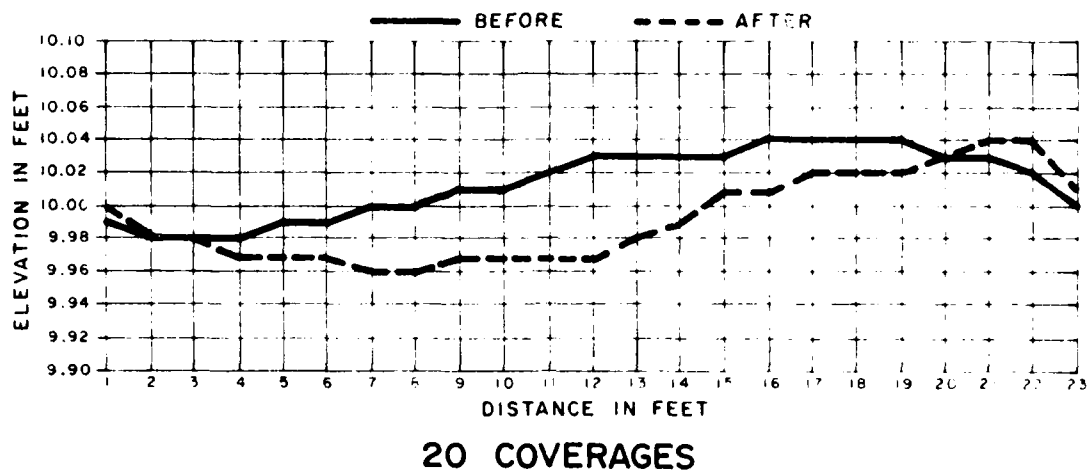
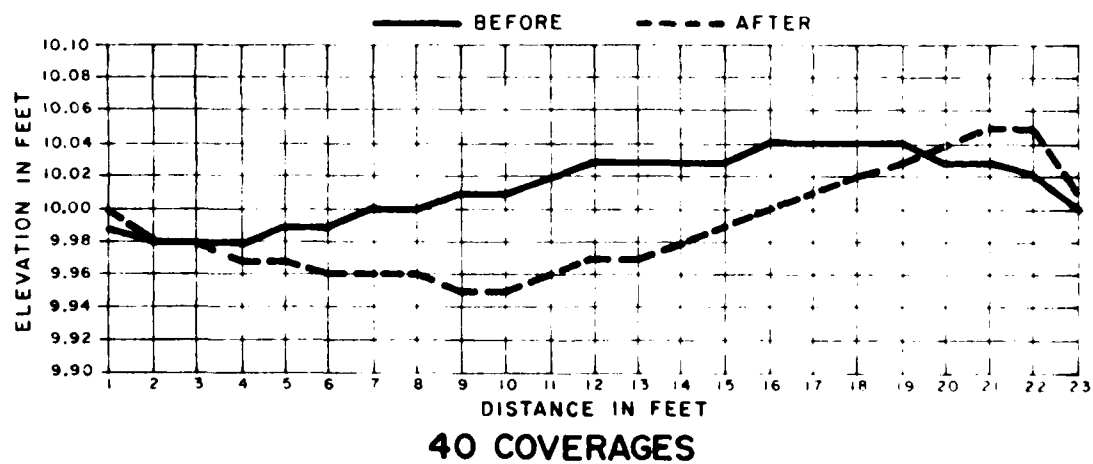
Figure 44. Coverages on Perimeter Rail System, F-4 Aircraft, Base Line B-B

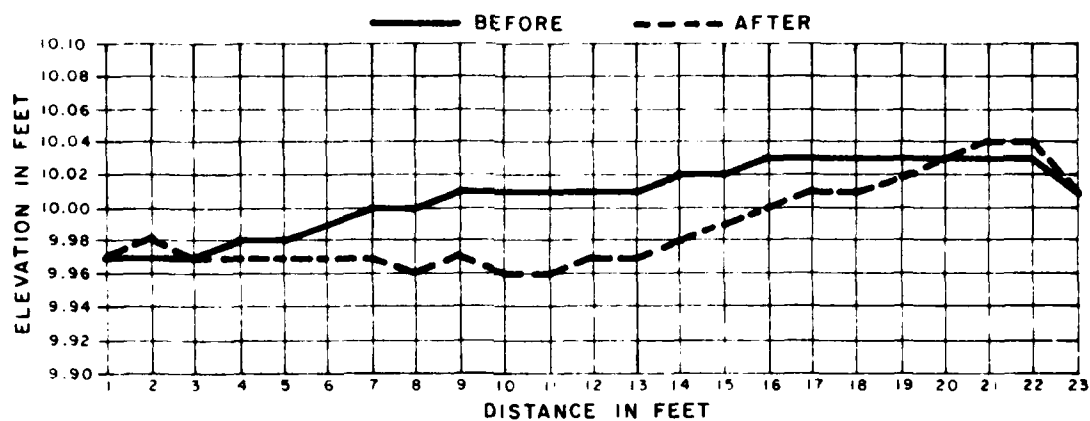
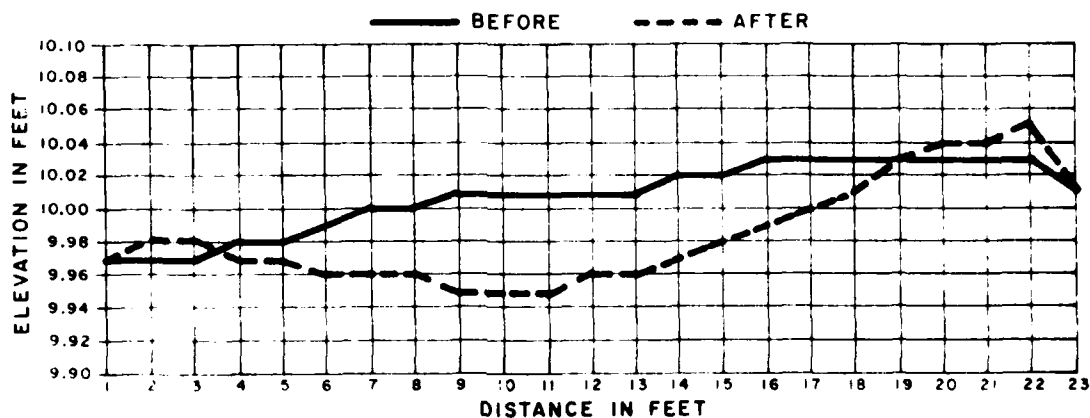
### 20 COVERAGES

### 40 COVERAGES

Figure 45. Coverages on Perimeter Rail System, F-4 Aircraft,  
Base Line C-C

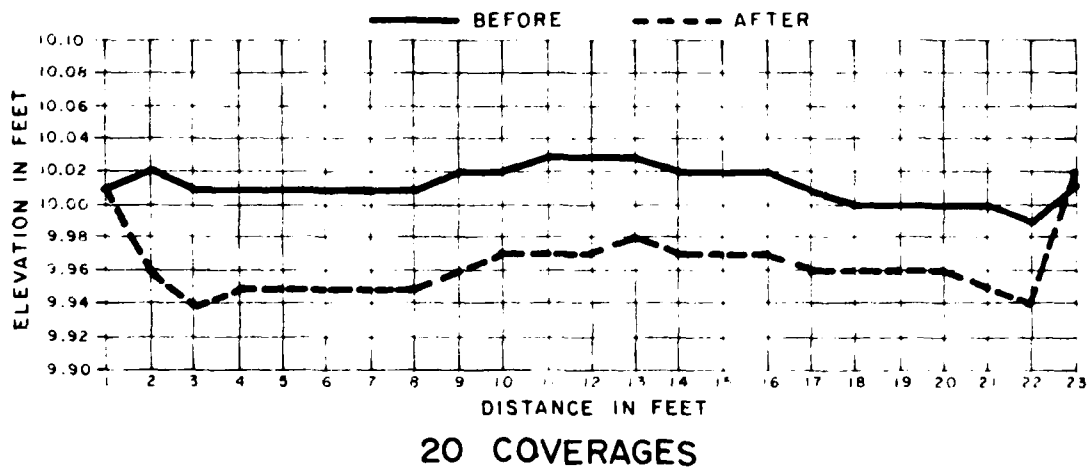
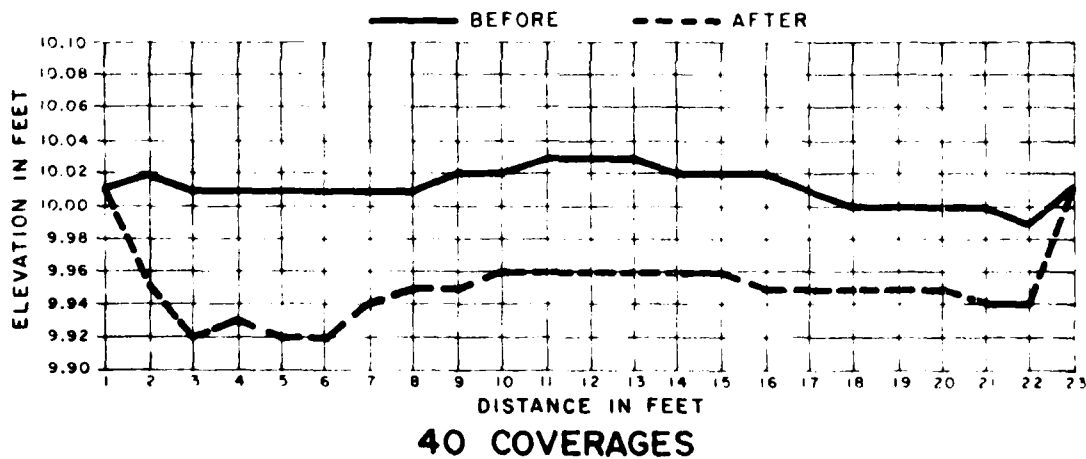
Figure 46. Coverages on Perimeter Rail System, F-4 Aircraft, Base Line D-D

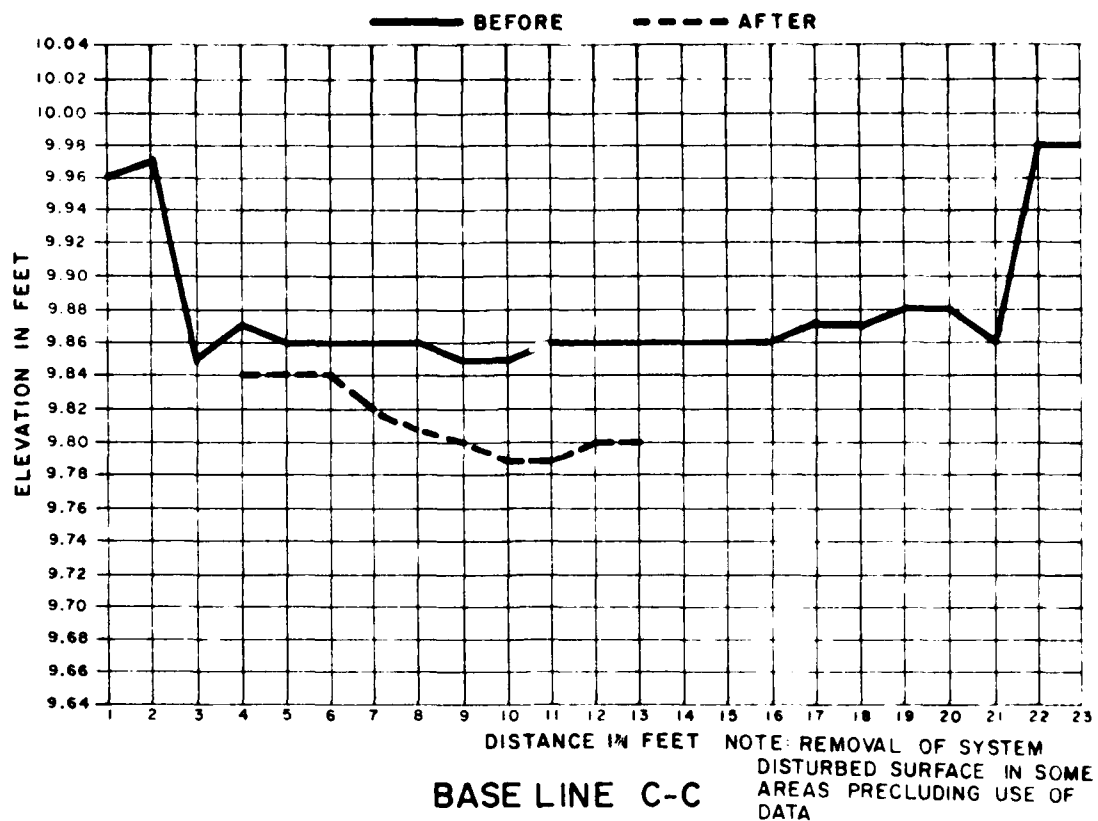
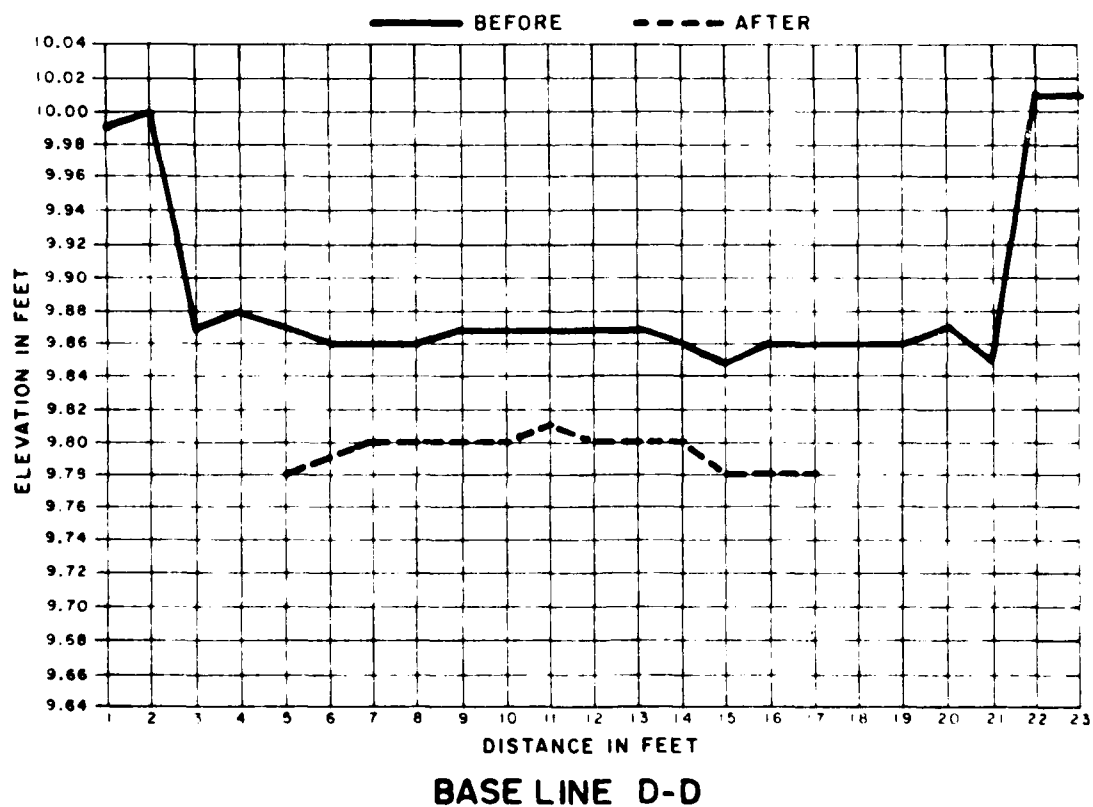
Figure 48. Coverages on Perimeter Rail System, F-4 Aircraft, 60 Coverages, Base Lines C-C and D-D

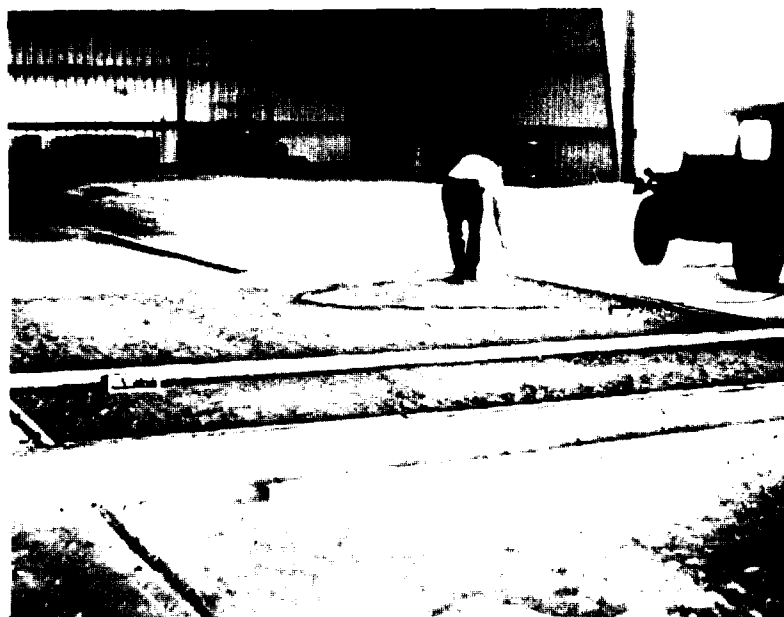
Figure 51. Test 2 (Perimeter Rail)-Blowing  
Aggregate From Perimeter Rail  
Locking Assembly

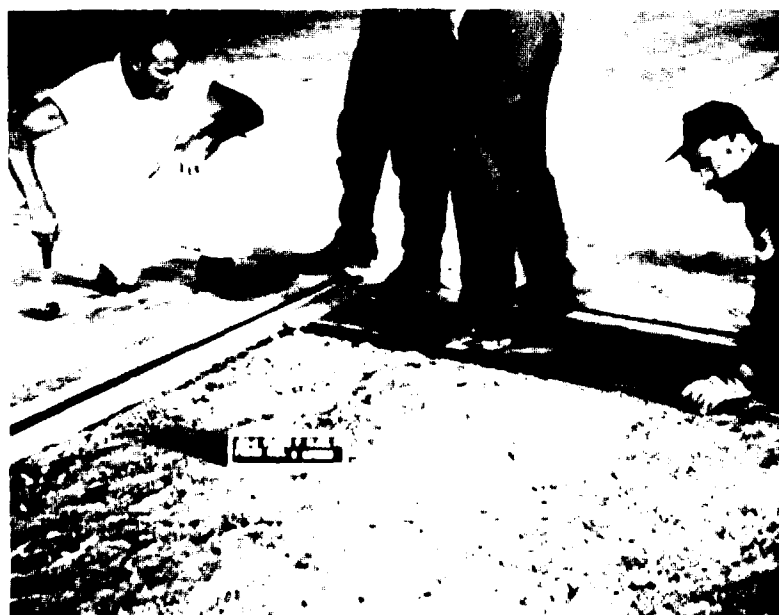
Figure 52. Test 2 (Perimeter Rail)-  
Installing AM-2 Mat

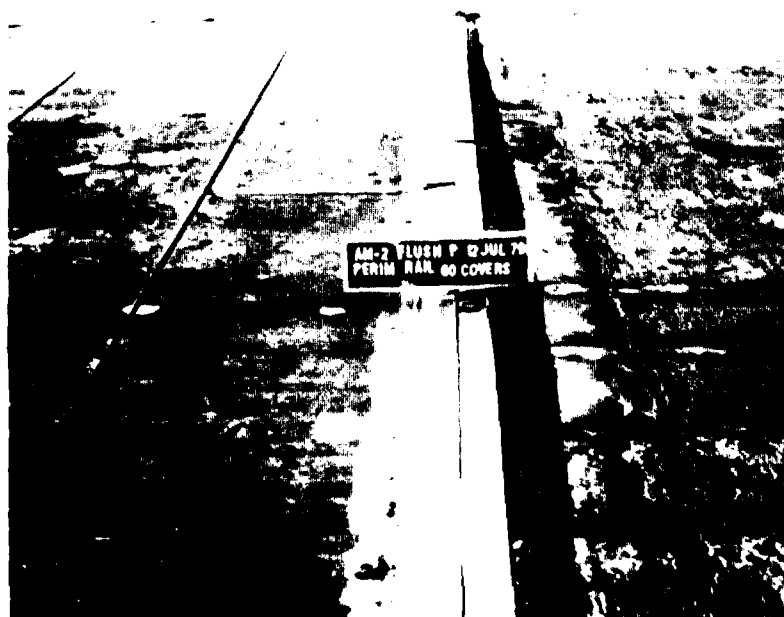
Figure 54. Test 2 (Perimeter Rail)-  
60 Coverages of F-4

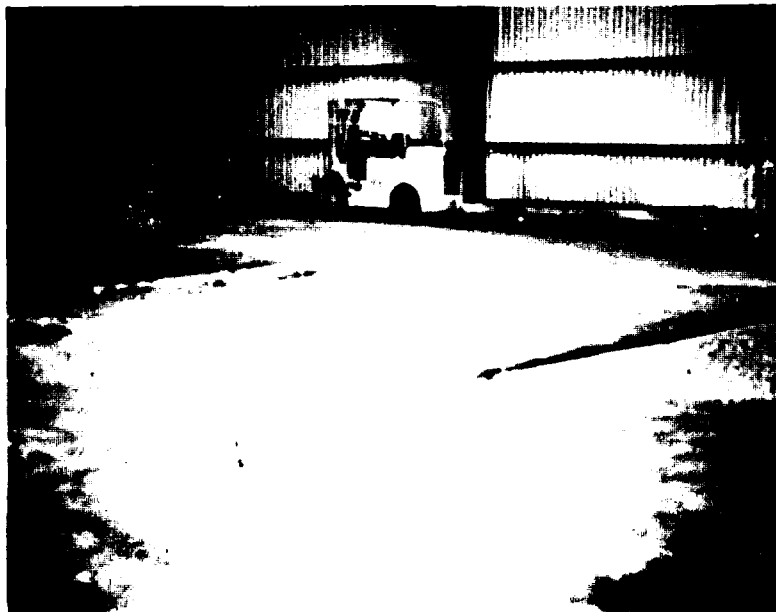
Figure 56. Test 2 (Perimeter Rail)-Base Course After Testing

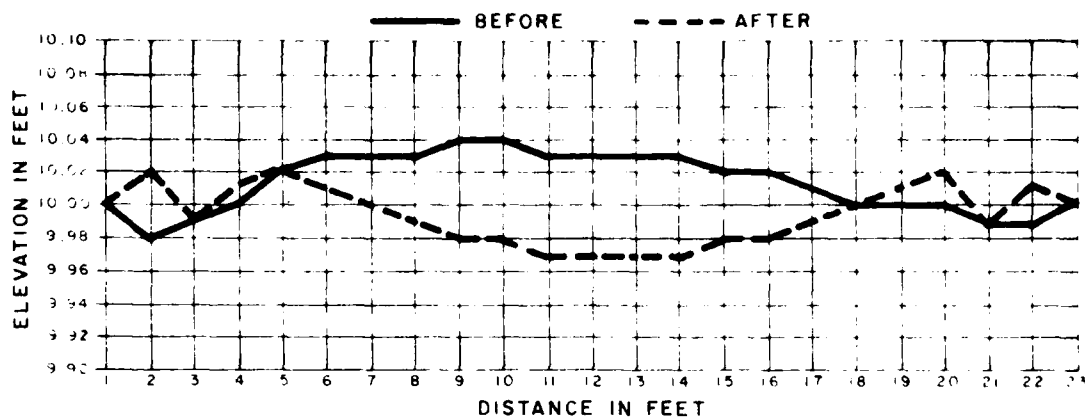
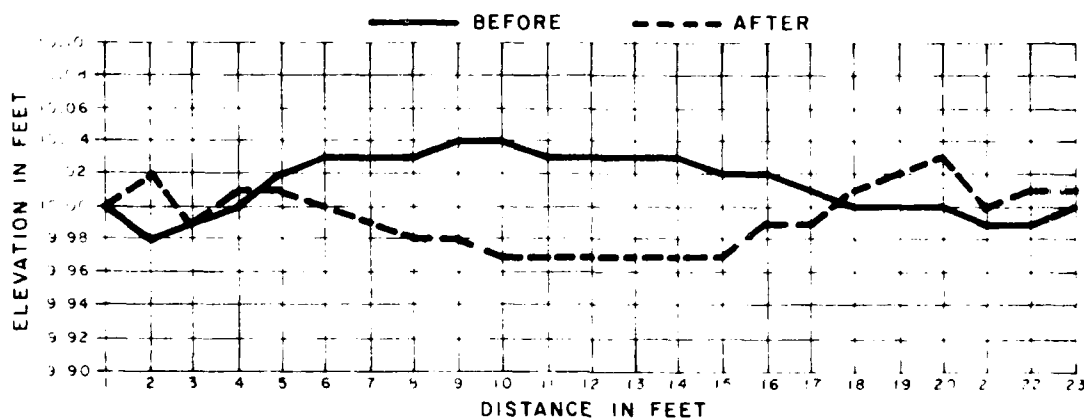
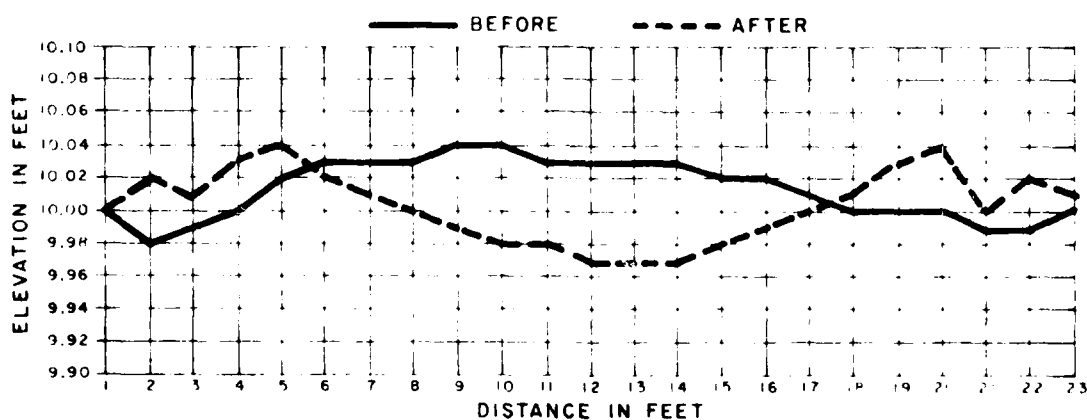
60 COVERAGES  
F-4

150 COVERAGES  
F-4

20 COVERAGES C-141

Figure 57. Coverages on Side Panel System, F-4 Aircraft and C-141 Aircraft, Base Line A-A

After six coverages of the F-4, it appeared the nails were beginning to loosen as deflection was noted in the locking assembly as the load cart passed. Several times during trafficking, an angle would come loose. This could have been prevented by making the projection on the angle longer so that it would not slip from the locking assembly when the assembly deflects under load. At 40 coverages the inside plate on the locking assembly was beginning to permanently bend towards the center of the pit. A total of 150 coverages of the F-4 were completed with only minor problems encountered.

Test data for this concept during testing are shown in Figures 57 through 62. Visual observations during testing are shown in Figures 63 through 77.

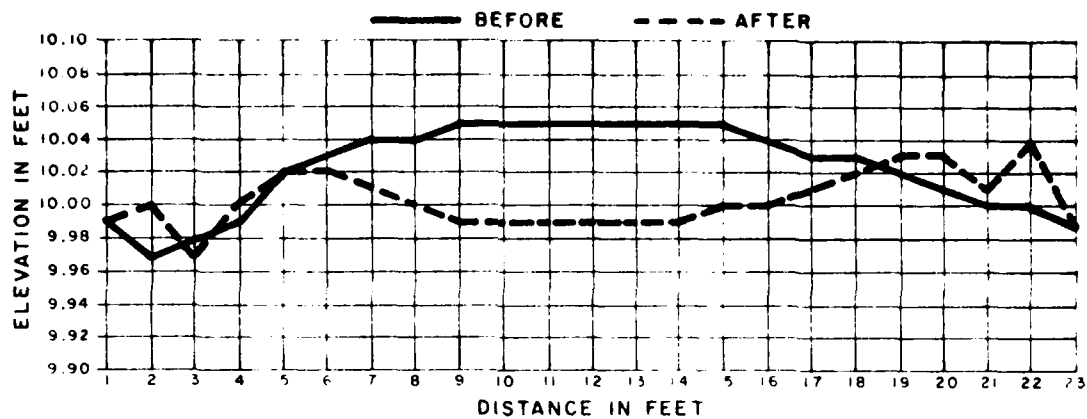
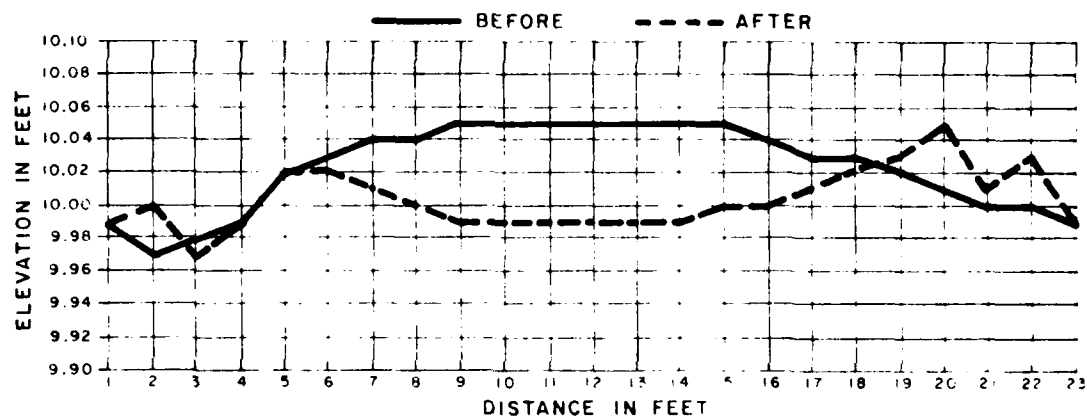
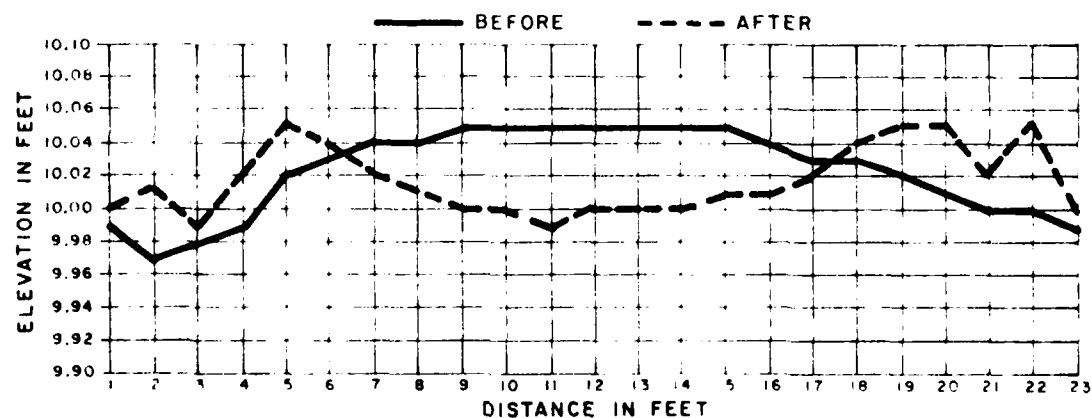
60 COVERAGES  
F-4

120 COVERAGES  
F-4

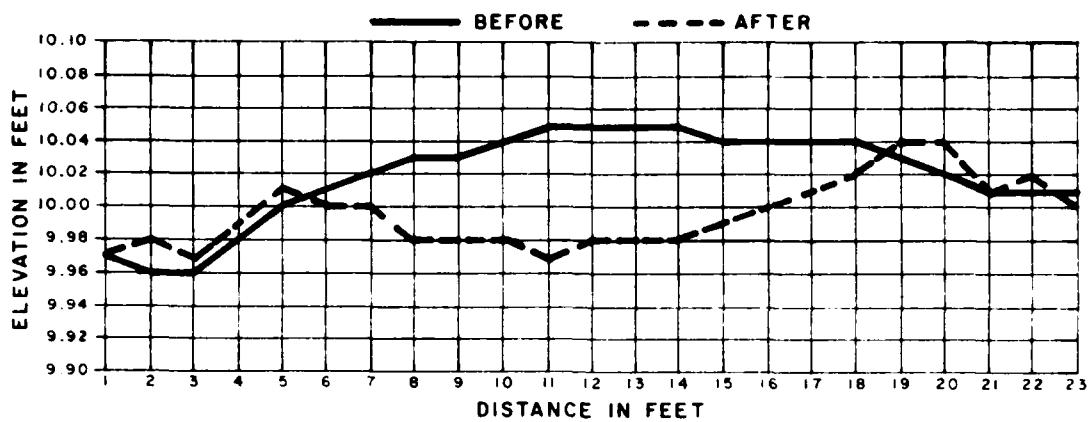
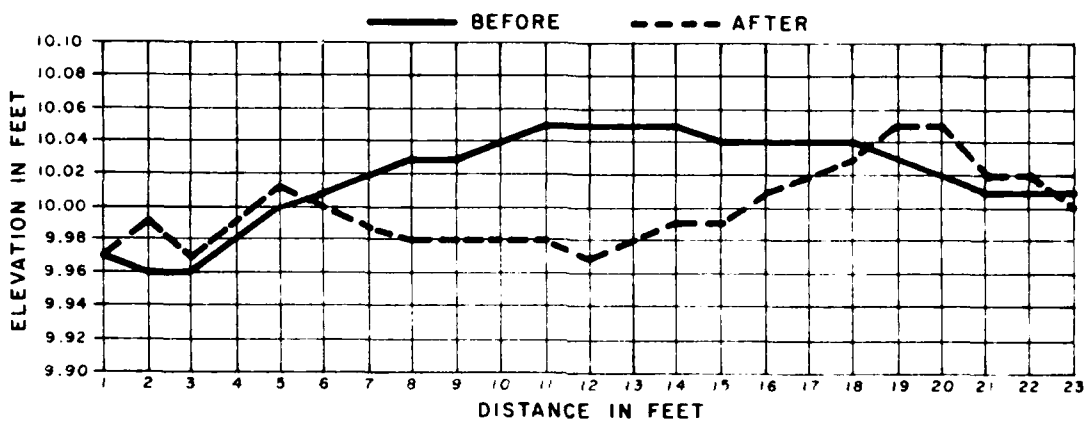
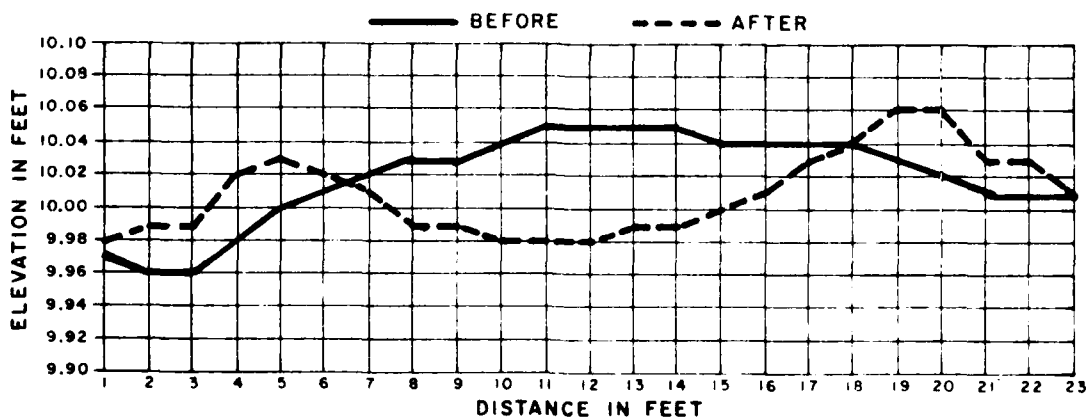
Figure 58. Coverages on Side Panel System, F-4 Aircraft and C-141 Aircraft, Base Line B-B

20 COVERAGES C-141

60 COVERAGES  
F-4

150 COVERAGES  
F-4
