ESL-TR-80-45

## FLUSH AM-2 MAT PATCH FOR RAPID RUNWAY REPAIR

JAMES L. GREENE

SEPTEMBER 1980

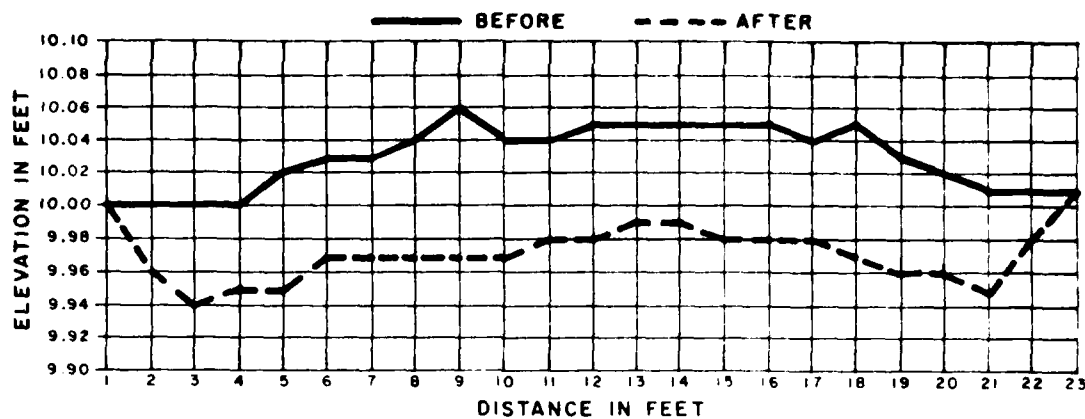
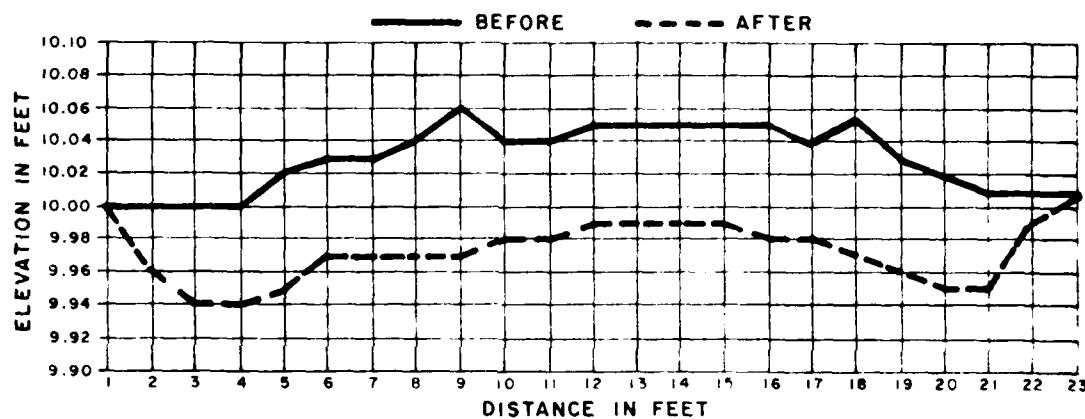
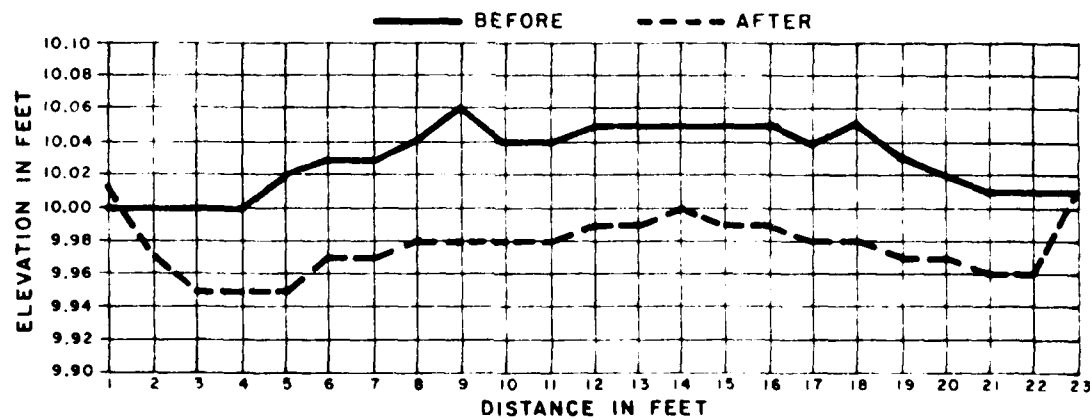
Figure 59. Coverages on Side Panel System, F-4 Aircraft and C-141 Aircraft, Base Line C-C

20 COVERAGES C-141

60 COVERAGES  
F-4

150 COVERAGES  
F-4

Test data for this concept during testing are shown in Figures 57 through 62. Visual observations during testing are shown in Figures 63 through 77.

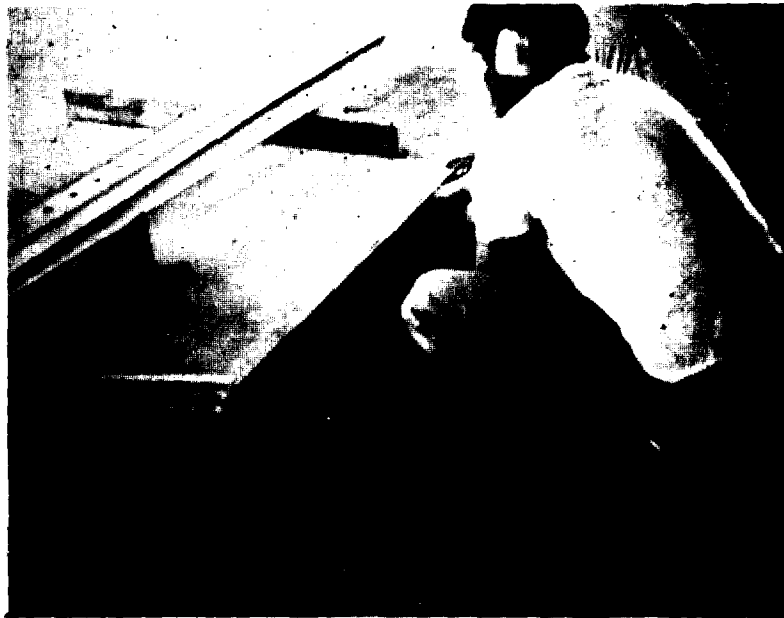
Figure 63. Test 3 (Side Panel)- Installing  
Locking Assembly to Perimeter of Pits

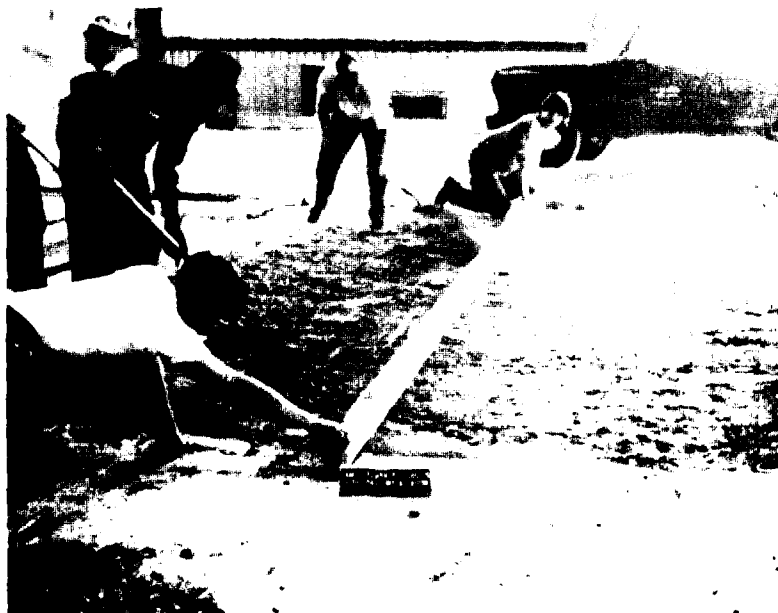
Figure 64. Test 3 (Side Panel)-Screeding  
Base Course

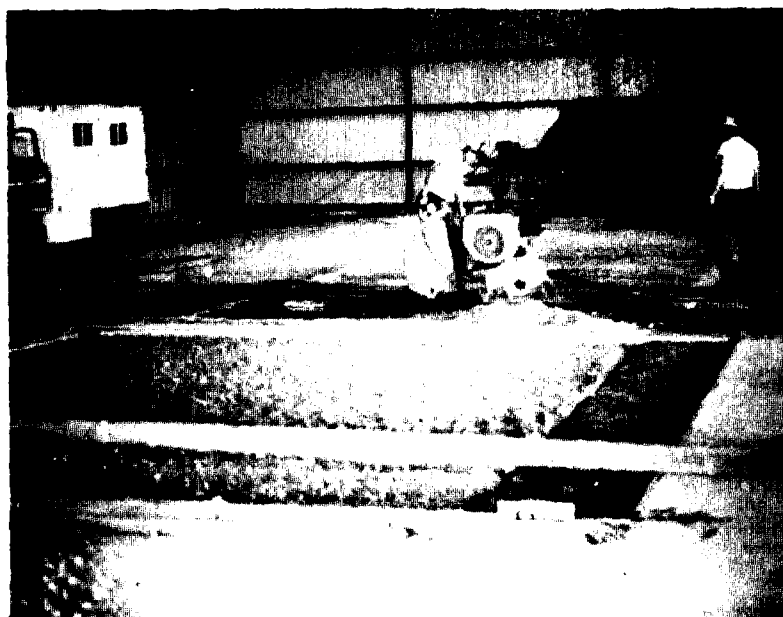
Figure 65. Test 3 (Side Panel)-Placing  
Bottom AM-2 Panel

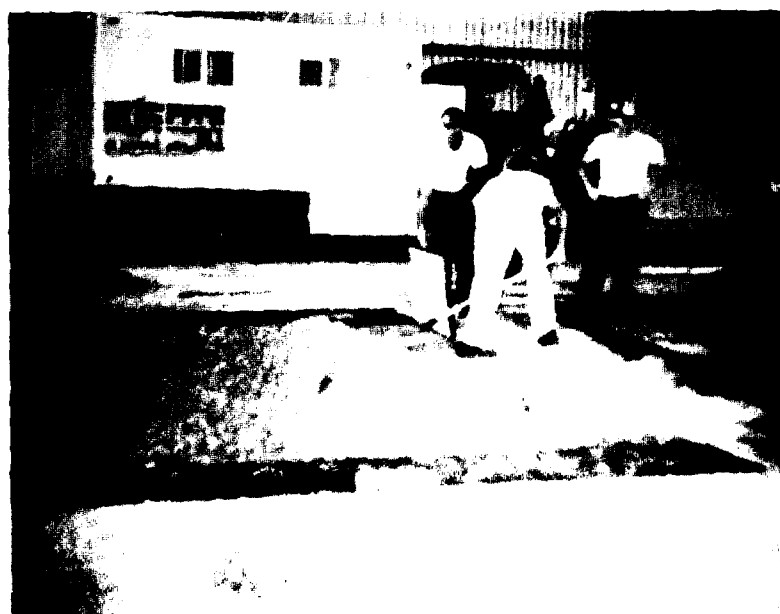
Figure 66. Test 2 (Side Panel)-Placing  
Bottom AM-2 Panel

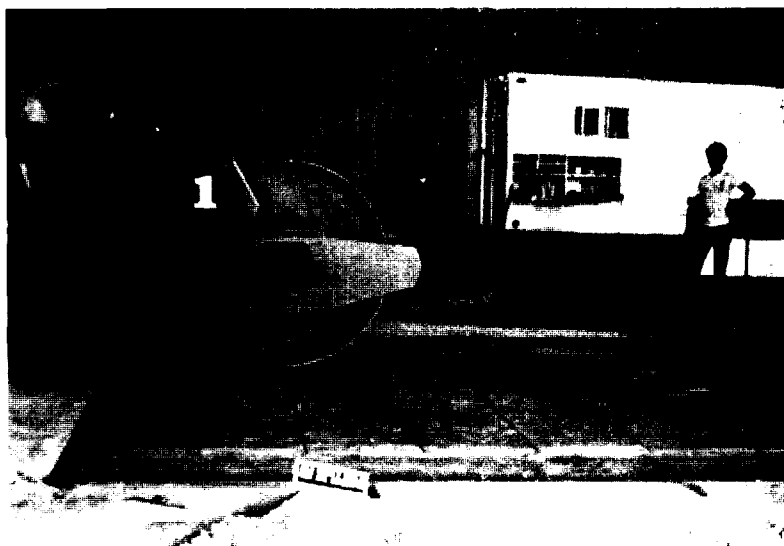
Figure 71. Test 3 (Side Panel)-  
Installing Locking Angle

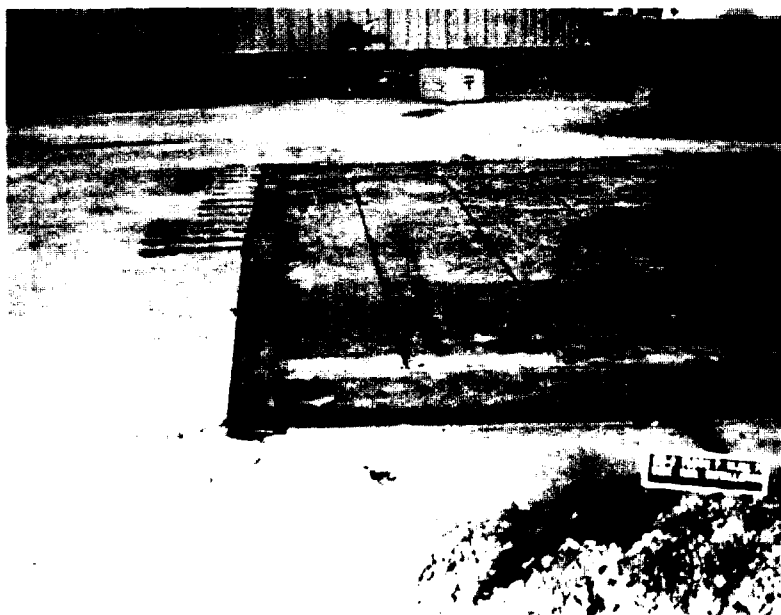
Figure 72. Test 4 (Side Panel)-  
Completed Patch

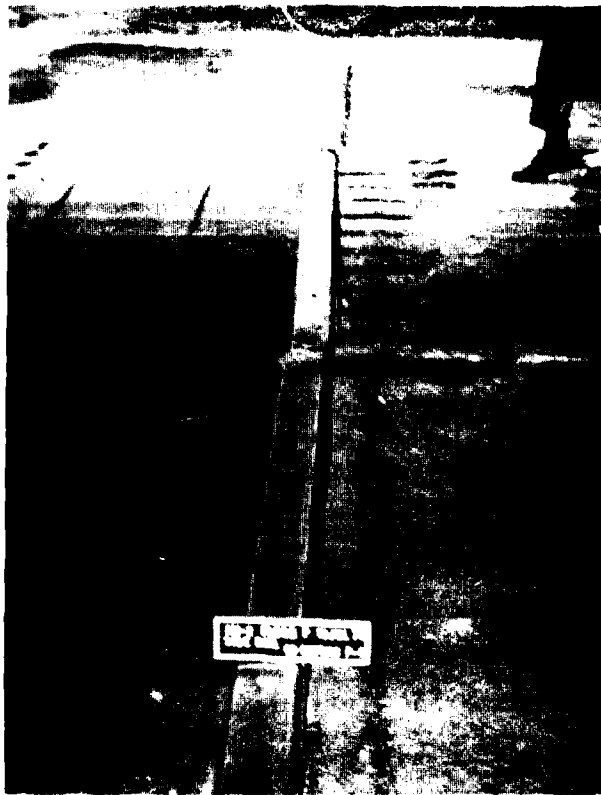
Figure 73. Test 3 (Side Panel)-  
60 Coverages of F-4

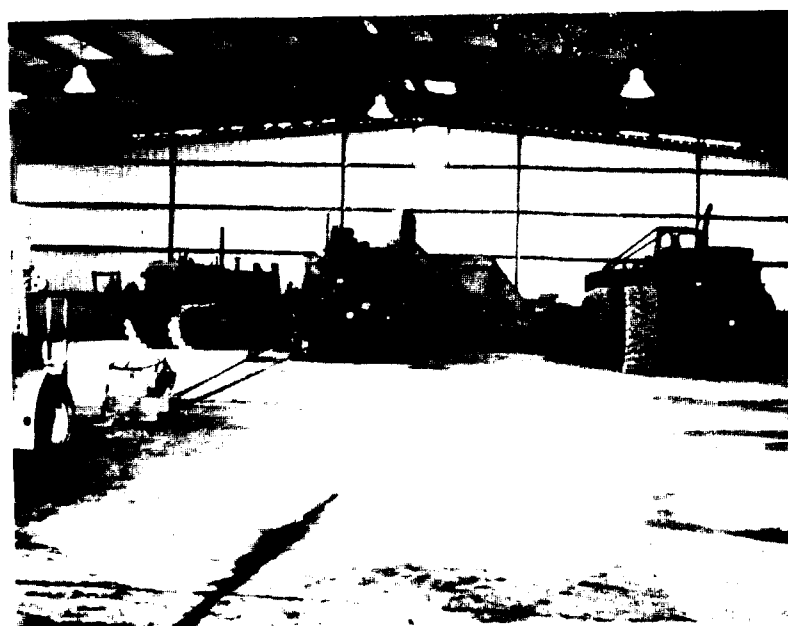
Figure 76. Test 3 (Side Panel)-  
60- Pull Test

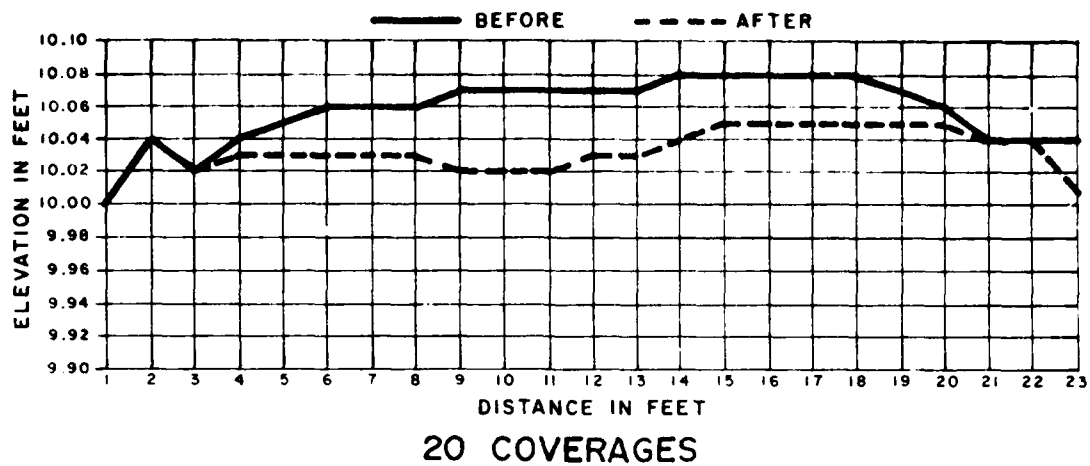
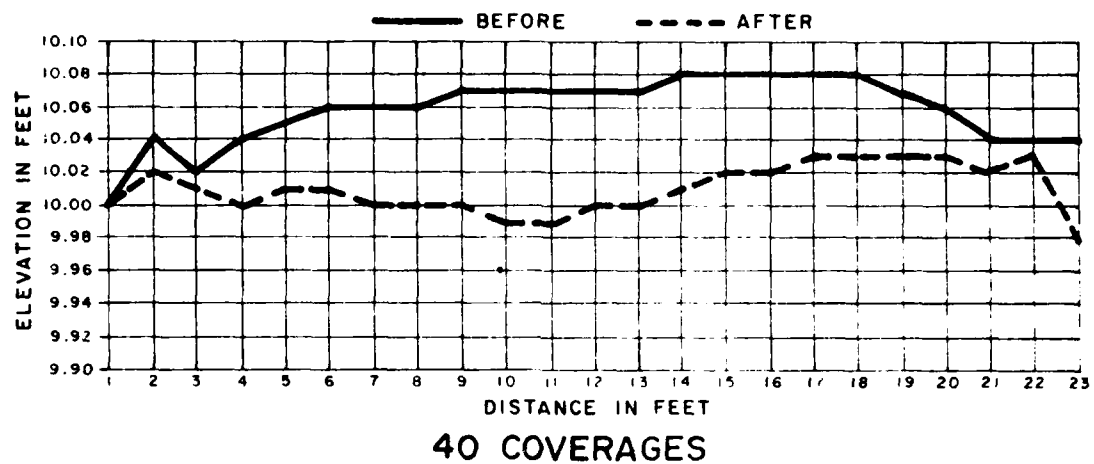
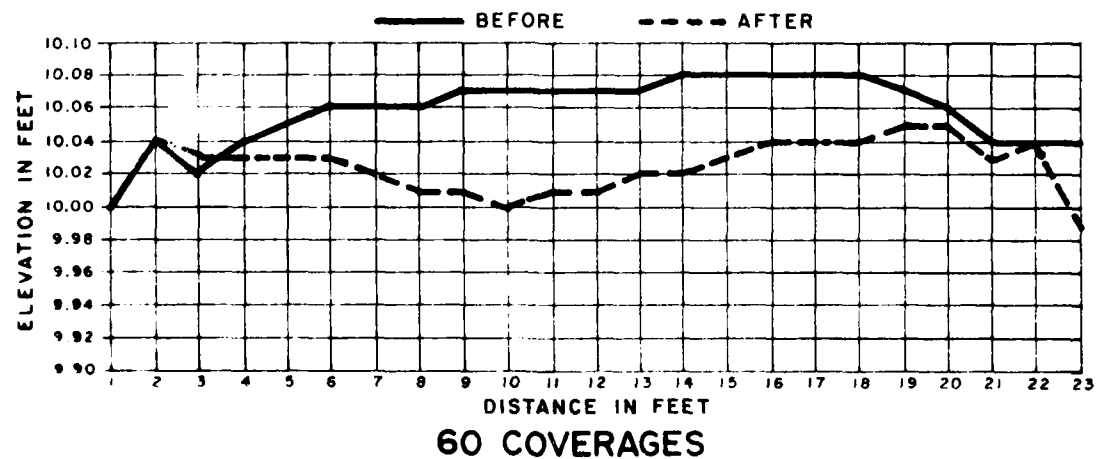
4. 4. 14. Coverages on Modified Side Panel System, F-4 Aircraft, Base Line A-A

Elevations of the mat and base course after trafficking are shown in Figures 78 through 83. Photographs taken during testing are included as Figures 84 through 91.

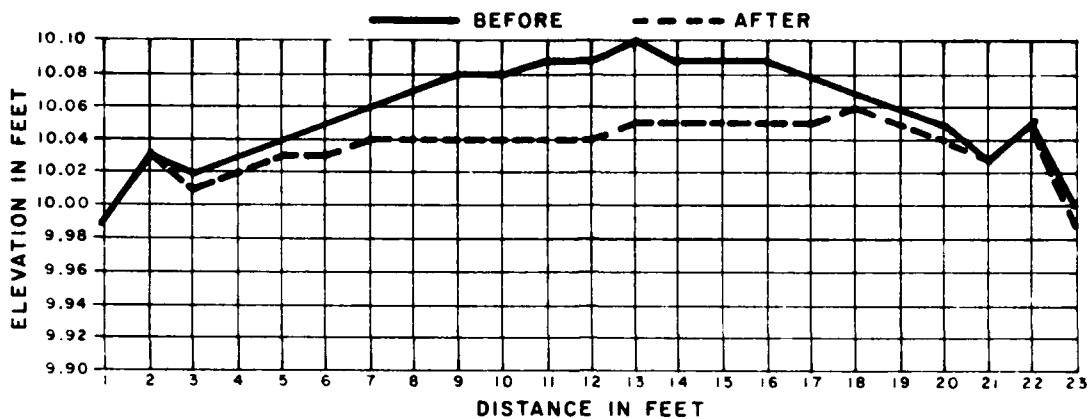
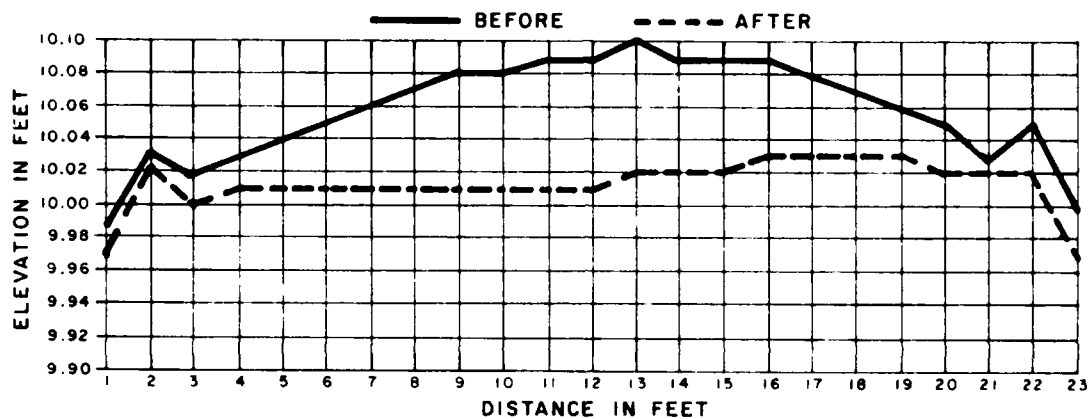
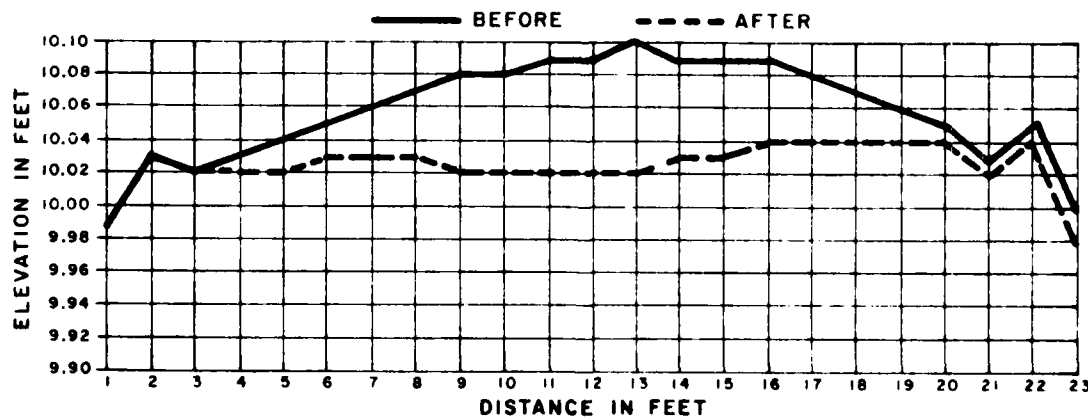
Figure 79. Coverages on Modified Side Panel System, F-4 Aircraft, Base Line B-B

20 COVERAGES

40 COVERAGES

60 COVERAGES

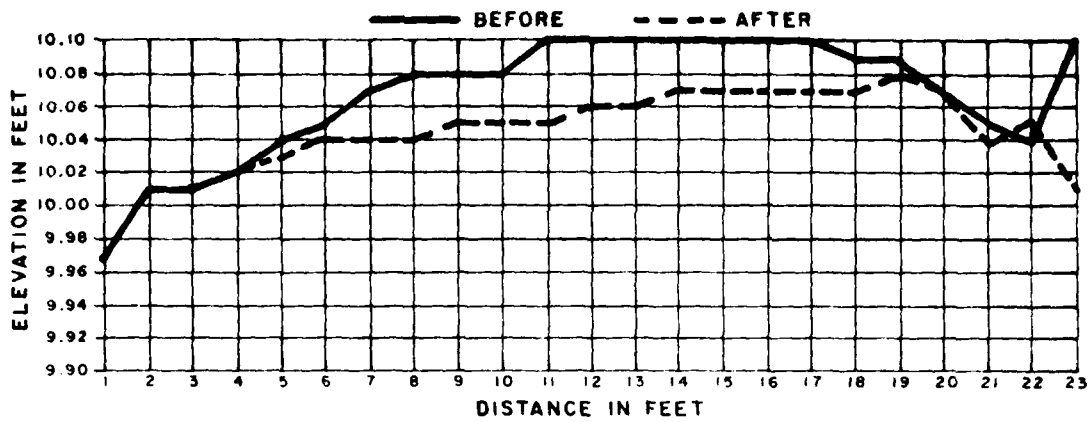
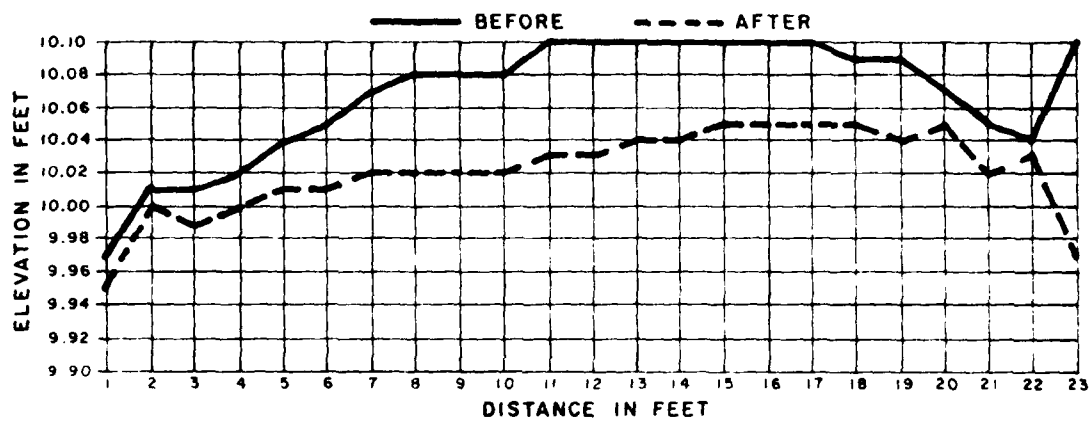
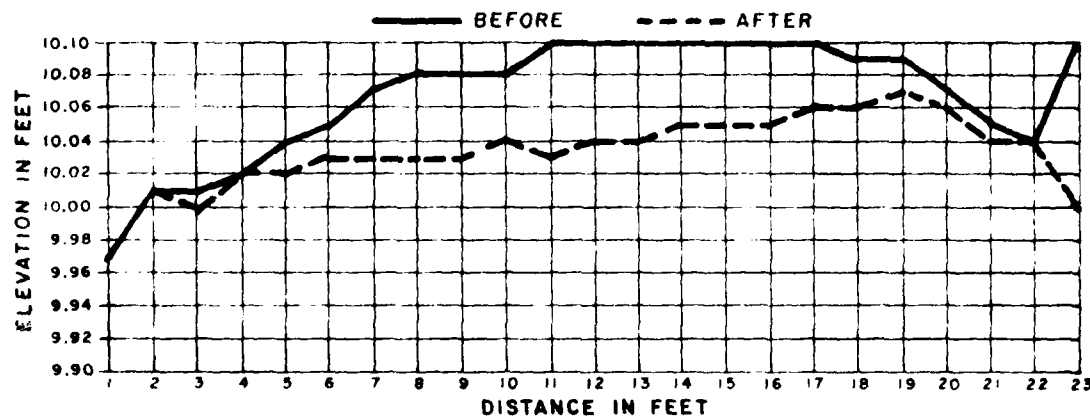
Figure 80. Coverages on Modified Side Panel System, F-4 Aircraft, Base Line C-C

20 COVERAGES

40 COVERAGES

60 COVERAGES

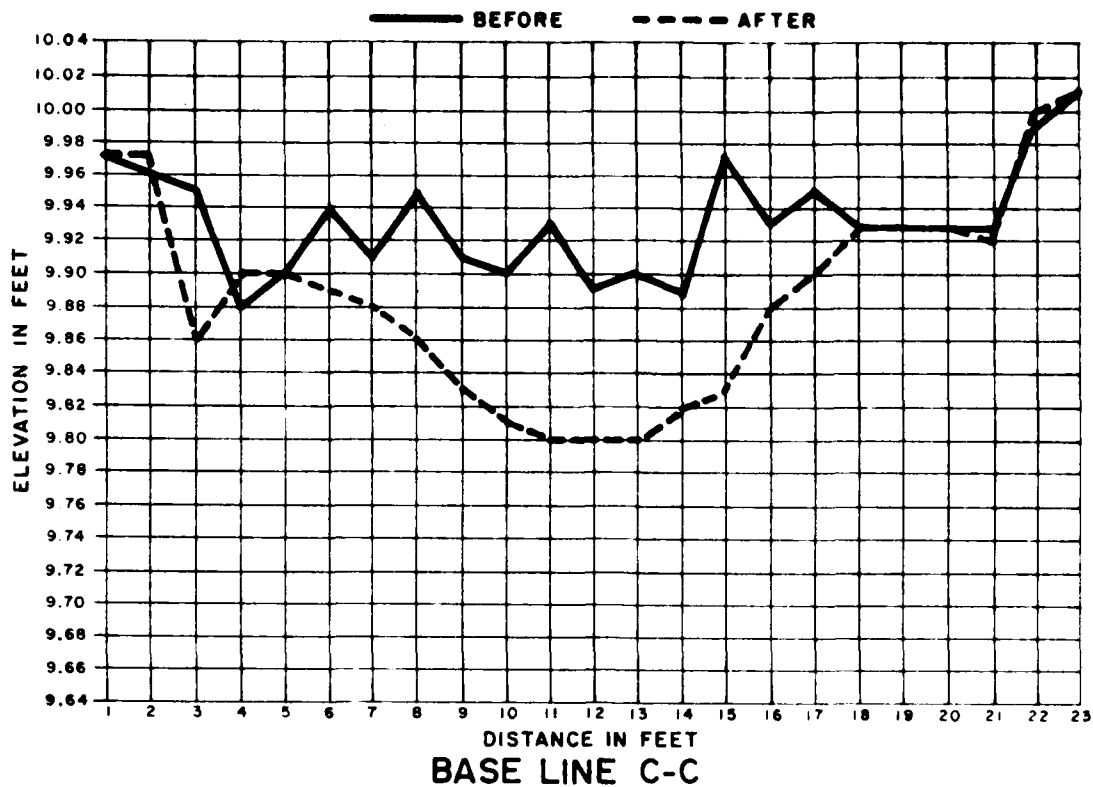
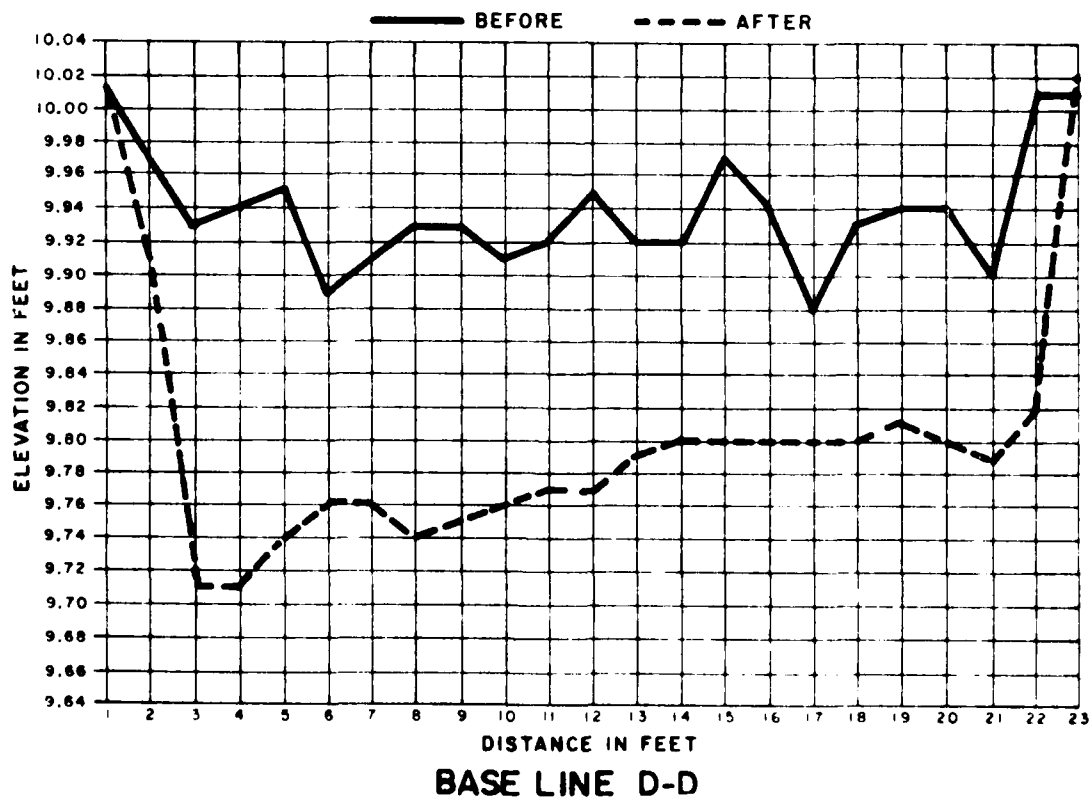
Figure 83. Base Course - Modified Side Rail, 60 Cov. F-4, Base Lines C-C and D-D

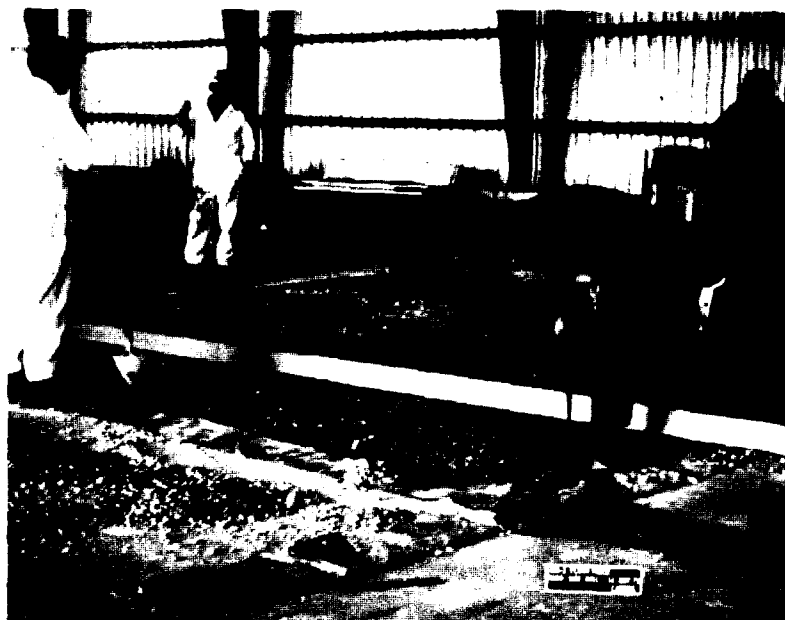
Figure 84. Test 4 (Modified Side Panel)-  
Leveling Base Course

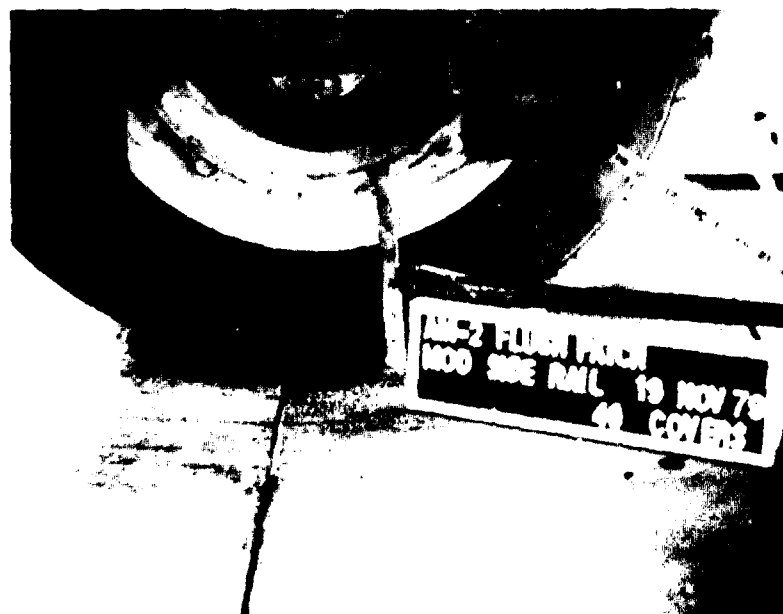
Figure 87. Test 4 (Modified Side Panel)-  
40 Coverages of F-4

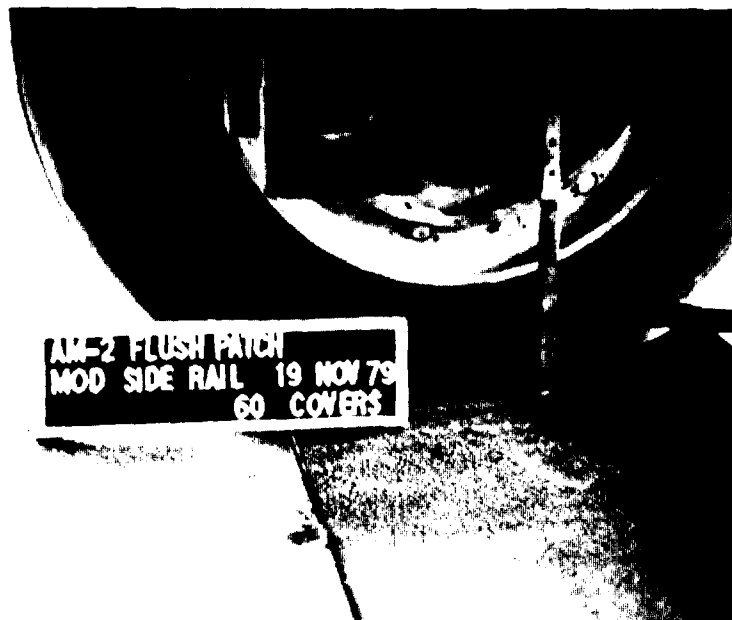
Figure 88. Test 4 (Modified Side Panel)-  
60 Coverages of F-4

Considerable consolidation was noted after ten coverages of the F-4 load cart. The side angles were bending towards the center and, as a result, bending the back plate of the locking assembly. After 20 coverages the nails were beginning to pull out. It appeared the base course was being pushed out of the traffic lane and mounding on the sides. At 40 coverages the angle and assembly were experiencing considerable deflections, indicating the nails had pulled out of the concrete. This caused the load cart to bounce as it came off the edge of the concrete. Sufficient deflection had taken place at 60 coverages that the patch was determined to have failed. Observations made during removal of the patch are as follows:
