United States  
Department of  
Agriculture  
Forest Service  
Forest  
Products  
Laboratory

Research  
Paper  
FPL 387  
December 1980

# Development of An Improved Hardboard-Lumber Pallet Design

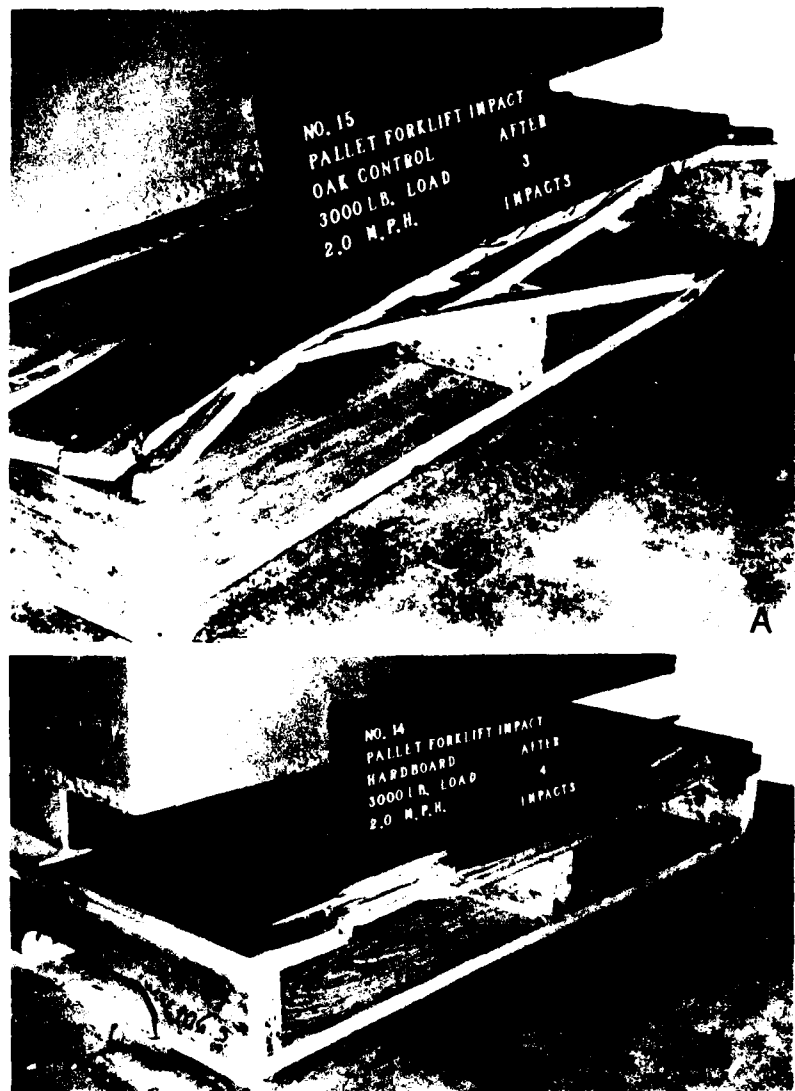
(M 147 272)  
(M 147 269 B)

Figure 5—Representative condition of pallets after failure from handling impact testing: (A) Lumber control and (B) hardboard-lumber pallet

**Lumber control pallets.**—As testing progressed, the damage patterns observed were quite similar to those encountered in (9). Specifically, all of the lumber control pallets failed by a combination of splitting and nailhead pullthrough of the top leadboard. Usually, splits were associated with unrelieved stress caused by the nails. The total number of impacts required for pallet failure ranged from two to four and averaged about three. Typical condition of a lumber control pallet after testing is shown in figure 5A.

**Lumber pallets with hardboard decks.**—As expected, failure occurred in lumber pallets with hardboard decks in every instance because of "forkbite"—i.e., indentation at the contact points between the forklift truck and the leading edge of the hardboard deck. When progressive forkbite reached a cumulative total of 2 inches in depth, further testing of that particular pallet was halted (fig. 5B).

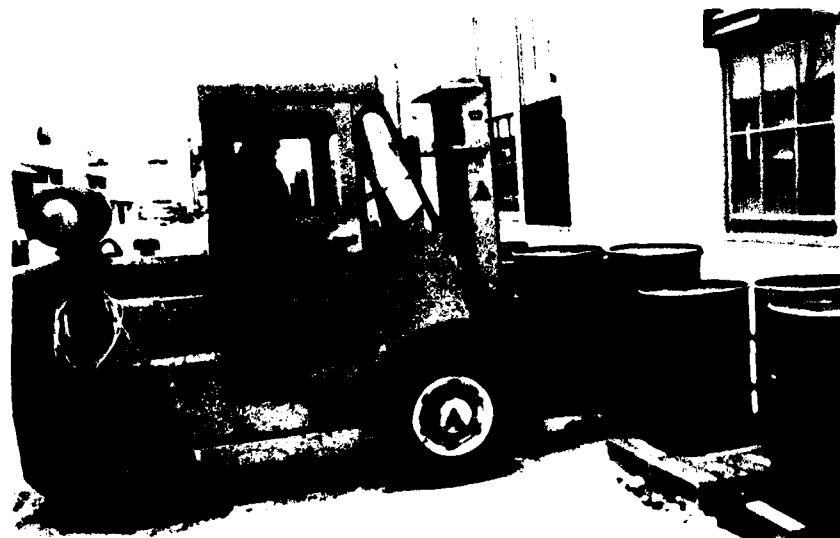
(M 147 215 8)

Figure 8.—The FPL forklift truck in operation handling a loaded experimental hardboard-lumber pallet.

The condition of the pallets was monitored periodically, except on weekends, during the regularly scheduled 9 weeks of the program and after the additional 190-day static outdoor storage period that followed. Handling and shuttling were done in all instances with the Laboratory's 6,000-pound capacity LP gas operated forklift truck shown in figure 8. The speed employed for handling was about 0.2 mile per hour and 0 to 10 miles per hour for shuttling and transfer.
