PENNSYLVANIA  
**EDINBORO LAKE DAM**

NDI ID NO. PA-18  
DER ID NO. 25-4

BOROUGH OF EDINBORO  
PHASE I INSPECTION REPORT  
NATIONAL DAM INSPECTION PROGRAM

PHASE I INSPECTION REPORT,  
NATIONAL DAM INSPECTION PROGRAM

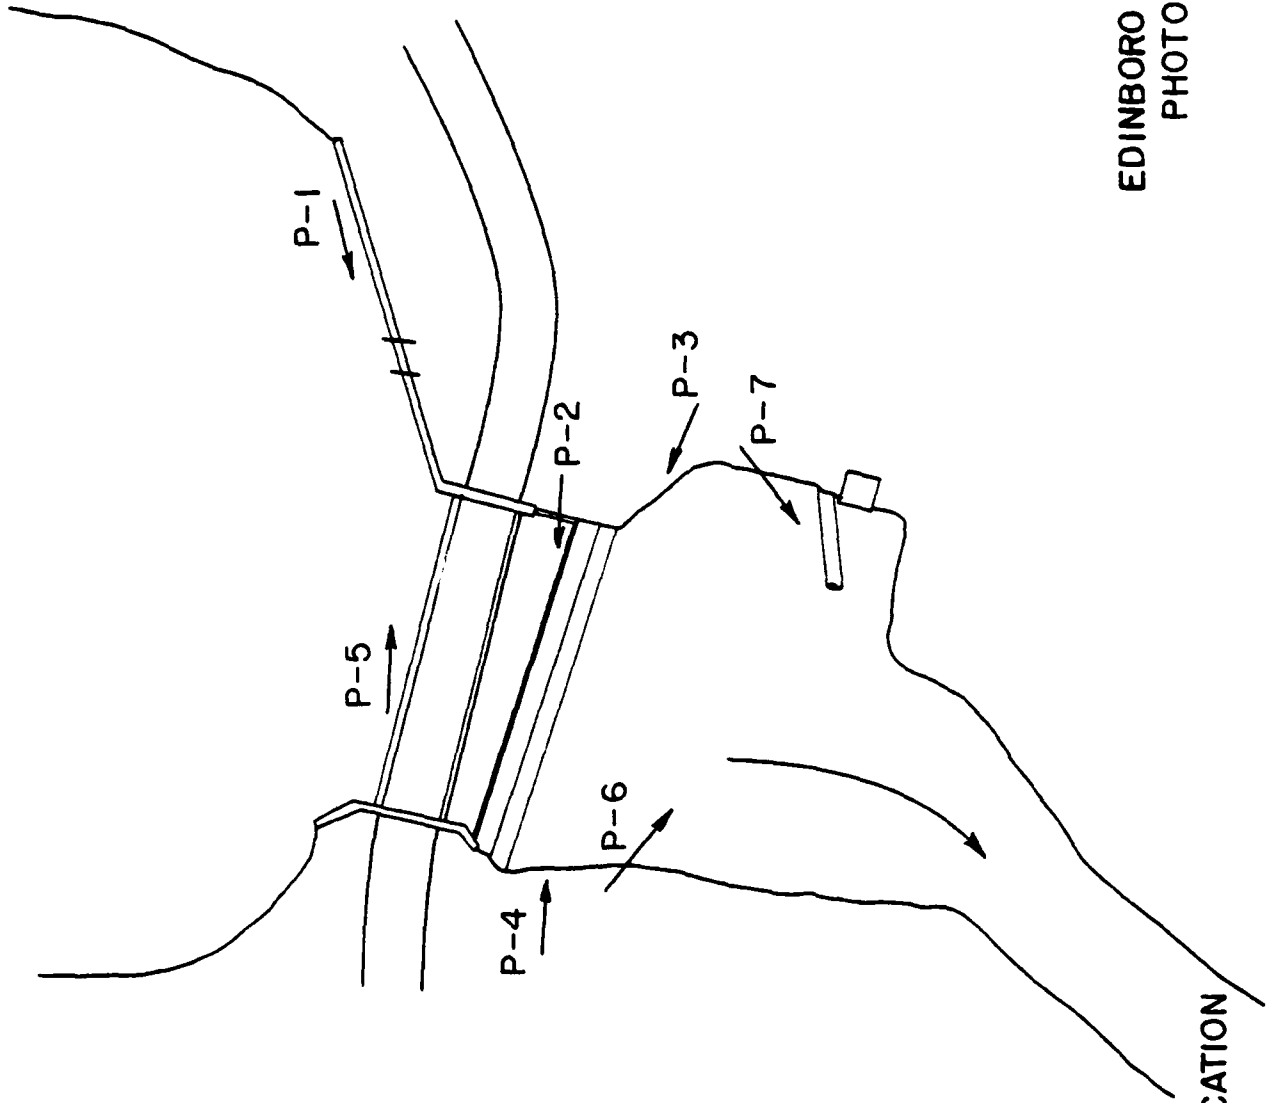
EDINBORO LAKE DAM  
PHOTO INDEX

P - INDICATES PHOTO LOCATION

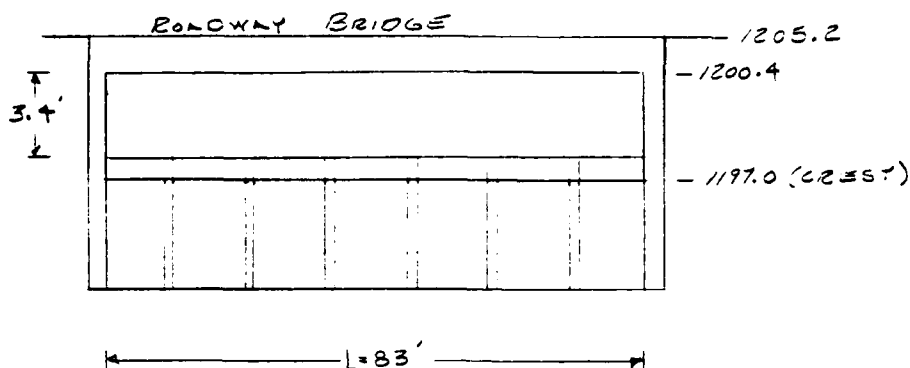
## DISCHARGE RATING

NOTE: THE EFFECTIVE LENGTH IS LESS THAN 83' BELOW ELEVATION 1198 (APPROX.). FOR THE PURPOSE OF THIS ANALYSIS THE TOTAL WEIR LENGTH WILL BE CONSIDERED AS 83'.

USE 3.3 FOR THE COEFFICIENT OF DISCHARGE FOR A SHARP CRESTED WEIR.

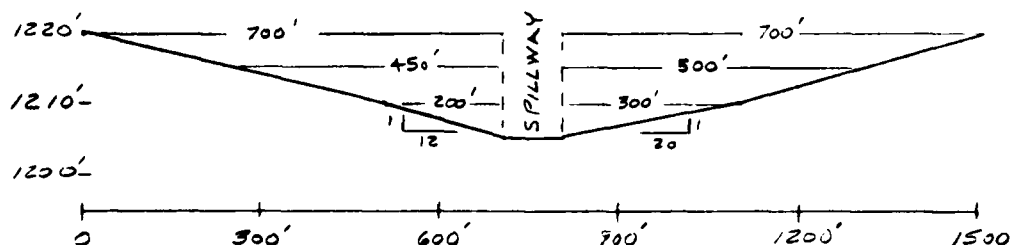
TOP OF DAM (LOW SPOT) = 1204.3'  
LENGTH OF DAM (EXCLUDING SPILLWAY) = 110'

| #L | 30 | 500 | 950 | 1400 |
| #Y | 1205 | 1210 | 1215 | 1220 |

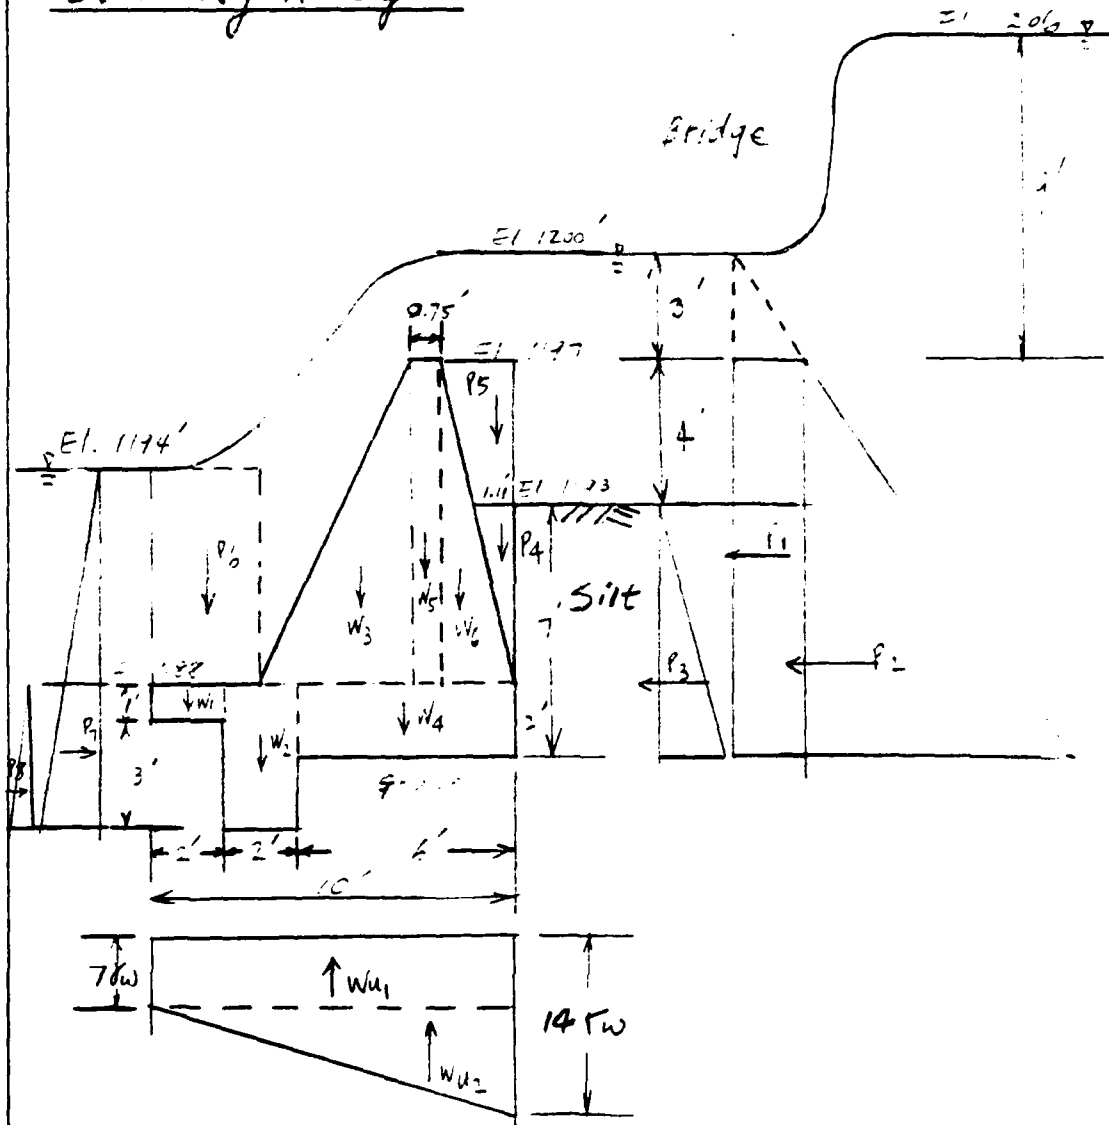
## Stability Analysis

Assumptions: 1. Velocity head is negligible  
length of spillway = 83'

$$A = (83)(7) = 581 \text{ sq-ft}$$
