FLOOD PLAIN INFORMATION REPORT

OWASCO INLET AND HEMLOCK CREEK VILLAGES OF MORAVIA AND LOCKE CAYUGA COUNTY, NEW YORK

PREPARED THROUGH THE COORDINATION OF THE NEW YORK STATE DEPARTMENT
OF ENVIRONMENTAL CONSERVATION BY THE DEPARTMENT OF THE ARMY, BUFFALO
DISTRICT, CORPS OF ENGINEERS, BUFFALO, NEW YORK.

JULY 1976 81 6 29 032

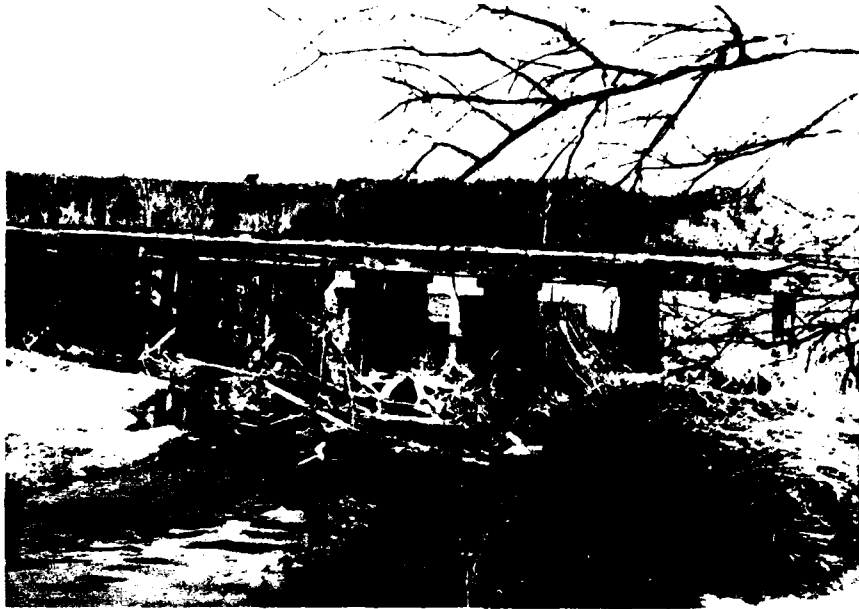
Figure 2 - Upstream face of the Lehigh Valley Railroad Bridge at Stream Mile 9.31. Note debris at face of bridge. Route 38 bridge in background.

The trees which line the banks of the Inlet for most of its length are a potential source of debris which could clog bridge openings during a flood. Figure 2 shows present debris conditions at the Lehigh Valley Railroad bridge at mile 9.3.

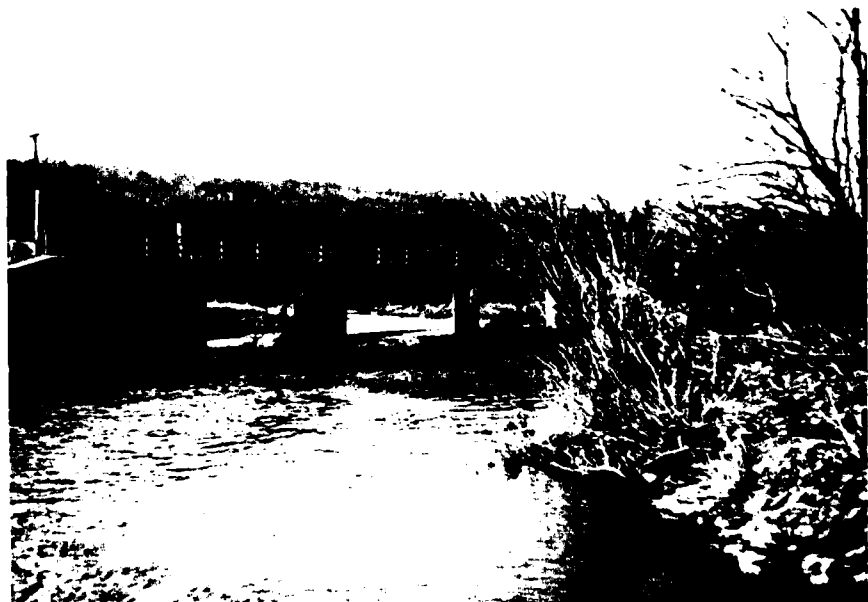
Figure 7 - Upstream face of the new Route 38 bridge at Stream Mile 7.98.

Table 4 lists relevant data on each of the bridges which cross the Inlet and Hemlock Creek within the study area. Figures 1 through 10 depict several other bridges which cross the Inlet.

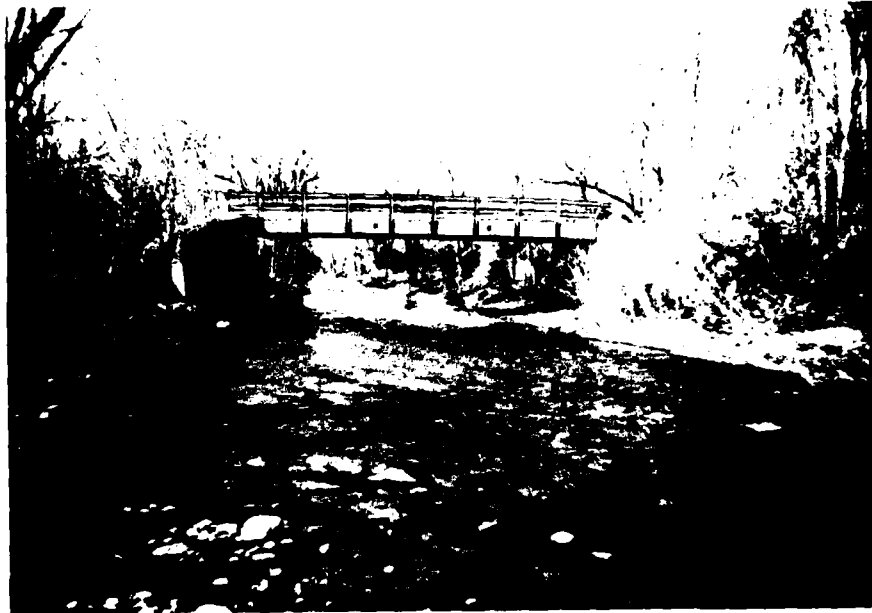
Figure 8 - Upstream face of the Erron Hill Road bridge,
Stream Mile 8.4.

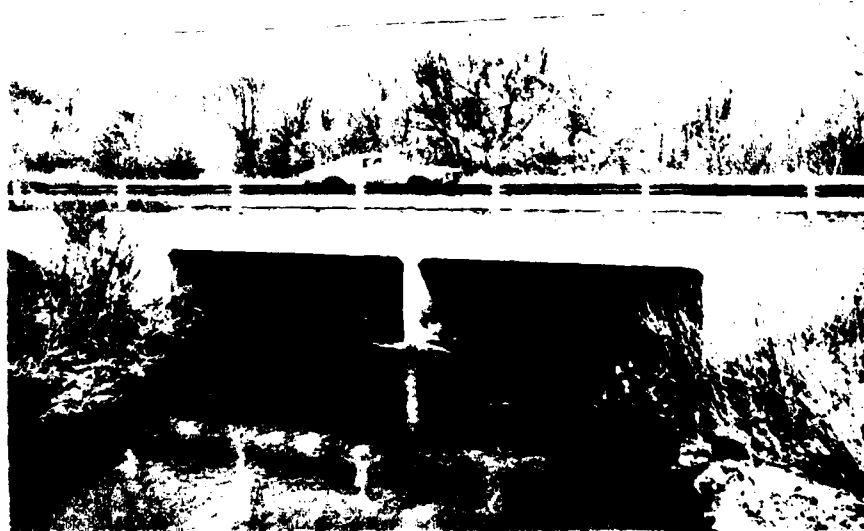
Figure 9 - Upstream face of the Route 38 bridge at Mile 9.29.

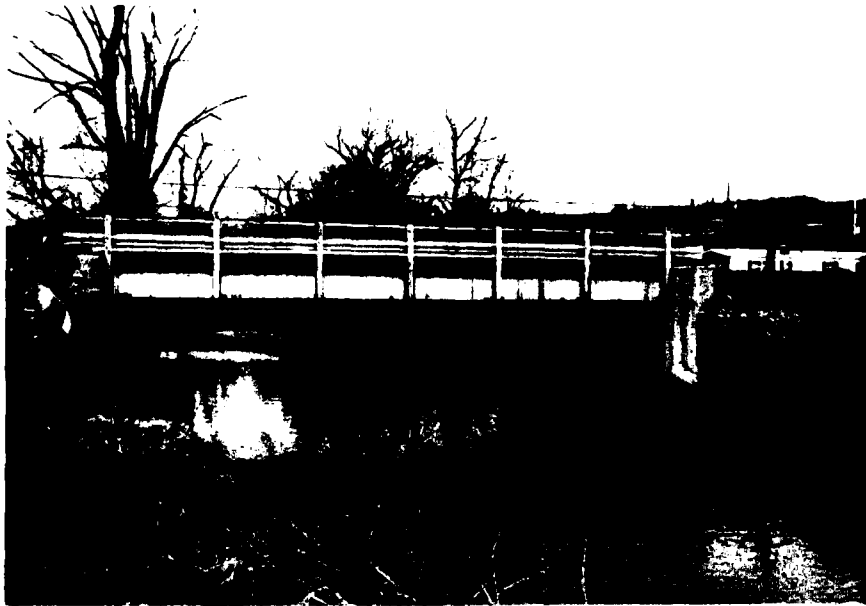
Figure 10 - Upstream face of the Cat Path Road bridge at Stream Mile 9.45.

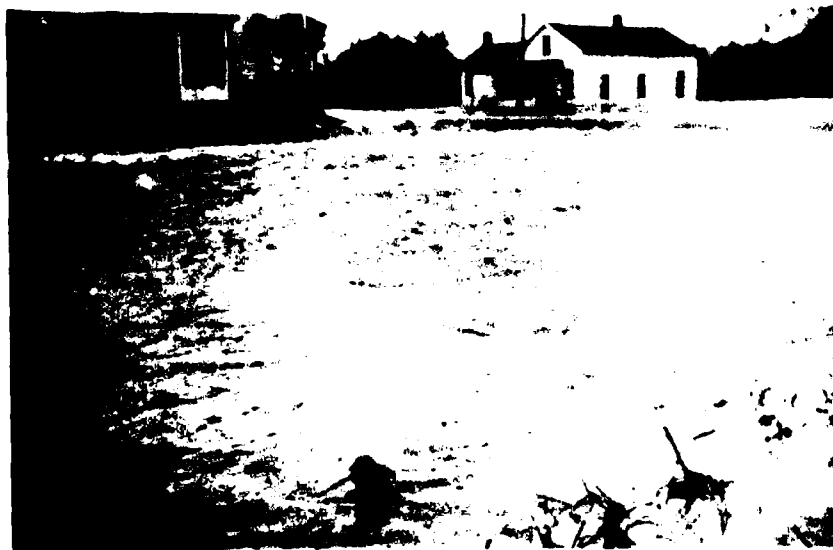
Figure 12 - Storm of 1935 flood conditions at Route 90, Locke, NY. Just downstream of confluence with Berlock Creek, Stream Mile 8.65.

July 1935 - This storm, centered over south-central New York, consisted of a series of thunder showers occurring during the period 6-9 July. The heaviest precipitation occurred in an area from Keuka Lake to central Chenango County, in extent approximately 100 miles from west to east, and 15-20 miles from north to south. The southern portion of the Owasco Inlet Watershed extends into that area, wherein rainfall for 7-8 July exceeded nine inches. In Moravia, flood depths of one foot and two feet occurred in the business and residential sections, respectively. Figures 11 and 12 depict flooding conditions at Locke, NY during the flood.

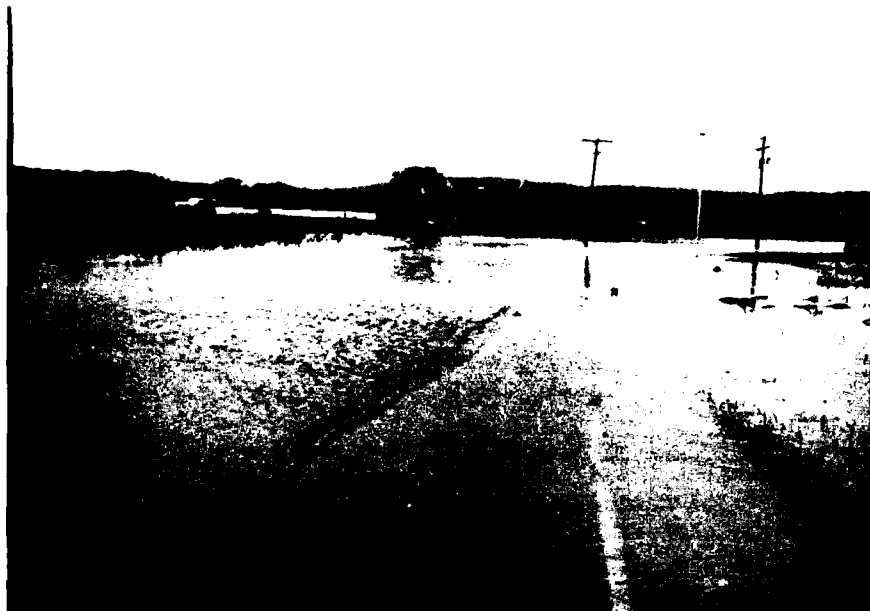
Figure 13 - Flooding conditions on Long Hill Road looking east towards Moravia, NY during September 1975 high water. Stream Mile 4.5.

Figures 13 and 14 depict flooding conditions at Moravia during the storm.

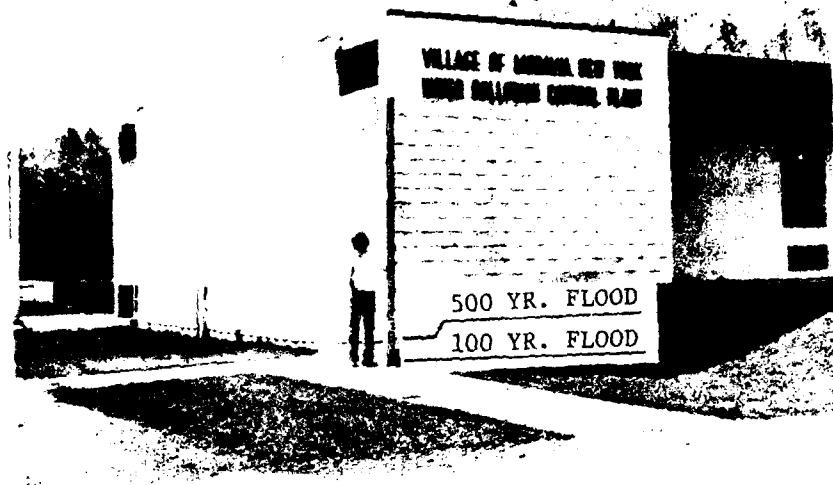
Figure 15 - Future flood heights at village of Moravia Water Pollution Control Plant, Stream Mile 4.5.

Photographs, future flood heights - The expected levels of the 100- and 500-year floods for locations in the study area are indicated on Figures 15 and 16.

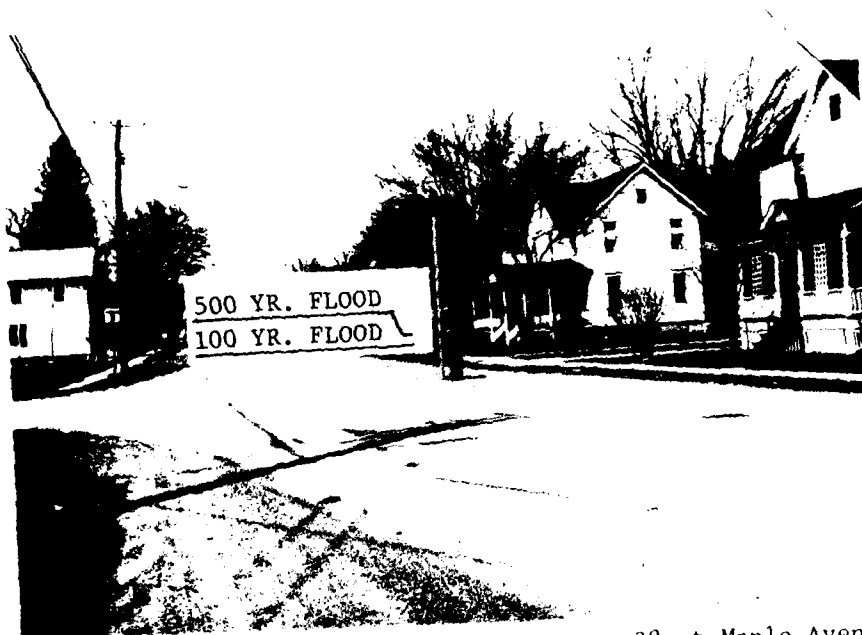
Figure 16 - Future flood heights on Route 38 at Maple Avenue, Locke, NY near Stream Mile 8.65.

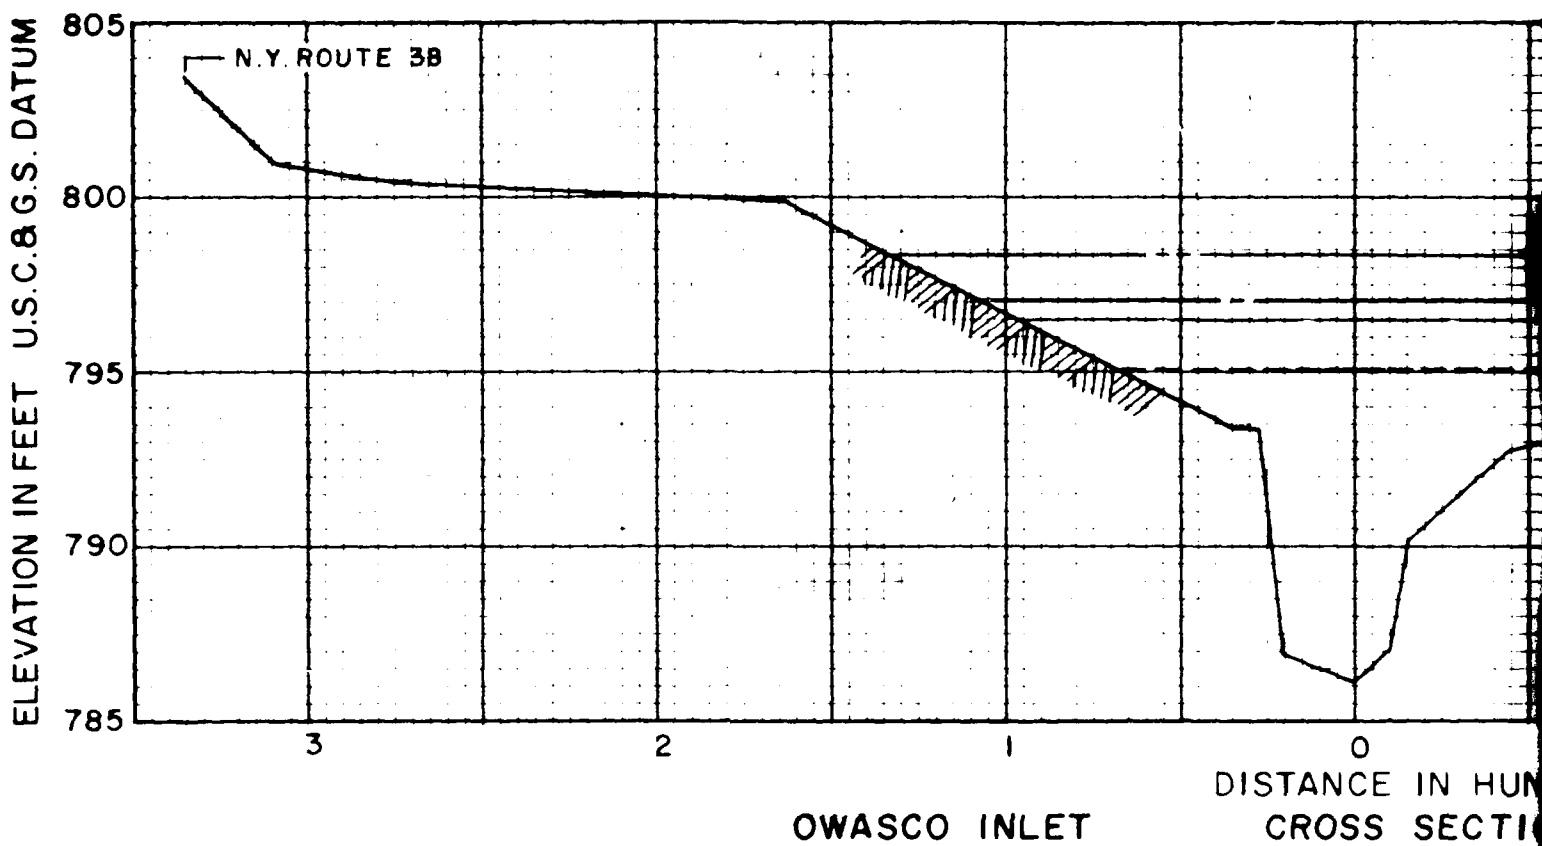
0
 DISTANCE IN HUNDREDS OF FEET
 CROSS SECTION NO.22

2 3 4
 MILE POINT 9.10

Plates 7 through 9 show water surface profiles for the 10-, 50-, 100- and 500-year floods. Depth of flow in the channel can be estimated from these illustrations. Typical cross sections of the flood plain at selected locations, together with the water surface elevation and lateral extent of each of the floods, are shown on Plates 10 through 12.
