# FLOOD PLAIN INFORMATION

LEVEL  
NINEMILE CREEK

TOWNS OF MARCELLUS, CAMILLUS AND GEDDES,  
ONONDAGA COUNTY, NEW YORK

PREPARED FOR THE NEW YORK STATE DEPARTMENT OF ENVIRONMENTAL CONSERVATION  
BY THE DEPARTMENT OF THE ARMY, BUFFALO DISTRICT, CORPS OF ENGINEERS  
BUFFALO, NEW YORK OCTOBER 1976

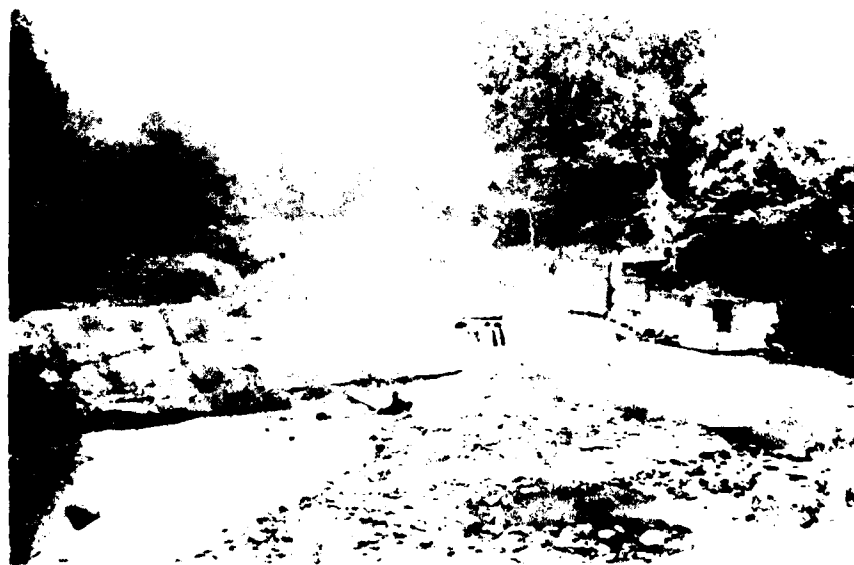
FIGURE 9 - Dam 1 located at stream mile 3.83 near the Warners Rd. bridge at Amboy in Camillus. A portion of the dam has been removed since the 1965 storm to reduce upstream flooding. Photo taken Sep 1969.

Obstructions to Floodflows - Natural obstructions to floodflows include trees, brush and other vegetation growing along the stream banks in floodway areas. Man-made encroachments on or over the streams such as dams, bridges and culverts can also create more extensive flooding than would otherwise occur. Representative bridges, dams and some obstructions to floodflows are shown in Figures 3 through 9.

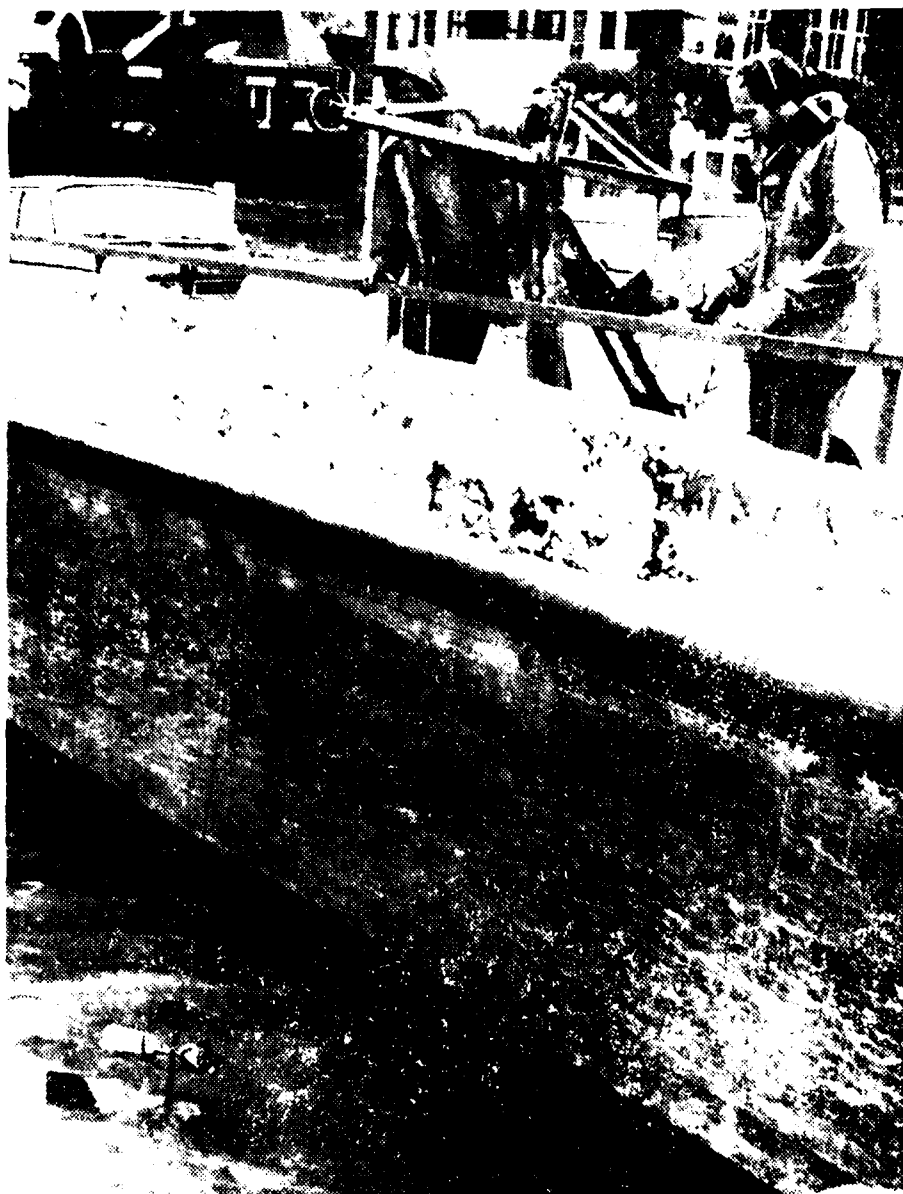
### Velocity Readings

Two U. S. Geological Surveyors, Joseph Robideau (left) and Mark Hays, lower a velocity meter which measures the speed of water into swollen Nine Mile Creek, off the Route 1 bridge in downtown Camillus yesterday, fishing for more facts in the creek whose flooding banks have

Robideau and Mark Have while working at the bridge in front of the Cutlery in Camillus said the stream, which "normally moves at 300 cubic feet per second, is now moving at about 1,700 cubic feet per second."

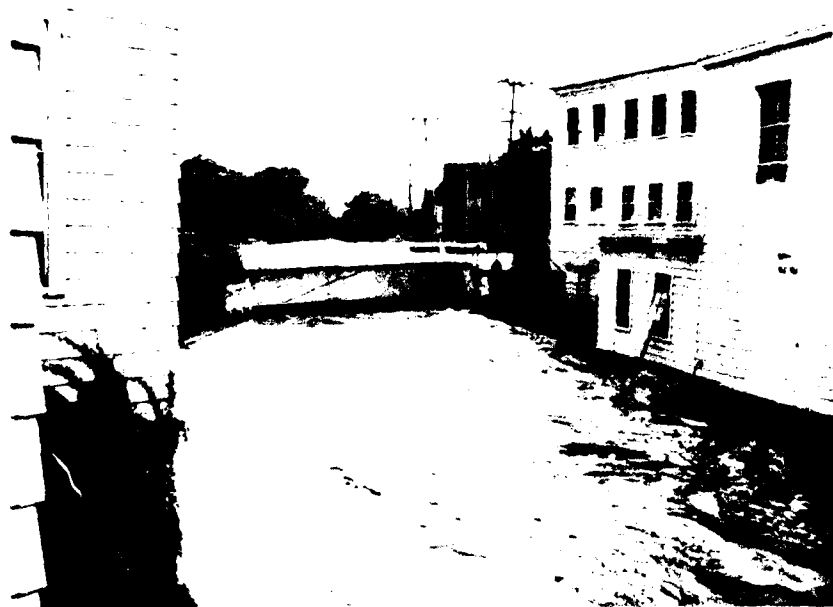
FIGURE 16 - Receding waters of the July, 1974 flood barely clear the bottom of the Genesee Street bridge in Camillus (stream mile 7.2). Building at right is part of the Camillus Cutlery Company.

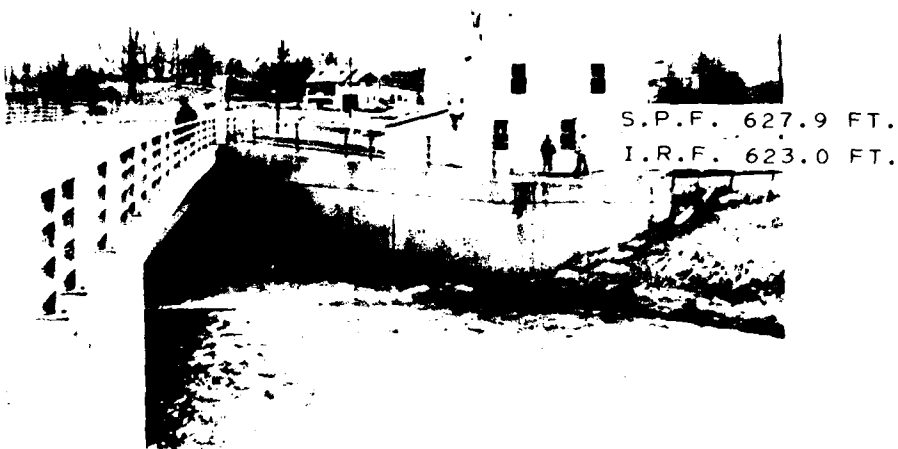
FIGURE 19 - Future flood heights at upstream side of Route 174 bridge (stream mile 12.08) in Marcellus. Photo taken April, 1975.

Photographs, Future Flood Heights - The anticipated water levels of the Intermediate Regional and Standard Project Floods at various locations along Ninemile Creek are illustrated on the photographs on the following pages.

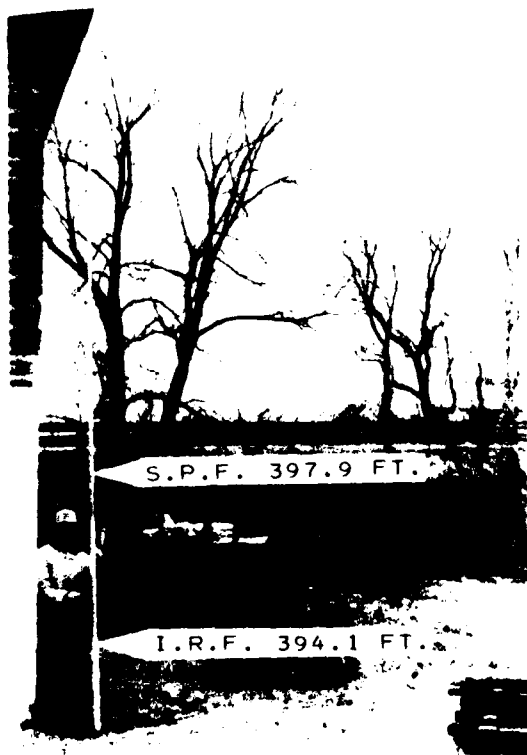
FIGURE 25 - Future flood heights in back of Robert D. Spence Plumbing Supplies building located at corner of Warners Road and Airport Road in Camillus. Warners Road bridge (stream mile 3.82) is 50 feet upstream in the background. Photo taken April, 1975.

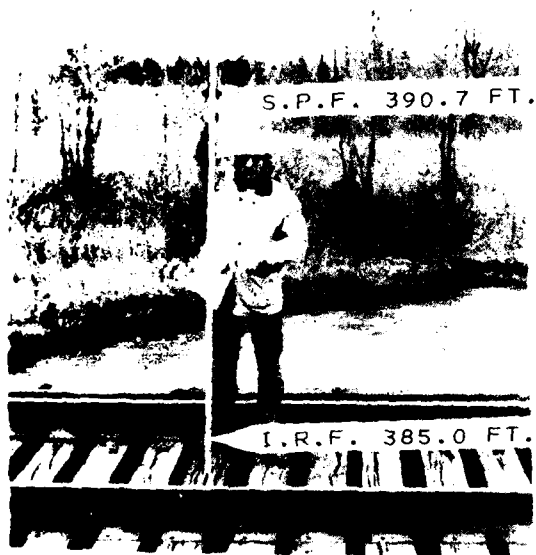
FIGURE 26 - Future flood heights at Penn Central Transportation Co. bridge over Ninemile Creek (stream mile 2.52) near intersection of Van Buren, Lakeland and Airport Roads in Camillus. Photo taken April, 1975.
