**GRAND-CHARITON RIVER BASIN**

BROOKFIELD CITY DAM  
LINN COUNTY, MISSOURI  
MO. 10181

**PHASE I INSPECTION REPORT**  
**NATIONAL DAM SAFETY PROGRAM**

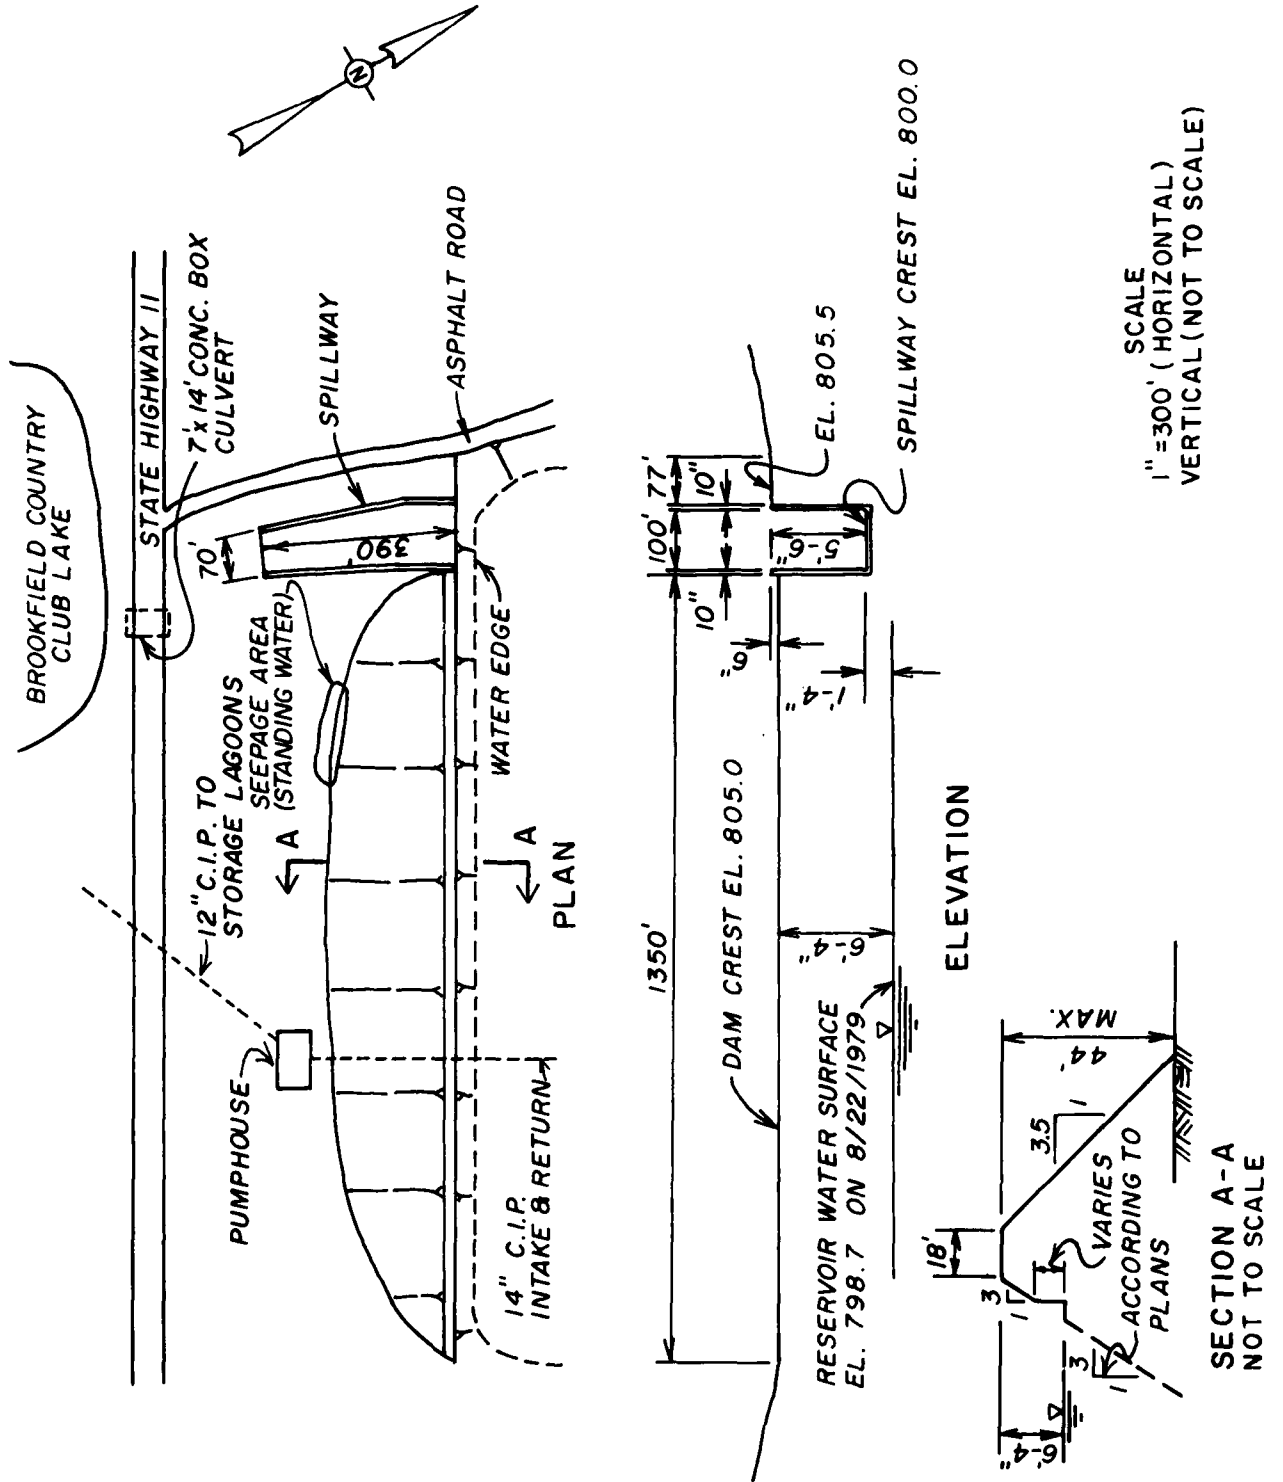
BROOKFIELD CITY DAM (MO.10181)  
 PLAN, ELEVATION & SECTION

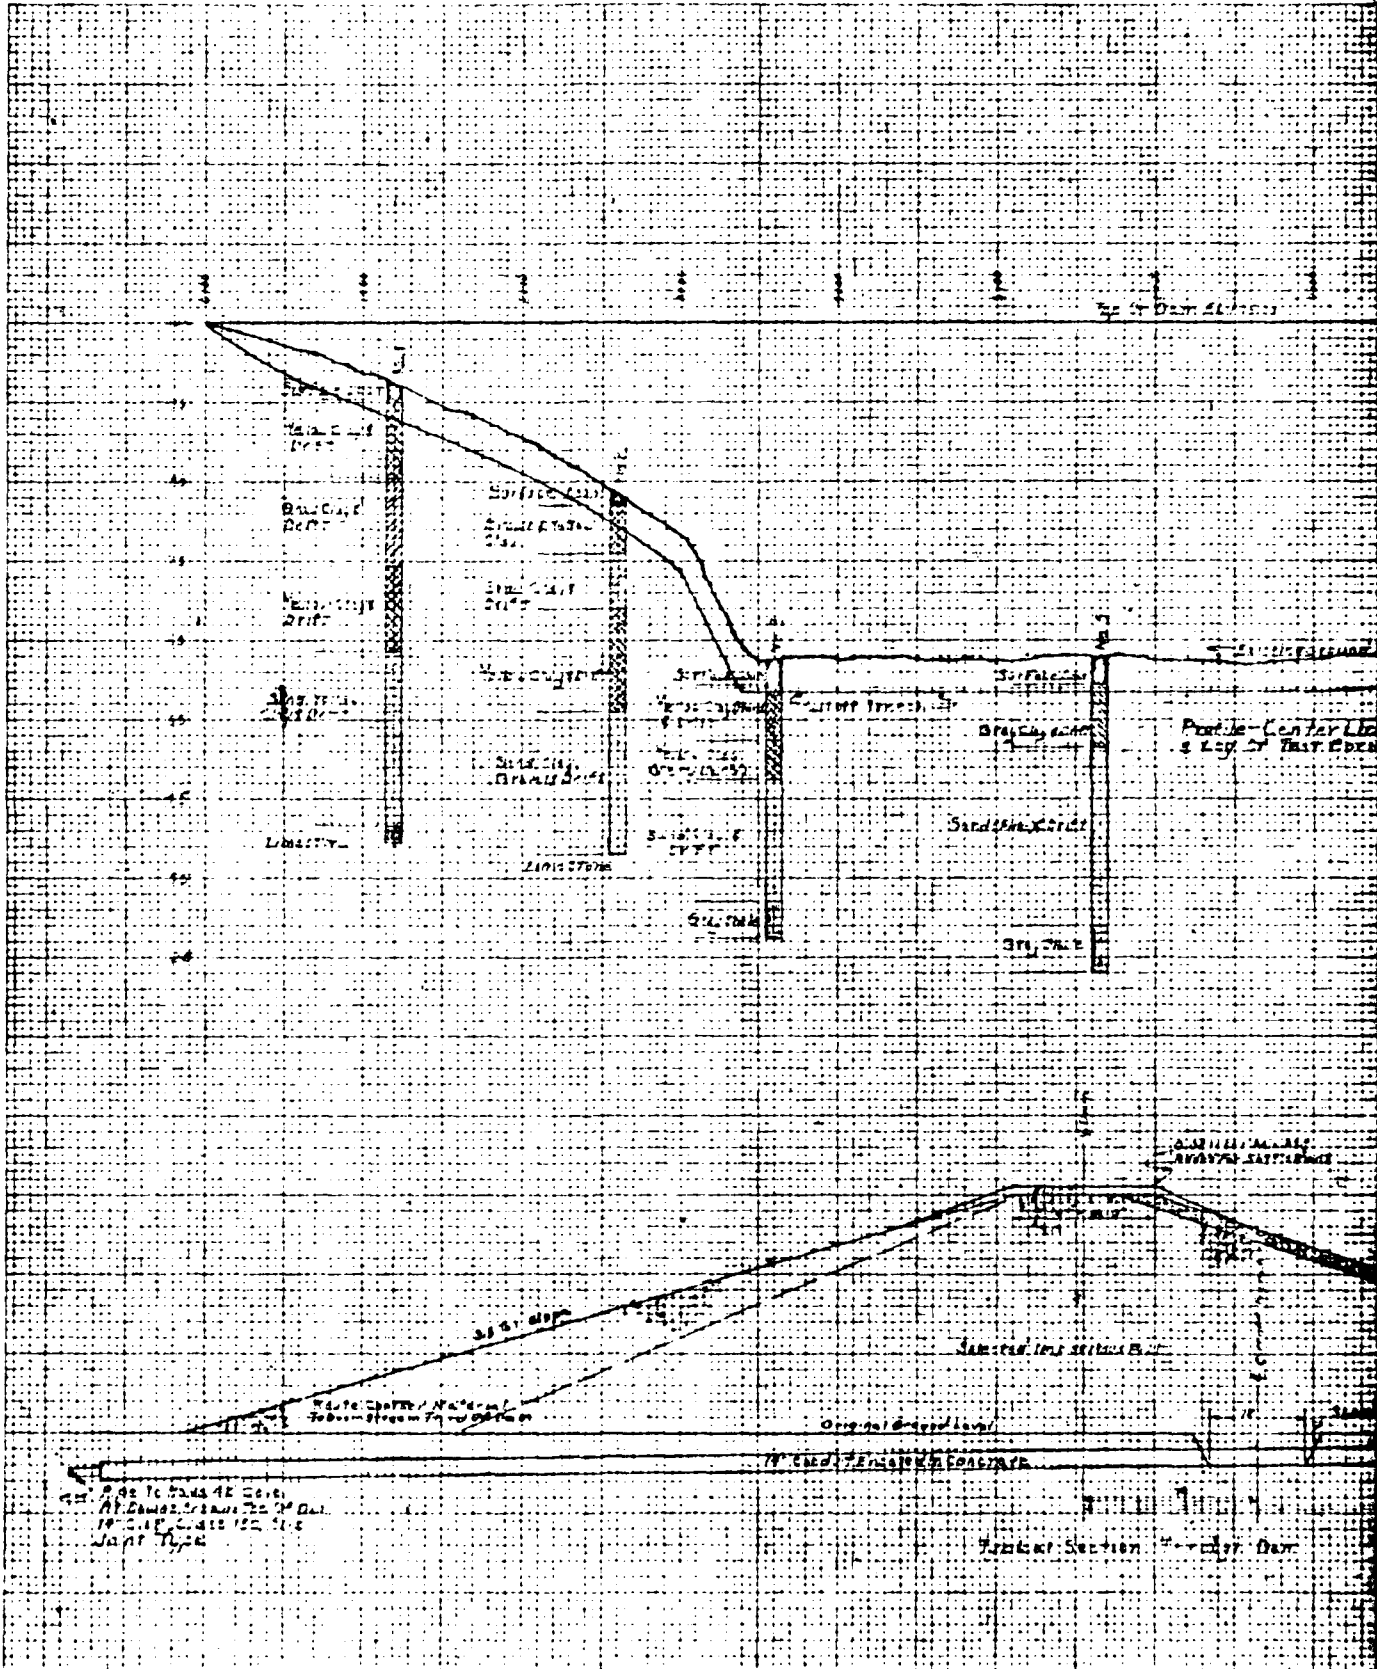
Profile - Center Line & Key of Test Cuts

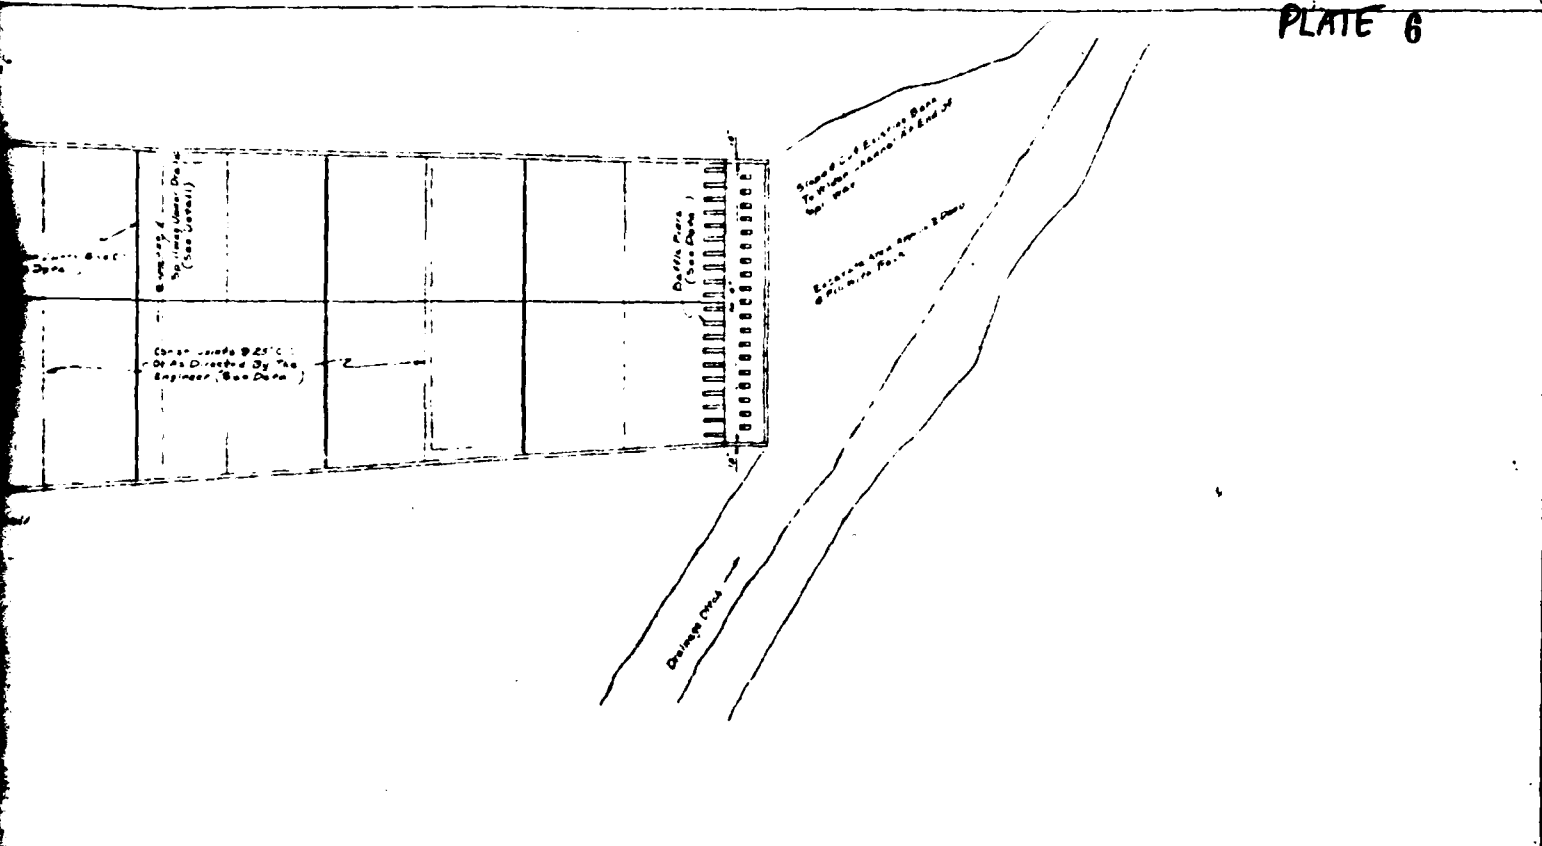
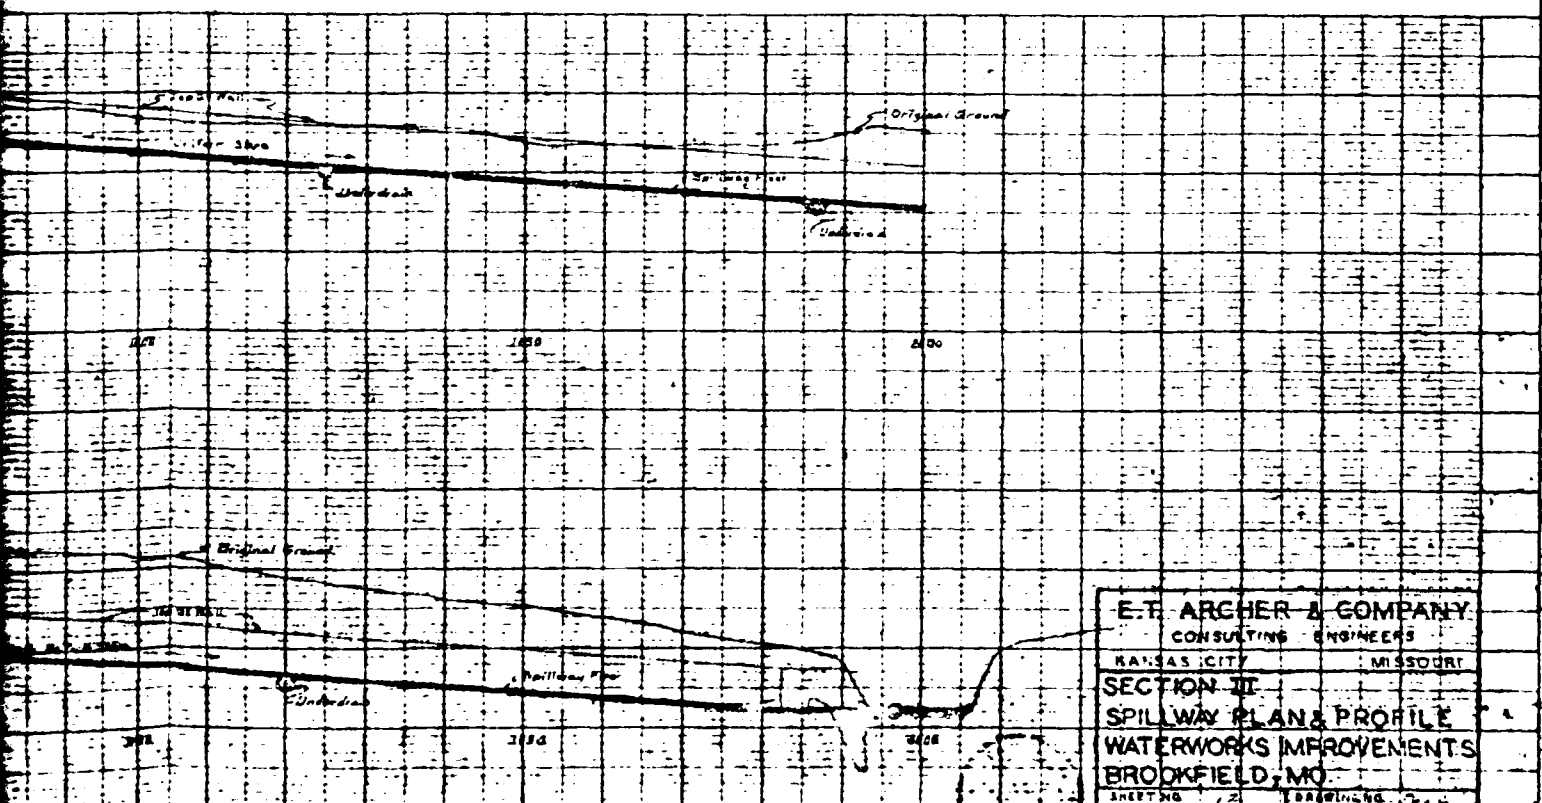
E. F. ARGHER & COMPANY  
 CONSULTING ENGINEERS  
 KANSAS CITY MISSOURI  
 SECTION III  
 SPILLWAY PLAN & PROFILE  
 WATERWORKS IMPROVEMENTS  
 BROOKFIELD, MO.  
 SHEET NO. 2

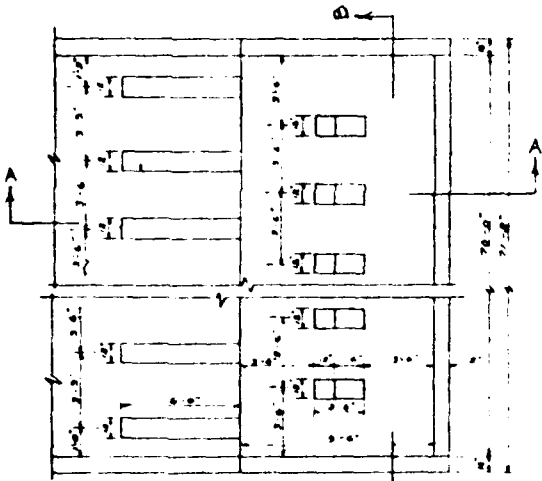
SPILLWAY TAILFACE - PLAN  
16'-11 1/2"

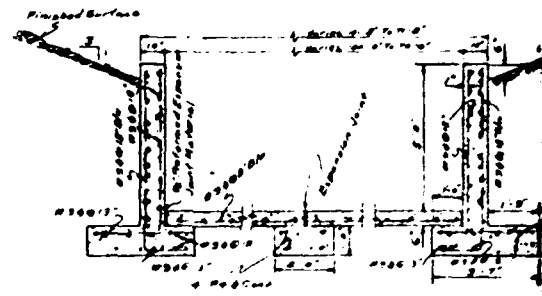
TYPICAL SPILLWAY CROSS SECTION ON  
32'-10 1/2"

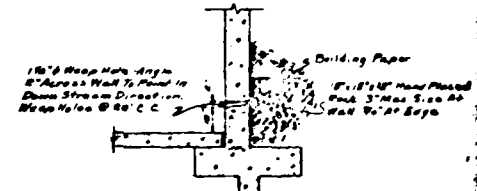
WEEP HOLE DETAIL  
16'-11 1/2"

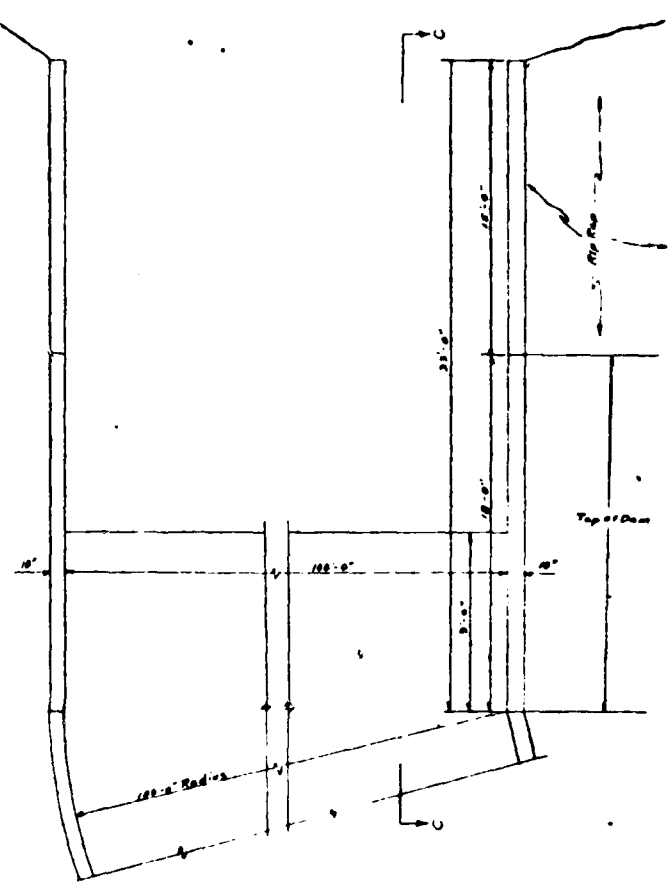
PLAN SPILLWAY CREST  
No. 12'

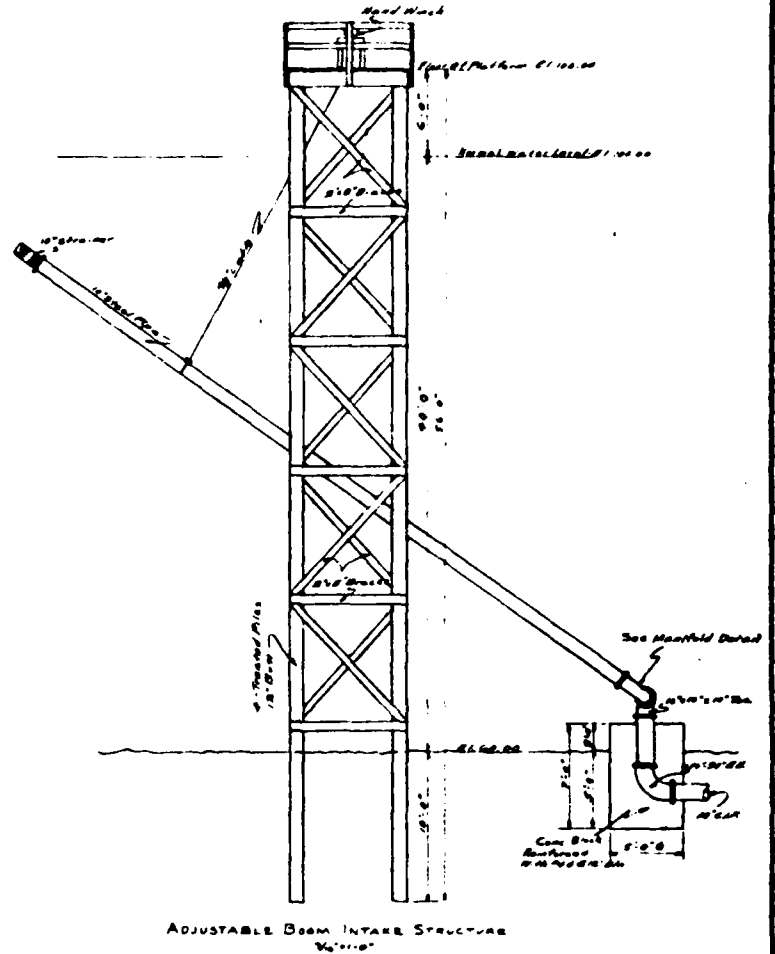
ADJUSTABLE BOOM INTAKE STRUCTURE  
No. 1110

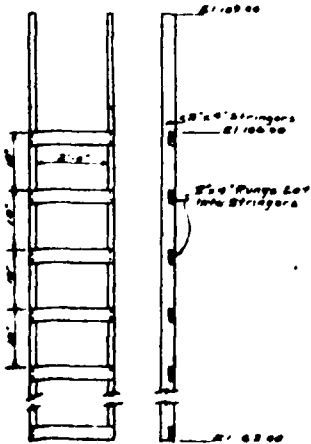
LADDER DETAIL  
No. 1110

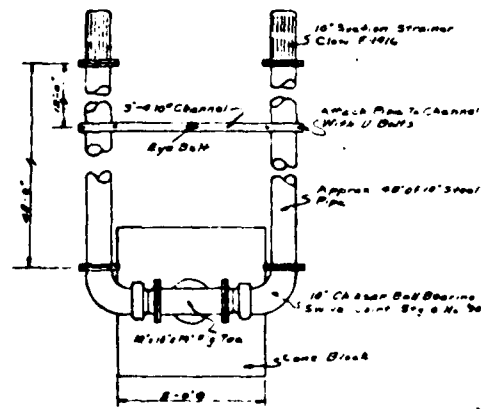
INTAKE MANIFOLD DETAIL  
No. 1110

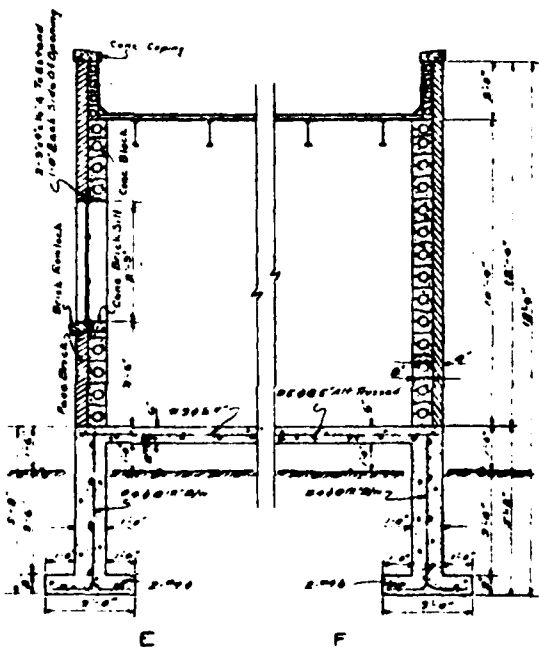
TYPICAL WALL SECTIONS  
16" WALL

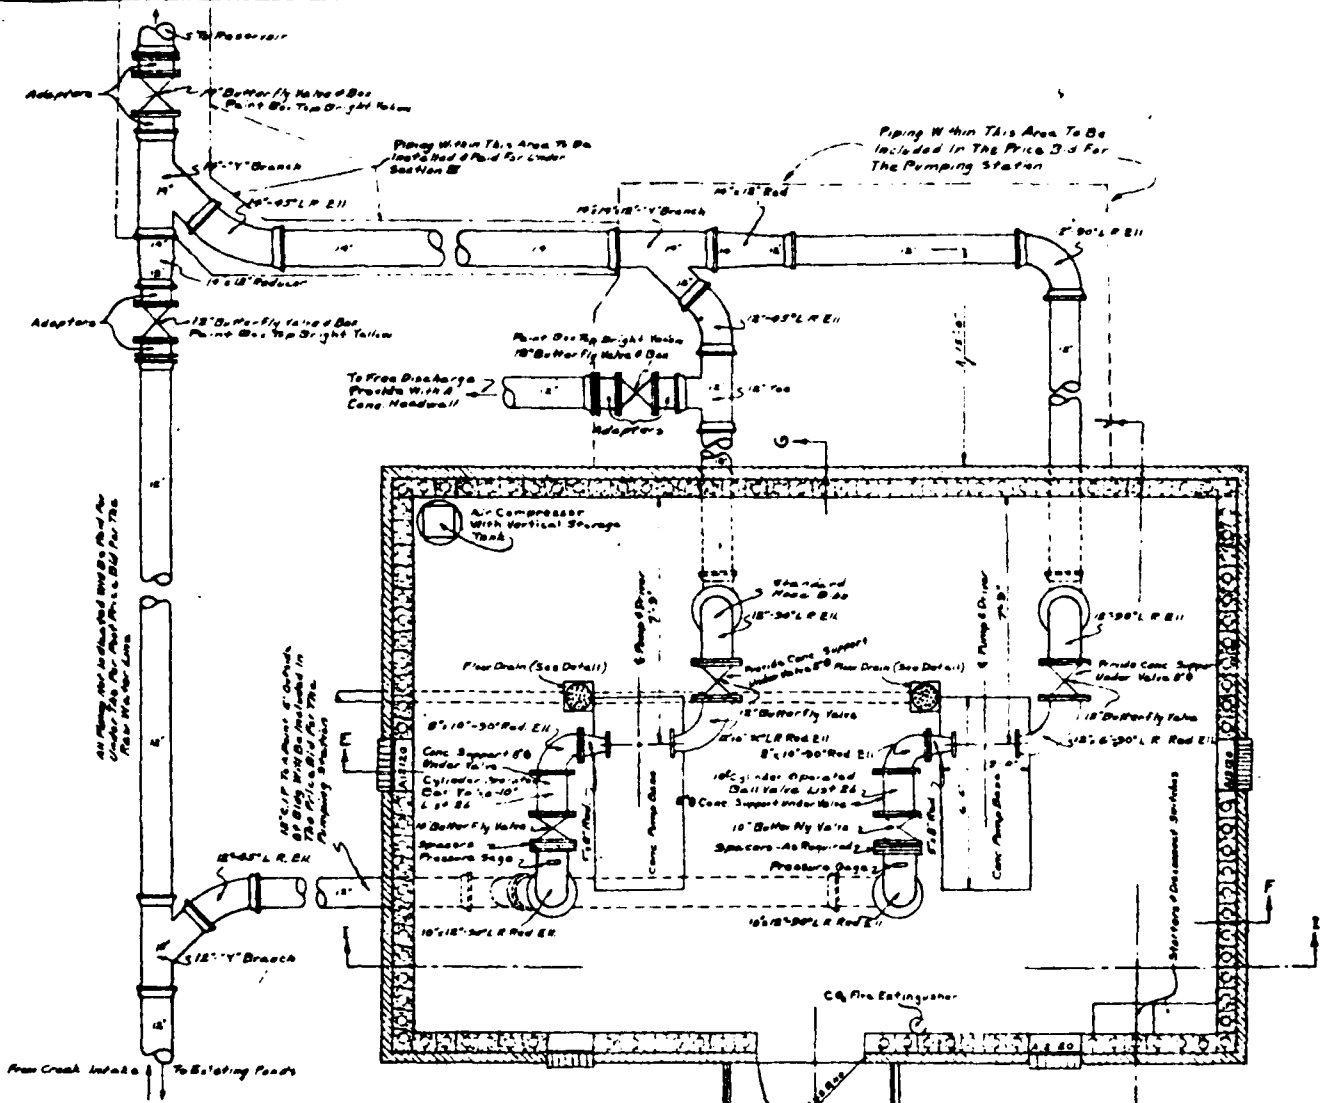
EQUIPMENT PLAN

E. T. ARCHER & COMPANY	
CONSULTING ENGINEERS	
KANSAS CITY	MISSOURI
SECTION IV	
LAKE PUMPING STATION	
WATERWORKS IMPROVEMENTS	
BROOKFIELD, MO.	
DWG. NO. 26	DRAWING NO. 5995

A regulated outlet works used in the Brookfield domestic water supply system was provided for the dam. The water supply system associated with the dam consists of two centrifugal pumps located in a pumphouse which is located immediately downstream of the dam. The pumphouse is located approximately 450 feet to the right of the left abutment. Each pump is controlled by a 12-inch butterfly valve. The capacity of each pump is 750 to 1000 gpm. The intake of the system consists of two 10-inch steel pipes, 50 feet in length, connected to a manifold which can swivel to allow the ends of the pipes to be lowered and raised. A wood piling tower was provided in the reservoir with a hand operated winch used to raise and lower the intake. A strainer was provided on the end of each pipe. From the manifold, a 14-inch C.I.P. encased in concrete passes under the embankment to the pumphouse where the pipe branches into two 12-inch cast iron pipes. The two pipes pass through the pumping system in the pumphouse and converge into a 12-inch C.I.P. which goes to some storage lagoons. A pump is located at the storage lagoons which can pump water back into the Brookfield City reservoir through the same system. On one of the 12-inch lines into the pumphouse, a 12-inch drain pipe was provided which is controlled by a gate valve.

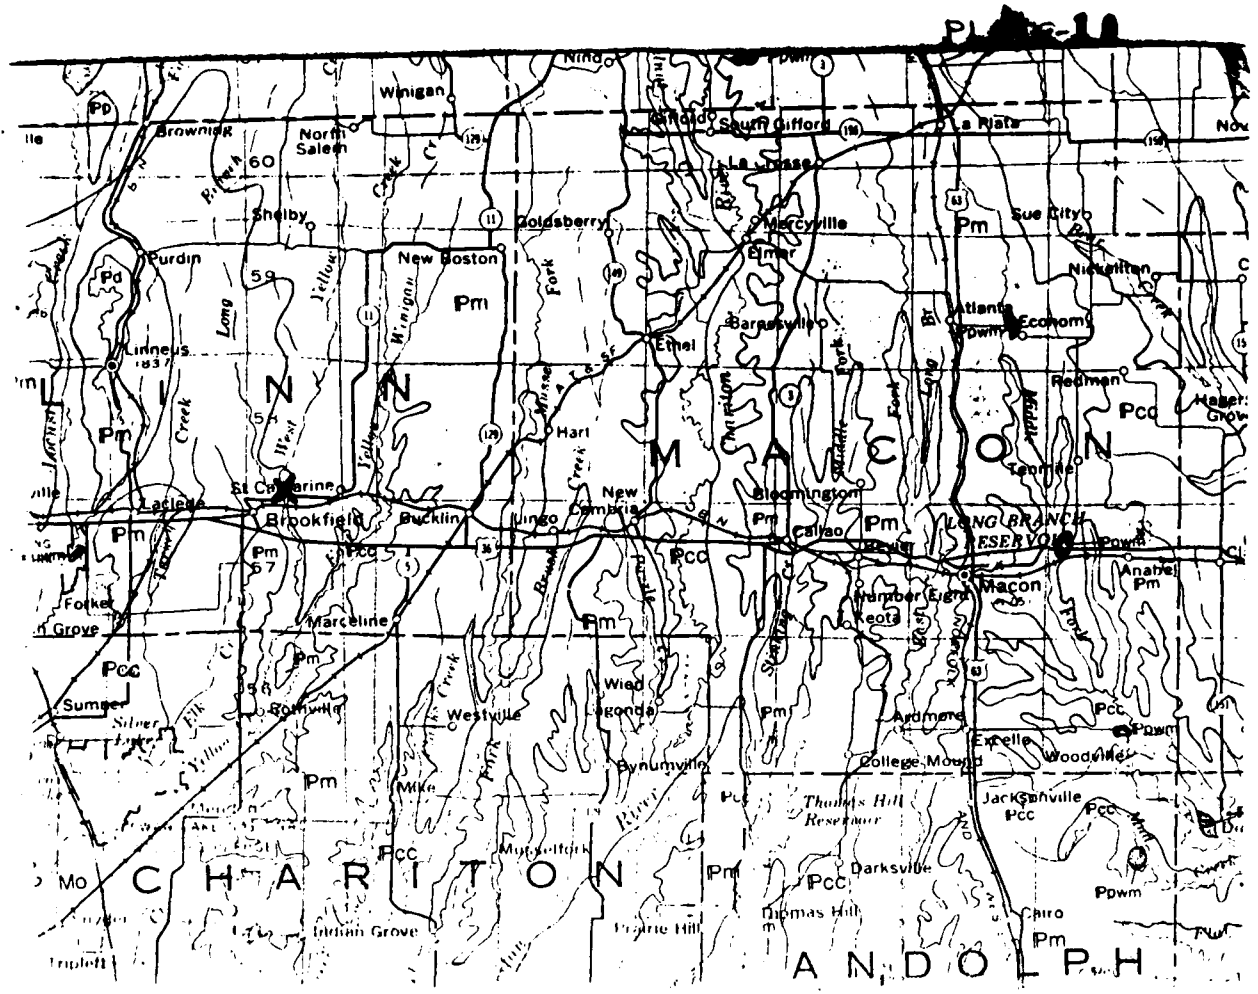
PENNSYLVANIAN { IPm - MARMATON GROUP  
 IPcc - CHEROKEE GROUP,  
 CABANISS SUBGROUP

GEOLOGIC MAP  
 OF  
 LINN COUNTY  
 AND  
 ADJACENT AREA

(see Plate 5). The subsurface soils consist of clayey soils, shale and sand and clay drift. No information on design hydrology, or hydraulic design was available, nor were seepage and stability analyses comparable to the requirements of the "Recommended Guidelines for Safety Inspection of Dams", which is considered a deficiency.

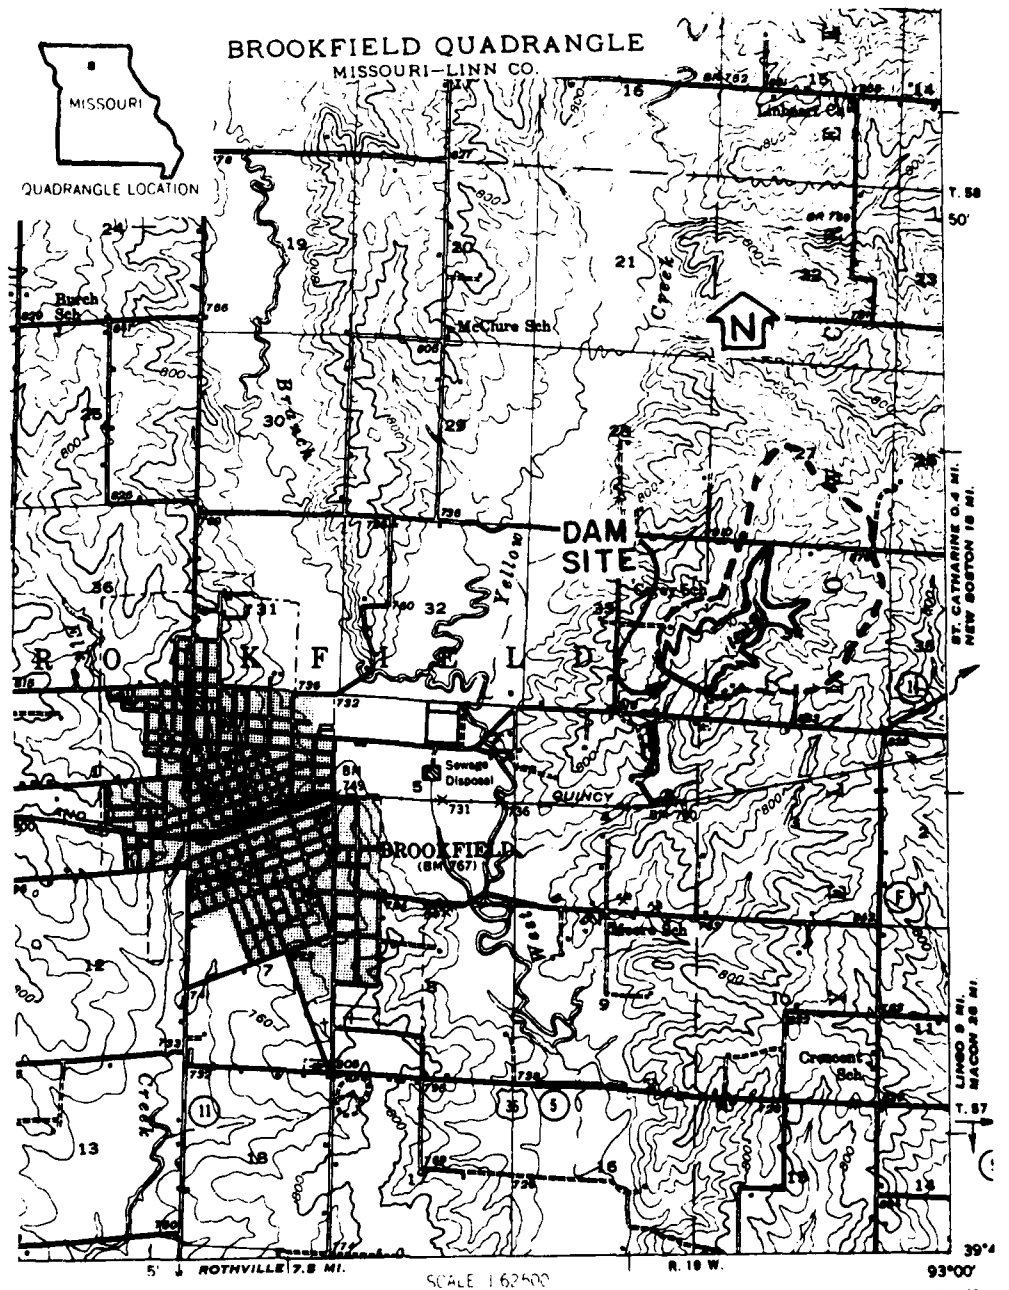
DRAINAGE BOUNDARY - - - - -

BROOKFIELD CITY DAM (MO 10181)  
DRAINAGE BASIN

The watershed area of the Brookfield City Dam upstream from the dam axis consists of approximately 702 acres. The watershed area is mostly pasture and range land. Land gradients in the higher regions of the watershed average roughly 4 percent, and in the lower areas surrounding the reservoir average about 8 percent. The Brookfield City Dam Reservoir is located on an unnamed tributary of the West Yellow Creek. The reservoir is about 1.6 miles upstream from the confluence of the unnamed tributary and West Yellow Creek. At its longest arm the watershed is approximately 1/2 mile long. A drainage map showing the watershed is presented as Plate 1 in Appendix B.

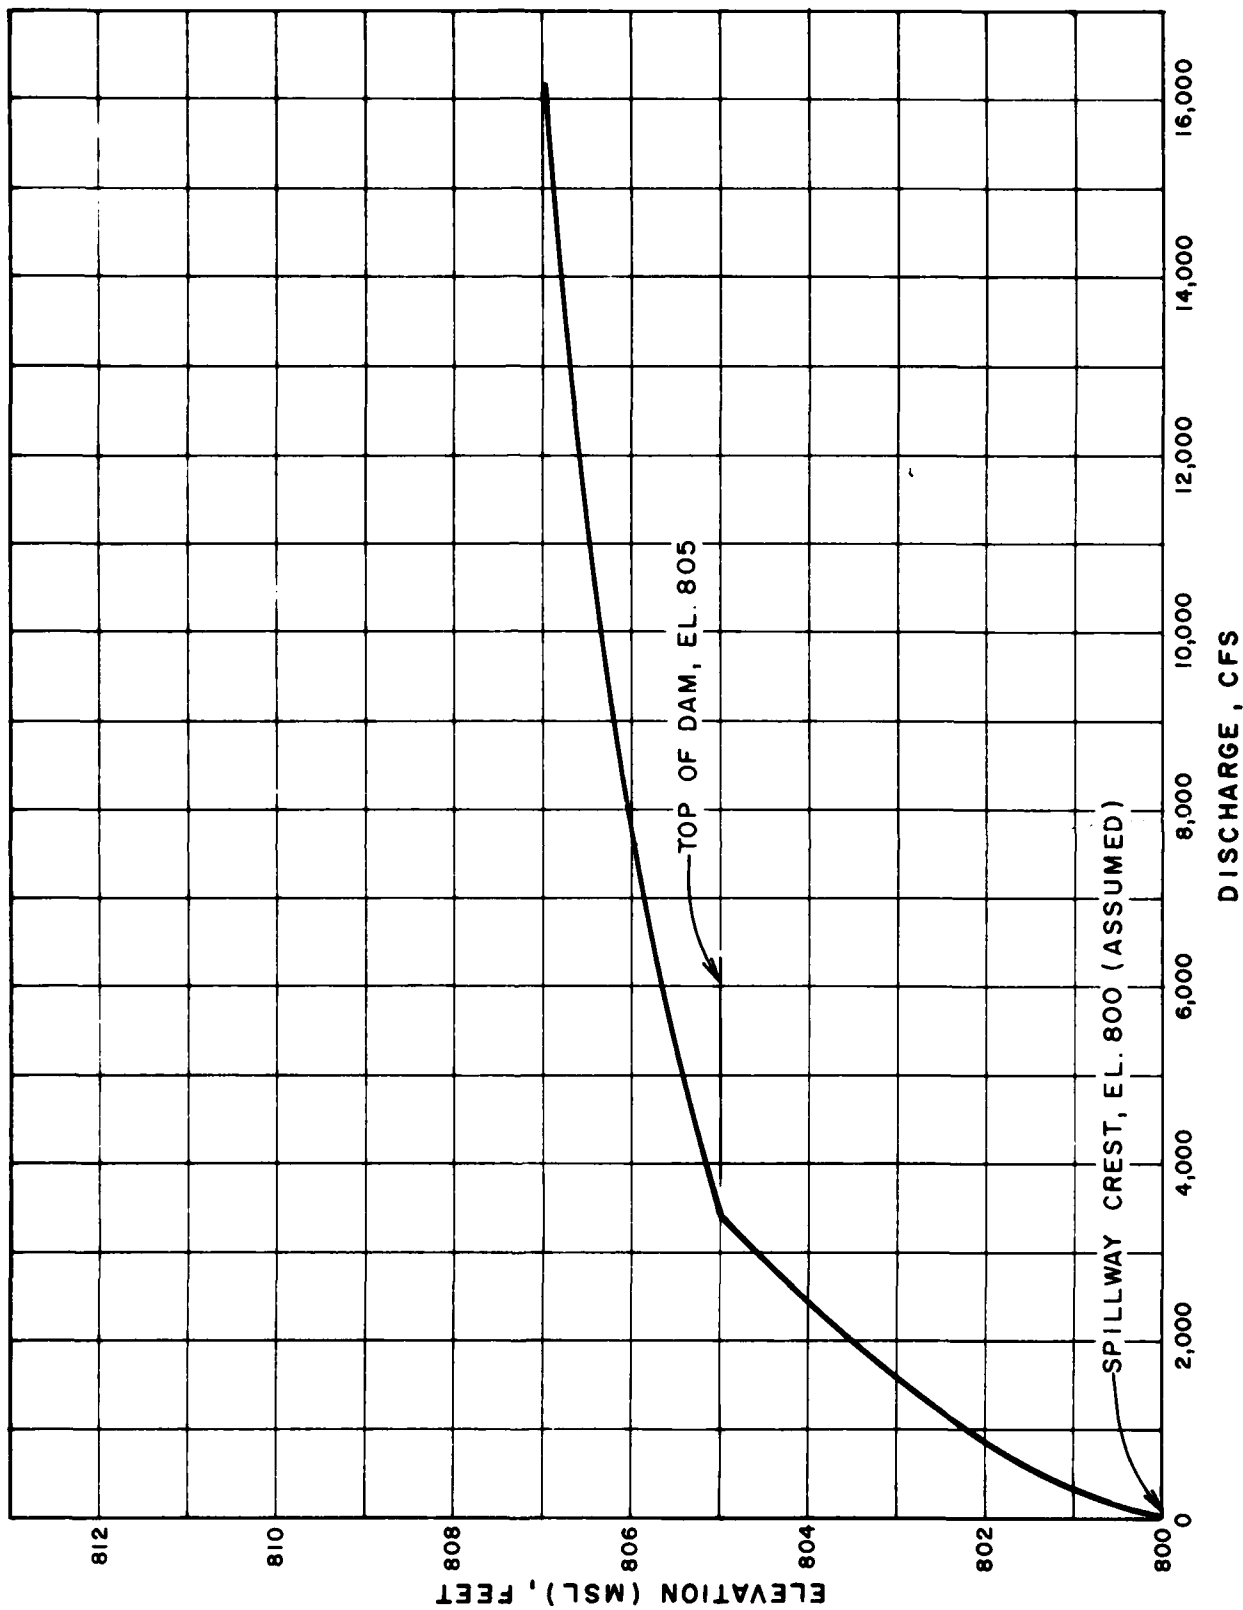
BROOKFIELD CITY DAM (MO. 10181)  
SPILLWAY AND OVERTOP RATING CURVE  
B-4

The size of physical features utilized to develop the stage-outflow relation for the spillway and overtopping of the dam were determined from field notes and sketches, prepared during the field inspection. The reservoir stage-capacity data were based on the U.S.G.S. Brookfield, Missouri Quadrangle topographic map (7.5 minute series). The spillway and dam overtop rating curve and the reservoir capacity curve are presented in Plates 2 & 3 respectively in Appendix B.

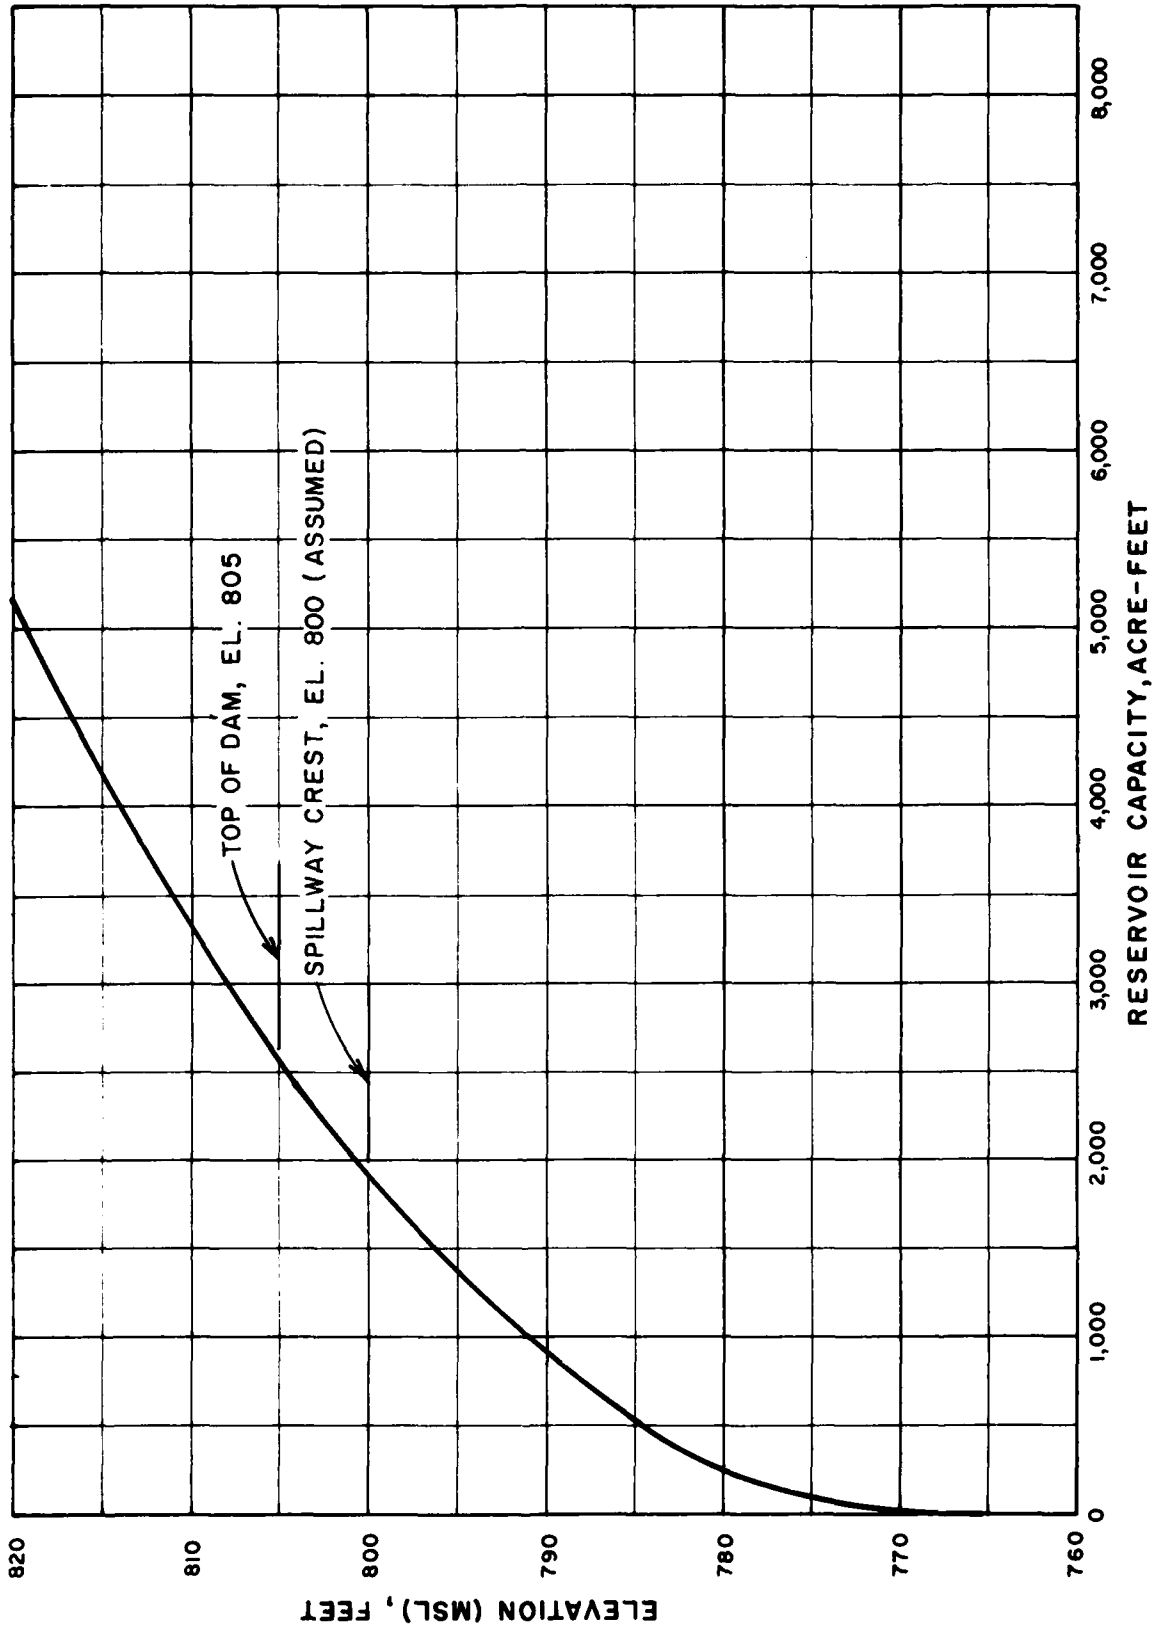
B-6

BROOKFIELD CITY DAM (MO.10181)  
RESERVOIR CAPACITY CURVE

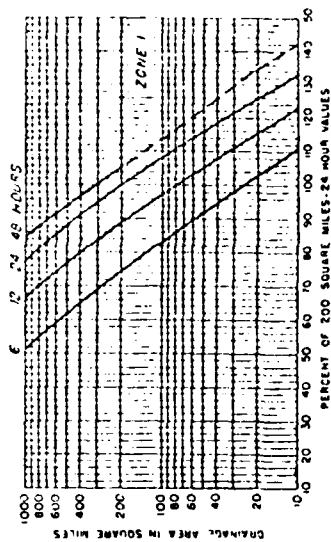
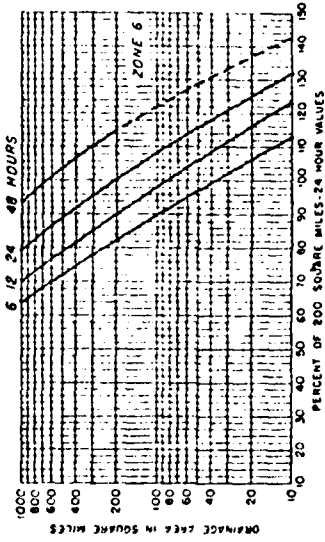
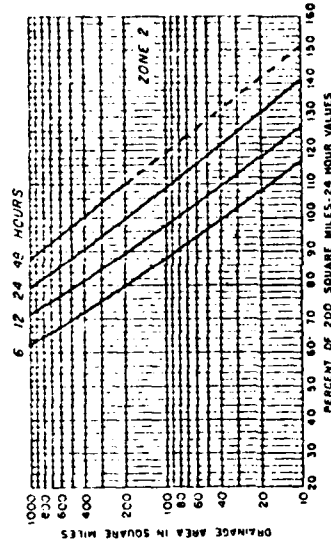
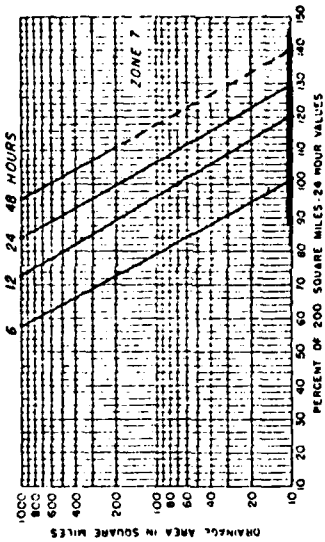
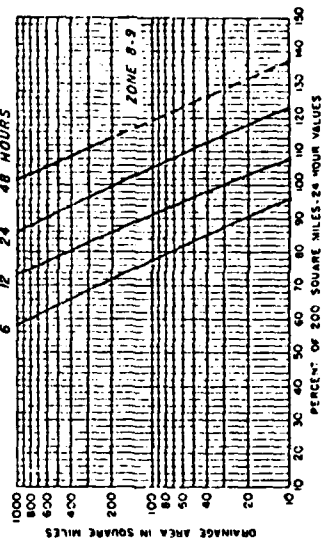
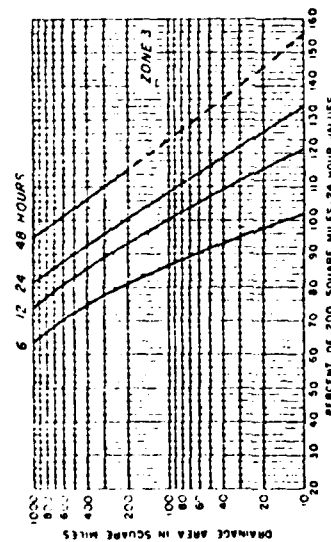
FIGURE 2  
SEASONAL VARIATION  
DEPTH-AREA-DURATION RELATIONSHIPS  
Percentage to be applied to 200 square miles  
24 hour probable maximum precipitation values  
for: THE-ALL SEASON ENVELOPE
