GLEN BASLER LAKE DAM

STE. GENEVIEVE COUNTY, MISSOURI

MO 31382

**PHASE 1 INSPECTION REPORT
NATIONAL DAM SAFETY PROGRAM**

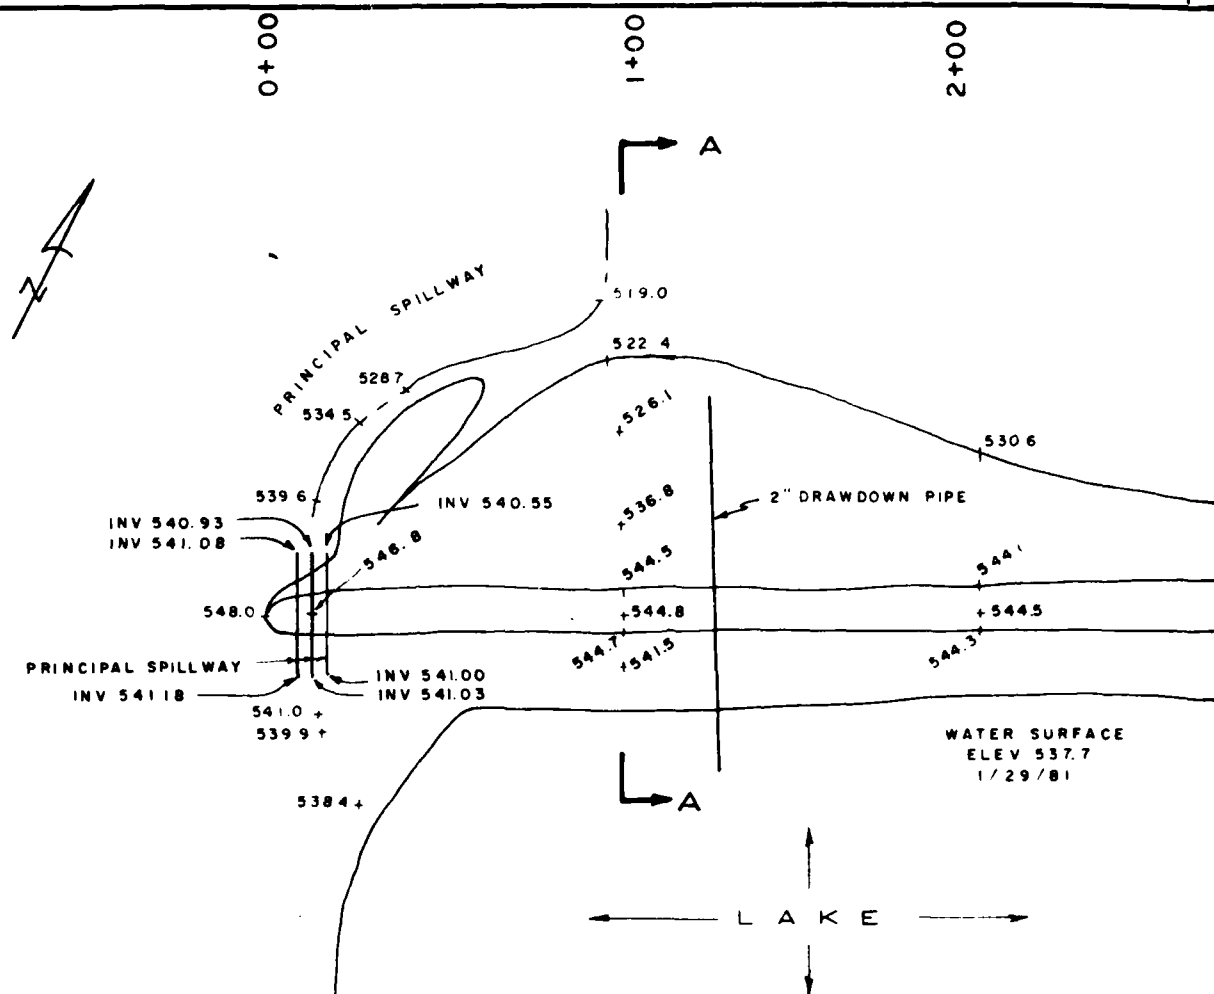
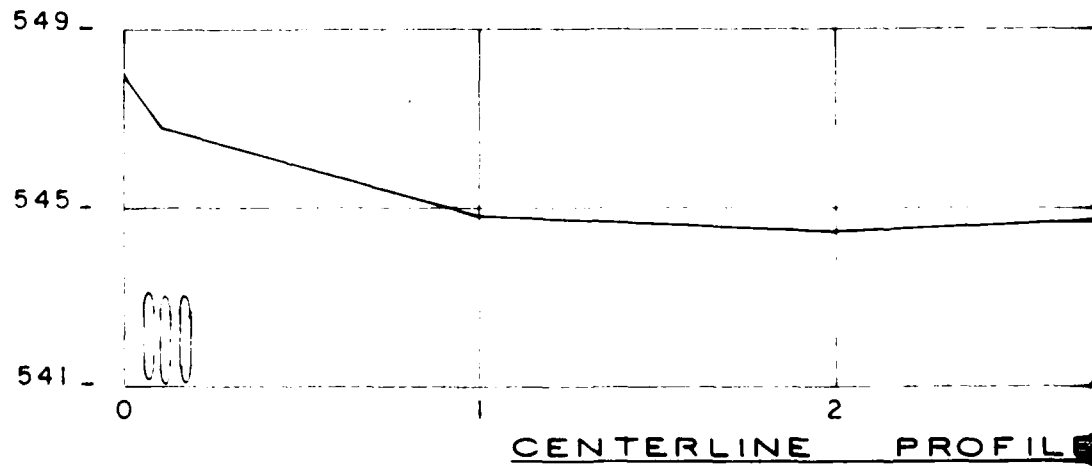
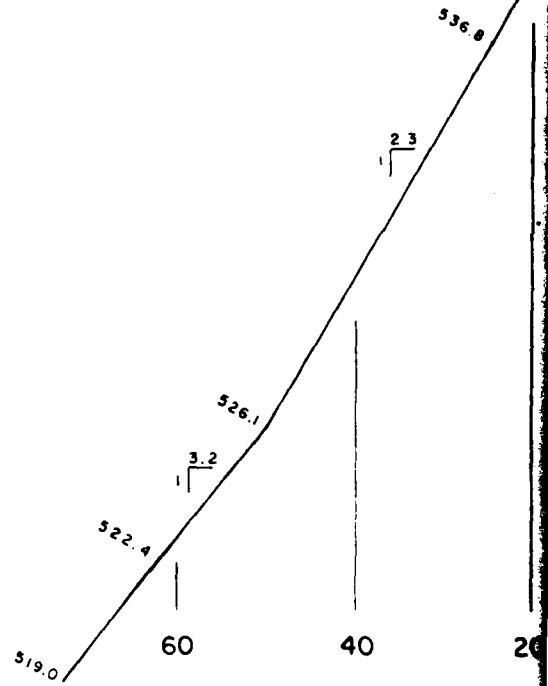
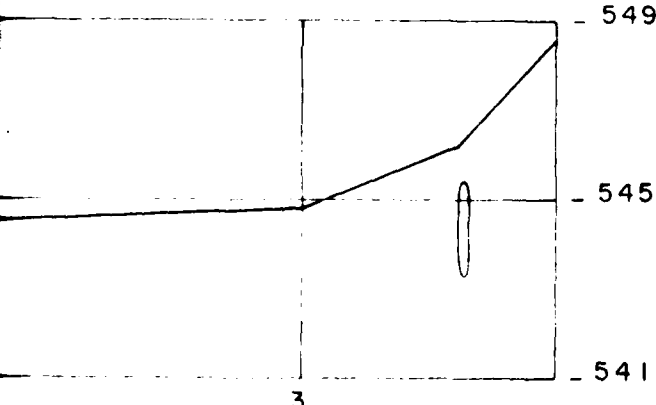
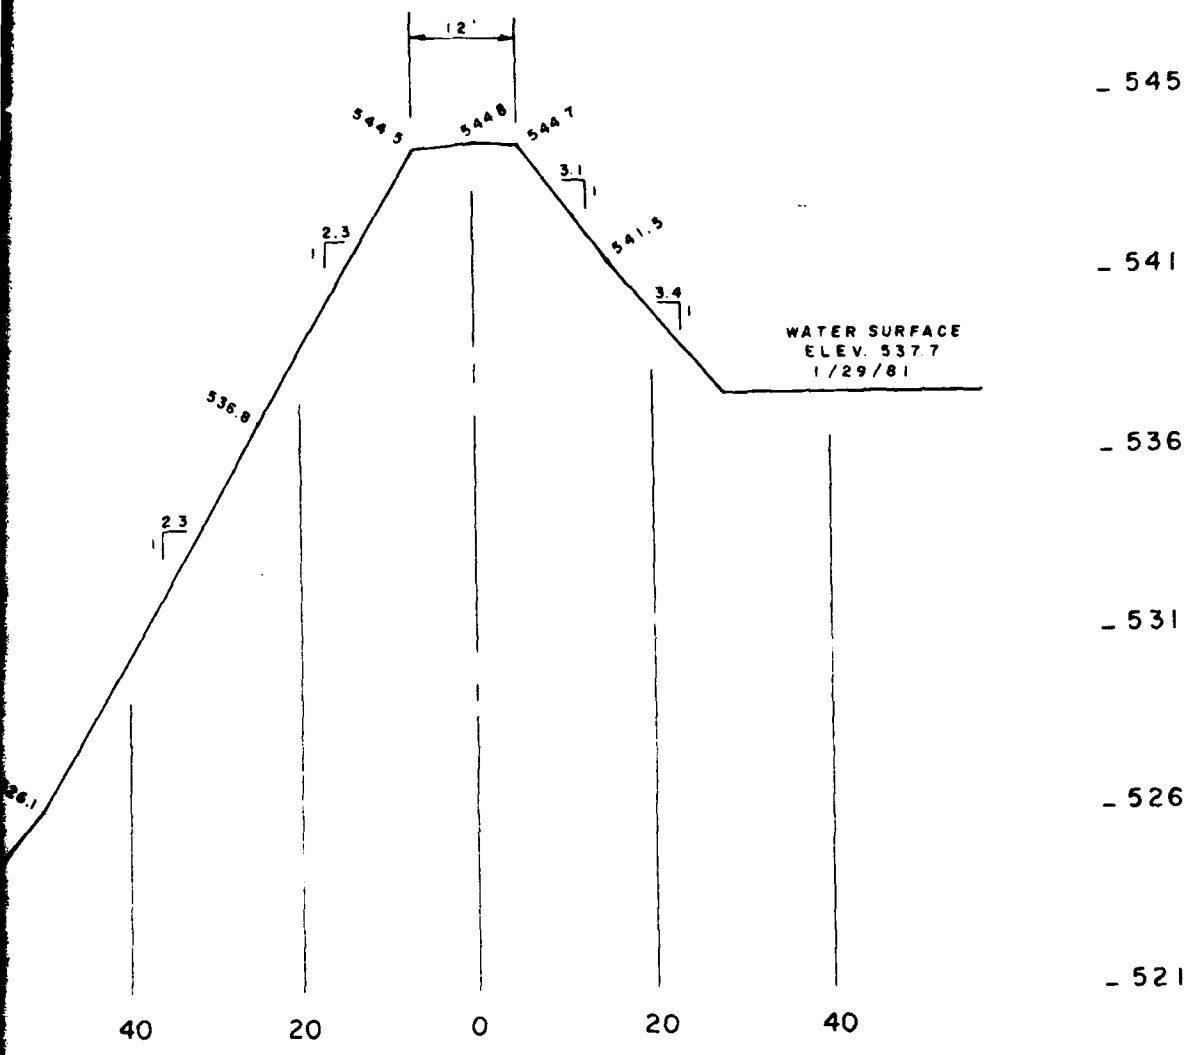
A/E	ANDERSON
	ENGINEERING, INC.
730 N. BENTON AVE. • SPRINGFIELD, MO. 65802	
GLEN BASLER LAKE DAM	
MO. No. 31382	
PLAN, PROFILE AND SECTION OF DAM	
STE. GENEVIEVE COUNTY, MISSOURI	
SHEET 3 , APPENDIX A

BENCHMARK:
INVERT EAST PIPE STA 0+17
16ft. RIGHT, ELEV. 541.0 M.S.L

PLAN VIEW
SCALE: 1" = 50'

EMERGENCY SPILLWAY
PIPE

SECTION

PROFILE

SECTION A - A STA 1+00

The embankment appears to be in good condition with grass cover noted on the upstream and downstream slopes of the embankment. The 12 foot wide crest of the embankment has a graveled access road across it. The embankment was constructed fairly straight and the vertical alignment was such that the middle of the embankment was approximately 4 feet lower than the ends.

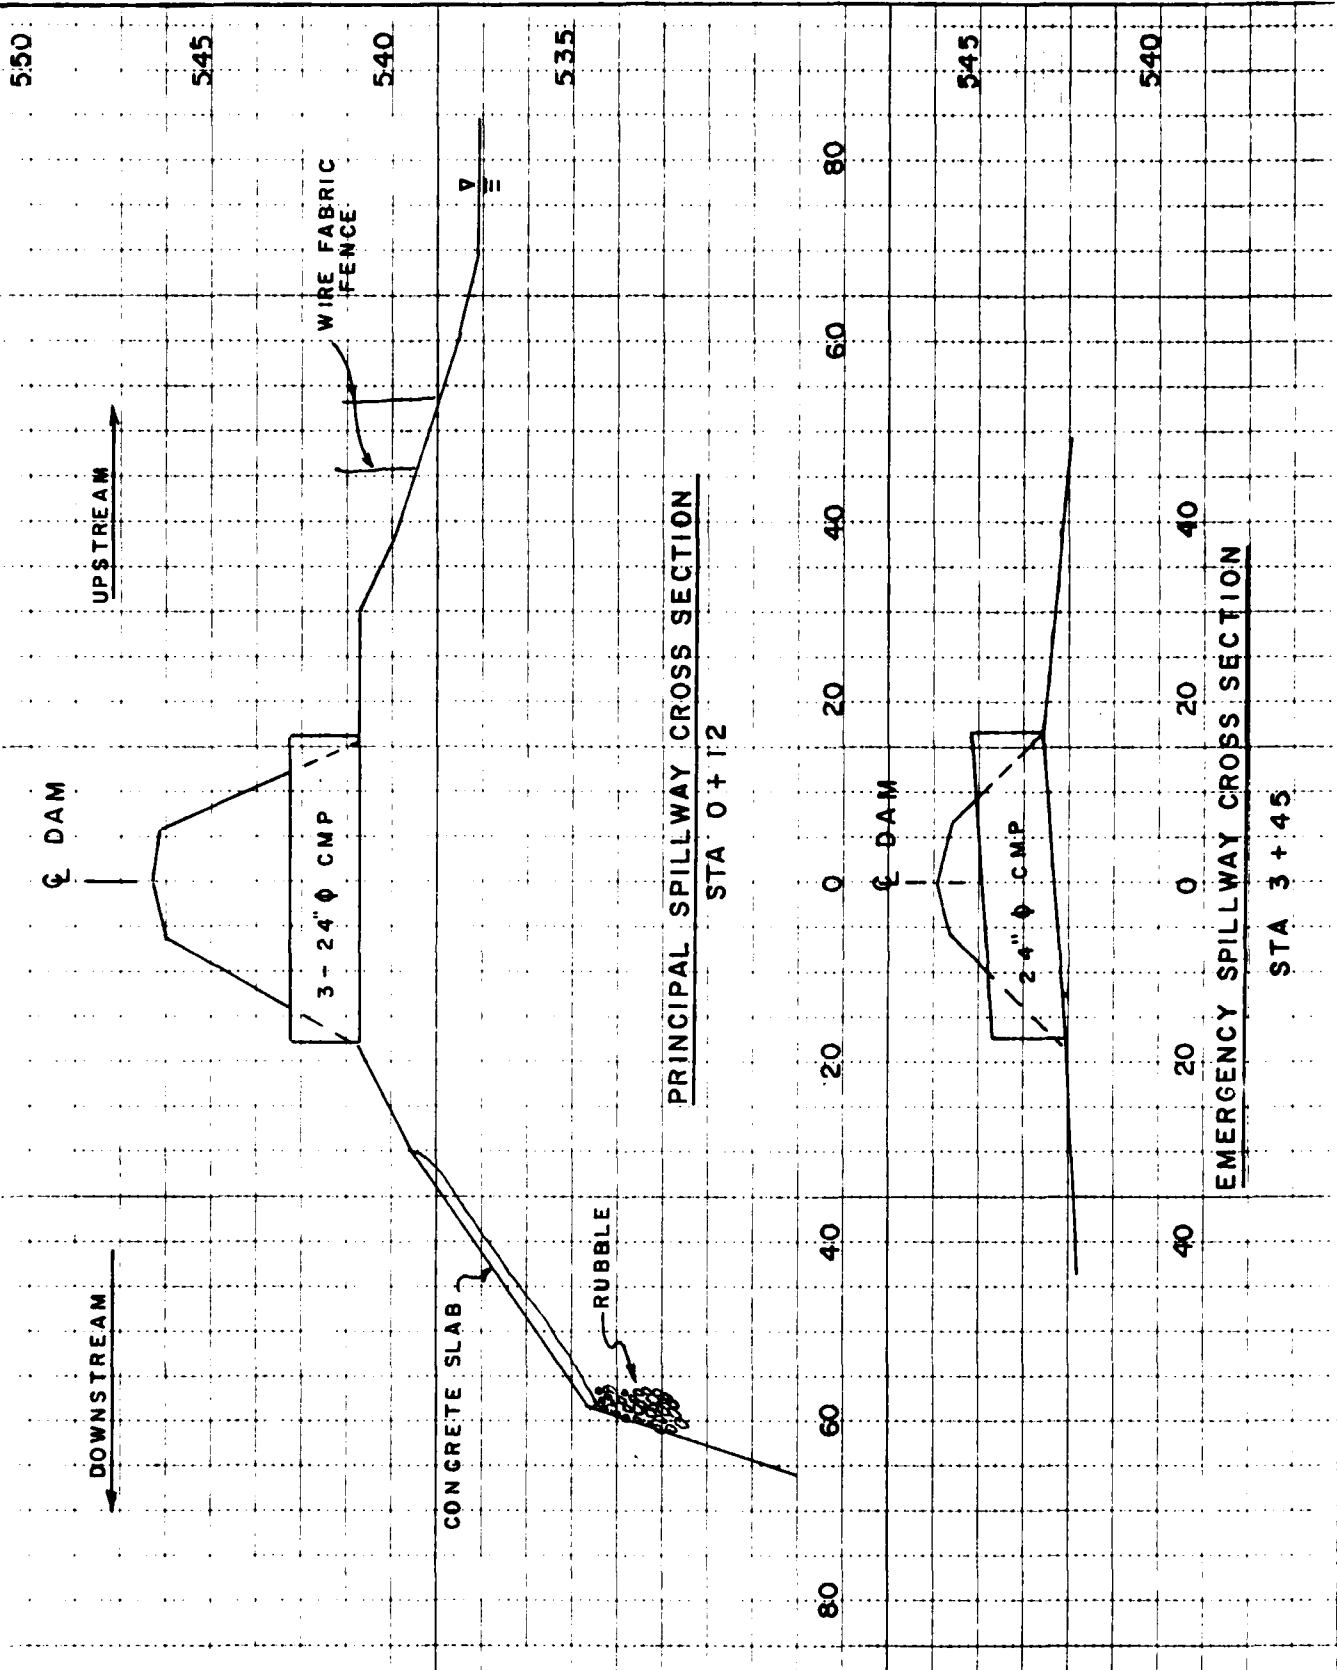
**PROFILE & SECTION OF SPILLWAY
 GLEN BASLER LAKE DAM
 STE. GENEVIEVE COUNTY, MISSOURI
 MO. I. D. No. 31382**

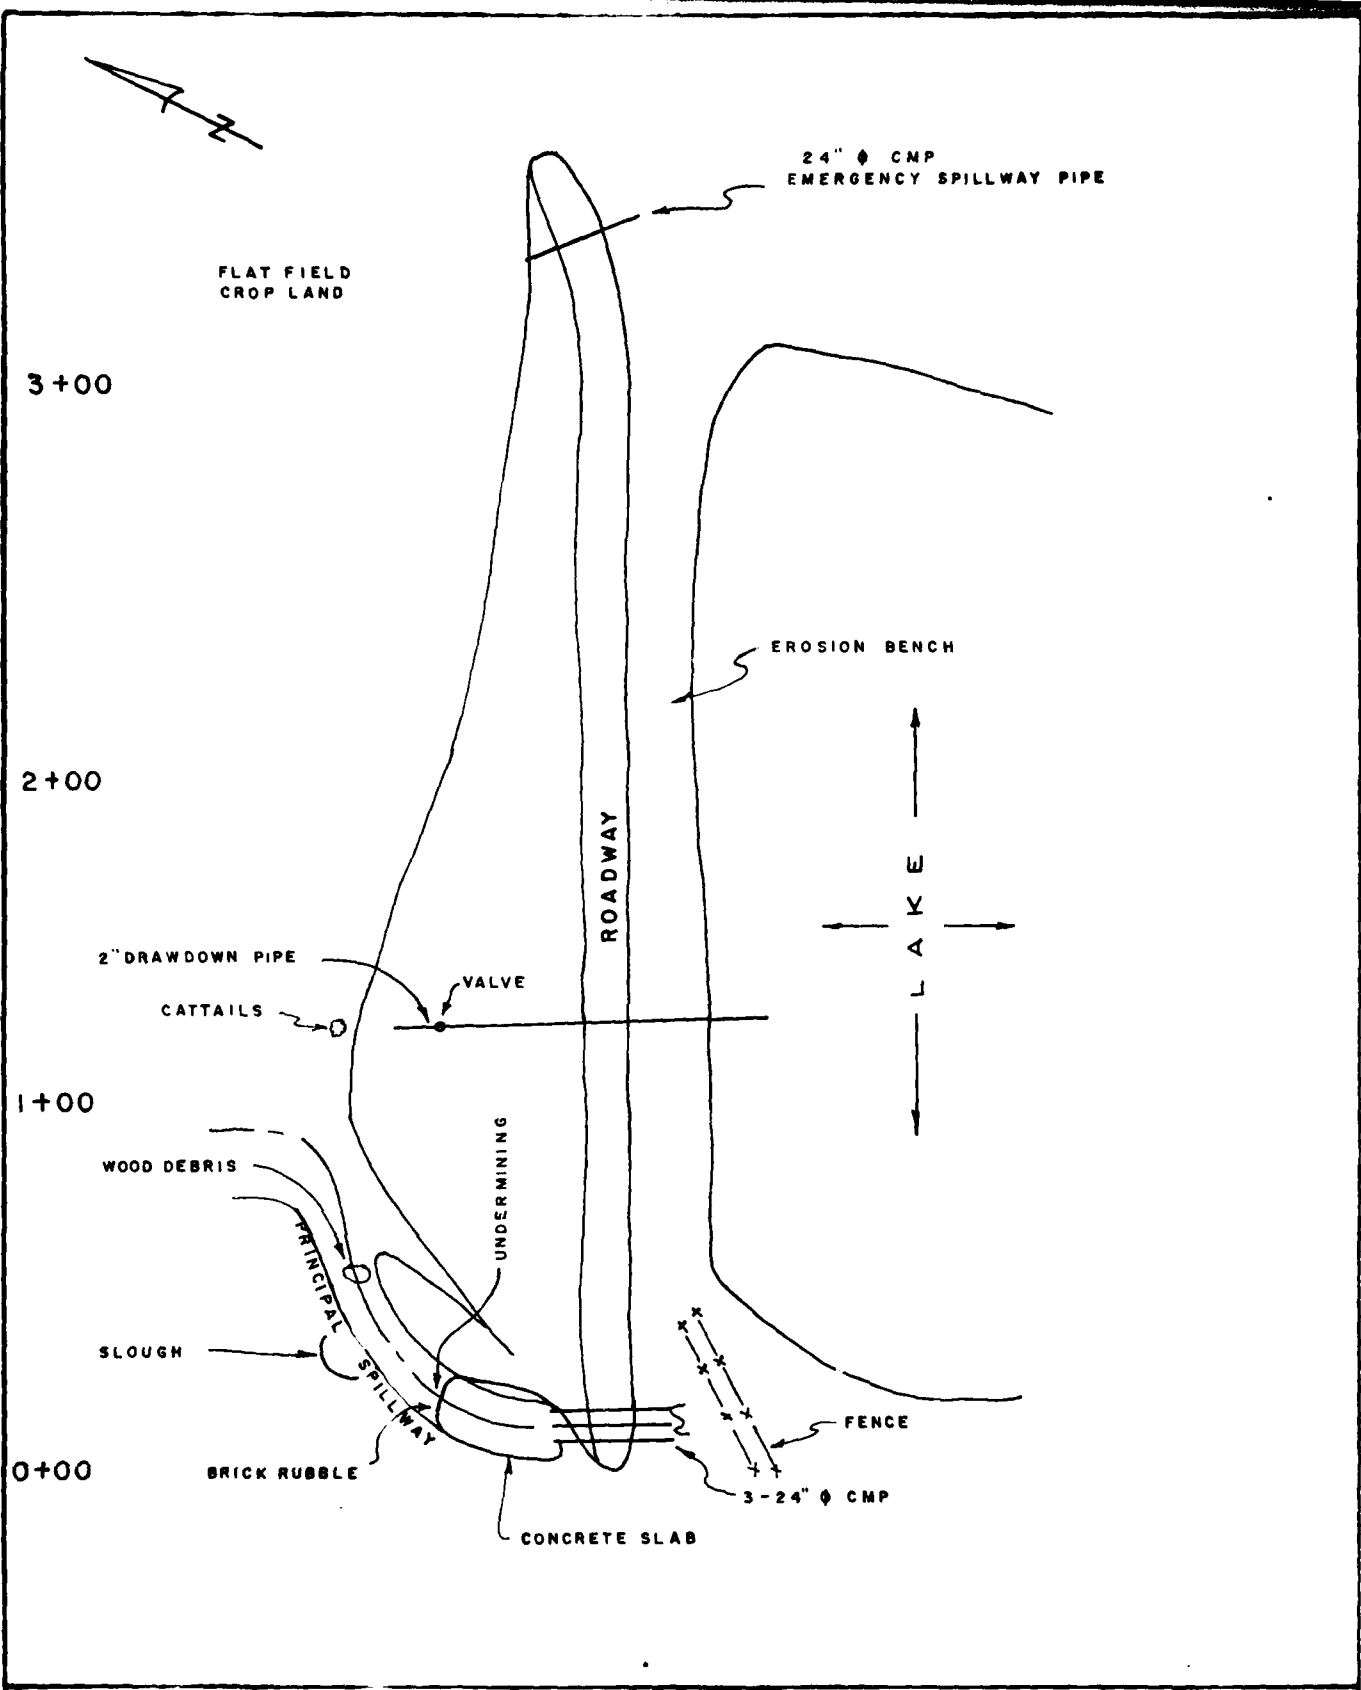
PLAN SKETCH OF DAM
GLEN BASLER LAKE DAM
STE. GENEVIEVE COUNTY, MISSOURI
MO. I. D. No. 31382

There is a 2 inch steel dewatering pipe through the dam at station 1+25 with a valve at the downstream end. There is a small area of cattail growth just beyond the watering pipe outlet. No seepage was noted.

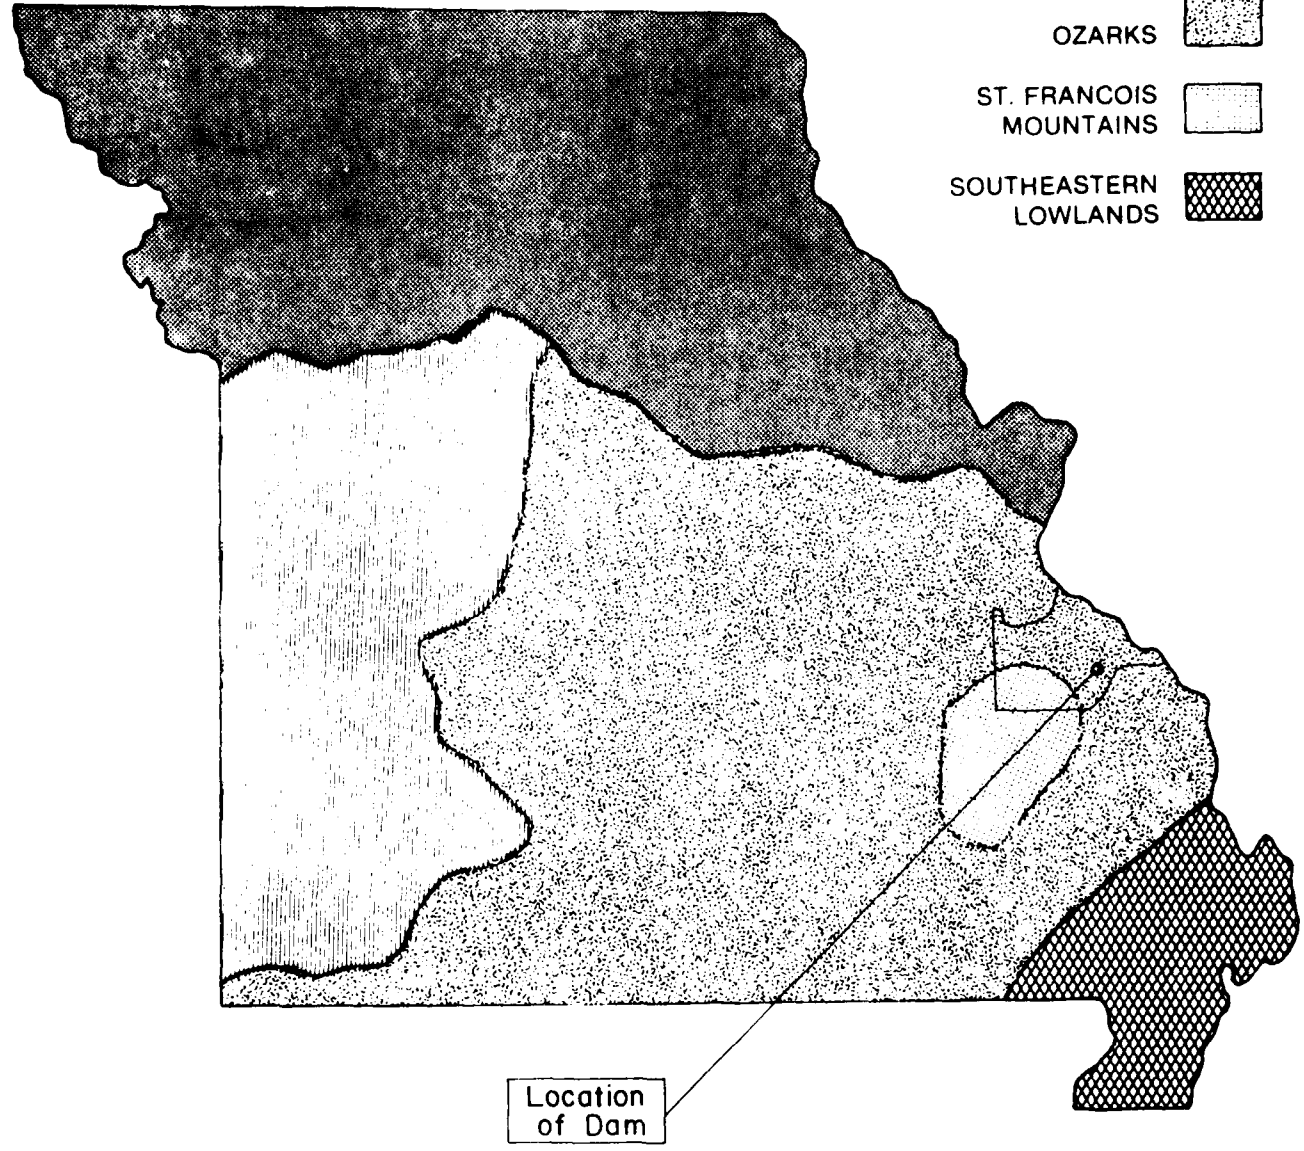
MAJOR GEOLOGIC REGIONS OF MISSOURI

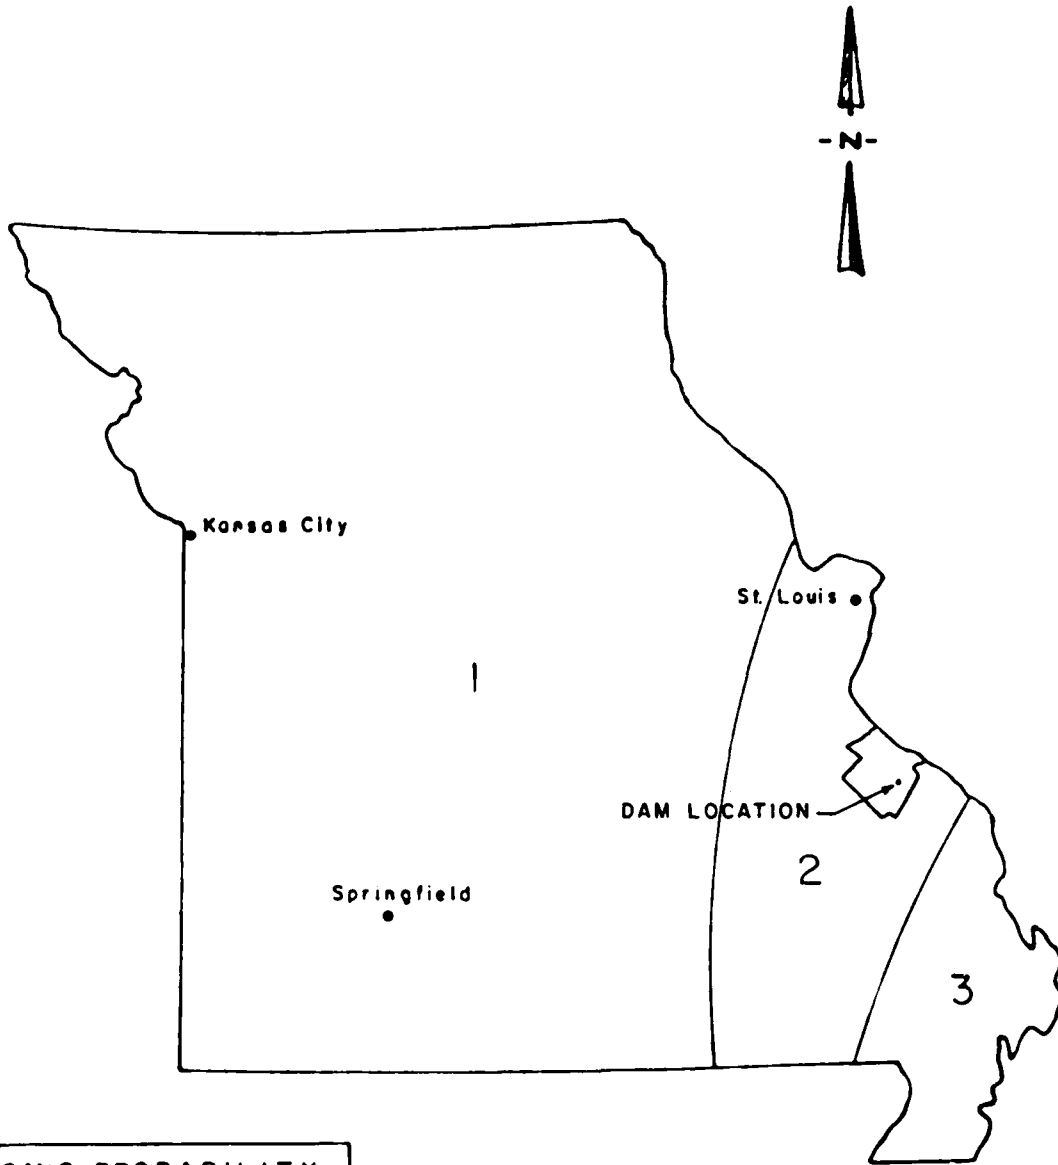
SEISMIC PROBABILITY	
ZONE	DAMAGE
1	MINOR
2	MODERATE
3	MAJOR

The "Geologic Map of Missouri" indicates several normal faults within the site area. The site is located in seismic zone 2 (moderate damage zone) but is close to the boundary of zone 3 (major damage zone see Sheet 3 of Appendix B).

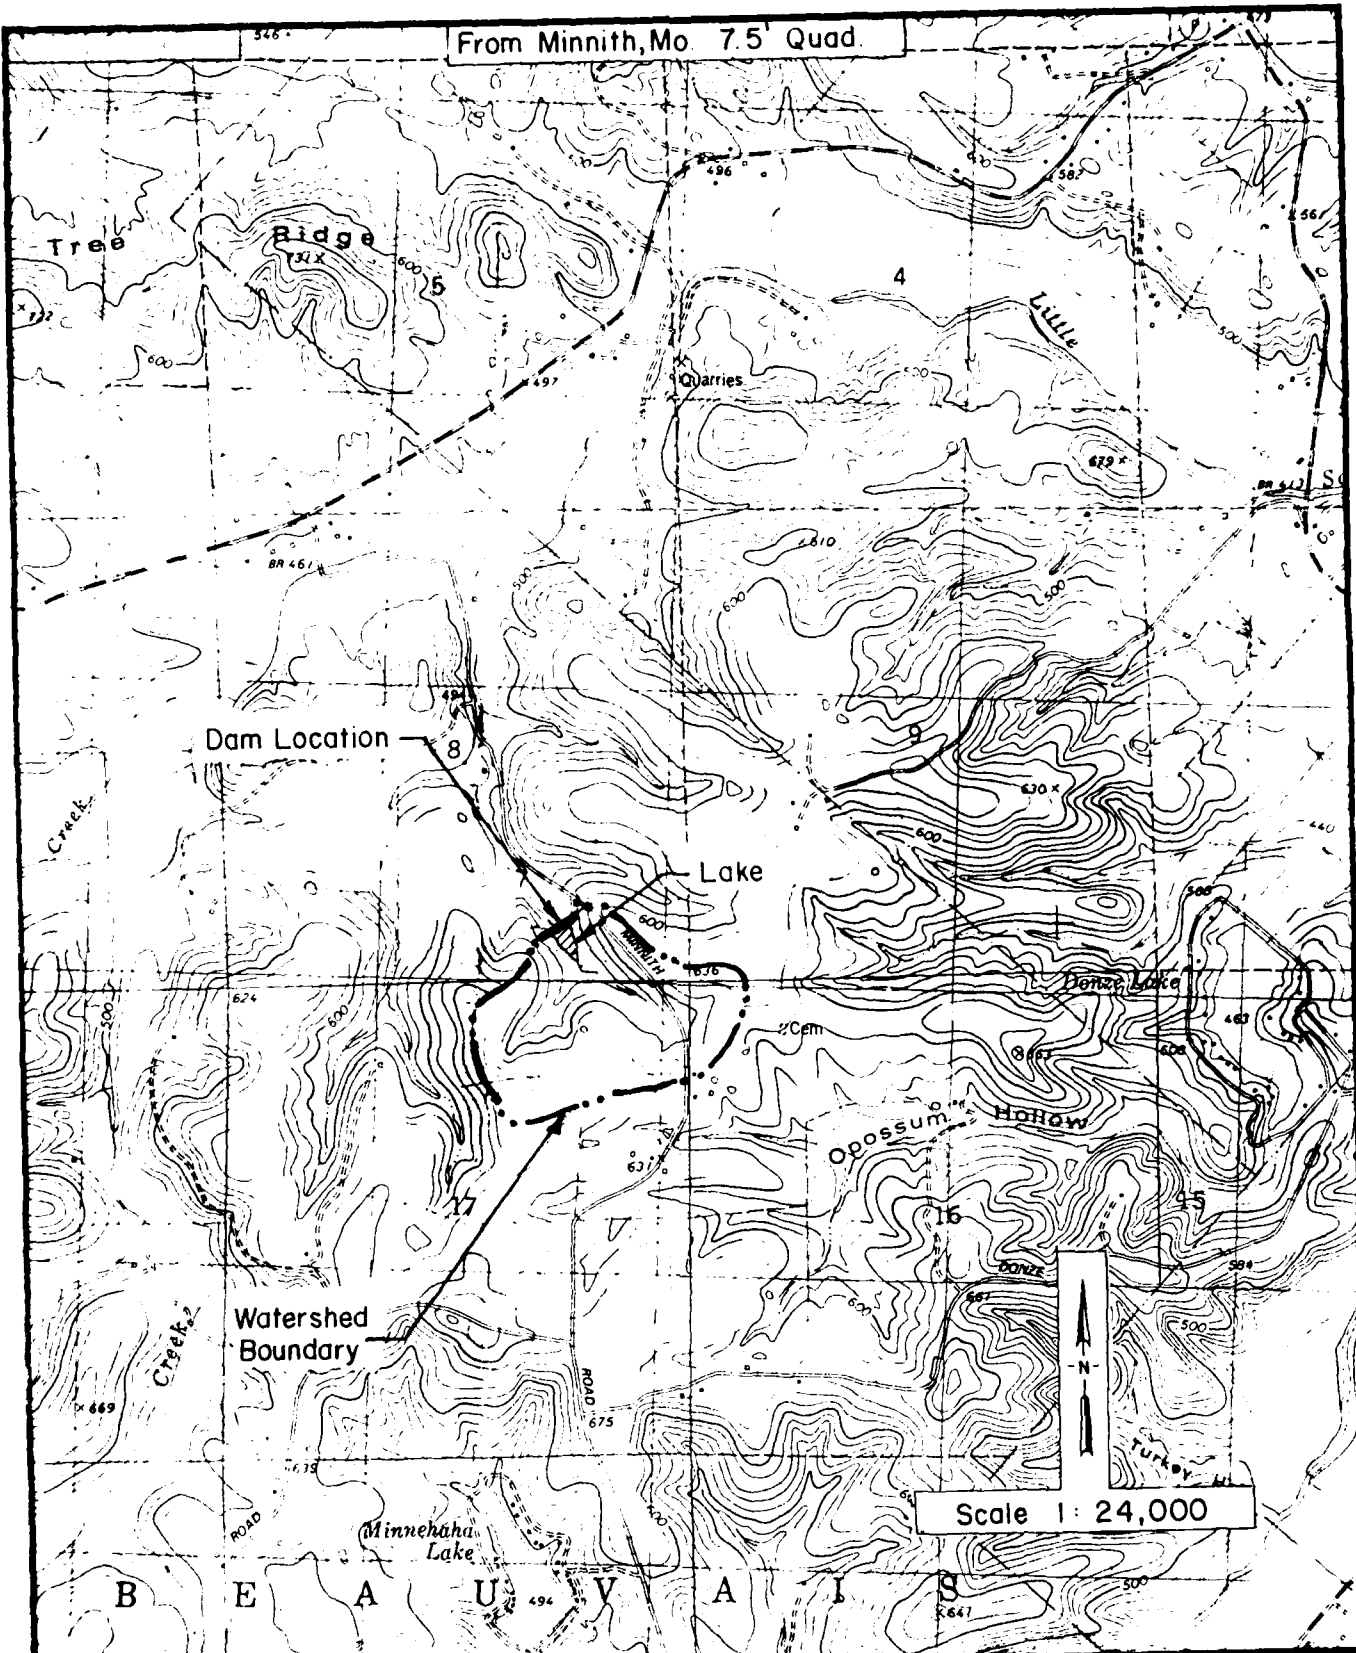
LAKE AND WATERSHED MAP

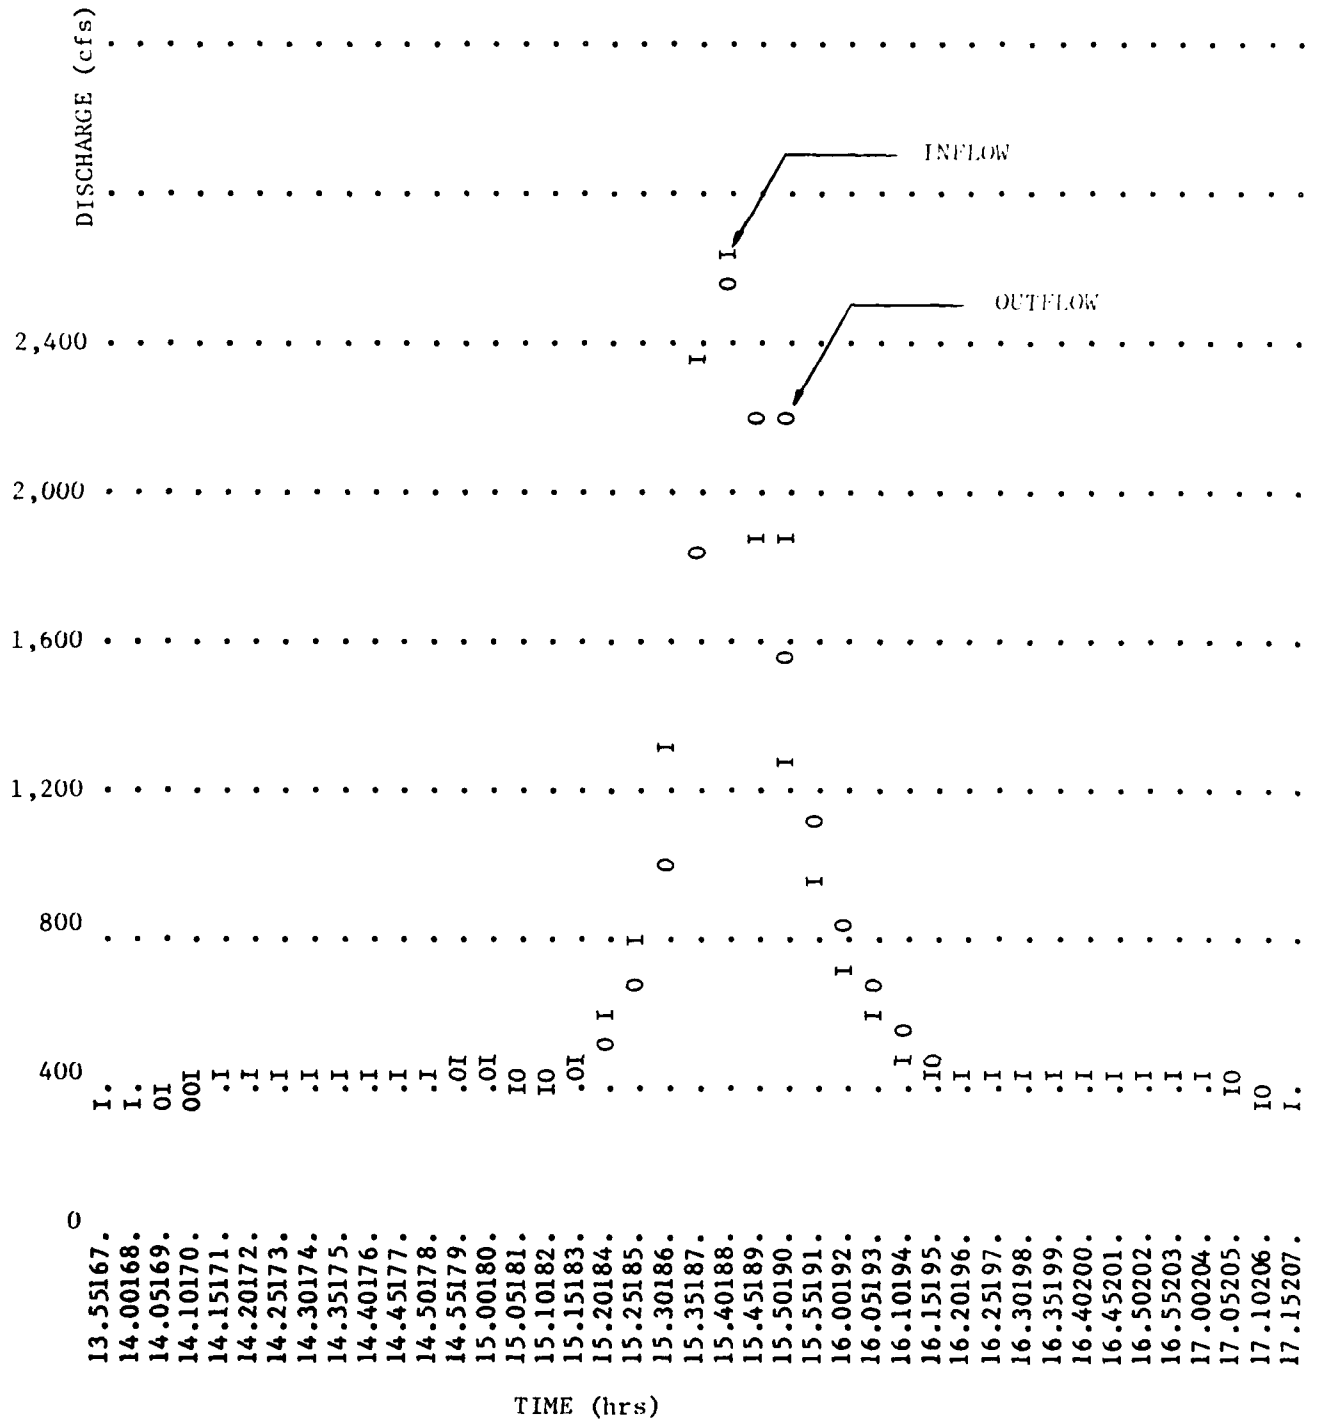
Max. Inflow = 2,630 cfs
 Max. Outflow = 2,570 cfs

INFLOW-OUTFLOW HYDROGRAPH
 FOR THE PMF

RATIO OF PMF	MAXIMUM RESERVOIR W.S. ELEV	MAXIMUM DEPTH OVER DAM	MAXIMUM STORAGE AC-FT	MAXIMUM OUTFLOW CFS	DURATION OVER TOP HOURS	TIME OF MAX OUTFLOW HOURS	TIME OF FAILURE HOURS
0.10	544.42	0.00	41.	63.	0.00	16.08	0.00
0.15	545.04	0.54	44.	230.	2.00	15.83	0.00
0.20	545.32	0.82	45.	435.	3.08	15.75	0.00
0.25	545.46	0.96	46.	559.	4.33	15.75	0.00
0.30	545.58	1.08	47.	683.	5.08	15.67	0.00
0.40	545.81	1.31	48.	947.	6.08	15.67	0.00
0.50	546.01	1.51	49.	1214.	6.75	15.67	0.00
0.75	546.44	1.94	51.	1886.	7.83	15.67	0.00
1.00	546.81	2.31	53.	2565.	10.17	15.67	0.00

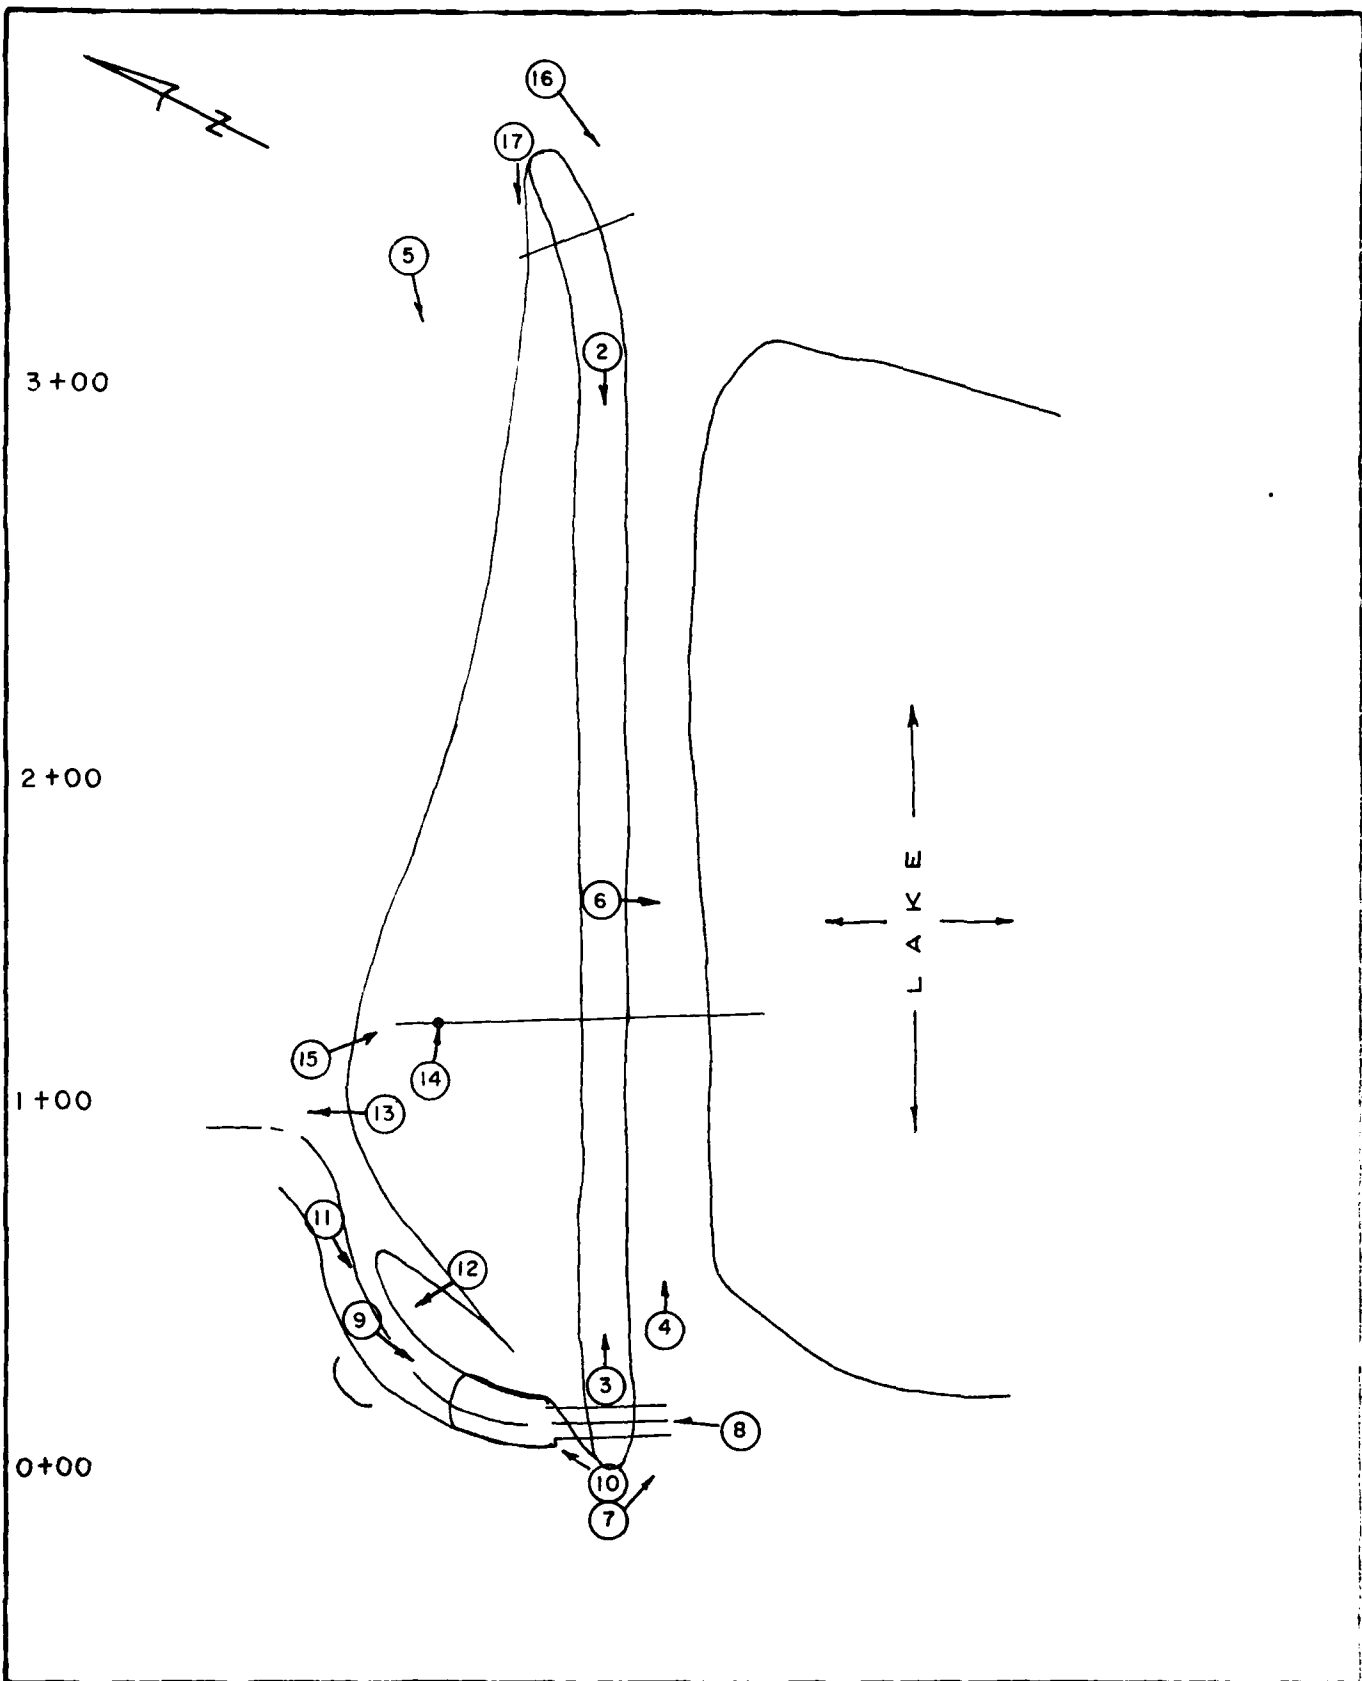
SHEET 2 , APPENDIX D

PHOTOGRAPHIC INDEX
GLEN BASLER LAKE DAM
STE. GENEVIEVE COUNTY, MISSOURI
MO. I. D. No. 31382

<u>Photo No.</u>	<u>Description</u>
1	Aerial (looking South)
2	Crest of Dam (looking West)
3	Crest of Dam (looking East)
4	Upstream Face of Dam (looking East)
5	Downstream Face of Dam (looking Southwest)
6	Reservoir Watershed (looking Southeast)
7	Principal Spillway Inlet Area
8	Principal Spillway Inlet Area
9	Undermining of Principal Spillway Concrete Slab
10	Principal Spillway Outlet Channel
11	End of Principal Spillway Outlet Channel
12	Slough in Outlet Channel Wall
13	Downstream Channel
14	Watering Pipe Valve
15	Discharge End of Watering Pipe
16	Emergency Spillway Inlet Area
17	Emergency Spillway Outlet Area
18	Downstream Hazard Feature
19	Downstream Hazard Feature
20	Downstream Hazard Feature
