BELTZVILLE LAKE CONDITION REPORT, DAM, OUTLET WORKS AND SPILLWA--ETC(U)

LEHIGH RIVER BASIN  
POHOPOCO CREEK, PENNSYLVANIA  
**BELTZVILLE LAKE**

CONDITION REPORT

DAM, OUTLET WORKS & SPILLWAY,  
PERIODIC INSPECTION REPORTS NO. 3 & NO. 4,  
SEPTEMBER 1972 & AUGUST 1973

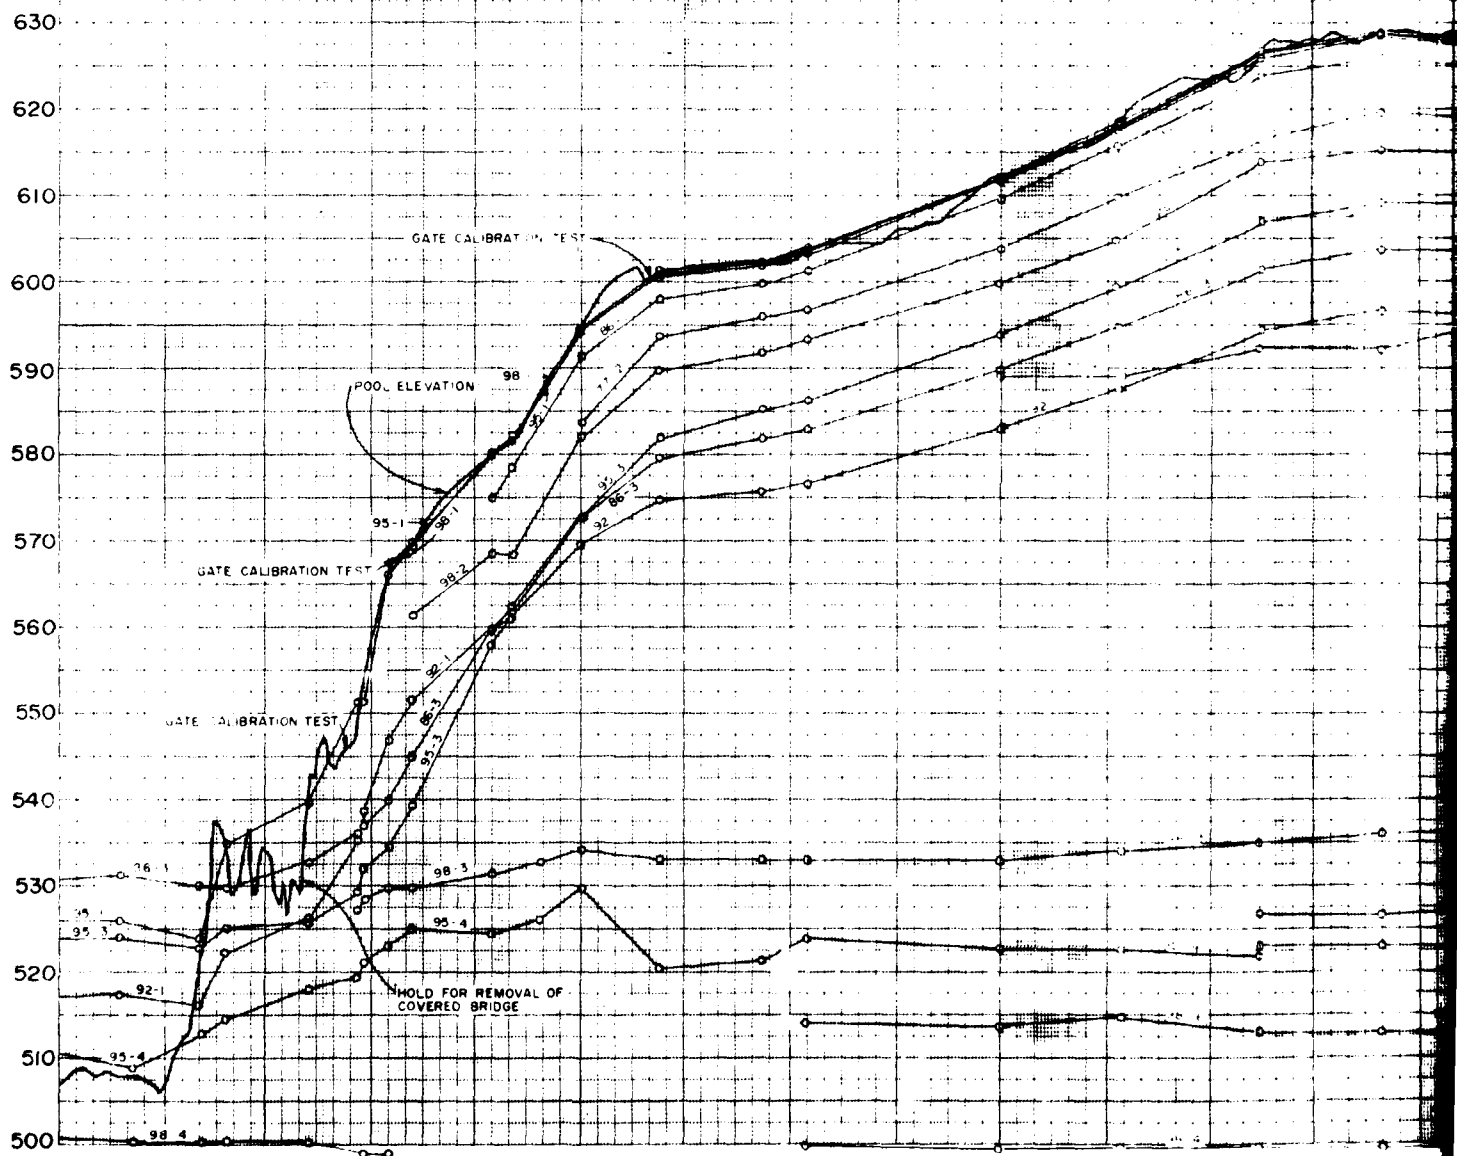
PIEZOMETER DATA  
1971-1972

Piezometer No. 95-4 became inoperative after 15 Dec 1971
