AFWAL-TR-79-3095  
VOLUME I

ADVANCED RESIDUAL STRENGTH DEGRADATION RATE  
MODELING FOR ADVANCED COMPOSITE STRUCTURES  
VOLUME I - TASK I: PRELIMINARY SCREENING

Lockheed-California Company  
Burbank, California

August 1979  
Final Report for 1 August 1977 to 29 June 1979

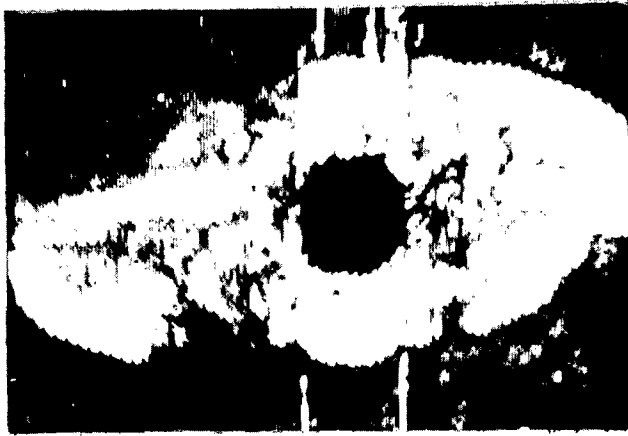
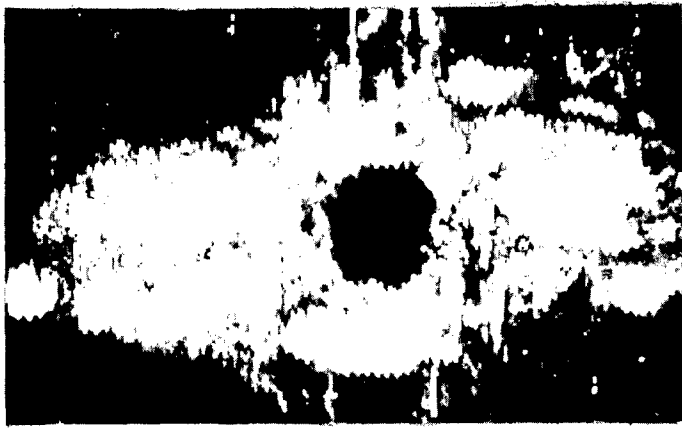
Cumulative B-Scan

Figure 92d. Damage Growth Characteristics of Damaged Hole Specimen BC-28, 32-Ply Quasi-Isotropic Laminate,  $R = -1$ ,  $\sigma_{\max} = 23 \text{ ksi}$  (158 MPa)

Typical damage growth results are presented in Figures 91 through 93. Additional data for other stress levels are presented in Appendix C.

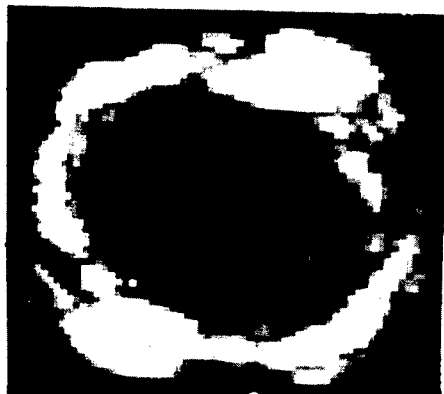
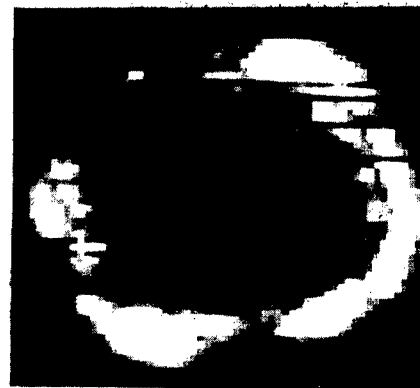
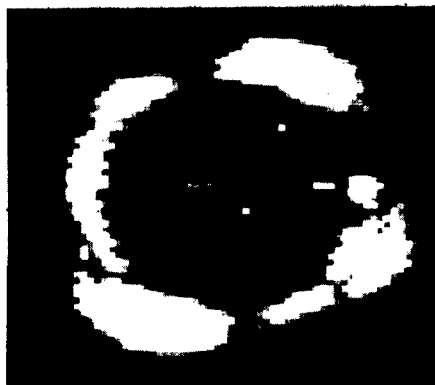
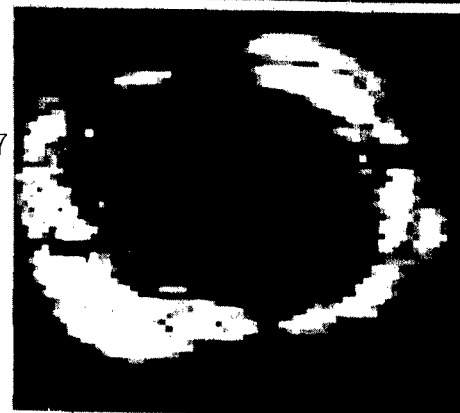
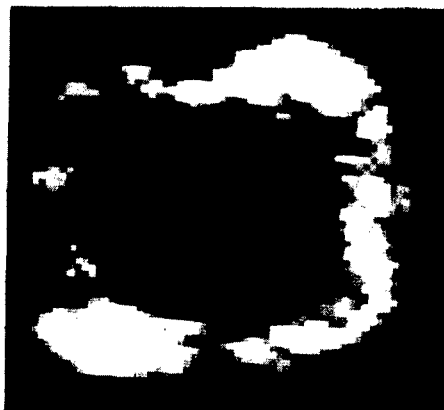
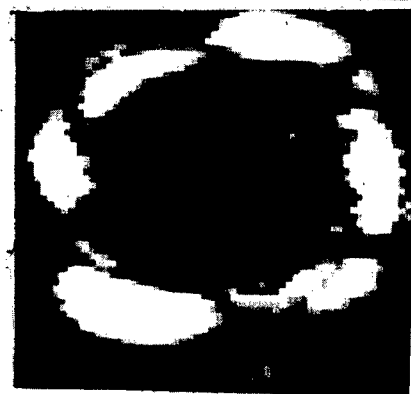
TV MONITOR, 2X

Figure 3. Typical Initial Damages for 24-Ply Laminate Specimens Tested in Static Tension

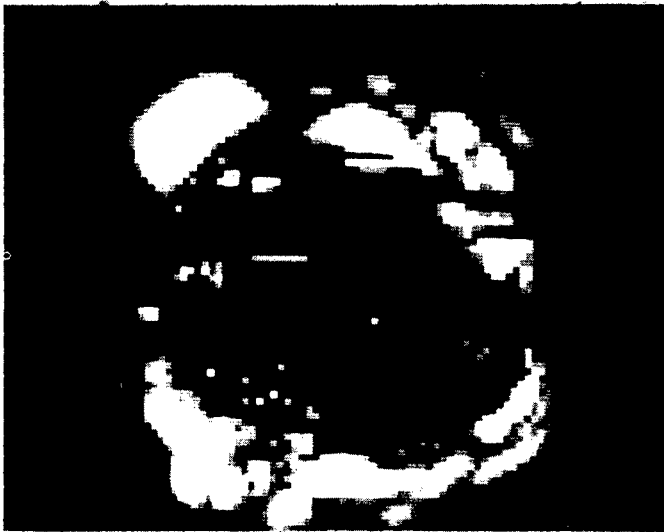
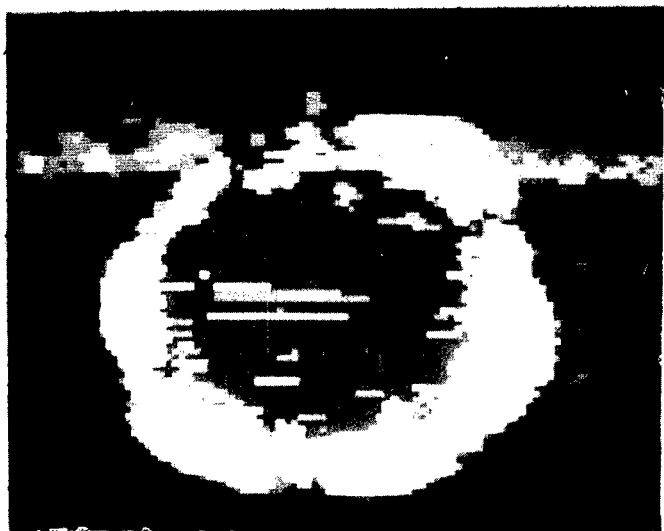
TV MONITOR, 2X

Figure 5a. Typical Initial Damages for 32-Ply Laminate Specimens Tested in Static Tension
