TECHNICAL REPORT HL-82-14

**KAHULUI BREAKWATER STABILITY STUDY
KAHULUI, MAUI, HAWAII**
Hydraulic Model Investigation

Dennis G. Markle

**U. S. Army Engineer Waterways Experiment Station
P. O. Box 631, Vicksburg, Miss. 39180**

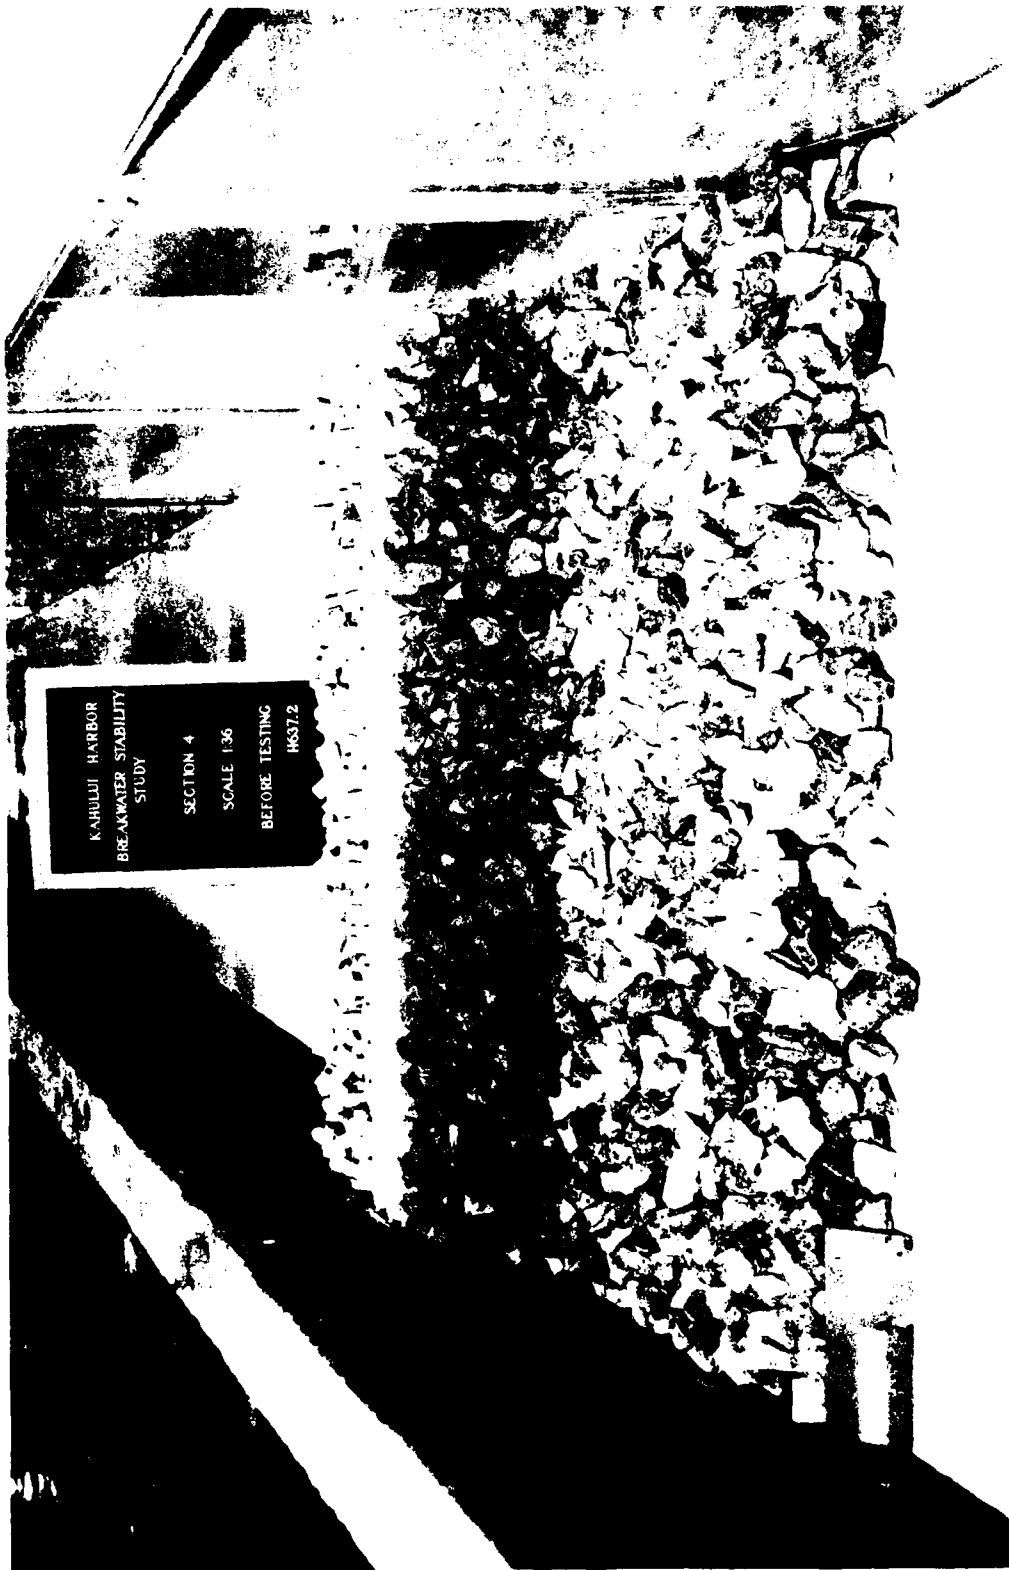
Photo 3. Harbor-side view of Plan 1 before testing

KAHULUI HARBOR
BREAKWATER STABILITY
STUDY
SECTION 4
SCALE 1:36
BEFORE TESTING
H637.2

18. Plan 1, Plate 6 and Photos 1-3, consisted of existing conditions, except for one minor modification, and incorporated the proposed harbor-side rehabilitation design. The existing 38,000-lb tribars were represented in the model as 38,220-lb tribars. This minor difference in weight was due to the available model armor unit sizes and the selected scale necessary to model the 13,600- to 18,400-lb harbor-side armor stone proposed for the rehabilitation work. The harbor-side armor stone was randomly placed on a 1V-on-2H slope from the 16,000-lb stone apron to an elevation of +15.3 ft mllw. During Hydrograph A, Plan 1 accrued no damage to the sea-side tribars and significant damage to the harbor-side, 13,600- to 18,400-lb armor stone. During Steps 3-5, 21 armor stones were displaced from the 1V-on-2H slope. The displacement was caused by a combination of wave energy transmitted through and overtopping the structure. Minor rocking of one or two of the sea-side tribars was noted throughout the test, but no displacement occurred. By the end of Step 5, all damage had ceased and the structure sustained no further damage during the remainder of Hydrograph A. Photos 4-6 show the condition of Plan 1 after its first testing with Hydrograph A. Plan 1 was rebuilt and exposed to Hydrograph A once again. Results of the second test were very similar to the first, with 15 armor stones displaced from the 1V-on-2H, harbor-side slope and minor rocking of 2 or

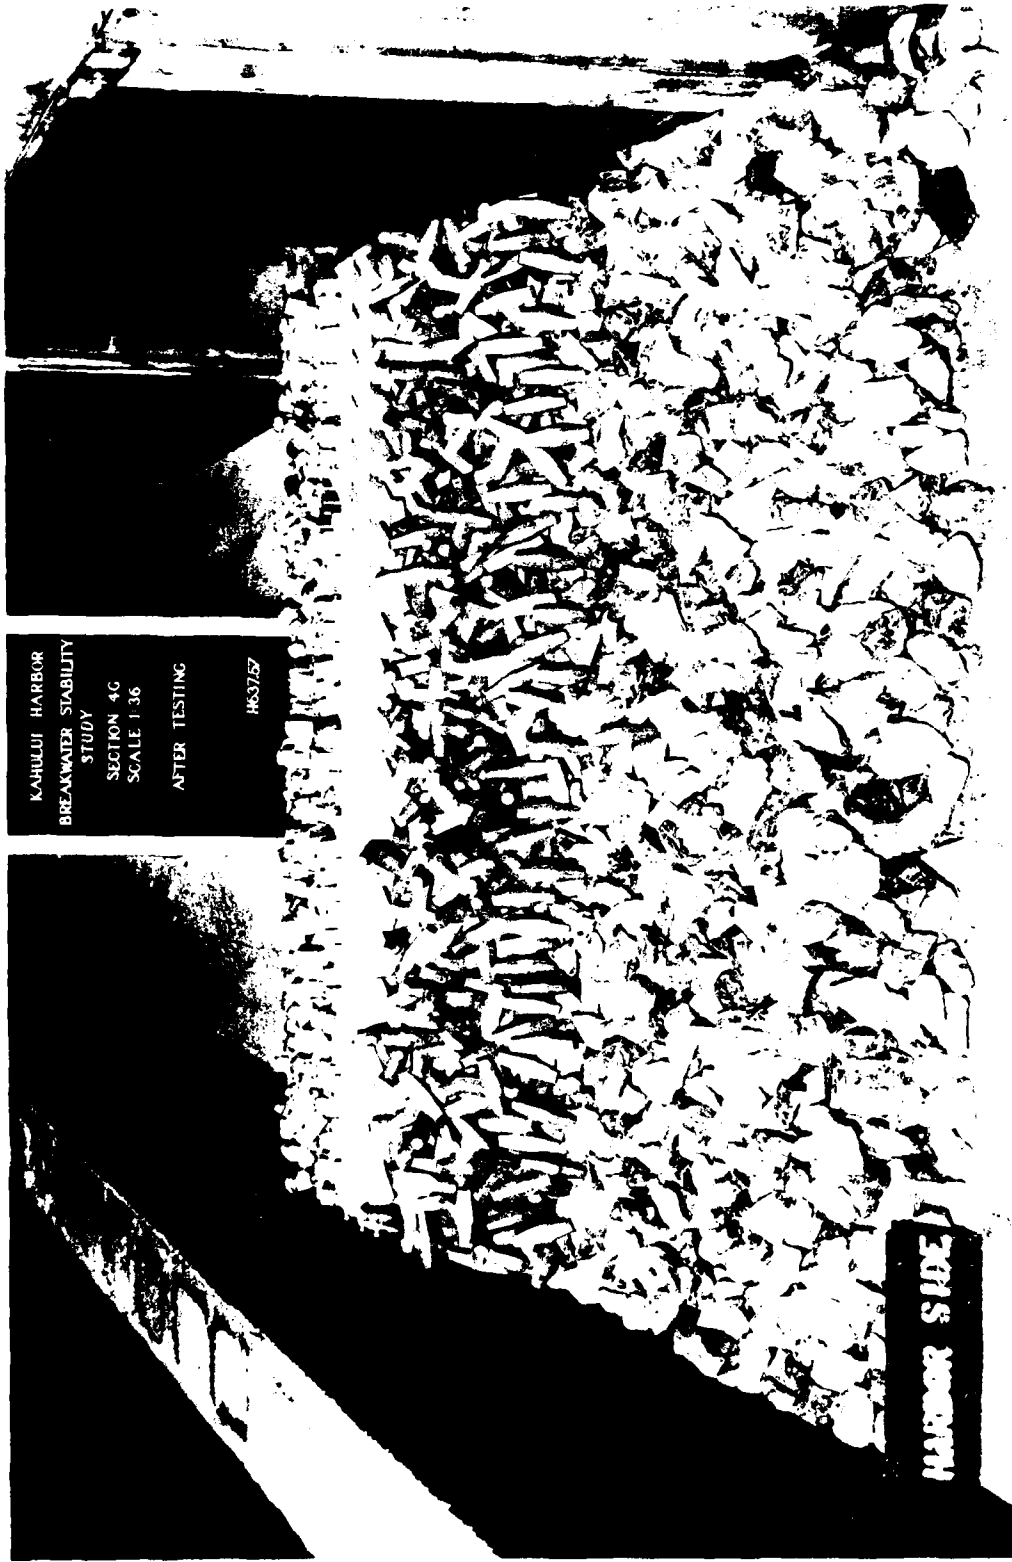
Photo 35. Harbor-side view of Plan 1E after testing

28. Plan 1E, Plate 11, was tested to determine if larger dolosse would be stable without the toe of the slope being trenched. Two layers of 20,945-lb dolosse were placed on the harbor-side slope using extra special placement along the toe and random placement on the remainder of the slope. One dolos was displaced during Step 5 of Hydrograph A. This dolos was originally positioned at the top of the slope next to the concrete rib and a large portion of the dolos projected up higher than the +16.3-ft mllw crown elevation. This was the only movement observed during testing of Plan 1E. Photos 34 and 35 show Plan 1E after testing.

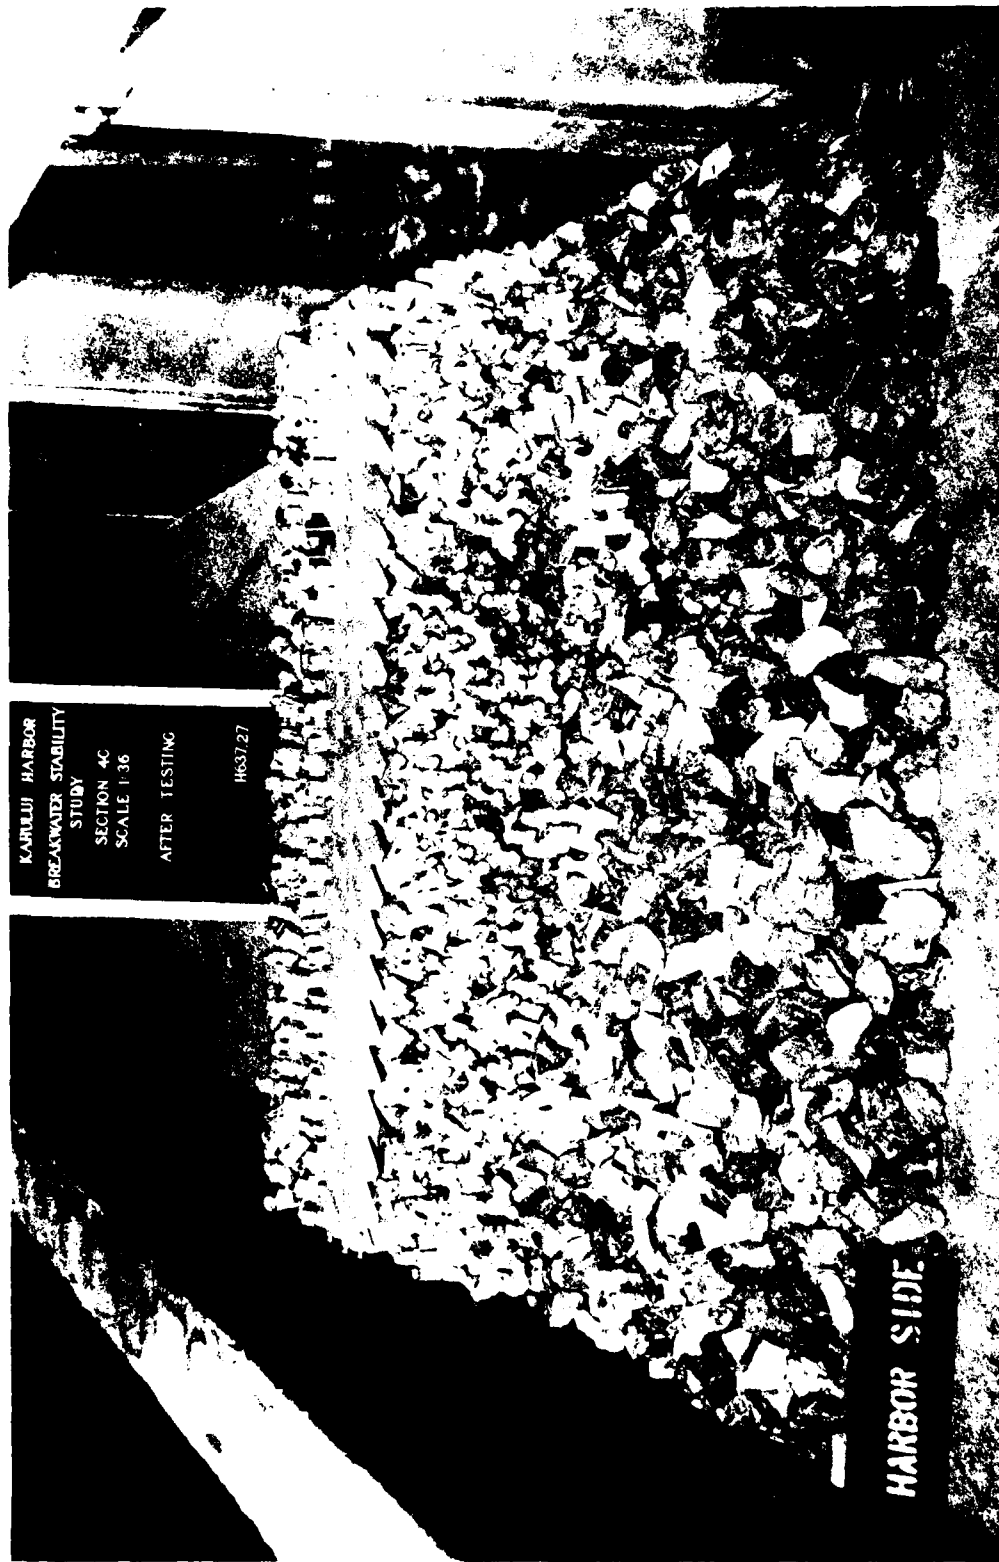
Photo 37. Harbor-side view of Plan 1F after testing

29. Having found both low- and no-damage dolos designs for the harbor-side slope (based on one testing only), tests were initiated to find a tribar armor unit size that would be stable on the harbor-side slope when exposed to Steps 1, 3, and 5 of Hydrograph A. Plan 1F, Plate 12, was identical to all previous plans tested, except for the 1V-on-2H harbor-side slope design. One layer of uniform-placed, 13,065-lb tribars was used to protect the harbor-side slope. Stones with an average weight of 1,307 lb were used as fill between the tribars and the 16,000-lb stone. Major offslope displacement of the harbor-side tribars occurred during Steps 3 and 5. A total of 34 tribars had been displaced and the damage had not subsided when the test ended. The condition of Plan 1F at the end of the test is shown in Photos 36 and 37.

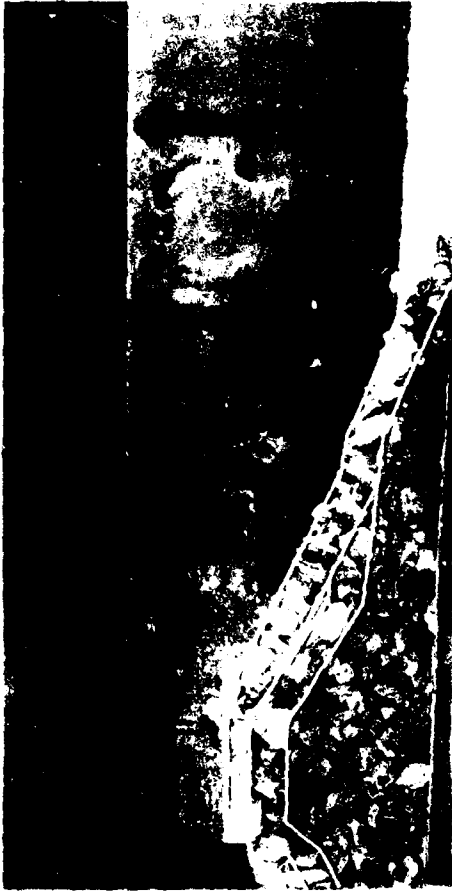
KAHULUI HARBOR
BREAKWATER STABILITY
STUDY
SECTION 3A
SCALE 1:33
BEFORE TESTING
H637.91

Photo 68. Side view of Plan 2A before testing

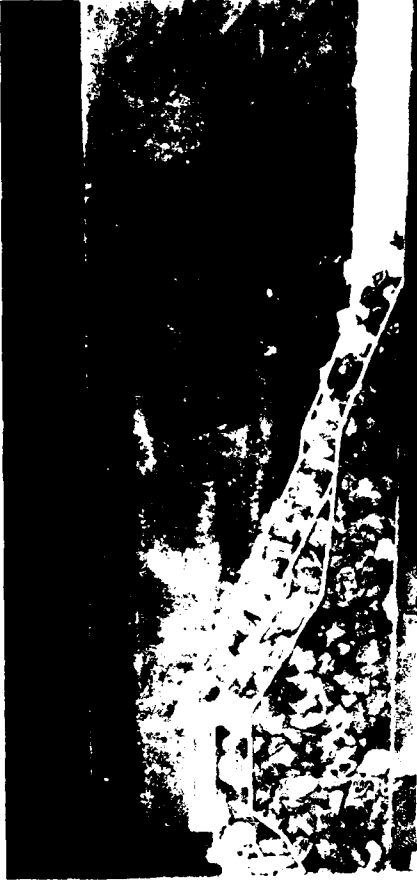
KAHULUI HARBOR
BREAKWATER STABILITY
STUDY
SECTION 3A
SCALE 1:33

AFTER TESTING

Photo 74. Side view of Plan 2A after testing, 2nd test

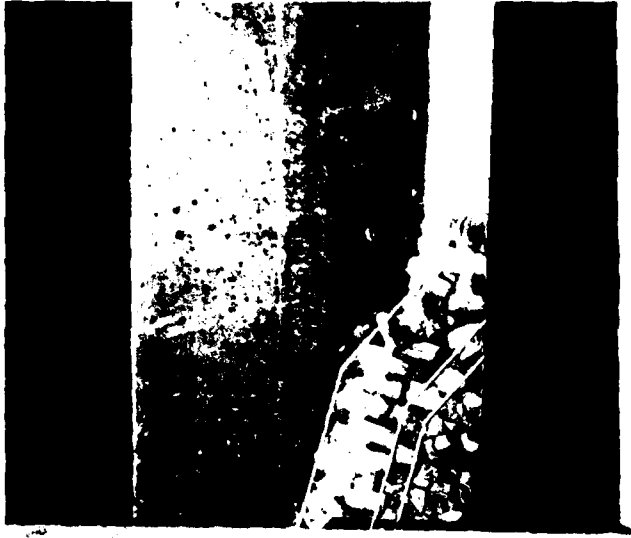
KAHULUI HARBOR
BREAKWATER STABILITY
STUDY

AFTER TESTING

Photo 80. Side view of Plan 3 after testing, 1st test

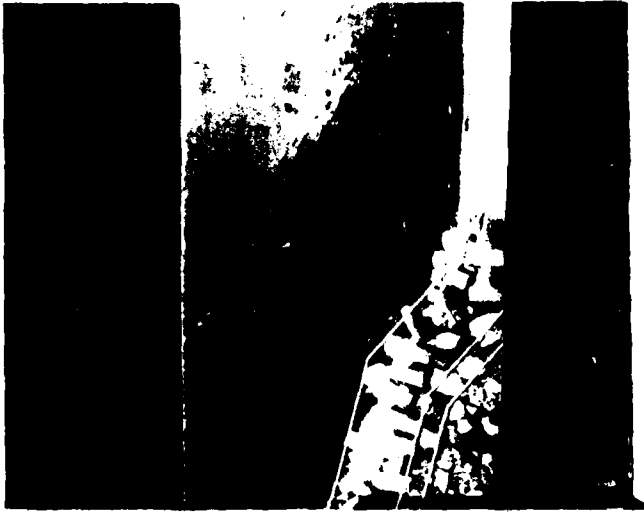
KAHULUI HARBOR
BREAKWATER STABILITY
STUDY
SECTION 2
SCALE 1:40
AFTER TESTING
H637/111

Photo 83. Side view of Plan 3 after testing, 2nd test

44. Plan 3, Plate 20 and Photos 77-79, was constructed in the model and reproduced the existing conditions except for the following modifications: (a) the 70,000-lb sea-side tribars were represented as 70,800 lb due to size of available model units and the 1:40-scale selected to reproduce the size of tribar units tested on the harbor-side slope, and (b) the -38.0 ft mllw elevation was selected as the controlling depth for the maximum breaking wave height that could reach the breakwater; therefore, the model breakwater toe was located at this elevation. The harbor-side rehabilitation work consisted of one layer of 17,920-lb tribars, uniformly placed on a 1V-on-2H slope. The toe of the tribars was trenched into the 16,000-lb stone and the tribar protection extended up to +12.6 ft mllw. The area between the tribars and 16,000-lb stone was filled with 1,790-lb stone. Plan 3 accrued very slight damage during its first exposure to the wave conditions of Hydrograph C. The existing sea-side tribars showed some slight reorientation and two units were displaced on slope. The only other movement observed was some displacement of 16,000-lb stone on the harbor-side toe and some slight rocking in place of two or three tribar units on the upper harbor-side slope. All damage had stopped well before the end of Hydrograph C and Photos 80-82 show that Plan 3 was in excellent condition at the end of the first test. The harbor-side rehabilitation area was rebuilt and the test conditions of Hydrograph C were repeated. The test results were identical to the first test, except for the displacement of one harbor-side tribar unit that occurred during Step 1. All damage stabilized well before the end of the test. Photos 83-85 show Plan 3 after testing.

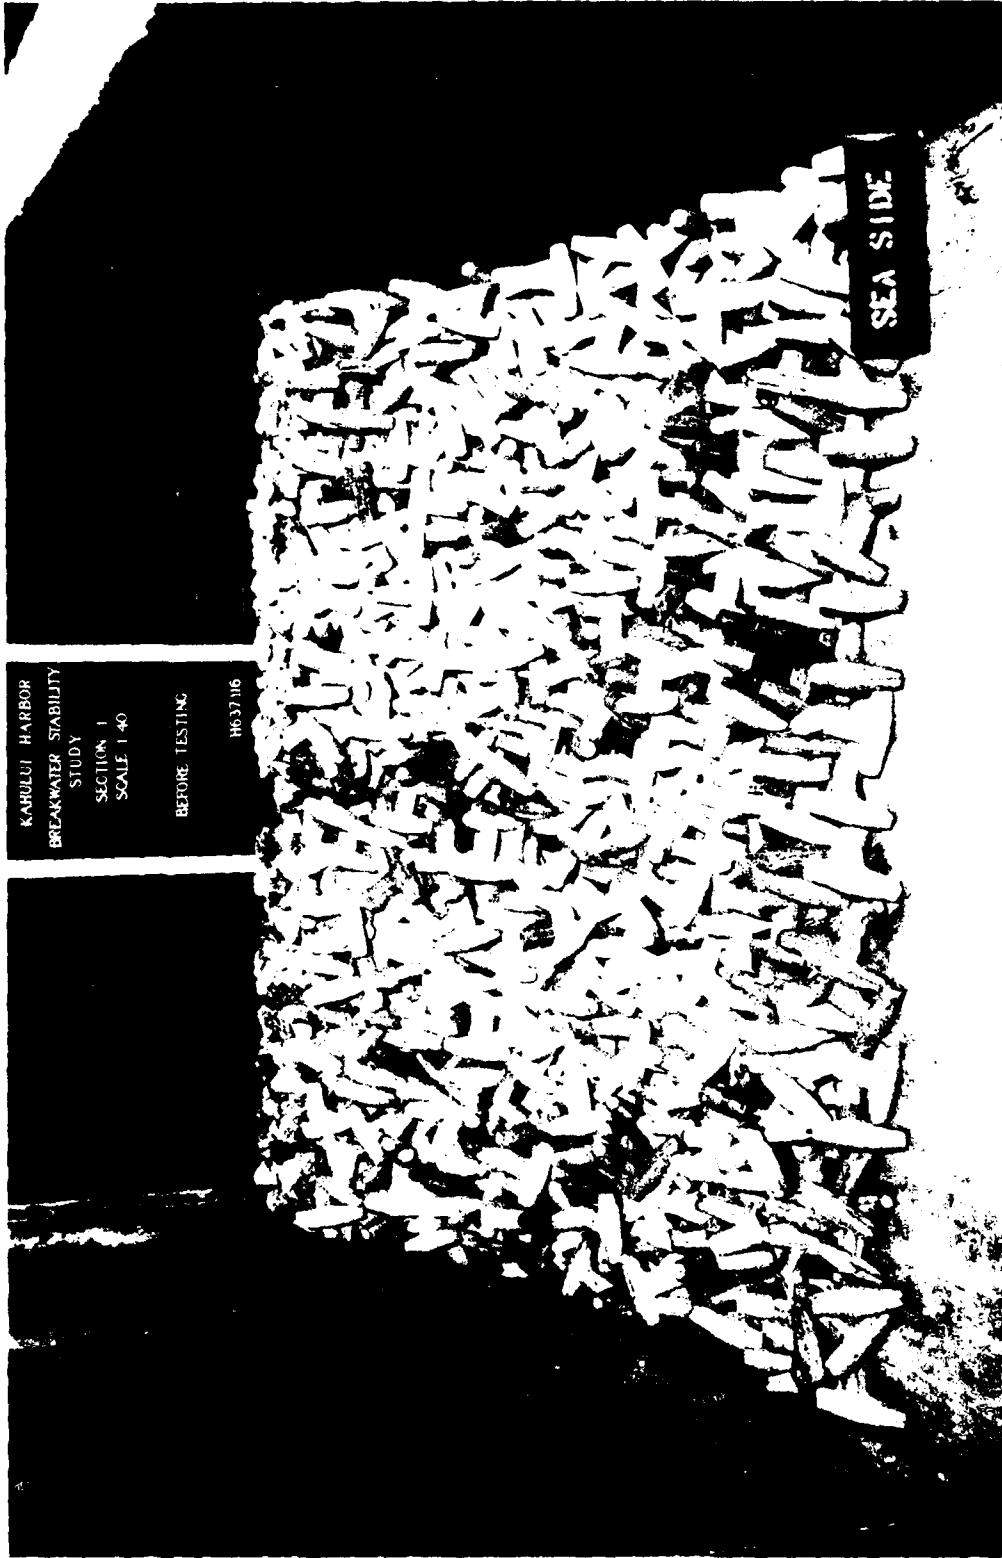
KARULU HARBOR
BREAKWATER STABILITY
STUDY
SECTION 1
SCALE 1:40

Photo 87. Sea-side view of Plan 4 before testing

46. Plan 4, Plate 22 and Photos 86-88, was constructed in the model to reproduce conditions described in the previous paragraph. Due to the 1:40 scale necessary to reproduce the proposed harbor-side tribar size, the nearest available size of model dolos units represented 58,500 lb instead of the desired 60,000 lb. The harbor-side rehabilitation construction was composed of one layer of 17,920-lb tribars uniformly placed on a 1V-on-2H slope. The tribar toe was trenched into the 16,000-lb stone and the units extended up to the +11.5 ft mllw crown elevation. Stone weighing an average of 1,790 lb was used as fill between the tribars and 16,000-lb stone. During the shakedown and both steps of Hydrograph D, significant damage was accrued by the breakwater crown area. A large amount of reorientation, rocking in place, and displacement of the 58,500-lb dolosse occurred along the upper sea-side slope. Four dolosse were displaced over the crown and down onto the harbor-side slope. One additional dolos was locked into the 16,000-lb stone on the crown. The 16,000-lb crown stones were displaced both toward the back of the crown and completely over the crown and down the harbor side of the breakwater, resulting in up to 10-ft reductions in crown elevation at isolated locations. One harbor-side tribar was displaced from the upper slope down to the harbor-side stone apron. No

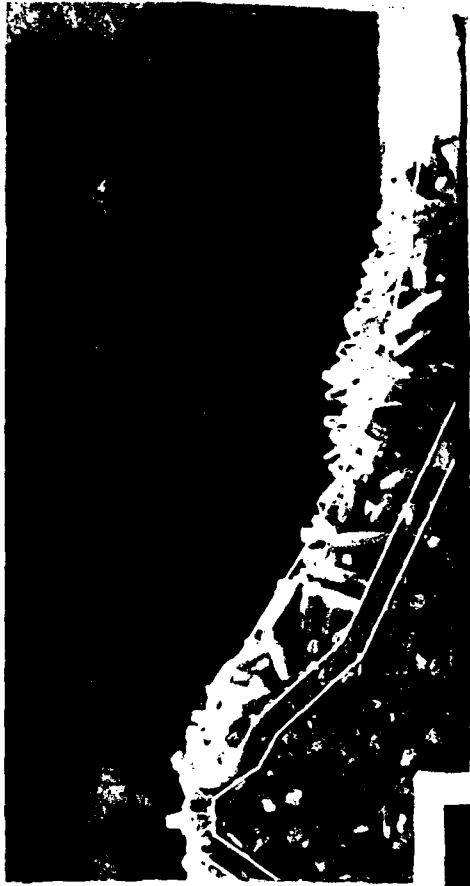
KAHULUI HARBOR
BREAKWATER STABILITY
STUDY
SECTION 1
SCALE 1:40
AFTER TESTING
H637.117

Photo 89. Side view of Plan 4 after testing

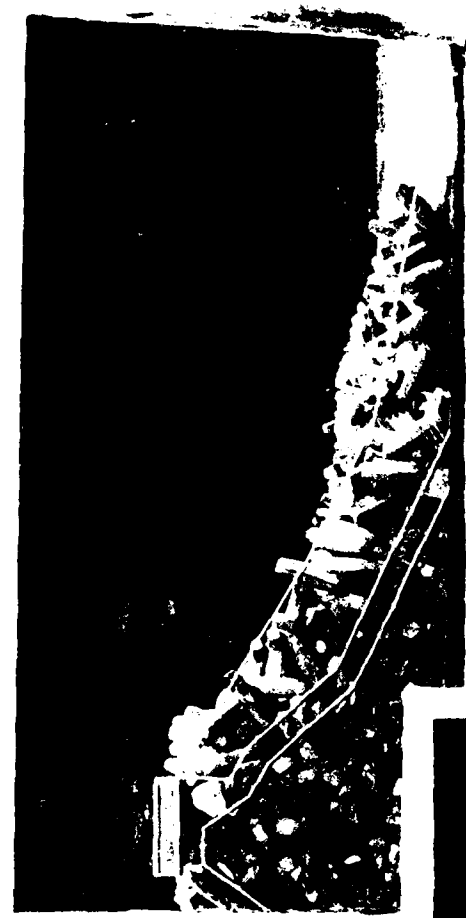
KAHULUI HARBOR
BREAKWATER STABILITY
STUDY
SECTION 1A
SCALE 1:40
AFTER TESTING
H637123

Photo 95. Side view of Plan 4A after testing, 1st test

47. A concrete rib cap was added to the section to provide buttressing for the dolosse and to help stabilize the armor-stone crown. The rib cap used in Plan 3A was modified to represent a constant 4-ft height. Plan 4 was rebuilt and with the rib cap installed was referred to as Plan 4A, Plate 22 and Photos 92-94. During exposure to Hydrograph D there was some minor in-place rocking and reorientation of the dolos and tribar units along the edges of the breakwater crown. In a repeat test, the harbor-side armor layer was rebuilt and the section was once again subjected to the wave conditions of Hydrograph D. Results of the repeat test were very similar to results of the original test. During both tests, a significant reduction in overtopping wave energy was observed for Plan 4A relative to Plan 4. Photos 95-97 and 98-100 show the conditions of Plan 4A after the first and second tests, respectively.

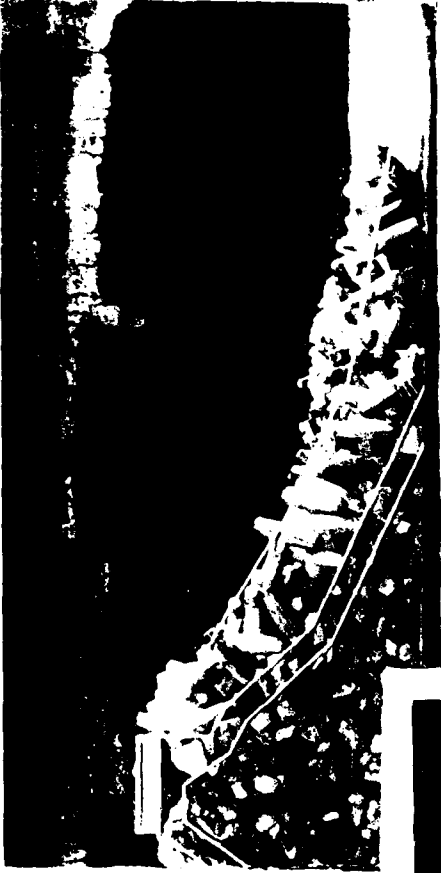
Photo 98. Side view of Plan 4A after testing, 2nd test

KAHULUI HARBOR
BREAKWATER STABILITY
STUDY
SECTION 1A
SCALE 1:40
AFTER TESTING
H637.126

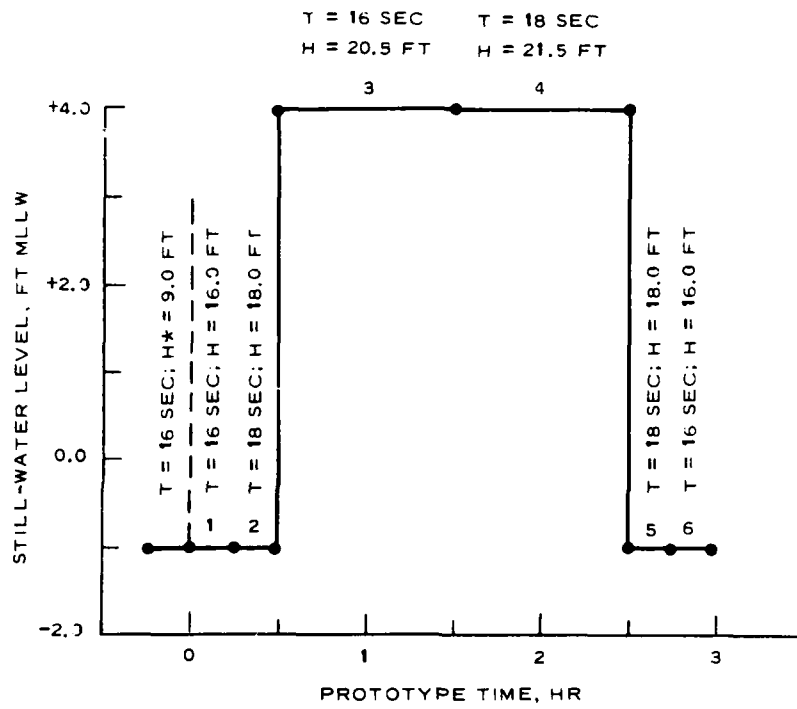
HYDROGRAPH B

- T WAVE PERIOD
- H* SHAKEDOWN WAVE HEIGHT
- H WORST BREAKING WAVE HEIGHT
- 1-6 HYDROGRAPH STEPS

- b. The proposed rehabilitation designs for the sea- and harbor-side slopes of Plan 2 for the west breakwater at sta 18+50 are not adequate for the wave and swl conditions of Hydrograph B, Plate 2 and Table 2. With the addition of a concrete rib cap (Plan 2A), the same armor and slope designs tested for Plan 2 proved to be adequate. The sea-side slope rehabilitation consisted of 11-ton tribars, and 5-ton tribars were used on the harbor-side slope. Both slopes were IV on 2H and were keyed into the existing 8-ton stone layer with a trench.

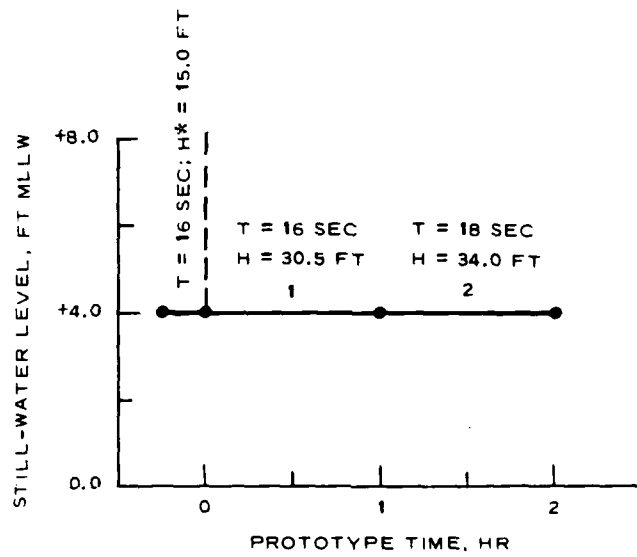
HYDROGRAPH C

- T WAVE PERIOD
- H* SHAKEDOWN WAVE HEIGHT
- H WORST BREAKING WAVE HEIGHT
- 1 AND 2 HYDROGRAPH STEPS

- c. The existing sea-side slope (35-ton tribars) and the proposed harbor-side rehabilitation design for Plan 3 for the east breakwater at sta 26+10 proved to be adequate for the test conditions of Hydrograph C, Plate 3 and Table 3. The harbor-side rehabilitation consisted of 9-ton tribars on a 1V-on-2H slope layered into the existing 8-ton stone layer with a trench.
