**THE STREAMBANK EROSION CONTROL  
EVALUATION AND DEMONSTRATION ACT OF 1974  
SECTION 32, PUBLIC LAW 93-251**

## **Appendix C - Geotechnical Research**

| REPORT DOCUMENTATION PAGE | | READ INSTRUCTIONS<br>BEFORE COMPLETING FORM |
|---|---|---|
| 4. TITLE (and Subtitle)<br>LITERATURE SURVEY AND PRELIMINARY EVALUATION OF<br>STREAMBANK PROTECTION METHODS | | 5. TYPE OF REPORT & PERIOD COVERED<br>Final report |

Consisting of  
A SUMMARY REPORT OF LABORATORY RESEARCH AND FIELD  
EXPERIMENTS ON STREAM STABILITY AND IDENTIFICATION OF  
CAUSES OF STREAMBANK EROSION

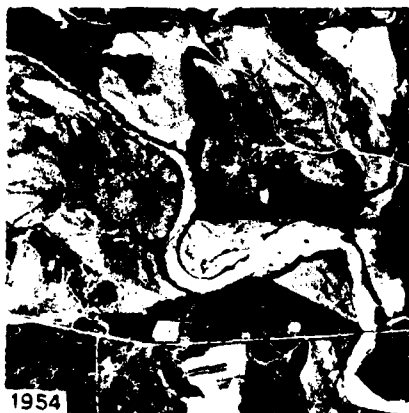
Figure C7. Aerial photographs of the lower reach of North Fork Tillatoba Creek showing the geomorphic changes between 1937 and 1976 (from Whitten and Patrick 1981)

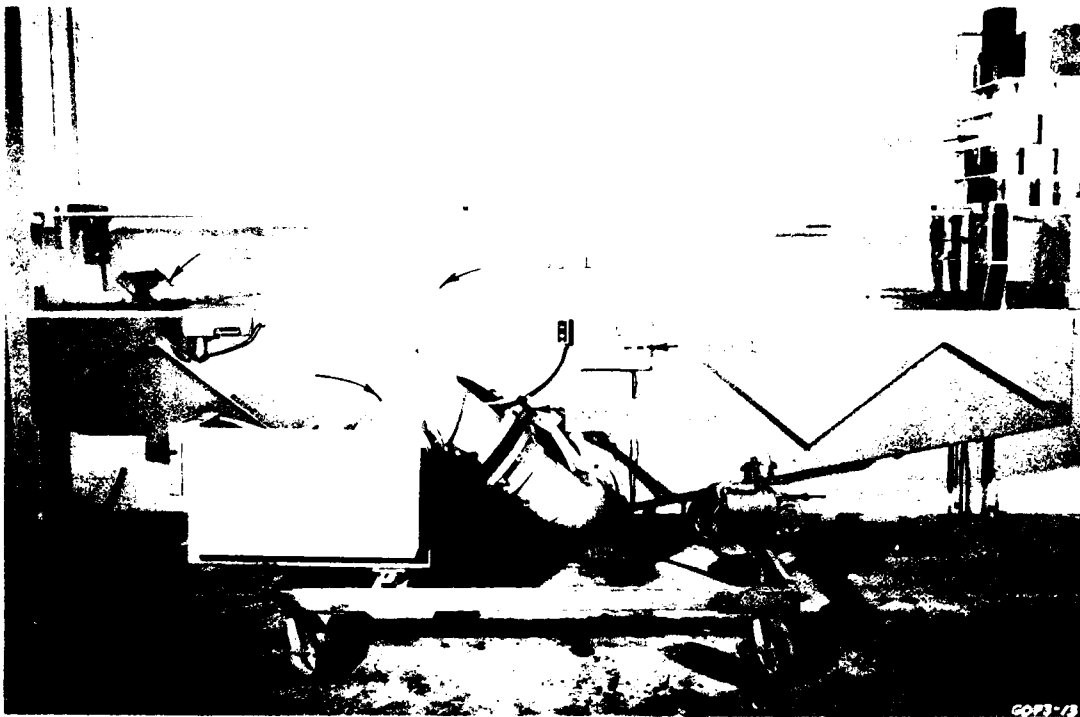
Figure C27. Overall view of laboratory recirculating tilting flume to measure soil erosion

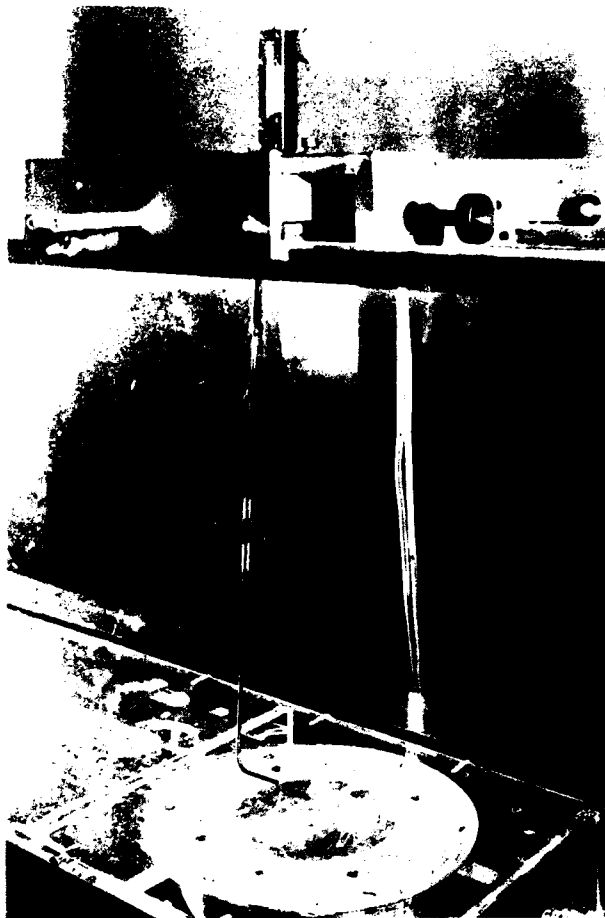
Figure C36. Pitot tube used to measure stagnation pressure and piezometric pressure in calibrating the flume

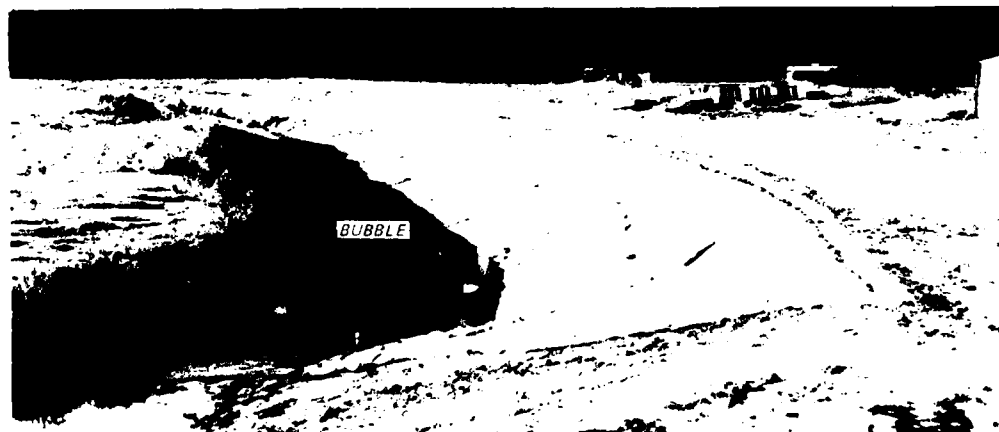
Photo C6. View (looking downstream) of test area with water in creek channel

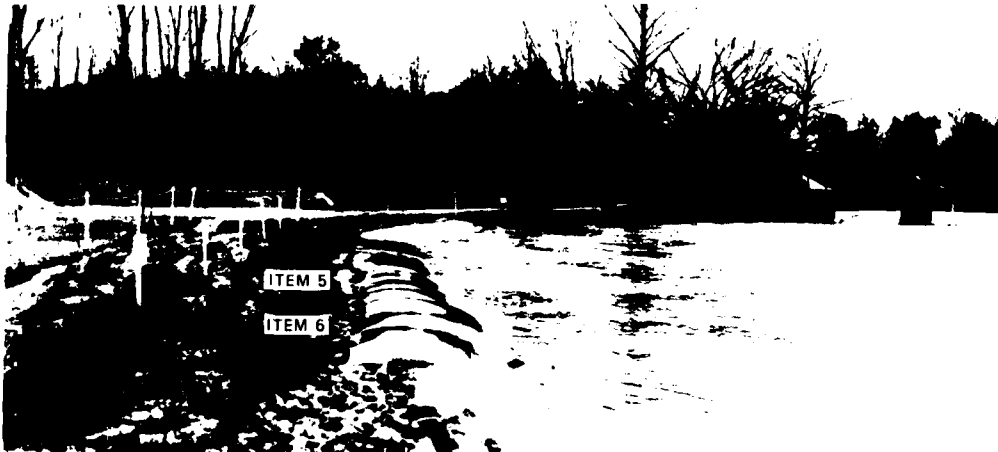
Photo C8. View (looking upstream) of test area during rain and high water level in creek (January 1980) (note membrane raised up in Items 5 and 6 because of air being entrapped)

158. The materials on all items at the Durden Creek test site performed satisfactorily during the period they were monitored. There were only two problem areas with the materials. Some of the membrane (T15) of the second step of the stepped item (Item 1) "ballooned" out (Photo C6). This condition occurred after the first few times the water rose in the creek. The "ballooned" area was approximately 3 ft wide and 8 ft long (Photo C9) at the end of the monitoring period. No other damage to this item resulted nor did this condition cause any damage to the other items. The other problem area involved the sandbags that were used in the anchor ditches and for ballast on the membrane. The bag

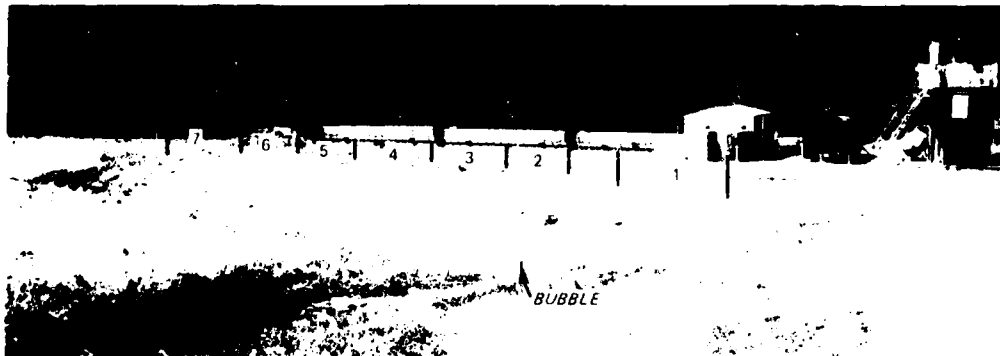
Photo C9. View (looking downstream) of test area (September 1980)

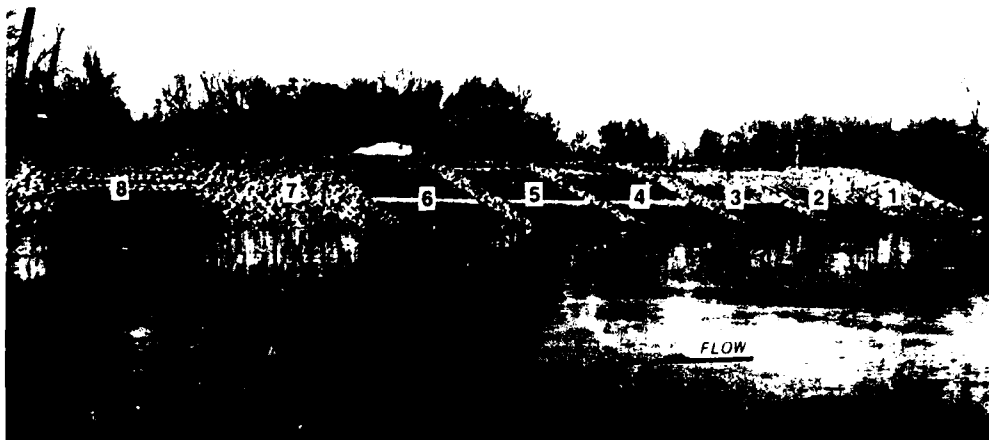
Photo C11. View from river of completed test area with water at toe of test materials

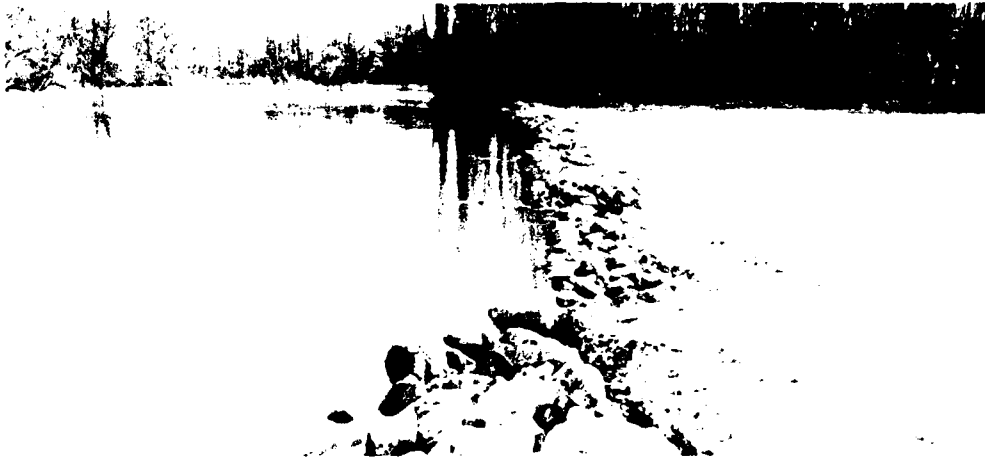
Photo C13. View looking downstream from the top bank with water at the top bank

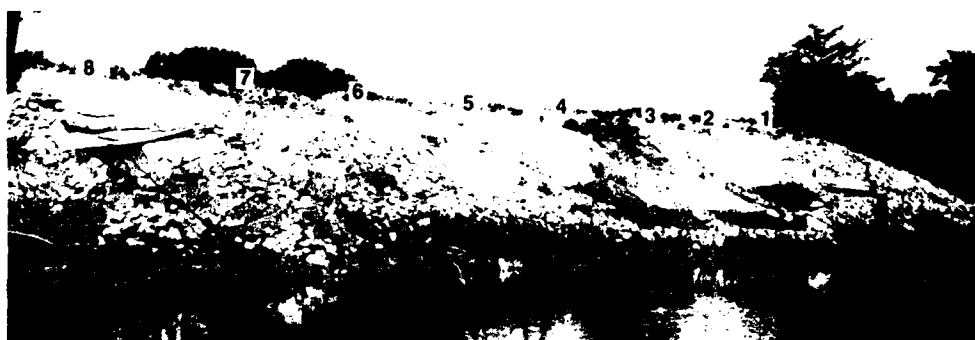
Photo C22. View (from river) of test area, July 1980

170. The water level during the summer months rose only twice to the point where one third of the bank was covered with water. These changes in the water level were slow and caused no additional damage to the bank. Photo C22 shows the condition of the bank in July 1980. Photo C23 is a view of the riverbank approximately 3 miles below the test area where shifting and settlement of the bank occurred around a bridge pier on Mississippi Highway 27.
