TECHNICAL REPORT CERC-83-4

EFFECTS OF DOLOS BREAKAGE ON THE STABILITY OF RUBBLE-MOUND BREAKWATER TRUNKS SUBJECTED TO BREAKING AND NONBREAKING WAVES WITH NO OVERTOPPING

Dennis G. Markle, D. Donald Davidson
Coastal Engineering Research Center
U. S. Army Engineer Waterways Experiment Station
P. O. Box 631, Vicksburg, Miss. 39180

December 1983
Final Report

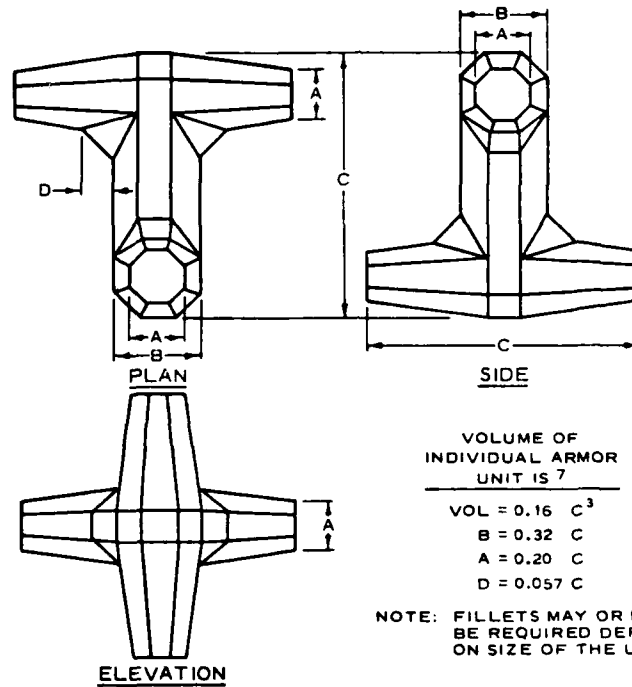
Figure 1. Dolos specifications

NOTE: SHAPE AND DIMENSIONS OF UNIT WERE BASED ON THOSE USED IN MODEL TESTS. AT PRESENT TIME, INVENTOR RECOMMENDS B = 0.32C TO 0.36C, DEPENDING ON THE WEIGHT OF AN INDIVIDUAL UNIT.

5. Experimental tests of dolos-armored breakwater trunks (Figure 1) subjected to nonbreaking waves with no overtopping (Carver and Davidson 1977) and breaking waves with no overtopping (Carver, in preparation) have been conducted previously at the U. S. Army Engineer Waterways Experiment Station (WES). Both the breaking and nonbreaking wave tests covered a wide range of relative depths (d/L) and wave steepnesses (H/L) and the breaking wave tests also included a large range of relative wave heights (H/d). The nonbreaking wave tests were conducted with a flat bottom seaward of the test section, while the breaking wave tests incorporated a 1V-on-10H bathymetry seaward of the test section toe. Breakwater slopes of 1V on 1.5H, 1V on 2H, and 1V on 3H were constructed using two layers ($n = 2$) of random-placed dolosse. Data from these tests showed that for a density of units per given area equal to $0.83V^{-2/3}$, i.e. $n = 2$, $k_{\Delta} = 0.94$, and $P = 56$ percent:

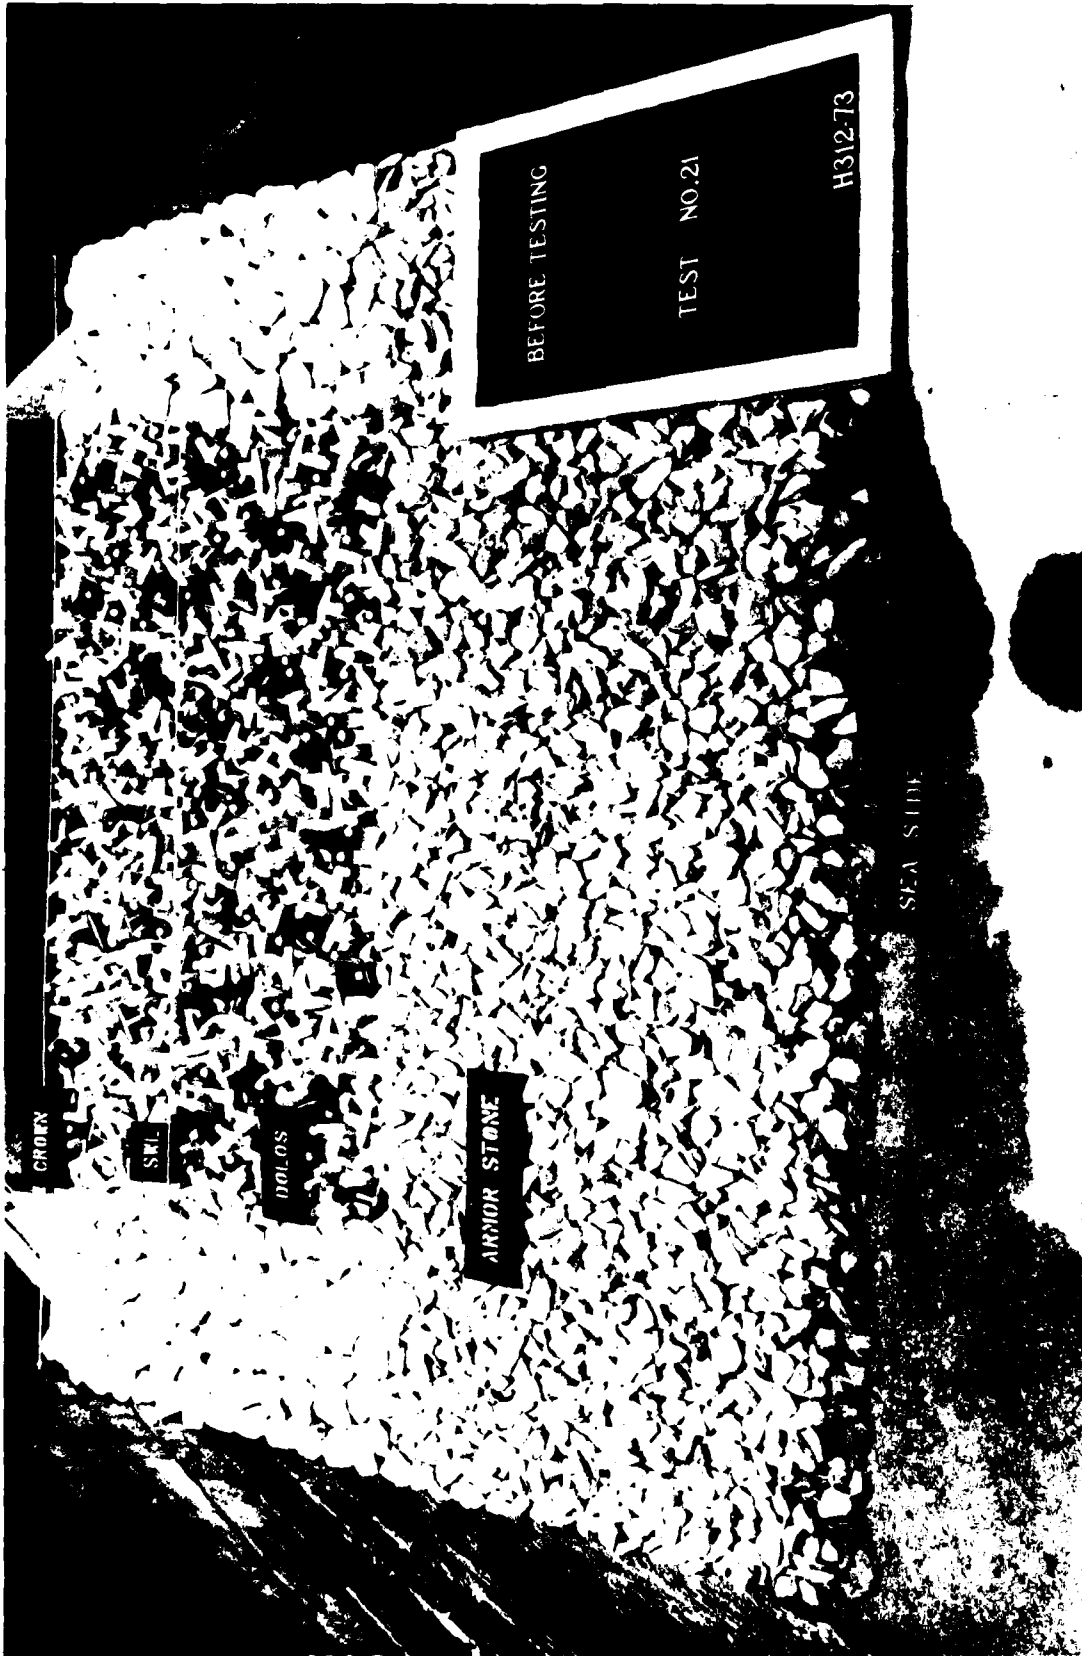
Photo 1. Before testing, 15 percent uniform breakage in top layer, nonbreaking waves

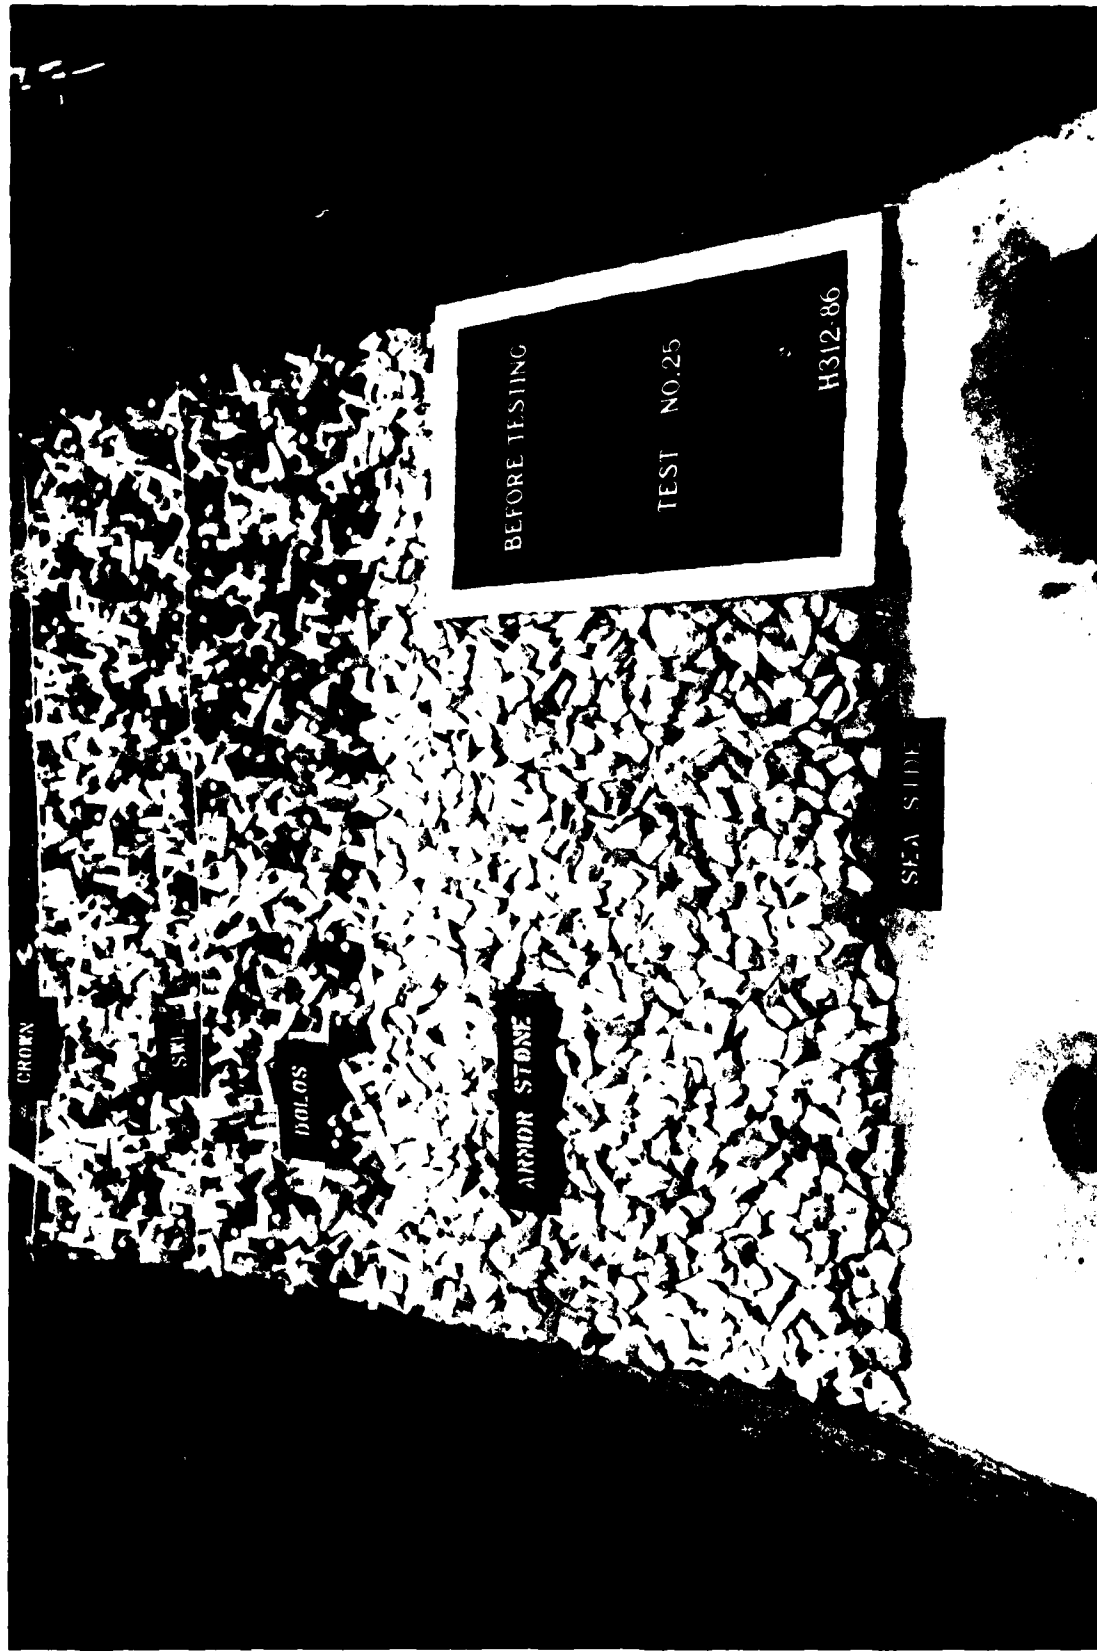
Photo 3. Before testing, 35 percent uniform breakage in top layer, nonbreaking waves

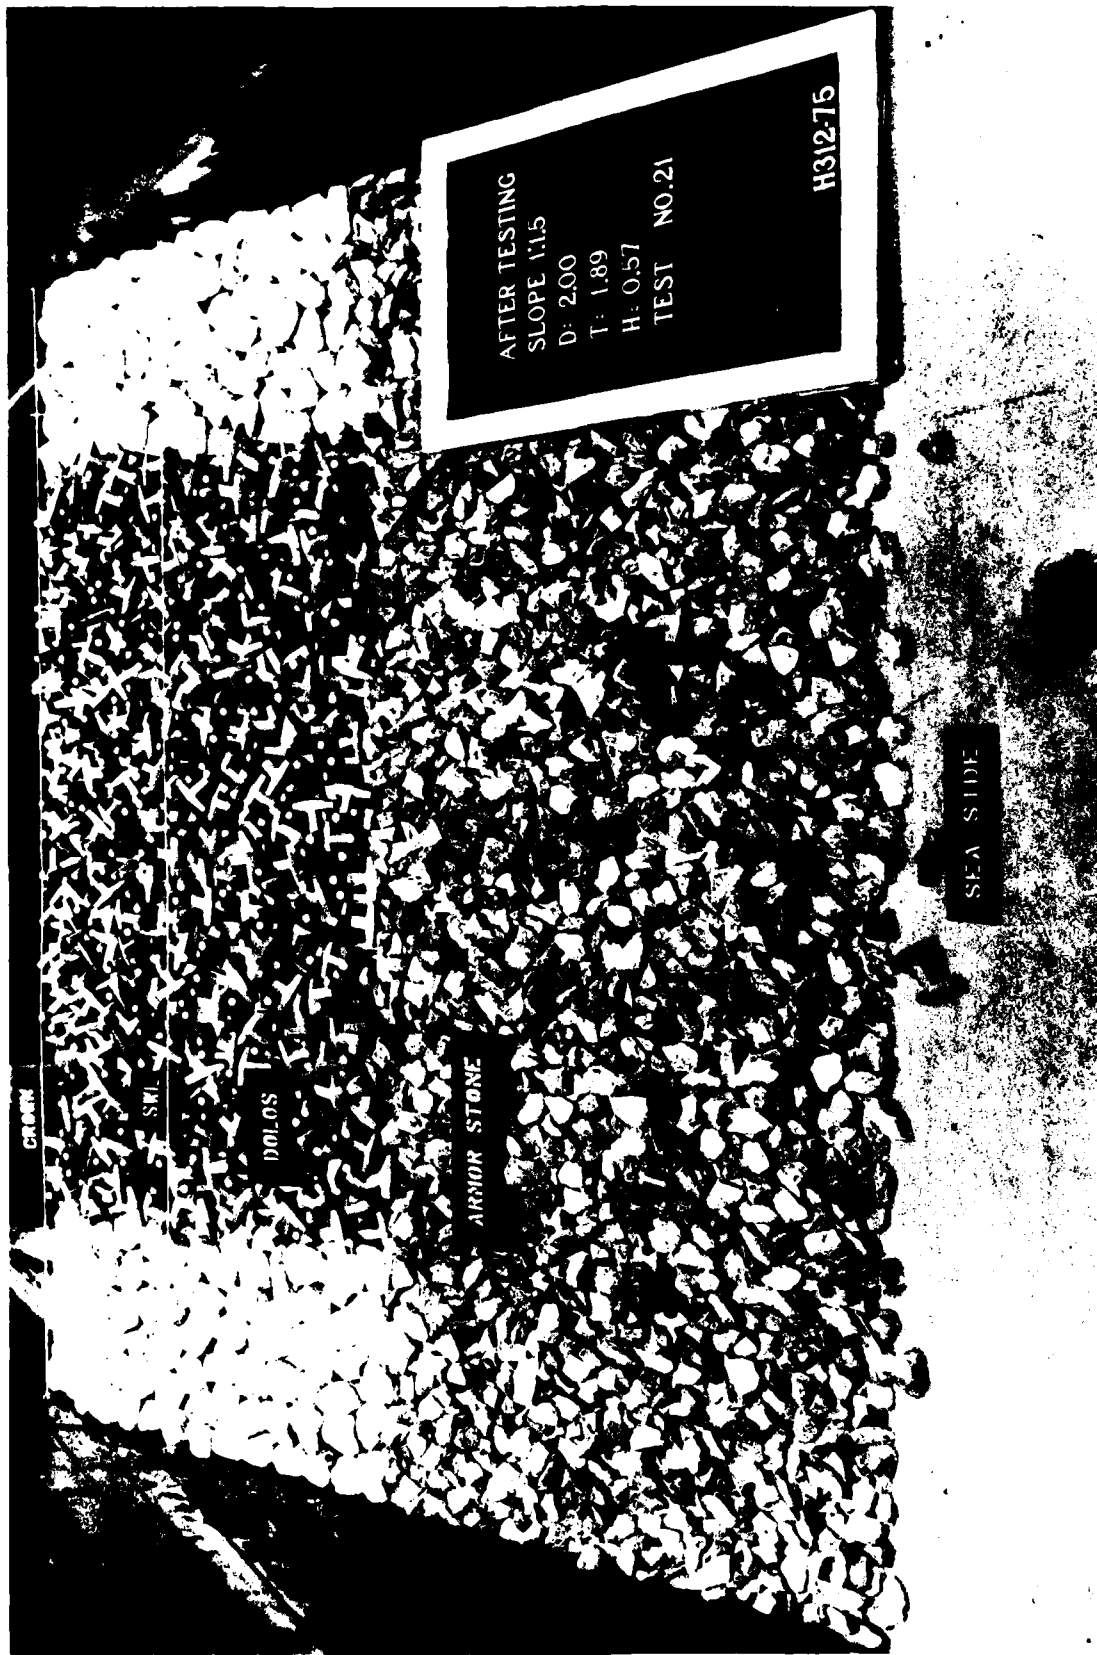
Photo 4. After testing, 15 percent uniform breakage in top layer, nonbreaking waves

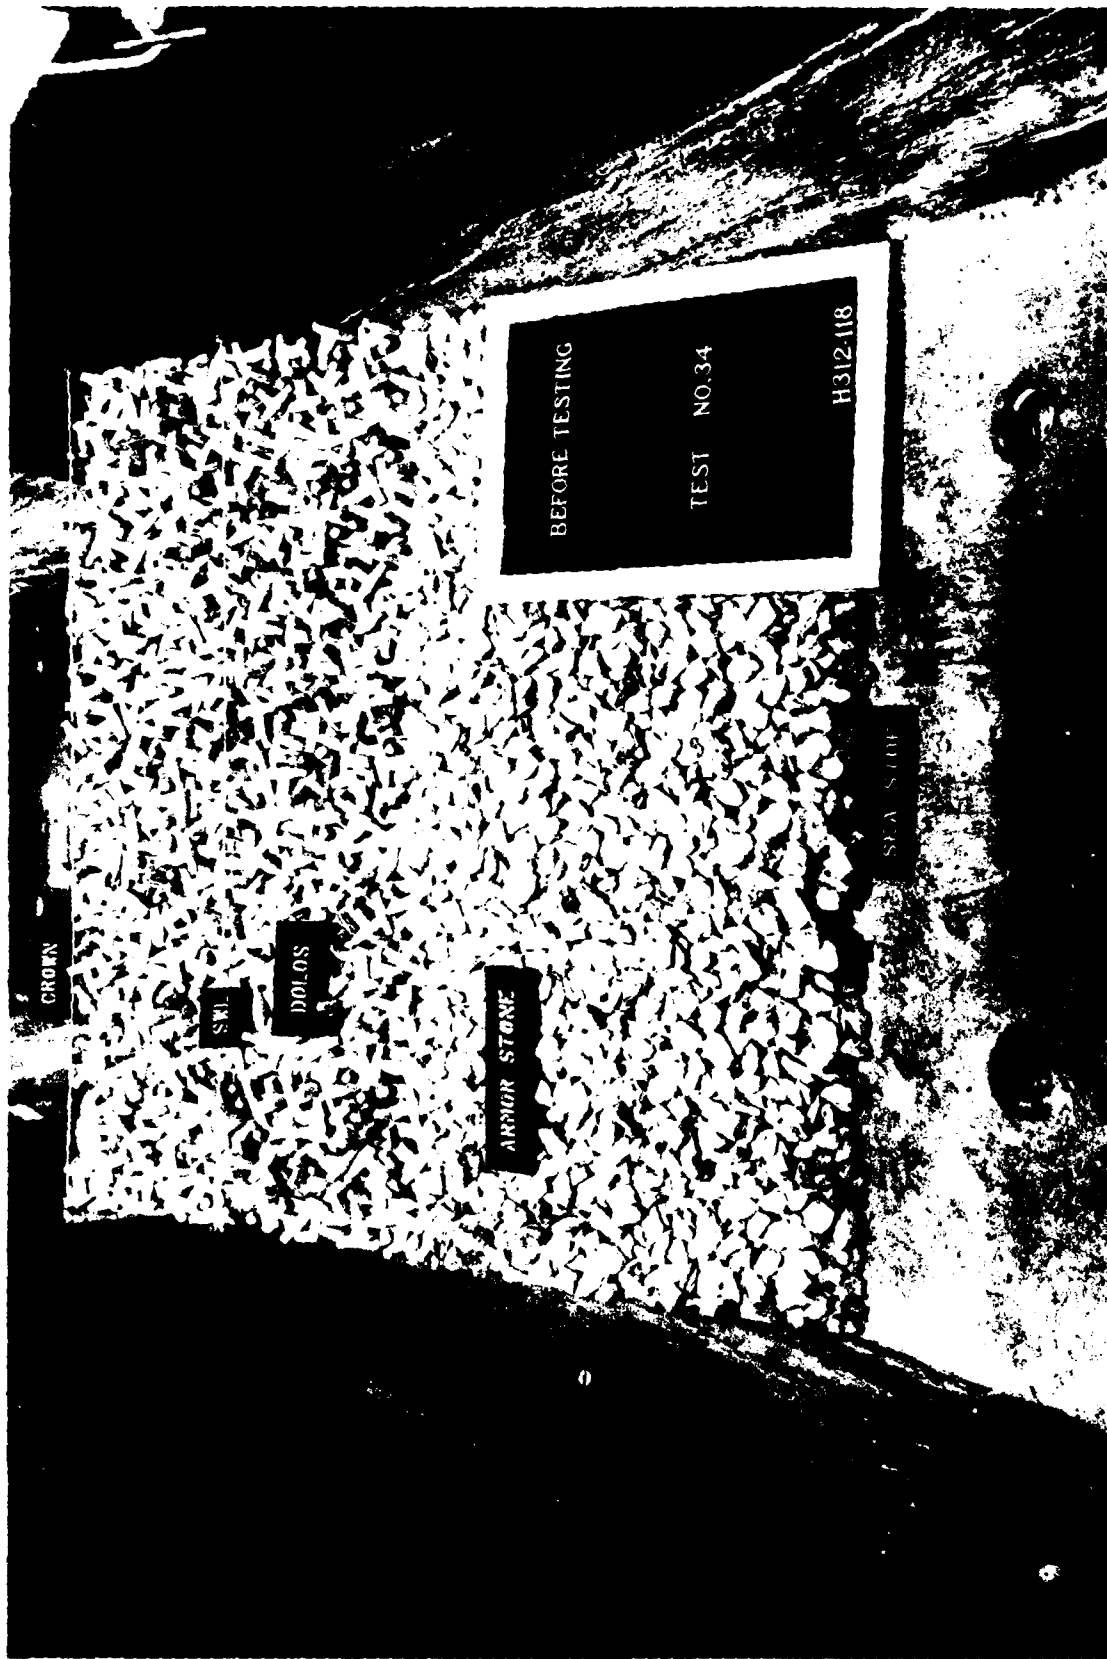
Photo 11. Before testing, 7.5 percent uniform breakage in both layers, nonbreaking waves

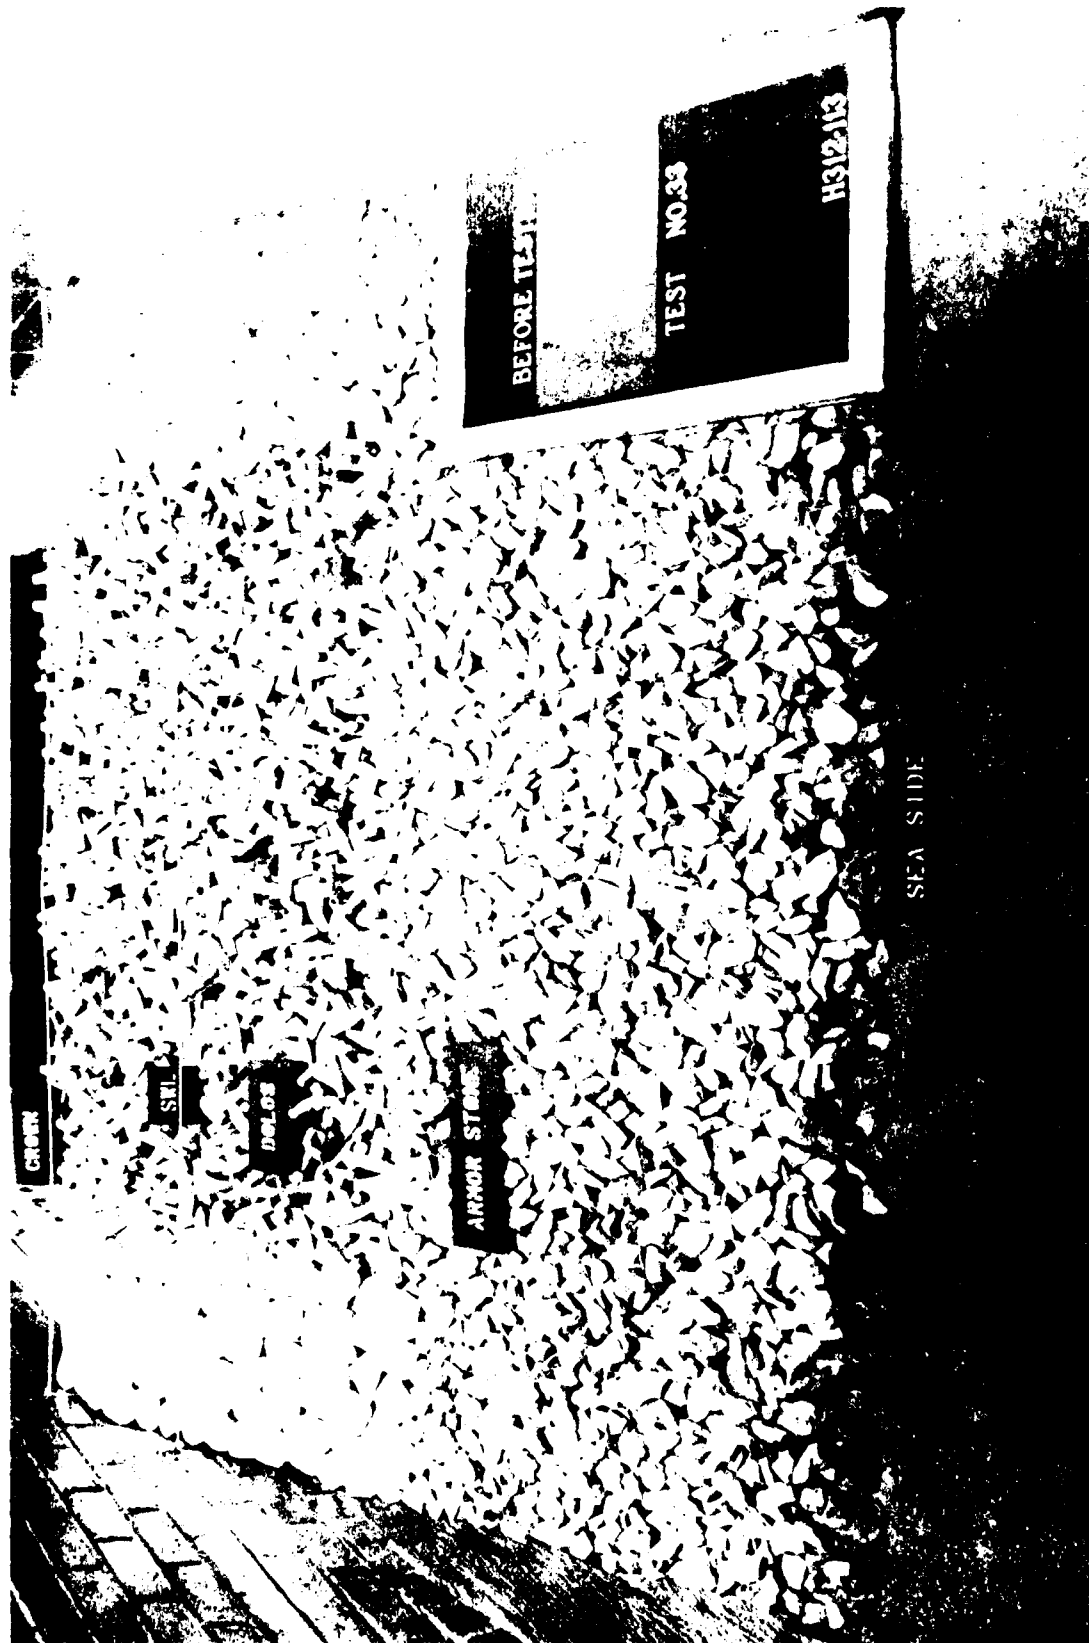
Photo 12. Before testing, 10 percent uniform breakage in both layers, nonbreaking waves

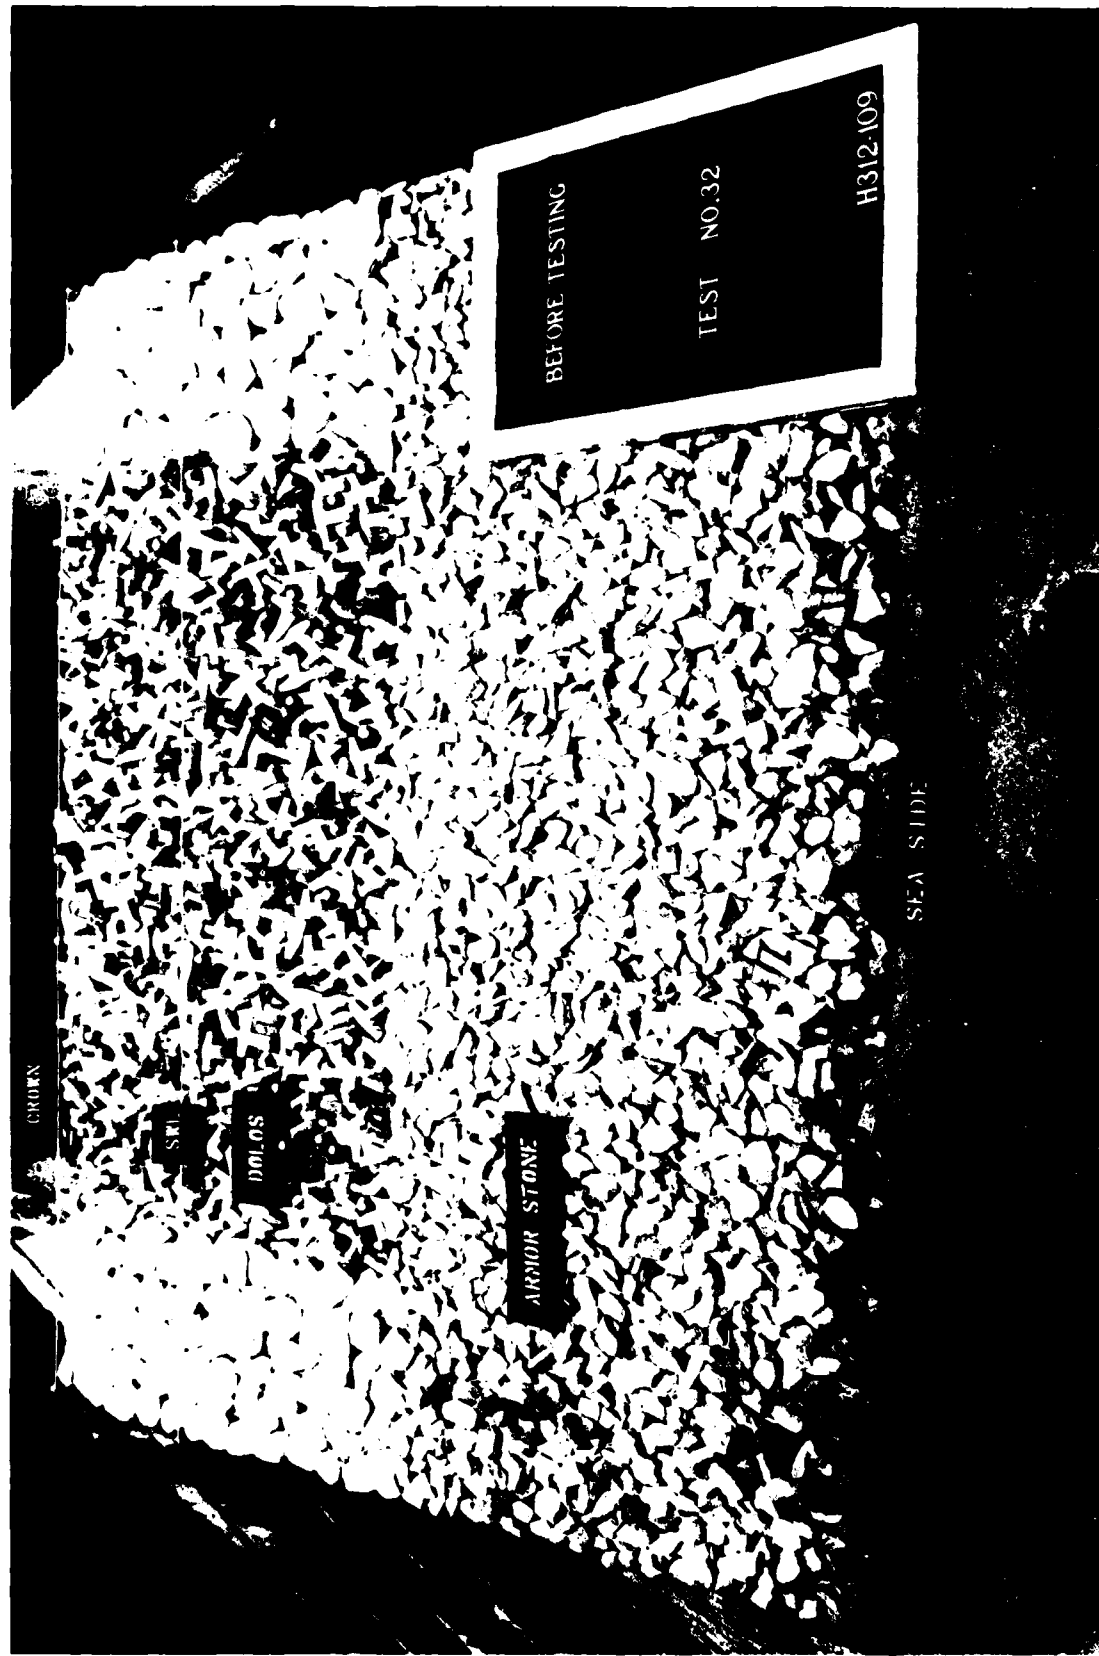
Photo 13. Before testing, 15 percent uniform breakage in both layers, nonbreaking waves

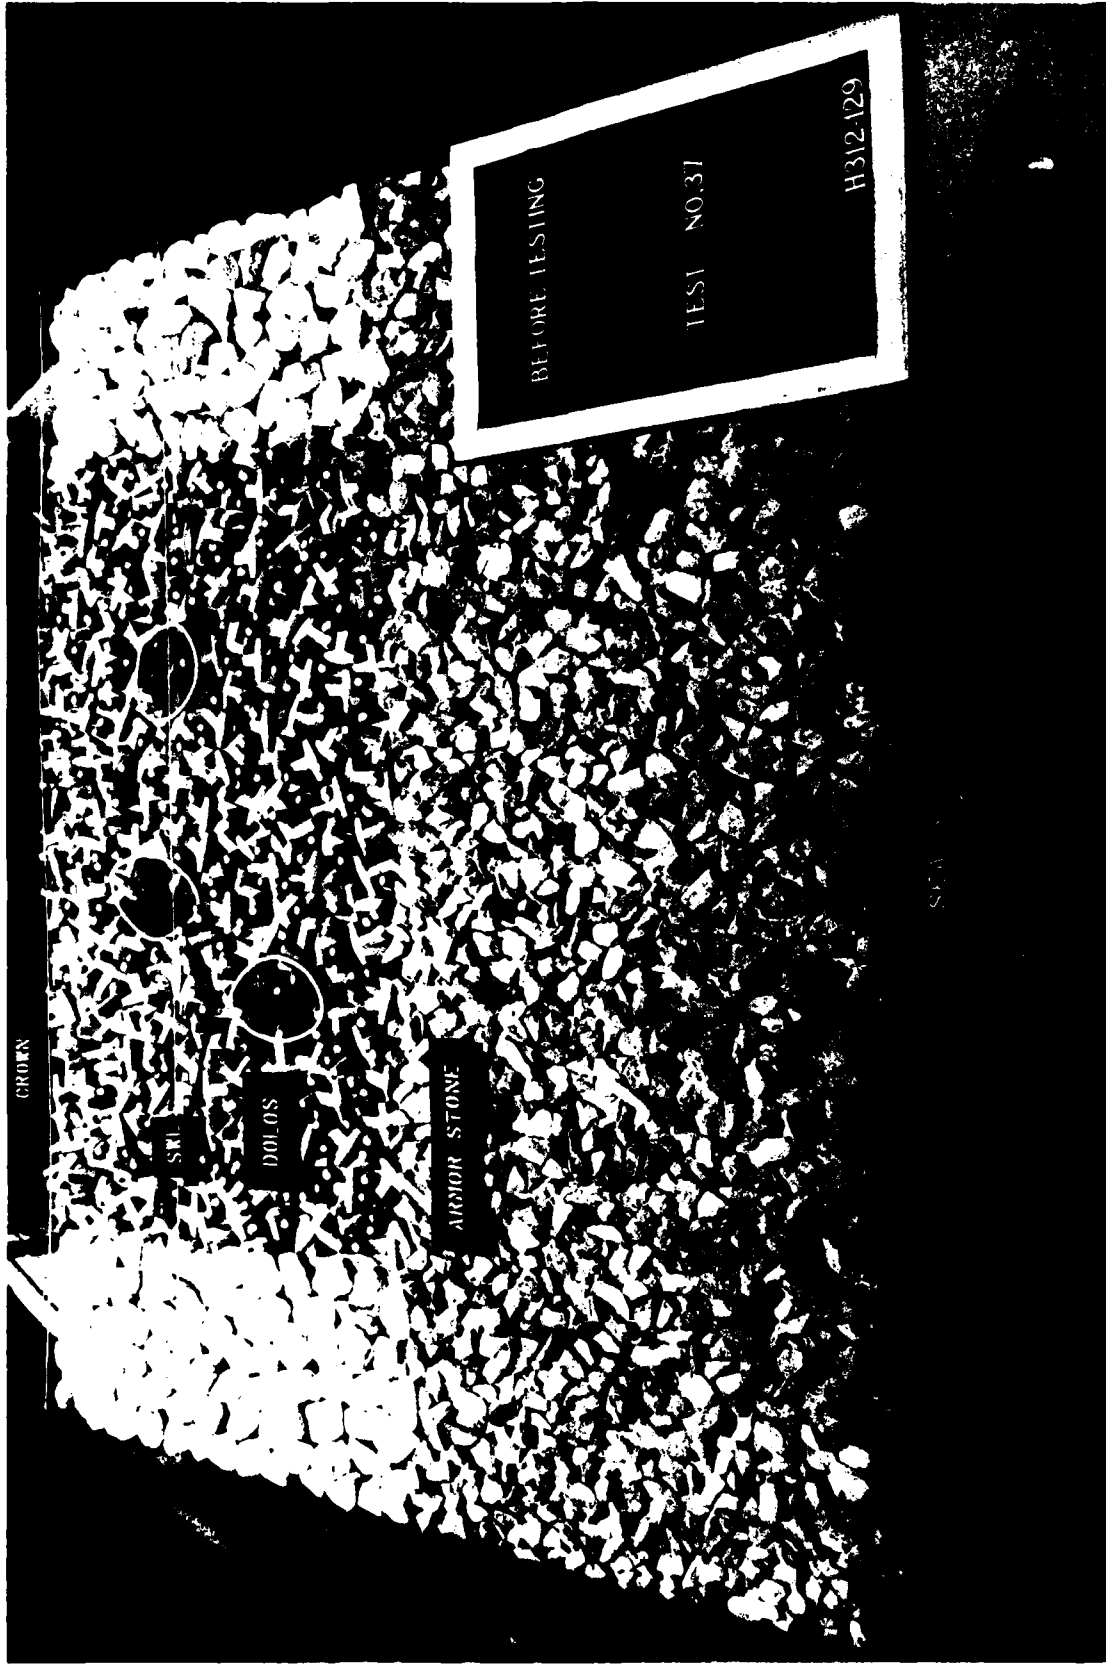
Photo 18. Before testing, 10-unit cluster breakage, nonbreaking waves

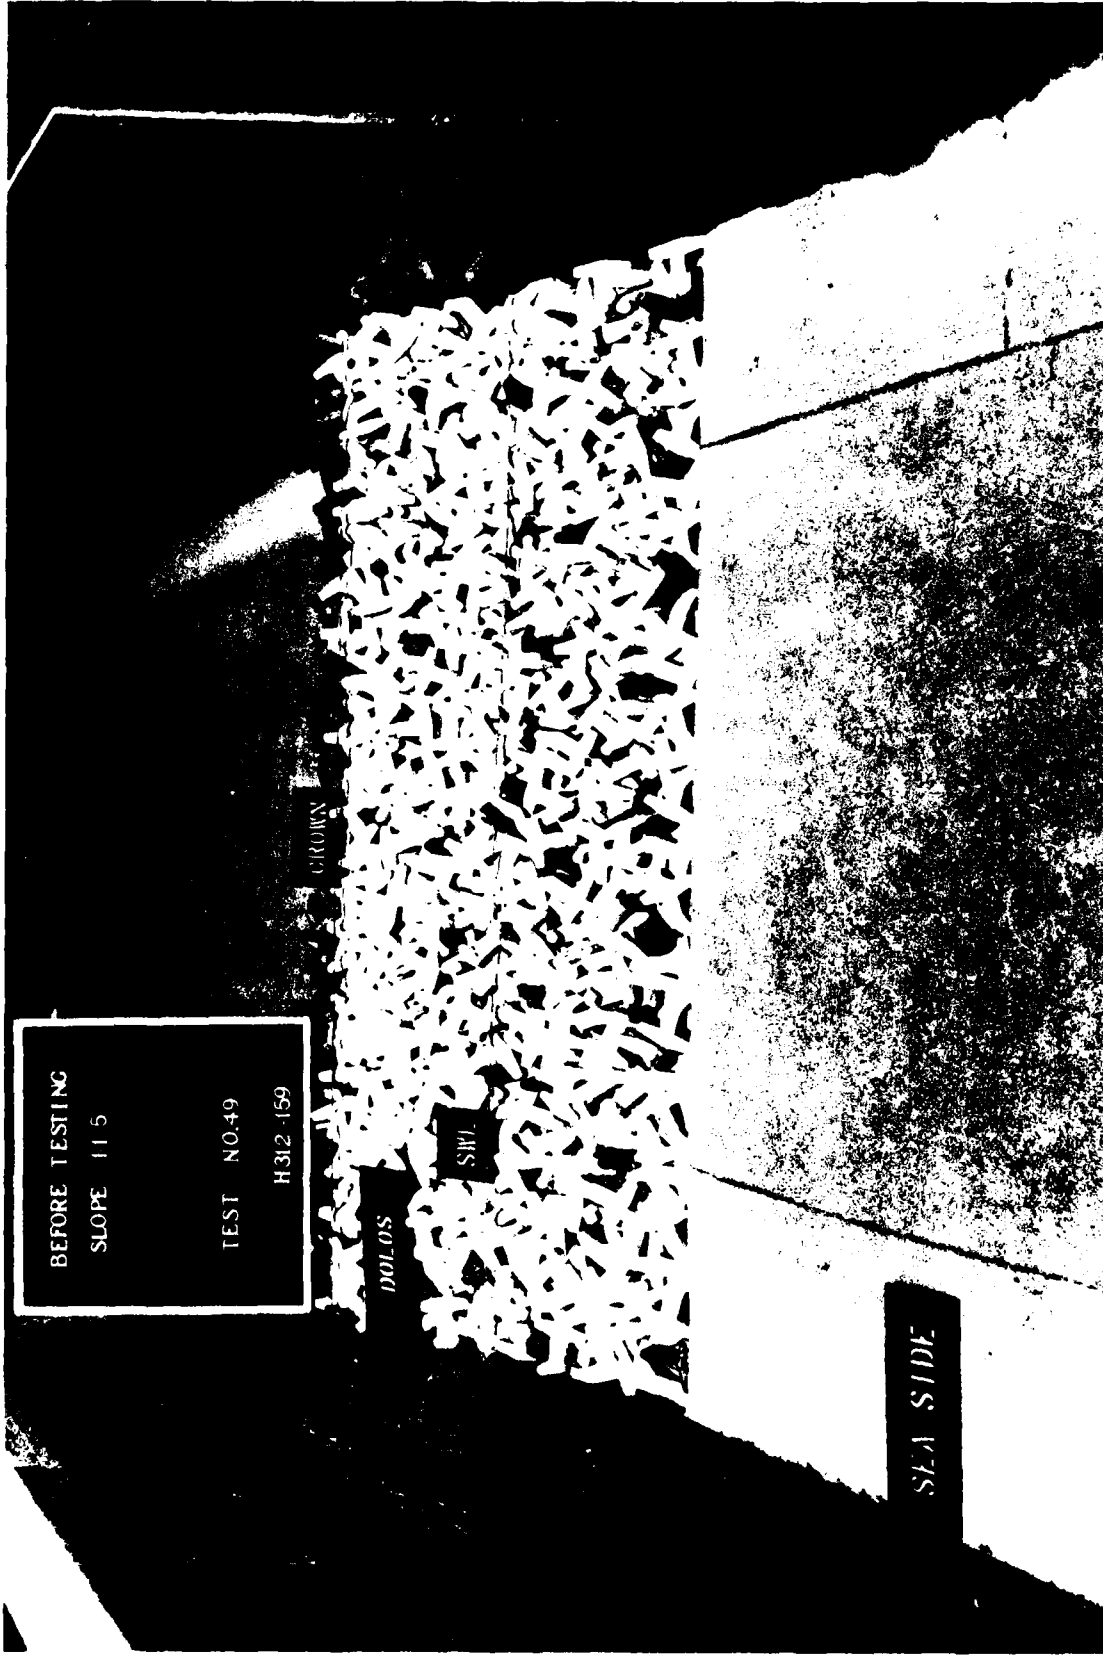
Photo 27. Before testing, 20 percent uniform breakage in bottom layer, breaking waves

31. The 20 and 15 percent bottom layer breakage test sections (Photos 27 and 28) were exposed to the 1.62-sec breaking wave conditions. Both breakage conditions accrued minor amounts of offslope displacement of whole armor units. The 20 percent breakage test sections had significant amounts of in-place rocking, onslope reorientation, and onslope displacement of whole dolos units. These activities resulted in both spot underlayer exposures and

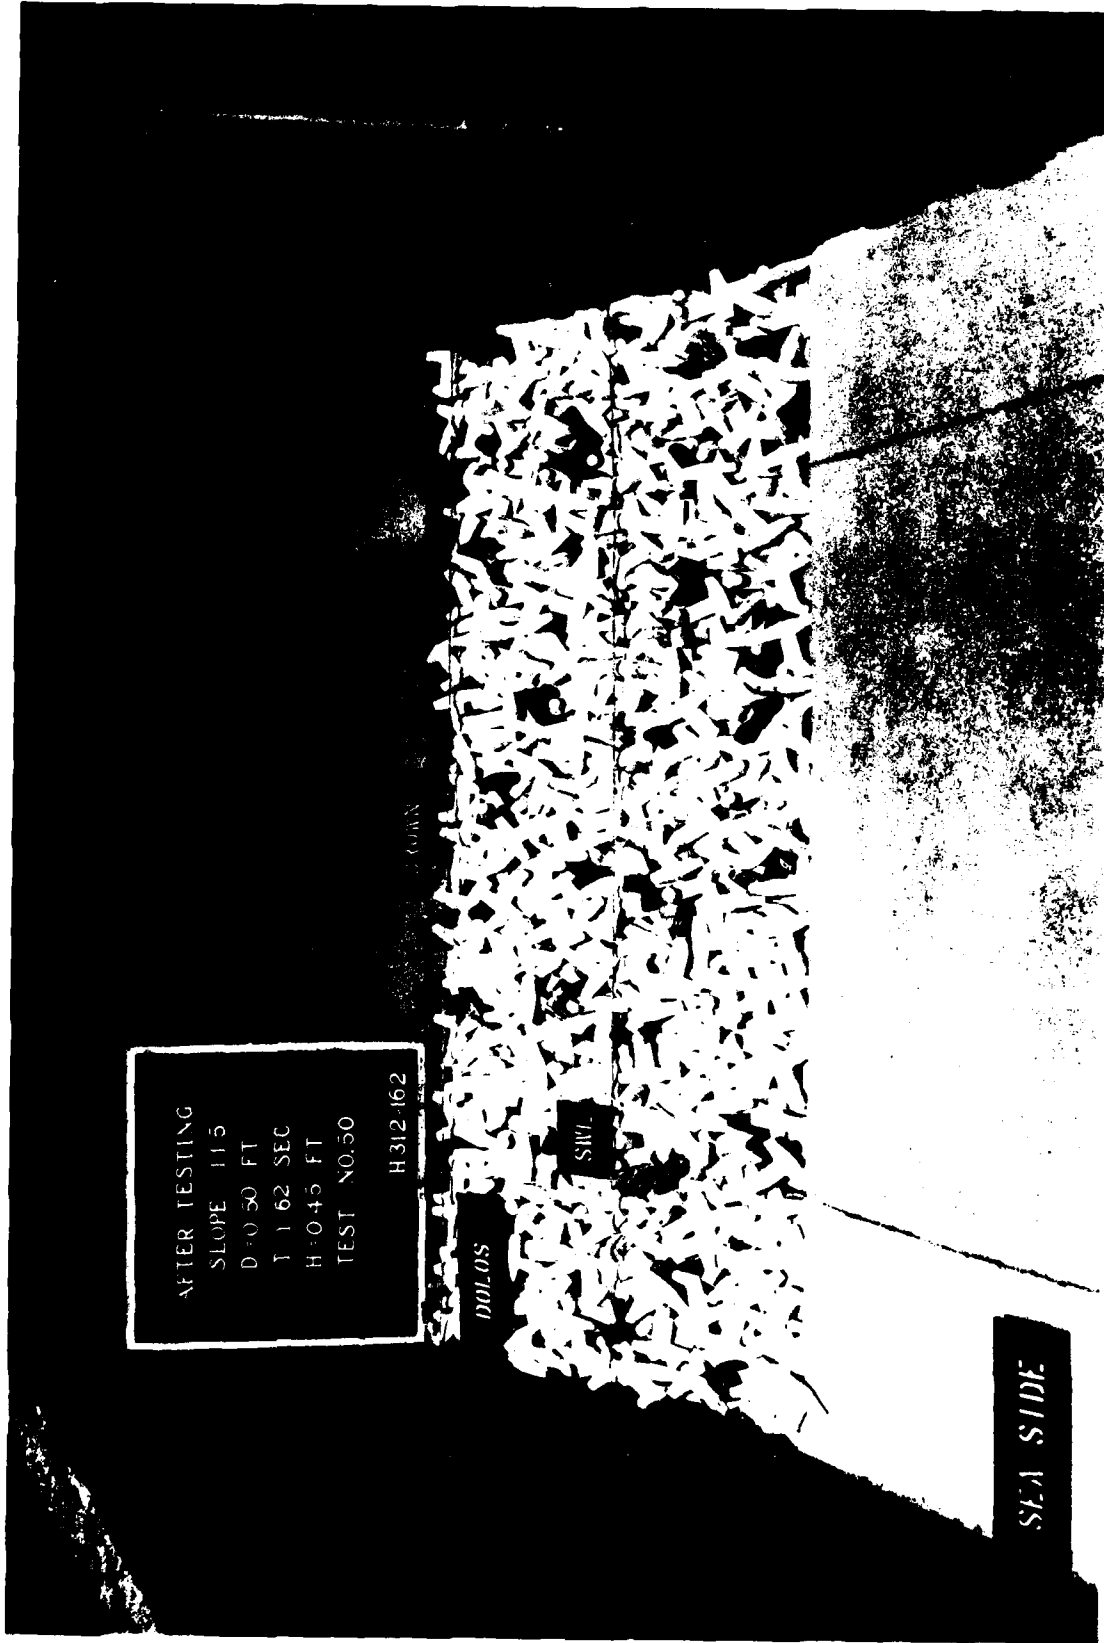
AFTER TESTING
SLOPE 1:1.5
D: 0.50 FT
T: 1.62 SEC
H: 0.45 FT
TEST NO. 50
H 312-162

Photo 33. After testing, 7.5 percent uniform breakage in both layers, breaking waves

32. Combined dolos breakages of 12.5 percent in the top layer and 12.5 percent in the bottom layer (Photo 31) and 7.5 percent in the top layer and 7.5 percent in the bottom layer (Photo 32) were exposed to the 1.62-sec breaking wave conditions. The 12.5 percent breakage sections showed moderate to significant dolos activity, including in-place rocking and reorientation and onslope displacement of both whole and broken dolosse. This activity was not confined to the top layer of dolosse. In some areas, displacement of top layer dolosse allowed some of the bottom layer dolosse to move, resulting in spot exposures of underlayer stone. The 12.5 percent breakage test sections also accrued enough dolos displacement to have obvious areas with only one layer of dolos protection. The 7.5 percent breakage test sections exhibited moderate amounts of in-place rocking and reorientation and minor to moderate onslope displacement of both whole and broken dolosse. The dolos activity was mainly in the top layer of units. By the end of the tests, the sections had accrued minor to moderate damage, but there were no underlayer stone exposures or areas with only one layer of dolos protection. After-test Photos 33 and 34 show the acceptable and unacceptable damage levels sustained by 7.5 and 12.5 percent breakage sections, respectively (Table 3).
