TITLE: EVALUATION OF NONDESTRUCTIVE UNDERWATER  
TIMBER INSPECTION TECHNIQUES

AUTHOR: C. A. Keeney and S. E. Pollio

DATE: August 1984

NAVAL CIVIL ENGINEERING LABORATORY  
PORT HUENEME, CALIFORNIA 93043

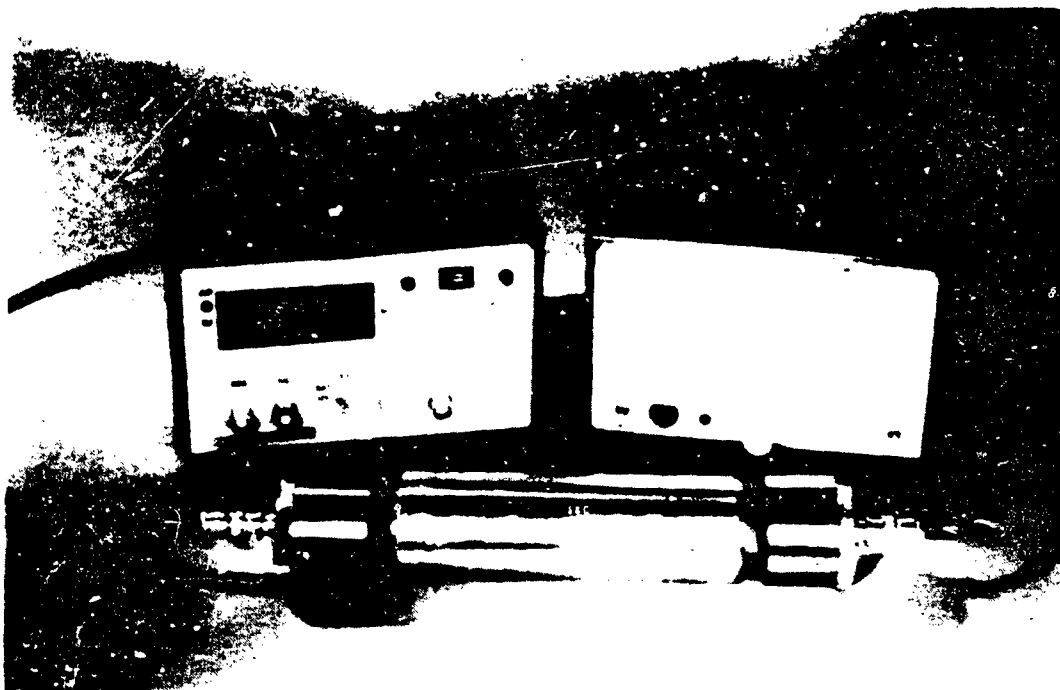
Figure 6. Transducers, ultrasonic v-meter and analog display unit.

The low frequency ultrasonic equipment used by NCEL is commercially available from James Electronics, Inc., Chicago, Ill. This ultrasonic equipment is used routinely during field inspections of lumber, utility poles, and concrete terrestrial structures. The entire system (Figure 6) consists of two lead-zirconate-titanate ceramic piezoelectric transducers mounted in stainless steel cases; a portable ultrasonic digital readout meter (called the V-meter) equipped with a factory-installed adapter to permit direct readout on an oscilloscope; and an analog display unit that converts digital transit time measurements into analog form. Initial ultrasonic tests determined that transit time measurements were not a reliable or accurate measure of cross-sectional wood loss; consequently, the analog display unit that converts digital transit time measurements to analog form was not employed. A schematic of the ultrasonic test system configuration is shown in Figure 7.
