MEMORANDUM REPORT BRL-MR-3429

PHYSICAL RESPONSE OF FLAT STEEL
PLATES TO DROP HAMMER IMPACTS

January 1985

US ARMY BALLISTIC RESEARCH LABORATORY
ABERDEEN PROVING GROUND, MARYLAND

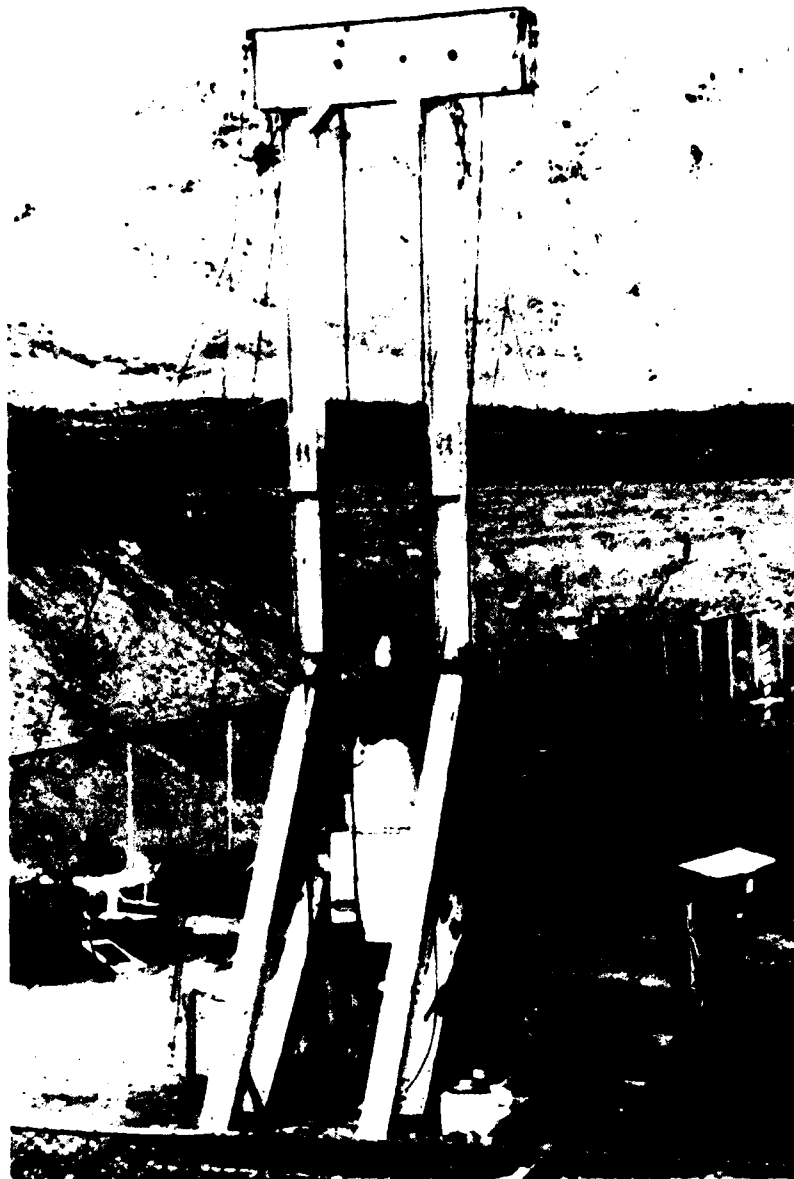
Figure 1: The FRA/BRL Drop Hammer Facility

The FRA/BRL Drop Hammer Facility was designed to enable one to inflict controlled damage on materials placed under the hammer. An overall view of the facility is shown in Figure 1. The hammer is a massive weight of 4,574 Kg {10,084 lbs} which is raised vertically to some predetermined height depending on the amount of kinetic energy desired on impact. The hammer is raised by a cable attached to its top end with a special hook which allows the hammer to drop with a minimum of delay once the procedure is initiated. This mechanism is referred to as the quick release. To trigger the quick release, a pin is pulled from its initial position by a device called an actuator. The actuator pulls on the pin gradually due to a hydraulic pump hand worked by a technician. A device which records the velocity of the hammer is called the comb. The data generated by the comb and associated accelerometers are fed directly into a computer and serve as basic data from which calculations are performed.

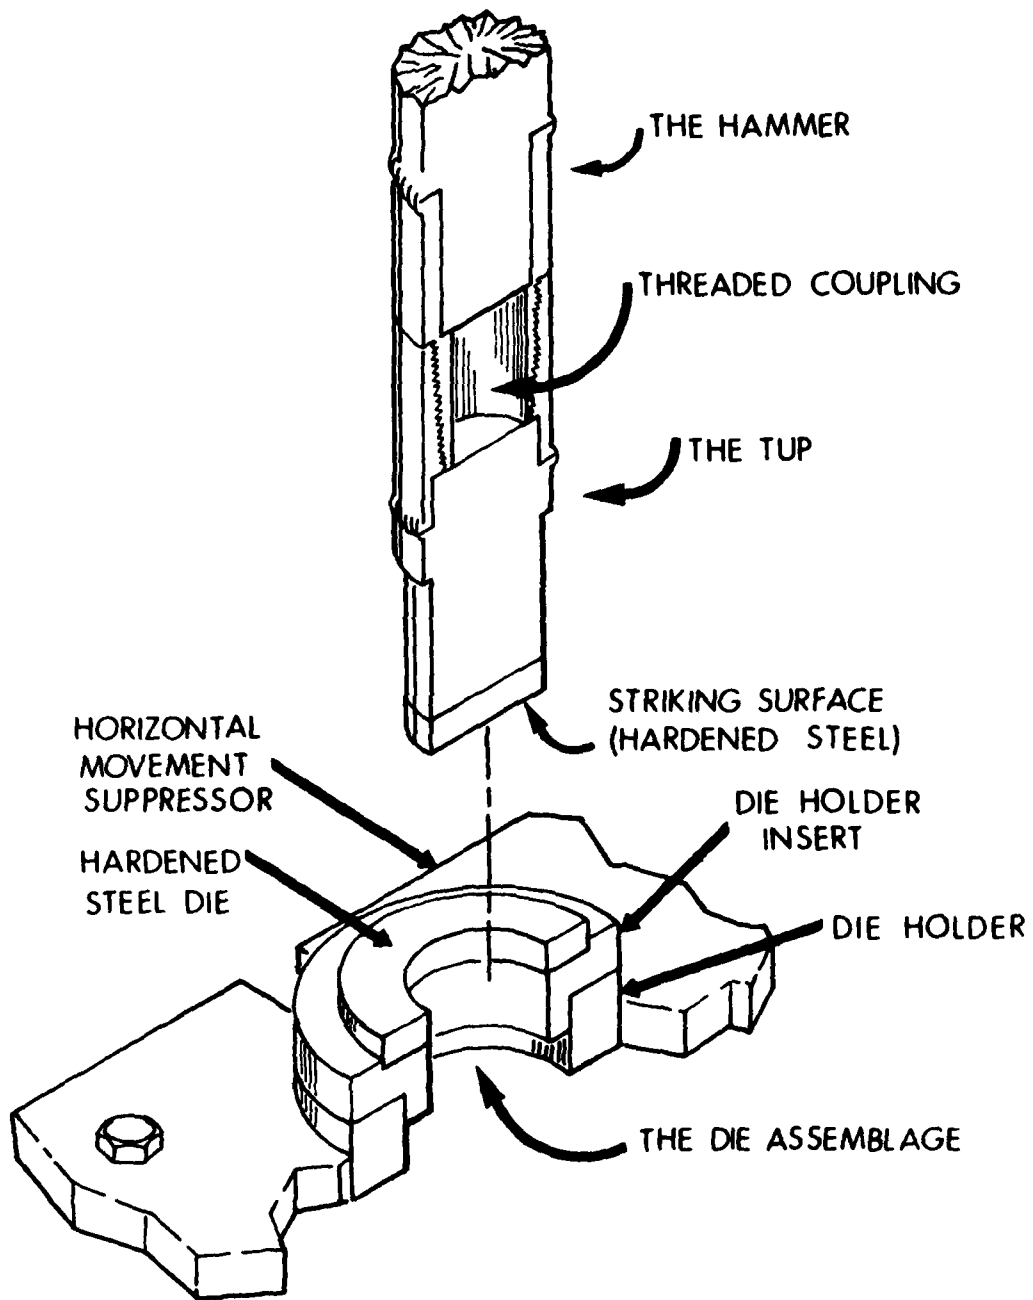
Figure 2: The Tup and Die Assemblage of the FRA/BRL Drop Hammer Facility

A diagram of the interacting parts which create the damage is presented in Figure 2. The hammer does not impact the material directly, but has an object called a tup attached to the bottom end. The tup is threaded to the hammer and can be of arbitrary shape and size. In the figure, the striking surface of the tup is shown to be flat with the tip consisting of a layer of hardened steel. Below the flat surface of the tup, the diagram indicates the die which is also composed of hardened steel. The die is held in place by a die holder which lies in a recess carved in the heavy steel base on which the entire structure is attached. If the tup perforates a plate, it can pass through the opening in the die. In the tests described in this report, the cutting edge of the dies were rounded off to yield more realistic results.

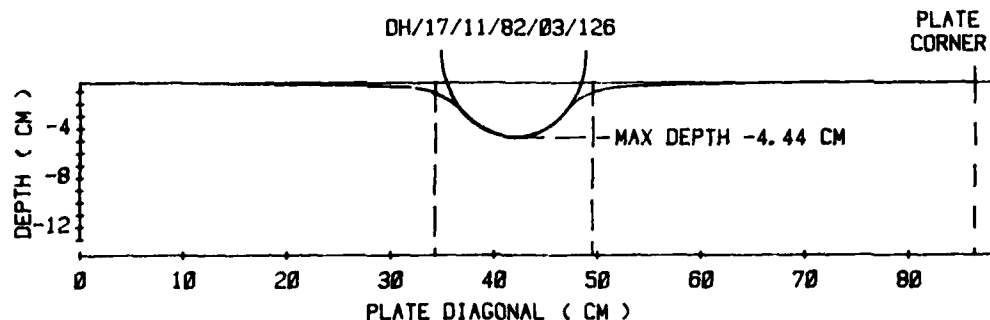
Figure 3: A Typical Example of the DM Dent Depth Plots

The test data were recorded in two different ways. One was simply to photograph both sides of the plate following each of the tests. The other consisted of measuring the depth of the dent along a diagonal using a dial micrometer {DM}. A typical sample of a DM measurement is presented in Figure 3. The abscissa in the figure represents positions along the diagonal from one corner at zero to 86.35 cm {34 inches} indicated by the vertical line denoted as the "plate corner". The horizontal line drawn along the entire length of the diagonal to the "plate corner" and located at the zero value on the ordinate represents the original position of the surface points on the impact side of the plate. The drawing of the die in the figure was located by assuming that the die was centered on the deepest point in the dent as determined by the DM. The center of the tup was located on the same basis. In practice, while there was a deliberate effort to center the plate on the center of the die, this was not possible to do exactly. However, the variation in the placement of the plates had no affect on the quality or the usefulness of the data.

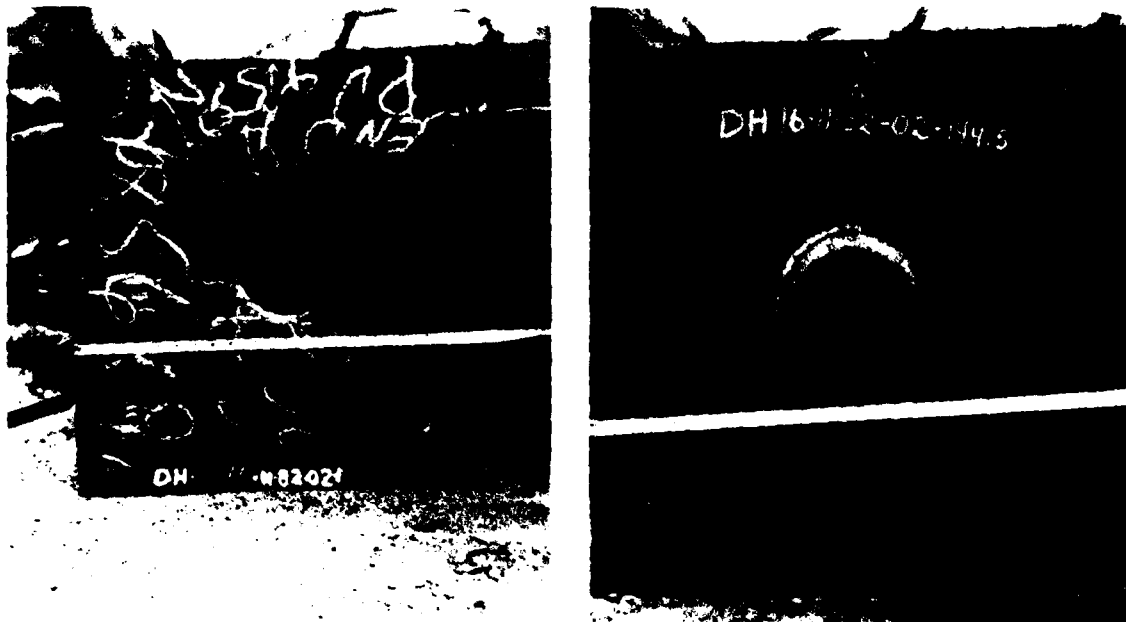
Figure 4: Steel Plate Response to 5.5 Inch Flat Tip in Test Number 1

In the first three tests listed in Table 1, the die diameter was only 1.27 cm {0.5 inches} larger than the tup diameter. Past experience using this combination had previously shown that the primary failure mechanism would be shear in these tests. The reason is due to the fact that the bulk of the energy deposition is concentrated around the edge of the tup which causes a punching type action {Ref.3}. Figure 4 presents the impact side and the bottom side of the plate for Test Number 1. Both photographs shows the flat impression reflecting the flat tup. There were no visible cracks on either side of the plate.

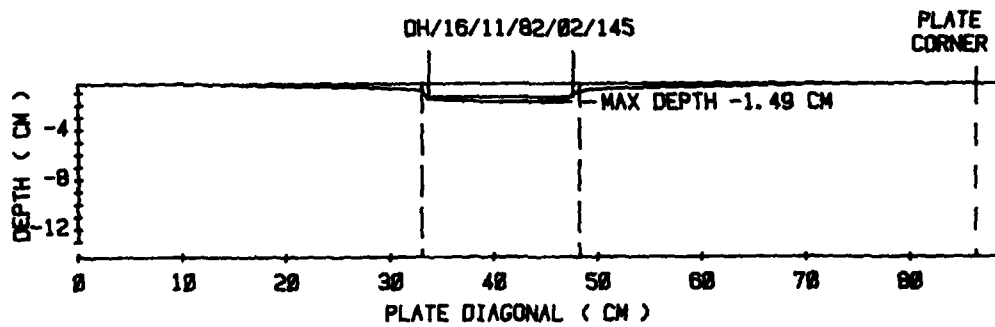
Figure 5: The DM Measurements of Impact Dent From Test Number 1

The DM measurements for Test Number 1 are presented in Figure 5. The diameter of the bottom of the dent, measured from the plot, is less than the diameter of the tup. This indicates that the tup's impacting surface failed to reach the bottom of the dent. However, the hammer bounces when the tup fails to perforate so that as the hammer rebounds, the plate probably contracted because of the elasticity of the plate material.

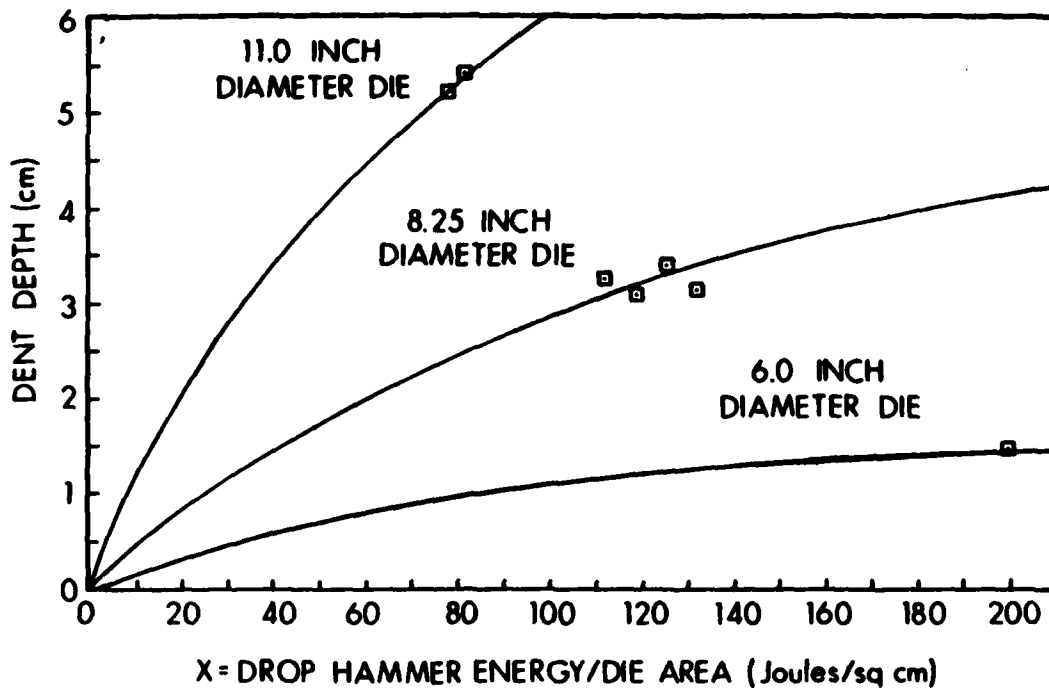
Figure 7: Dent Depth Summary of the 5.5 Inch Flat Top Data

In the remaining tests there were no perforations, thus the dent depths for each were measured. In order to present the dent depth data on one plot, the potential energy of the hammer {hammer height} was divided by the presented area of the die. The results are presented in Figure 7. In general, for a specific kinetic energy {potential energy}, the maximum depth of the dents increased as the die diameter was increased. This was attributed to an increase in the bending mode between the edge of the tup and the edge of the die. The curves were drawn merely to assist in visualizing the trend of the data.

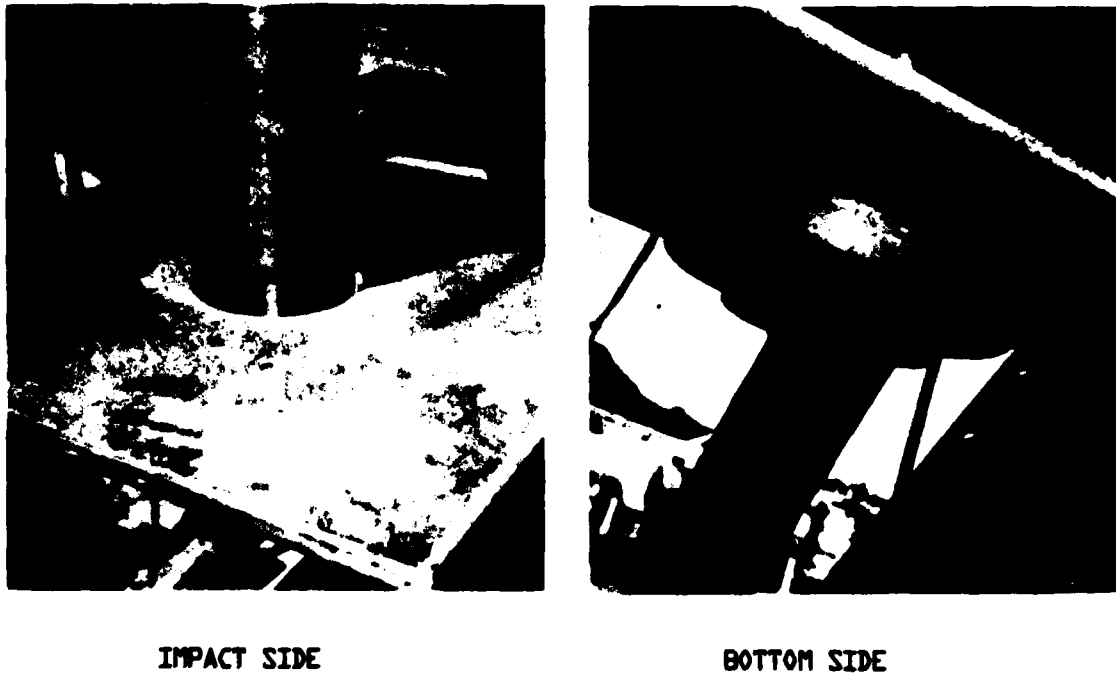
Figure 8: Steel Plate Response to 5.5 Inch Hemispherical Tup in Test Number 15

the plates on Test Numbers 15, 25, 32, and 33. The photographs of the impacted plates are presented in Figures 8 through 11. The impact side and the bottom side of the plate for Test Number 15, where the die diameter was 15.3 cm (6.0 inches) and the hammer height was 178.0 cm (70 inches), are presented in Figure 8. In that test a punched-out plug was achieved which lodged inside the die. The impact side and the bottom side of the plate for Test Number 25 are presented in Figure 9. The die diameter for this test was 28.0 cm (11.0 inches) and the hammer height was 178.0 cm (70 inches). The large crack generated probably started on one side of the bulge and propagated circumferentially toward the edges of the bulge. The impact sides and the bottom sides of the plates for Test Number 32 and 33 are presented in Figures 10 and 11 respectively. The die diameter was 35.0 cm (13.75 inches). The crack in each plate was similar to the one generated in the previous test discussed. For those tests in which die diameters greater than 15.2 cm (6.0 inches) were used, the data indicates that ductile cracks forms rather than shear plugs. The responses of the plates consist of initial crack formation and crack enlargement as the hammer height is increased (more kinetic energy on impact). The damage mechanism was probably severe thinning of the steel around the sides of the bulge as the tups penetrated and then the thinned metals separated by ductile fracture.

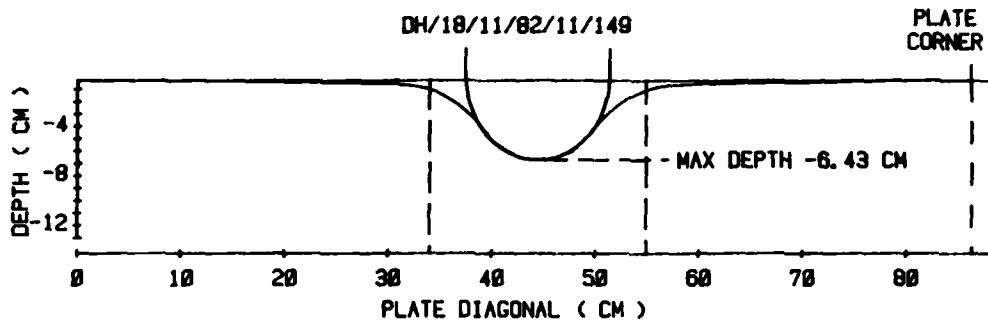
Figure 13: The DM Measurements of Impact Dent From Test Number 20

An example of the plate response to the tup when no perforation occurred is presented in Figure 12. The die diameter was 15.3 cm (6.0 inches). The shape and size of the tup and the diameter of the die was dominant in forming the geometry of the dent. Figure 13 presents an example of the DM plots for the tests where no severe cracking occurred. The dent depth as functions of the drop hammer energy/die diameter ratio (joules/sq. cm) data are presented in Figure 14. The curves indicate a gradual increase in the dent depth as the energy per area increased and the dent depth increased at a faster rate for the larger die diameters.

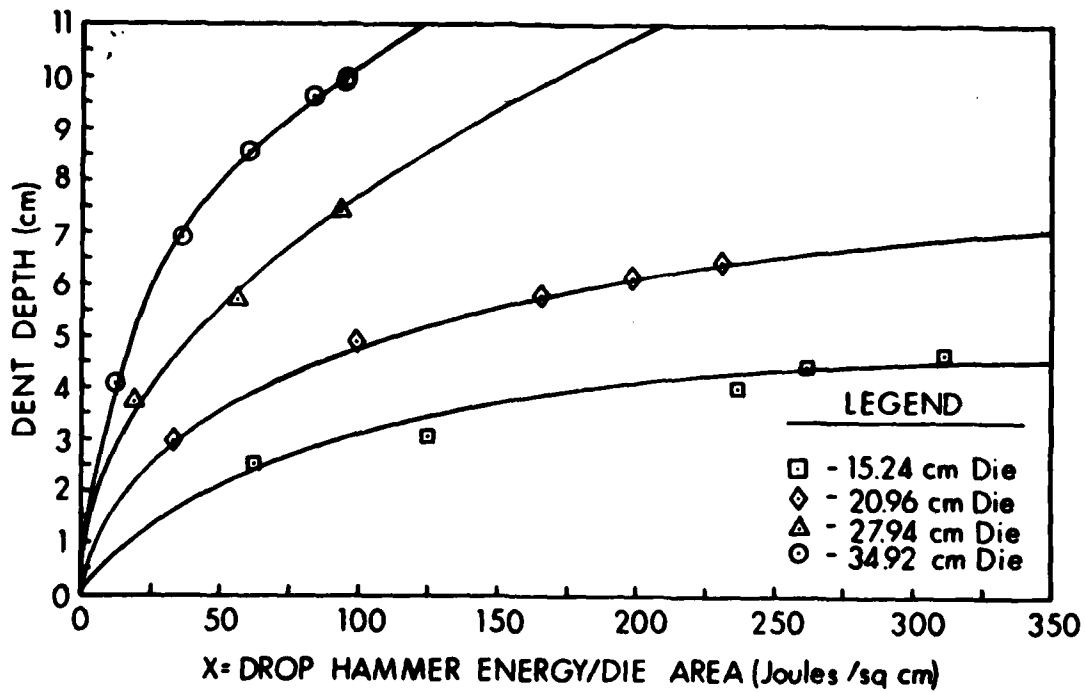
Figure 14: Dent Depth Summary of the 5.5 Inch Hemispherical Tup Data

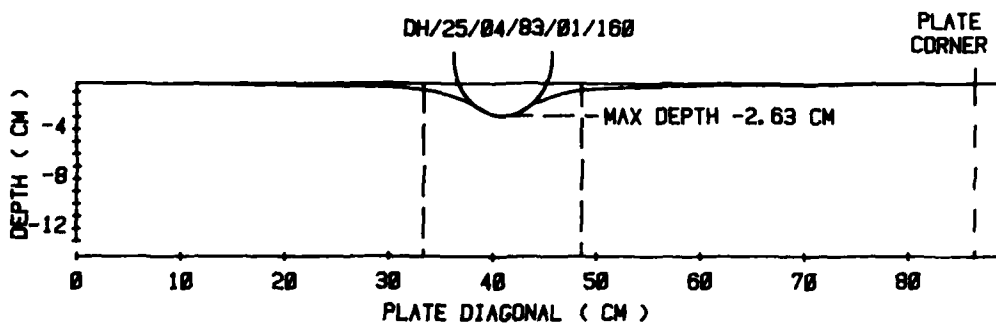
Figure 16: The DM Measurements of Impact Dent From Test Number 34

Figure 15 presents a view of the impact side and the bottom side of a sample impacted plate using the T_{MH} tup. The response of the plate was similar to that obtained for the larger T_{MH} hemispherical tup. Figure 16 presents a sample of the DM measurements for this group of tests which also is similar to the previously discussed group. The dent depth as functions of drop hammer energy/die area {joules/sq. cm} are presented in Figure 17. The trends are similar to the previous group's results but the dent depths are greater as anticipated.

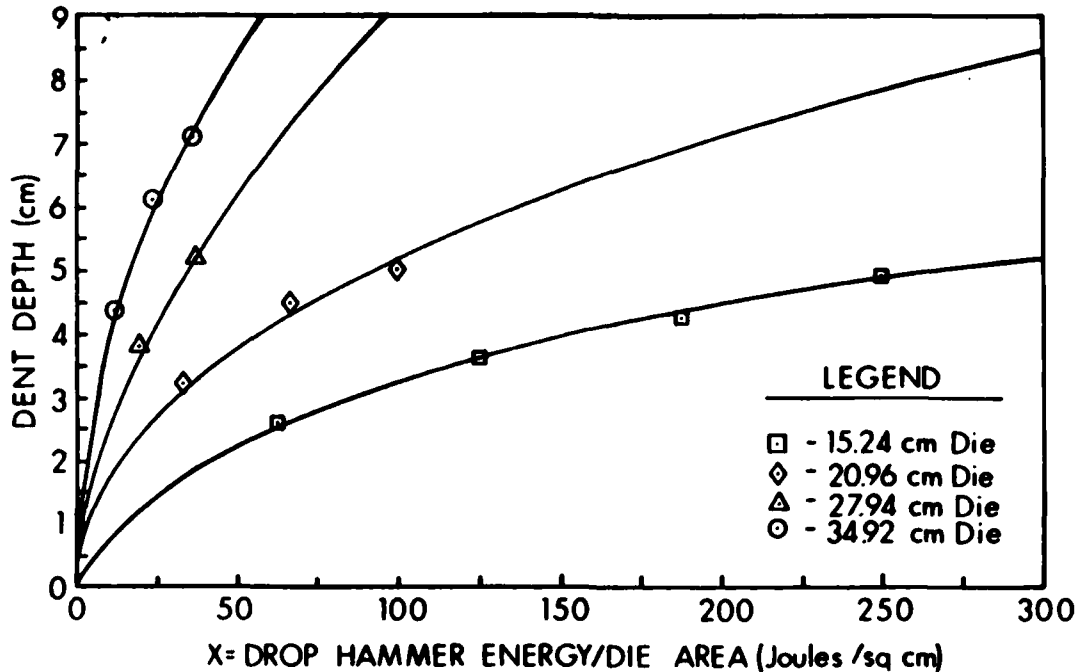
Figure 17: Dent Depth Summary for the 3.75 Inch Hemispherical Tup Data

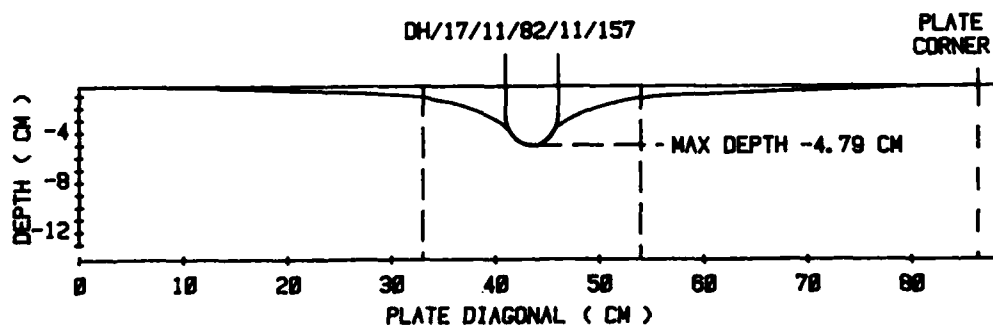
Figure 19: The DM Measurements of Impact Dent From Test Number 61

An example of one of the tests, where a 15.2 cm {6.0 inch} diameter die was used is presented in Figure 18. The imprint of the perimeter of the die is visible in both photographs. Figure 19 presents a sample DM measurement plot for Test Number 61 where a 21.0 cm {8.3 inch} diameter die was used. In general, the plates experienced a great deal of bending due to the relatively large distance between the edge of the die and the tup.

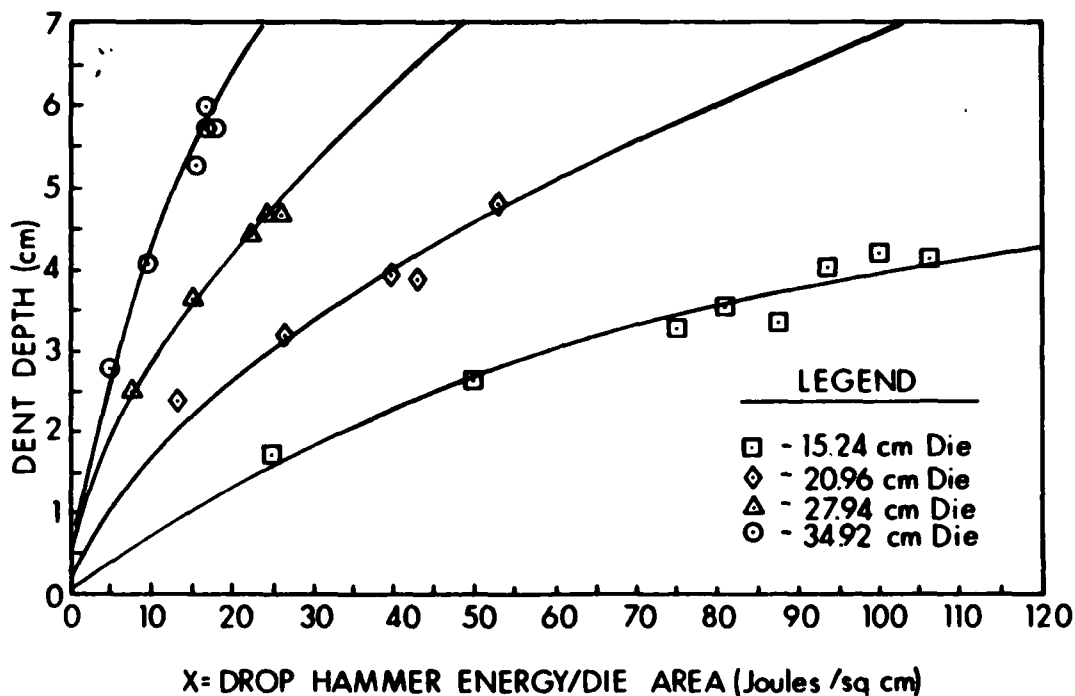
Figure 20: Dent Depth Summary for the 2.0 Inch Hemispherical Tup

inches) to 6.35 cm (2.5 inches), there will be surface cracking on the inside of the tank car. This is an example of how these data can be used in assessing a damaged tank car. Such a correlation can be expanded to include other flaw data obtained by using NDE techniques. Figure 20 presents a plot of the dent depth as functions of drop hammer energy/die area (joules/sq. cm). Again, these curves are similar to those obtained from test data obtained using the larger diameter tups.

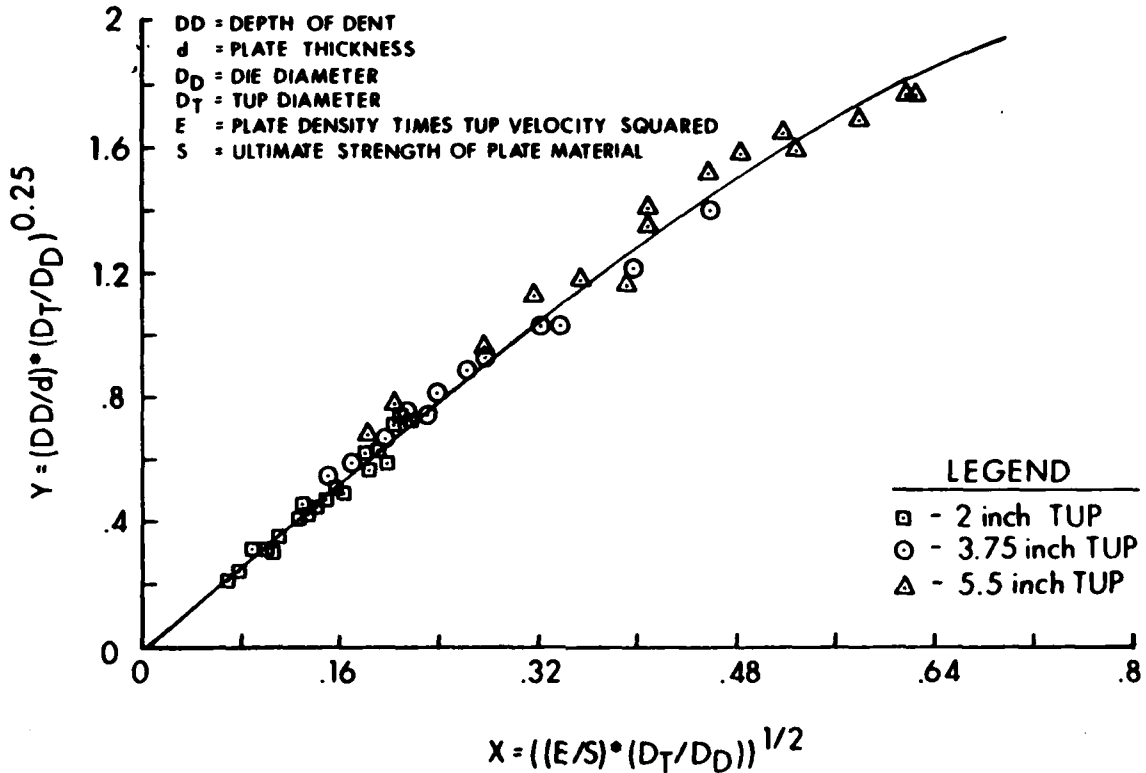
Figure 21: Summary of Dent Depth Versus Energy for the Hemispherical Tup Impact Data

As with any test program, in the event the data scales, a great deal of future test reduction may be realized. Consequently, an attempt to scale the dent depth as a function of drop hammer energy was pursued. The results of this effort are presented in Figure 21. As Figure 21 shows, the scaling was done by nondimensionalizing the X and Y terms. These terms are defined as follows:

These scaling relations were obtained using nondimensionalizing techniques in a totally empirical way. The most important aspect of this exercise is that the result shows that there is a high probability that these kinds of test data can be scaled. Additional work is required in the form of data generation for other initial conditions. For example, it would be very useful if expressions could be developed for scaling to other plate thicknesses and materials.

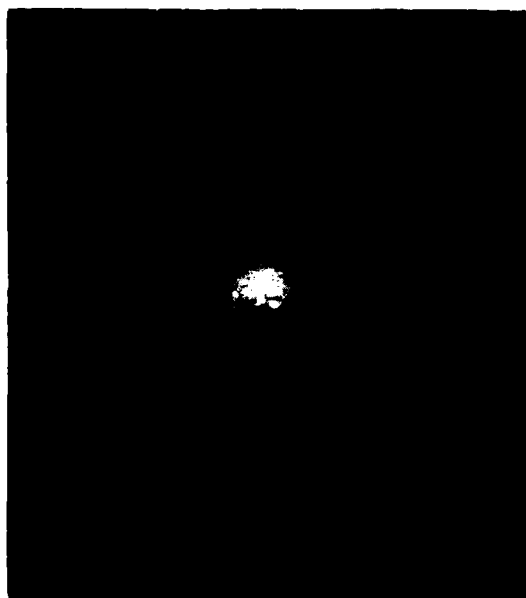
Figure B27: Steel Plate Response to 5.5 Inch Hemispherical Tip in Test Number 27

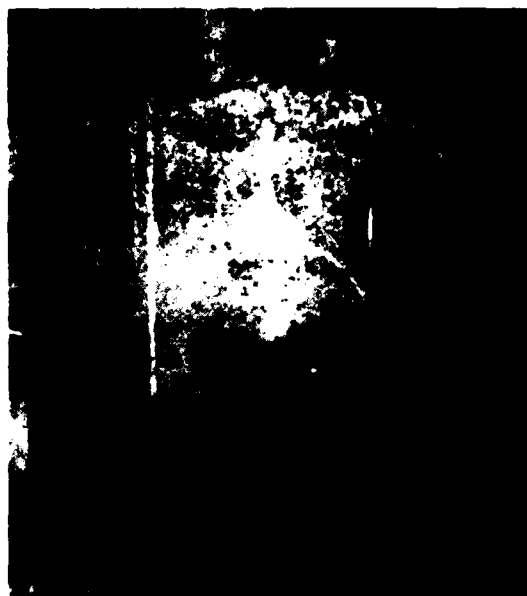
Figure B56: Steel Plate Response to 2 Inch Hemispherical Tup in Test Number 56

IMPACT SIDE

BOTTOM SIDE

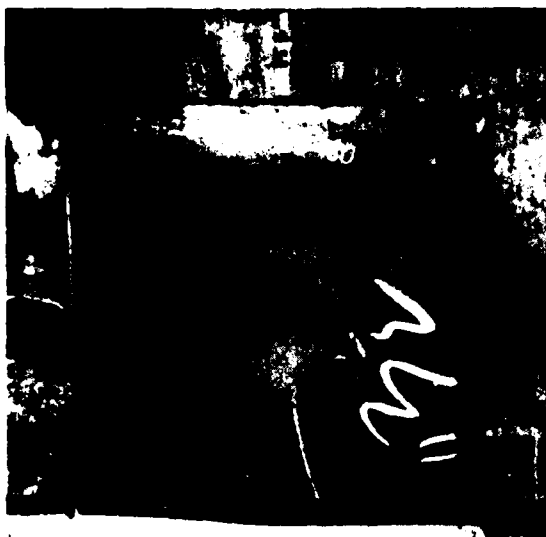
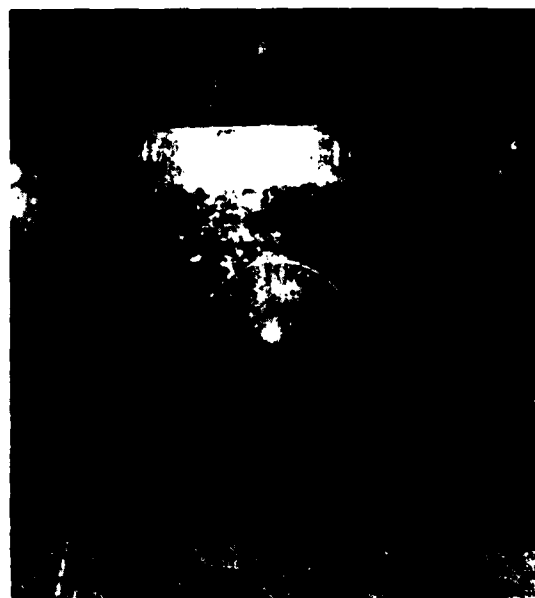
Figure B57: Steel Plate Response to 2 Inch Hemispherical Tup in Test Number 57

IMPACT SIDE

BOTTOM SIDE

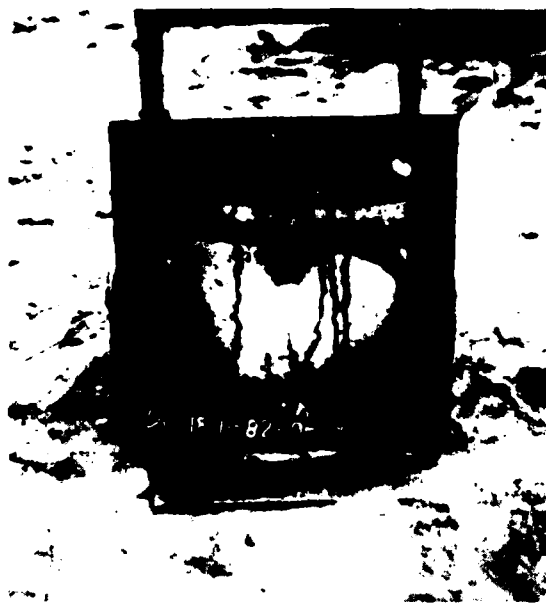
Figure B58: Steel Plate Response to 2 Inch Hemispherical Tup in Test Number 58

IMPACT SIDE

BOTTOM SIDE

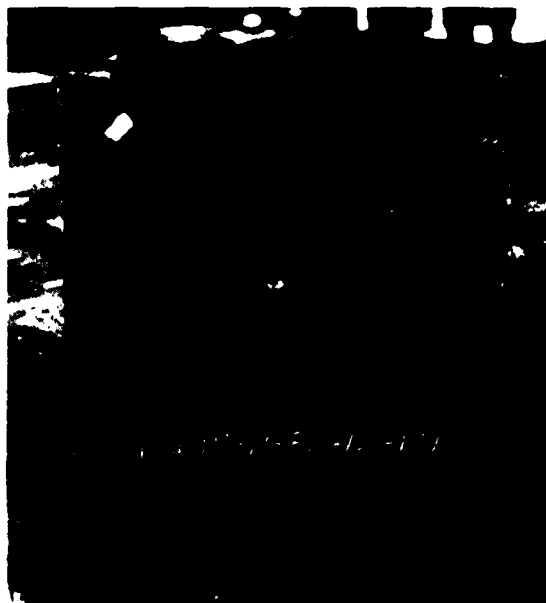
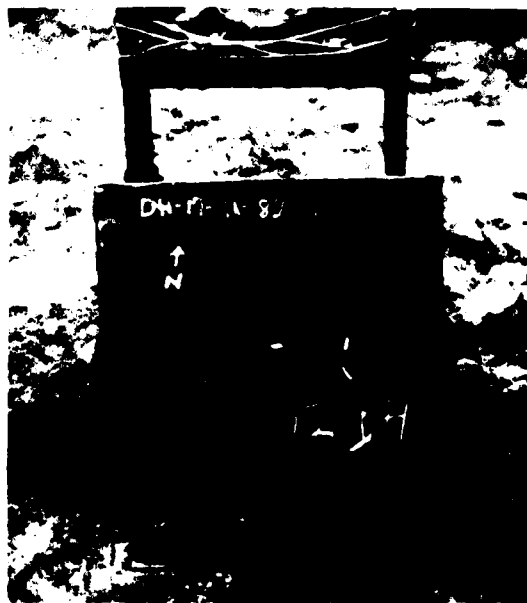
Figure B59: Steel Plate Response to 2 Inch Hemispherical Tup in Test Number 59

IMPACT SIDE

BOTTOM SIDE

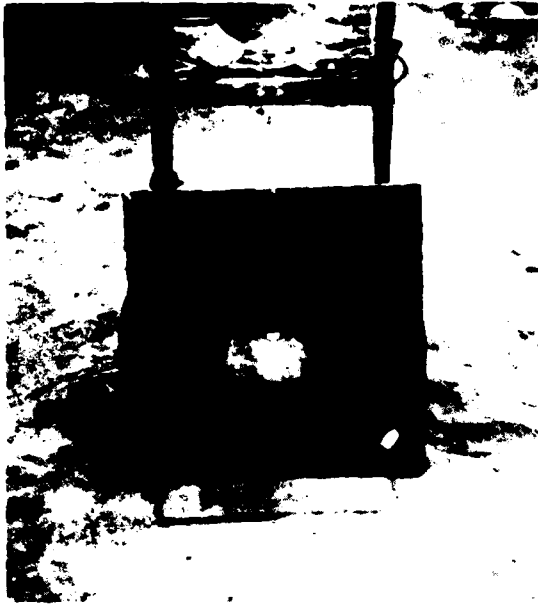
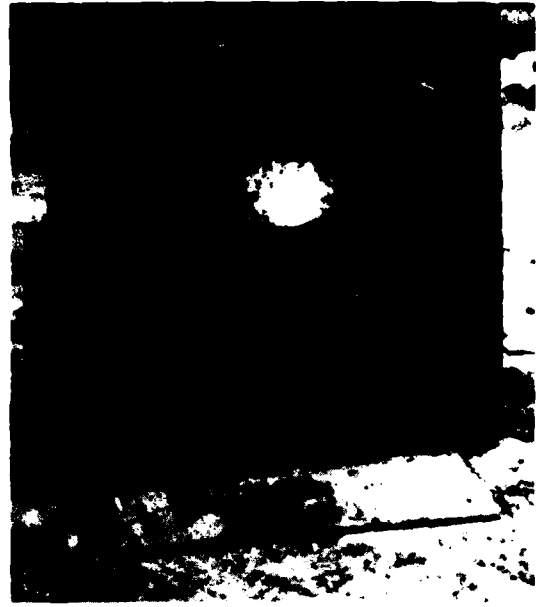
Figure B60: Steel Plate Response to 2 Inch Hemispherical Tup in Test Number 60

IMPACT SIDE

HEMISPHERICAL

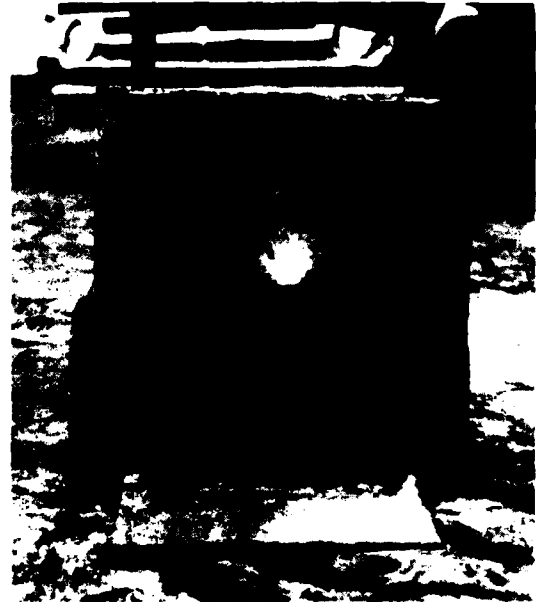
Figure B61: Steel Plate Response to 2 Inch Hemispherical Tup in Test Number 61

IMPACT SIDE

BOTTOM SIDE

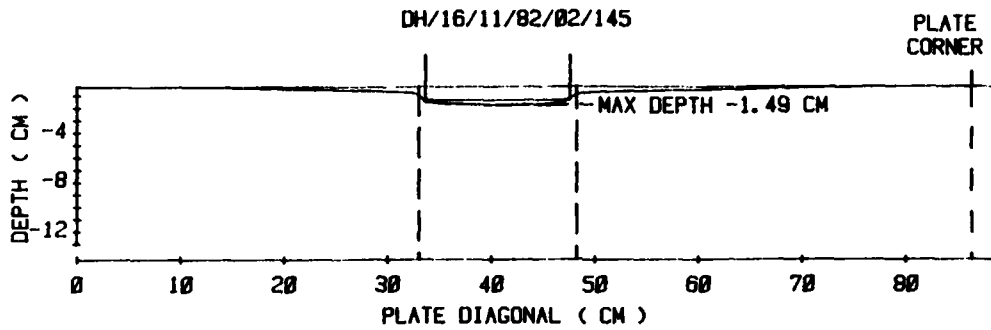
Figure C1: Dial Micrometer Measurements of Dent Depths for Test Number 1

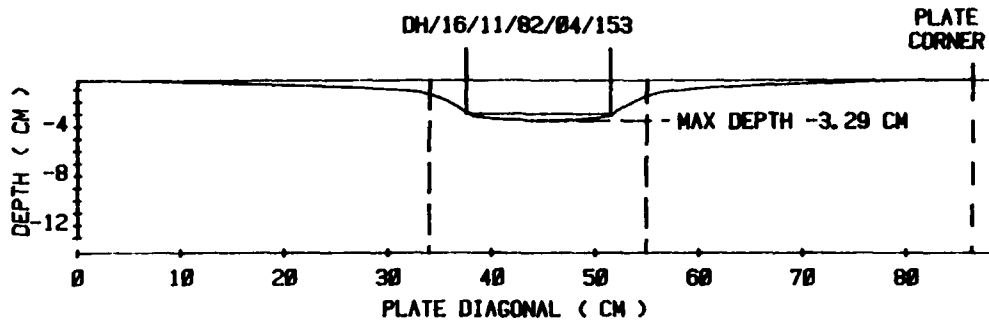
Figure C2: Dial Micrometer Measurements of Dent Depths for Test Number 4

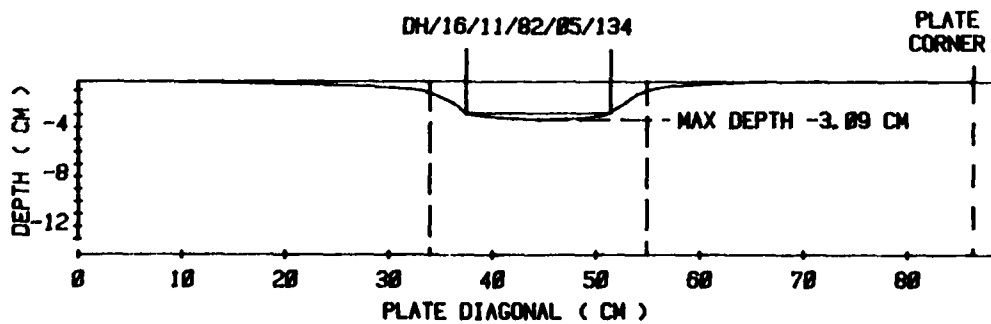
Figure C3: Dial Micrometer Measurements of Dent Depths for Test Number 5

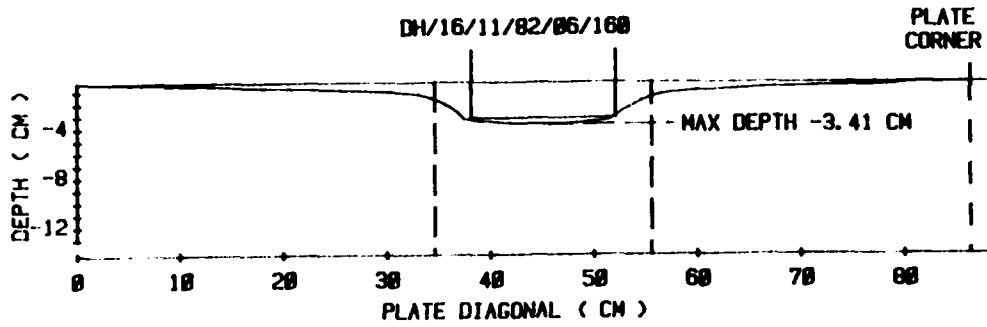
Figure C4: Dial Micrometer Measurements of Dent Depths for Test Number 6

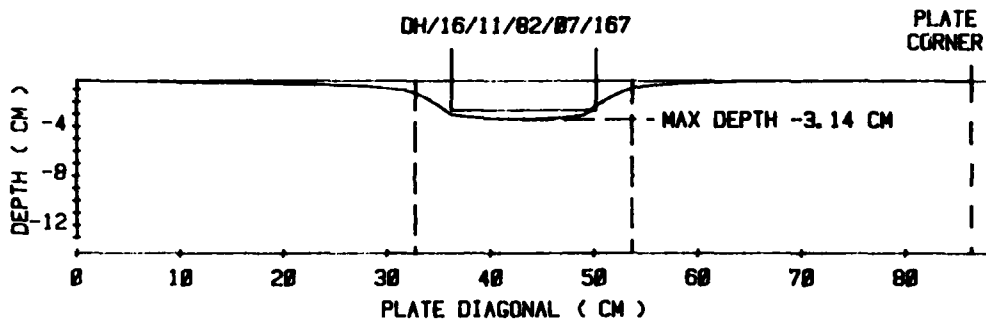
Figure C5: Dial Micrometer Measurements of Dent Depths for Test Number 7

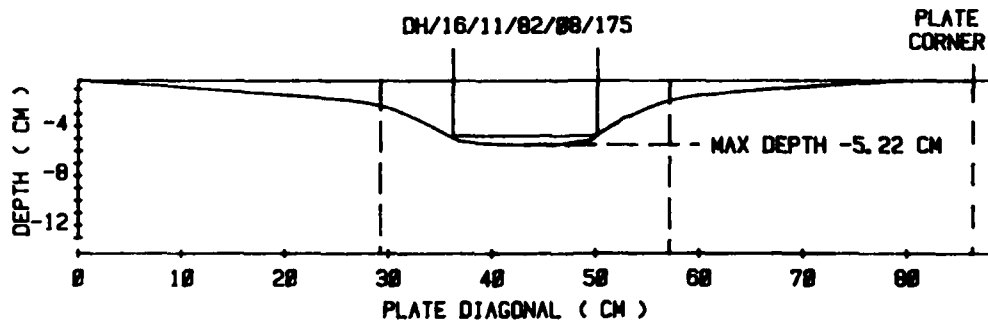
Figure C6: Dial Micrometer Measurements of Dent Depths for Test Number 8

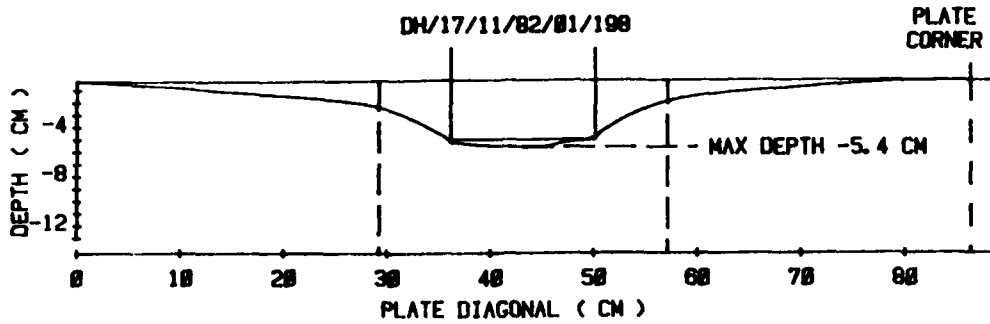
Figure C7: Dial Micrometer Measurements of Dent Depths for Test Number 9

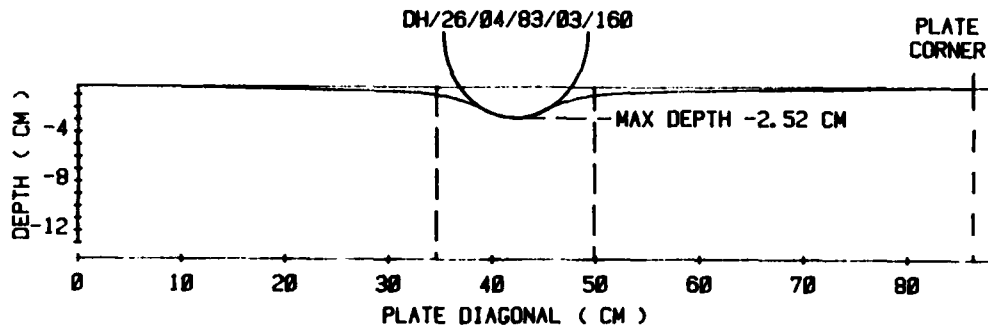
Figure C8: Dial Micrometer Measurements of Dent Depths for Test Number 10

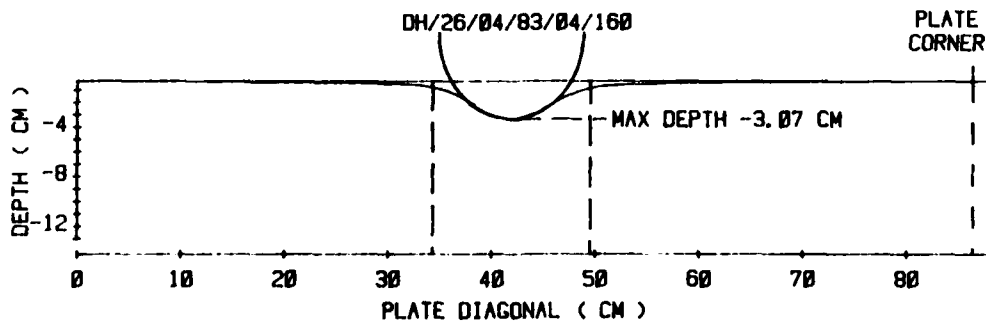
Figure C9: Dial Micrometer Measurements of Dent Depths for Test Number 11

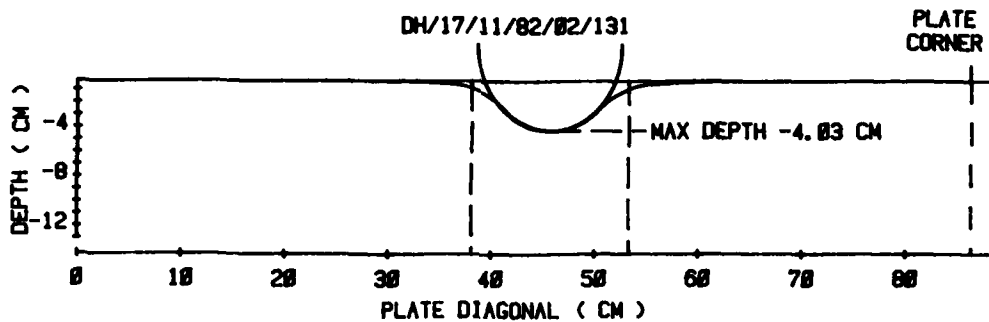
Figure C10: Dial Micrometer Measurements of Dent Depths for Test Number 12

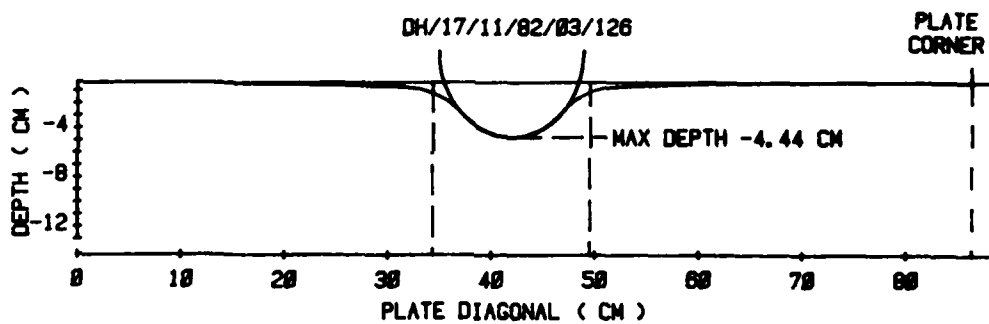
Figure C11: Dial Micrometer Measurements of Dent Depths for Test Number 13

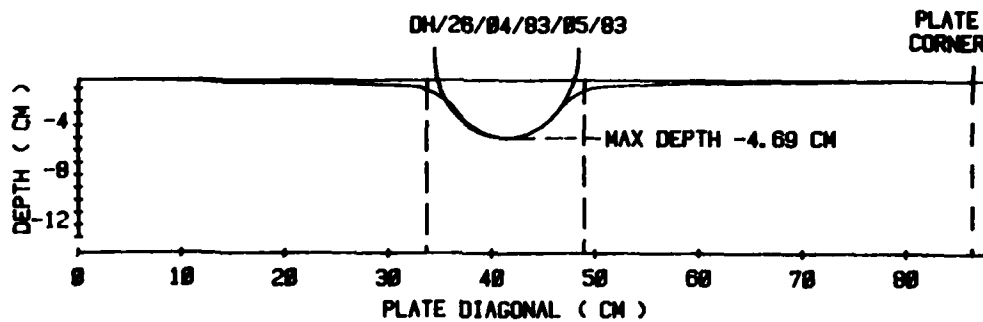
Figure C12: Dial Micrometer Measurements of Dent Depths for Test Number 14

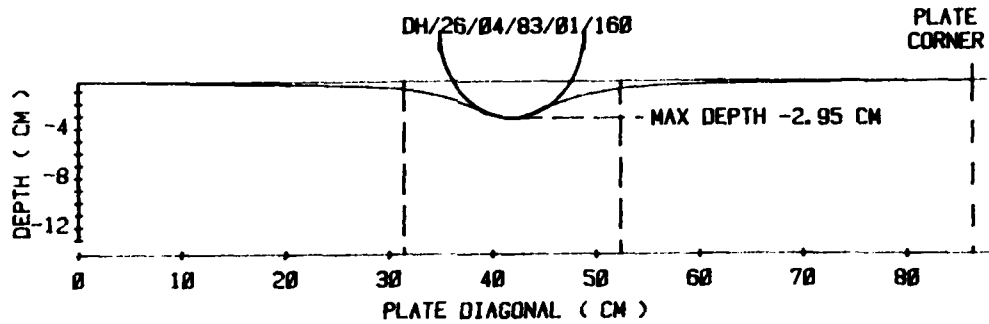
Figure C13: Dial Micrometer Measurements of Dent Depths for Test Number 16

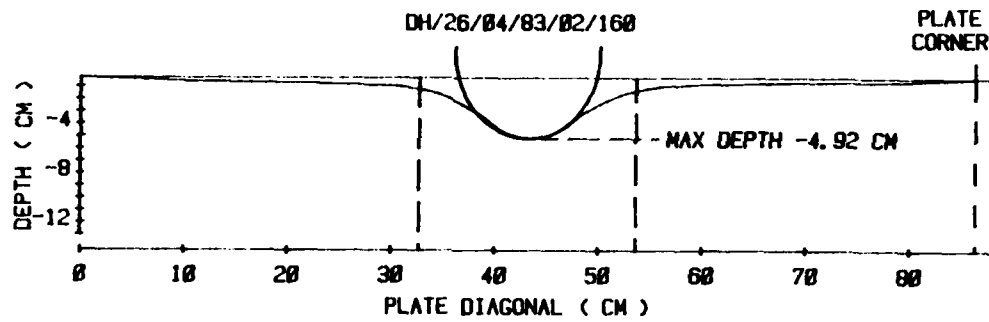
Figure C14: Dial Micrometer Measurements of Dent Depths for Test Number 17

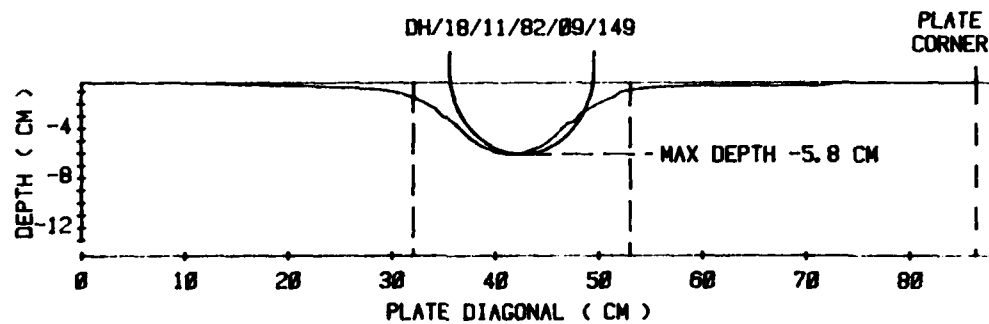
Figure C15: Dial Micrometer Measurements of Dent Depths for Test Number 18

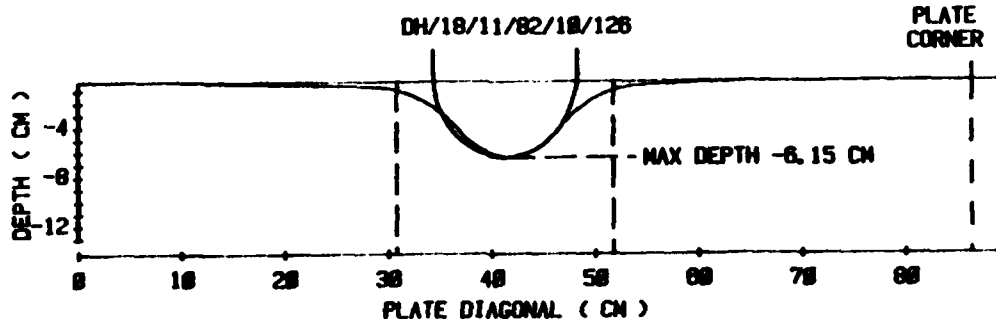
Figure C16: Dial Micrometer Measurements of Dent Depths for Test Number 19

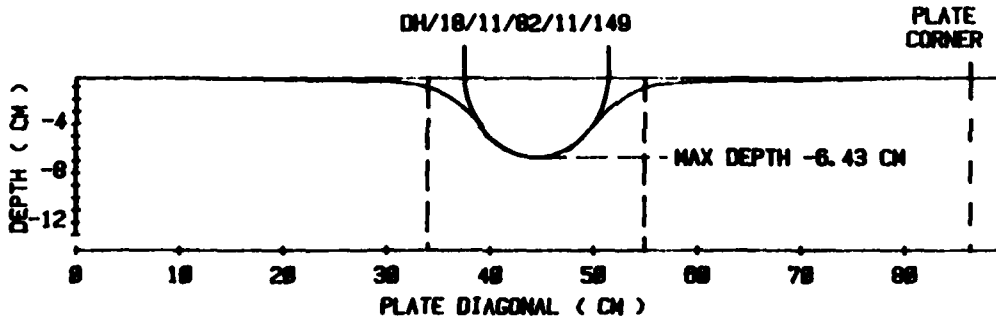
Figure C17: Dial Micrometer Measurements of Dent Depths for Test Number 20

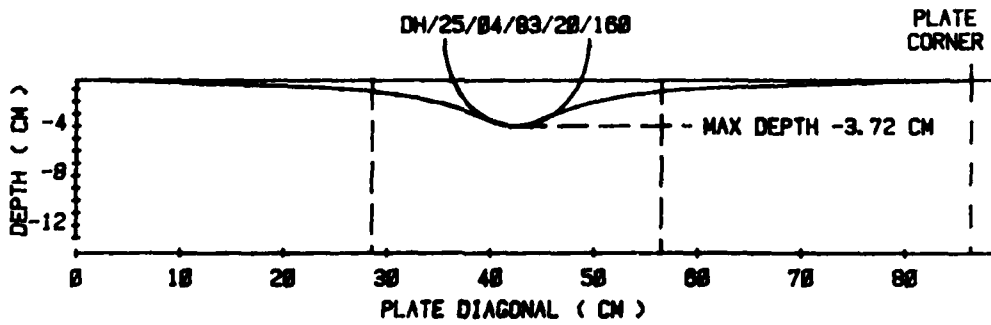
Figure C18: Dial Micrometer Measurements of Dent Depths for Test Number 22

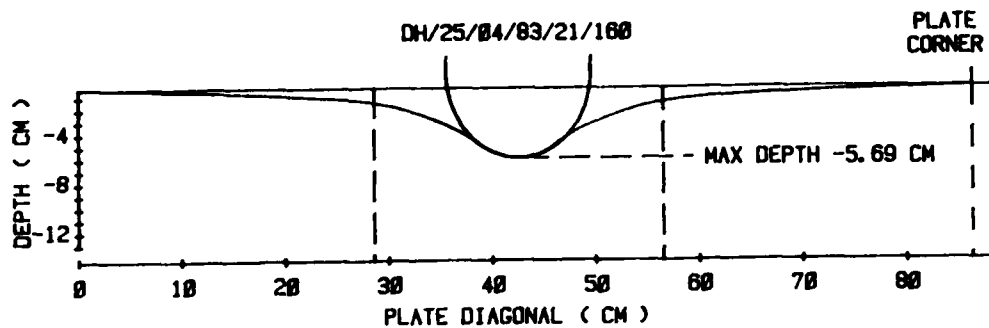
Figure C19: Dial Micrometer Measurements of Dent Depths for Test Number 23

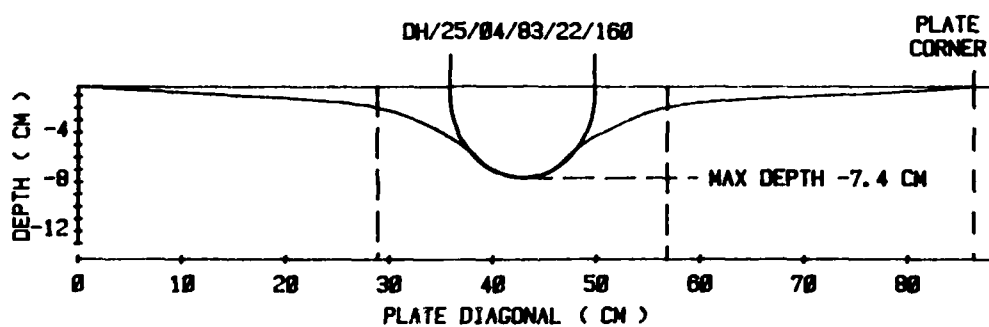
Figure C20: Dial Micrometer Measurements of Dent Depths for Test Number 24

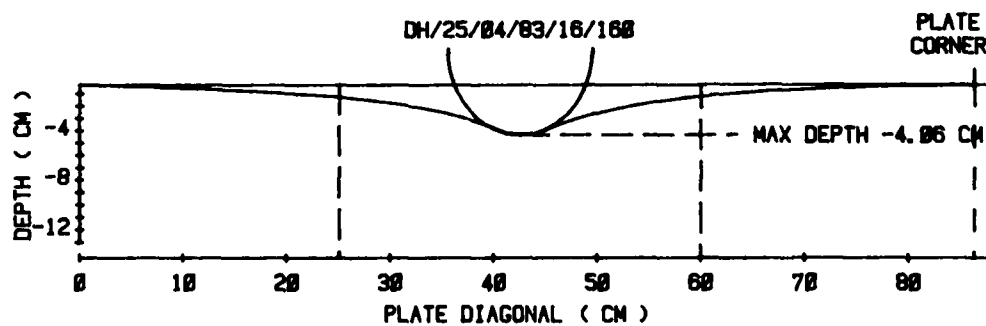
Figure C21: Dial Micrometer Measurements of Dent Depths for Test Number 26

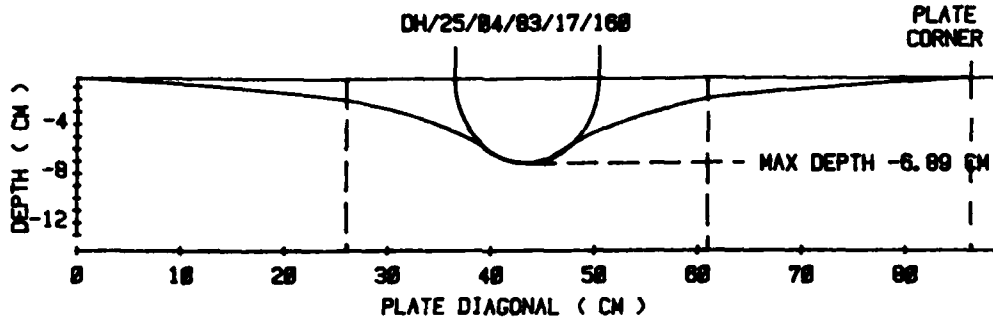
Figure C22: Dial Micrometer Measurements of Dent Depths for Test Number 27
