MEMORANDUM REPORT BRL-MR-3429

PHYSICAL RESPONSE OF FLAT STEEL
PLATES TO DROP HAMMER IMPACTS

January 1985

US ARMY BALLISTIC RESEARCH LABORATORY
ABERDEEN PROVING GROUND, MARYLAND

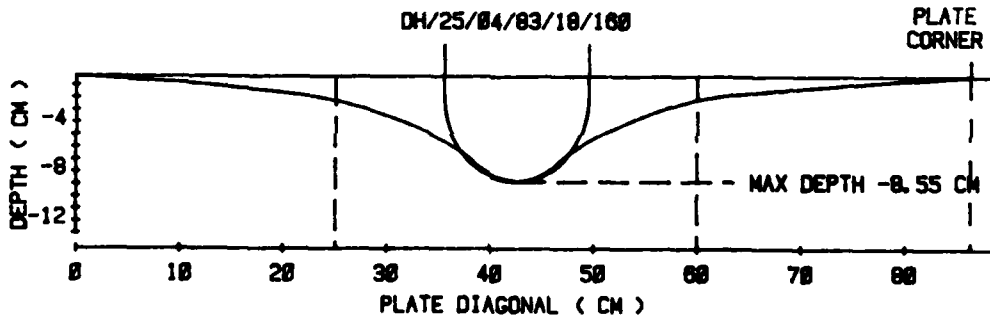
Figure C23: Dial Micrometer Measurements of Dent Depths for Test Number 28

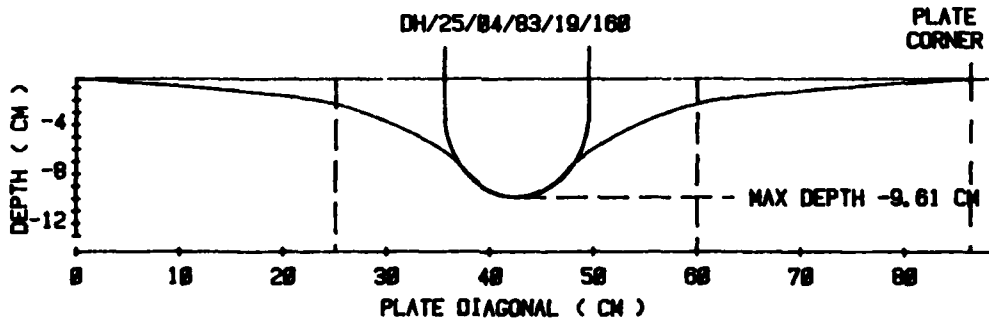
Figure C24: Dial Micrometer Measurements of Dent Depths for Test Number 29

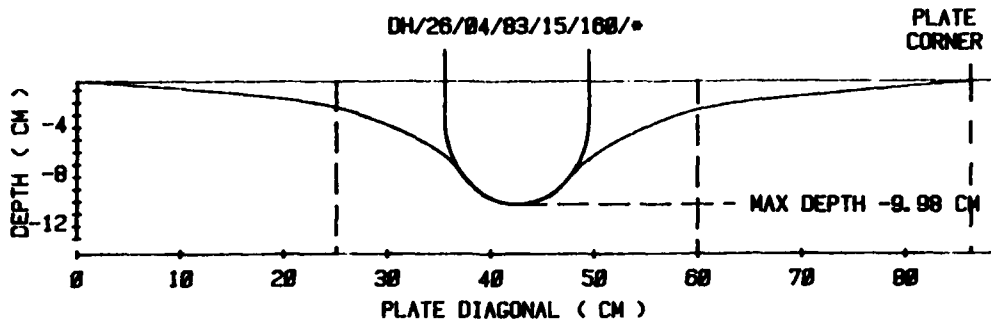
Figure C25: Dial Micrometer Measurements of Dent Depths for Test Number 30

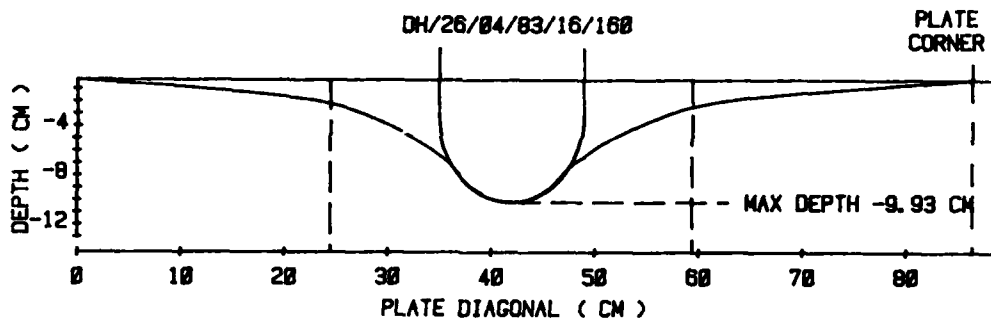
Figure C26: Dial Micrometer Measurements of Dent Depths for Test Number 31

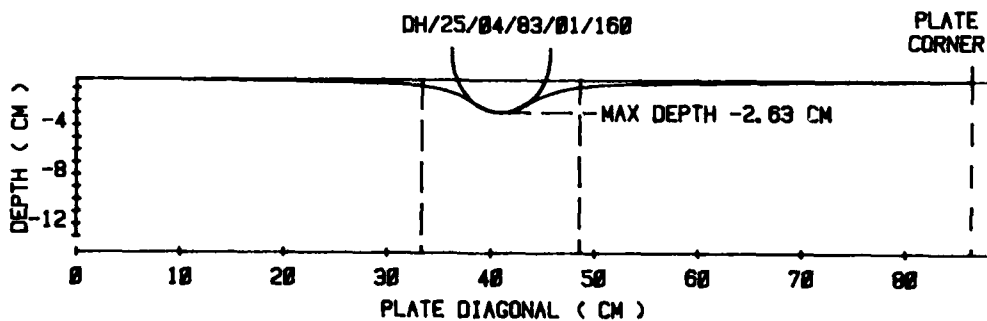
Figure C27: Dial Micrometer Measurements of Dent Depths for Test Number 34

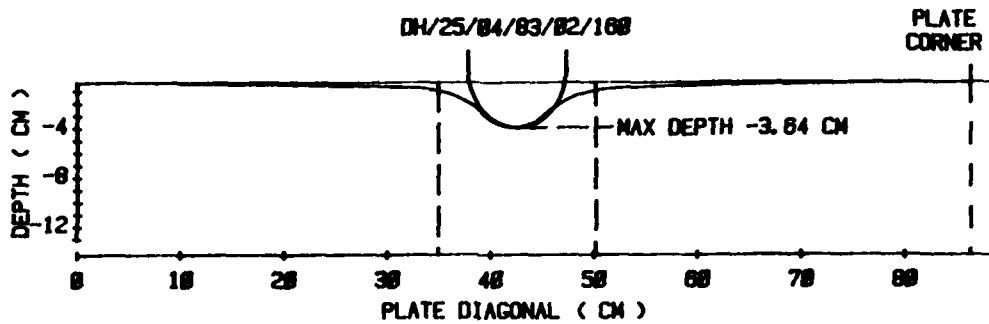
Figure C28: Dial Micrometer Measurements of Dent Depths for Test Number 35

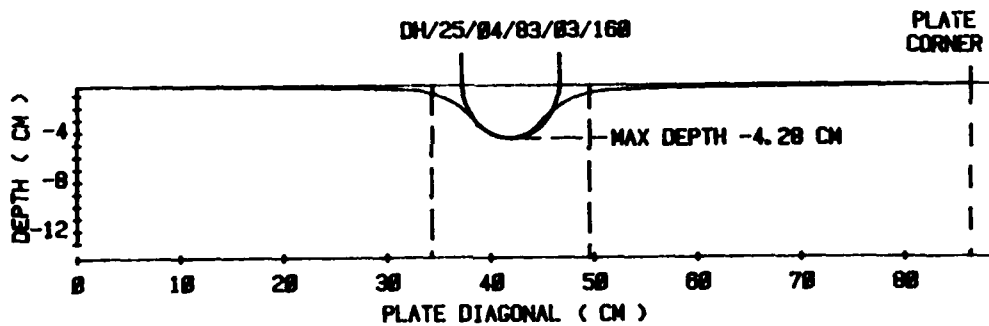
Figure C29: Dial Micrometer Measurements of Dent Depths for Test Number 36

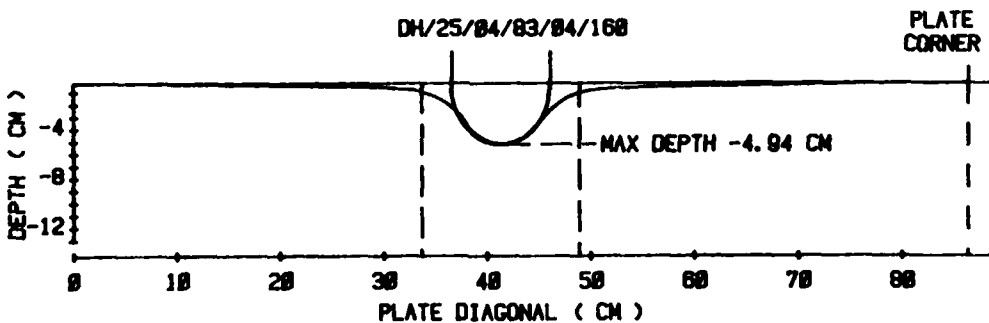
Figure C30: Dial Micrometer Measurements of Dent Depths for Test Number 37

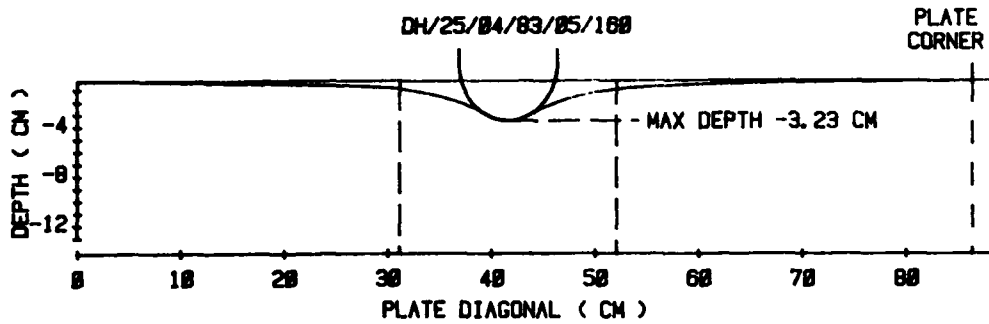
Figure C31: Dial Micrometer Measurements of Dent Depths for Test Number 38

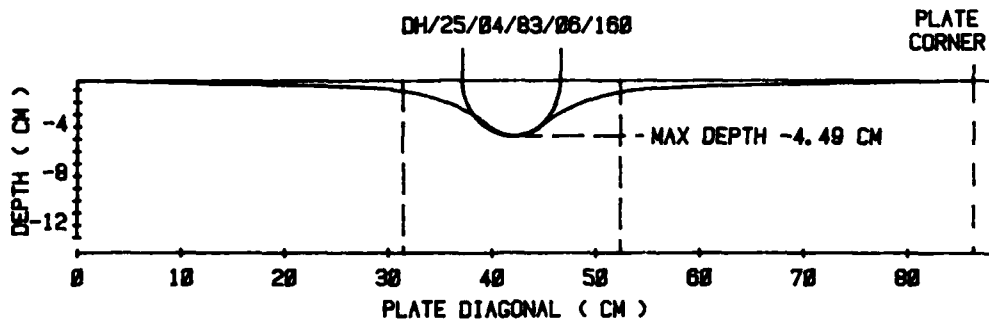
Figure C32: Dial Micrometer Measurements of Dent Depths for Test Number 39

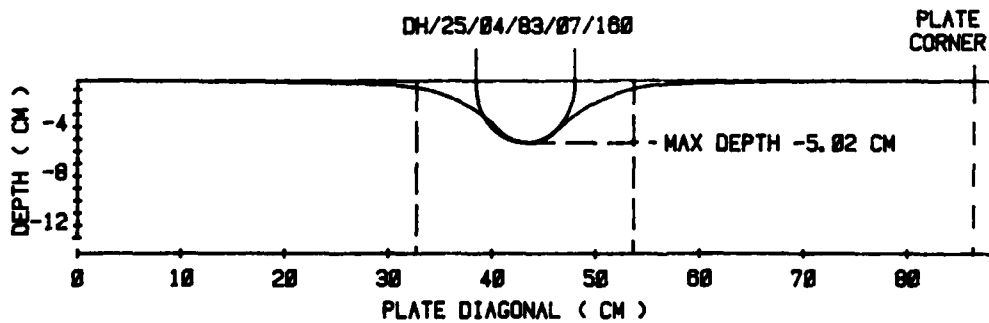
Figure C33: Dial Micrometer Measurements of Dent Depths for Test Number 40

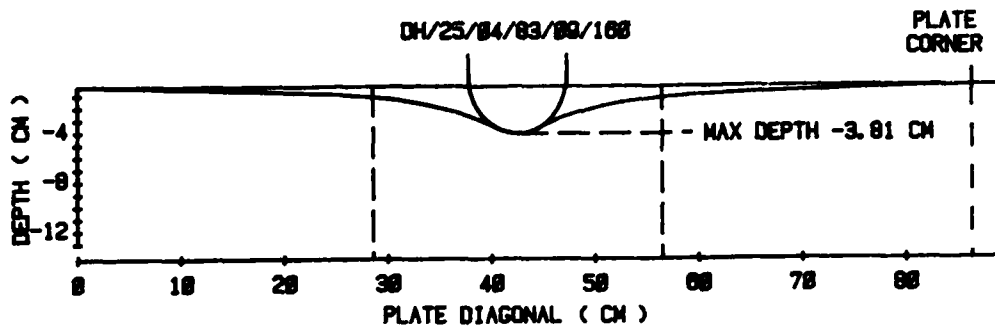
Figure C34: Dial Micrometer Measurements of Dent Depths for Test Number 42

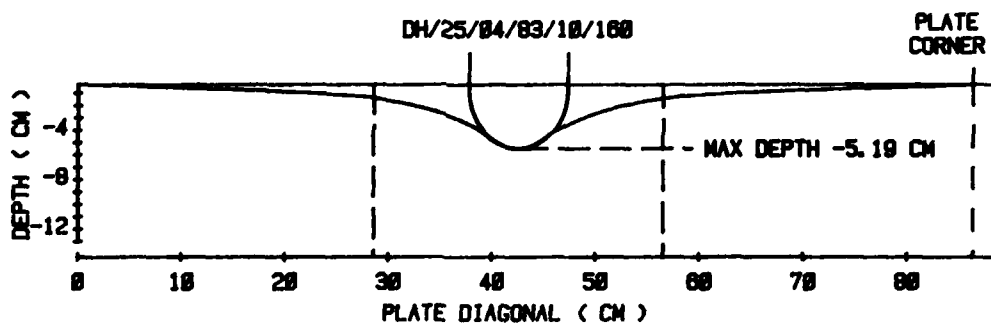
Figure C35: Dial Micrometer Measurements of Dent Depths for Test Number 43

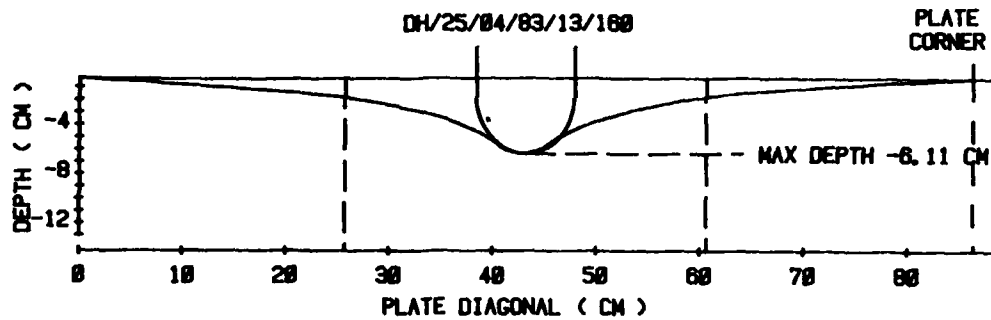
Figure C36: Dial Micrometer Measurements of Dent Depths for Test Number 45

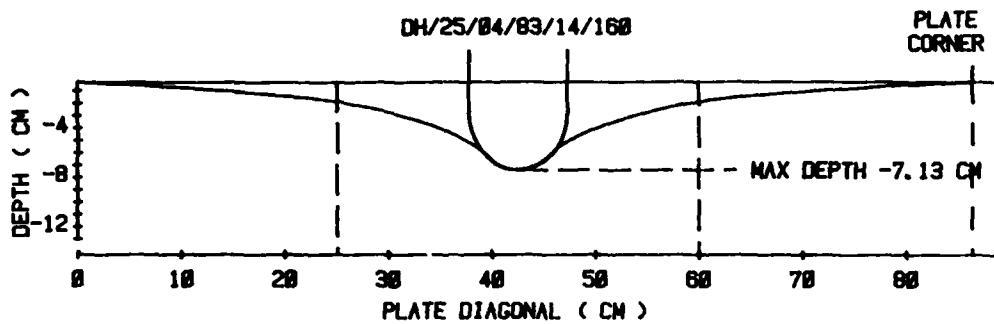
Figure C37: Dial Micrometer Measurements of Dent Depths for Test Number 46

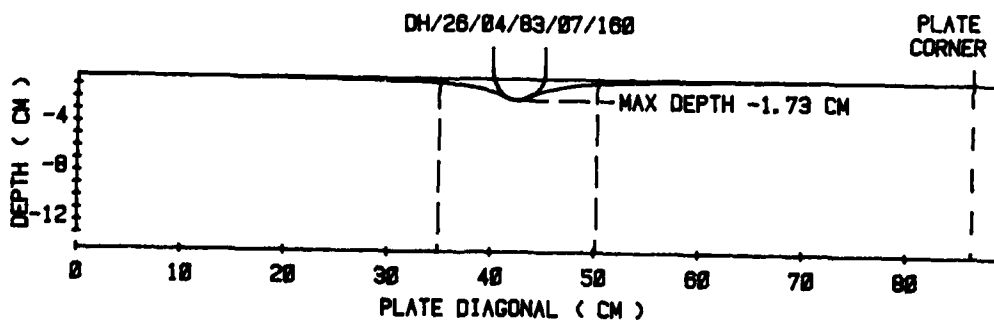
Figure C38: Dial Micrometer Measurements of Dent Depths for Test Number 47

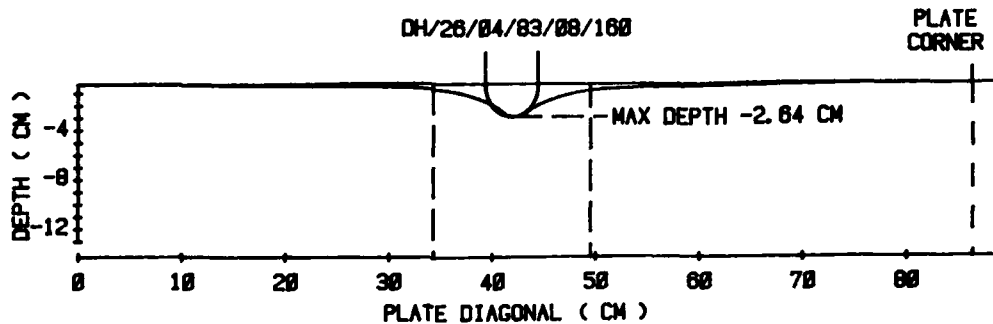
Figure C39: Dial Micrometer Measurements of Dent Depths for Test Number 49

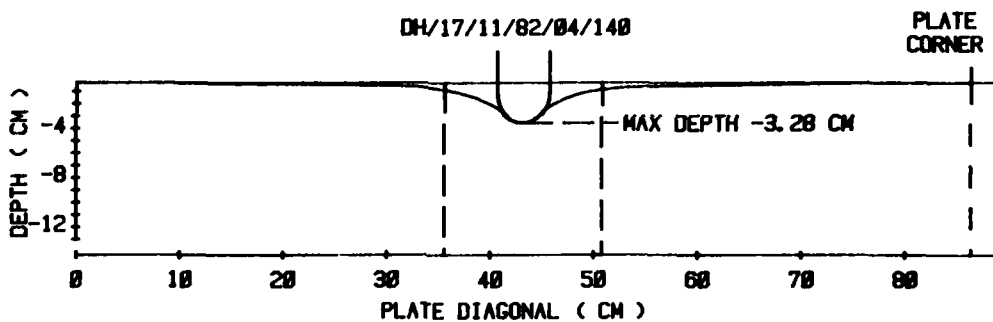
Figure C40: Dial Micrometer Measurements of Dent Depths for Test Number 50

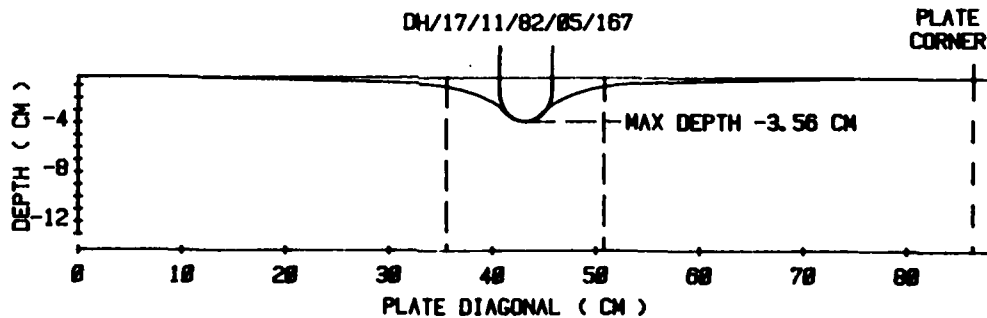
Figure C41: Dial Micrometer Measurements of Dent Depths for Test Number 51

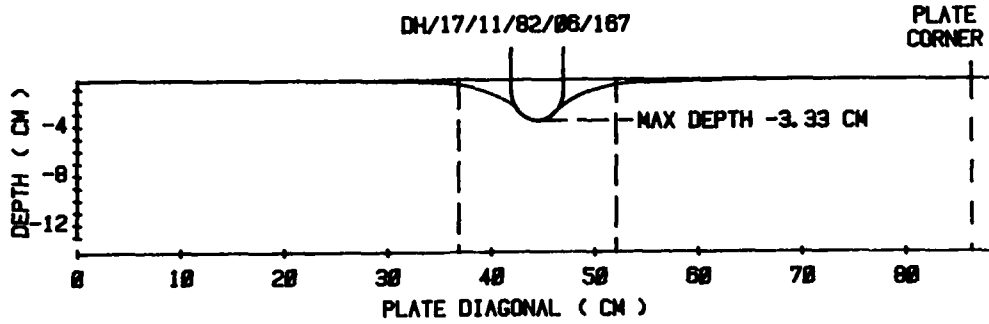
Figure C42: Dial Micrometer Measurements of Dent Depths for Test Number 52

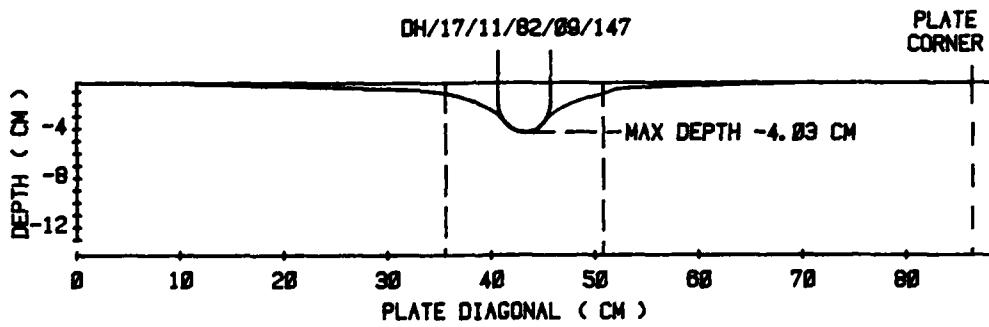
Figure C43: Dial Micrometer Measurements of Dent Depths for Test Number 53

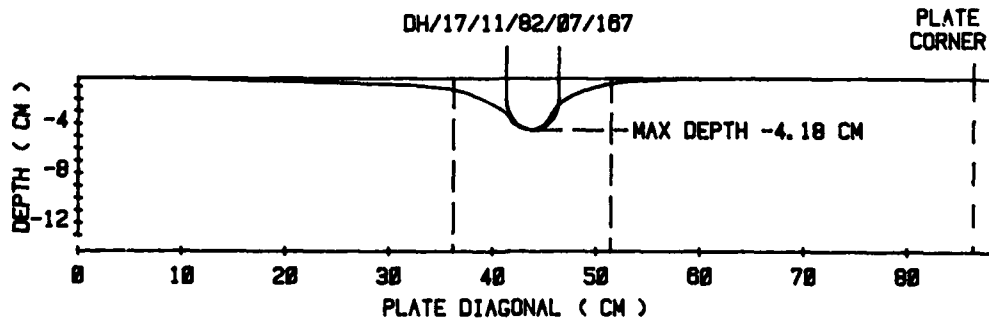
Figure C44: Dial Micrometer Measurements of Dent Depths for Test Number 54

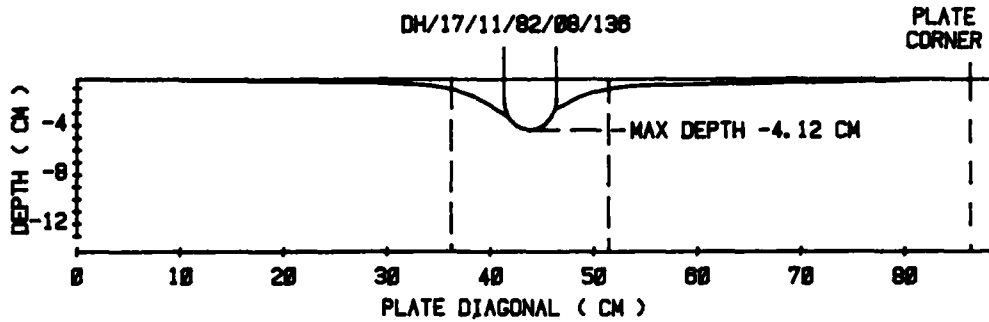
Figure C45: Dial Micrometer Measurements of Dent Depths for Test Number 55

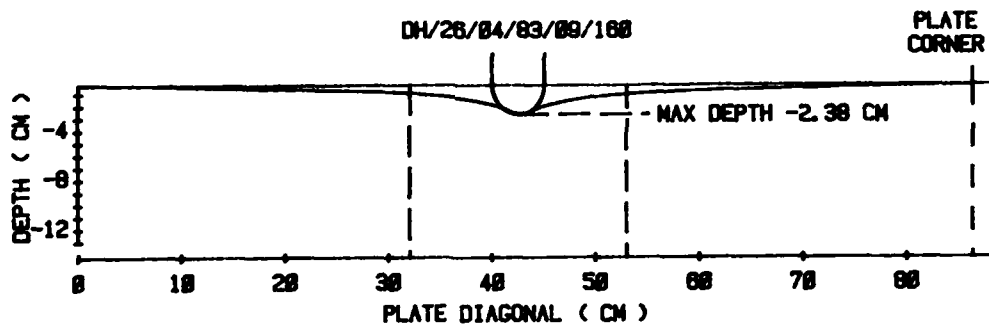
Figure C46: Dial Micrometer Measurements of Dent Depths for Test Number 56

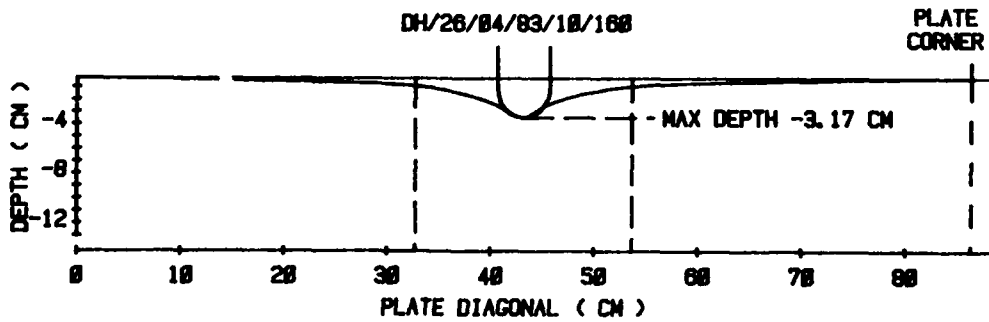
Figure C47: Dial Micrometer Measurements of Dent Depths for Test Number 57

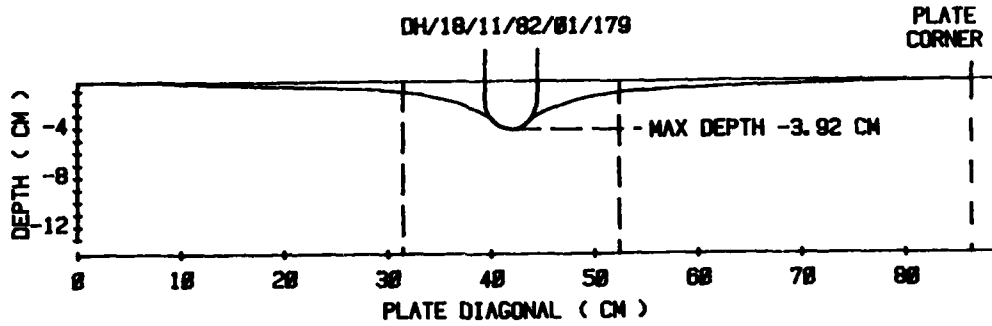
Figure C48: Dial Micrometer Measurements of Dent Depths for Test Number 58

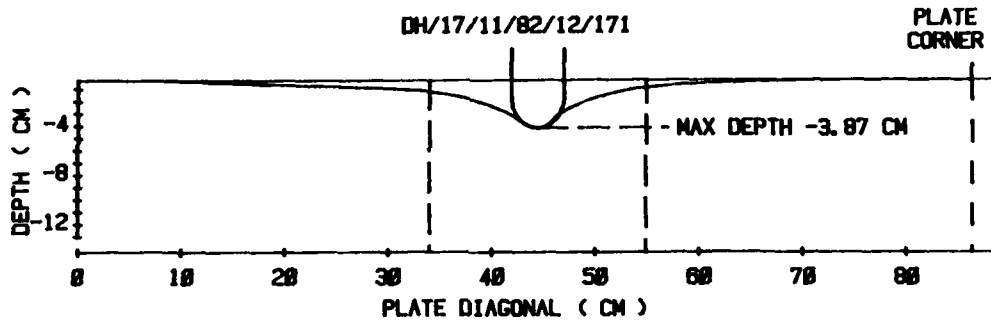
Figure C49: Dial Micrometer Measurements of Dent Depths for Test Number 59

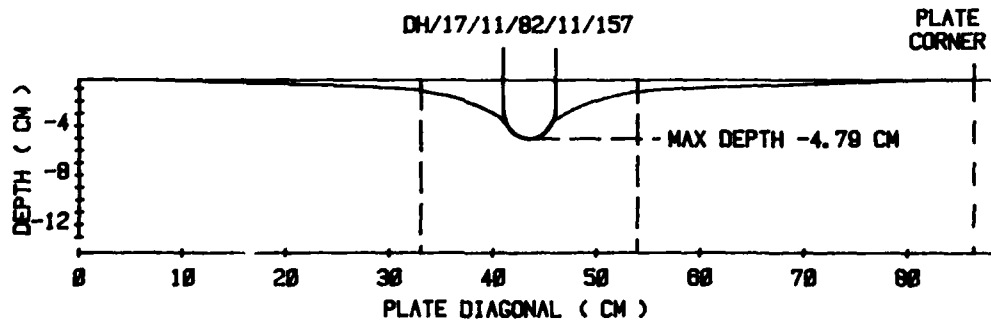
Figure C50: Dial Micrometer Measurements of Dent Depths for Test Number 60

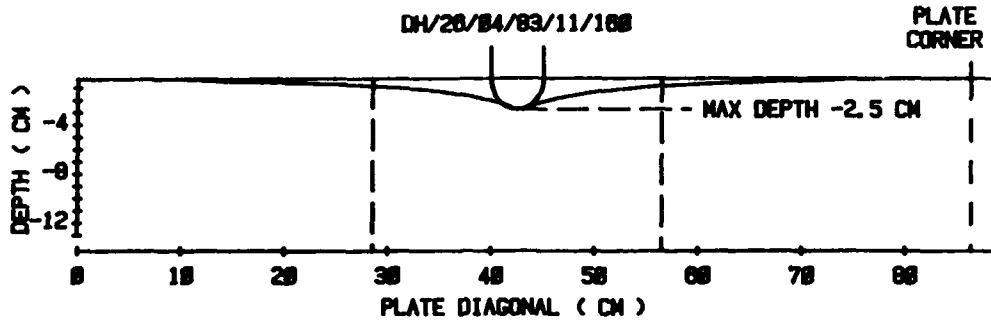
Figure C51: Dial Micrometer Measurements of Dent Depths for Test Number 61

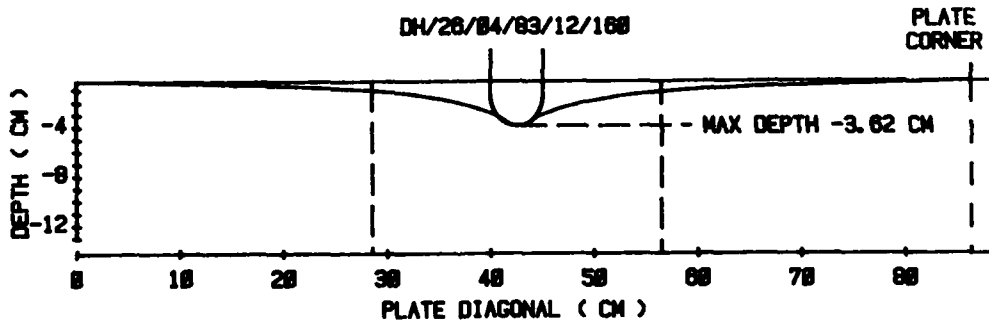
Figure C52: Dial Micrometer Measurements of Dent Depths for Test Number 63

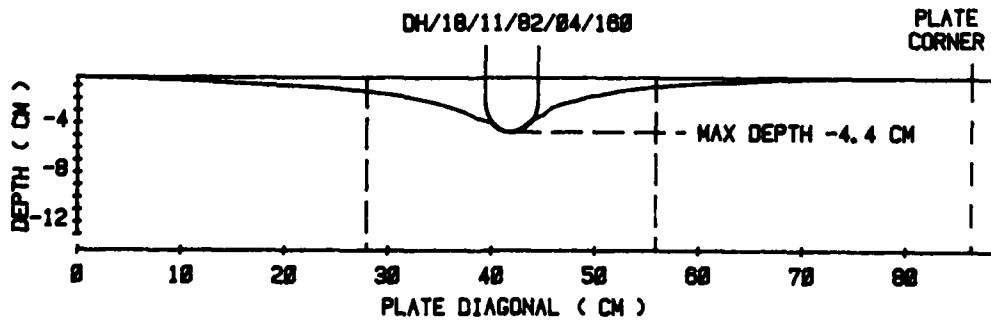
Figure C53: Dial Micrometer Measurements of Dent Depths for Test Number 64

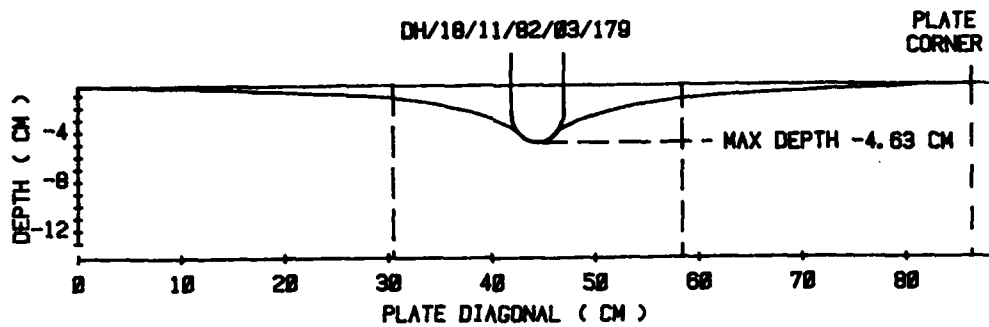
Figure C54: Dial Micrometer Measurements of Dent Depths for Test Number 65

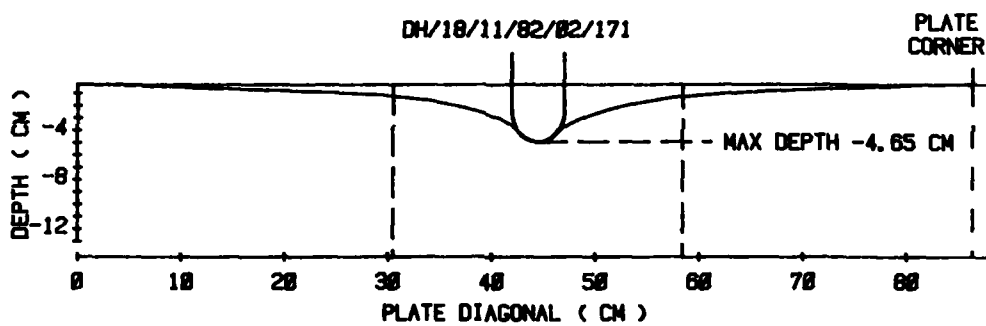
Figure C55: Dial Micrometer Measurements of Dent Depths for Test Number 66

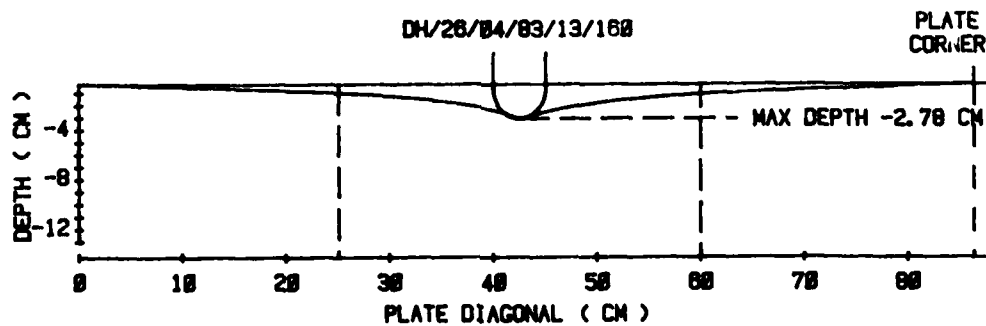
Figure C56: Dial Micrometer Measurements of Dent Depths for Test Number 67

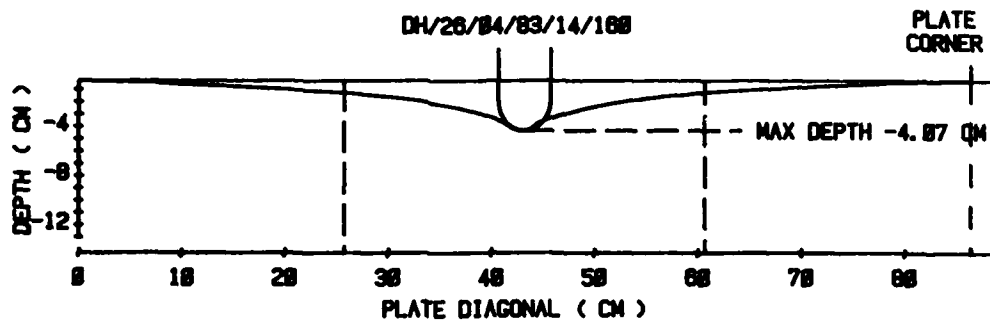
Figure C57: Dial Micrometer Measurements of Dent Depths for Test Number 68

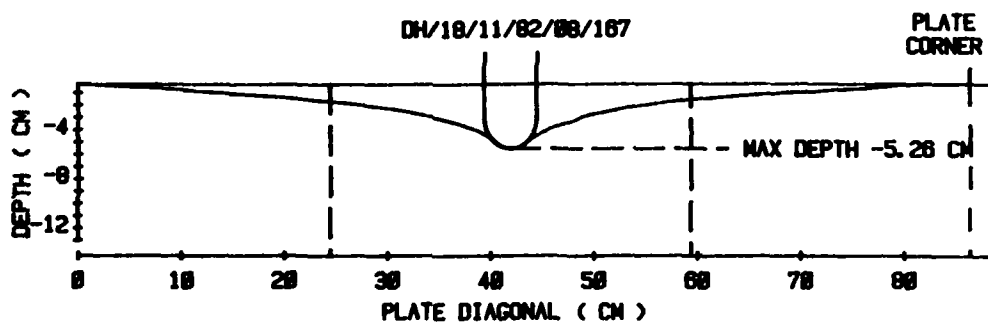
Figure C58: Dial Micrometer Measurements of Dent Depths for Test Number 69

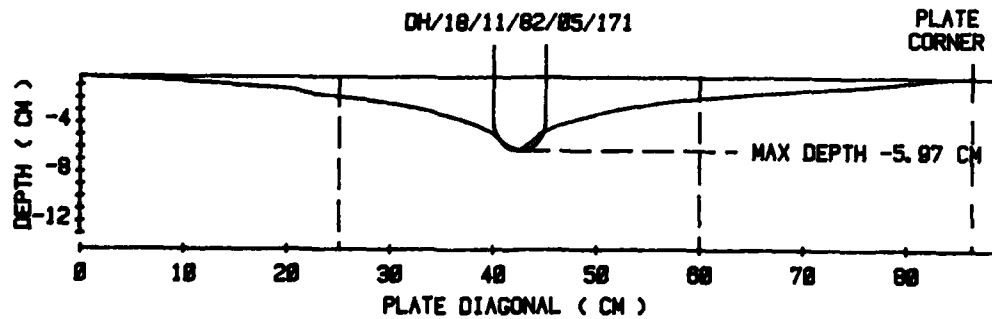
Figure C59: Dial Micrometer Measurements of Dent Depths for Test Number 70

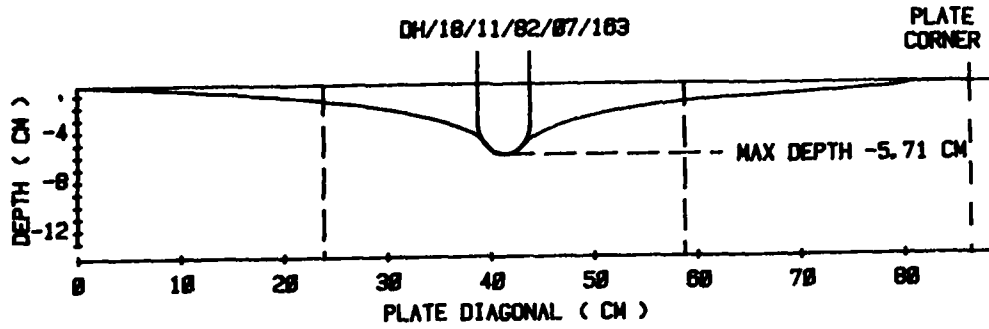
Figure C60: Dial Micrometer Measurements of Dent Depths for Test Number 71

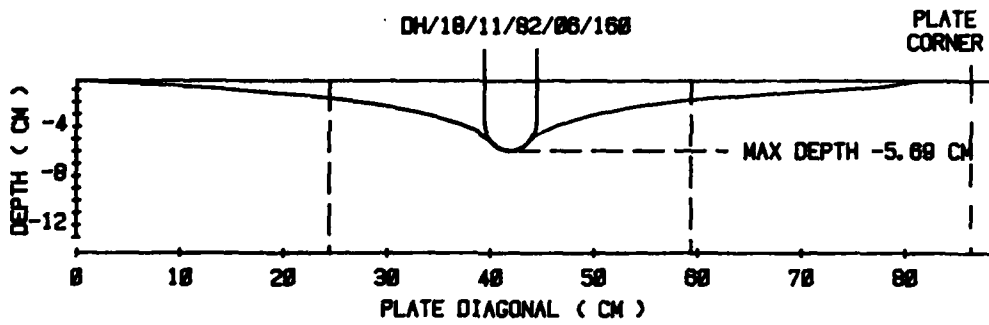
Figure C61: Dial Micrometer Measurements of Dent Depths for Test Number 72
