CERL-SR-E-85/06

SPECIAL REPORT E-85/06
March 1985

**HEAT RECOVERY INCINERATION:
A SUMMARY OF OPERATIONAL EXPERIENCE**

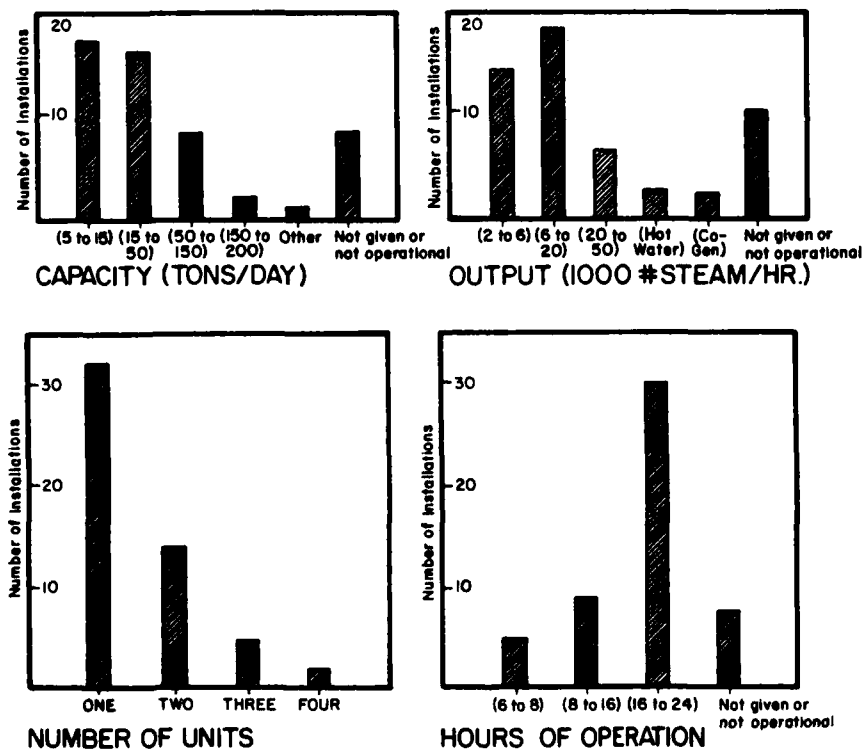
Figure 1. Description of installations.

a. Capacity, production, units, and hours of operation.

Figure 1 describes the physical plants included in this study. The figure determines the equipment, the basic operating parameters, and certain economic factors for the sites evaluated.

Figure 1a plots the number of installations within a given range of incinerator capacity (tpd), output production (pounds of steam per hour), number of units, and hours of operation per day. Figure 1b summarizes these same sites by boiler type and the type of waste burned. Figure 1c shows the initial project cost, yearly operational and maintenance budgets, number of plant personnel, and years of operation (since 1983).

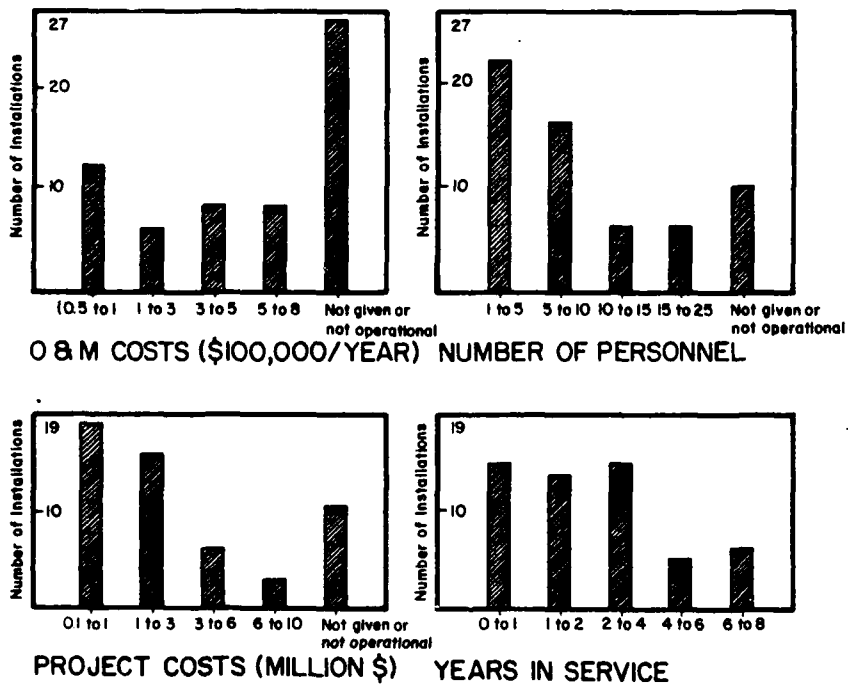
Figure 1. (Continued)

c. Initial project cost, yearly O&M budgets, number of personnel, and years of operation.
