**ARCHAEOLOGICAL TESTING OF THE  
CONFEDERATE OBSTRUCTIONS. IMB28  
MOBILE HARBOR, ALABAMA**

PREPARED FOR:  
U. S. ARMY CORPS OF ENGINEERS,  
MOBILE DISTRICT

PREPARED BY:  
ESPEY, HUSTON AND ASSOCIATES, INC.  
AUSTIN, TEXAS

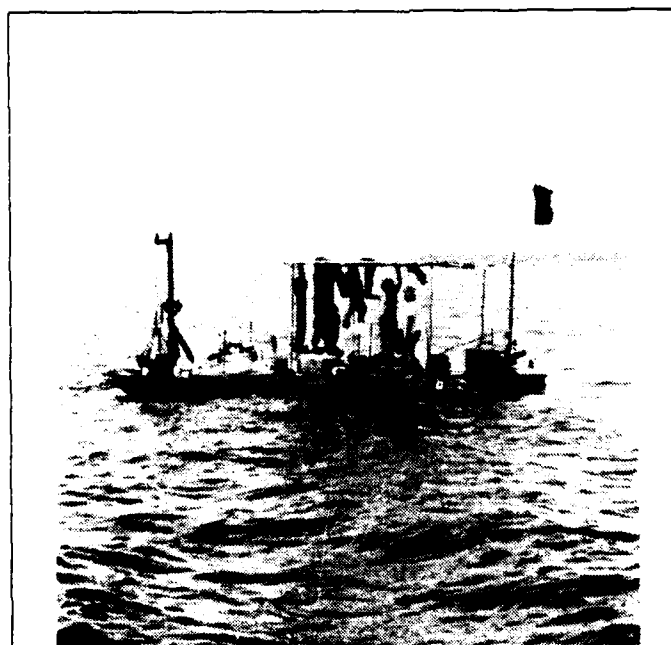
Figure 8  
PROJECT VESSELS

21ft. MonArk Crewboat

Dive Barge Anchored  
Over the Site

The major disadvantage to working in such shallow water lay in the limitation of the type of equipment which could be deployed over the site. Only vessels of shallow draft could reach the site, much less stay in position throughout the project (Fig. 8). Heavy, powered lifting equipment was precluded because the draft of the barge required to carry such equipment exceeded the depth of the water at low tide. As a result, all work had to be performed from a small, shallow-draft flat using a hand winch attached to a small davit. The necessity of this equipment is discussed in the following section. The crew boat used to reach the site was also required to be of shallow draft, although it was not entirely suited to the 3-foot (0.9-m) seas occasionally experienced in the bay. It was, however, a necessary compromise.

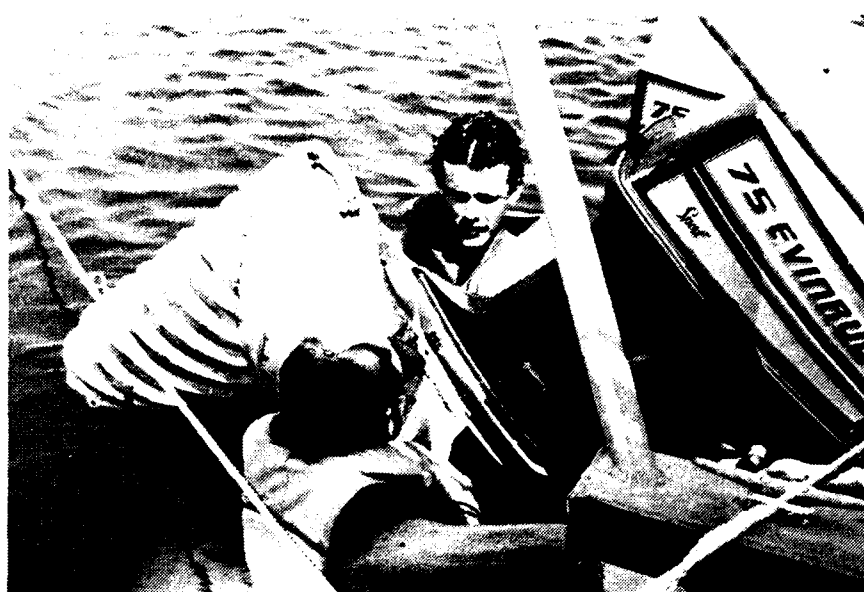
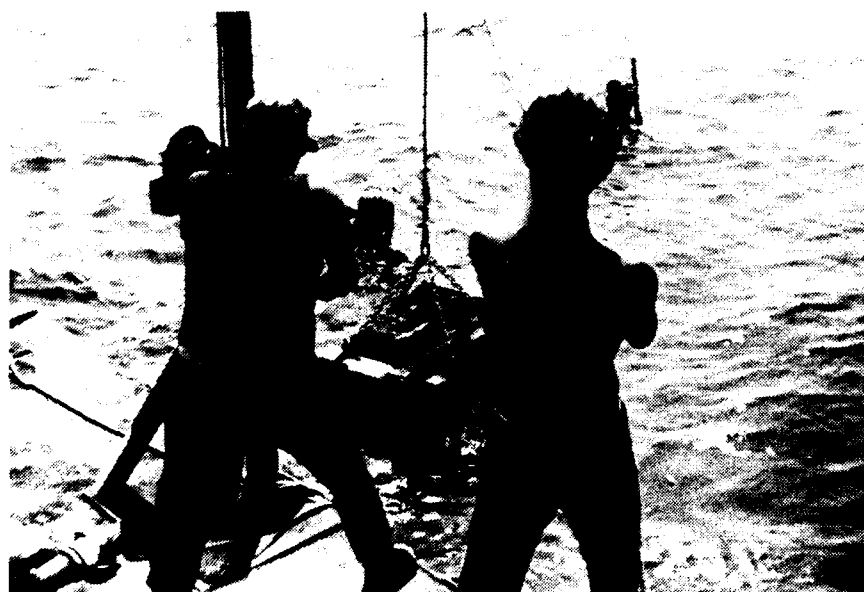
Figure II  
TECHNIQUES OF EXCAVATION

"A" Crew Members Preparing the Prop Wash for operation

"B" Hoisting Excavated Bricks to the surface

The silt overburden was first cleared from the trench using a prop wash deflector attached to a 75 hp outboard motor (Fig. 11A). Previous testing had indicated that the prop wash could remove the unconsolidated sediment without disturbing the cultural component underneath. By using the prop wash, the 1.5 ft (.45 m) of overburden was cleared from the trench in about two hours while causing virtually no damage to the structure of the ship or displacement of artifacts. During the course of the prop washing operation, the engine was periodically shut down and divers were dispatched to inspect the progress of the trench and to ensure that no damage to the ship had occurred.

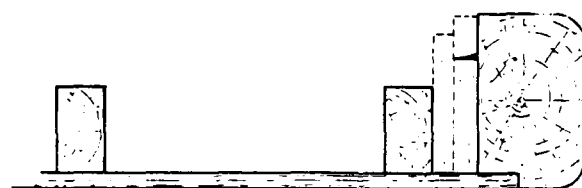
Figure 20

CROSS-SECTION

C-C'

D-D'

CROSS-SECTIONS OF STERN

Trench C was excavated in the stern section of the vessel. Approximately the last 5 ft (1.5 m) of the hull were exposed to the keelson (Fig. 19). An ancillary trench was excavated along the transom to the starboard side to determine the absolute width of this timber. The stern is flat and rectangular (Fig. 20). Although nothing remains above the heavy timber which forms the lowest strake of the transom, mortises cut into its upper face suggest that there was no rake to the stern. This timber is 1 ft (30 cm) wide, 14 in (36 cm) high and 20 ft 2 in (6.15 m) long. It is rabbeted at the two ends to receive the first side strake, which was held in place by an iron spike driven from the stern. The side strake no longer survives at this point in the hull. It was probably rabbeted to receive the last floor frame, which is separated from the transom timbers by a 5-in (12.7 cm) thick spacer. The next-to-the-last floor frame is dove-tailed like those in Trench A.
