TECHNICAL REPORT CERC-85-10

# WAVE STABILITY TESTS OF DOLOS AND STONE REHABILITATION DESIGNS FOR THE EAST BREAKWATER, CLEVELAND HARBOR, OHIO

Experimental Model Investigation

Coastal Engineering Research Center

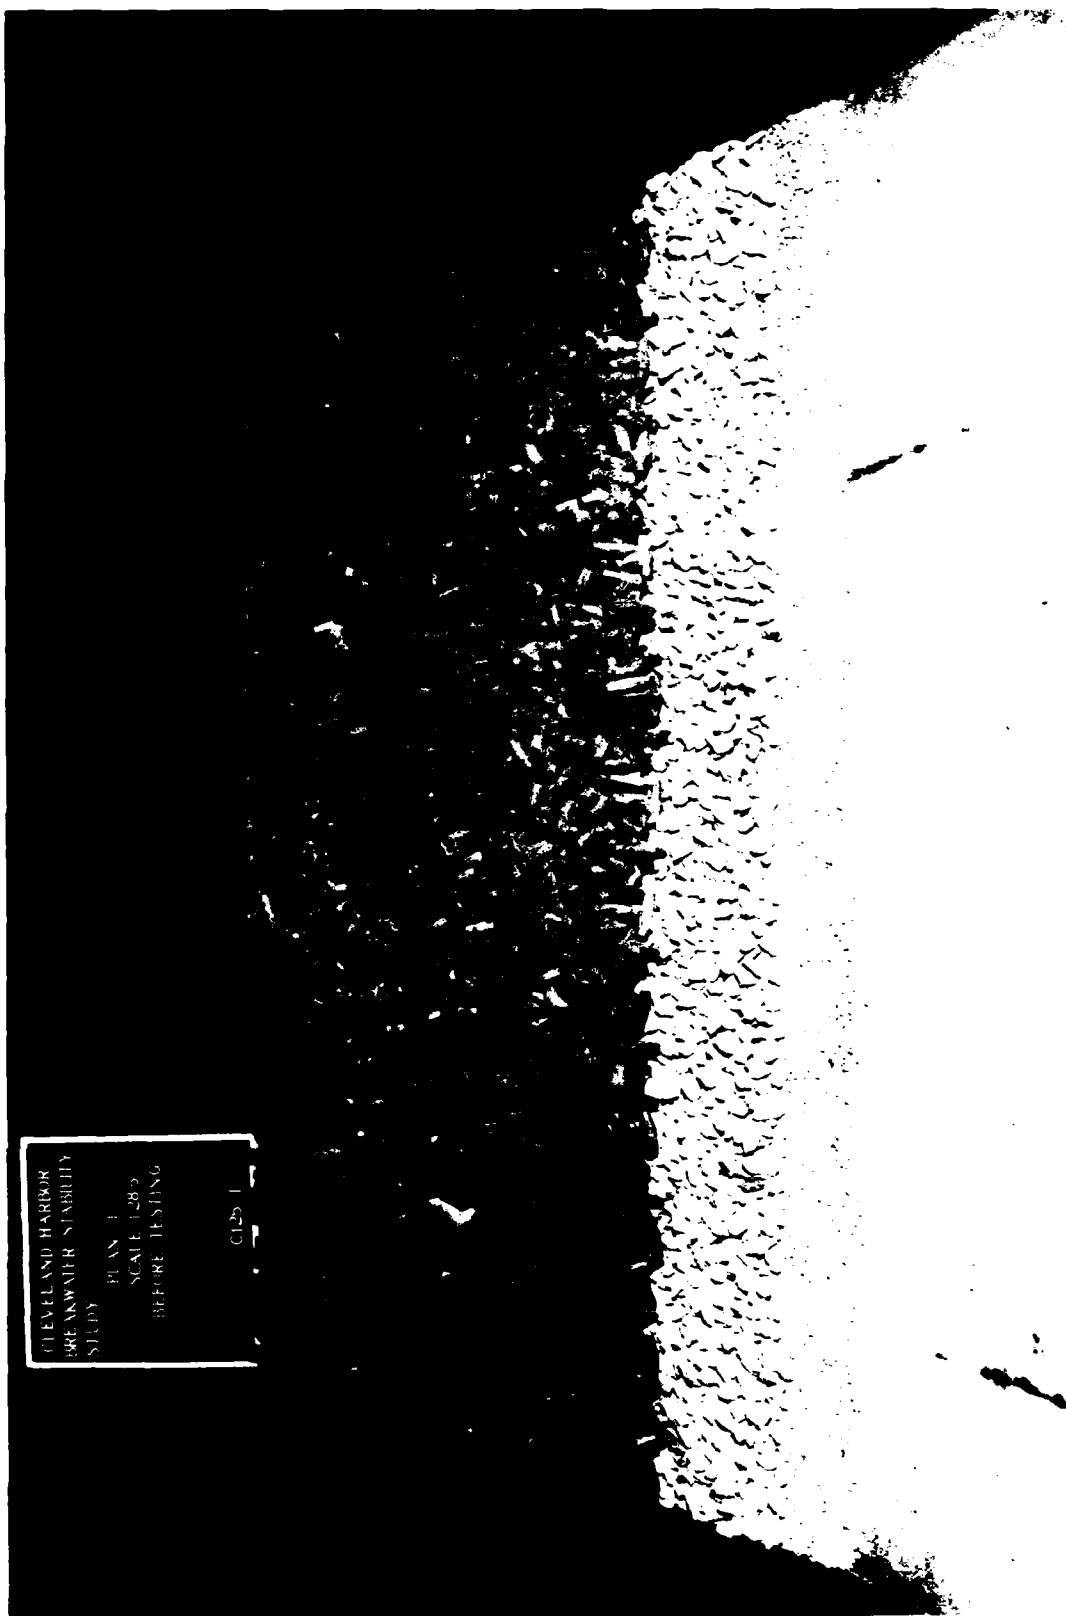
CLEVELAND HARBOR  
BREAKWATER STABILITY  
STUDY PLAN 1  
SCALE 1:285  
BEFORE TESTING  
CL25 1

Photo 1. Lakeside view of Plan 1 before testing, first test section

13. The proposed 4-ton dolos rehabilitation section (Plan 1, Plate 1 and Photos 1 and 2) was a two-layer system of randomly placed dolosse on a 1V-on-2H lakeside slope. The dolosse coverage extended from a 13-ft-wide crown (elevation +10.3 ft lwd) to a toe berm elevation of -22.0 ft lwd. Plan 1 was exposed to the wave and swl conditions of Hydrograph A (Table 1). During Step 1, minor to moderate rocking of several dolosse was observed around the swl and on the upper slope and crown. Two dolosse were displaced from the dolos crown area onto the old laid-up stone crown and one of these dolos then was displaced onto the harbor-side slope during a later cycle of Step 1. It also was noted that the combined upslope packing and downslope consolidation of the dolos armor around the swl created an area of dolos separation around the swl. In this area, the dolos armor porosity was much higher than other areas of the structure and the underlayer had become very visible but was showing no signs of movement. Four additional dolosse were displaced from the crown onto the harbor-side slope and one dolos originally placed below the swl was displaced down the lakeside slope during Step 2. The severity of dolos rocking and number of units rocking seemed to increase slightly at the start of this step, but appeared to decrease in severity by the end of Step 2. The wave conditions of Steps 1 and 2 produced moderate to significant overtopping while major overtopping was observed during Step 3 of Hydrograph A. It appeared that the 9-sec waves were not impacting as hard on the dolos, but that most of the wave energy was passing over the breakwater crown and was being dissipated on the harbor-side of the structure. No additional displacement occurred during this step and the amount of dolos rocking appeared to have decreased from that observed during the previous step. At the end of Hydrograph A, the dolos armor showed minor spot damage on the breakwater crown, slight localized damage on the lower lakeside slope, and moderate amounts of dolos reorientation around the swl (Photos 3 and 4). The dolos reorientation around the swl was the result of the upslope packing and downslope consolidation of dolosse that occurred during Step 1 and did not seem to increase in severity during Steps 2 and 3 of Hydrograph A.

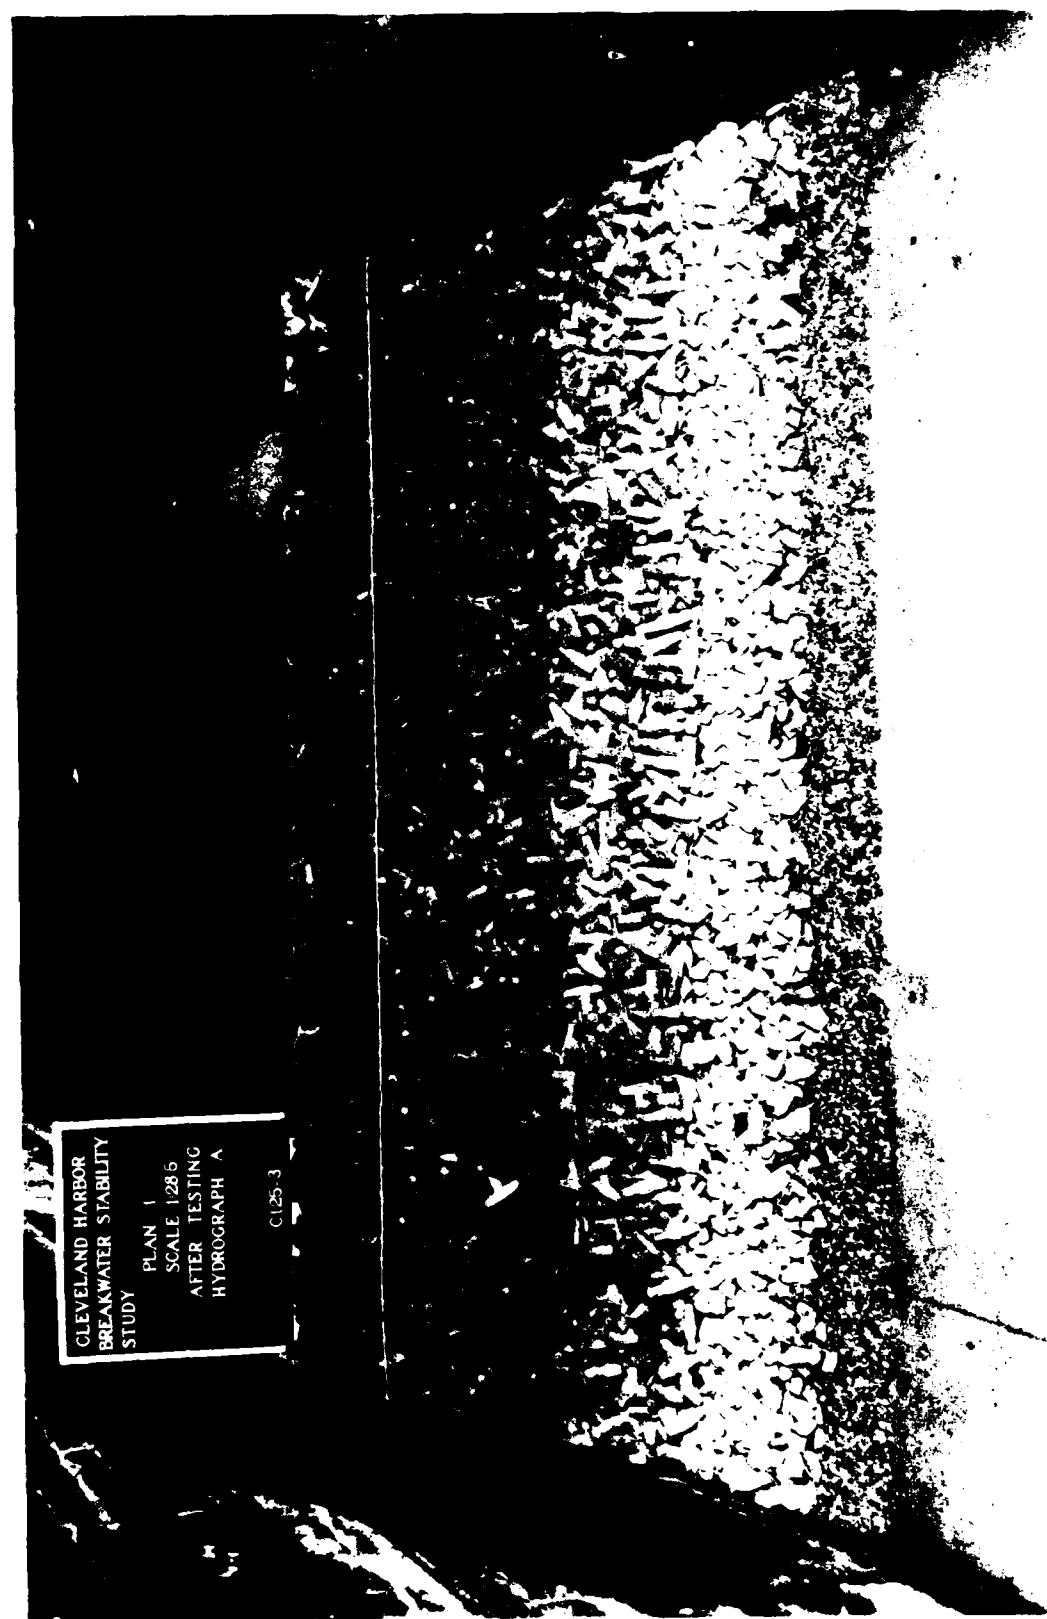
Photo 3. Lakeside view of Plan 1 after testing Hydrograph A, first test section

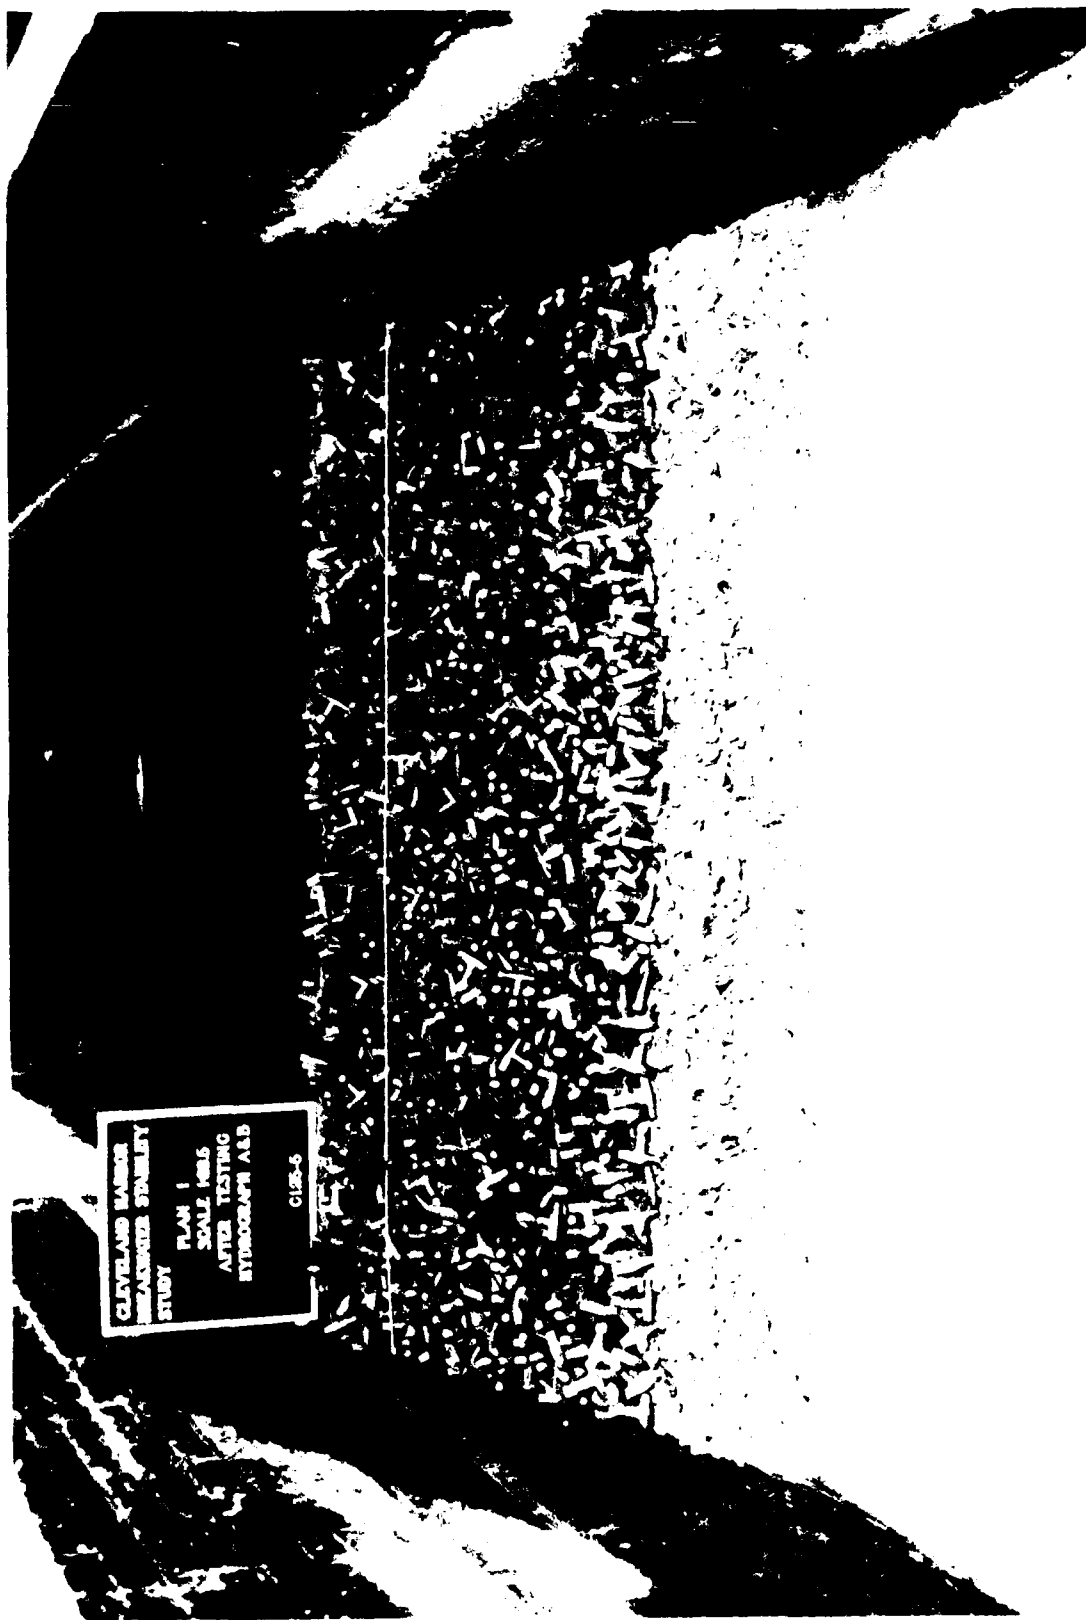
Photo 5. Lakeside view of Plan 1 after testing Hydrographs A and B, first test section

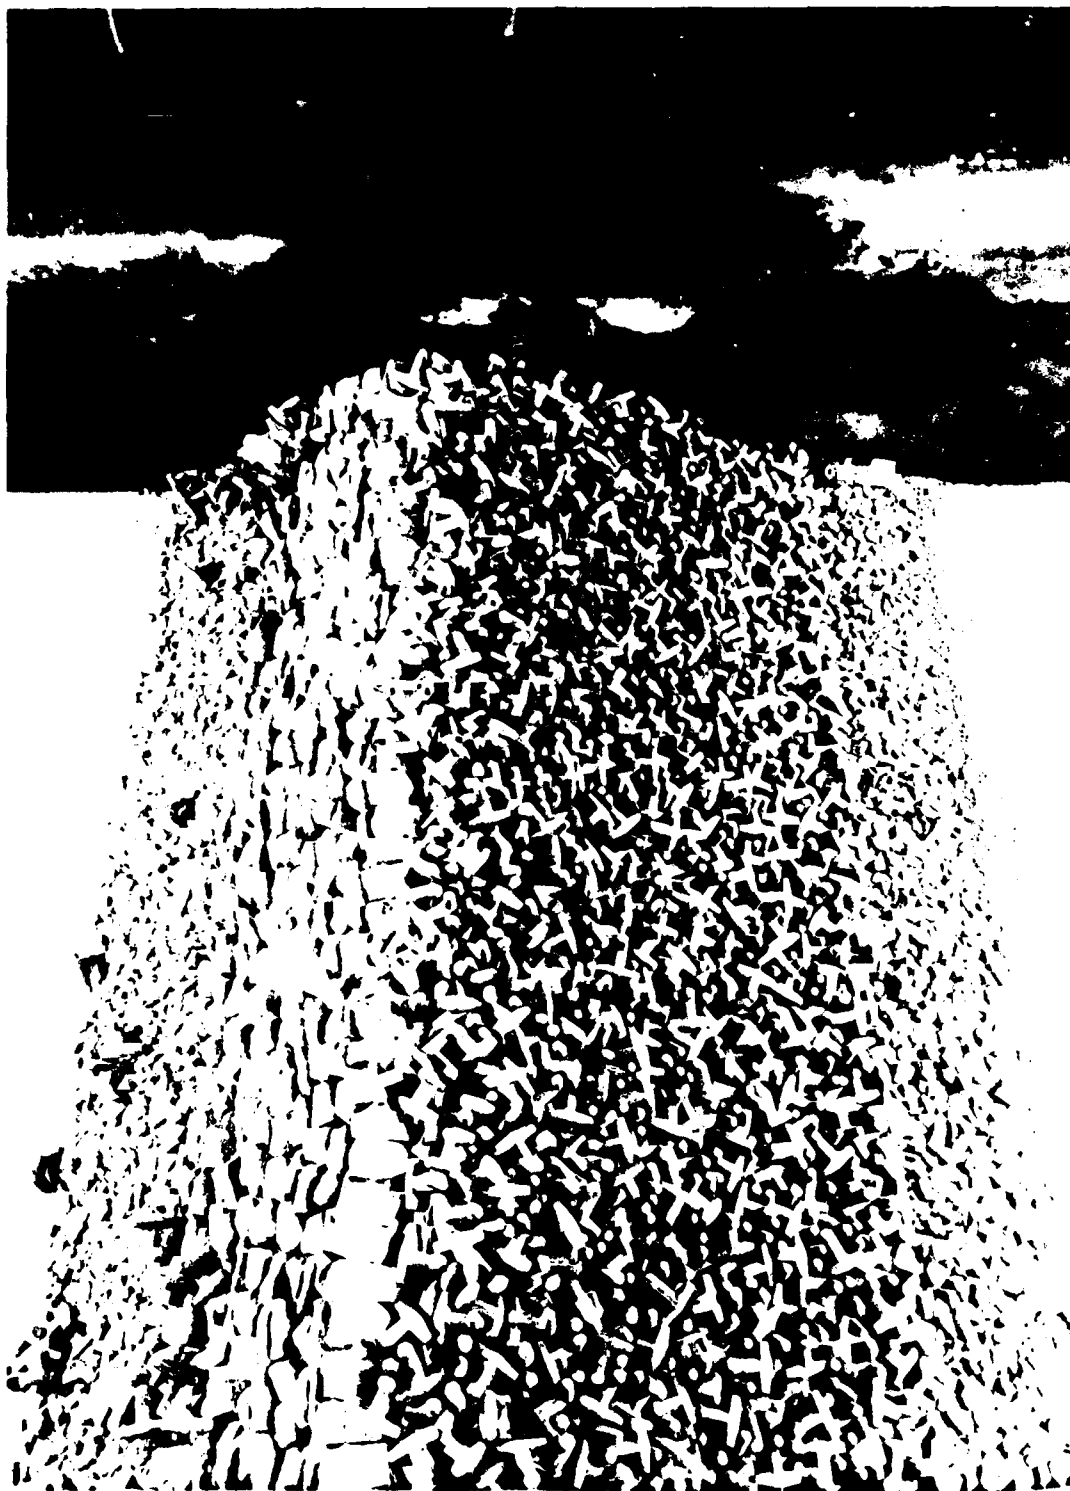
Photo 6. Overhead view of Plan 1 after testing Hydrographs A and B, first test section

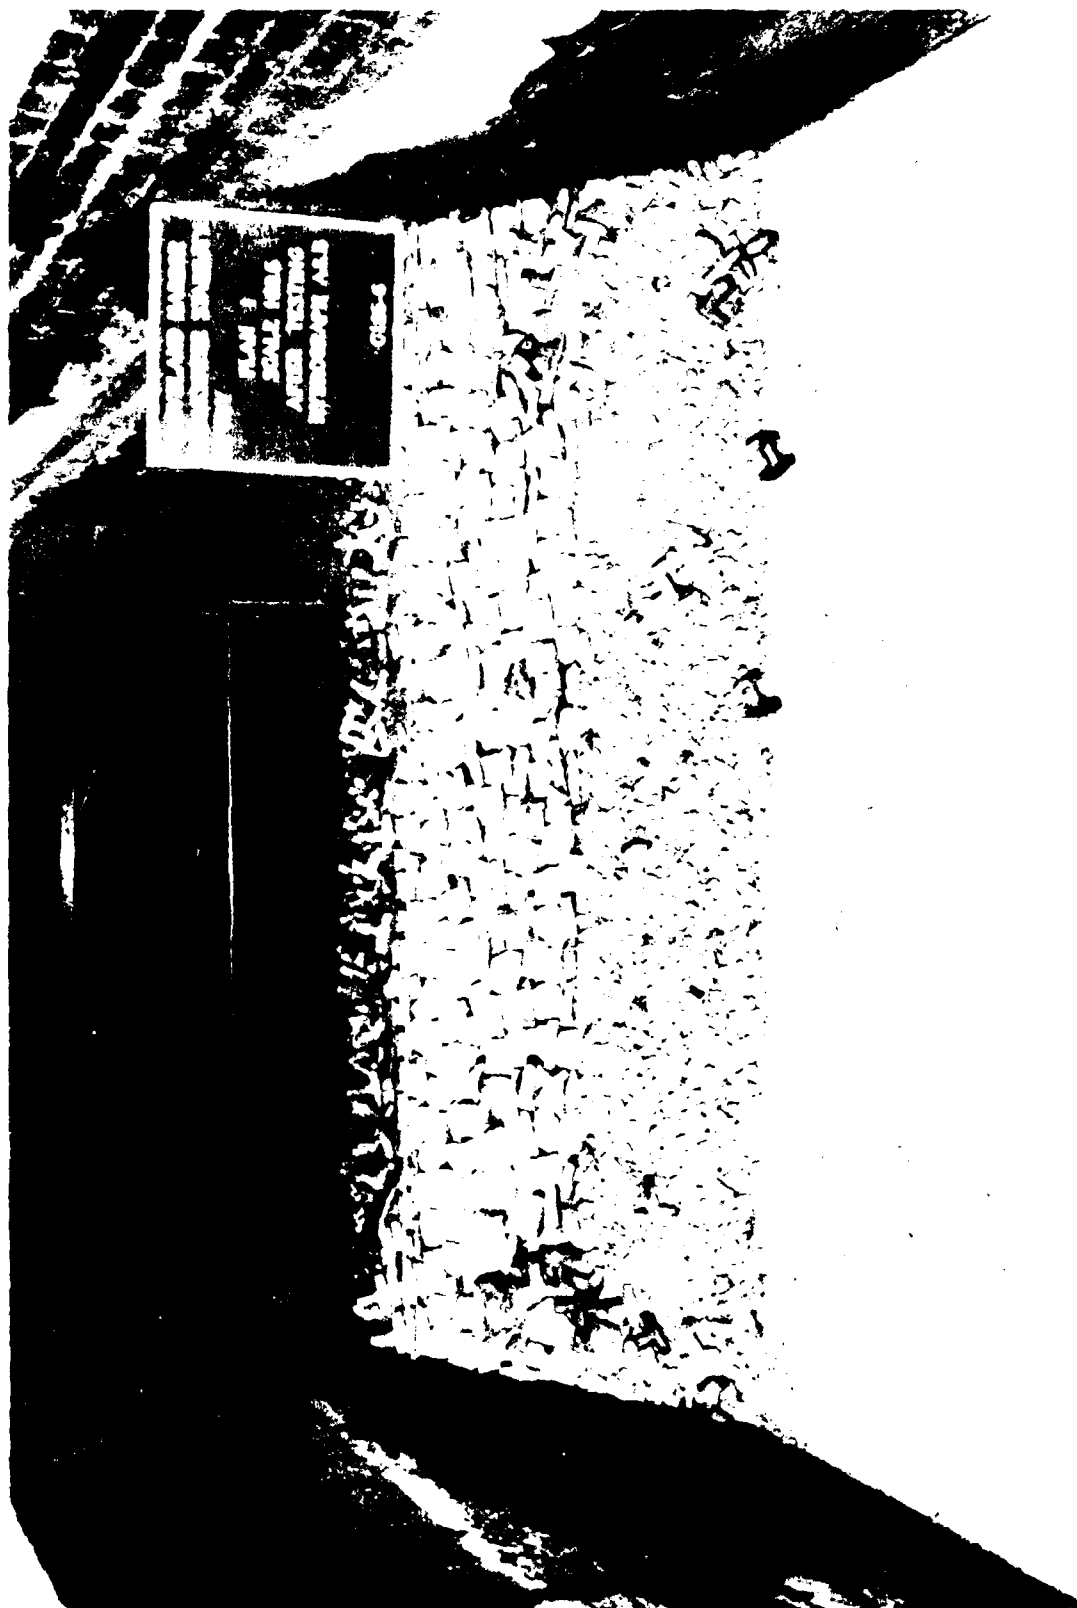
Photo 7. Harbor-side view of Plan 1 after testing Hydrographs A and B, first test section

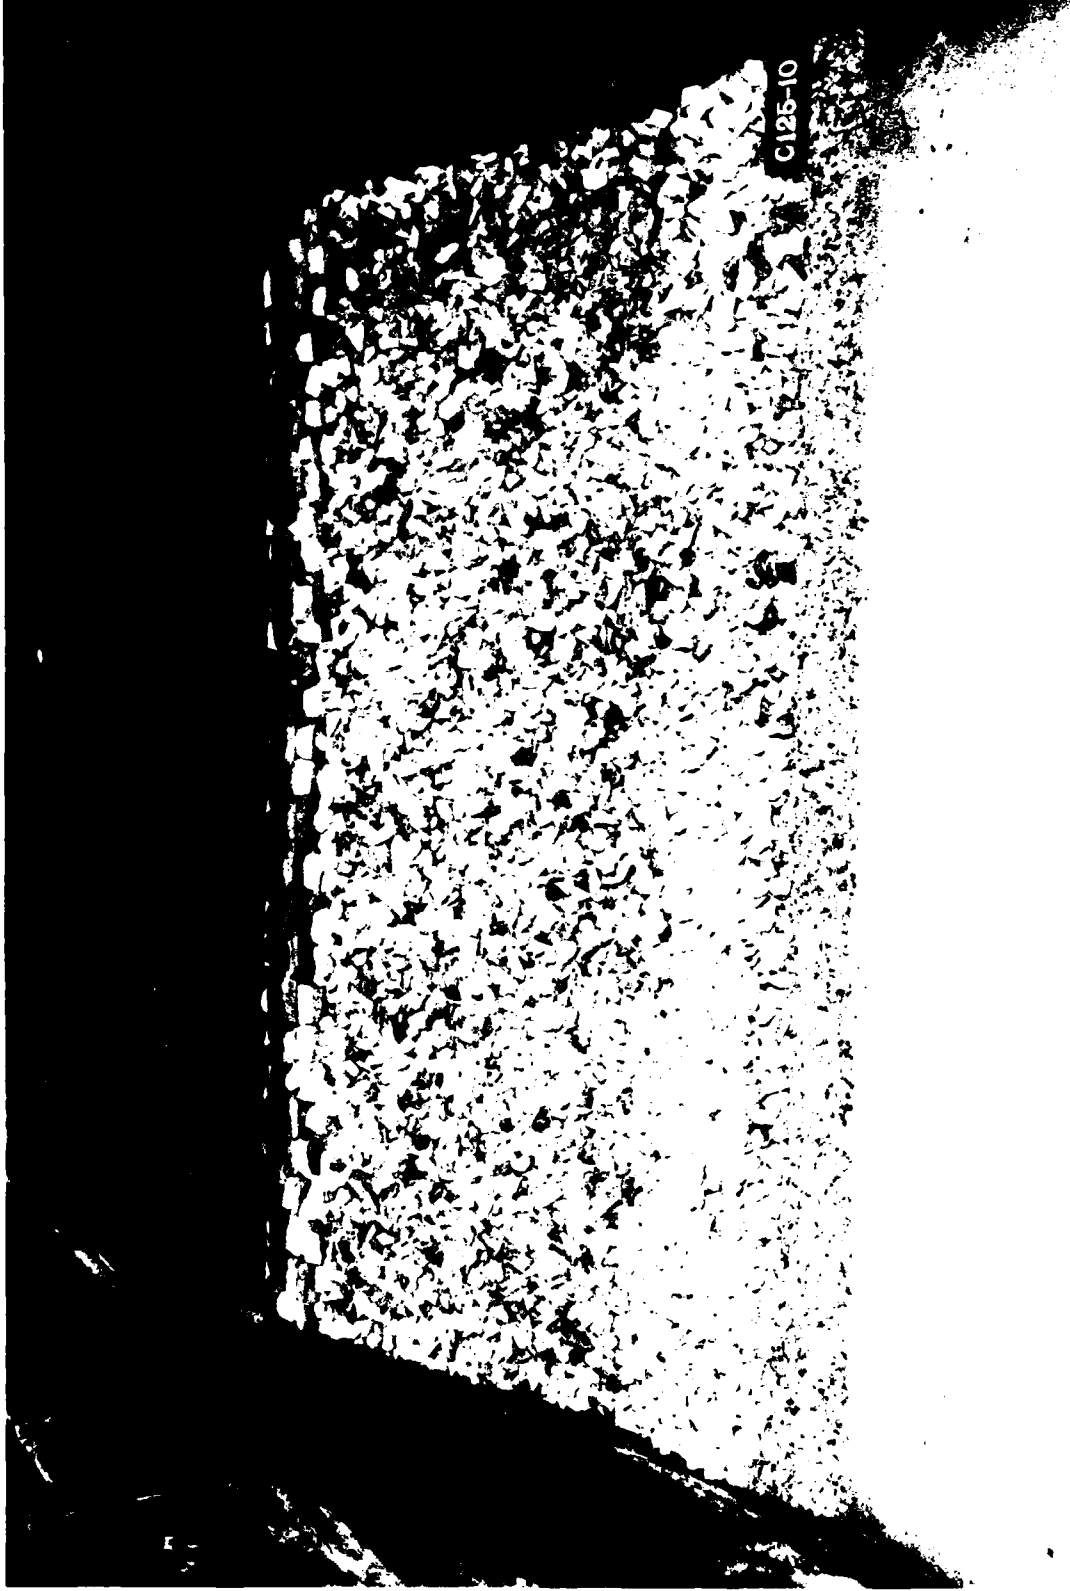
Photo 8. Lakeside view of Plan 1 prior to placement of dolos armor, second test section

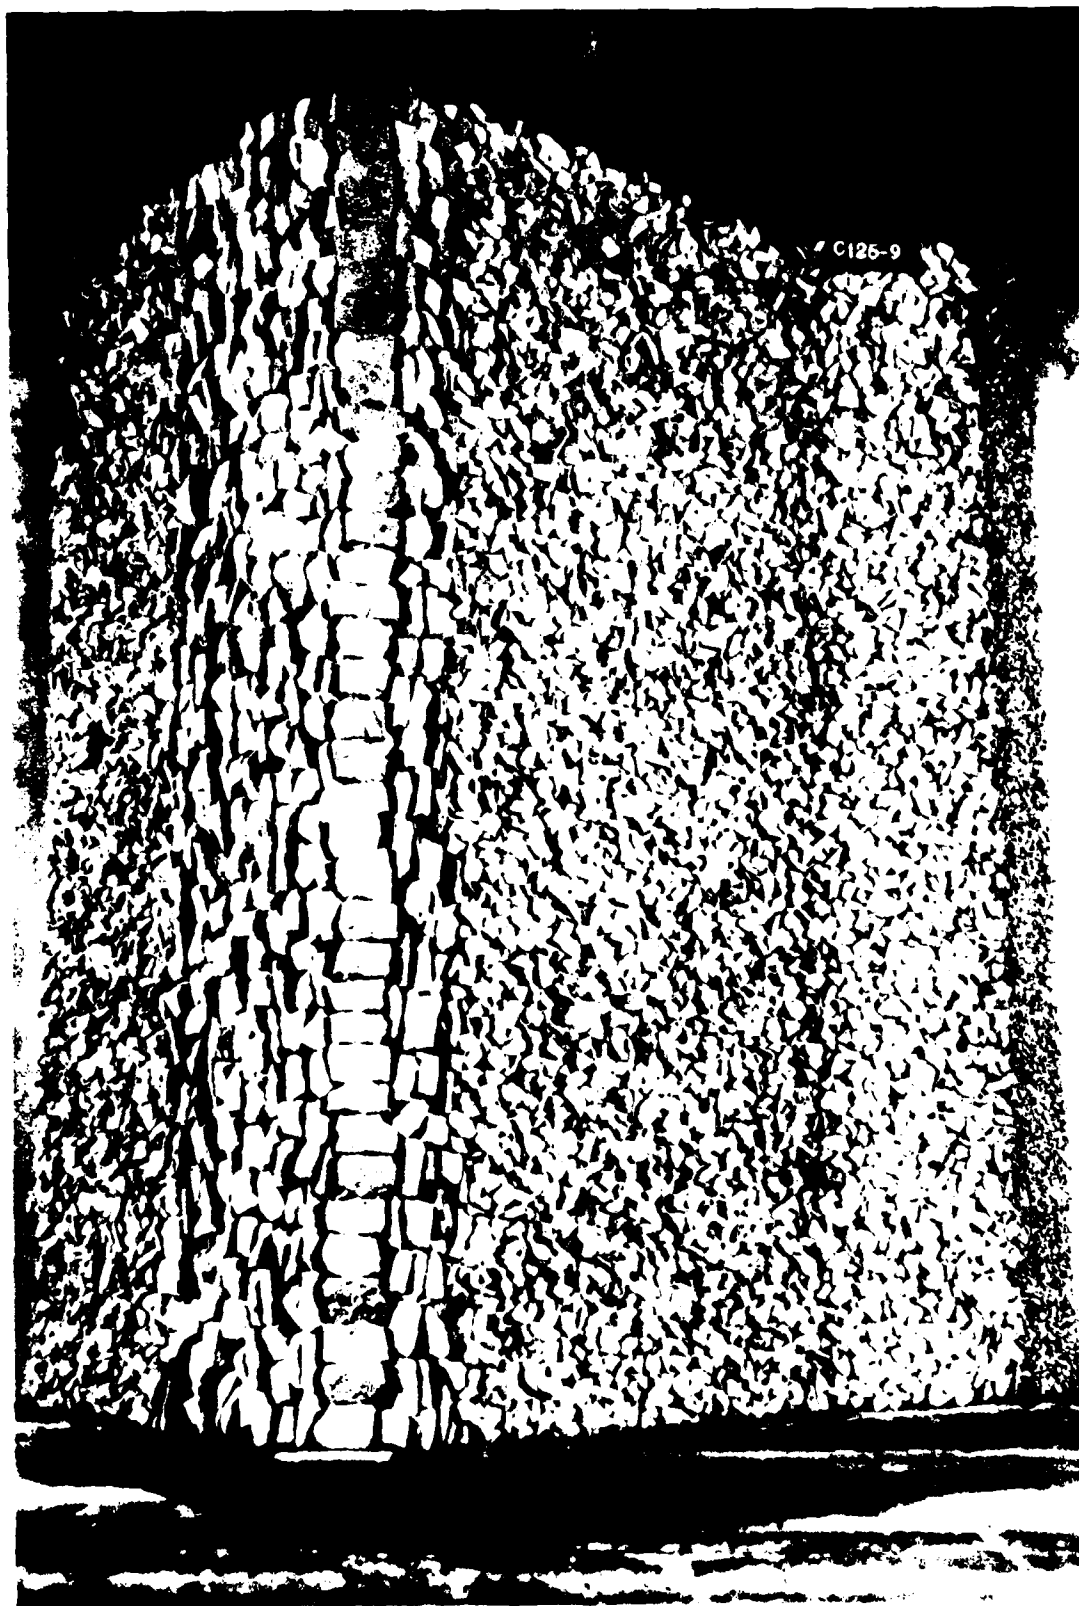
Photo 9. Overhead view of Plan 1 prior to placement of dolos armor, second test section

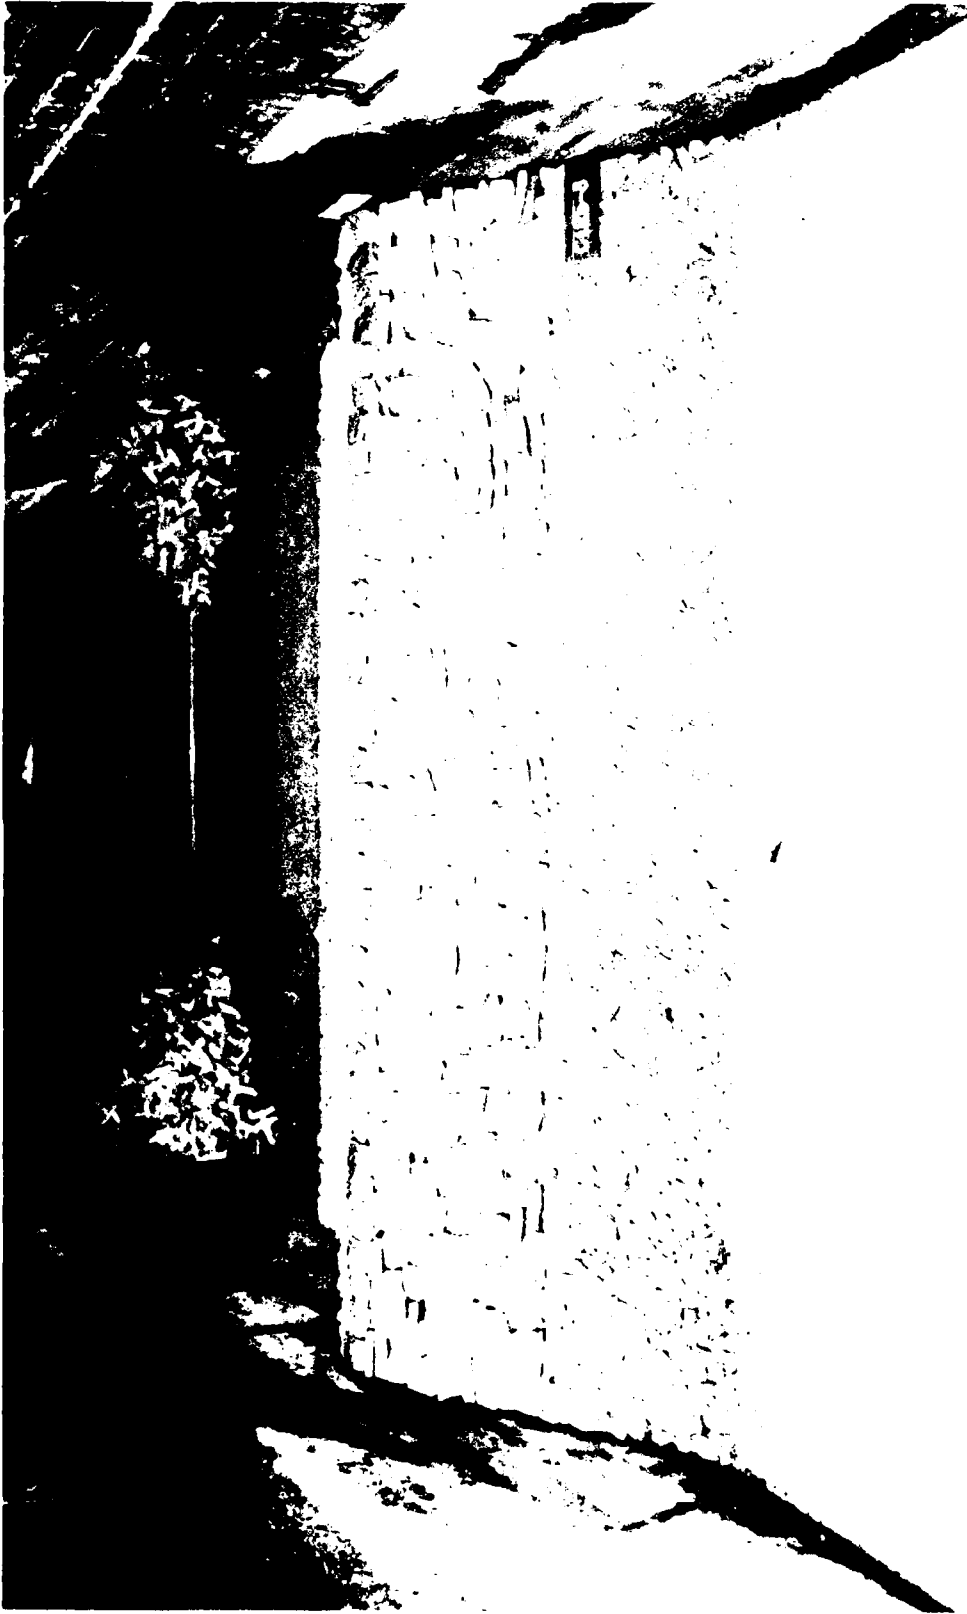
Photo 10. Harbor-side view of Plan 1 prior to placement of dolos armor, second test section

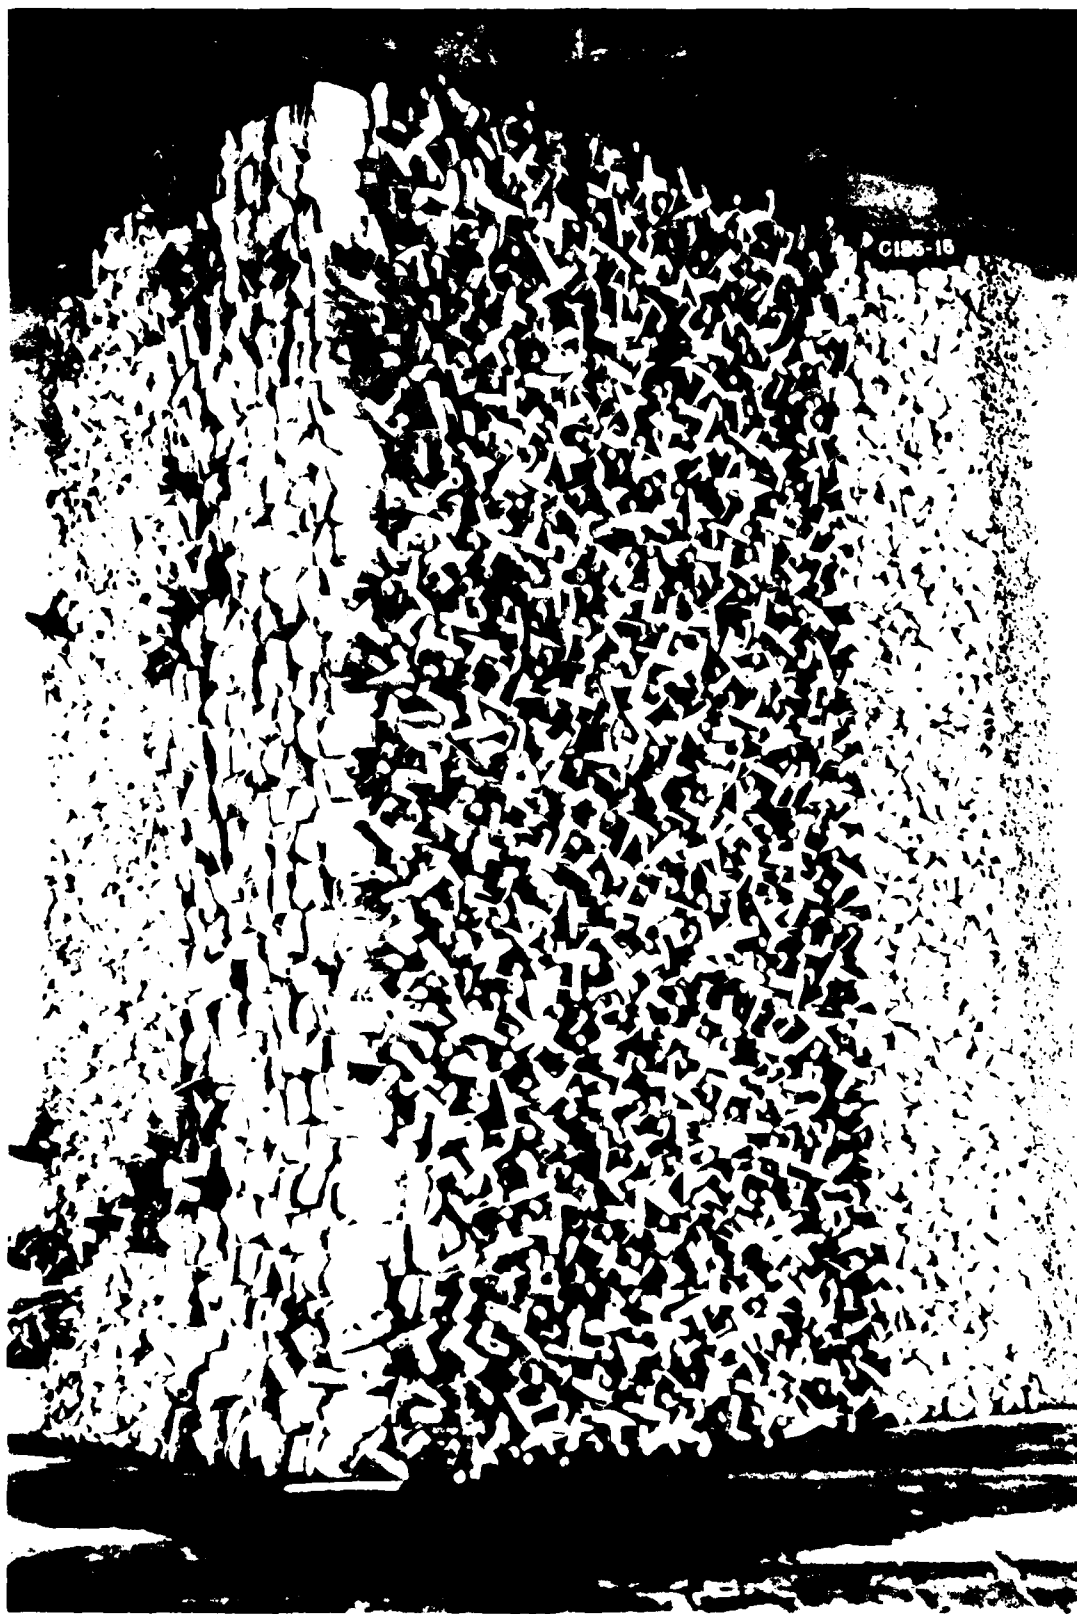
Photo 14. Overhead view of Plan 1 after testing Hydrograph A,  
second test section

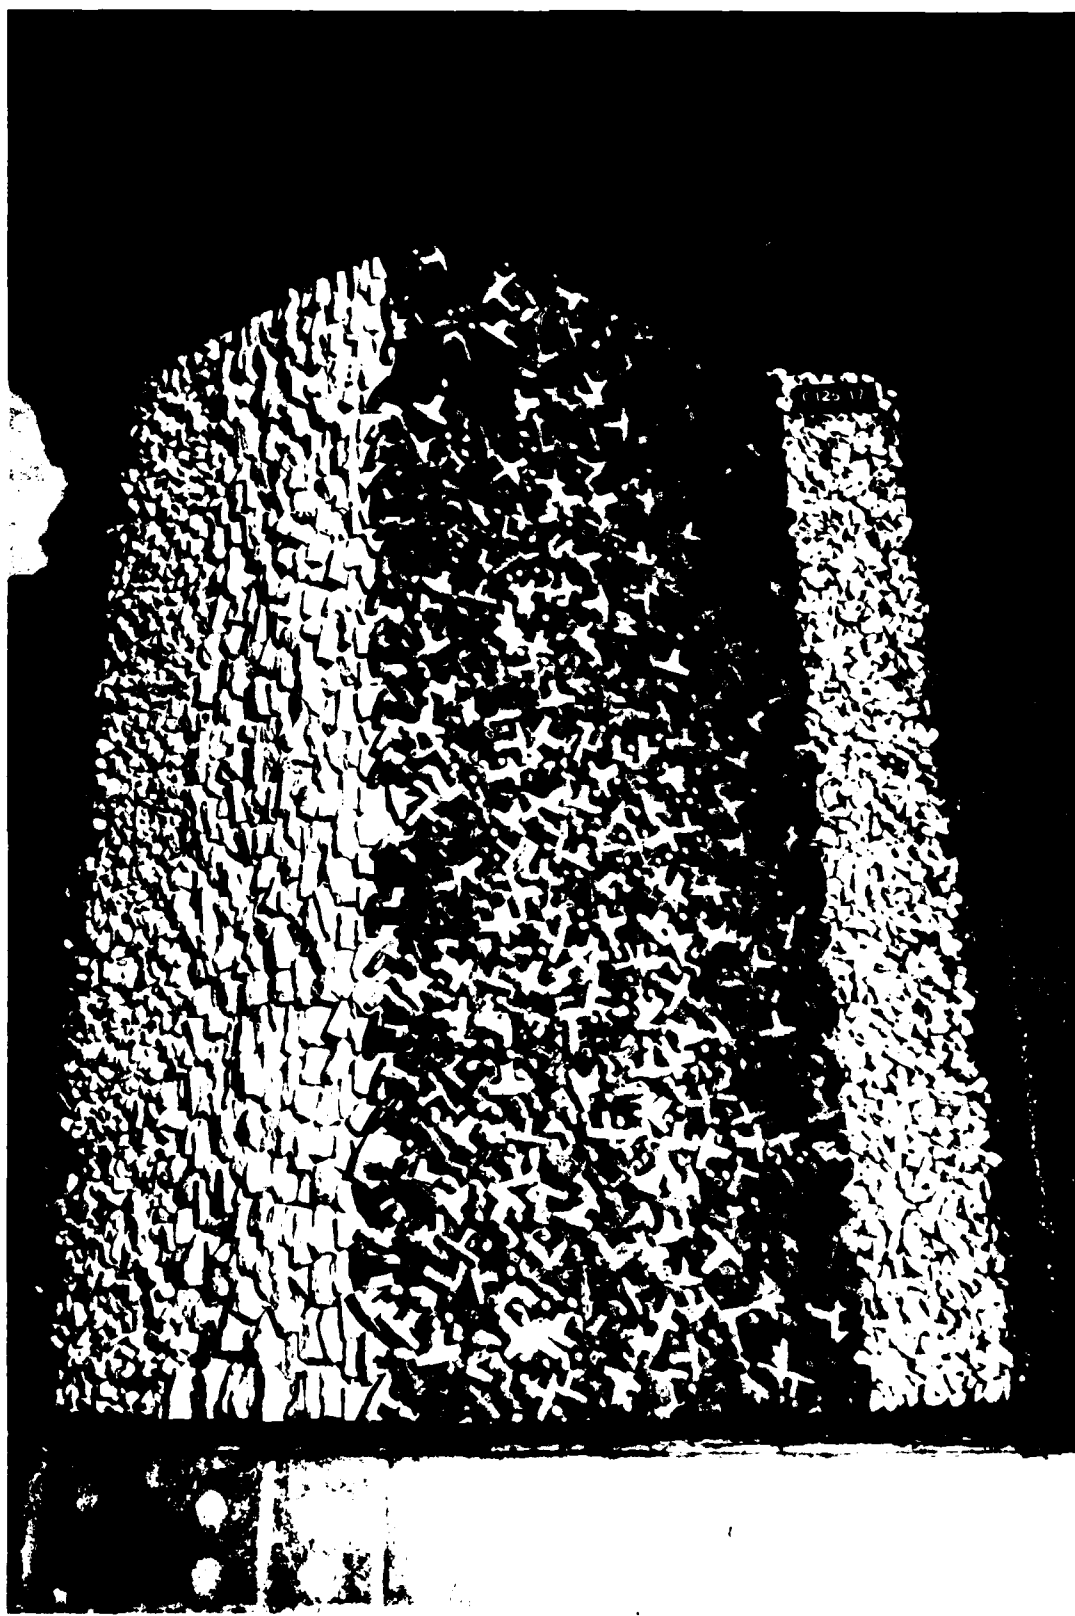
Photo 16. Overhead view of Plan 1 before testing,  
third test section

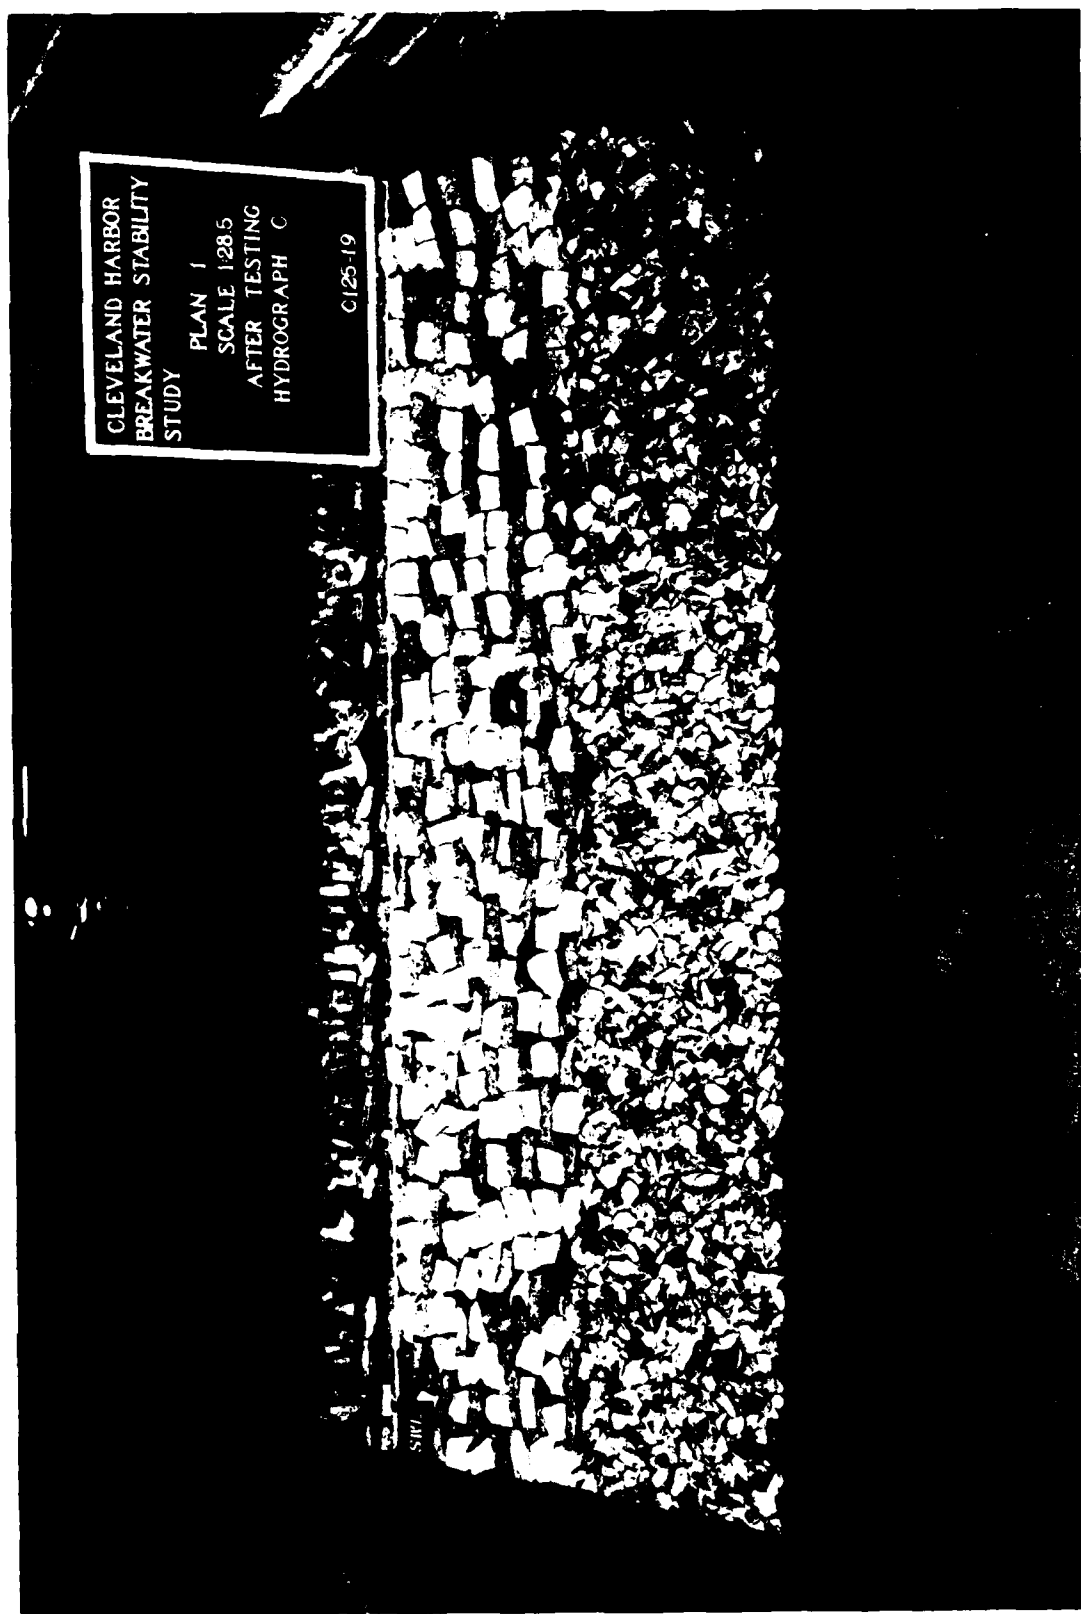
Photo 19. Harbor-side view of Plan 1 after testing Hydrograph C, third test section

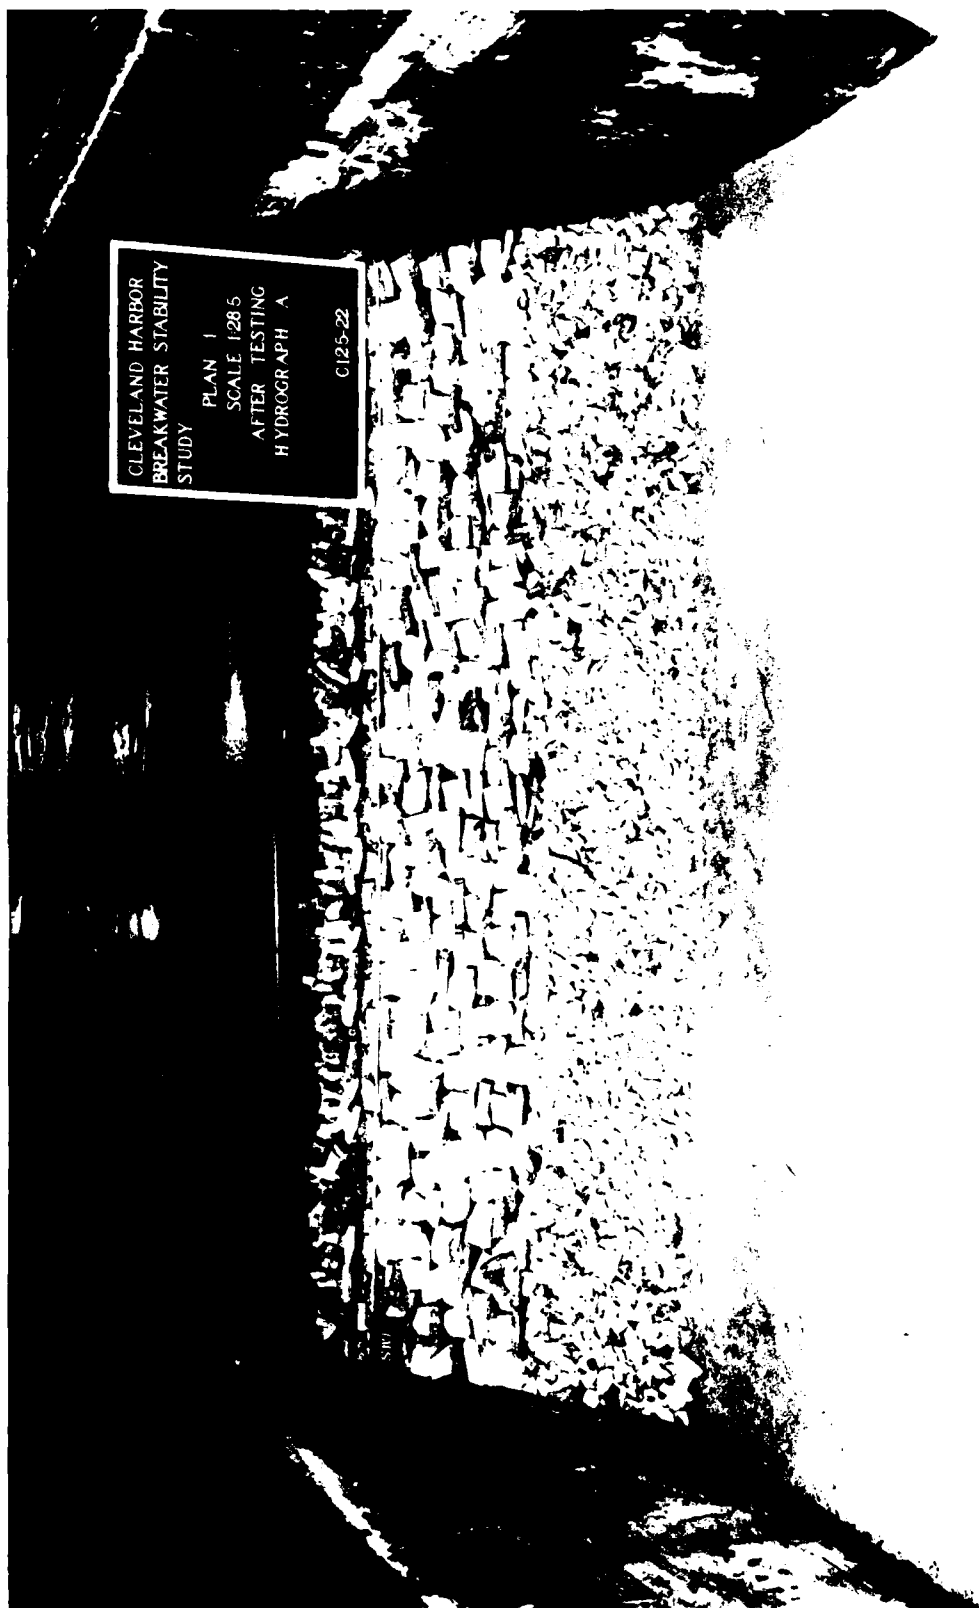
Photo 22. Harbor-side view of Plan 1 after testing Hydrographs C and A, third test section

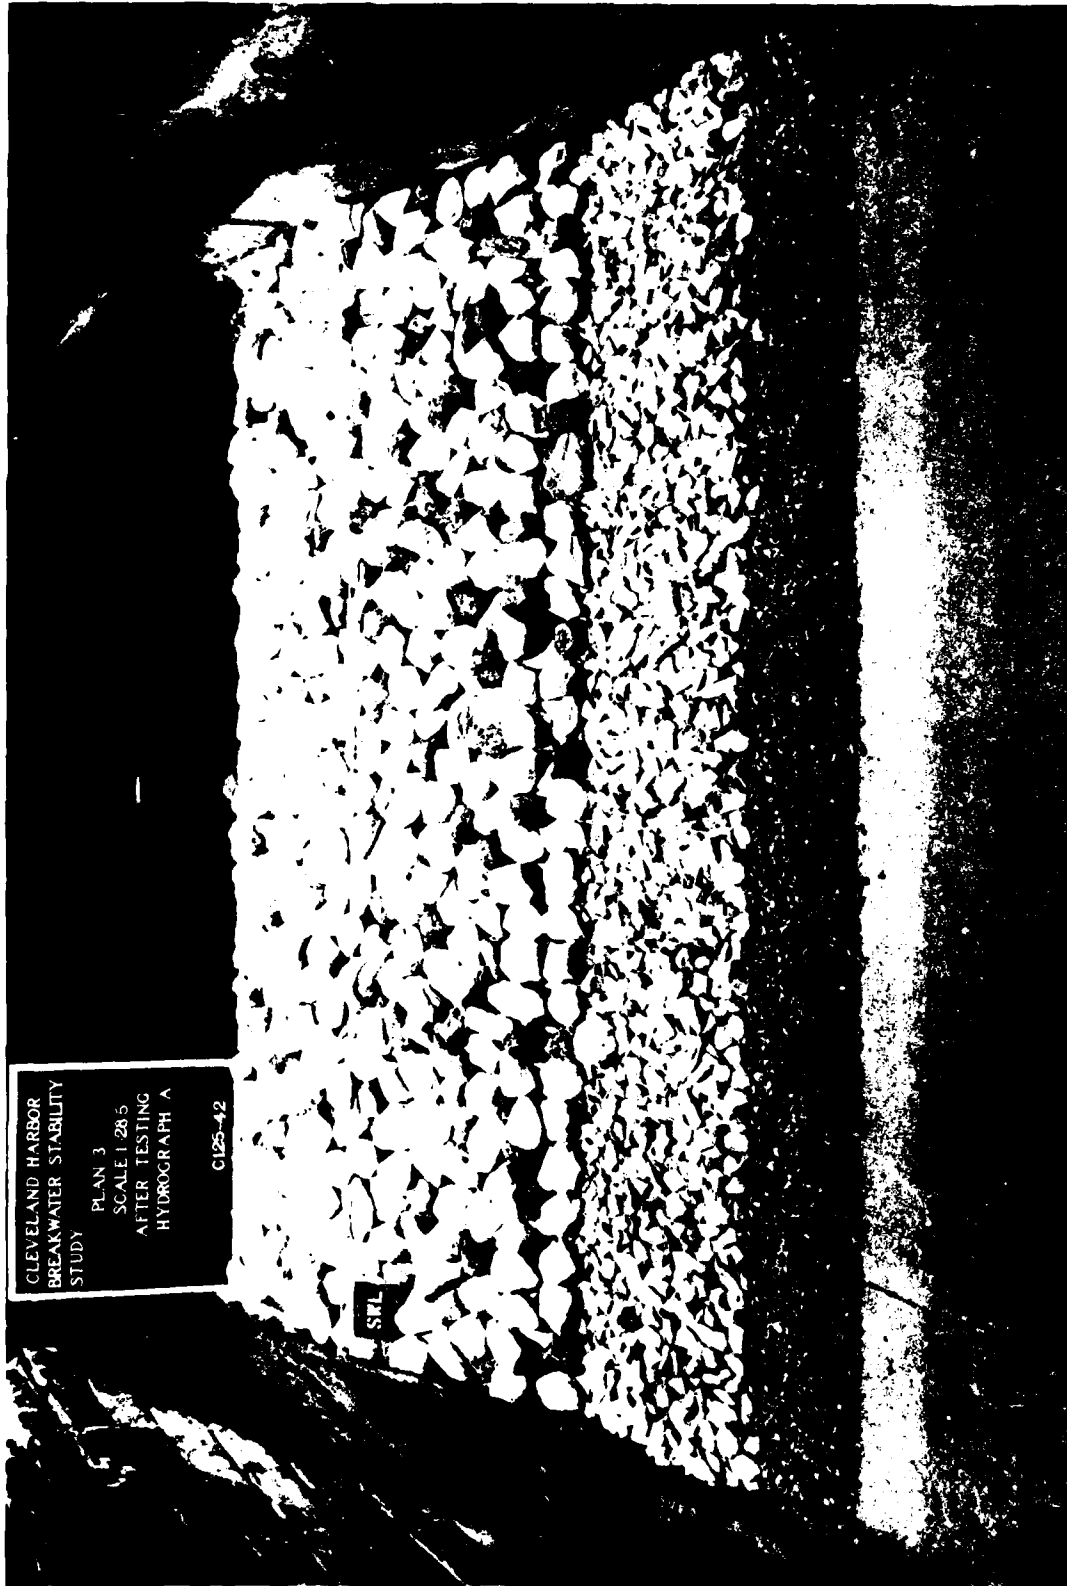
Photo 41. Lakeside view of Plan 3 after testing Hydrograph A, second test section
