TECHNICAL REPORT CERC-85-10

# WAVE STABILITY TESTS OF DOLOS AND STONE REHABILITATION DESIGNS FOR THE EAST BREAKWATER, CLEVELAND HARBOR, OHIO

Experimental Model Investigation

Coastal Engineering Research Center

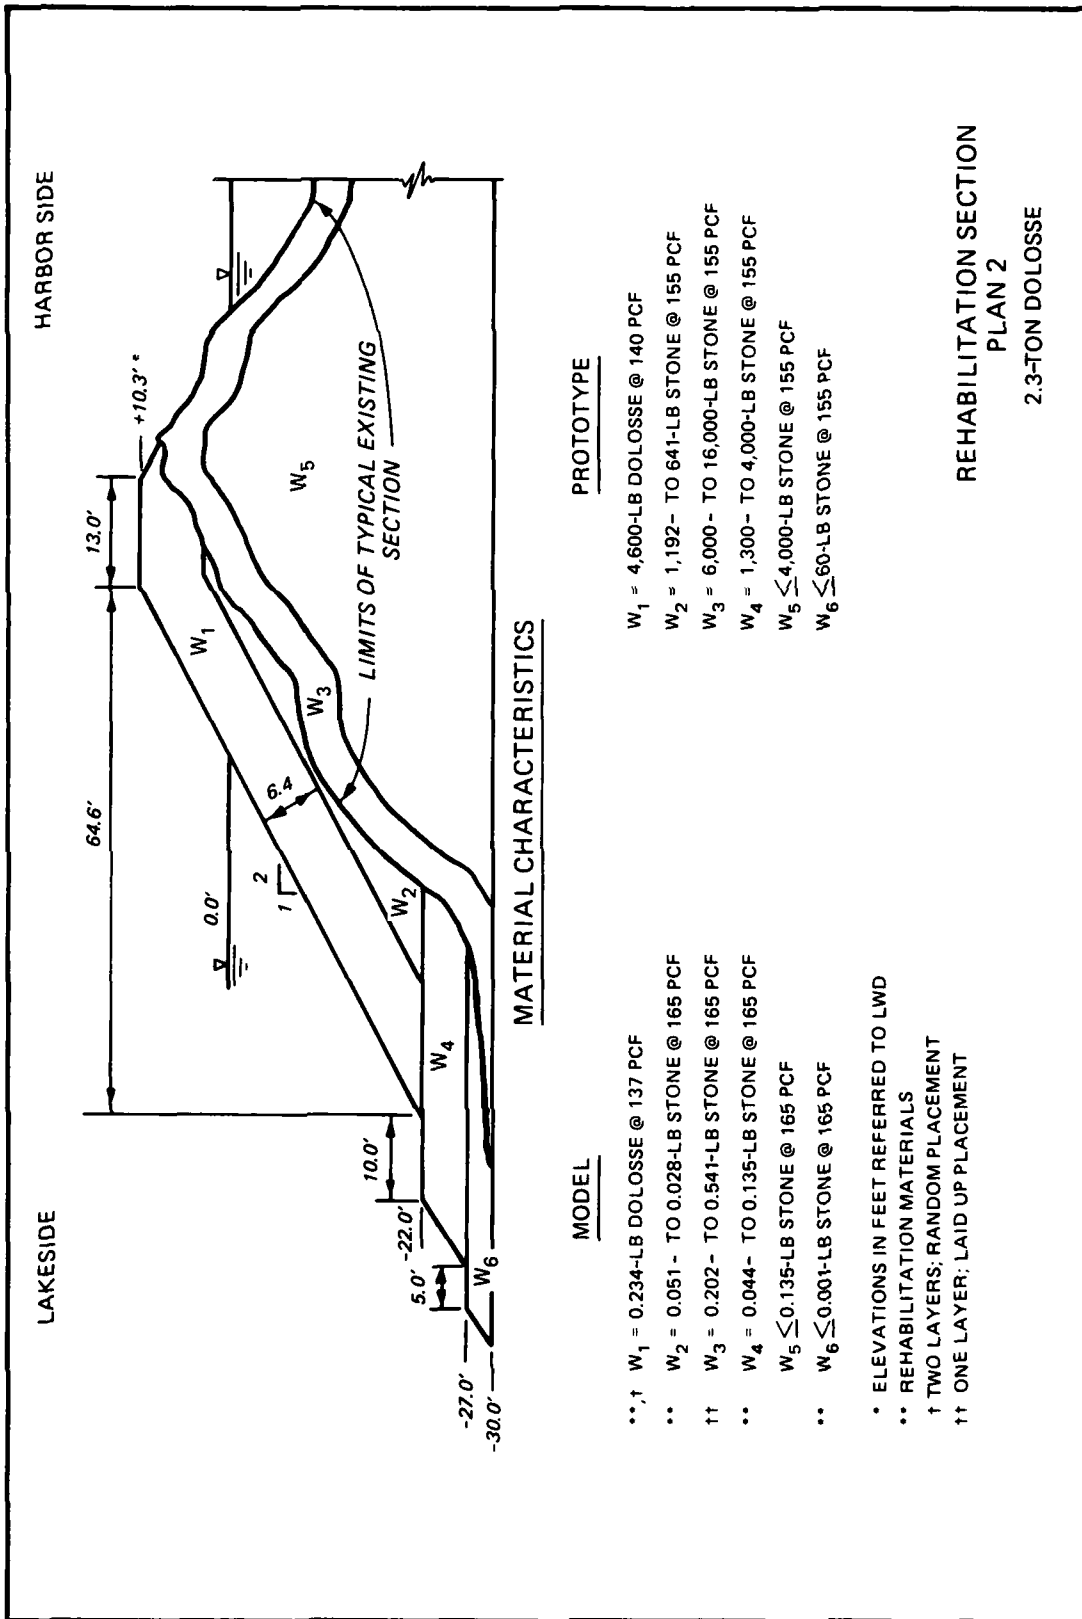
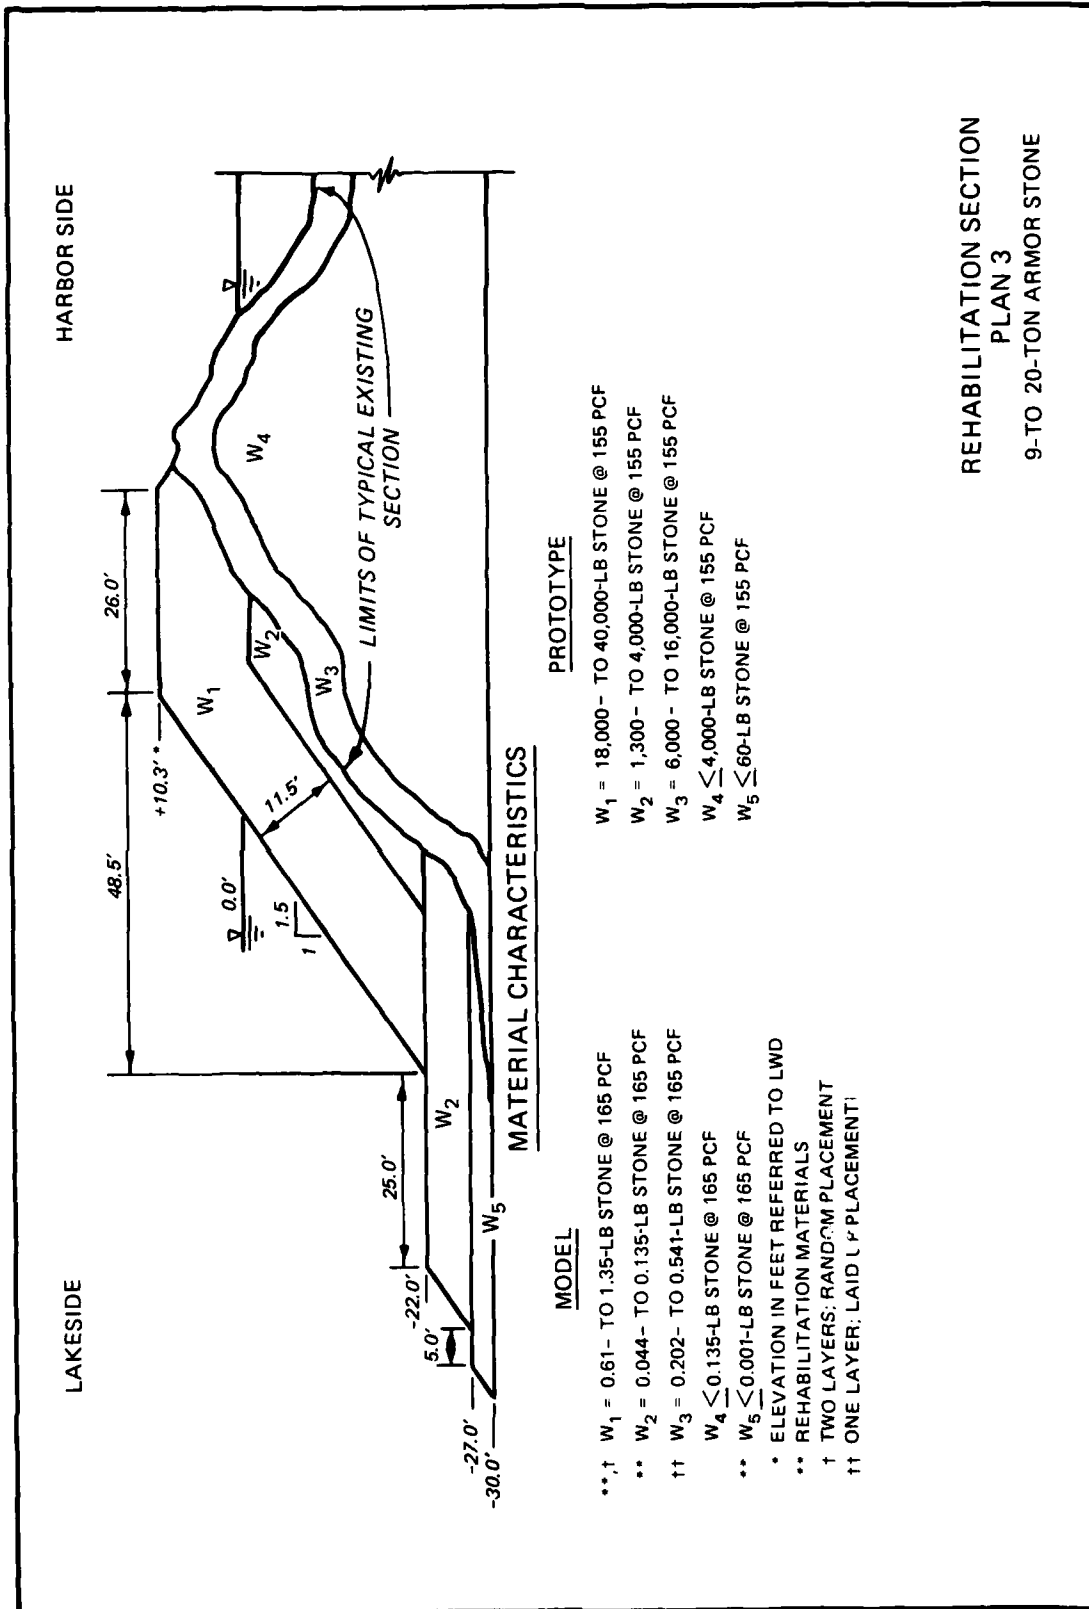
REHABILITATION SECTION  
PLAN 3  
9-TO 20-TON ARMOR STONE

- \*\* 1 W<sub>1</sub> = 0.290-LB DOLOSSE @ 144.4 PCF
- \*\* W<sub>2</sub> = 0.037 - TO 0.071-LB STONE @ 165 PCF
- †† W<sub>3</sub> = 0.202 - TO 0.541-LB STONE @ 165 PCF
- \*\* W<sub>4</sub> = 0.044 - TO 0.135-LB STONE @ 165 PCF
- \*\* W<sub>5</sub> ≤ 0.135-LB STONE @ 165 PCF
- \*\* W<sub>6</sub> ≤ 0.001-LB STONE @ 165 PCF

- W<sub>1</sub> = 8,000-LB DOLOSSE @ 140 PCF
- W<sub>2</sub> = 1,100 - TO 2,100-LB STONE @ 155 PCF
- W<sub>3</sub> = 6,000 - TO 16,000-LB STONE @ 155 PCF
- W<sub>4</sub> = 1,300 - TO 4,000-LB STONE @ 155 PCF
- W<sub>5</sub> ≤ 4,000-LB STONE @ 155 PCF
- W<sub>6</sub> ≤ 60-LB STONE @ 155 PCF

- \* ELEVATIONS IN FEET REFERRED TO LWD
- \*\* REHABILITATION MATERIALS
- † TWO LAYERS; RANDOM PLACEMENT
- †† ONE LAYER; LAID UP PLACEMENT

25. With the completion of tests for Plan 2, tests were initiated to determine the design wave condition for the proposed 9- to 20-ton armor-stone rehabilitation design alternative (Plan 3, Plate 3). The model armor stone represented a uniformly distributed gradation of 9- to 20-ton armor stone randomly placed on a 1V-on-1.5H slope. The armor stone had a crown width of 26 ft at an elevation of +10.3 ft lwd and extended down to the -22.0 ft lwd toe berm.
