**DEPARTMENT OF DEFENCE**  
**DEFENCE SCIENCE AND TECHNOLOGY ORGANISATION**  
**AERONAUTICAL RESEARCH LABORATORIES**

Structures Technical Memorandum 438

**DYNAMIC RESPONSE OF A GRAPHITE/EPOXY  
COMPOSITE PLATE**

M. HELLER AND S. J. RUMBLE

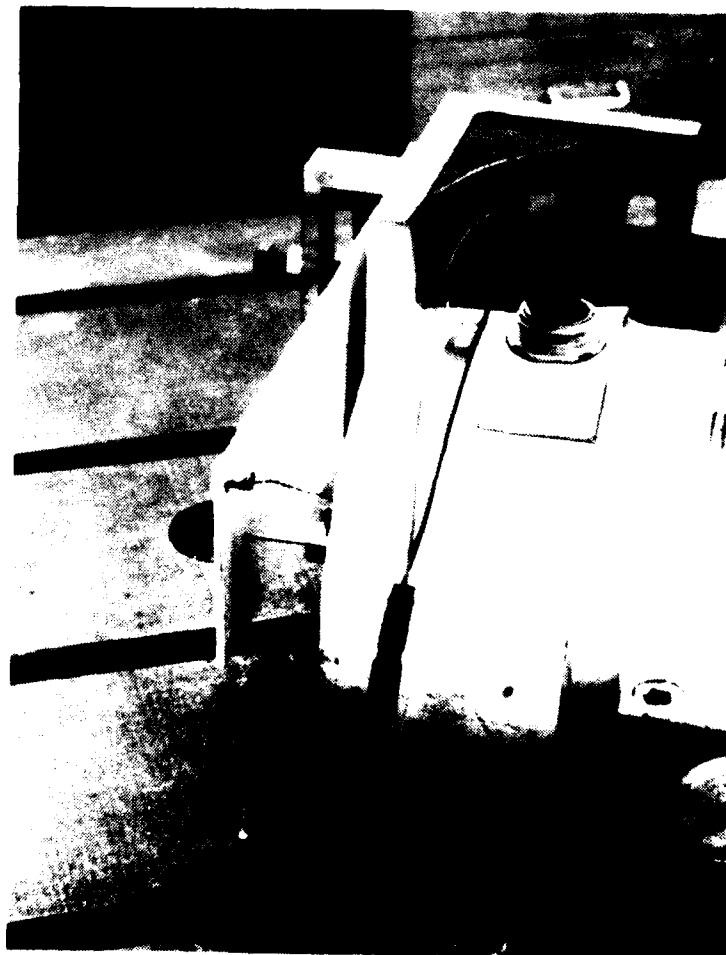
FIG.3. SPECIMEN EXCITATION ARRANGEMENT

The excitation source used in these tests was the periodic random output of a HP3582A Fourier analyser. The excitation was fed to an ARL high output impedance power amplifier which in turn drove a Ling 409 electromagnetic shaker. The response was measured using a PCB309-A accelerometer and analysed using a Nicolet 411B analyser. The analysed data were subsequently stored on a NOVA3 minicomputer and plotted on a Tektronix 4662 plotter. The specimen was mounted in a clamping arrangement at one end as shown in Figs. 2 and 3, the excitation force being applied laterally at the other end on the back face of the specimen. The mounting position of the accelerometer is also clearly shown. Accelerometer response data were first recorded and analysed with the shaker and specimen in an initial condition.

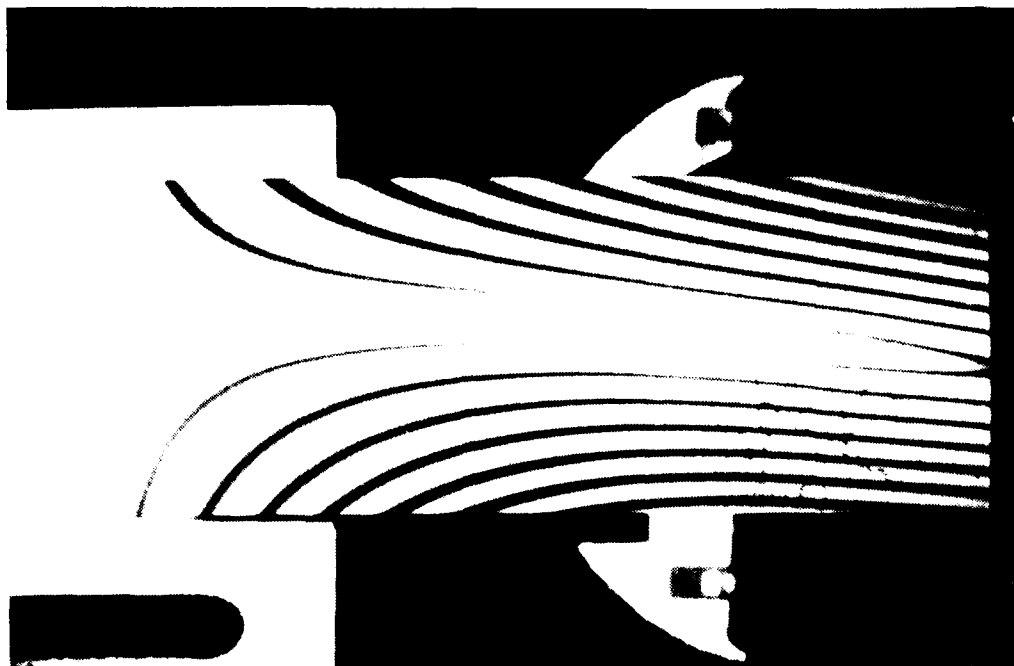
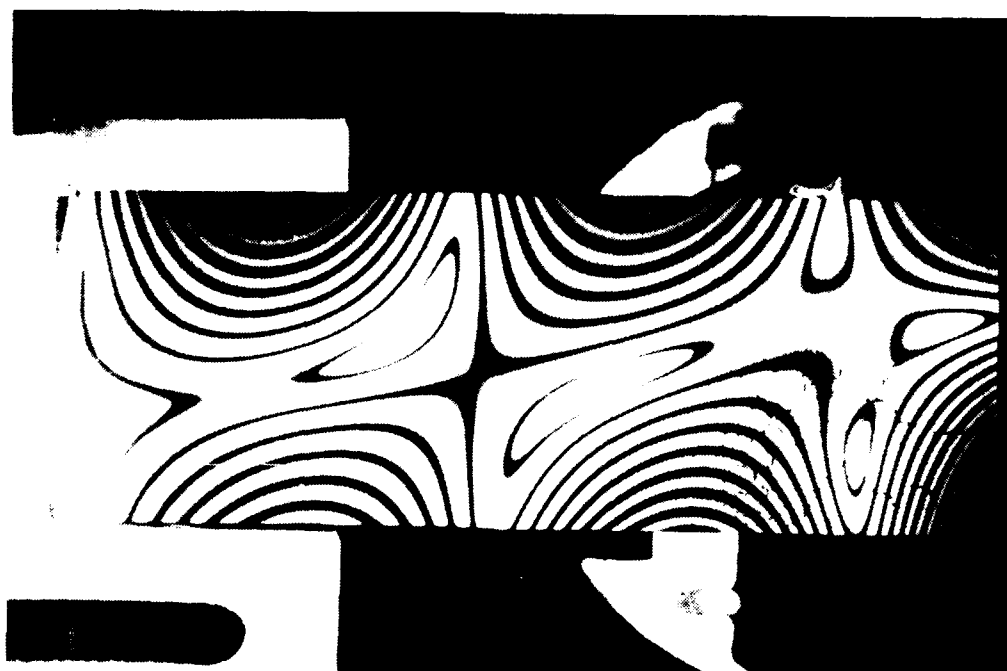
FIG.12 HOLOGRAM AT 434 Hz FOR UNDAMAGED SPECIMEN

FIG.13 HOLOGRAM AT 1125 Hz FOR UNDAMAGED SPECIMEN

FIG.14 HOLOGRAM AT 1530 Hz FOR UNDAMAGED SPECIMEN

FIG.15 HOLOGRAM AT 2100 Hz FOR UNDAMAGED SPECIMEN

Photographs of the holograms taken of various modes before and after damage are given in Figs. 12 to 18.

The mode shapes as indicated by holographic interferometry also showed that changes in boundary conditions appear to dominate changes due to damage. However, damage could be observed as perturbations to nearby fringes.

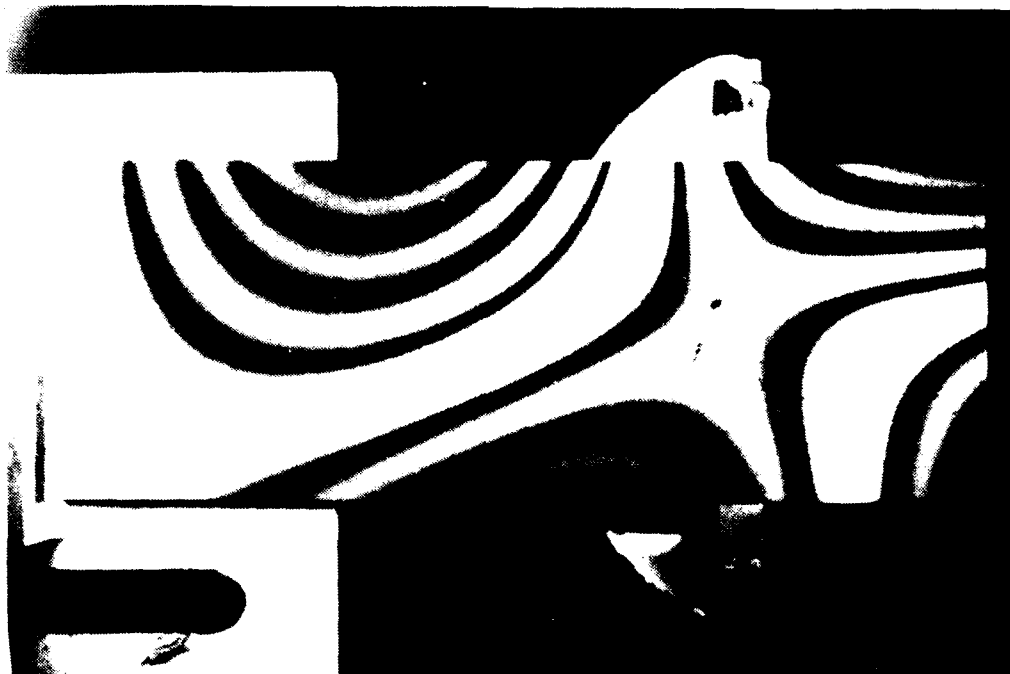
FIG.16 HOLOGRAM AT 1157 Hz FOR DAMAGED SPECIMEN

FIG.17 HOLOGRAM AT 2160 Hz FOR DAMAGED SPECIMEN

FIG.18 HOLOGRAM AT 2340 Hz FOR DAMAGED SPECIMEN
