COMPENDIUM OF POST-FAILURE ANALYSIS TECHNIQUES  
FOR COMPOSITE MATERIALS

RAY GROVE, BRIAN SMITH  
BOEING MILITARY AIRPLANE COMPANY  
P. O. BOX 3707  
M/S 73-43  
SEATTLE, WASHINGTON 98124

JANUARY 1987

The objective of this document is to describe the analytical and diagnostic techniques that can be used to determine the causes of failure in continuous fiber reinforced composite materials. The material of primary emphasis in this compendium is the continuous carbon fiber-epoxy resin matrix system.

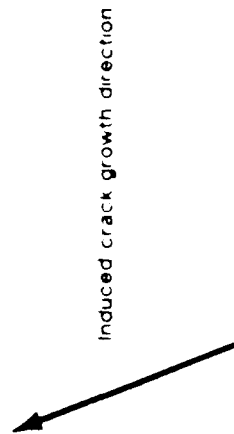
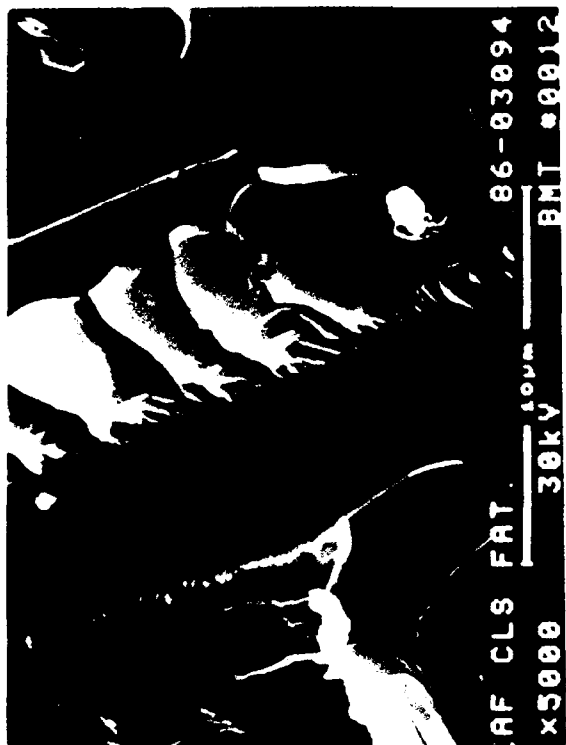
30-deg tilt

0-deg tilt

Figure 3-61. SEM Photomicrographs of Effect of Tilt on Striation Resolution

Object tilt probably provides the greatest effect on the overall image and thus should be optimized. Specimen tilt, which causes the beam penetration depth and scattering to vary, results in contrast between topographical features, similar to side lighting in optical macroscopy or shadowing for the TEM. The effect of tilting is more pronounced for the backscatter mode than the secondary emission mode. Since tilting can be used to enhance subtle features on smooth fractures, the use of high tilts are often required for examination of fatigue features, as shown in Figure 3-61, where fatigue striations are not visible until tilts beyond 30 degrees are employed. Similarly, the use of tilt often provides a quite different perspective of the fracture morphology such as hackles, as shown in Figure 3-62.

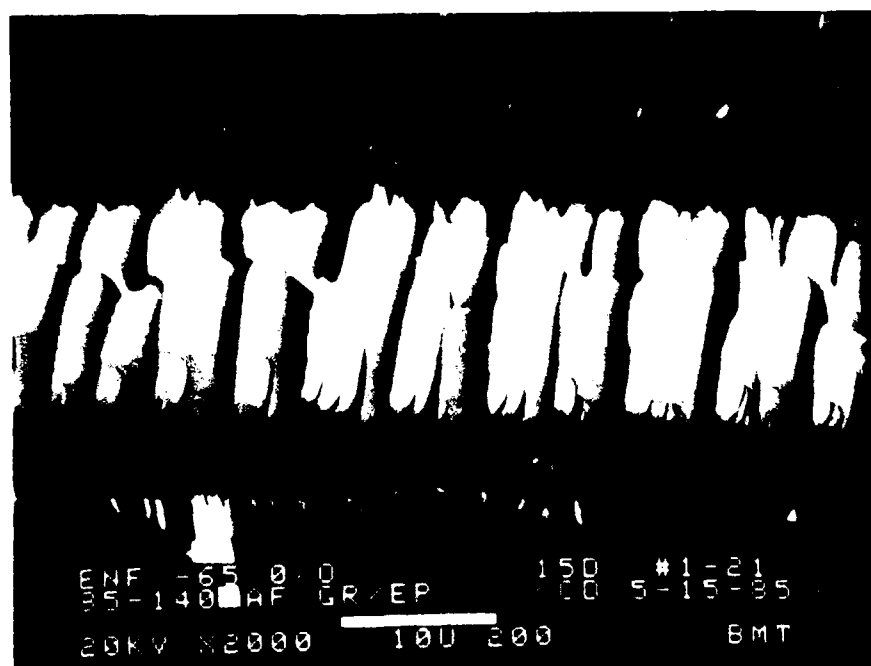
Figure 3-62. SEM Fractographs of Mode II Delamination Between Adjacent 0-deg Plies Illustrating the Effect of Tilt Angle

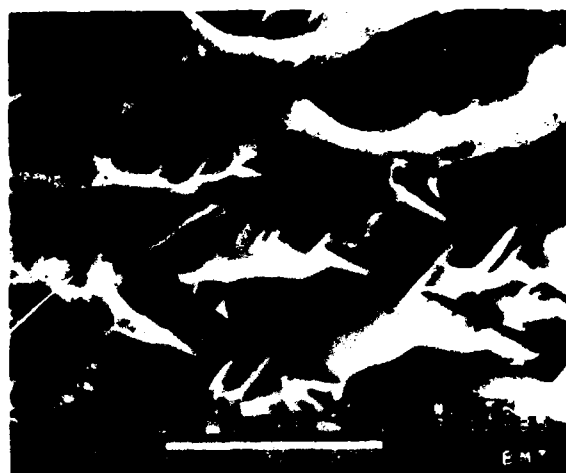
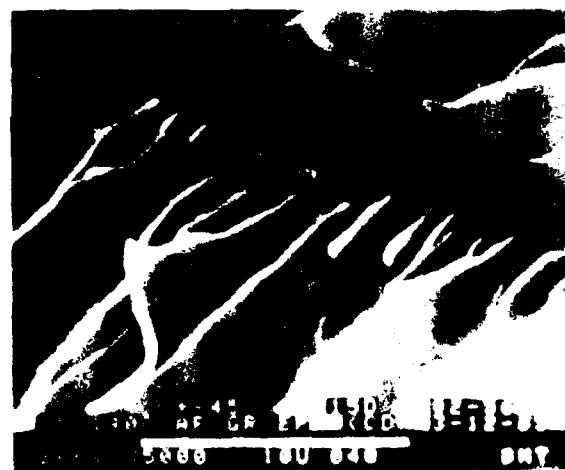
5-B70227-91

Mechanically induced crack direction

- M Matrix fracture
- F Fiber matrix separation
- R River markings
- T Textured microflow

Figure 4-17. SEM Fractographs of Mode I Delamination Between +45/+45-deg Plies

Mode I tension fractures produced at angles relative to the direction of fiber reinforcement typically exhibit both the river markings and resin microflow as noted above. However, significant variations in the fracture topography can occur at the microscopic scale, depending upon the number of fibers exposed by the fracture and their orientation relative to the direction of microscopic crack growth (Figures 4-15 and 4-16). Cracking often occurs in the resin rich region between plies, particularly between plies of large angular differences (that is,  $0^\circ$  and  $90^\circ$ ). Fractures which occur at the interface between plies exhibit relatively large areas of flat-resin fracture with distinct river marks in a fairly consistent microscopic direction. Alternatively, fractures which occur within a ply exhibit variable and often seemingly inconsistent localized microscopic directions of fracture. River marks and microflow are oriented in a wide variety of directions across the fracture surface. Variations in the direction of microscopic crack propagation can often be averaged together to obtain a more accurate estimate of the overall direction of crack propagation (Figure 4-17).

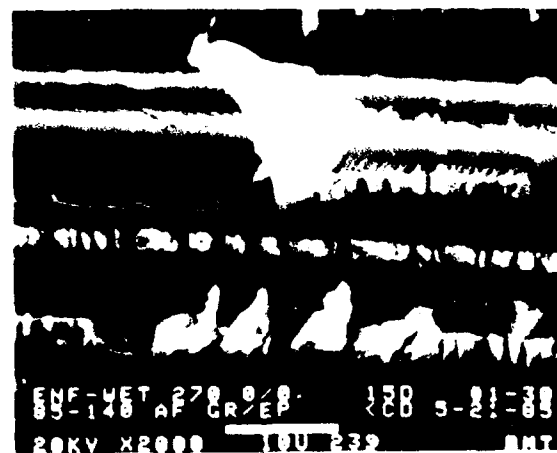
← Mechanically induced crack direction

Figure 4-43. High Magnification SEM Series of 0/0-deg Interface Mode II (Shear) Fractures Showing Features of Fiber-Matrix Separation

For delamination fractures, similar tendencies are evident for conditions of increasing amounts of absorbed moisture and temperature. Fractures in 177°C cure epoxy systems which occur at temperatures below approximately 90°C are very similar in appearance to the room temperature fractures. However, above this temperature range, increased fiber/matrix separation is evident and the fracture plane tends to occur within, or adjacent to, densely packed fiber regions within the lamina, resulting in a fiber-dominated fracture appearance, with small, localized regions of resin fracture (Figures 4-42 and 4-43).

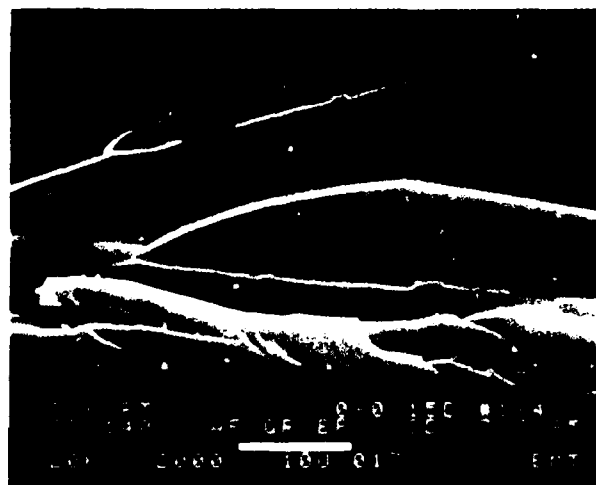
F Fiber matrix separation  
R River markings  
M Matrix fracture

-65°F, dry

70°F, dry

Figure 6-10. -65°F and 70°F Dry Conditions (SEM)

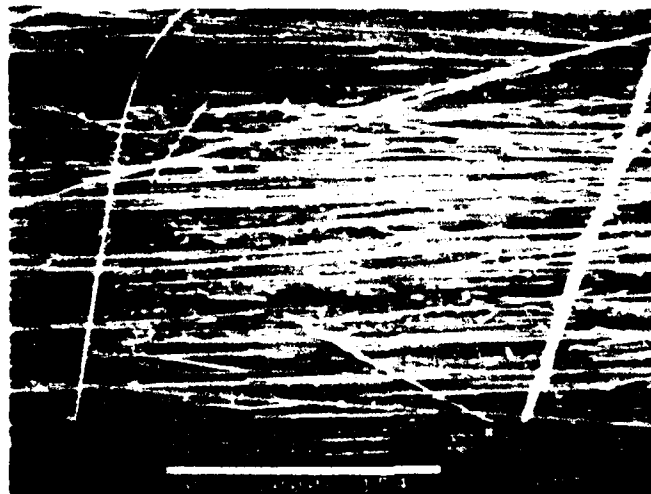
-65°F. dry

70°F. dry

270°F. dry

Figure 6-12. -65°F Dry, 70°F Dry, and 270°F Dry Conditions (SEM 50X)

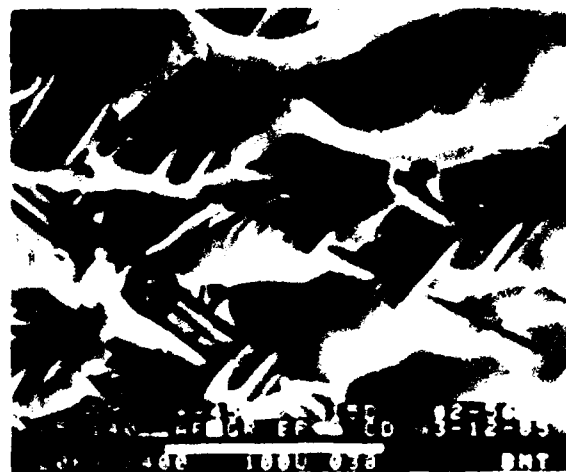
- F Fiber matrix separation
- M Matrix fracture
- R River markings
- T Textured microflow

Figure 6-15. +45/-45 Plies With Matrix Fracture, Fiber Separation, River Marks, and Textured Microflow

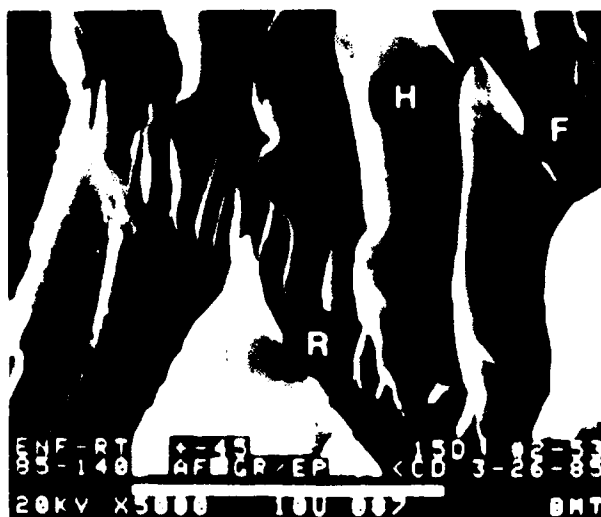
←  
Mechanically induced crack direction

- F Fiber matrix separation
- H Hackles
- R River markings

Figure 6-38 +45/-45 Plies at 21°C Dry Condition With Fiber Separation, River Marks, and Hackles

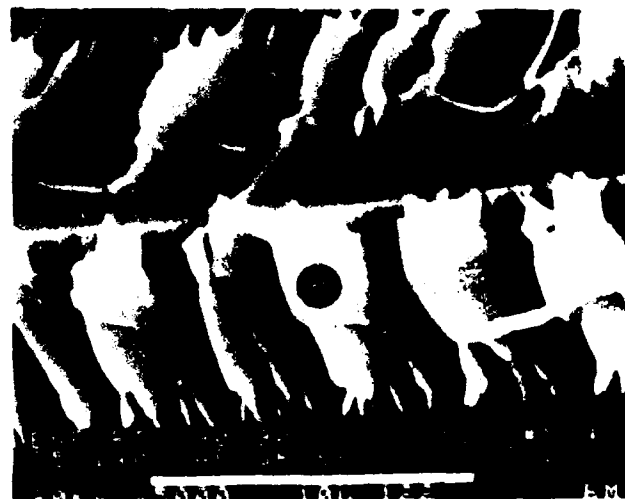
Mechanically induced crack direction

- F Fiber matrix separation
- H Hackles
- R River markings

Figure 6-46. 90/90 Plies at 21°C Dry Condition With Fiber Separation River Marks and Hackles
