# **Naval Weapons Center Active Fault Map Series**

by  
G. R. Roquemore  
and  
J. T. Zellmer  
*Research Department*

**NAVAL WEAPONS CENTER  
CHINA LAKE, CA 93555-6001**

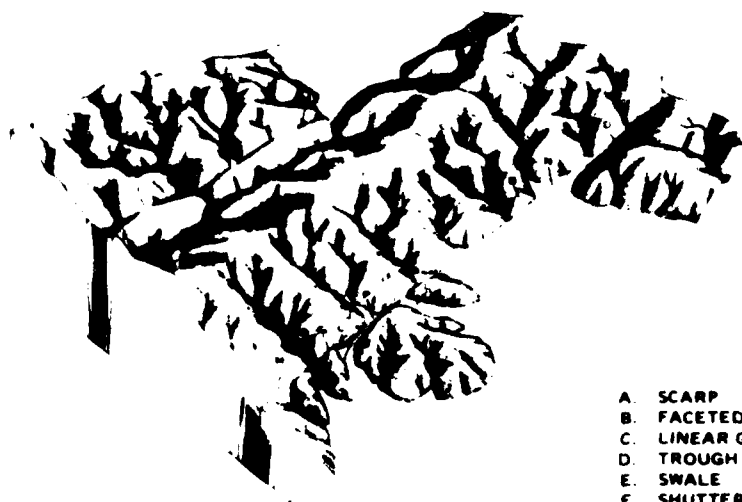
GENERALIZED DIAGRAM OF FAULT FEATURES

- A. SCARP
- B. FACETED RIDGE
- C. LINEAR GULLY
- D. TROUGH OR LINEAR CANYON
- E. SWALE
- F. SHUTTER-RIDGE SCARP
- G. NOTCH
- H. TRENCH
- I. BENCH
- J. OFFSET DRAINAGE CHANNEL
- K. DEFLECTED DRAINAGE CHANNEL
- L. BEHEADED DRAINAGE CHANNEL
- M. BEHEADED DRAINAGE CHANNEL  
WITH ALLUVIAL RAMP
- N. SAG POND
- O. DEPRESSION (PLAYA BASIN)
- P. PONDED ALLUVIUM
- Q. SPRING

Geomorphic (landform) criteria such as that described above are useful in estimating the ages or relative ages of fault scarps (Reference 9). Typical fault-related geomorphic features are shown in the block diagram on each map sheet. In practice, subjective judgments of the ages of the features must be made. Young, fault-related geomorphic features tend to be sharp and angular whereas older features become more rounded and subdued. The fault scarp bevels shown in Figure 3 are an example of this phenomenon. Although they do not yield definitive ages, geomorphic features help the geologist determine the number of earthquakes that have occurred, their ages, and amounts of displacement. Data such as these are used in reconstructing the earthquake history of the fault which is used as an indicator of future seismic activity.

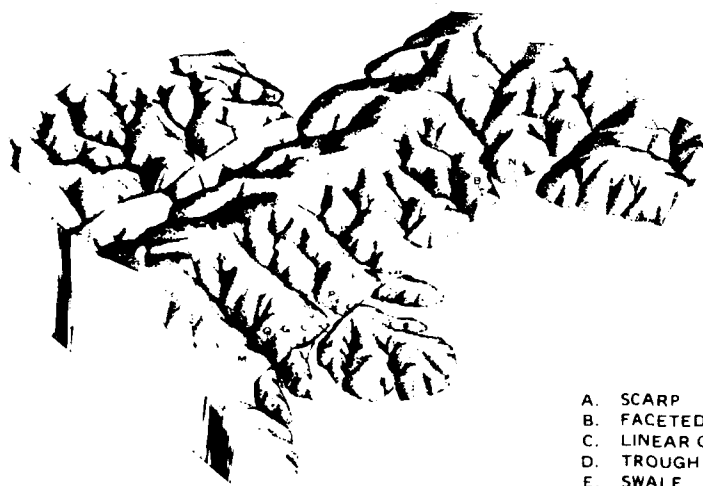
GENERALIZED DIAGRAM OF FAULT FEATURES

- A. SCARP
- B. FACETED RIDGE
- C. LINEAR GULLY
- D. TROUGH OR LINEAR CANYON
- E. SWALE
- F. SHUTTER-RIDGE SCARP
- G. NOTCH
- H. TRENCH
- I. BENCH
- J. OFFSET DRAINAGE CHANNEL
- K. DEFLECTED DRAINAGE CHANNEL
- L. BEHEADED DRAINAGE CHANNEL
- M. BEHEADED DRAINAGE CHANNEL WITH ALLUVIAL RAMP
- N. SAG POND
- O. DEPRESSION (PLAYA BASIN)
- P. PONDED ALLUVIUM
- Q. SPRING

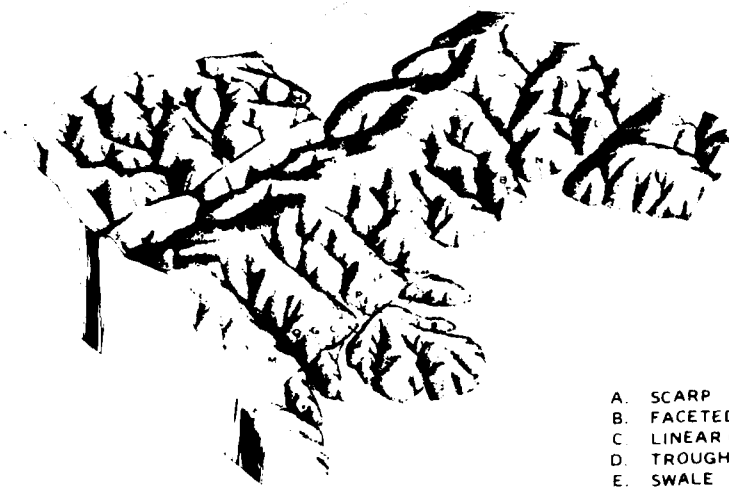
GENERALIZED DIAGRAM OF FAULT FEATURES

- A. SCARP
- B. FACETED RIDGE
- C. LINEAR GULLY
- D. TROUGH OR LINEAR CANYON
- E. SWALE
- F. SHUTTER-RIDGE SCARP
- G. NOTCH
- H. TRENCH
- I. BENCH
- J. OFFSET DRAINAGE CHANNEL
- K. DEFLECTED DRAINAGE CHANNEL
- L. BEHEADED DRAINAGE CHANNEL
- M. BEHEADED DRAINAGE CHANNEL WITH ALLUVIAL RAMP
- N. SAG POND
- O. DEPRESSION (PLAYA BASIN)
- P. PONDED ALLUVIUM
- Q. SPRING

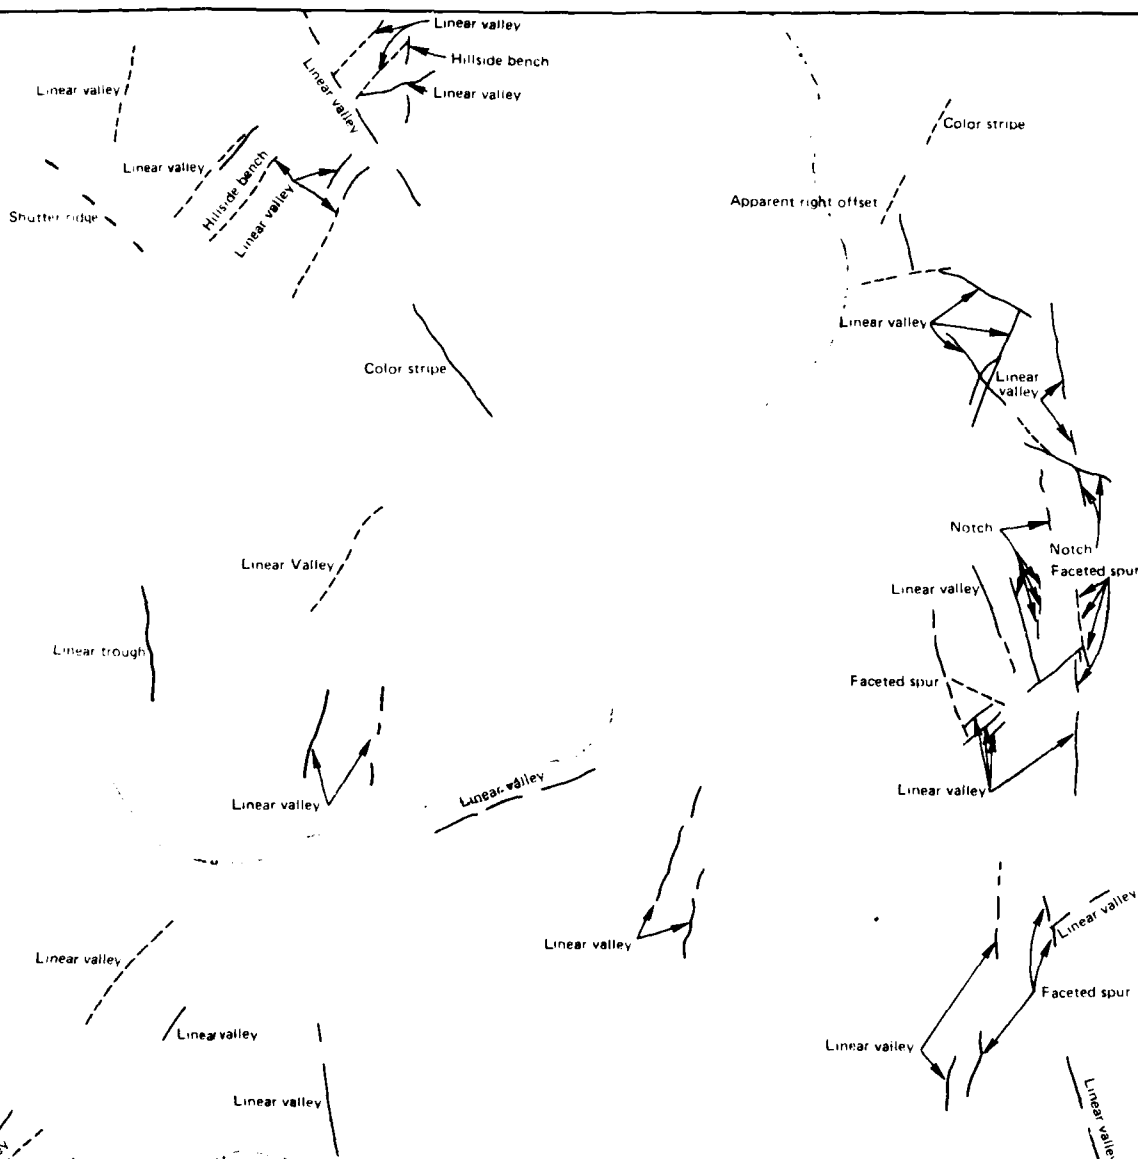
PILOT KNOB QUADRANGLE-NE  
CALIFORNIA-SAN BERNARDINO CO.

Solid line, field or photogeologic evidence of fault scarps, trenches, sag ponds, or other surface features where noted; queried line, possible interpretations not excluded; dashed line, probable distinctive surficial features of faulting not present; active fault trace concealed by very recent alluvium regarded as approximate; ball on down throw side of relative motion.

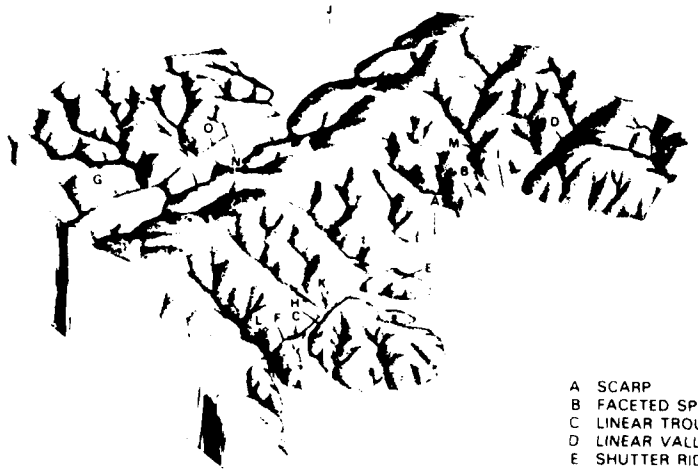
GENERALIZED DIAGRAM OF FAULT FEATURES

- A SCARP
- B FACETED SPUR
- C LINEAR TROUGH
- D LINEAR VALLEY
- E SHUTTER RIDGE
- F NOTCH
- G BENCH
- H OFFSET DRAINAGE CHANNEL
- I SAG POND
- J DEPRESSION (PLAYA BASIN)
- K PONDED ALLUVIUM
- L SPRING
- M OFFSET RIDGE
- N LINEAR RIDGE
- O HILLSIDE VALLEY

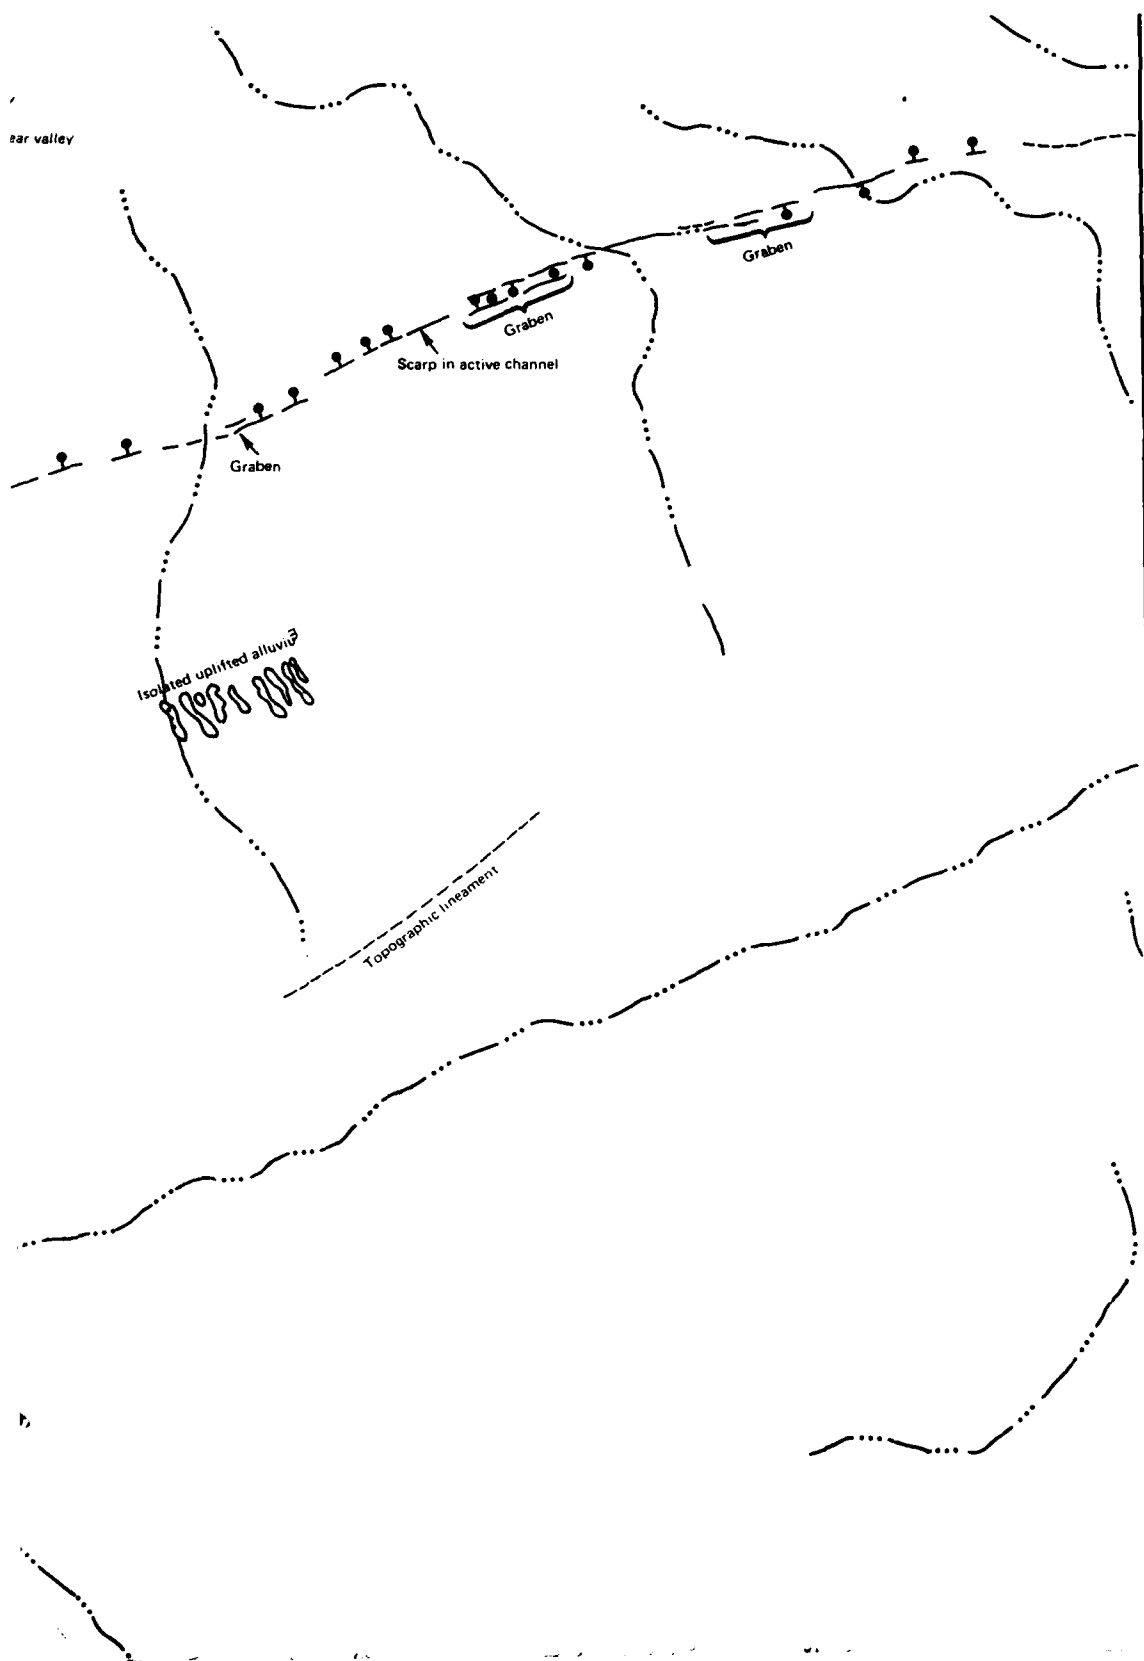
WINDGATE QUADRANGLE-SW  
CALIFORNIA-SAN BERNARDINO CO.

<sup>1</sup>The brief notes along the fault traces indicate locations where the features are clear. Fault trace features are not limited to these localities but are present on the mapped fault lines.
