TECHNICAL REPORT HL-88-5

# OLD RIVER OVERBANK STRUCTURE, LOUISIANA

## Hydraulic Model Investigation

Prepared for US Army Engineer District, New Orleans  
New Orleans, Louisiana 70160-0267

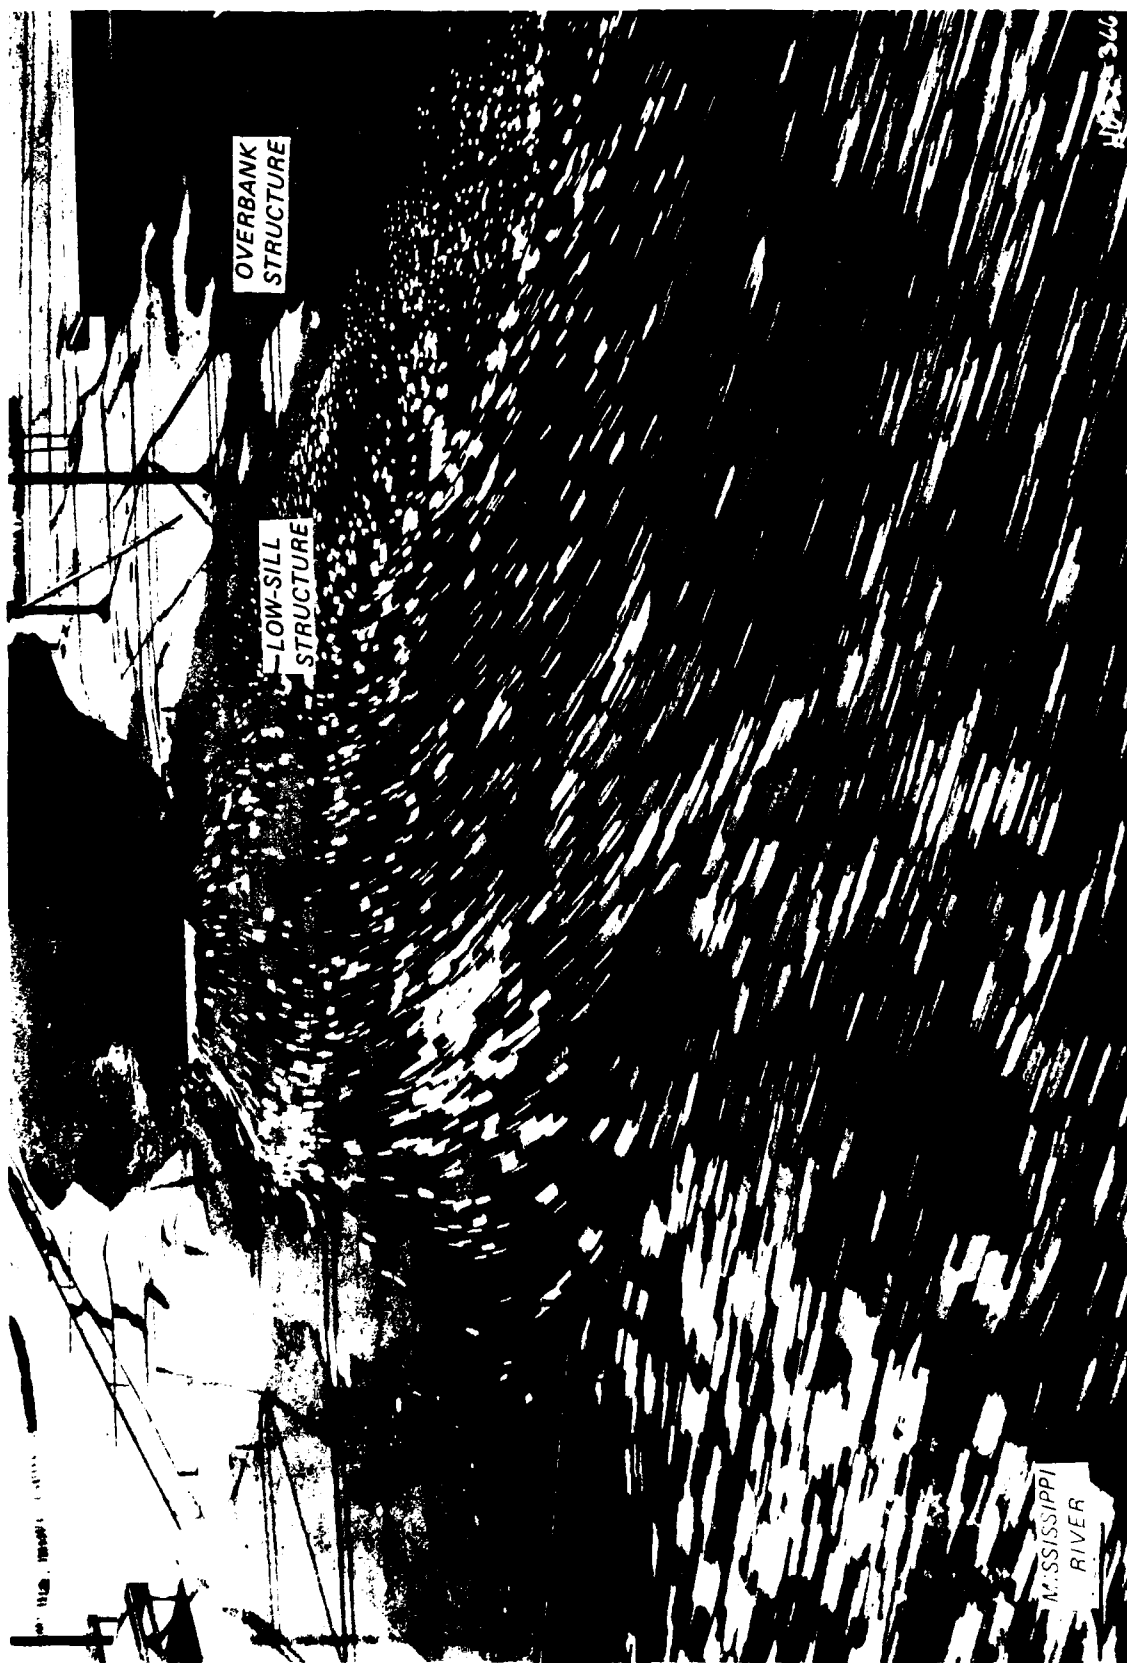
Figure 4. 1:120-scale fixed-bed model

8. Supplementary to the tests conducted in the models described previously, tests were conducted in an existing 1:120-scale general fixed-bed model to investigate modifications to the approach to the overbank structure. This model (Figure 4) reproduced the entire low-sill and overbank structures with portions of the connecting levees and the approach and outflow channels.

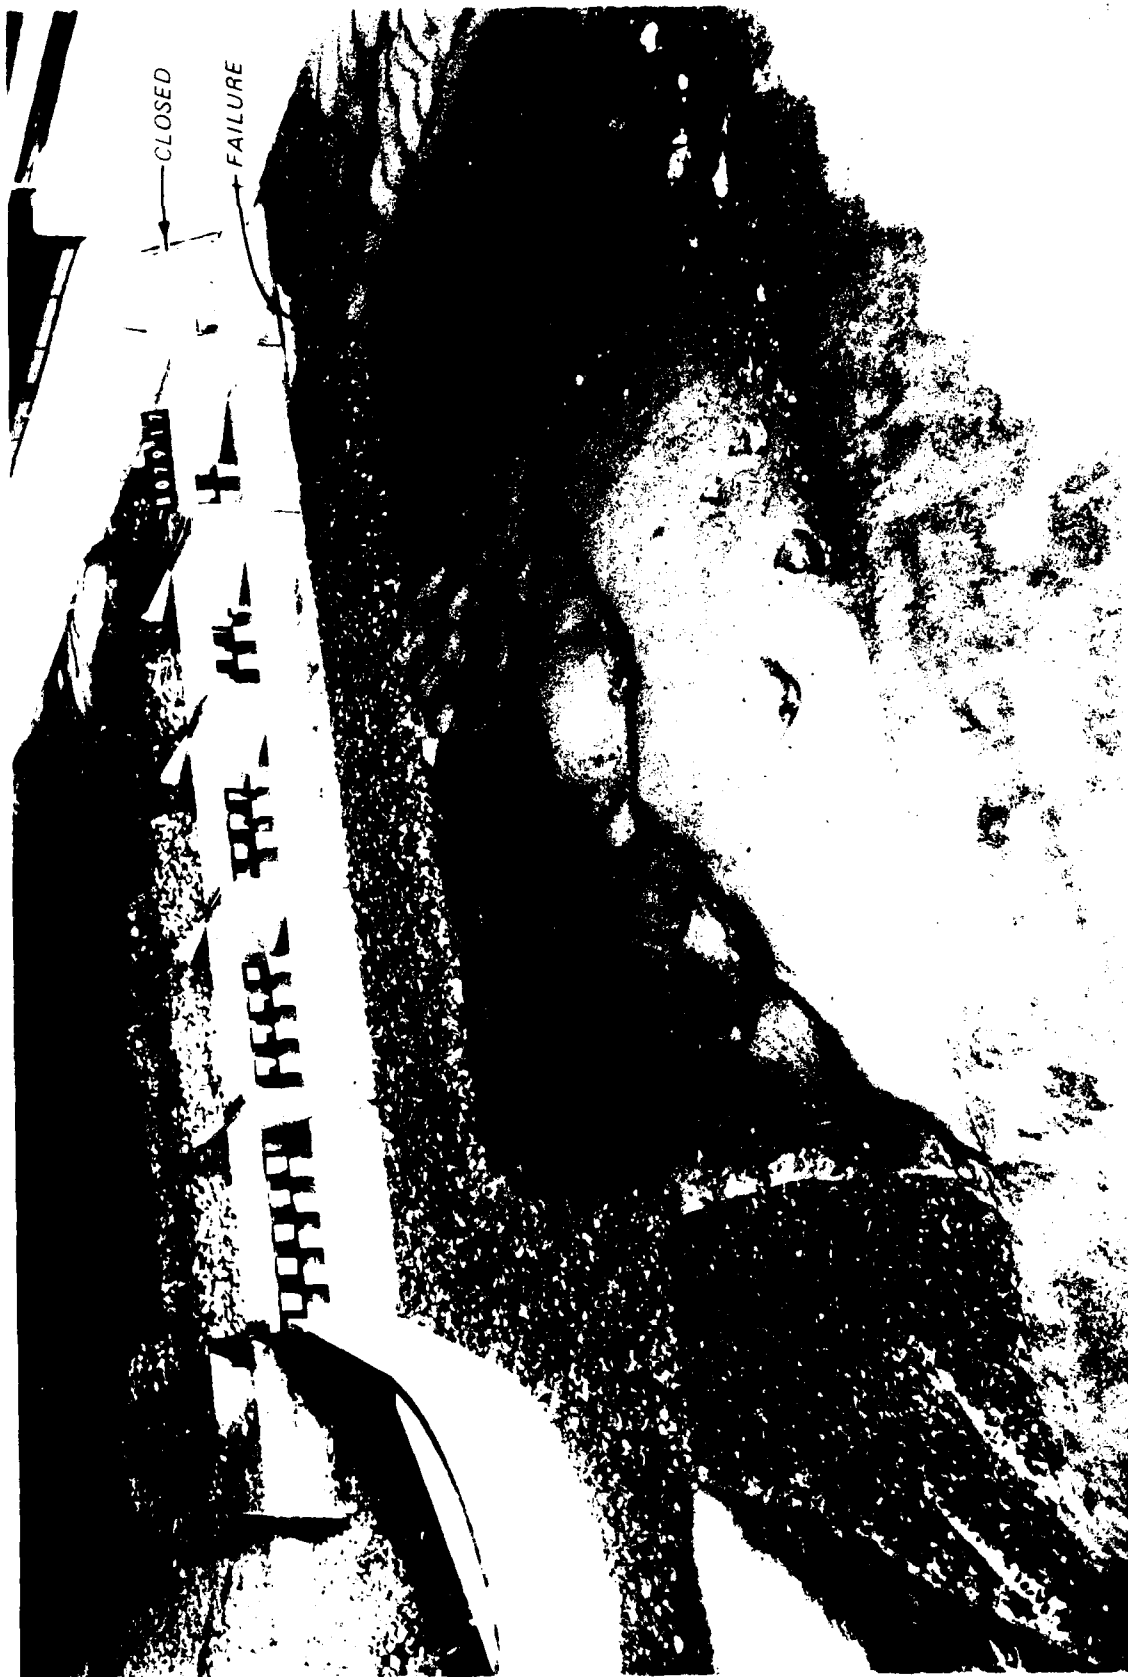
Photo 25. Areas of instability and scour potential, existing upstream riprap, five consecutive bays fully open, headwater el 68.0, tailwater el 56.0
