REPAIR, EVALUATION, MAINTENANCE, AND  
REHABILITATION RESEARCH PROGRAM

TECHNICAL REPORT REMR-CO-5

STABILITY OF DOLOS OVERLAYS FOR  
REHABILITATION OF DOLOS-ARMORED  
RUBBLE-MOUND BREAKWATER AND JETTY  
TRUNKS SUBJECTED TO BREAKING WAVES

Robert D. Carver, Brenda J. Wright  
Coastal Engineering Research Center

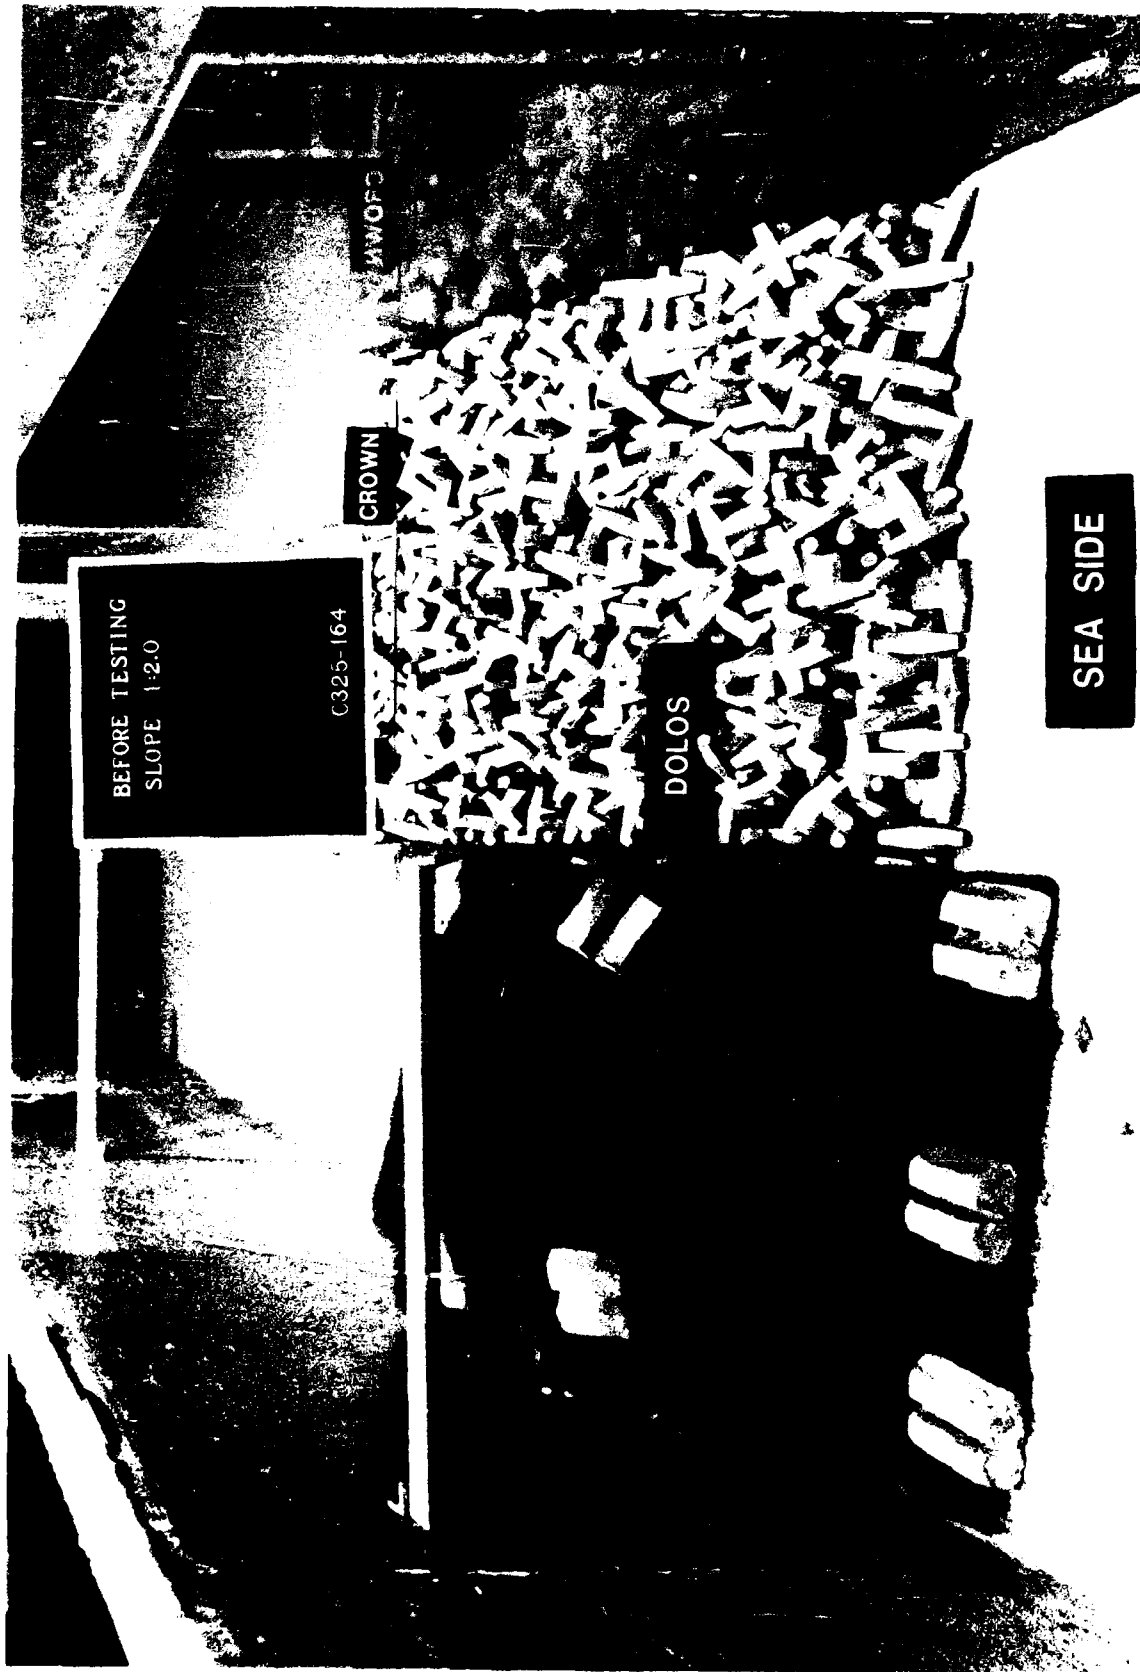
Photo 4. Sea-side view of a typical test section before wave attack at a IV-on-2H-sea-side-structure slope;  $W_a = 0.442 \text{ lb}$

17. All stability tests were conducted on sections of the type shown in Figure 1 and Photos 1-4. Sea-side slopes of 1V on 1.5H and 1V on 2H were investigated, while the beach-side slope was held constant at 1V on 1.5H. Heights of the simulated existing structures (prior to placement of the dolos overlays) varied from 1.0 to 1.2 ft. The height necessary to prevent wave overtopping of the existing structure was determined from slopes and estimated water depths and wave heights to be investigated in determining stability coefficients for the dissimilar armor overlays.

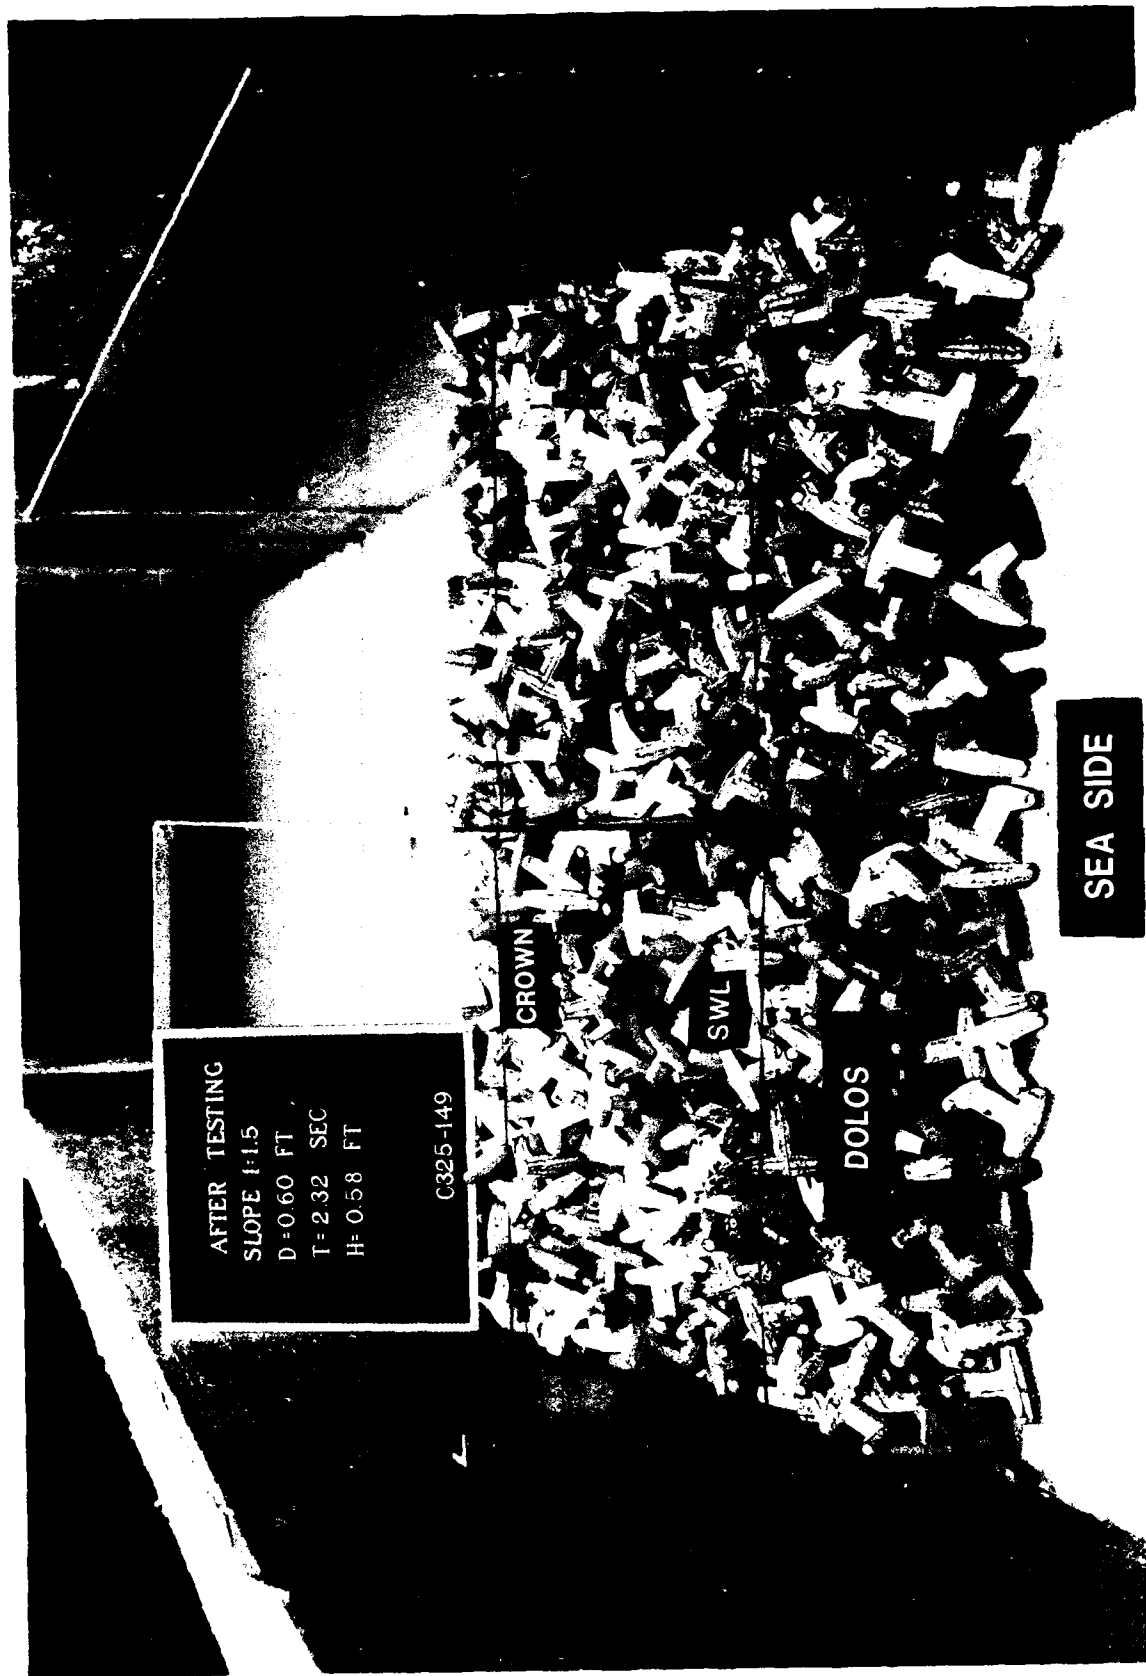
Photo 7. Sea-side view after attack of 2.32-sec, 0.58-ft waves;  $d = 0.60$  ft;  
 $W_a = 0.589$  lb; 1V-on-1.5H-structure slope

Armor units were placed randomly in two layers, and the number of armor units per given surface area was equal to that presently recommended for new construction in EM 1110-2-2904 (Headquarters, Department of the Army 1986). Photos 5-20 show typical after-testing conditions of the structures.

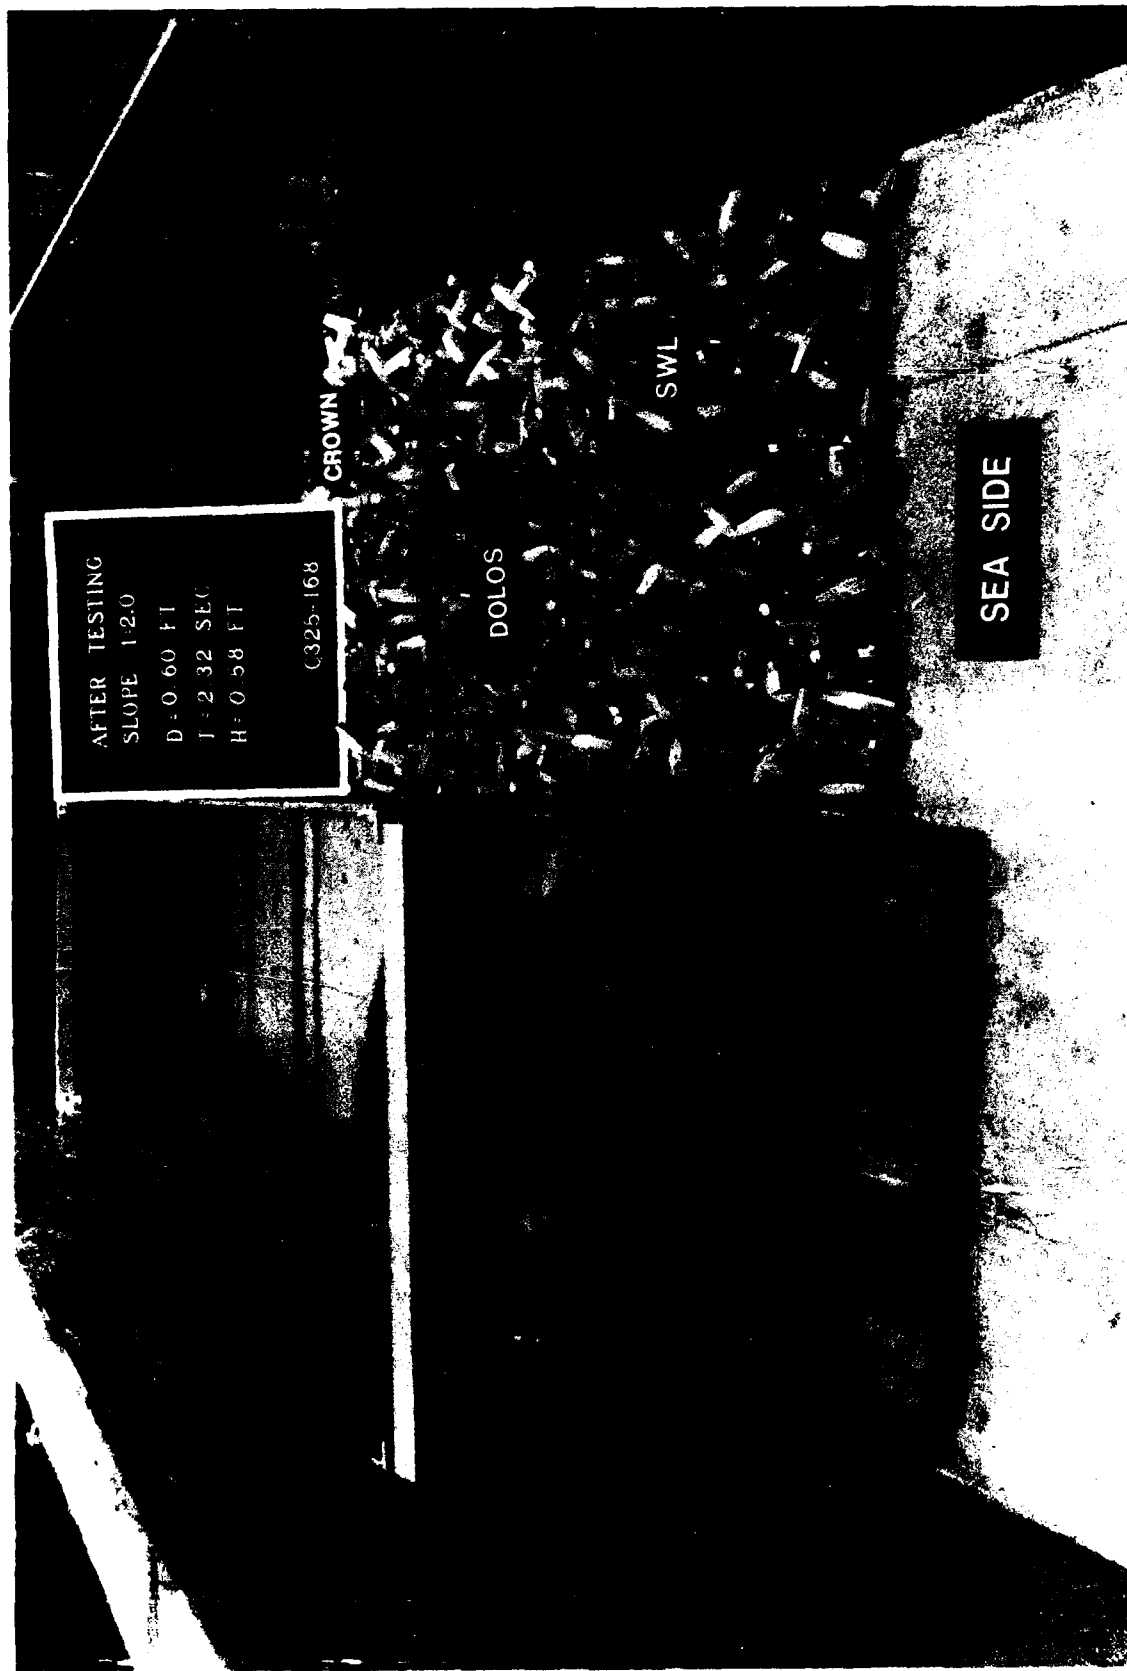
Photo 13. Sea-side view after attack of 2.32-sec, 0.58-ft waves;  $d = 0.60$  ft;  
 $W_a = 0.442$  lb; 1V-on-2H-structure slope

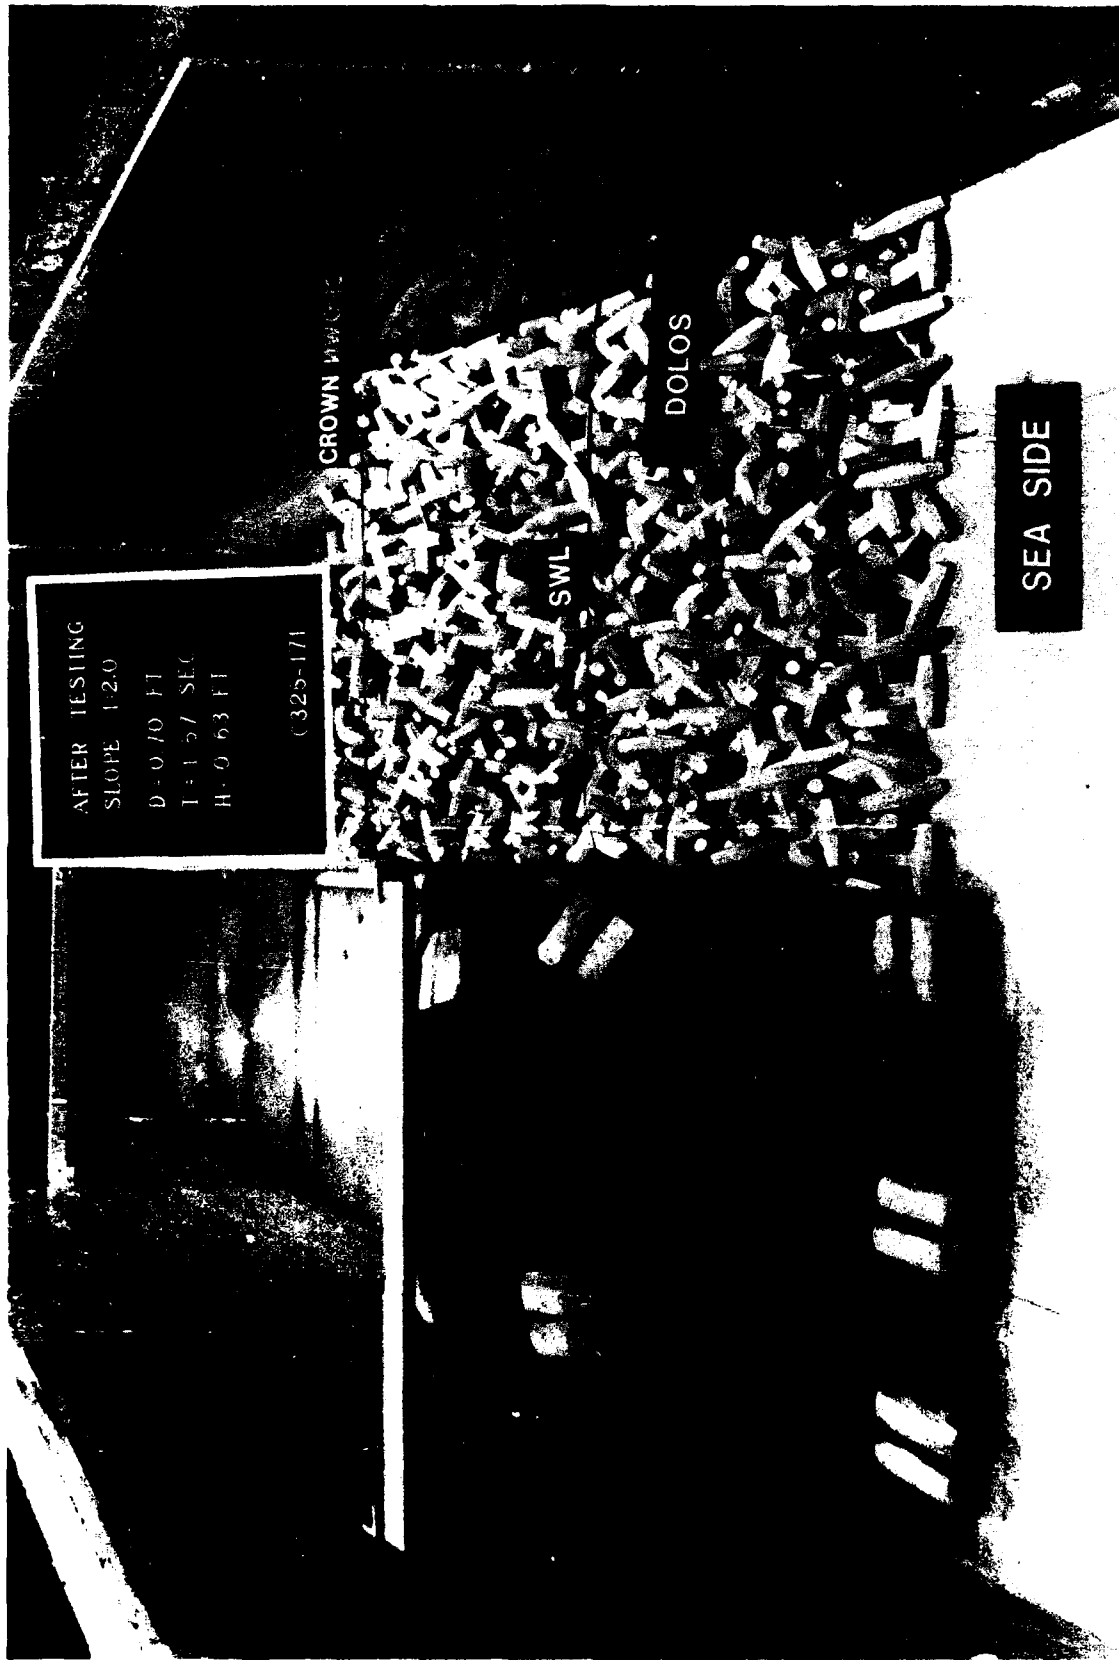
Photo 15. Sea-side view after attack of 1.57-sec, 0.63-ft waves;  $d = 0.70$  ft;  
 $W_a = 0.442$  lb; 1V-on-2H-structure slope
