ANALYSIS OF BANK STABILITY IN THE DEC WATERSHEDS, MISSISSIPPI

Final Technical Report

Colin R. Thorne

May 1988

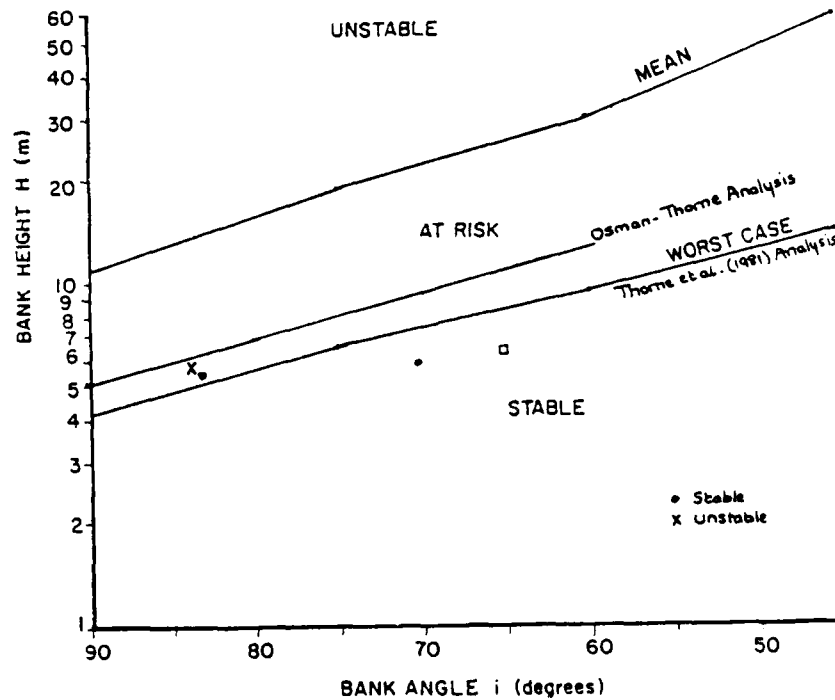
Figure 11 Bank Stability Chart for Johnson Creek at Tommy Florence Site, section 4 (Site 3 in this study)

4.4.3 Bank Stability at Johnson Creek Site:- In the 1981 study (Thorne et al., 1981) detailed strength measurements were made at the site on Johnson Creek. The data were used to produce the stability chart shown in Fig. 11.

to produce the line of limiting stability shown in Fig. 11. The data points corresponding to the banks surveyed in 1981 and in this study have been added to Fig. 11. The Osman-Thorne line of limiting stability in Fig. 11 is close to that from the Thorne et al. report and is in reasonable agreement with the observed condition of the banks, which of marginal stability.
