| MEMS-ACL-11 | | AFOSR-TR. 88-0769 | |
| Fundamentals of Interfacial Strength in Composite Materials | | | |
| A.W. Thompson, I.M. Bernstein, A. Voelkel | | | |

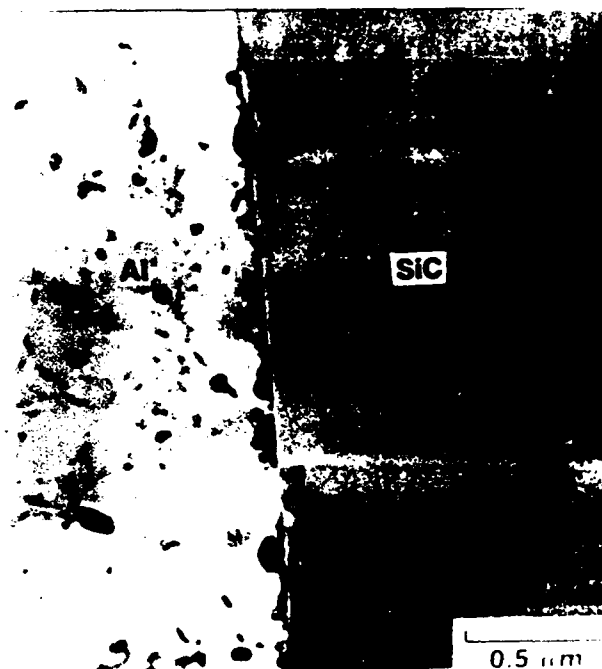
Figure 9. TEM micrograph showing  $\eta(\text{MgZn}_2)$  precipitates at the SiC particulate/MB78 matrix boundary in the T7X3 (over-aged) condition (from Lewandowski, Liu and Hunt, *Microstructural Effects on the Fracture Micromechanisms in 7xxx Al P/M-SiC Particulate Metal Matrix Composites*, Alcoa Laboratories Technical Report, June 19, 1987)

Precipitation occurs at the SiC particle/matrix interface in the over-aged condition for 7090-SiC<sub>p</sub>, and most likely for 6061-SiC<sub>p</sub>. This leads to more particle decohesion from the matrix during failure. In the over-aged condition, the area fraction of cracked SiC particles found on the tensile fracture surface was lower than in either of the other two conditions.
