## COMPOSITE HULL FOR AN AMPHIBIOUS VEHICLE

Design, Fabrication, and Testing of a  
Composite Hull for a Tracked Amphibious Vehicle  
Phase I and II Final Report

August 1988  
Period Covered:  
30 December 1983 - 31 October 1986

Martin Marietta Corporation  
Aero & Naval Systems  
103 Chesapeake Park Plaza  
Baltimore, Maryland 21220

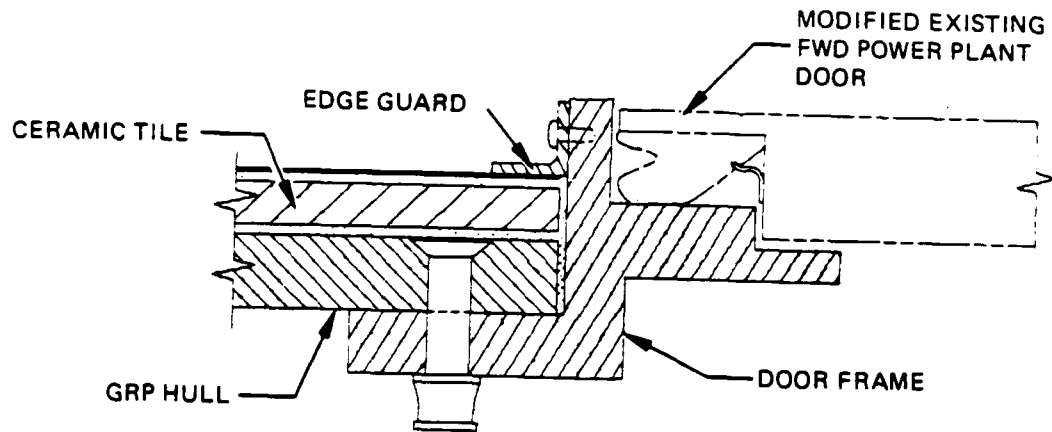
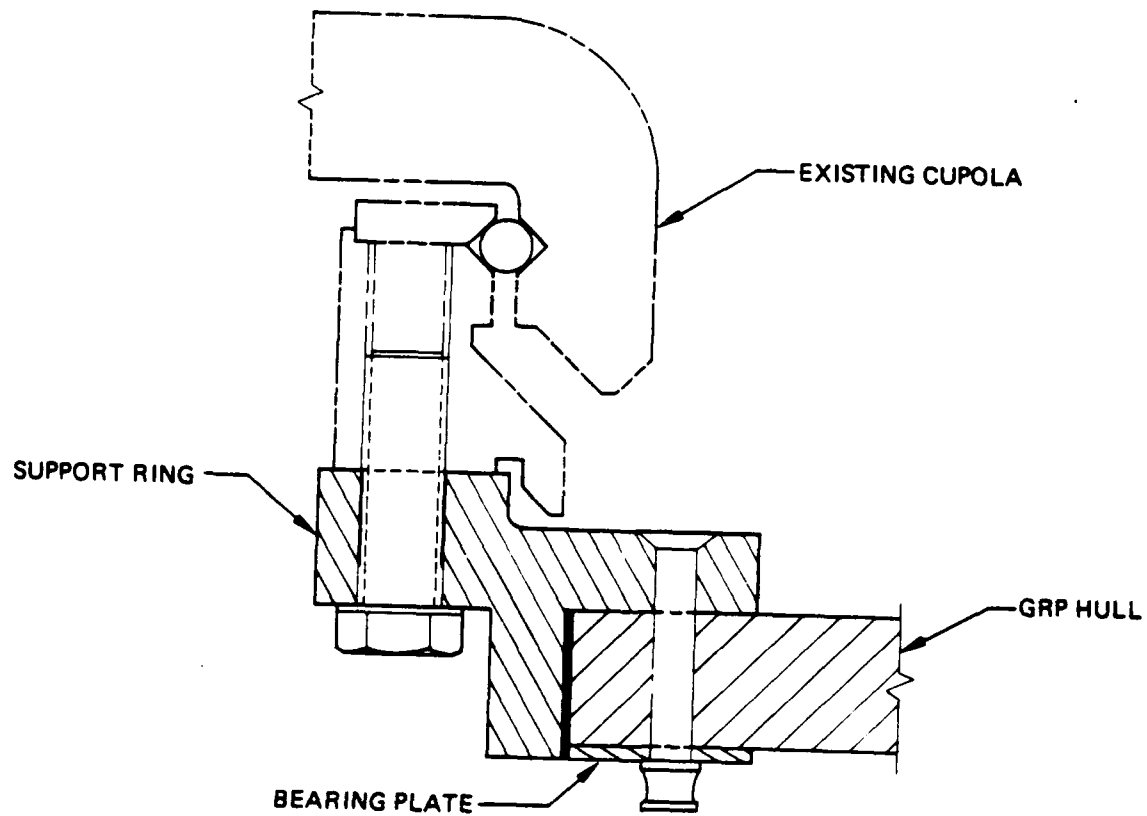
**Figure 2-8. Cross Section of Typical Hull Openings**

**A) POWER PLANT DOOR**

**B) COMMANDER'S CUPOLA**

Other general design features of the final design configuration include: the use of aluminum rings and frames to protect exposed laminate edges from fraying and delamination due to traffic abuse (Figure 2-6), the incorporation of aluminum rub strips to protect the GRP in areas routinely subjected to severe abrasion (e.g., in the track channels -- Figure 2-7), and the complete sealing of edges and joints where the composite material is exposed to severe operational environments.

It is seen that both the rings and the frames are designed to accommodate the thickness variations inherent in the GRP construction by allowing bearing plates or edge guards to move relative to the rings and frames. Vehicle edges are fitted with aluminum guards to protect exposed edges of the ceramic tiles. Typical edge guard installations are shown in Figure 2-8.

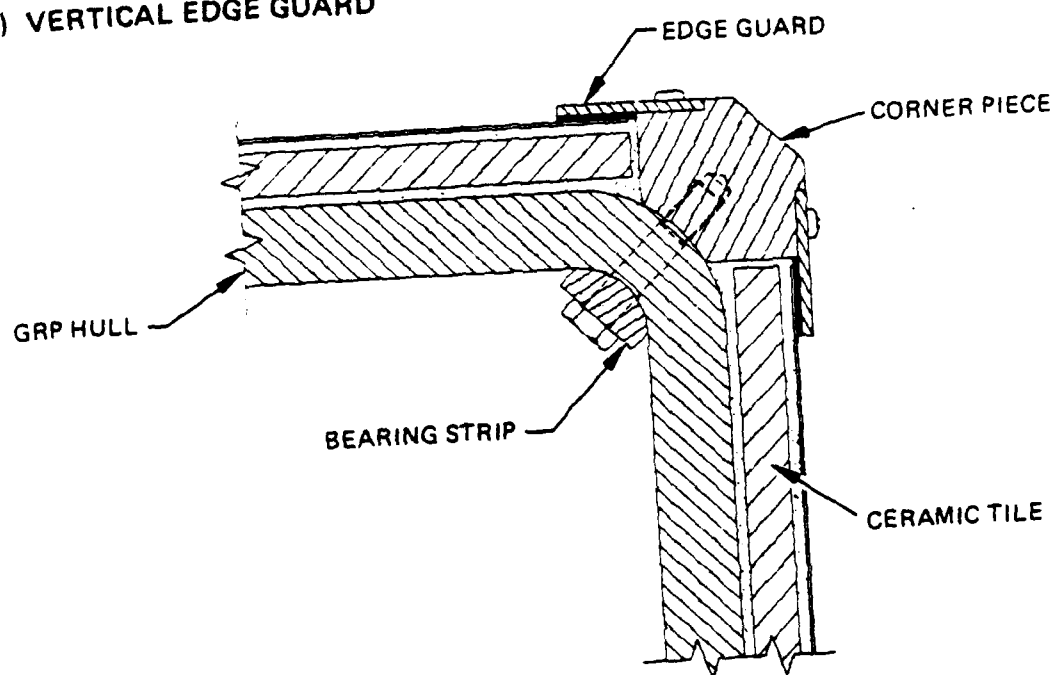
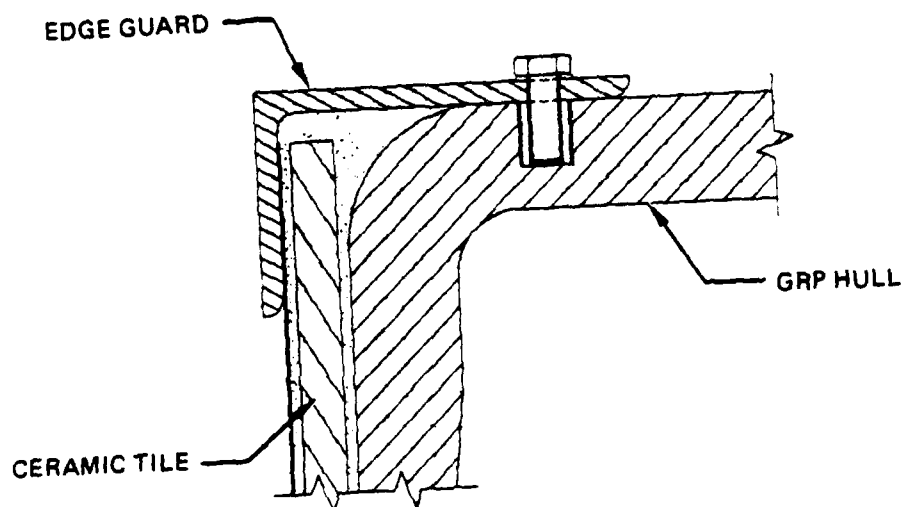
Figure 2-8. Edge Guard Installation

A) VERTICAL EDGE GUARD

B) UPPER EDGE GUARD

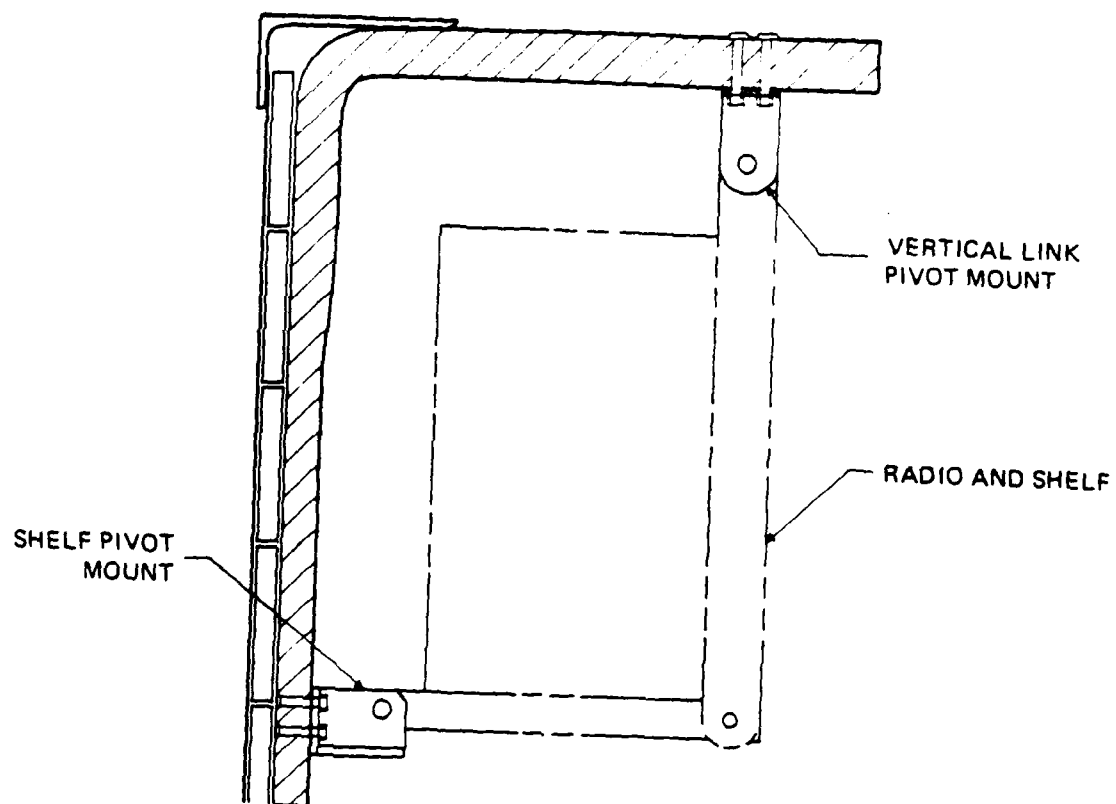
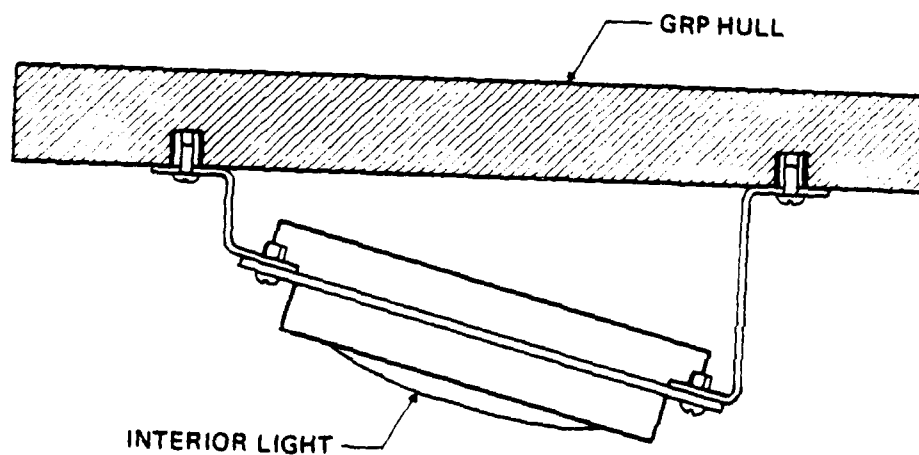
Figure 2-9. Typical Equipment Installations

A) BOLT THROUGH GRP ATTACHMENT

B) BOLT TO GRP ATTACHMENT

The general design approach for this program is to keep attachments identical to those in the existing hull wherever possible (i.e., welded to the lower hull), to bolt through the GRP for upper hull when attachment loads are greater than 20 pounds and to bolt to the GRP hull, using inserts, for loads less than 20 pounds (Figure 2-9), with special consideration being given to lightweight objects which can be unintentionally or routinely used as a hand or foothold. Table 2-1 provides a summary of the selected mode of attachment for the vehicle equipment and controls to be incorporated in the composite vehicle.

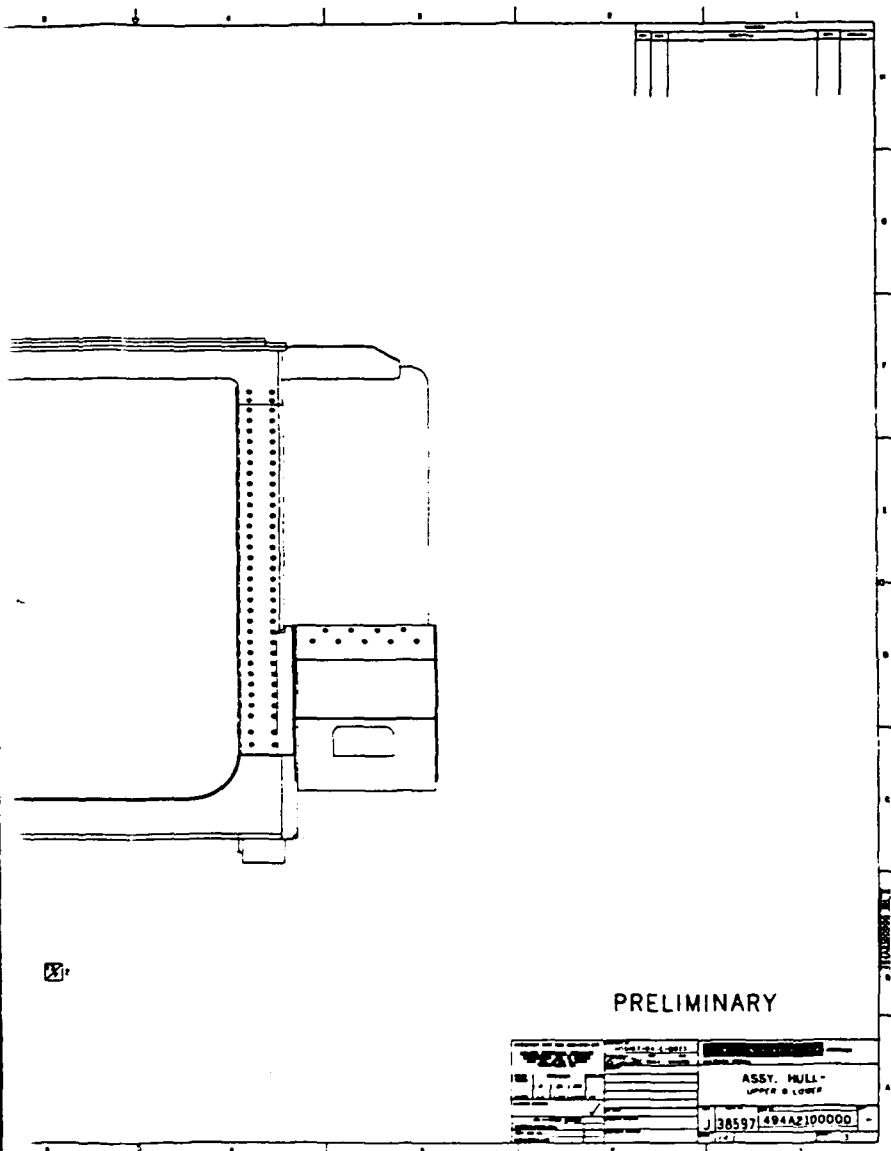
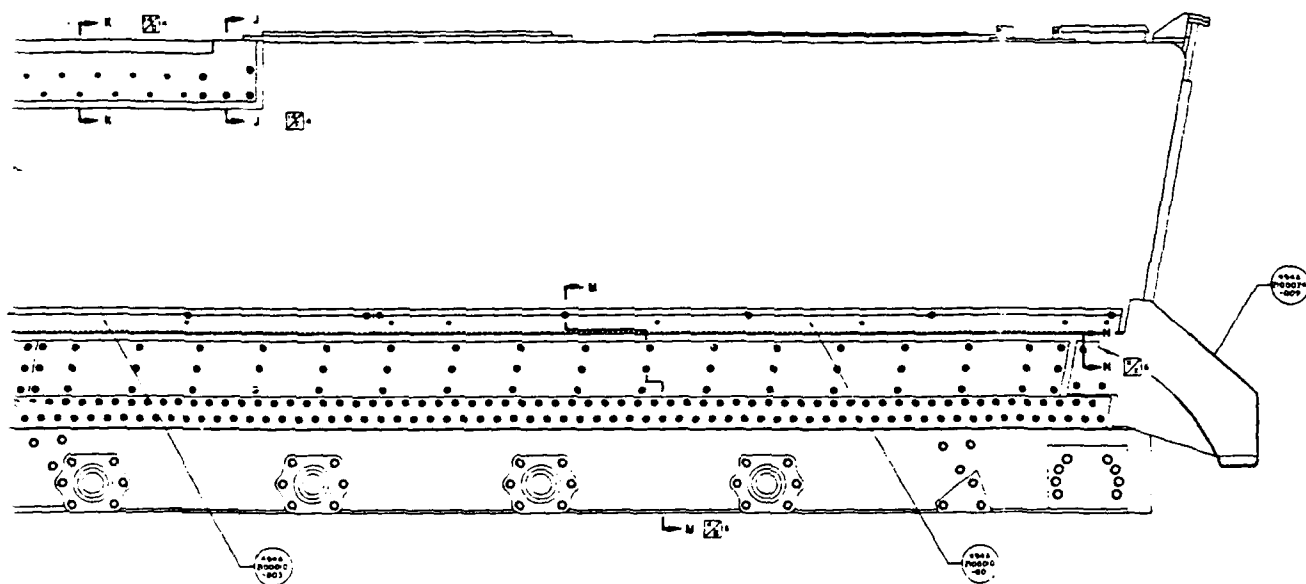
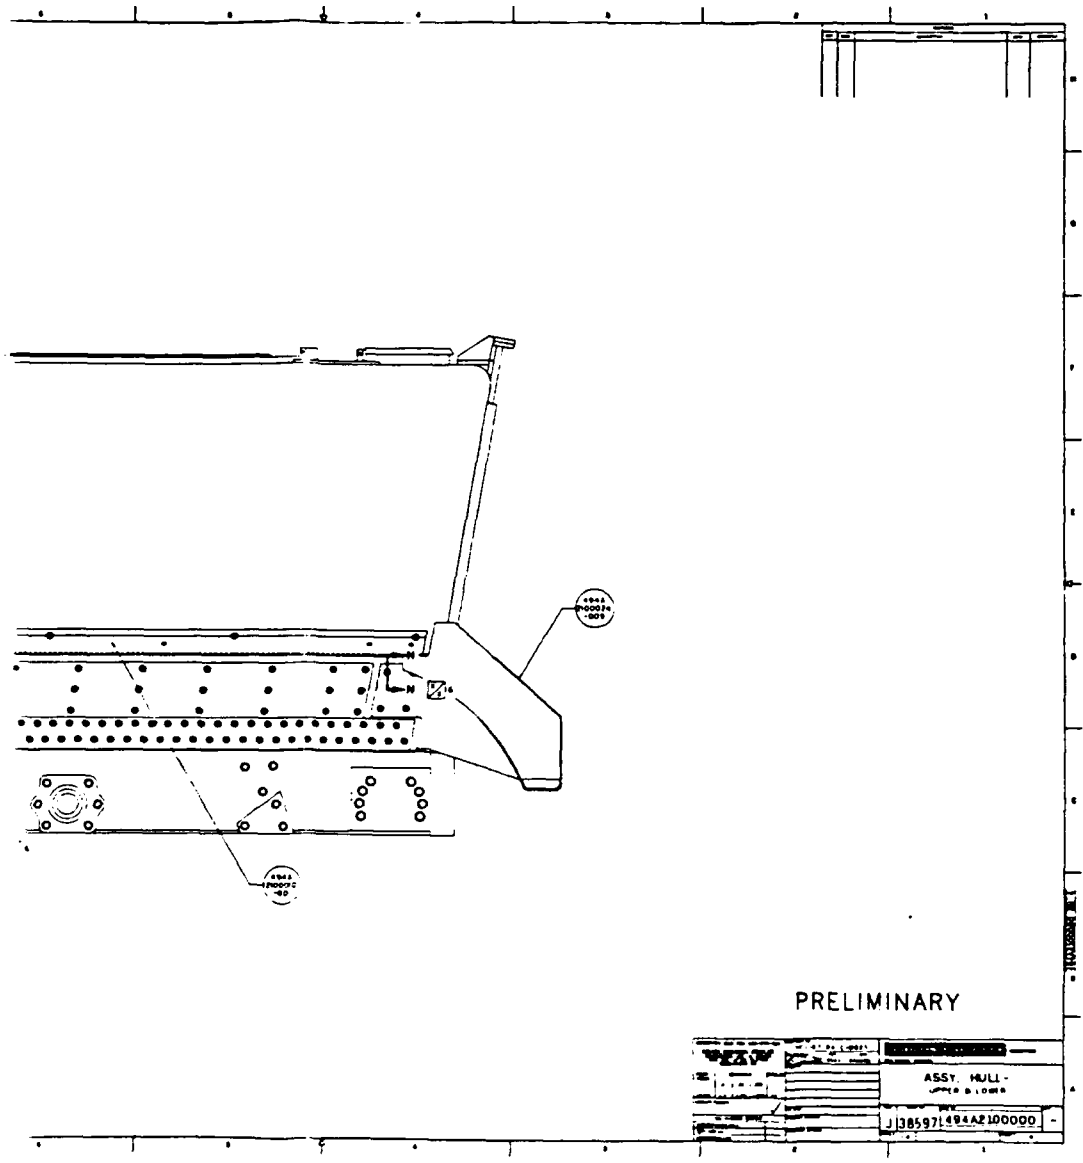
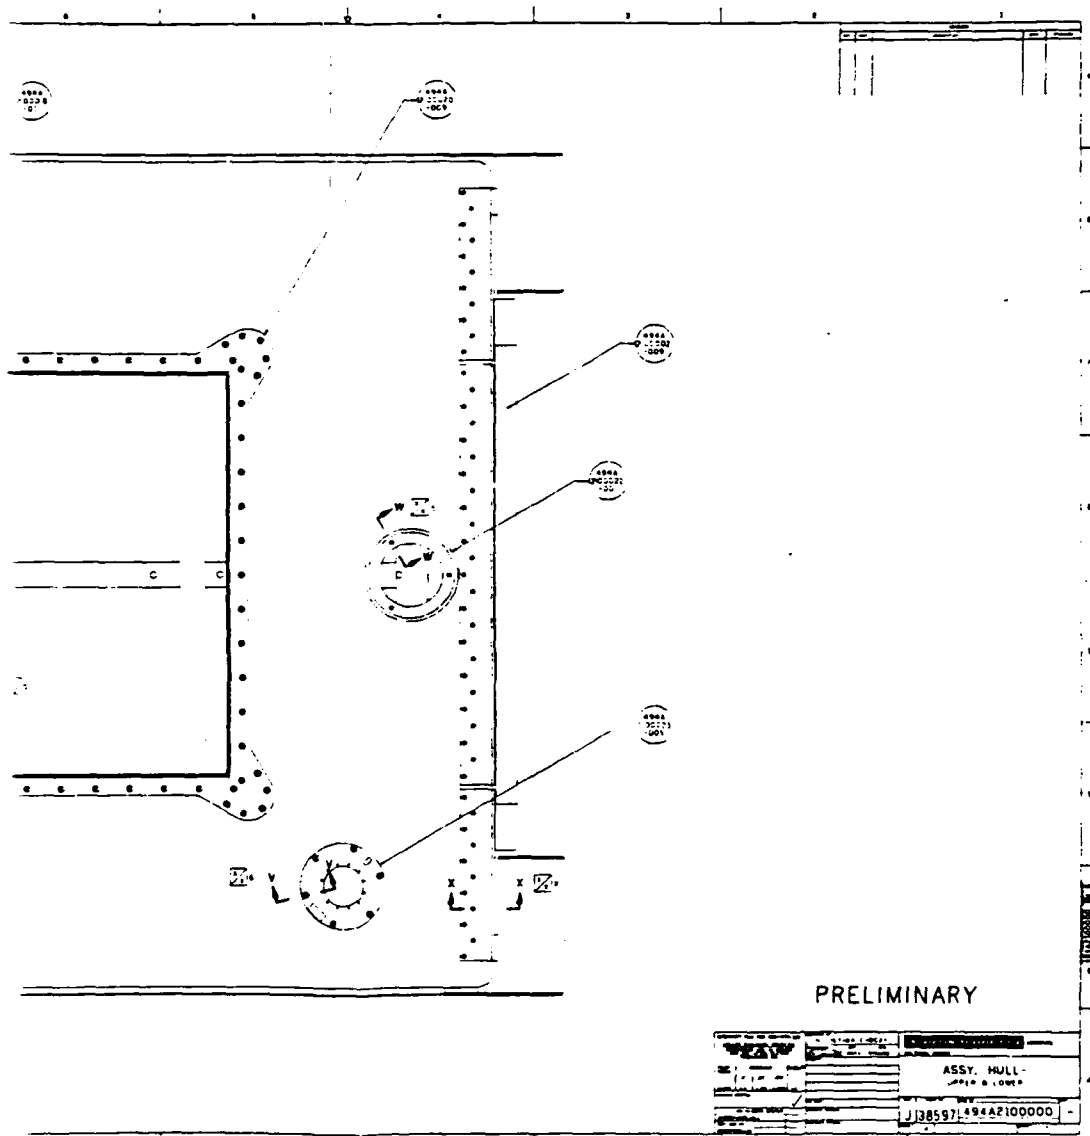
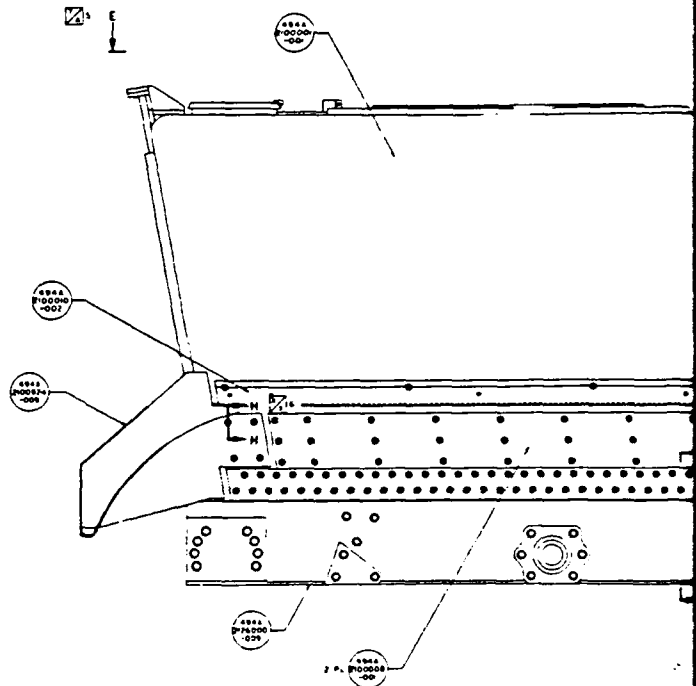
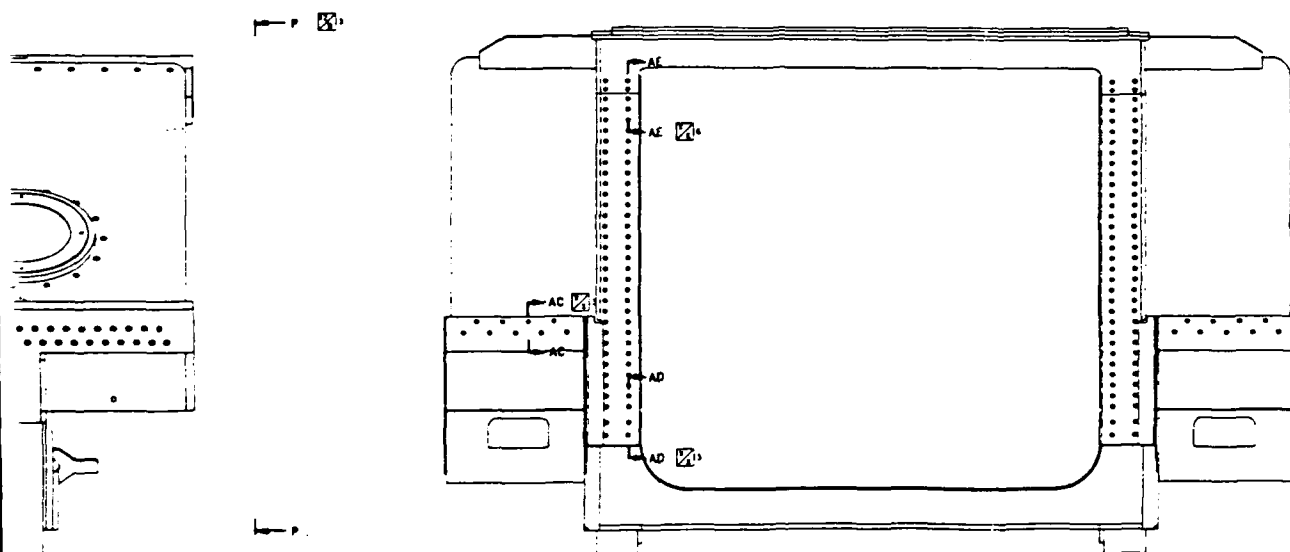
Figure 2-10. Upper and Lower Hull A

Figure 2-10. Upper and Lower Hull Assembly (Continued)

The complete hull assembly is detailed in Figure 2-10.

The GRP hull is shown in Figures 2-1 through 2-10. It is made up of a GRP upper hull attached to an aluminum lower hull. The two are joined by a bolted, bonded joint at water line (WL) 25.5. For structural analysis, a minimum 0.75 inch wall thickness and a 1.25 inch roof thickness were used. "B" Basis allowable stress and stiffness properties were used in the analyses. The allowables were developed from 0° and 90° lamina data. The "SQ5" composite analysis computer code was used to generate laminate properties. The allowable strength for the aluminum alloys used (5083, 5086, and 6061) were obtained from MIL-HDBK-5C. The strengths of screws and bolts were obtained from National Aerospace Standards (NAS) data sheets.

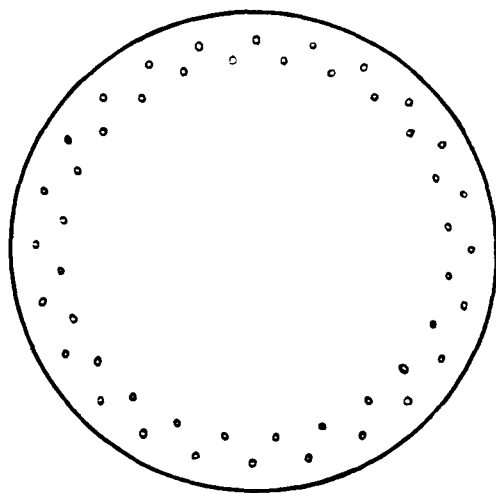
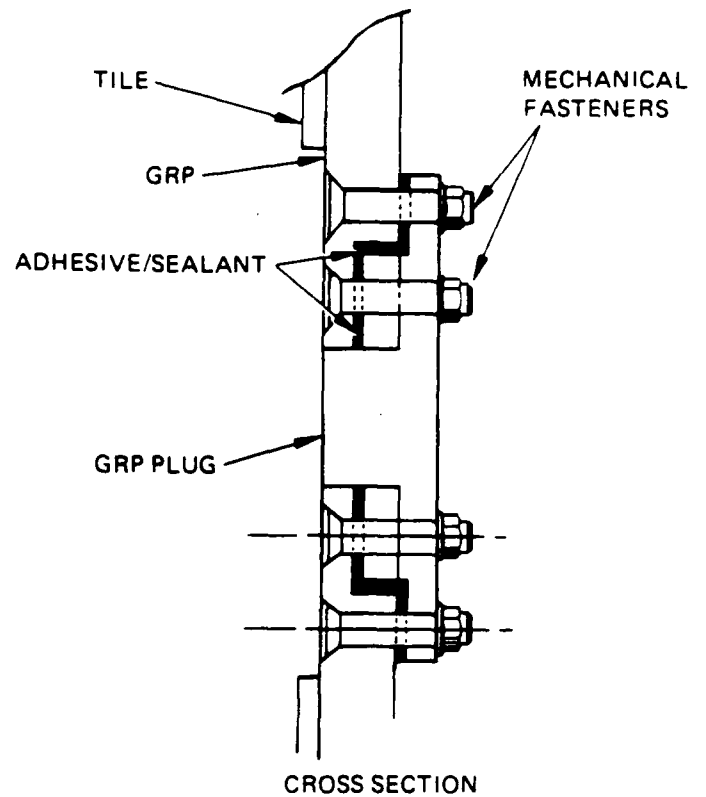
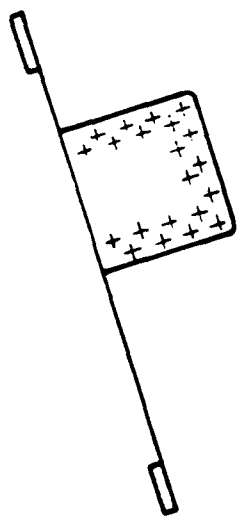
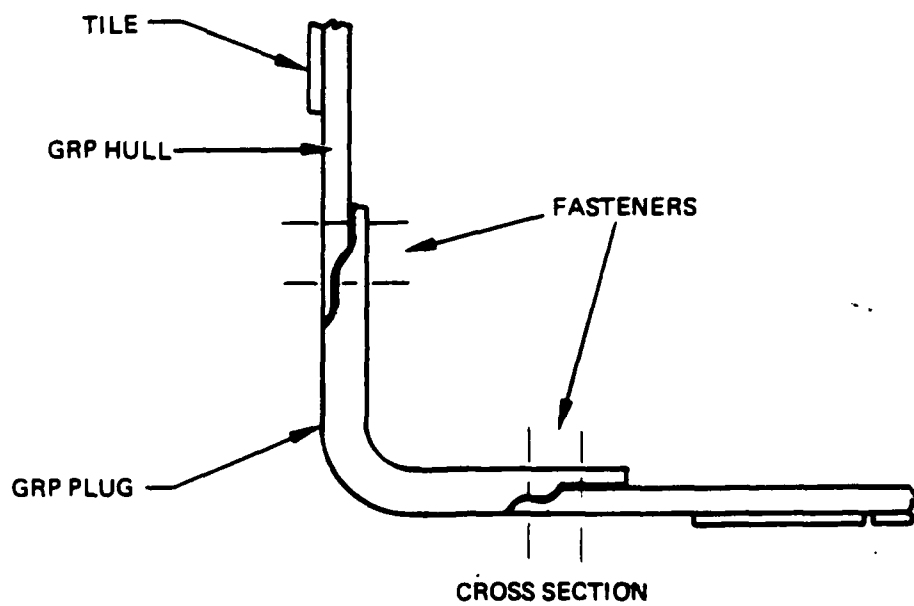
Figure 3-2. Field/Organizational and Depot Level Repair

### A) FLAT SURFACES

TOP VIEW

### B) CORNER REPAIR

SIDE VIEW

The repair procedure recommended for Level II and III repairs is a bolted and bonded patch similar to those illustrated in Figure 3-2. Bonded-only repairs are not recommended because of the uncertainty of being able to clean the damaged laminate well enough to reliably obtain high strength bonds and the time required to process a bonded-only repair. A hull which has been damaged in service will have been exposed to an unknown variety of materials which could impair the strength of a bonded repair. Removing these contaminants completely so that a reliable bond can be obtained between a patch and a hull is very uncertain because cleaning processes must be tailored to specific contaminants. Because of the uncertainty involved in the cleaning process, a bonded and bolted repair procedure is recommended. In this approach all loads are carried by the bolts and the adhesive acts as a sealant and a shim to fill gaps caused by tolerances on the patch and cut out area.

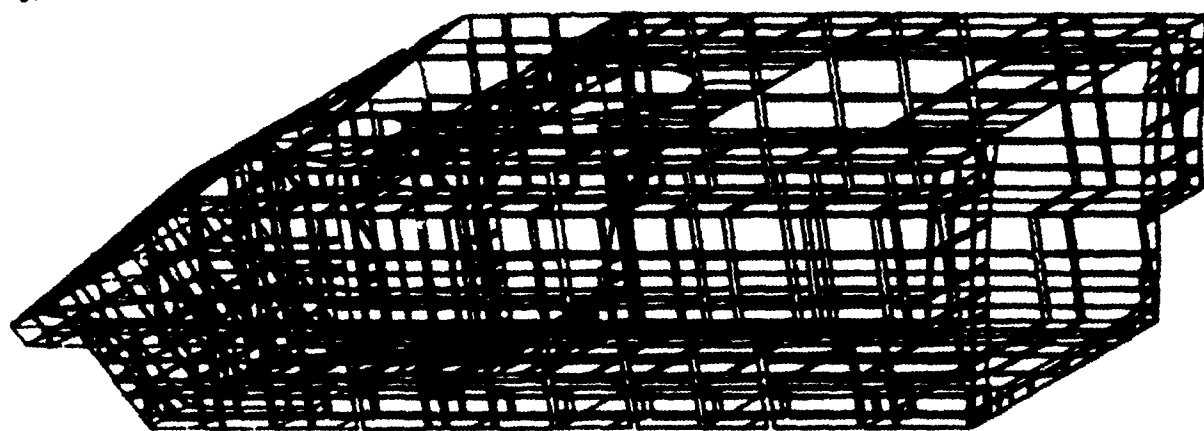
Figure 4-2. Three-Dimensional View of Finite Element Model

8652 DEGREES OF FREEDOM  
1559 ELEMENTS

The M113 hull was modeled primarily with QUAD4 and TRIA3 isoparametric membrane/bending elements. The composite laminate was input through the use of the PCOMP bulk data card. MAT8 cards were used to input the anisotropic material properties of the composite material. The NASTRAN program generates the required PSHELL cards containing the membrane and bending stiffnesses for the plate elements. A total of 1303 QUAD4 and 120 TRIA3 elements were used. CBAR elements were used for the wheel arms and stiffening rings around the cutouts. CONROD elements were used for the tie down and lifting cables. Figures 4-2 through 4-5 outline the FEM elements.

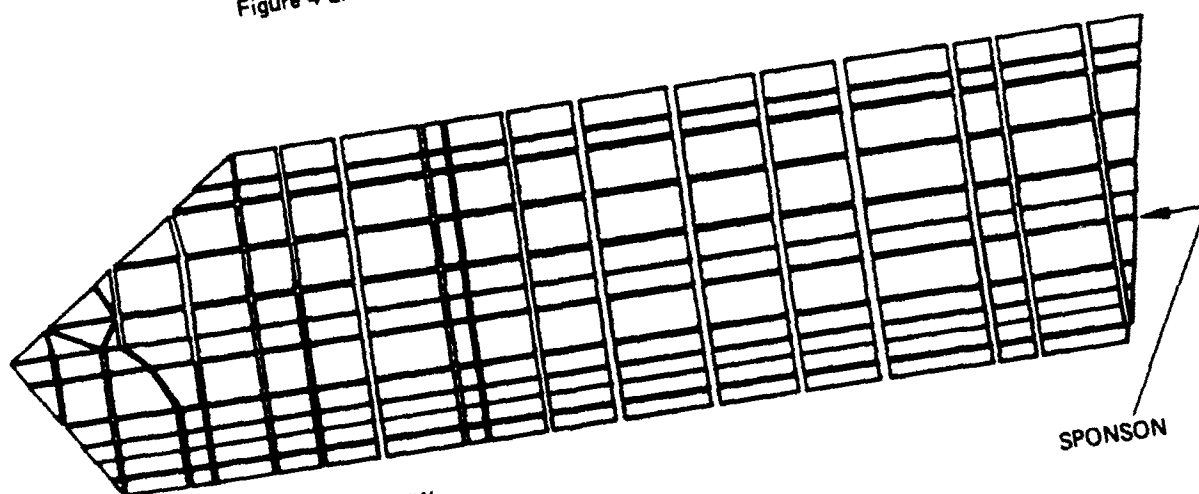
Figure 4-3. Side View of Finite Element Model

LEFT SIDE VIEW  
(RIGHT SIDE, MIRROR IMAGE)

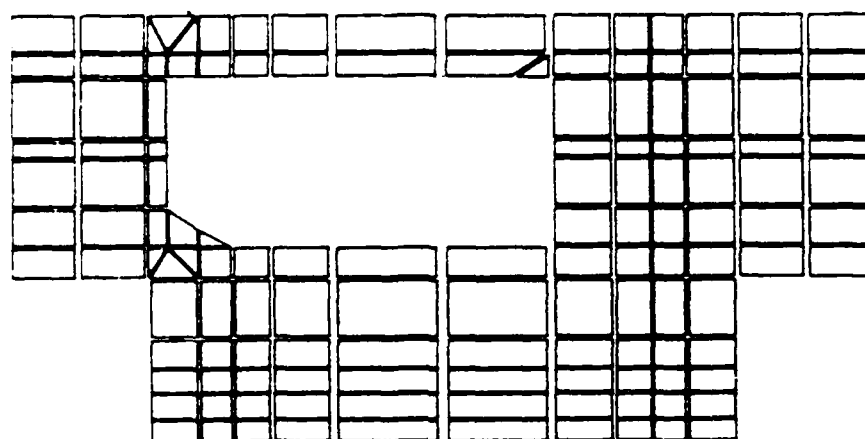
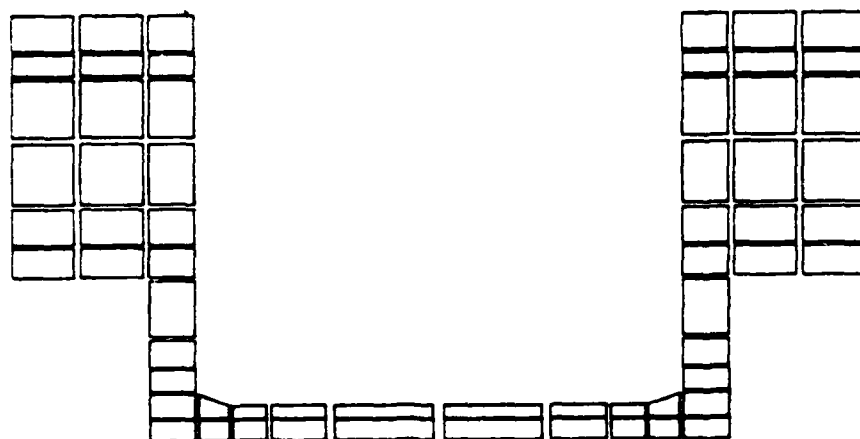
Figure 4-4. Front and Aft View of Finite Element Model

FRONT VIEW

AFT VIEW

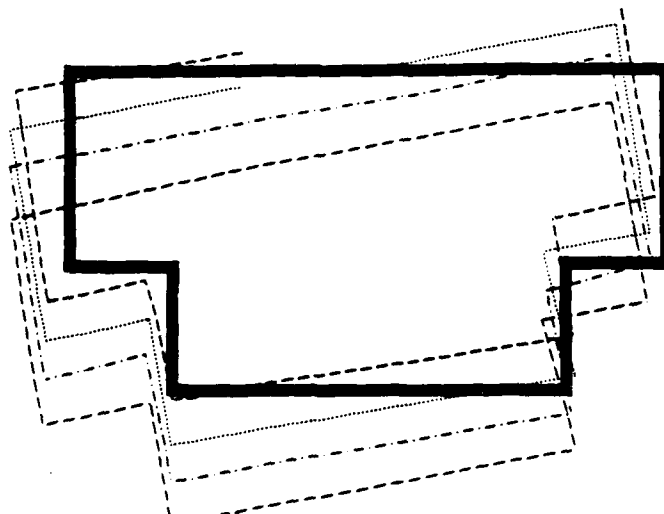
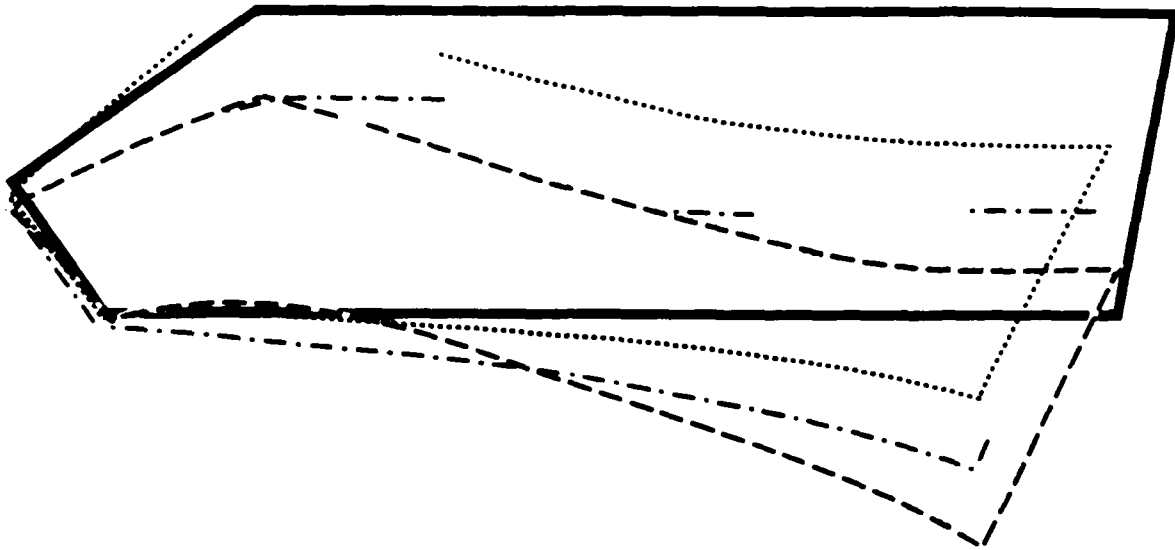
Figure 4-6. Diagonal Support Load Case at -40° F

A) SIDE

BUTT LINE 32.75 ——— 0.1 IN.  
 BUTT LINE 0.0 ..... 0.1 IN.  
 BUTT LINE -32.75 - - - 0.1 IN.

B) FRONT

STATION 28.81 - - - 0.1 IN.  
 STATION 71.37 - - - 0.1 IN.  
 STATION 111.0 ..... 0.1 IN.  
 STATION 162.62 ——— 0.1 IN.

All load cases were plotted to determine the overall deflections of the hull. Cross-sectional plots were made at stations 28.81, 71.37, 111.0, 162.62, and at butt lines + 32.75, -32.75, and 0.0 for the load cases where significant deflections are predicted, see Figures 4-6 through 4-8. The largest deflection was for the diagonal support case

where a maximum deflection of the hull of 4.5 inches is predicted. The maximum relative deflection of the hull was for the rail transport (2g down) load case with a 0.5 inch deflection over 100 inches in the roof forward of the cargo hatch cutout. The maximum relative deflection of the sponson corner area was 0.25 inches for the rail transport (6g forward) load case. Distortion of the engine mounts was also checked. The maximum relative deflections in this area result from the diagonal support load case. The method of engine mounting, using three attachment points, allows rotation of the front mount that will be adequate to isolate the engine from structural deflections.

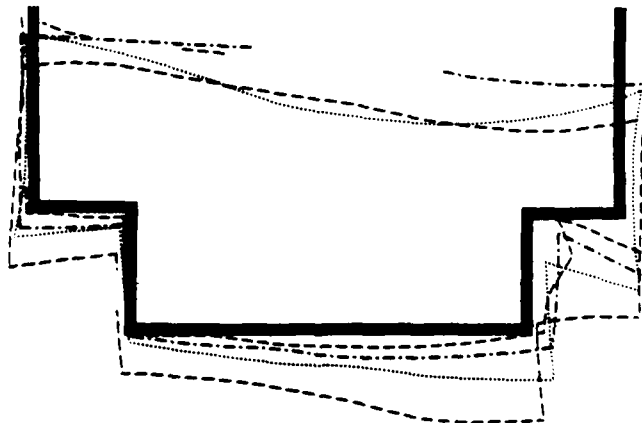
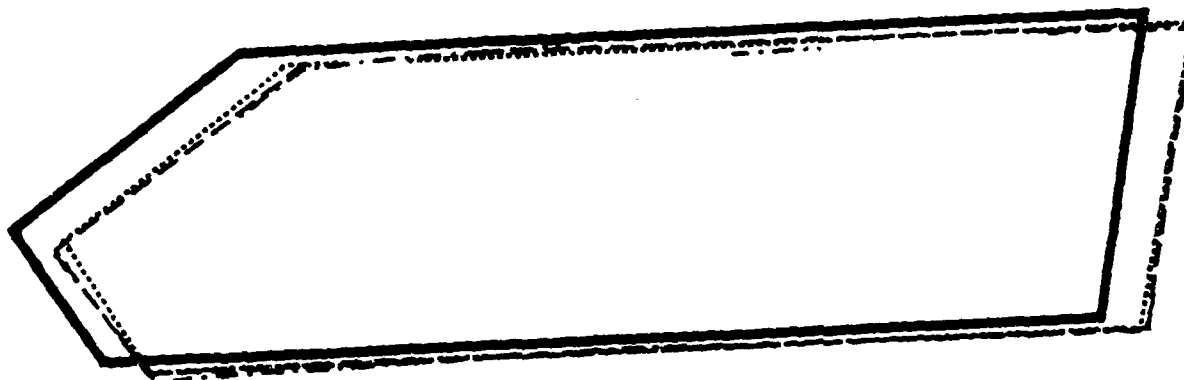
Figure 4-7. Load Case, 50,000 Lbs Applied at Bump Stop at -40° F

A) SIDE

BUTT LINE 32.75 — — 1.0 IN.  
 BUTT LINE 0.0 ..... 1.0 IN.  
 BUTT LINE -32.75 - - 1.0 IN.

B) FRONT

STATION 28.81 . - - 0.1 IN.  
 STATION 71.37 ..... 0.1 IN.  
 STATION 111.0 . - - 0.1 IN.  
 STATION 162.62 . - - 0.1 IN.

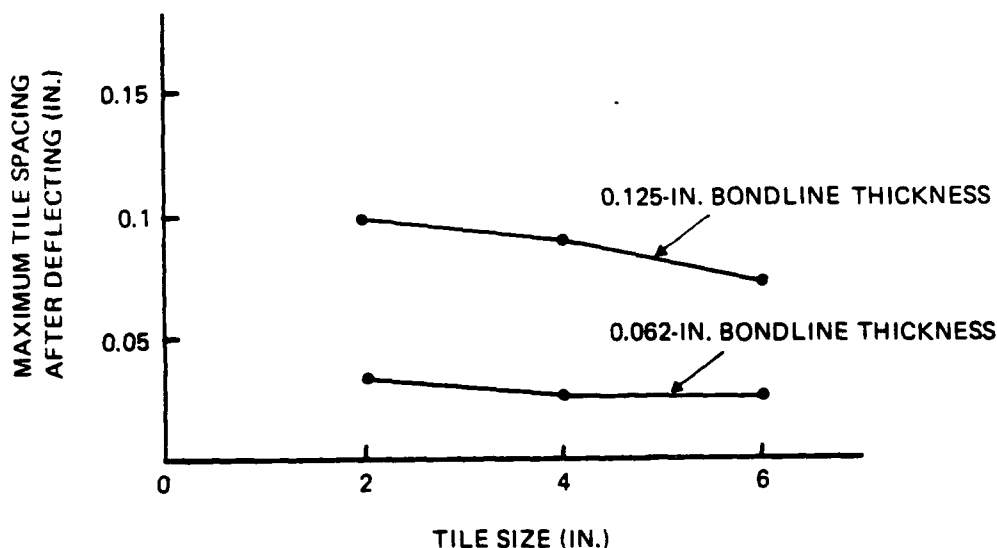
Figure 4-9. Effect of Bondline Thickness on Tile Gap Spacing

Because the tiles are very brittle compared with the composite laminate (i.e., strain allowables of 600 micro inches/inch vs 9400 micro inches/inch), they must be isolated from the structural deflections of the hull. A study was performed using a 2-D finite element model to determine the effect of bondline thickness on tile stress and gap spacing for various size tiles. The results for tile gap spacing shown in Figure 4-9 indicate very little change in tile spacing with a change in tile size. Tile stresses were higher for the 6 inch tile but still below the allowable. From these findings it was apparent that tile size could be selected based on other design criteria. A 4 inch x 4 inch tile was selected for the prototype hull to provide a good balance between the number of tiles required for assembly, tile gap area and tile availability.

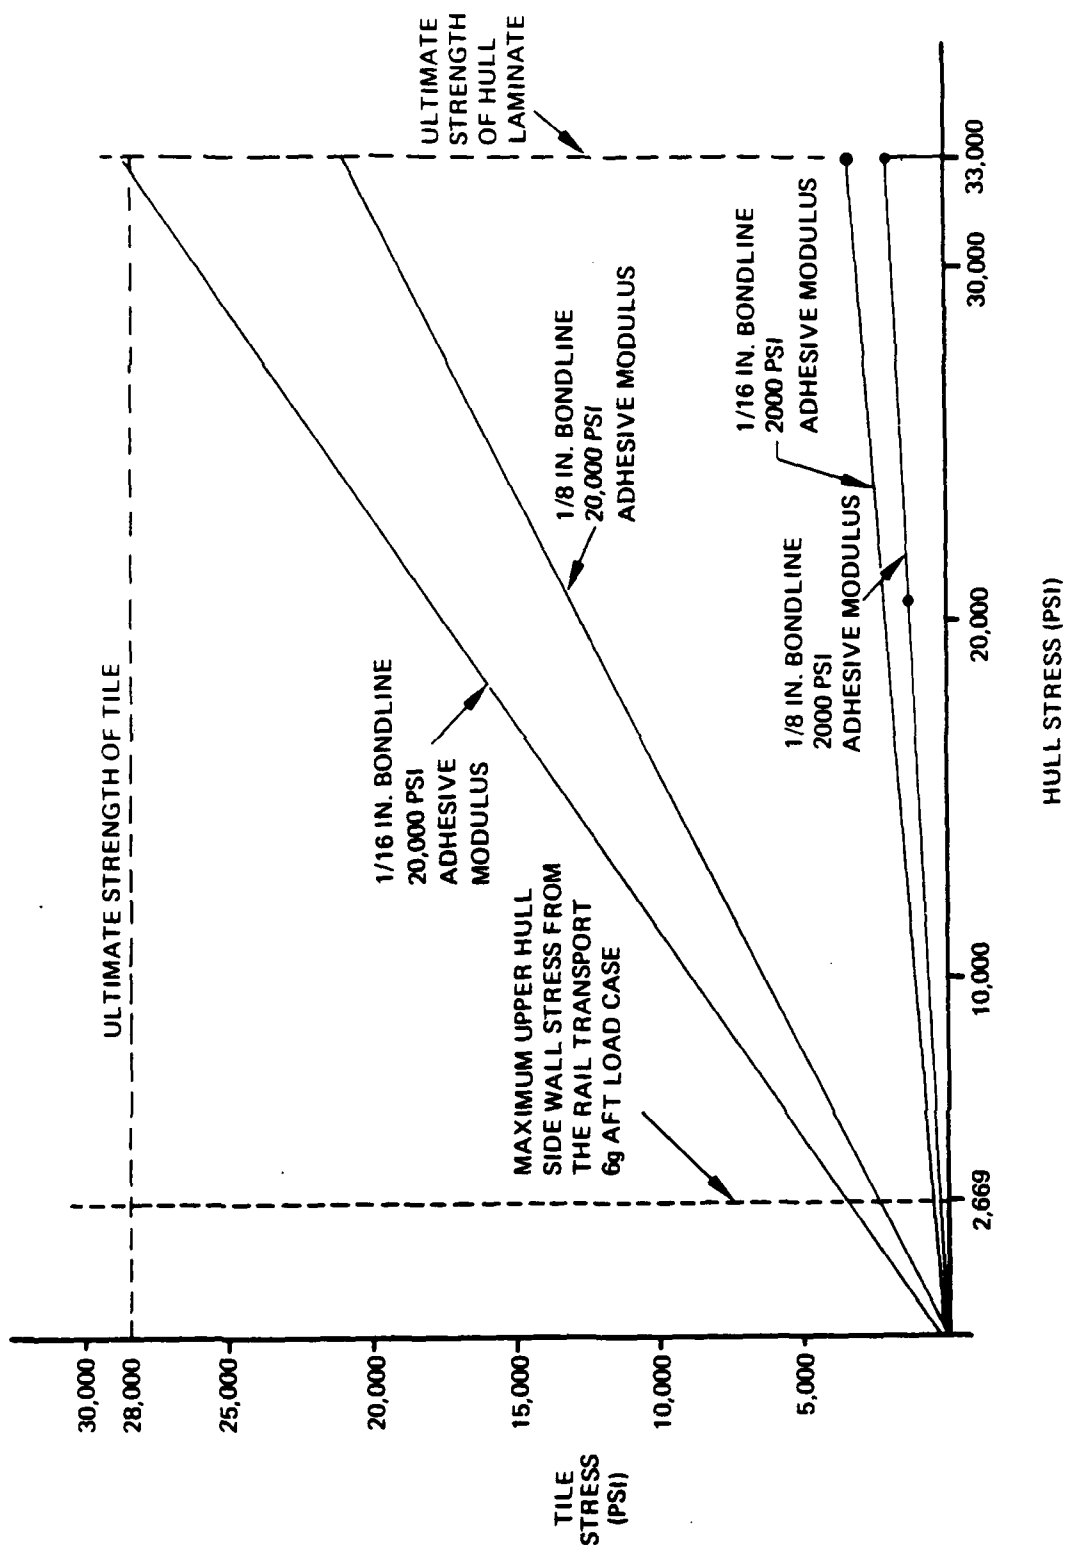
Figure 4-10. Tile Stress - Axial Load

After selection of the 4 inch tile size, further analysis was performed to determine the effects of bondline thickness and adhesive modulus on the tile stresses and change in gap spacing. Figures 4-10 and 4-11 show the effect of bondline thickness and adhesive modulus on tile stress due to axial and bending loads, respectively. Based on these curves a maximum adhesive modulus of 20,000 psi (at the lowest design temperature of -40°F) and minimum bondline thickness of 0.062 inch was selected. These criteria will maintain low tile stresses for all operational conditions as shown in the curves.

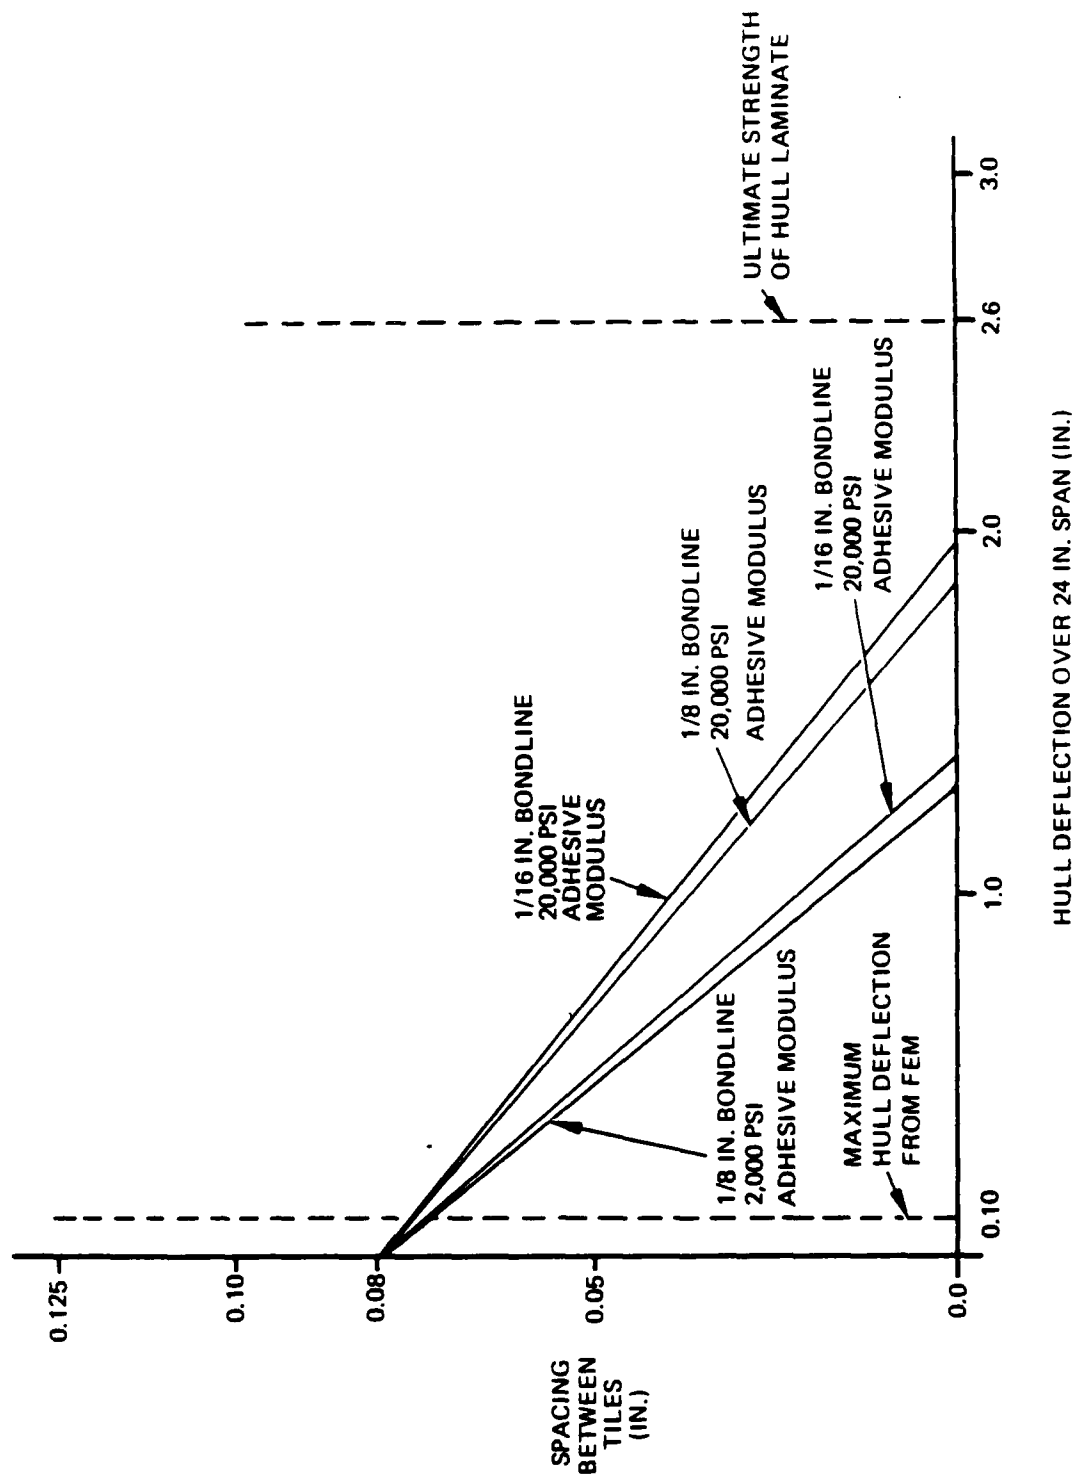
Figure 4-12. Tile Spacing

Figure 4-12 shows the change in tile gap spacing due to bending deflections of the hull. As shown on the curve, the tile gap spacing is expected to change only slightly with the maximum deflections of the upper side wall of the hull. Conservatively, a minimum tile spacing of 0.062 inch was selected based on the expected change in tile gap spacing if the hull were to reach the maximum compressive strain allowable.

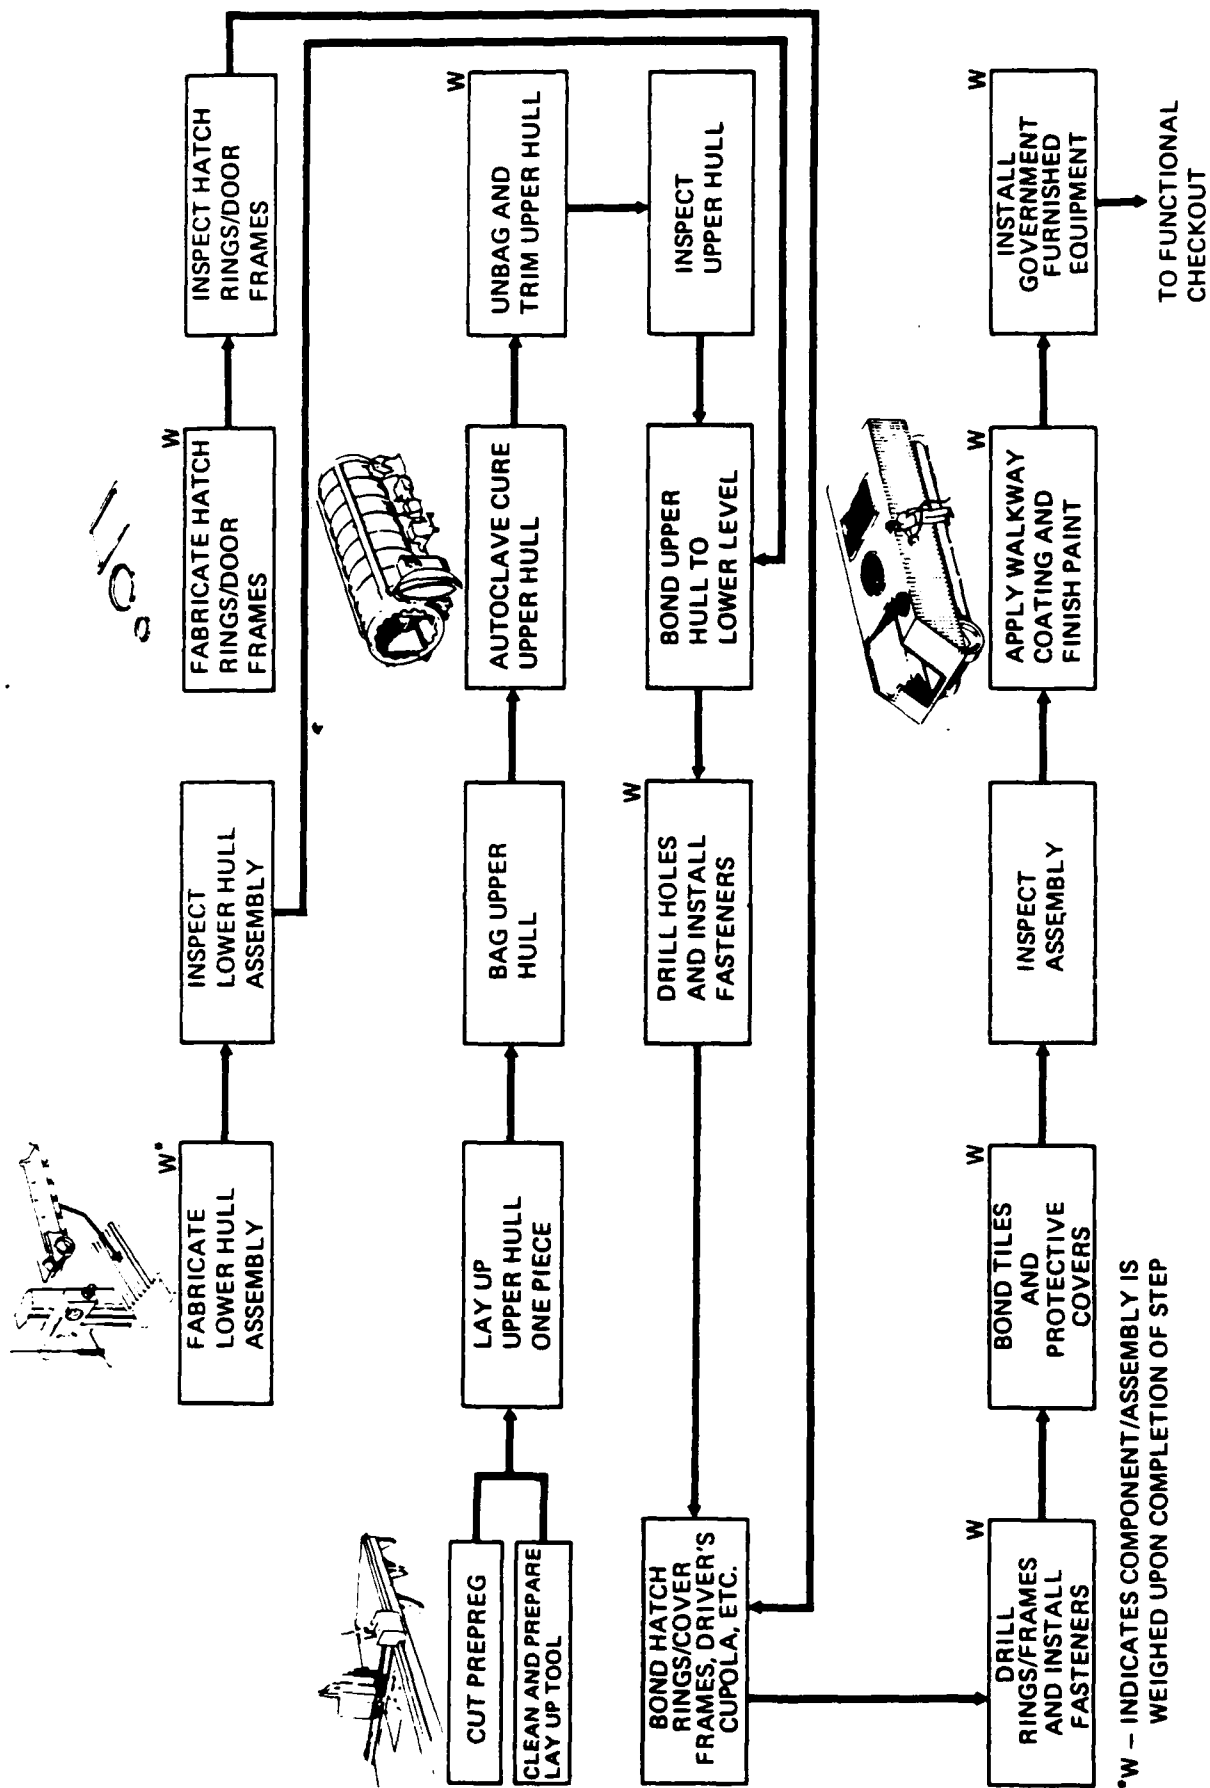
Figure 6-1. M113 Hull Fabrication Flow

The general approach to fabricating the prototype hull is shown in Figure 6-1. The fabrication approach used for the feasibility demonstration hull differed from a production approach only in that hand labor and set up were used in lieu of hard tooling and automated techniques.
